**ABU GHRAIB DAIRY  
ABU GHRAIB, IRAQ**

**SIGIR PA-09-172  
JANUARY 14, 2009**

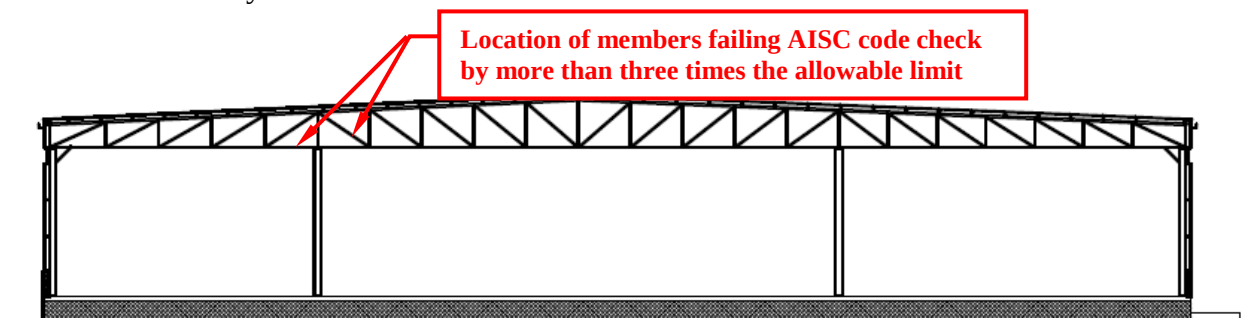
**Figure 2. Primary truss configuration**

- Based on the contractor's calculations, five members of the truss were designated as failing the AISC code check. Two of the members failed the code check by more than three times the allowable limit (Figure 2). Failing by a factor of this magnitude indicates that the members could yield and possibly fracture under the design load.

The contractor's proposed structural design consists of steel columns and continuous truss construction with sandwich panel cladding<sup>18</sup> for the roof and sidewalls. Roof loads are carried by the multi-span steel trusses, which have two configurations. The primary configuration has steel columns supporting the truss at the ends and at approximately one-third span (Figure 2). The columns are centered on a truss panel point (the location of intersecting truss members), which is appropriate. Based upon the contractor's drawings, it appears that the member sizes have been modified to accommodate the stress reversal<sup>19</sup> over only one of the interior columns.

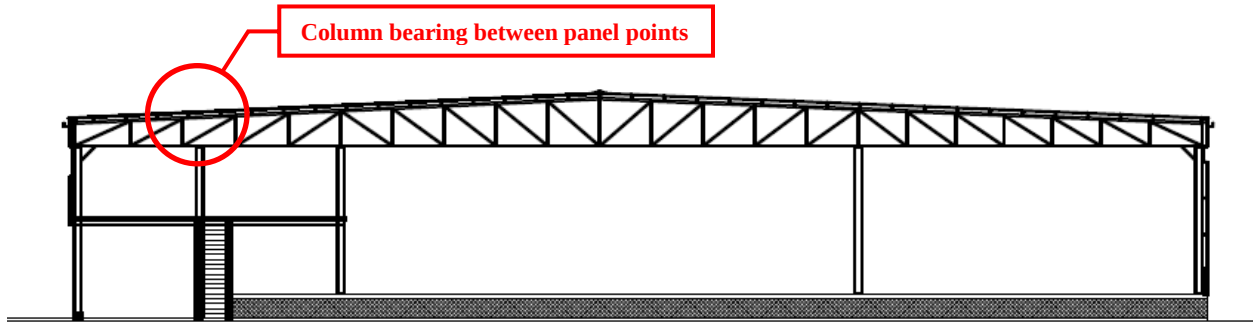
**Figure 3. Truss configuration at mezzanine level**

In the area of the mezzanine, the plans show additional columns (Figure 3), which extend through the mezzanine to the underside of the truss. The additional bearing locations provided by these columns are not at a truss panel point. The resulting reactions from these columns will introduce bending into the lower chord of the truss. SIGIR is

concerned that the members used in the lower chord of the truss are relatively light and do not appear to have the capacity to resist a significant amount of bending stress in addition to the compressive load that will result from the intermediate support.

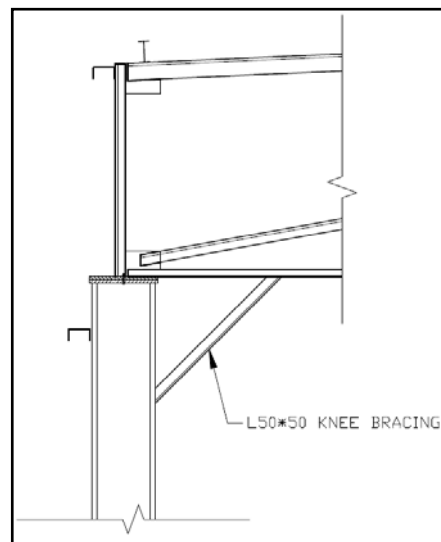
**Figure 4. Knee brace detail**

The contractor's design drawings do not address the method used to resist lateral loads parallel to the building's gable. It appears that the design incorporates diagonal cross bracing between several bays in the direction parallel to the ridge; however, there is no indication of bracing parallel to the gable (slope). In addition, the building's use of column and truss construction requires additional consideration of lateral loads. The only members that appear to be placed to provide lateral stability in the axis of the gable are the diagonal knee braces (Figure 4). These knees appear to be severely undersized, considering their location and configuration.

If the braces are used to resist lateral loads, the connection between the columns and truss would become, at least, partially fixed. This would introduce significant load into the lower chord of the truss, which appears to be already undersized. Fixing the truss/column connection would also introduce a lateral component into the column reaction; special consideration would then be required in the design of the foundation to resist this load.

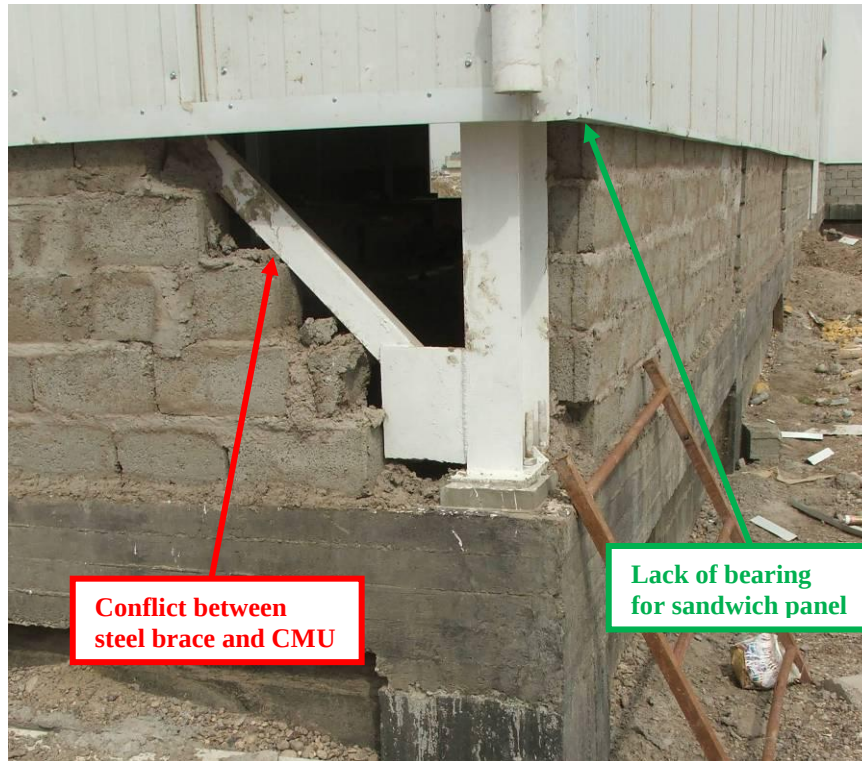
The CMU wall interferes with the steel cross bracing between several of the columns (Site Photo 4). It appears as if the contractor's solution to this issue was to lay the CMU wall around the bracing and coat the entire area with plaster. However, this approach may cause future problems as the steel bracing moves independently of the CMU wall causing recurrent cracking at the location.

**Site Photo 4. Cross brace conflict with CMU perimeter wall**

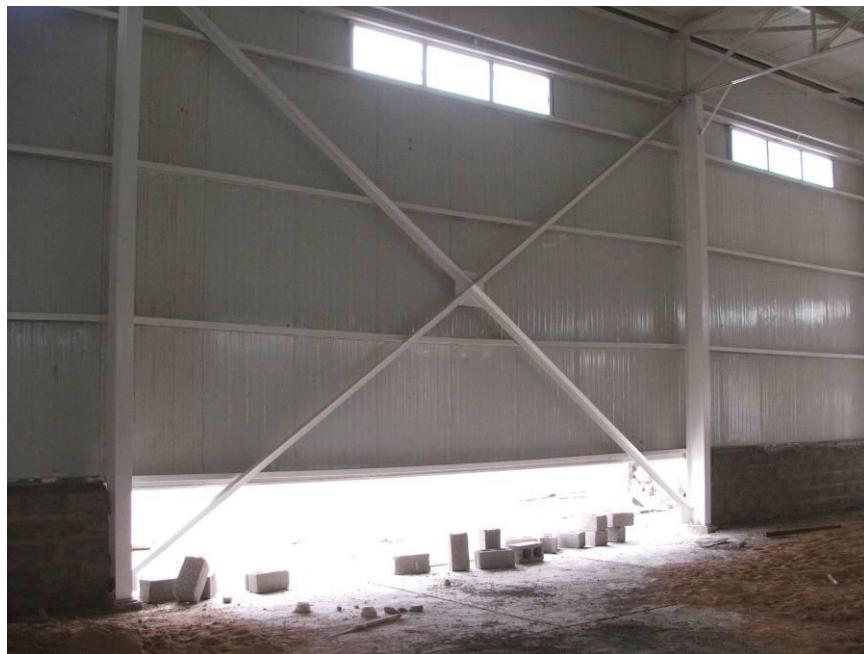
Lateral bracing is provided along exterior column lines of the structure. The bracing is provided as vertical steel cross-bracing along the exterior column line perpendicular to the steel trusses (Site Photo 10). As previously noted, the bracing interferes with the

**Site Photo 10. Lateral cross bracing between columns**

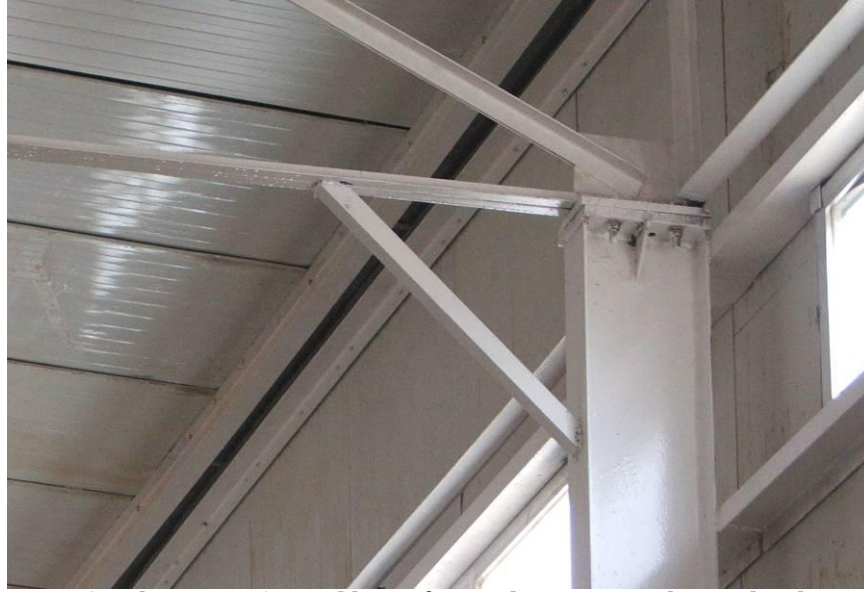
To provide lateral bracing parallel to the trusses, diagonal braces were welded to the steel columns and the lower chord of the truss (Site Photo 11). SIGIR observed what appeared to be significantly undersized braces in place, which could lead to excessive bending in the lower chord of the truss.

**Site Photo 11. Diagonal brace from column to truss lower chord**

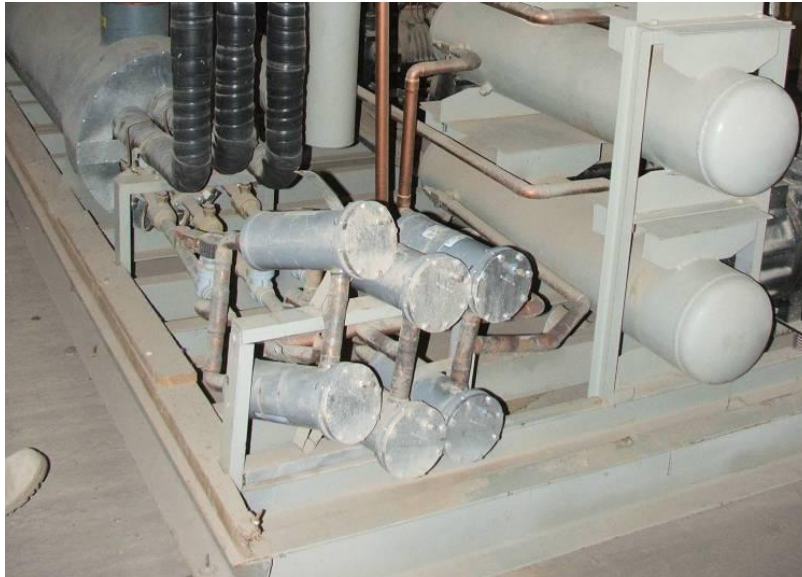
With the exception of one large piece of equipment already located inside the newly constructed facility, the milk processing and packaging equipment is stored inside a leaking warehouse<sup>23</sup> near the Abu Ghraib Dairy (on the Ministry of Industry and Minerals compound). SIGIR toured the warehouse and found most of the equipment in its original packaging and appeared to be in good condition. One of the pieces of equipment sustained some damage due to either improper storage or handling (Site Photo 16). SIGIR was able to identify several pieces of equipment with visible nameplates (Site Photo 17), and the remainder of the equipment was labeled with shipping labels.

**Site Photo 16. Damaged dairy production equipment**

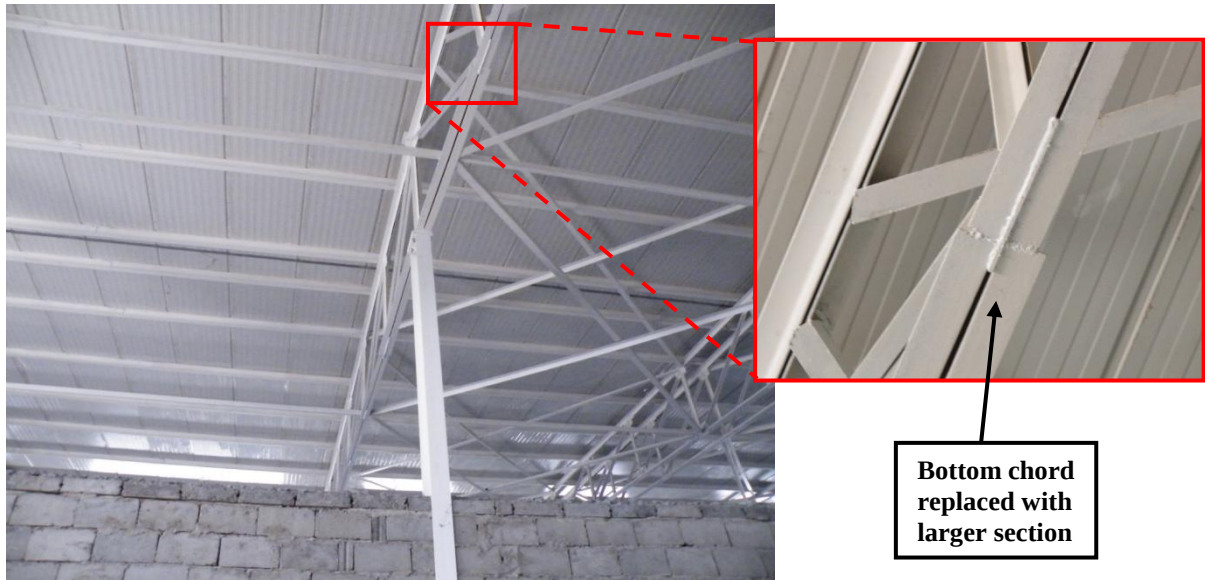
it was inadequate and replaced it with a larger section. Aerial lift capabilities were not available at the time of the site visit; therefore, a hands-on inspection of the repair could not be made. However, SIGIR was able to verify that the trusses had a larger bottom chord section in the areas previously noted as deficient (Site Photo 18).

**Site Photo 18. Contractor's truss modification**

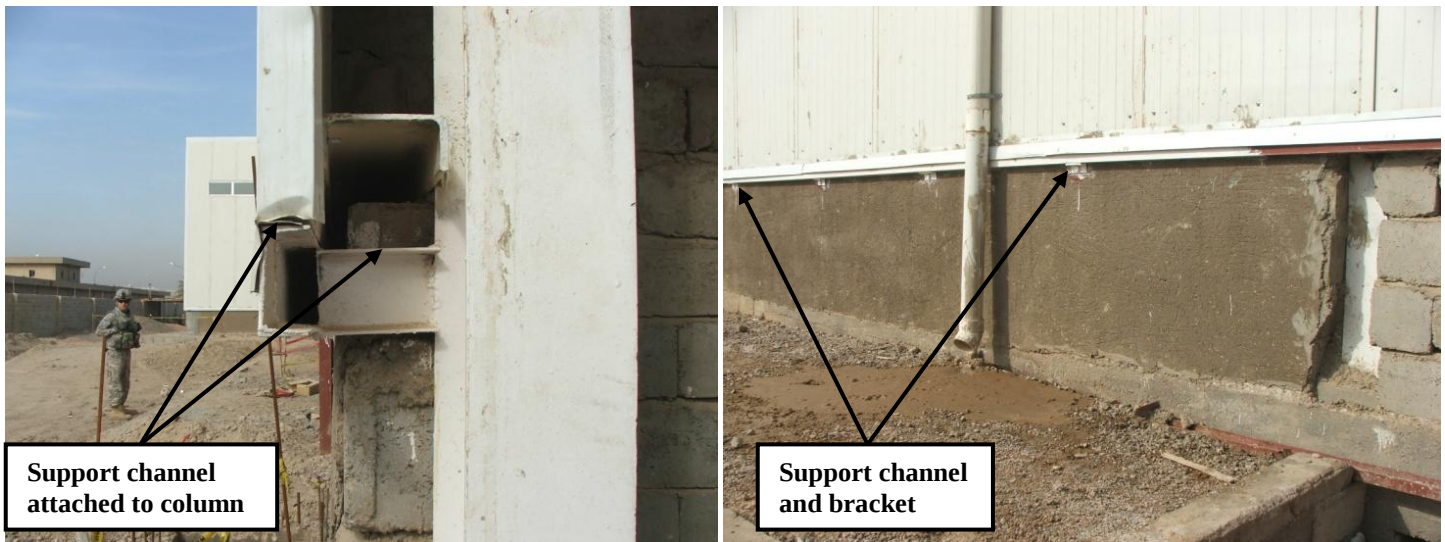
Site Photos 21 and 22. Support channel for sandwich panel

Another previously noted deficiency was the lack of support for the sandwich panels used as cladding for the building exterior. This lack of support was due to the contractor's deviation from the original design, which located the perimeter CMU wall to the interior of the steel framing. To remedy this situation, the contractor installed steel channels

around the perimeter of the building attached to the columns and supporting the panels (Site Photos 21 and 22).

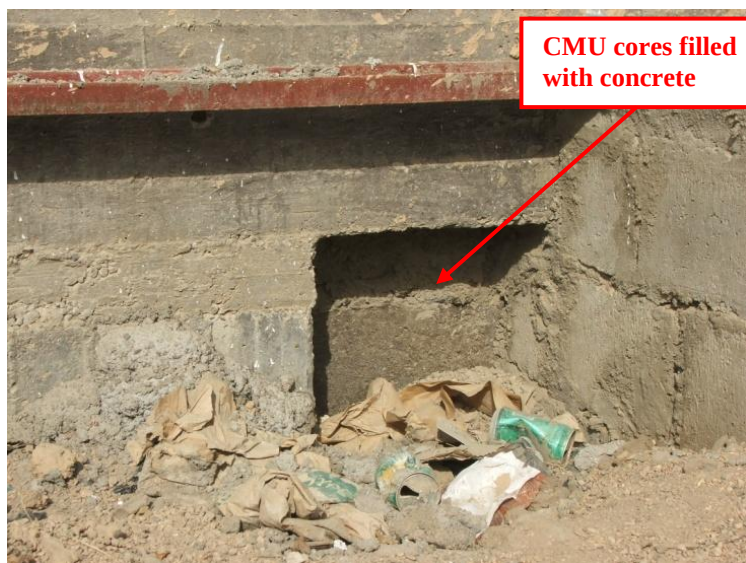
Site Photo 23. CMU cores filled with concrete

Initially, the contractor incorrectly placed CMUs with their sides' horizontal along the foundation wall. This orientation significantly weakened the CMUs. The contractor corrected this deficiency by using concrete to fill the cores of the CMUs, which provides increased strength to the wall (Site Photo 23).
