# Life Test of 76-Ah Nickel-Hydrogen Cell Designs after 14 Years of Storage

10 January 2010

Albert H. Zimmerman and Michael V. Quinzio  
Electronics and Photonics Laboratory  
Physical Sciences Laboratories

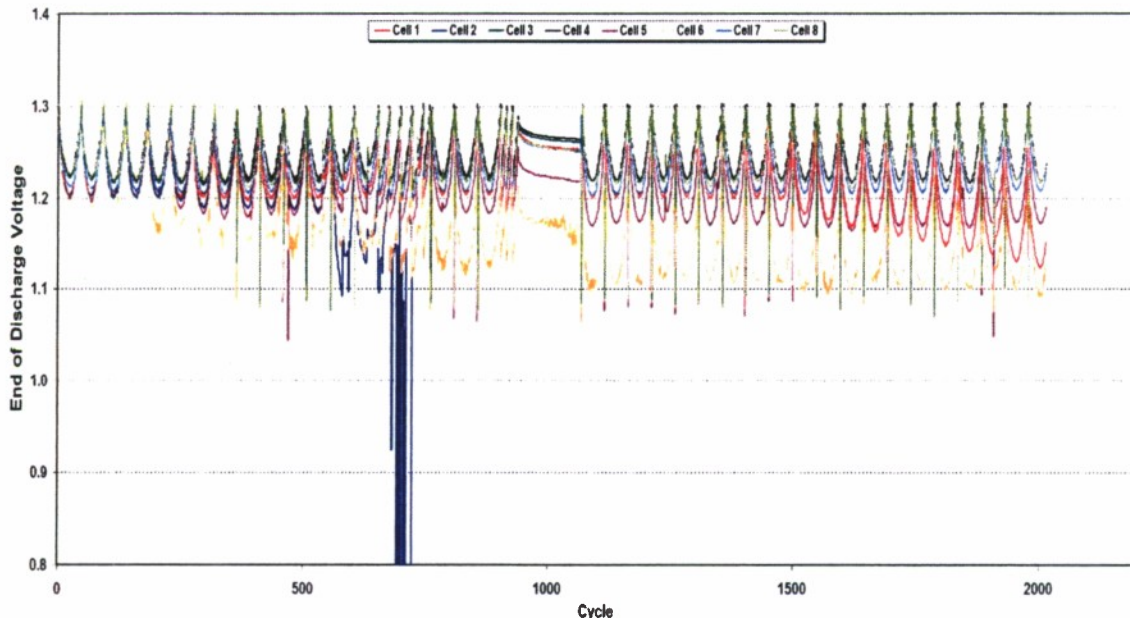
Figure 1. End of discharge voltage for each cell during cycling sequences completed.

This life test has completed 44 of the 45-day cycling sequences, amounting to 2020 total cycles over the approximately 6 years that it has been operating. The minimum voltage during each cycle (excluding the reconditioning and capacity check cycles after each sequence) are shown in Figure 1. As indicated in Figure 1, there have been several periods during the test where programming errors resulted in a few abbreviated or extended cycling sequences. The voltage of cell 5 appeared to be affected by a series resistance arising from the terminal connections that was estimated to be 4.43 m $\Omega$ . This has been constant at all times throughout this test for cell 5. The end of discharge voltage for cell 5 in Figure 1 has been corrected for this added resistance.

Inspection of Figure 1 shows that cell 2 developed some performance problems after about 700 cycles. This cell was declared as failed and removed from the test after 742 cycles, with the failure being caused by intermittent short circuit. Within the first 500 to 1000 cycles, cell 6 also developed a low end-of-discharge voltage from elevated internal impedance, although to date, cell 6 has not failed. After cycle 2020, cell 1 failed due to an internal short circuit, and was also removed from the test. Figure 1 shows cell 1 discharge voltage dropping for 400–500 cycles prior to its failure.

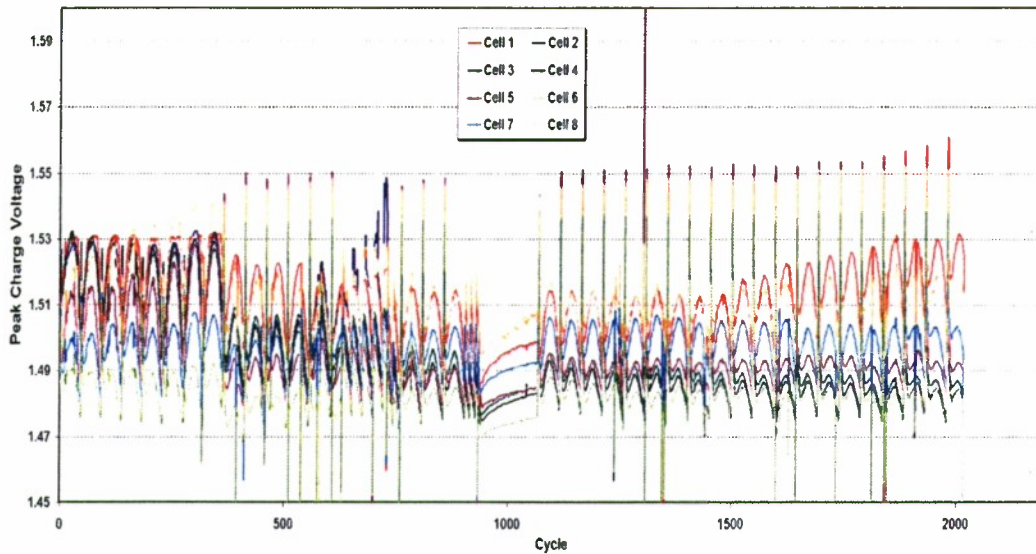
Figure 2. Peak recharge voltage for each cell during cycling sequences completed.

Figure 2 shows the peak recharge voltages during the cycling, which typically occurs at the end of the 6.5 A recharge when the 1.10 recharge ratio has been reached. All cells have remained in the range of about 1.48 to 1.53 V during the test. Elevated peak recharge voltages are seen just prior to the

failure of cell 2 near 700 cycles, and then again for cell 1 near cycle 2000. The voltage spikes that periodically occur up to about 1.55 V are caused by the capacity check recharge done between each 45-day cycling sequence.

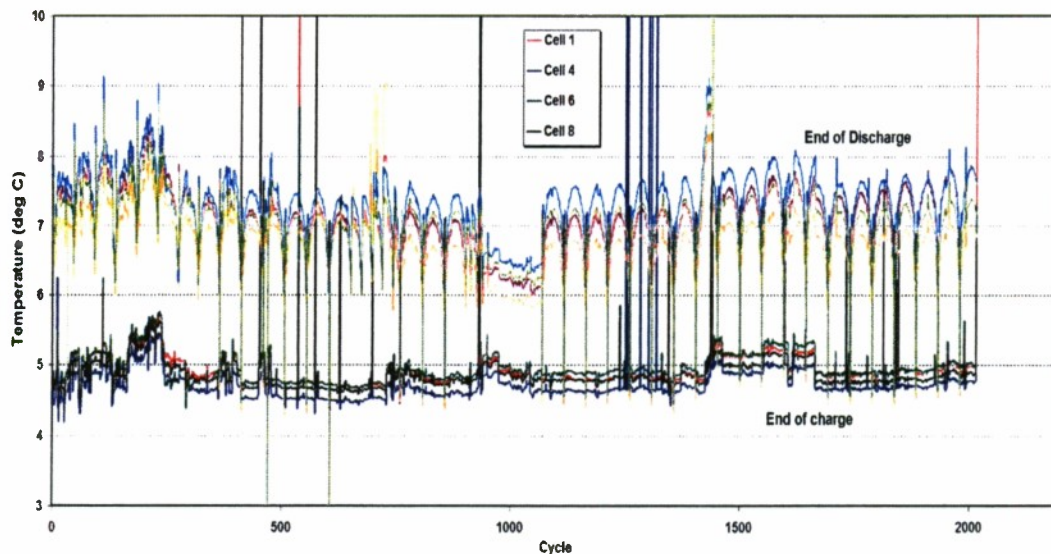
Figure 3. End of discharge and end of recharge temperatures for instrumented cells during cycling sequences completed. The test is being controlled to about a 5°C end of charge temperature.

The test temperatures are shown in Figure 3. The significant temperature spikes occasionally seen above 9°C or below 3°C correspond to test problems that upset the chiller thermal control. Such events included power interruptions, bad data readings, and chiller malfunctions. The test temperature has been controlled such that the end-of-charge temperature was held at about 5°C. Discharge heating has resulted in a 2–3°C warming of cells at the end of discharge relative to end of charge.

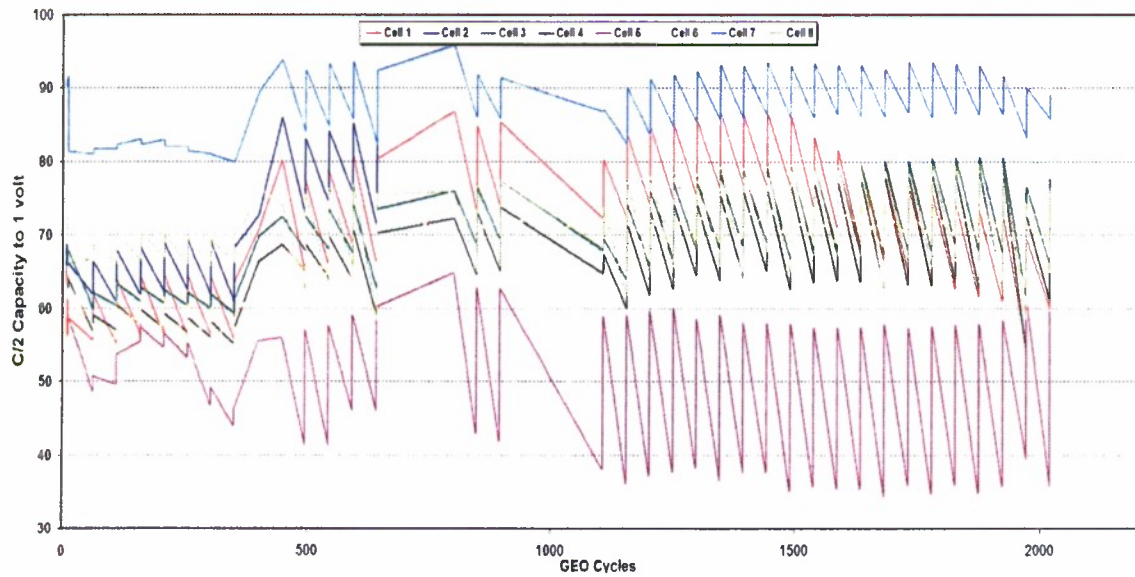
Figure 4. Capacity measurements after each cycling sequence. The lower one is directly from cycling, and the higher one is after reconditioning.

After each 45-day cycling sequence, a capacity discharge is performed from the state of charge that the cells had at the end of the sequence, followed by a second capacity discharge after reconditioning. The cell capacities measured by these capacity checks after each sequence are plotted in Figure 4. The saw-tooth appearance of Figure 4 results from the first capacity measurement, which is directly from the cycling state of charge, always being lower than the second capacity, which is following reconditioning and a full recharge. The lower reconditioned capacity for the first 400 cycles results from the cells only being charged for 12 h following reconditioning, vs. 16 h later in the test. The capacities of all these cells have been relatively stable, with the notable exception of cell 1, which dropped about 15 Ah during the 500 cycles prior to its failure after cycle 2020. Cell 2 showed no significant capacity drop prior to its failure around cycle 700. The main reason for the anomalously low capacity for cell 5 is the extra resistance in the cell circuit, which is believed to be a test artifact since it has not varied with time, cell state of charge, or any other cell-related variable.

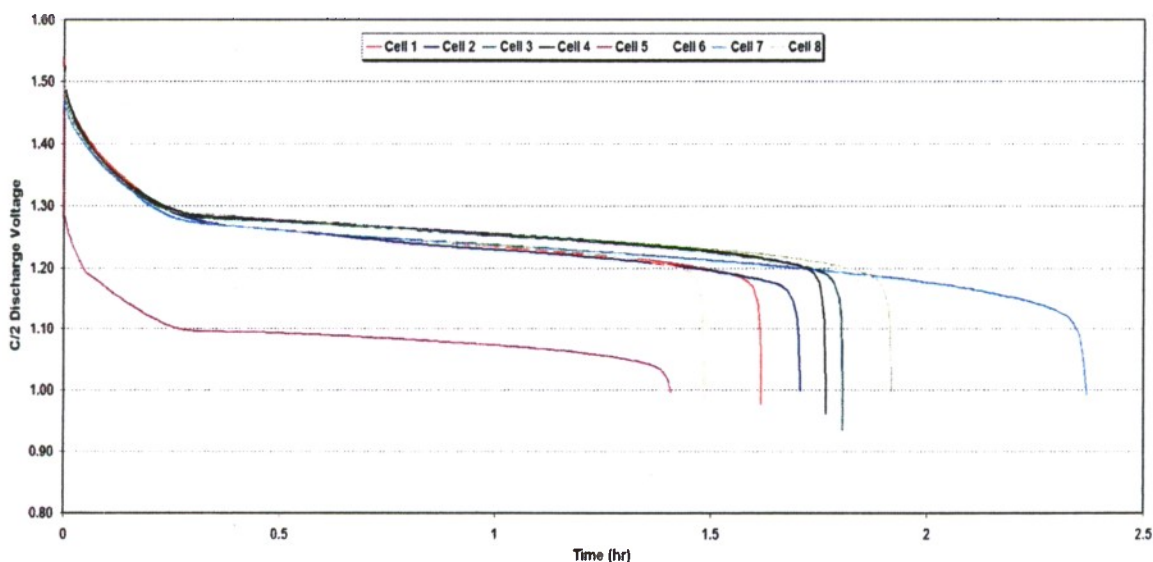
Figure 5. Discharge voltage profiles at beginning of life with a C/2 discharge rate.

The charge and discharge voltage profiles and how they change during the testing can reveal much about what is occurring in a cell as it degrades. Figures 5 and 6 show the beginning of life discharge and recharge voltages for the cells. Figure 5 shows that the discharge voltage plateaus were similar for all the cells, except cell 5, which had an anomalous resistance in the cell connection wiring. However, all the cells except cell 7 displayed significant capacity loss relative to 76 Ah. These capacity losses range from less than 5% for cell 8 to about 25% for cells 5 and 6. It is believed that these capacity losses resulted from the 14 years of storage (over 15 years from cell activation). The cells with the greater amount of capacity losses tended to be the ones with hydrogen precharge, which is likely to be a contributing factor. It is not clear why cell 7 maintained much better capacity than all the other cells.

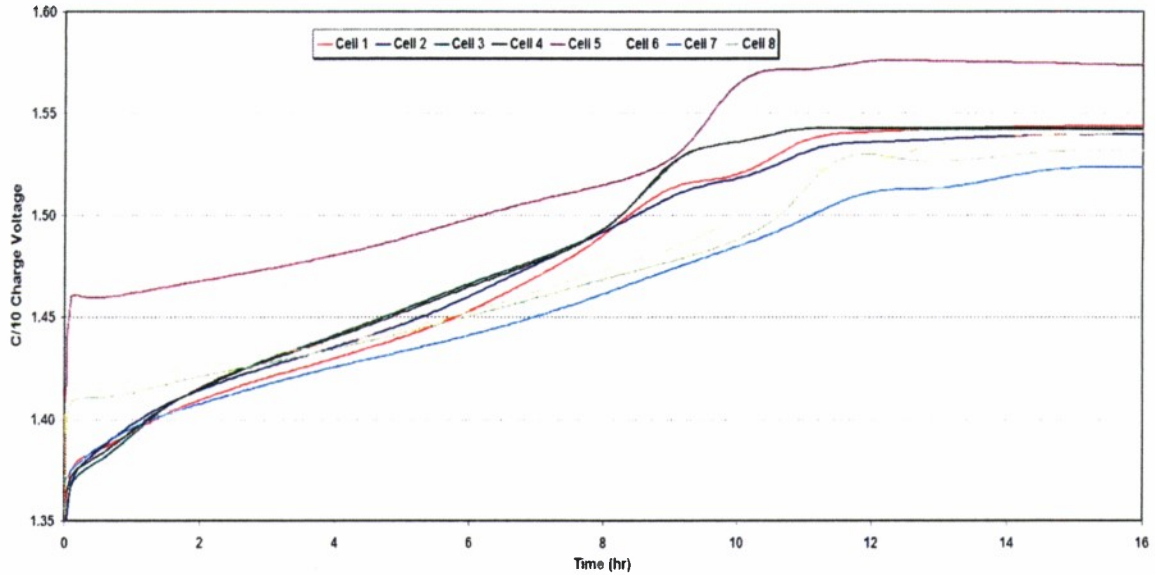
Figure 6. Recharge voltage profiles at beginning of life with a C/10 charge rate.

The recharge voltage profiles in Figure 6 clearly show that three of the cells had a hydrogen precharge at BOL (cells 5, 6, and 8), while the other cells had nickel precharge. This is recognized by the sharply increased voltage at the start of recharge, which is caused by a fully depleted nickel electrode. It is not clear why cell 2, which should have contained hydrogen precharge according to the test cell matrix of Table 1, showed nickel precharge here. This observation suggests there are factors that can affect the precharge settings enough to completely lose one atm of hydrogen precharge (one atm corresponds to only about 1.5% hydrogen precharge in this cell design).

The recharge profiles in Figure 6 also indicate which cells had the higher electrolyte concentration. The higher concentration stabilizes the formation of  $\gamma$ -NiOOH during overcharge, thus causing the charge voltage to peak, and then continue rising significantly as  $\gamma$ -NiOOH continues to be generated.

This is the profile seen for cells 1, 2, 6, and 7, which all contain the higher electrolyte concentration, as indicated in Table 1.

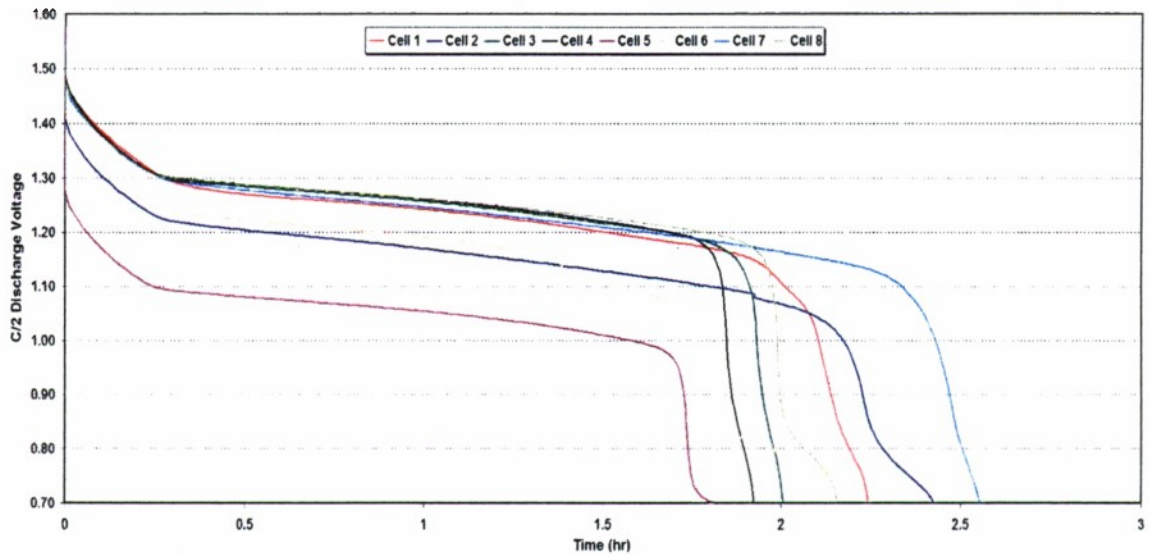
Figure 7. Discharge voltage profiles at cycle 643 with a C/2 discharge rate.

At the last post-reconditioning capacity check before cell 2 failed (cycle 643), the discharge and recharge voltage profiles are again plotted to determine how they had changed during the first 643 cycles. The results are shown in Figures 7 and 8. Figure 7 shows that significant discharge capacity was present in the form of a second plateau below 1 V for all cells. All the cells had significantly increased in capacity since the start of testing, with all except cells 2 and 5 attaining 76 Ah. Additionally, cells 2 and 6 had developed a decreased upper discharge voltage, which usually indicates resist-

tance from separator dry out. The drops in voltage for cells 2 and 6 at 1.5 to 2 h suggest that these cells may have intermittent shorting or impedance issues that could cause failure.

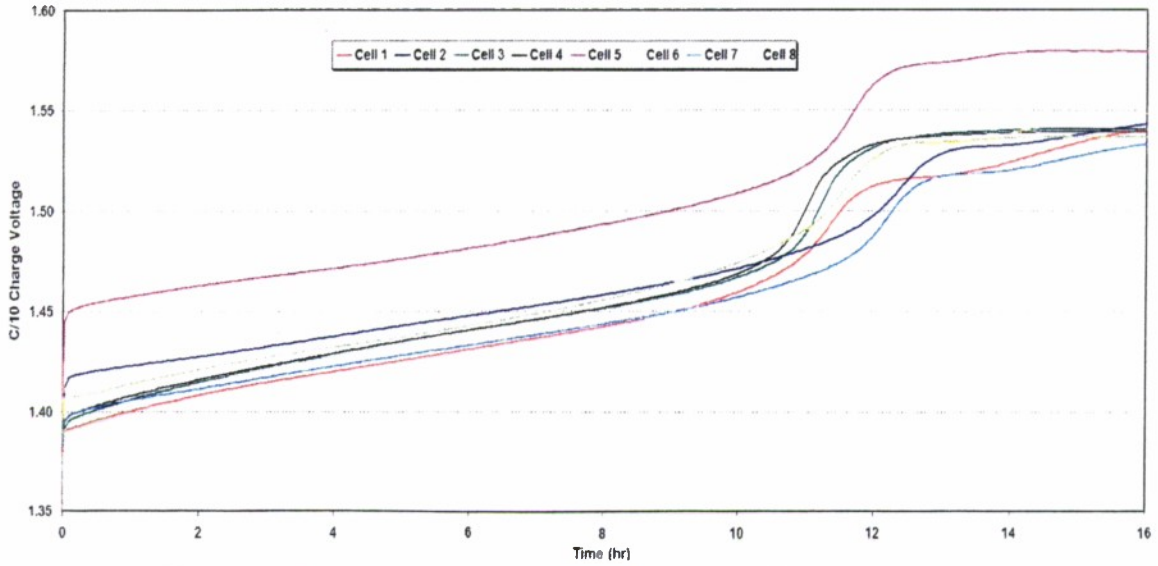
Figure 8. Recharge voltage profiles at cycle 643 with a C/10 charge rate.

Figure 8 suggests that all the cells either had hydrogen precharge or were close to the hydrogen pre-charged condition after 643 cycles.

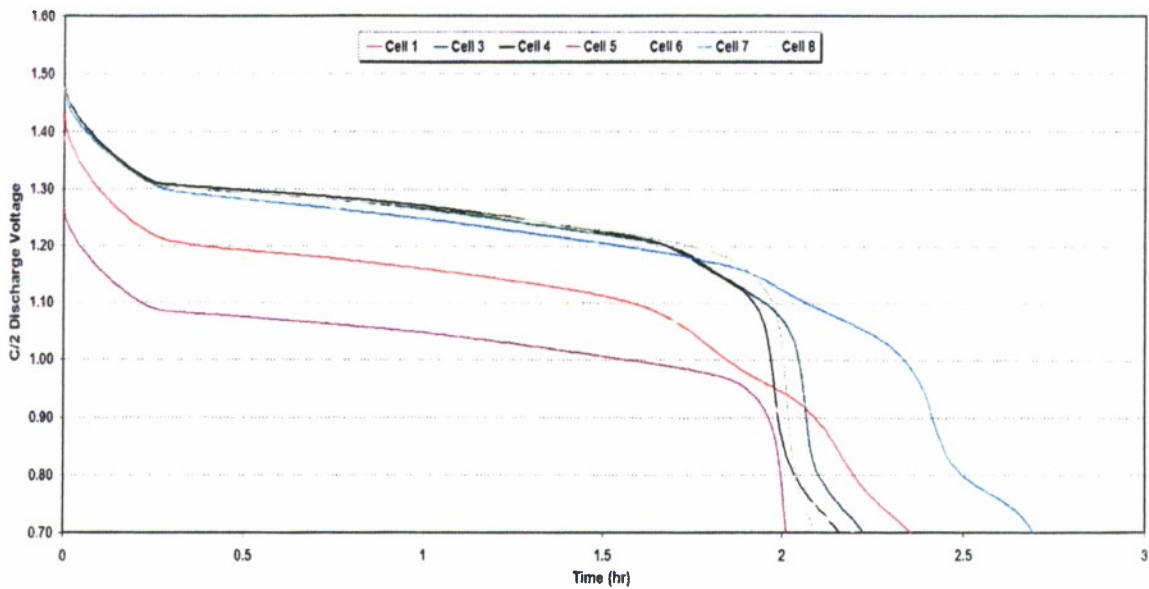
Figure 9. Discharge voltage profiles at cycle 2020 with a C/2 discharge rate.

At the last capacity check before cell 1 failed (cycle 2020), the discharge and recharge voltage profiles are again plotted to determine how they had changed during the first 2020 cycles. The discharge results shown in Figure 9 do not include cell 2 because it had failed. The discharge measurements in

Figure 9 show that the trend toward increased post-reconditioning capacity noted in Figure 7 after 643 cycles had continued, and all cells displayed at least 76 Ah of capacity. Cell 5 had 76 Ah above 1 V if the discharge voltage was adjusted for the 4.43 mΩ lead resistance that seems to be displacing the discharge voltage downward and the charge voltage upward. In addition, all cells appear to have a significant lower voltage plateau near 0.8 V that is not fully resolved in a discharge to 0.7 V.

Some interesting trends can be seen in the discharge data of Figure 9 that correlate with the design differences between the cells. First, the three remaining cells having high electrolyte concentration, cells 1, 6, and 7 (failed cell 2 was the fourth one with high concentration), all show evidence for a depressed discharge voltage plateau, although the depression is relatively small for cell 7. This signature typically is caused by separator dry out, which seems to be accentuated by the high electrolyte concentration. It is likely that the high electrolyte concentration causes accelerated swelling of the nickel electrodes, thus causing them to draw electrolyte out of the separator and raise its resistance.

A second interesting signature is seen in Figure 9 for all four of the cells that were manufactured with 15% nickel precharge, cells 1, 3, 4, and 7. Each of these cells displays a more rapidly declining segment of the upper discharge plateau at the end of the upper discharge plateau. This signature appears to be an emerging new discharge plateau that is roughly 50–100 mV lower than the normal discharge plateau. This plateau may correspond to discharge of  $\gamma$ -NiOOH, although it is significantly lower than the 1.20-V potential where  $\gamma$ -NiOOH normally undergoes discharge.\* An alternative explanation is that this emerging lower plateau corresponds to a novel nickel electrode material, such as the Pt-Ni-Co complex described in Ref. 3, which has a discharge voltage about 100 mV below the normal discharge plateau. The emergence of this slightly low secondary discharge plateau clearly is associated with aging of the cells since it was barely perceptible in Figure 7 at cycle 643. A novel observation, however, is the observation of this slightly low secondary discharge plateau only in cells that were built with nickel precharge. This correlation suggests that the Pt-Ni-Co complex,† which is known to form in nickel precharged cells during long-term storage, may have a significant effect on cell performance after many years of operation following removal from storage. More importantly, this effect does not appear to be deleterious to performance since all the cells showing the slightly low secondary discharge plateau have very good capacity, particularly if capacity delivered at cell voltages between 1.1 and 1.2 V can be effectively used.

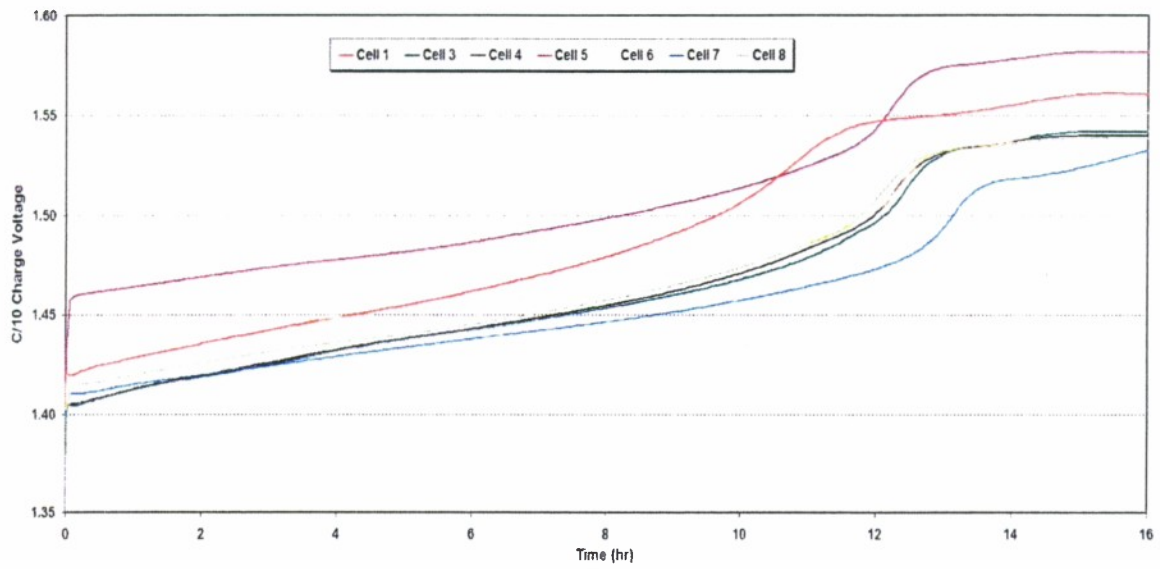
Figure 10. Recharge voltage profiles at cycle 2020 with a C/10 charge rate

Figure 10 shows the charge voltage profiles for the cells after reconditioning at cycle 2020. Again, the discharge results shown in Figure 10 do not include cell 2 because it had failed. Figure 10 shows that all the cells that originally had nickel precharge have clearly developed a hydrogen precharge, as indicated by the sharp rise over 1.40 V and peaked voltage behavior at the start of the charge. The three remaining cells with higher concentration electrolyte (cells 1, 6, and 7) continue to display a pronounced secondary voltage rise after going into overcharge as  $\gamma$ -NiOOH is formed at the end of charge. Cycle 2020 was the last capacity check prior to the failure of cell 1. The recharge voltage for cell 1 only suggested that the capacity had degraded about 20%, and that the charge voltage had increased 10–20 mV, certainly not clear indications of imminent failure.

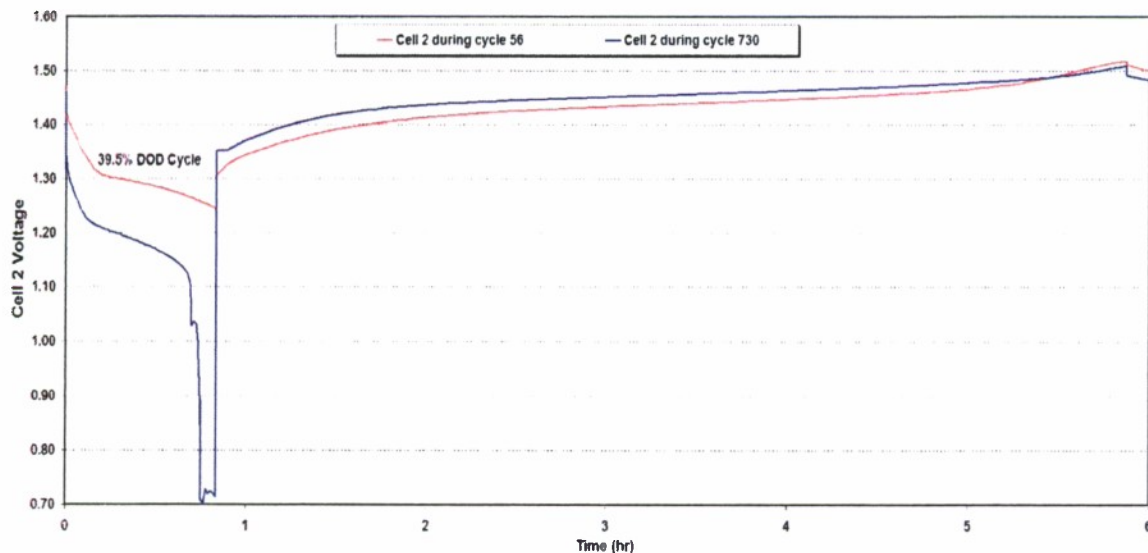
Figure 11. Erratic voltage signature displayed by cell 2 just prior to removal from the test.

As shown in Figure 1, cell 2 began displaying erratic voltages during discharge at about cycle 700. In Figure 7, the discharge curve at cycle 643 shows the beginnings of this erratic behavior as a small but sudden voltage drop almost 2 h into the capacity discharge. At cycle 768, the voltage of cell 2 had become so erratic that it could no longer continue cycling, and it was removed from the test. Figure 11 compares cycle 730, which was typical of the poorer performing cycles for this cell, to a cycle at the same depth of discharge early in life (cycle 56). Even near the end of its life, cell 2 occasionally gave cycles that were nearly normal in voltage performance.

After removal from the test station, cell 2 was subjected to three standard capacity cycles at 10°C. Both its voltage and capacity appeared normal during these cycles. The erratic voltages only seemed to appear after a number of cycles, becoming more erratic with time. The likely cause for the erratic voltages is variable soft shorting through the separation that gradually bleeds down cell capacity to below the threshold needed to support discharge above 1 V. These shorts seemed to come and go, but nearly always became worse during discharge when the nickel electrodes tend to undergo expansion. These observations suggest the failure is associated with nickel plate expansion, active material extrusion, and separator dry out, all which are likely to be accelerated by the higher electrolyte concentration and the absence of an electrolyte backfill in this cell. It is unclear whether the 14 years of storage with hydrogen precharge prior to testing contributed to this failure mode. It is also unclear why cell 2 failed so early in this test relative to the other cells. This could be an indication of degradation associated with the lengthy pre-test storage.

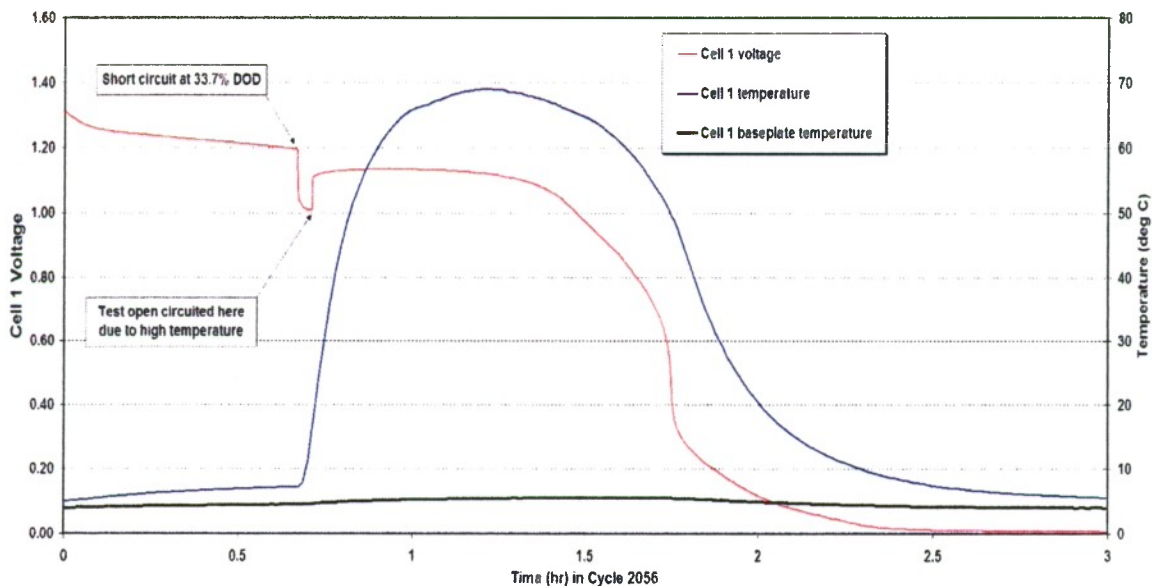
Figure 12. Voltage and thermal signatures during the failure of cell 1 at cycle 2056.

During cycle 2056, cell 1 developed an internal hard short that rapidly caused the cell to fail. The voltage and thermal signatures during cycle 2056, which accompanied this failure, are shown in Figure 12. The failure occurred precipitously during discharge (at 33.7% depth of discharge), and was characterized by a sudden drop in cell voltage to just above 1.00 V. At this point, the cell temperature began to rapidly increase. Discharge continued for about 4 min, whereupon the cells were open circuited because cell 1 temperature had increased to the maximum allowed limit of 15°C. Over the next 0.5 to 1.0 h, the cell voltage rose to just over 1.0 V for about 40 min and then began to drop toward 0 V. The cell temperature continued rising, and reached a maximum of nearly 70°C about 30 min after initiation of the short circuit. The voltage of the cell ultimately fell to zero, indicating that an internal hard short had developed in this cell.

Prior to disassembling cell 1 to determine the root cause for the failure, the hydrogen gas pressure in this cell was measured by puncturing the cell case and collecting the gas in an evacuated chamber. Using this method, the gas pressure within this shorted cell was 141.6 psia. This pressure indicates a significant pressure growth in this cell during the 6 years of cycling that it had experienced. It is very likely that some of this pressure growth could have occurred during the lengthy storage prior to starting this test.

Disassembly of cell 1 showed that the hard short occurred when the core assembly on which the stack was mounted and constrained broke. The core assembly broke as the result of the core nut flying off the end of the threaded core. Upon removal of the stack compression, the stack expanded significantly on the side opposite the tabs on the nickel plates, while expanding much less on the side having the nickel plate tabs. The short circuit was on the side having the nickel plate tabs, and was a sufficiently hard short that it prevented the stack from being readily disassembled.

The root cause for the failure of cell 1 is clearly associated with significant expansion of the nickel electrodes as the result of nickel corrosion and cycling stresses in the 38% KOH electrolyte. The higher KOH concentration is known to contribute significantly to plate expansion caused by cycling, and the high pressure indicates significant corrosion of the sinter, which had 84% porosity at beginning of life. The expansion increased the compressive force on the core assembly until eventually it exceeded the force required to break the core assembly. Based on these results, in the future, it would not be surprising to see similar types of failures in cells 6 and 7, which also contain the higher electrolyte concentration.
