**INVESTIGATION OF  
IGNITER COMPOSITION FIRE  
BAY 9 BUILDING G-11  
LONESTAR ARMY AMMUNITION PLANT  
15 MAY 1991**

**ROBERT A. LOYD**

**U.S. ARMY ARMAMENT  
MUNITIONS AND CHEMICAL COMMAND**

**25th DEPARTMENT OF DEFENSE  
EXPLOSIVES SAFETY SEMINAR  
18-20 AUGUST 1992**

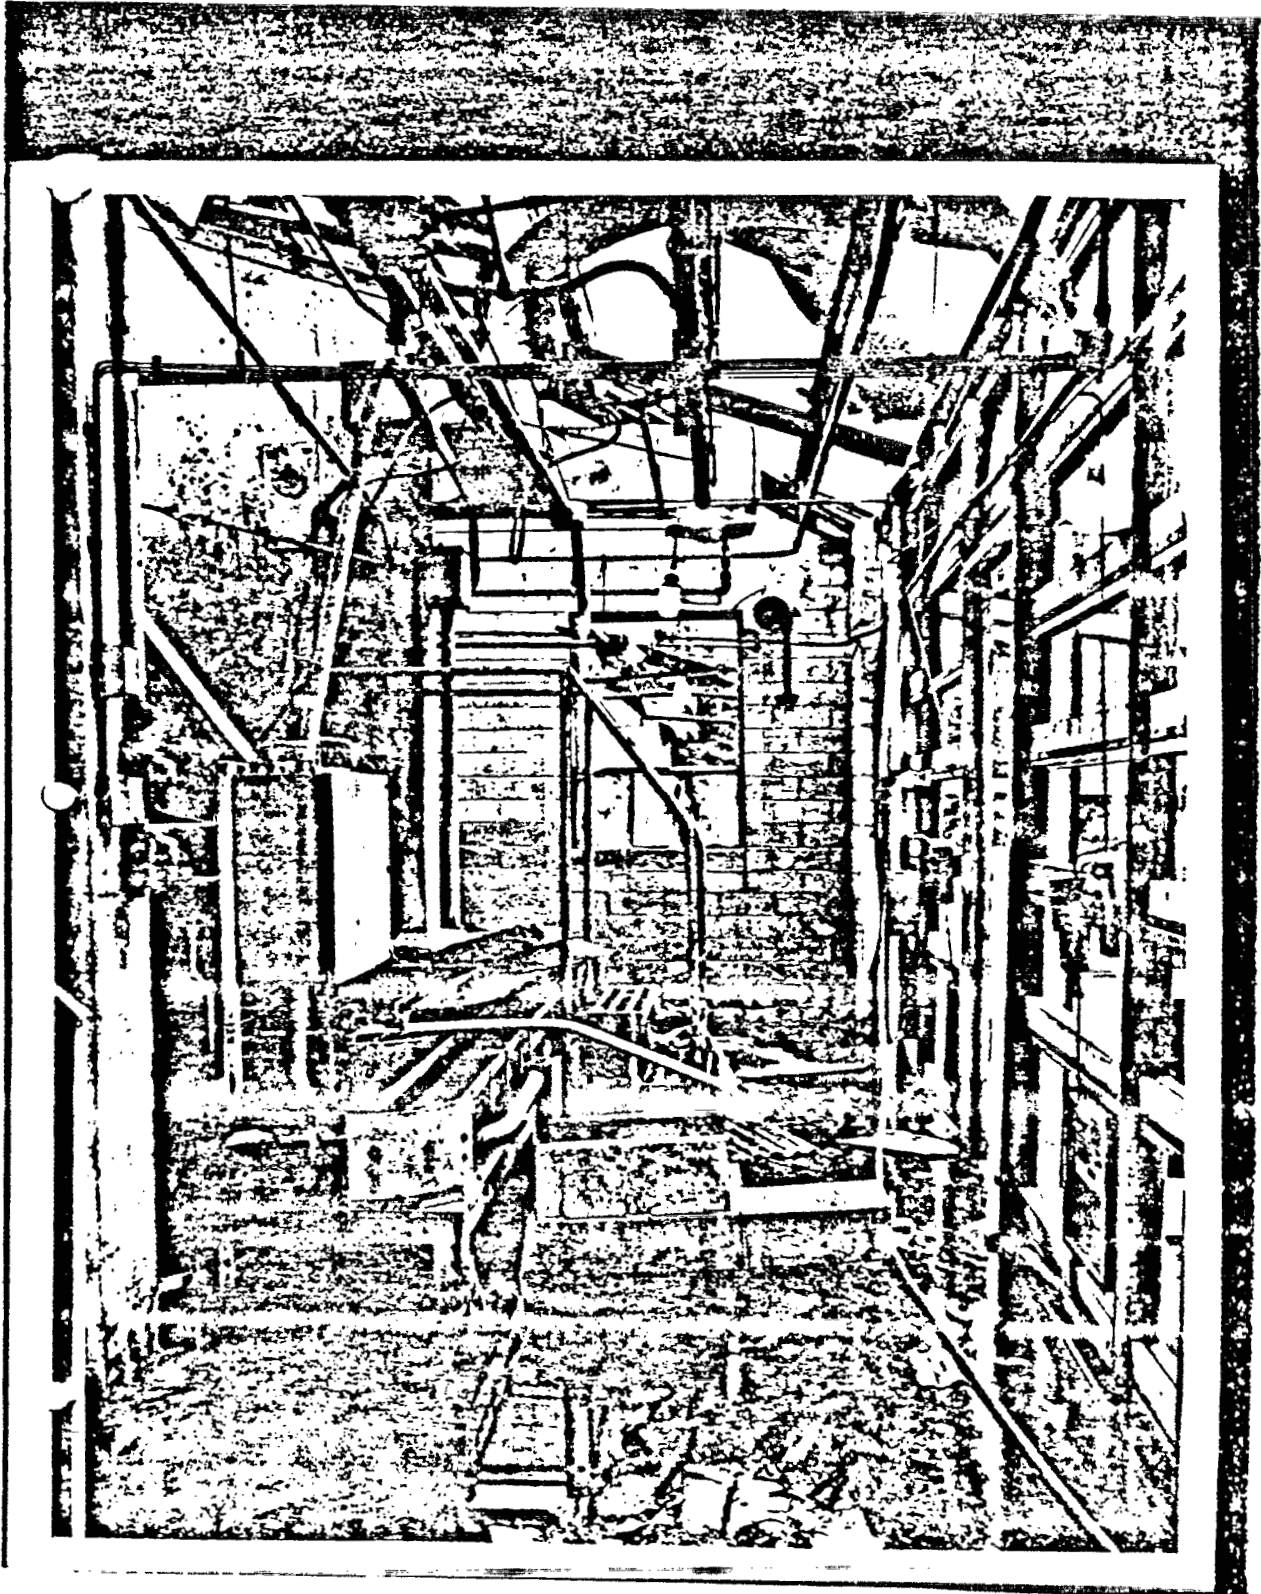
Corridor in front of Bay 9

c. The particle board covering the window on the west wall of the building prevented a more complete venting at that spot and channeled the pressure wave against the corridor doors.

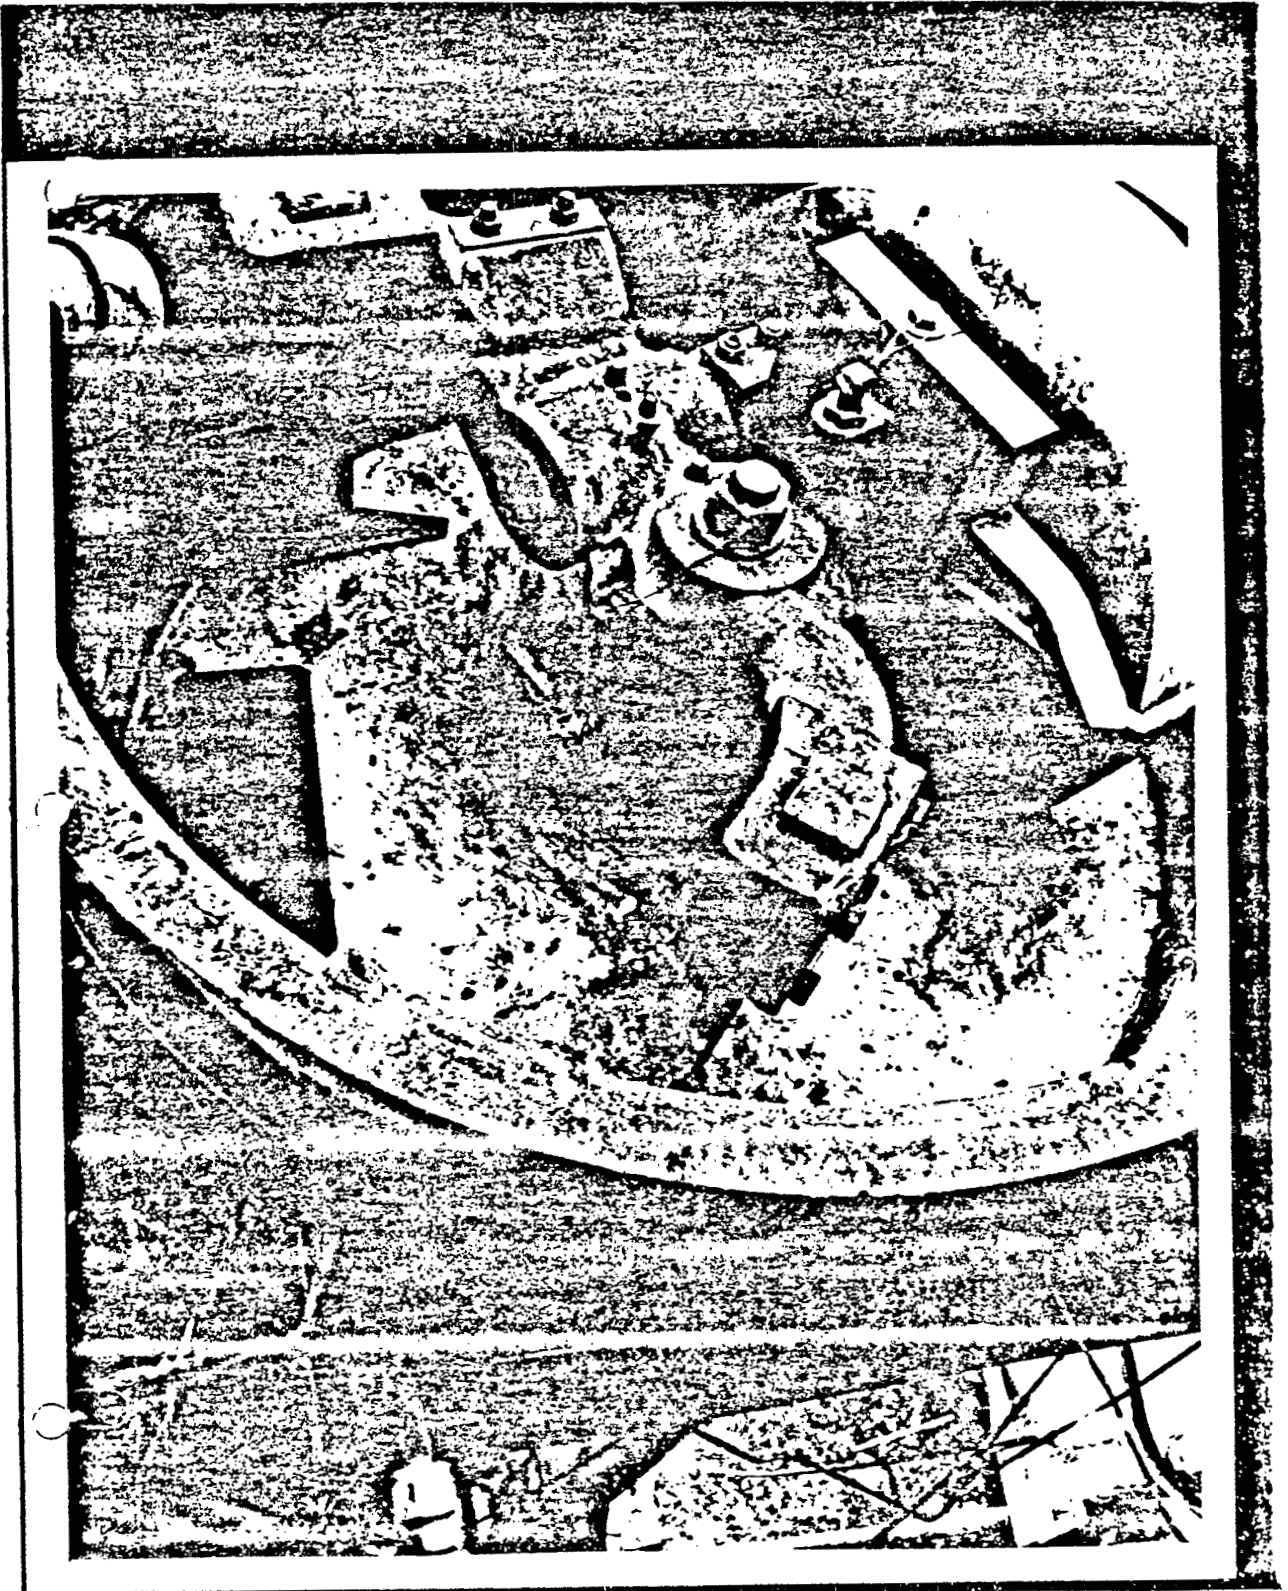
a. The mixer involved in the incident has been in service at Lone Star AAP since July 1951. It shows signs of wearing out as a result of extended service and an undetermined number of previous incidents.

a. The interior of the mixing bowl showed the presence of concentric circular grooves on the bottom of the bowl. The depth of the grooves was measured at four random locations. The depth varied from 0.007 inches to 0.015 inches. The maintenance personnel indicated that the grooves were there following the September 1990 incident. The grooves were hand-polished with emery cloth to attempt to smooth them down. It is not known if the depth of the grooves increased between September 1990 and May 1991.

b. There were marks on the side of the mixing bowl. The marks appeared from approximately the 7 o'clock to the 9 o'clock position. Eleven distinct sets of marks were visible and all had the appearance of being caused by metal to metal contact. The marks were vertically linear in arrangement. They occurred from approximately 4-8 inches above the floor of the bowl.

Mix muller. Dump door/opening is at 9:00 position.

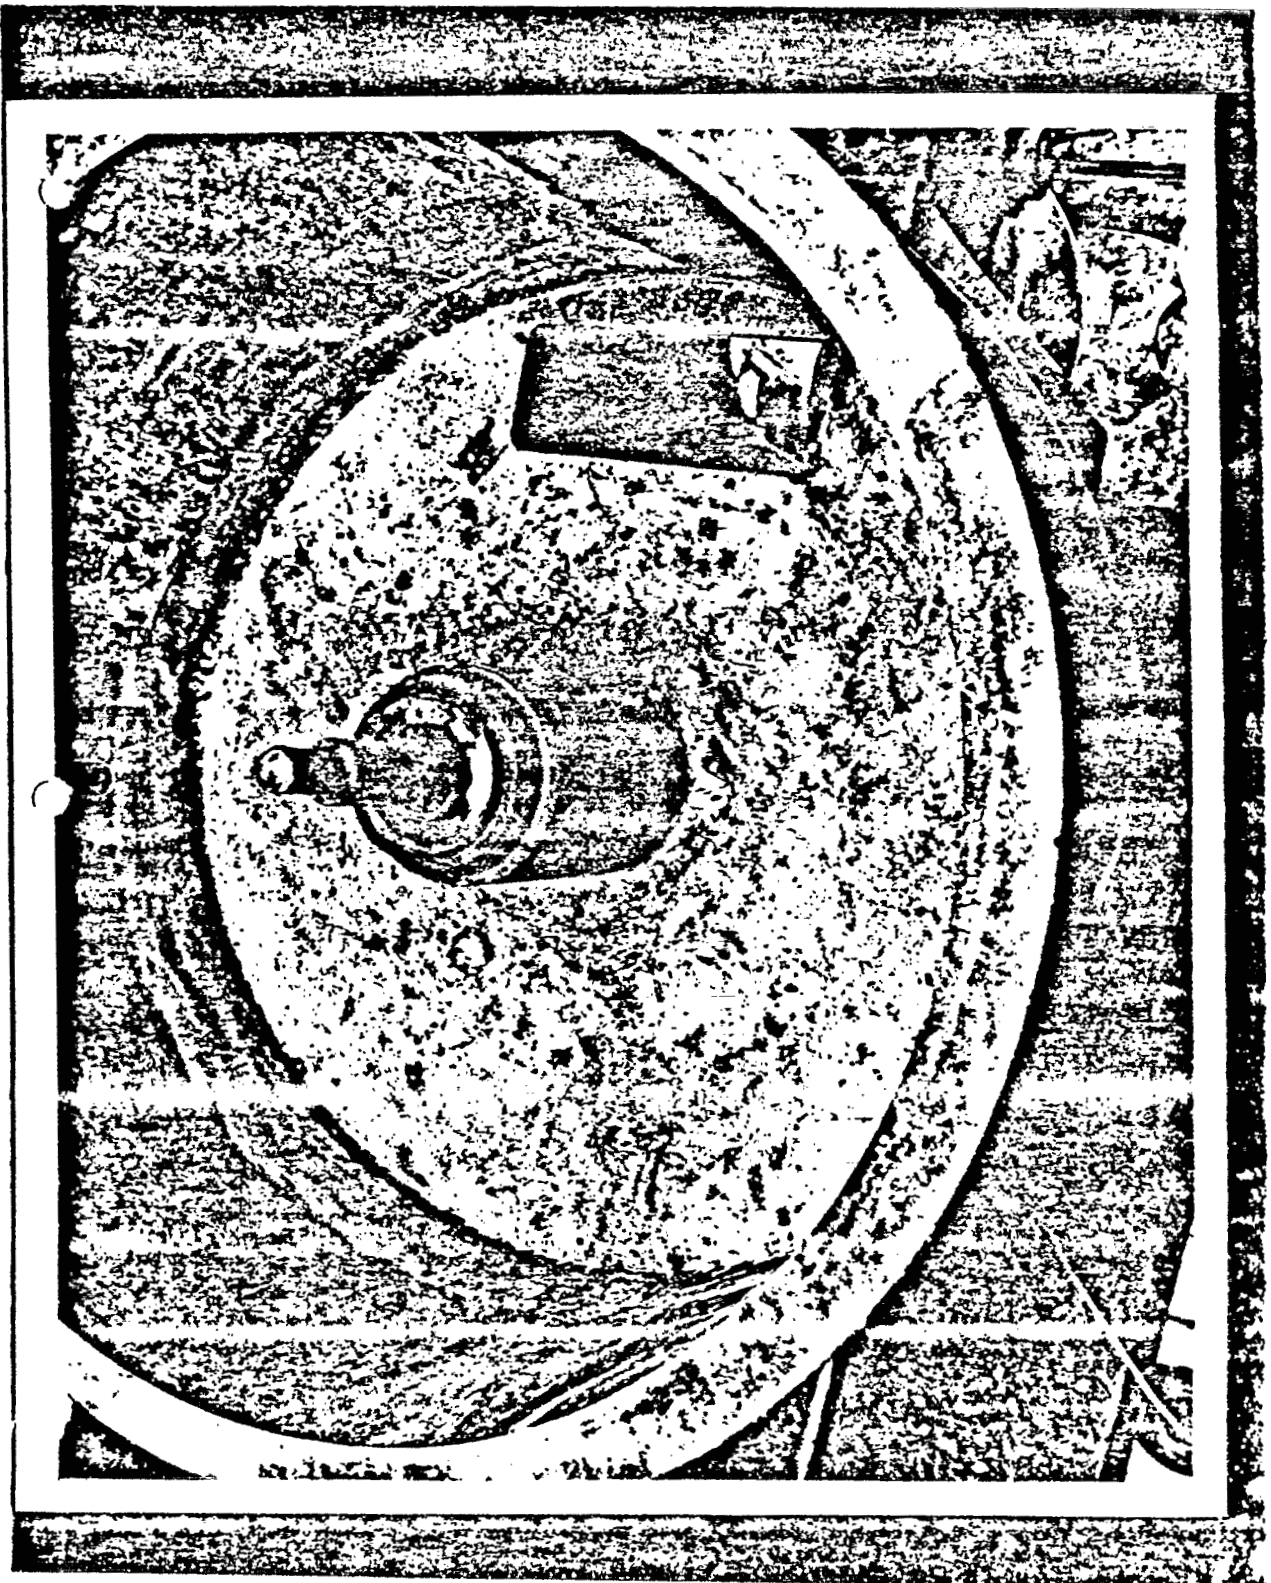
b. Worn areas were discovered in the hub area of the axle assembly in the mixing bowl. A sharpened edge and an indentation in the ring were discernible. Furthermore, extensive pitting of

the ring in the hub assembly was evident. The millwrights indicated they had not seen this pitting when they repaired the bowl after the September incident. The millwrights attributed this pitting to water buildup in that area. These hub anomalies could possibly cause a wobbling of the wheel and plow assembly.

Mix muller with wheel assembly removed.

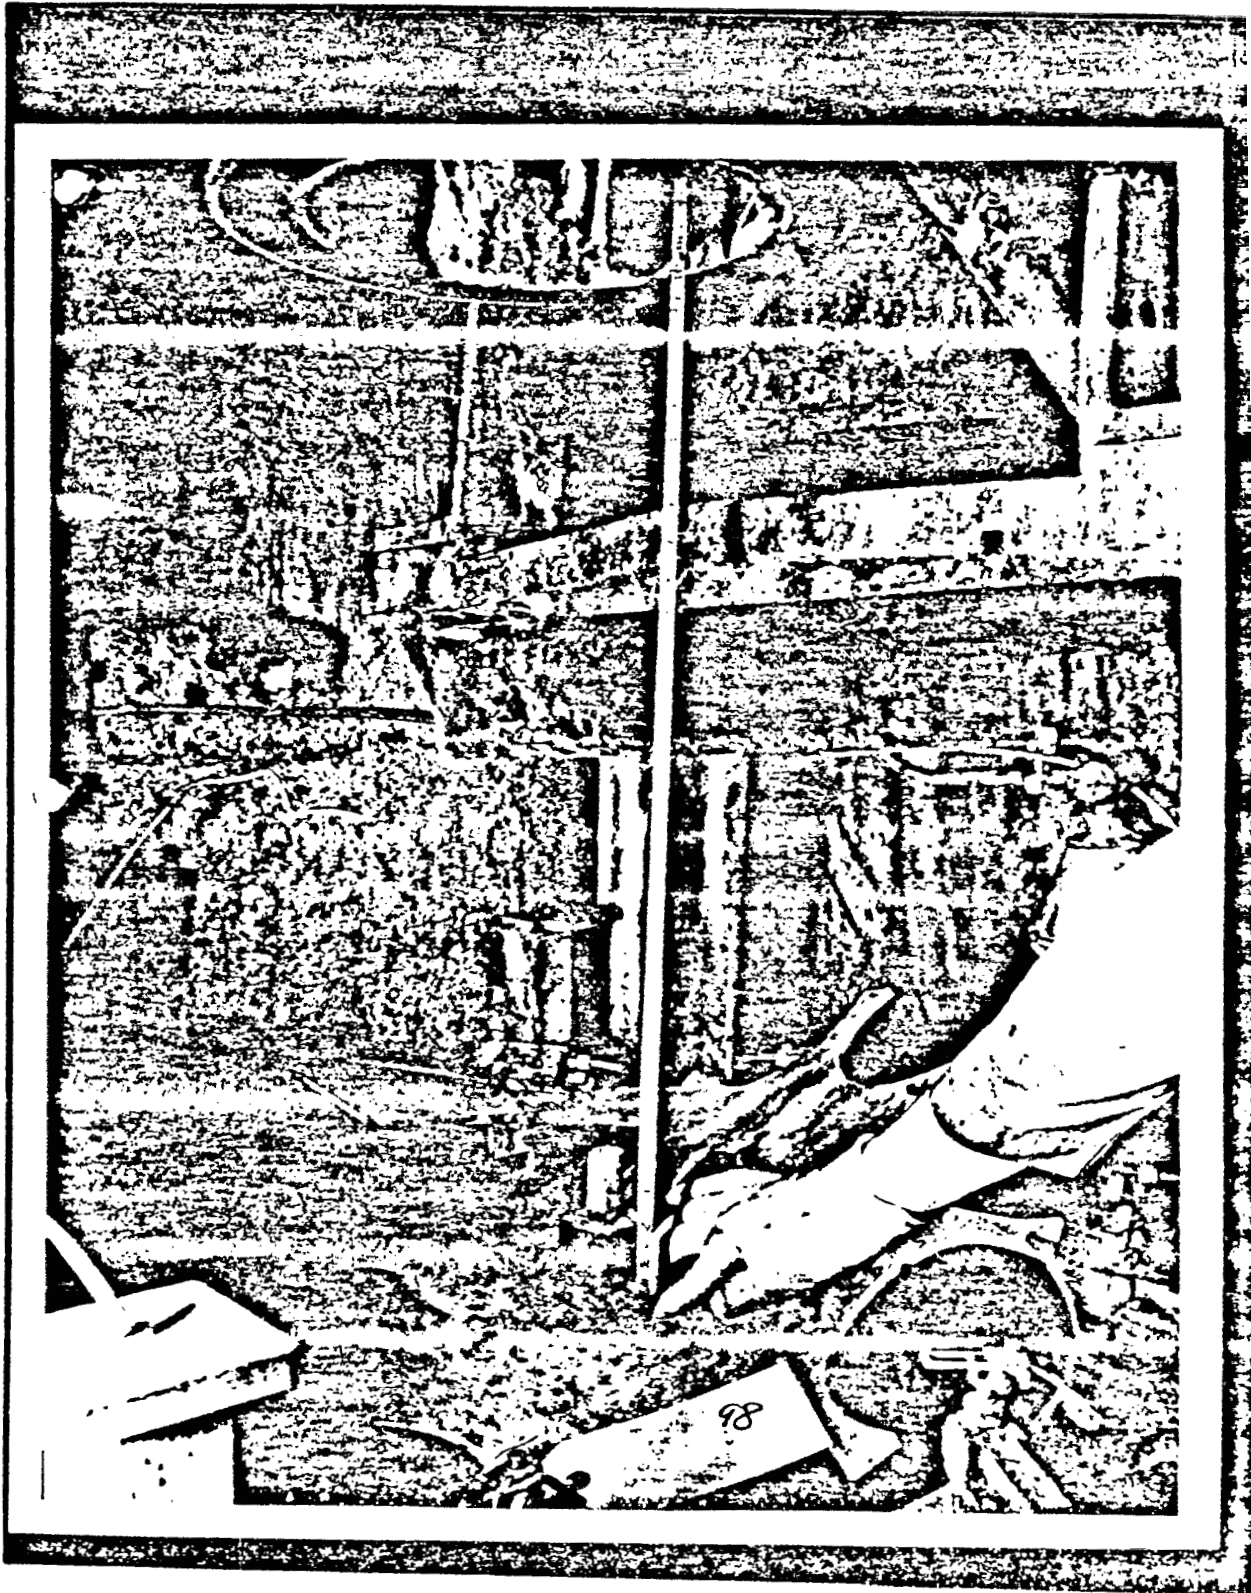
Shows the distance the igniter mix had to drop from the mixer to the dial assembly. (approximately 3.5 ft)

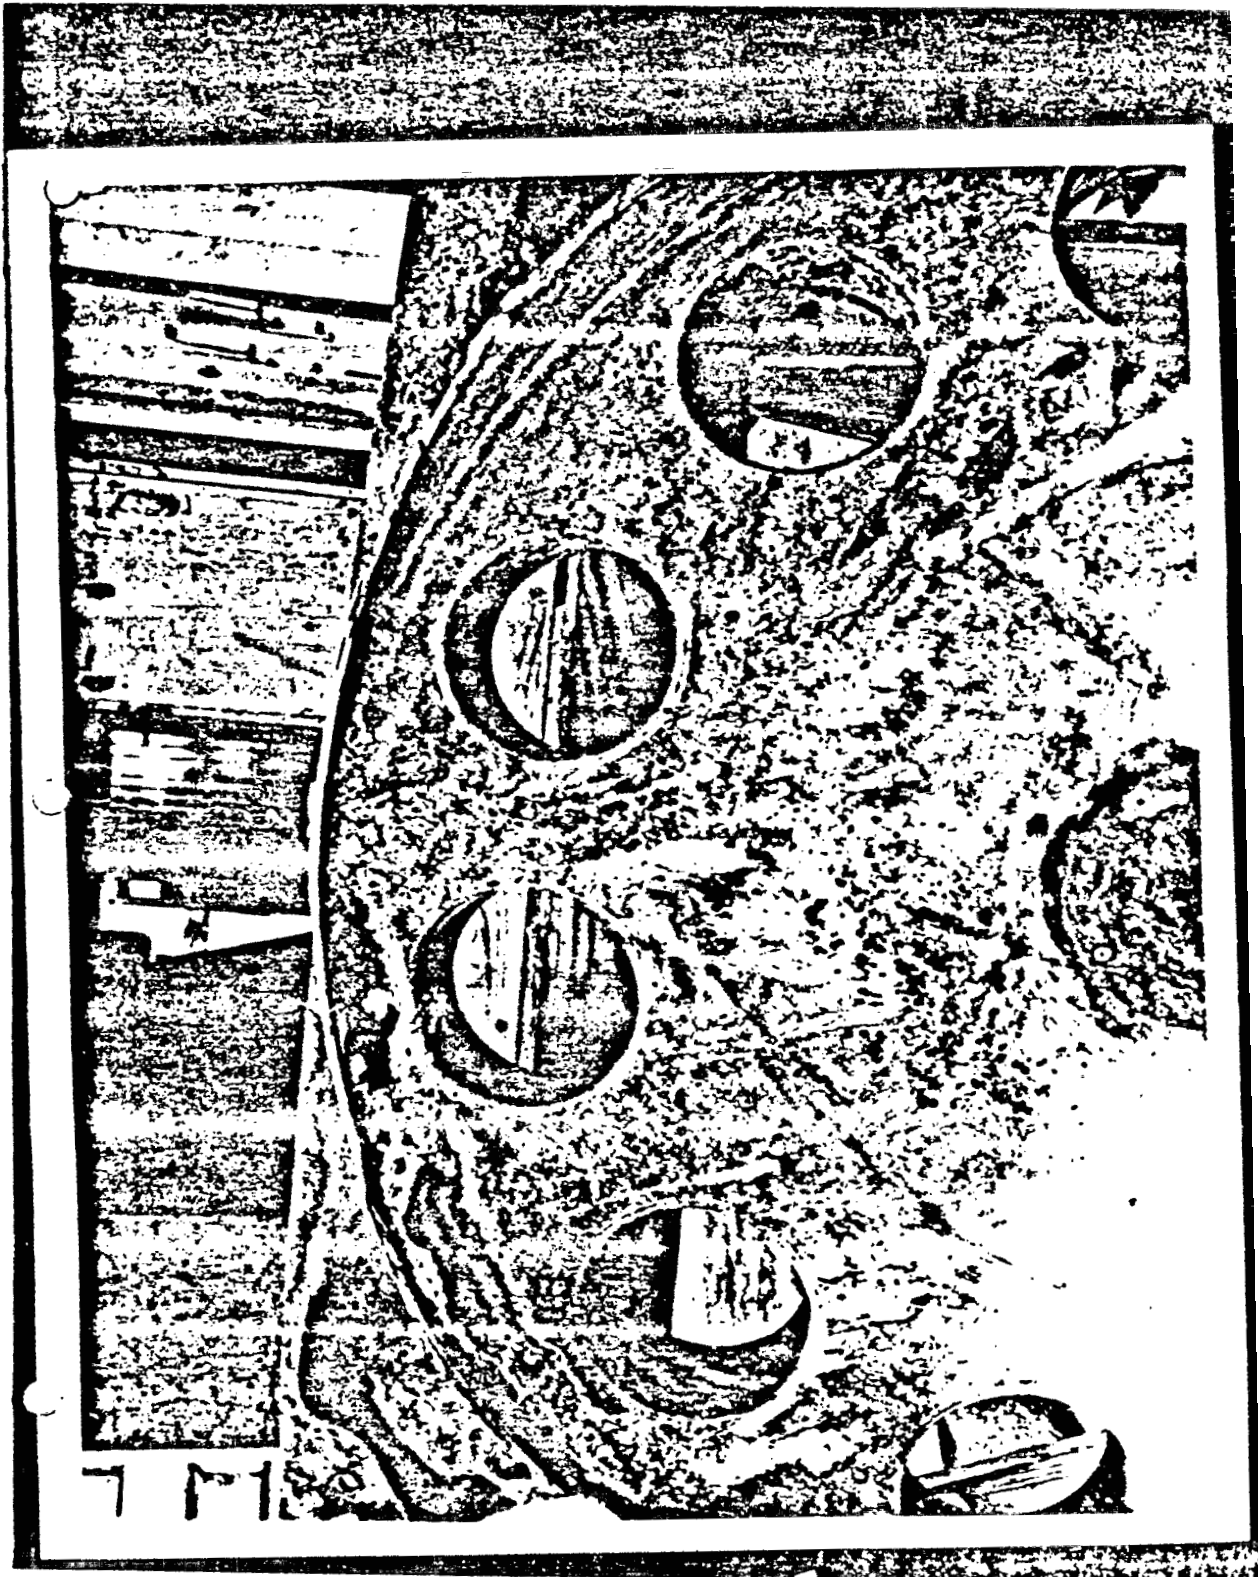
Lower Dial Assembly. Collection containers sit in the holes of the assembly.

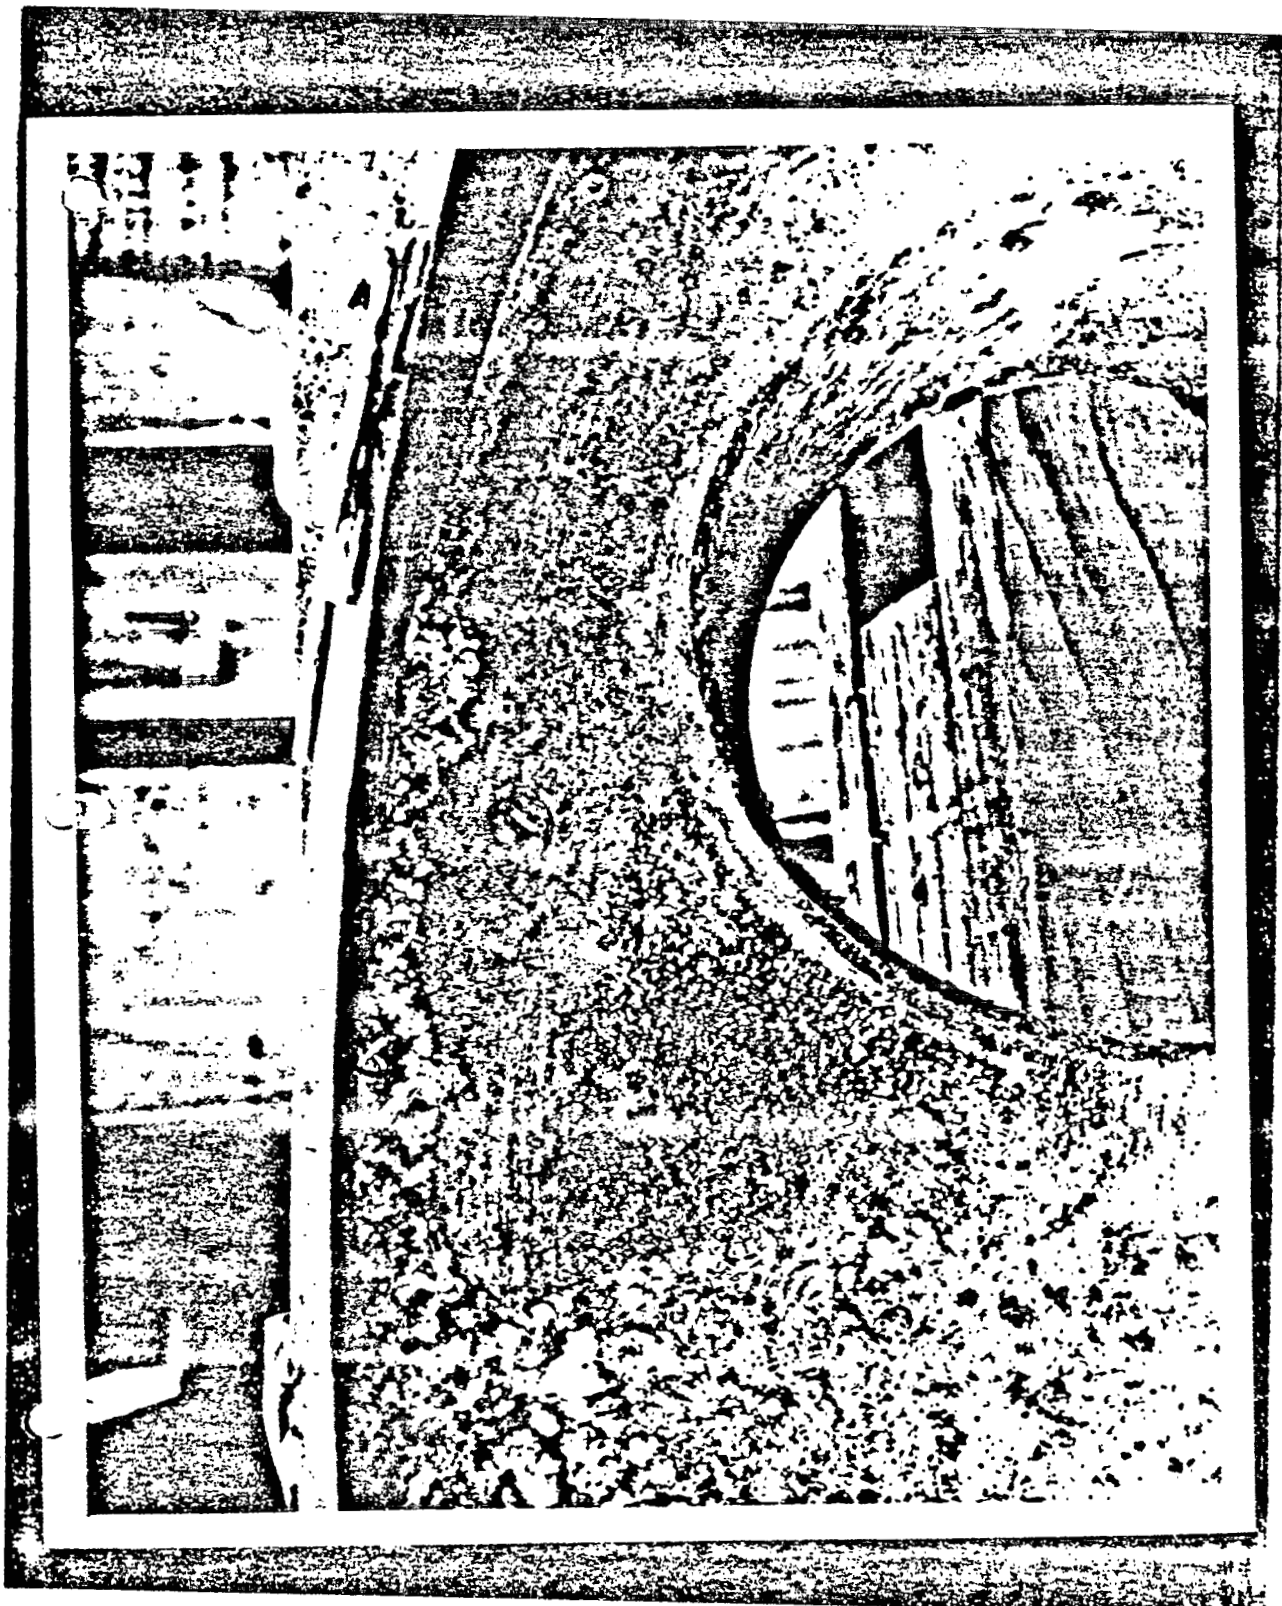
b. There was a buildup of material found between the wiper and the dial table. This material was nonconductive. The age of the material was not known. A pitted area discovered on the dial table near the 1 o'clock position. There was a corresponding mark as well as uneven wear on the dial wiper. There was also a good signature of a reaction at this location. This would indicate a probable point of initiation.

a. The most probable cause of initiation is electrostatic charge discharging between the wiper arm, collection can, and draw-off table.

b. A secondary cause of initiation is friction and heat due to varied clearances, and foreign matter buildup on the lower surfaces of the wiper blades.

Lower dial assembly near possible point of ignition.

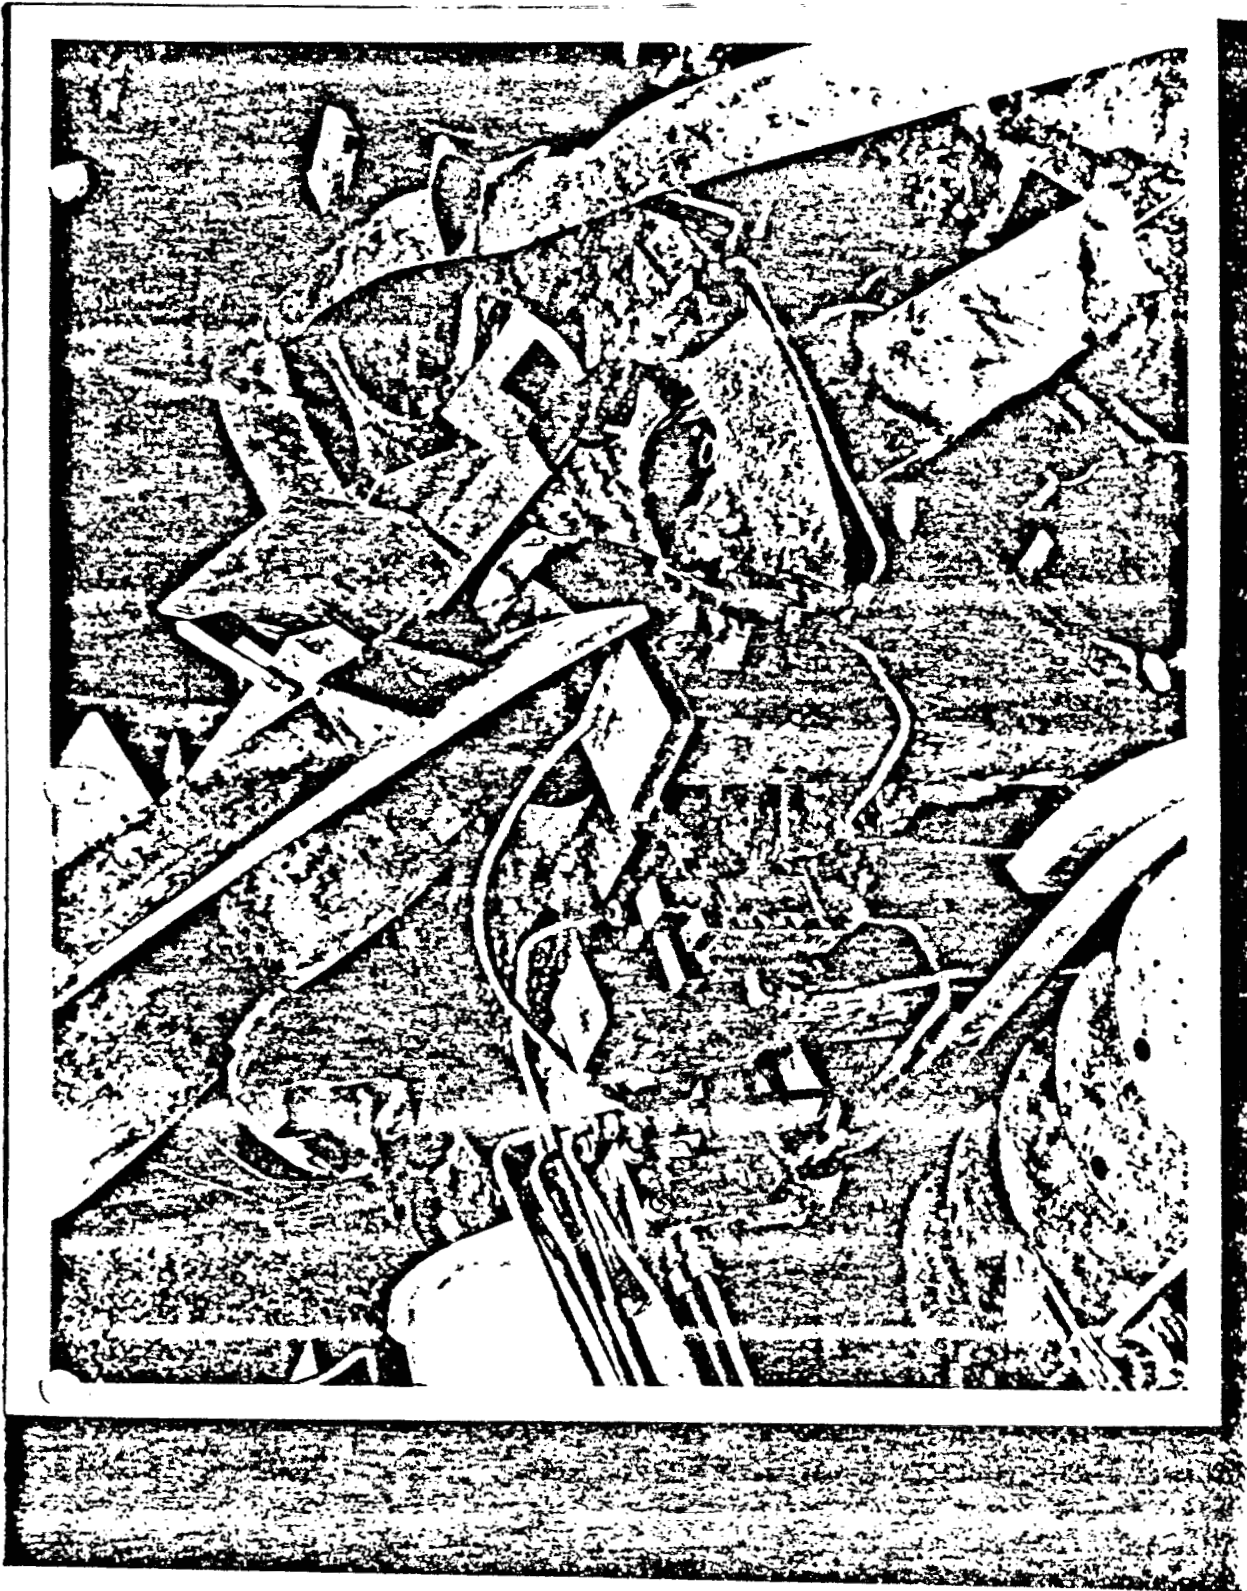
Lower assembly after the explosion is in the center of the picture.
