AVIATION BASE BUILDING  
KIRKUK, IRAQ

**SIGIR PA-06-040**  
**APRIL 12, 2006**

SUBJECT: Report on Project Assessment of the Aviation Base Building, Kirkuk, Iraq  
(Report Number SIGIR-PA-06-040)

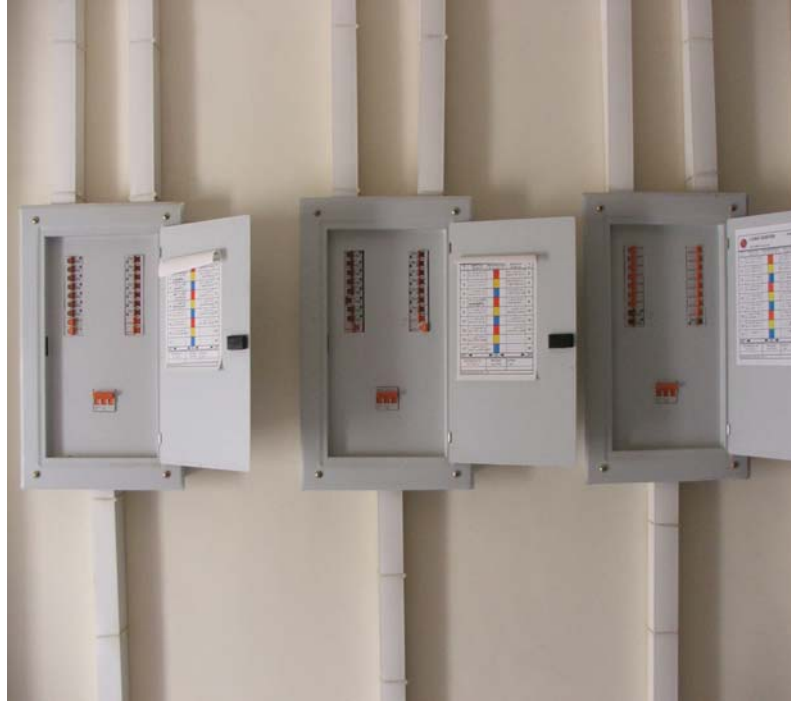
The first floor provided the Iraqi Air Force with living quarters. Currently, each room housed four Iraqi Air Force personnel with each person provided a bed, a metal locker, and lighting above the bed (Site Photo 18),. In addition, each room consisted of two windows a split air conditioning (A/C) unit, two ceiling fans (Site Photo 19), and fixed connections for all electrical equipment (Site Photo 20). We identified water leaking from windows in the living quarters (Site Photo 21) and office spaces, similar to the problems found in the aviation hangar.

**Site Photo 20. Circuit breaker**

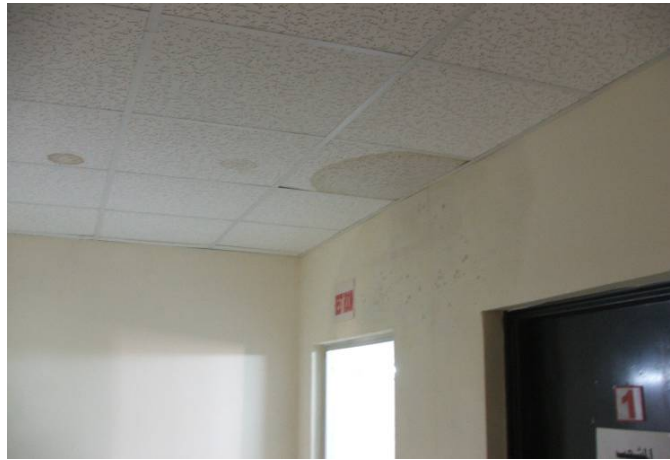
We identified plumbing issues on the ground and first floors. For example, water leaked from the first floor restroom through to the ground floor ceiling, damaging the ceiling tiles (Site Photos 27 and 28).

**Site Photo 28. Example of water leakage**

The contractor responded to the letter by making repairs under the contract’s warranty. We observed some corrective actions during the site visit. As mentioned in the site assessment section of the report (Site Photo 29), the contractor has removed the bathroom tiles to identify the cause of the leak and will correct the damage to the ground floor ceiling that was caused by the leak.

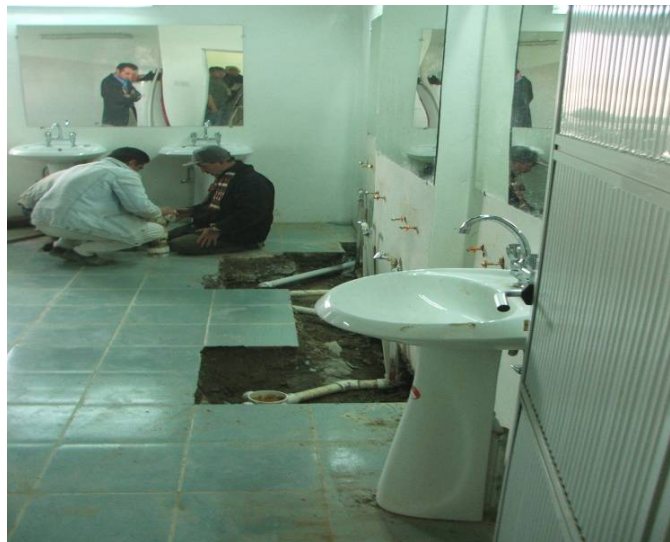
In addition, in the first floor restroom, the contractor removed floor tile in an effort to determine the cause of the leak (Site Photo 29).

**Site Photo 29. Floor tiles removed to determine cause of leak**

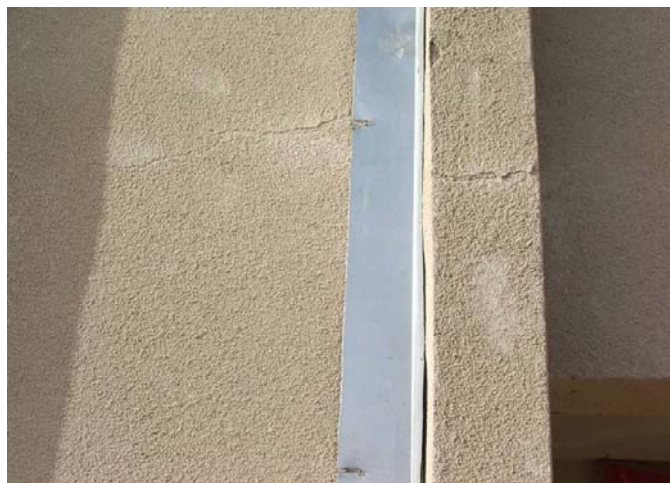
During the site assessment, we also identified minor construction issues that the contractor needs to correct under the contract's warranty. For instance, there were cracks in the outside wall stucco (Site Photo 30).

**Site Photo 30. Cracks in the outside wall stucco**
