AL KUT TRAINING ACADEMY
AL KUT, IRAQ

SIGIR PA-06-069
OCTOBER 18, 2006

SUBJECT: Report on Project Assessment of the Al Kut Training Academy,
Al Kut, Iraq (Report Number SIGIR-PA-06-069)

Al Kut Training Academy, Al Kut, Iraq

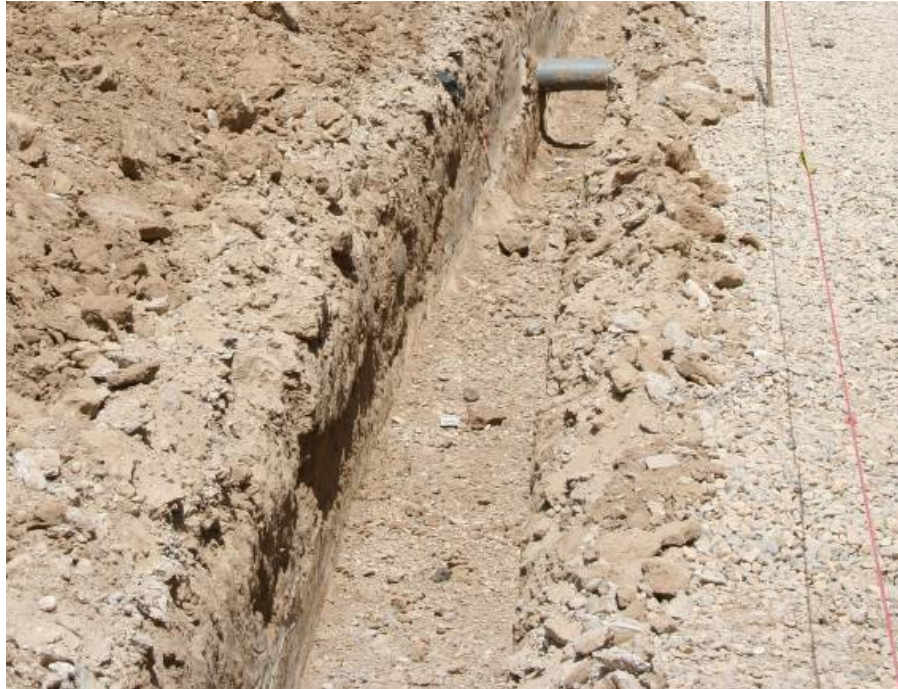
The contractor's original design was a simple septic system comprised of three main tanks. Based on the SIGIR engineer's calculations and a review of the contractor's design, the septic tank capacity varied significantly from actual requirements. In short, the septic tanks installed were substantially undersized. As the population of the academy increased during the early stages of facility operation, the unexpected waste volume and on-site drainage limitations spawned a serious problem. The soil proved to be hard with little drainage capacity and the contractor's design for the septic tank systems did not call for drain fields. During the assessment, the contractor's Program Manager confirmed that a perc test (percolation test) to determine the soil absorption rate for a septic drain field or "leach field" was never conducted. Site Photo 9 shows the nonporous soil.

Site Photo 9. Machine polished trench sidewall soil.

To alleviate the problem over the long term, a SOW modification pending at the time of our site visit called for a buried pressure line connecting the three separate septic tanks in order to pump the effluent underground to the “Dead River”. While original septic tank sizing and placement did not accurately account for soil conditions or daily volume input, the pending SOW, as modified, will alleviate the overflow problem.

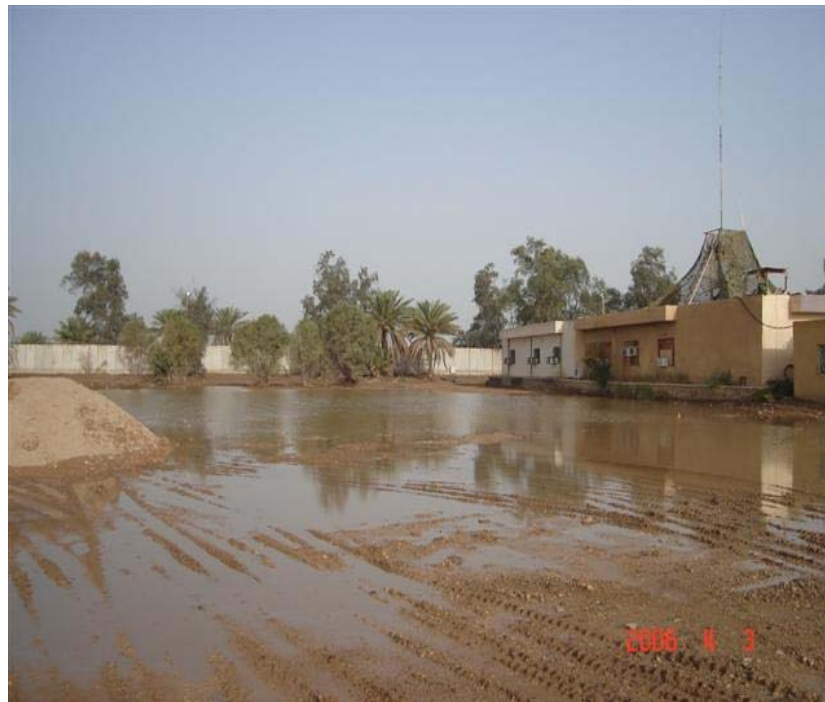
Rather than utilizing a drain field system, the permeable septic tanks were designed to depend on pump trucks to remove excess effluent. However, the contractor's design did not meet requirement because it did not support academy needs in terms of daily volume. When coupled with insufficient soil drainage and limited pump truck capacity, substantial excess waste water overflowed from the septic system. Site Photo 10 shows waste water overflow standing on academy grounds.

Site Photo 10. Standing waste water (Photo courtesy of ECCI).

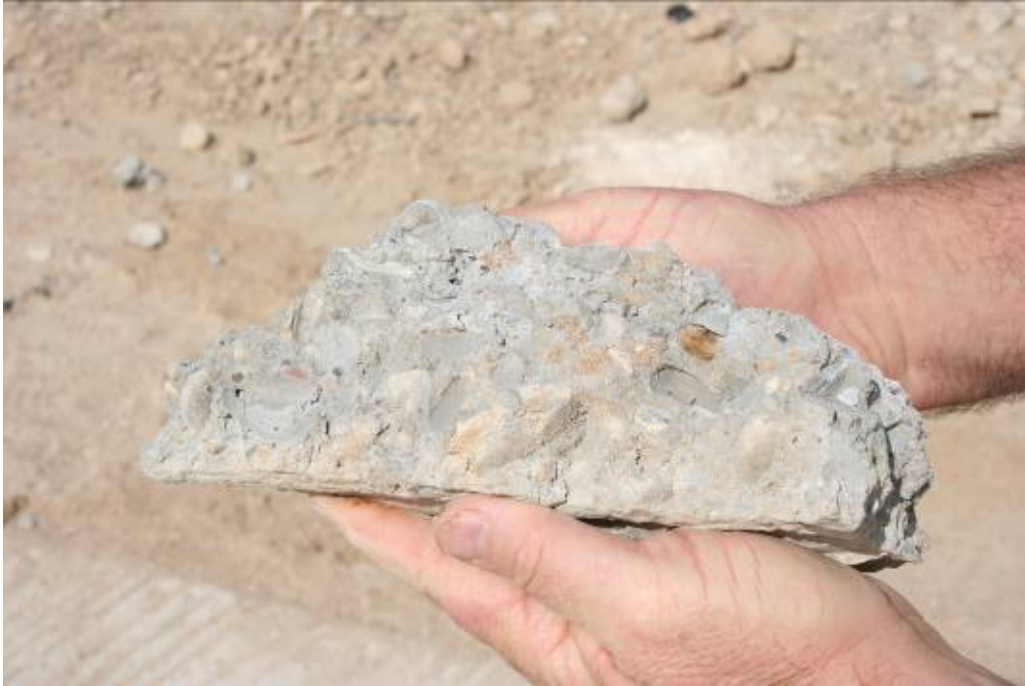
While on site, the assessment team observed that a section of roadway was poured with no hydration until much later in the day. July afternoon temperatures at Al Kut often exceed 110 degrees Fahrenheit. In addition, the team observed that the concrete was not cast to the full thickness of the roadway along the long edge of the casting. Rather, the fresh concrete was layered unevenly over the existing roadway. Site Photo 18 shows the casting just described. Several meters away on the same road, a SIGIR Inspector easily pulled up several pieces of cured cement by hand, without the aid of a tool. The concrete aggregate appeared too large and likely was mixed with an insufficient quantity of water, resulting in concrete that was weak and crumbly. Site Photo 19 shows a piece of concrete removed by hand while Site Photo 20 shows the crumbly nature of the roadway.

Site Photo 19. Concrete piece pulled from roadway by hand.

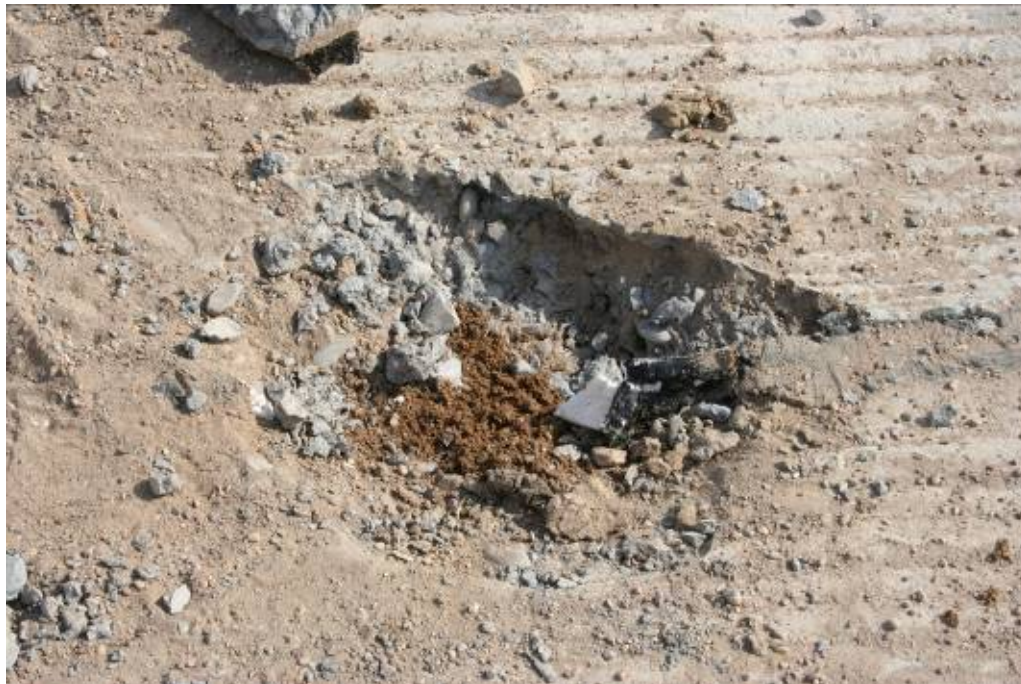
Site Photo 20. Roadway where piece was removed.

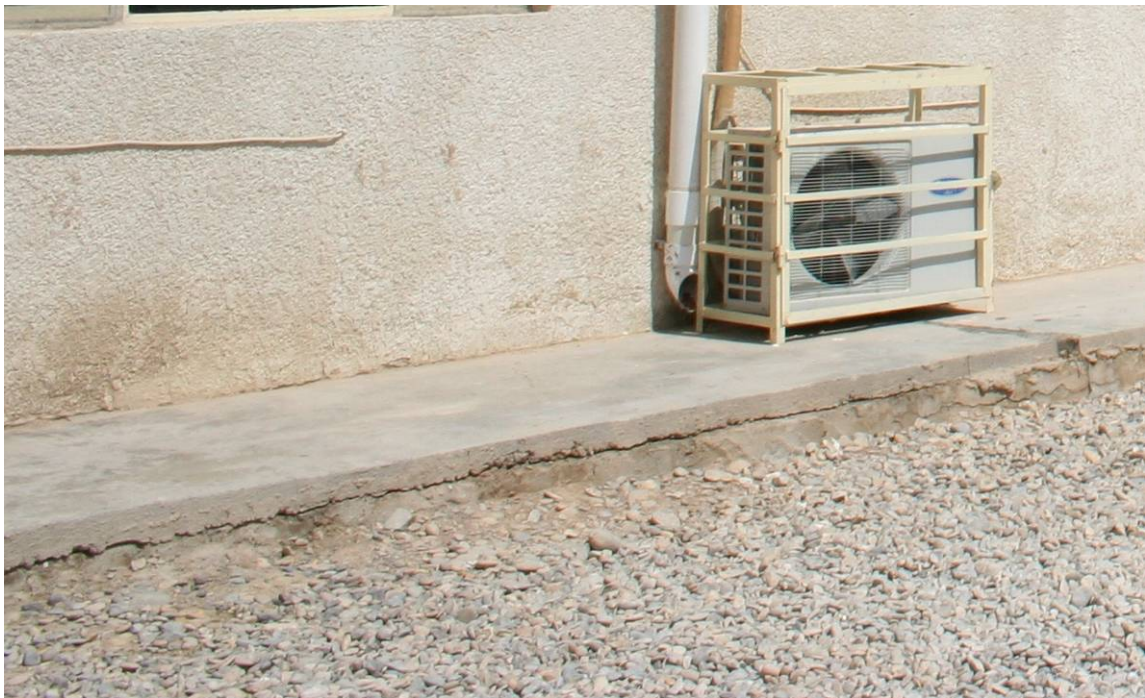
During the site visit, the team observed horizontal fractures that ran along almost the entire perimeter of the newly constructed middle and eastern barracks building foundations. Site Photos 22 and 23 show the described fractures. In addition, similar, but less obvious, horizontal fissures were observed on the second floors of the dormitories.

Site Photo 22. Horizontal fracturing along foundation of middle barracks.

During the assessment, the team was told by the contractor's Project Manager that concrete placement was conducted using small batches mixed by hand. Small hand batch mixing and improper joining techniques could have contributed to the horizontal fractures due to lack of consistency between the numerous small batches mixed by hand. For practicality reasons, each small batch was not subjected to a slump test.

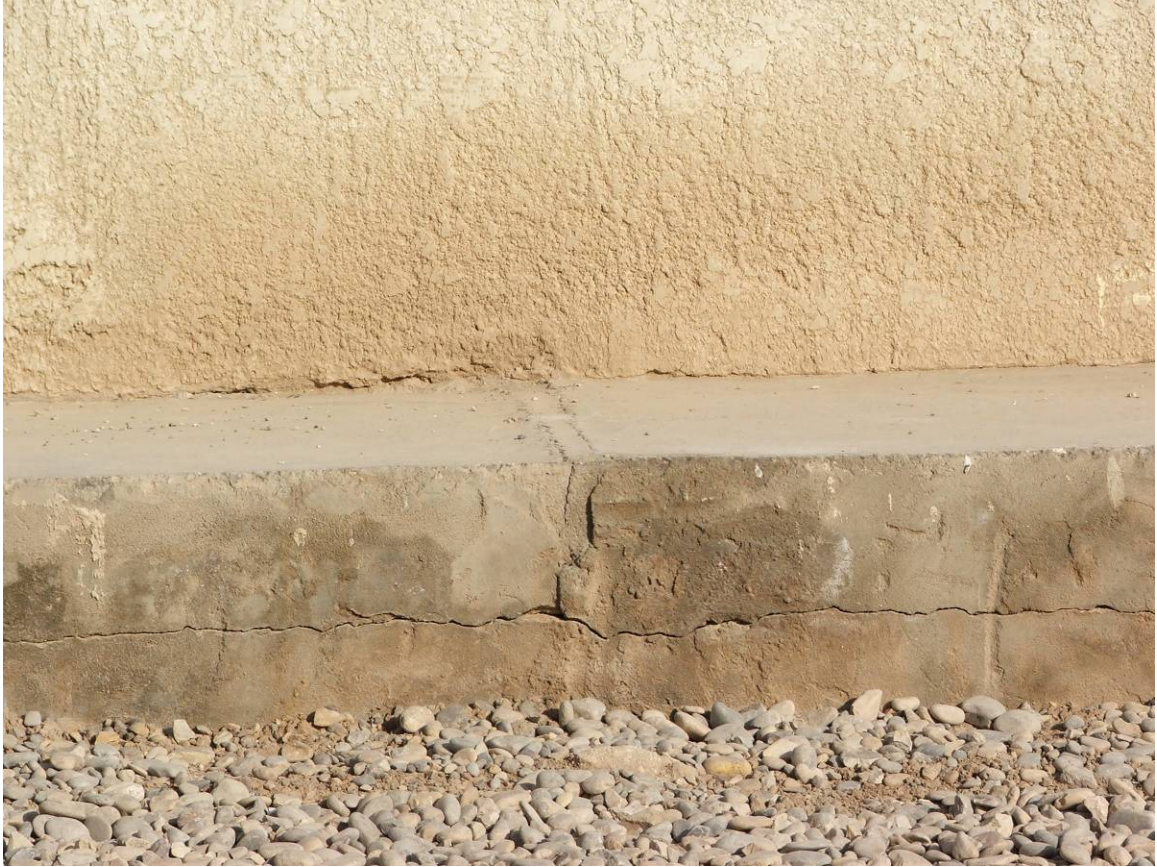
Site Photo 23. East barracks horizontal foundation fracture.

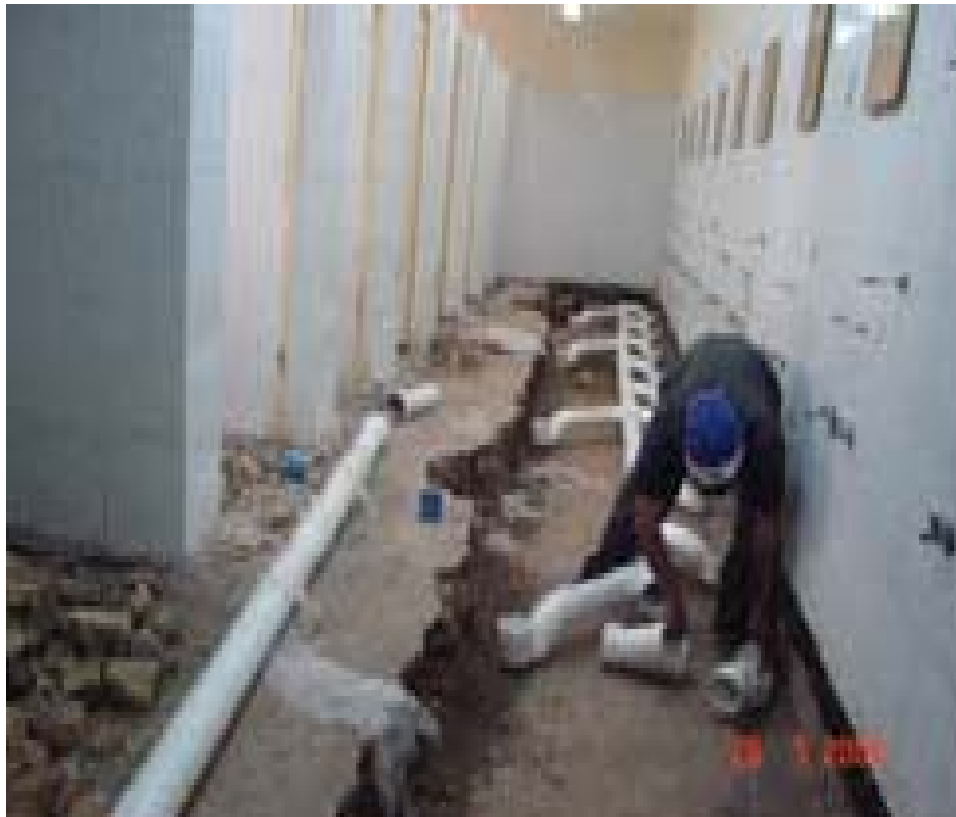
As a result, routine construction deficiencies not detected and corrected as they occurred turned into much larger rework issues. For example, dormitory building D-1 was accepted via DD Form 1354 dated 31 August 2005. However, extensive rework was required within the bathroom to correct the defective construction that should have been detected, monitored, and corrected during construction (Site Photo 24). Specifically, the connections between the smaller diameter feeder drain lines and the larger diameter main drain line system were not water tight because positive connection (glued or threaded) reducers and fittings were not used until the deficiency was corrected in March 2006 (Site Photo 25).

Site Photo 24. Extensive rework in progress (Photo courtesy of ECC).

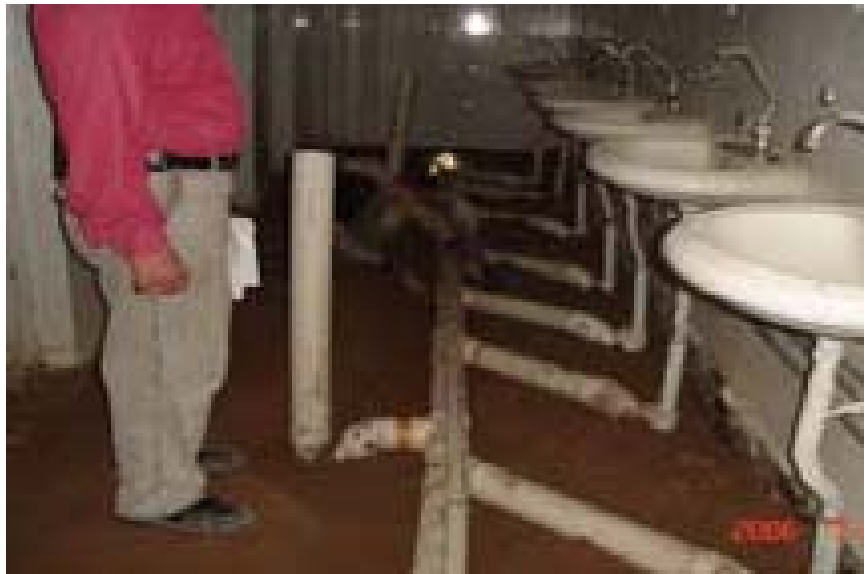
Site Photo 25. Reducers and fittings, before rework, were not water tight (Photo courtesy of ECC).

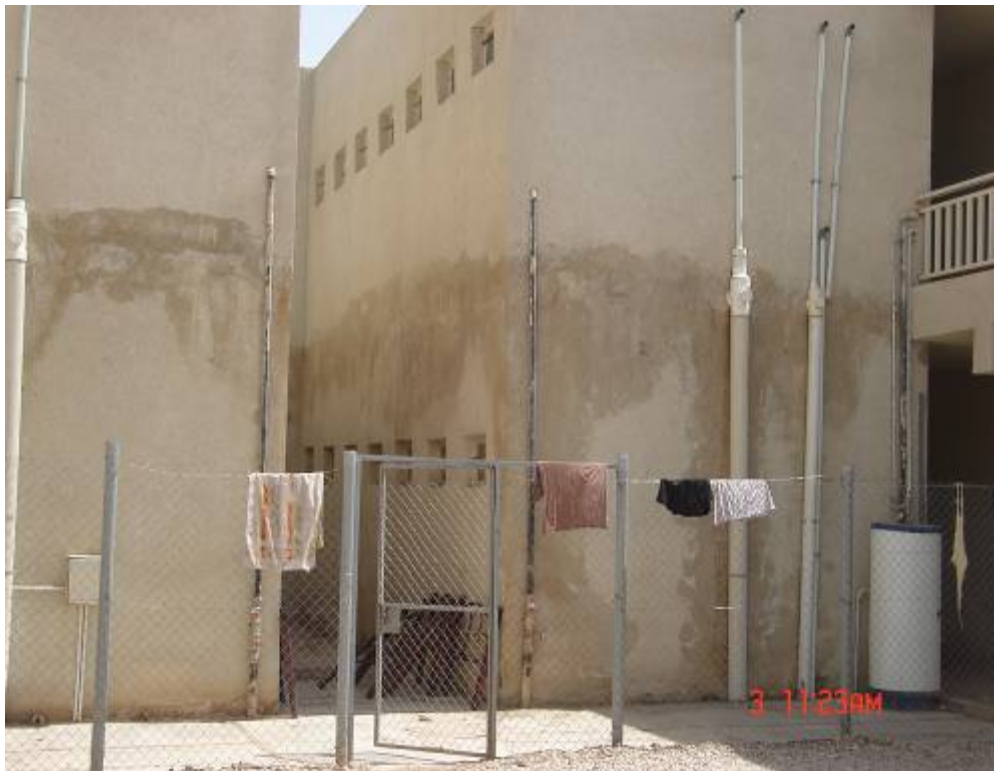
In another very similar example, dormitory building D-4 was accepted via DD1354 on 9 December 2005, but a serious plumbing leak was not reported by QA personnel until 20 April 2006. A photo taken by the government representative on 20 April 2006 shows that substantial water volume migrated subsurface within the second story floor to the outside walls of the building (Site Photo 26).

Site Photo 26. Water stains from improper plumbing (Photo courtesy of ECCI).

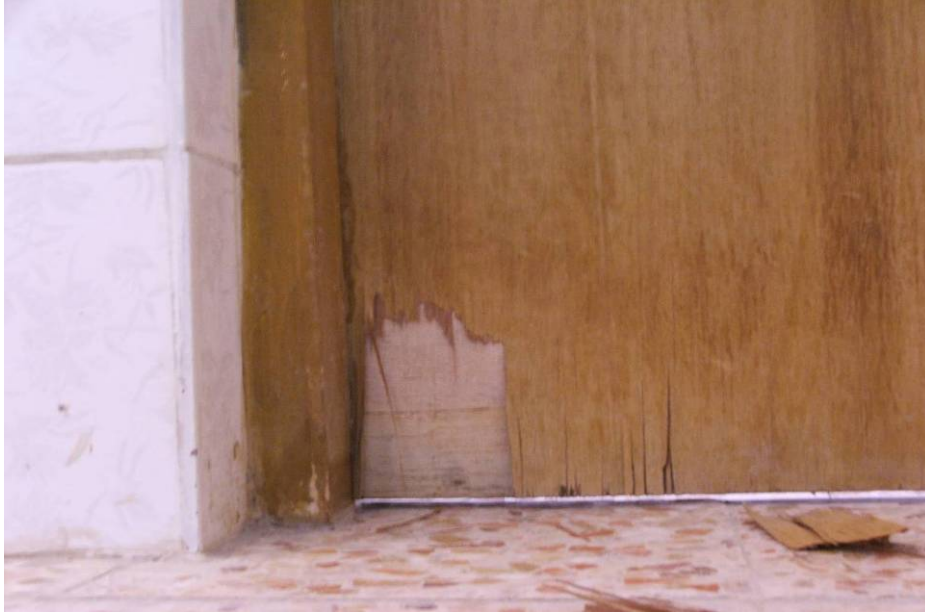
Comparisons of acceptable and not acceptable workmanship for the same task demonstrate the impact of inadequate QM oversight. In the first comparison, the metal roof cover material (Site Photo 27) fastened with too few and improperly located hooks/fasteners to secure the roof cover was compared to properly fastened tin (Site Photo 28) where a fastener was located at tangent points between the tin and the angle iron frame. The second comparison shows water damage to a plywood door improperly hung too close to a wet floor area in a bathroom (Site Photo 29) compared to a door in an adjacent stall properly hung approximately 1” above the floor (Site Photo 30).

Site Photo 29. Water damaged door installed too close to the floor.
