# HADITHA DAM PERIMETER SECURITY HADITHA, IRAQ

## SUSTAINMENT ASSESSMENT

**SIGIR PA-09-192**  
**APRIL 13, 2010**

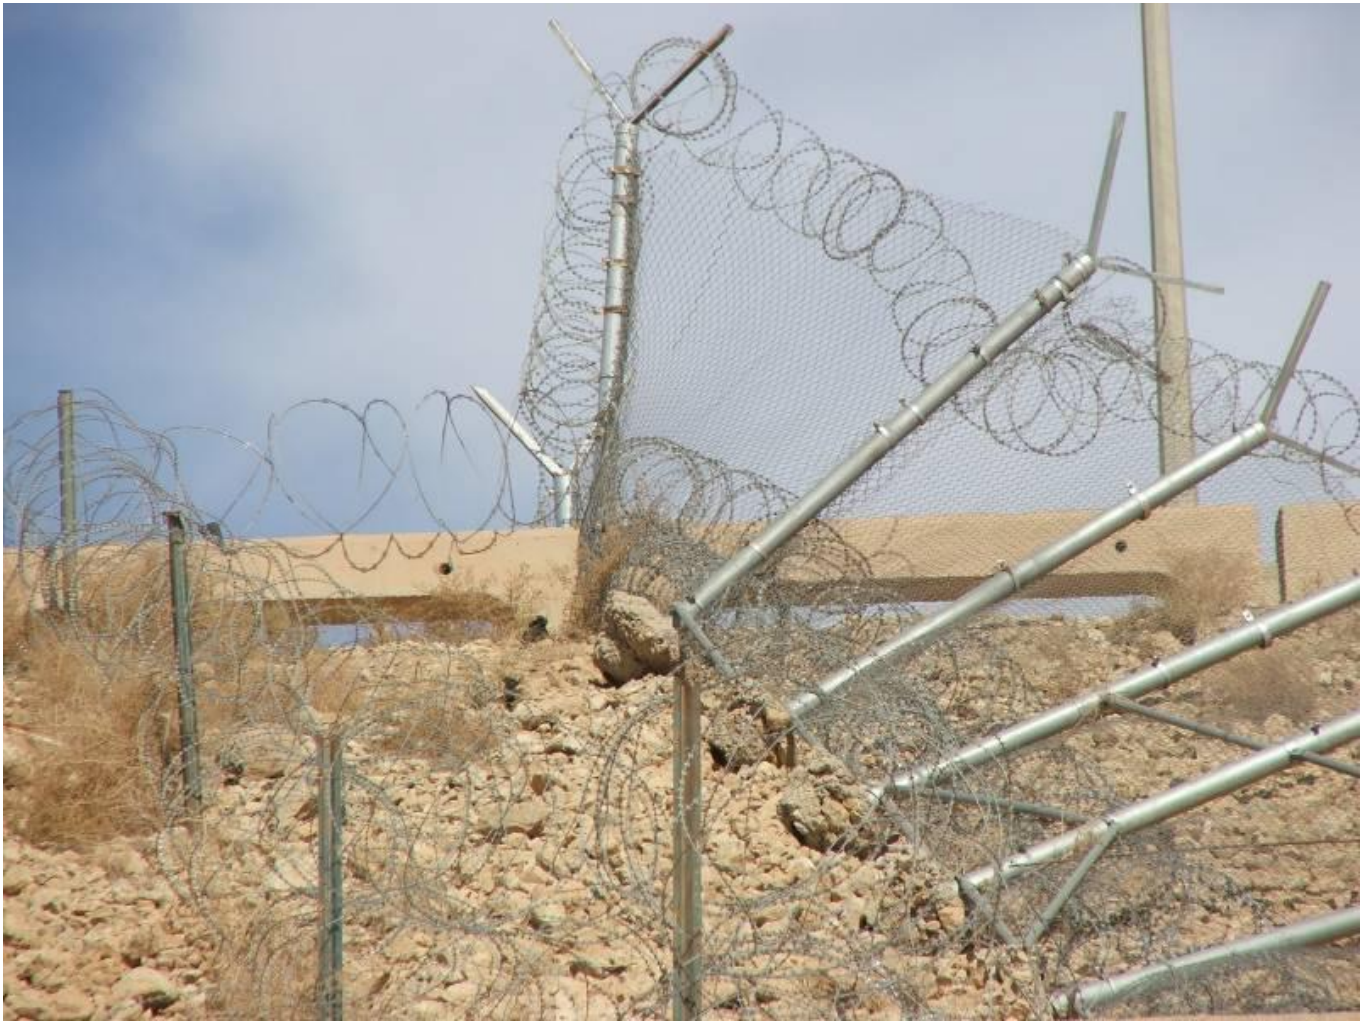
During the site assessment, SIGIR observed a fallen fence line approximately 150 feet long. The fallen fence section was located on the southern face of the dam and traversed the slope from the base of the dam to the paved road along the dam's breast<sup>6</sup> (Site Photos 4 and 5).

**Site Photo 5. Failed fence section, upper end**

After the inspection, it was determined that the fallen fence line poles were in the ground less than 0.5 meters. The Al Asad Resident Office stated that the contractor will replace and set the poles in concrete to the proper depth. In addition, approximately 10% of the remaining fence poles will be reset.

1. Replace and repair the collapsed fence line.
2. Reset the remaining fence poles that were not set to their proper depth.
3. Implement controls to ensure that the contractor provides daily quality control reports of the corrective actions taken for the deficiencies.

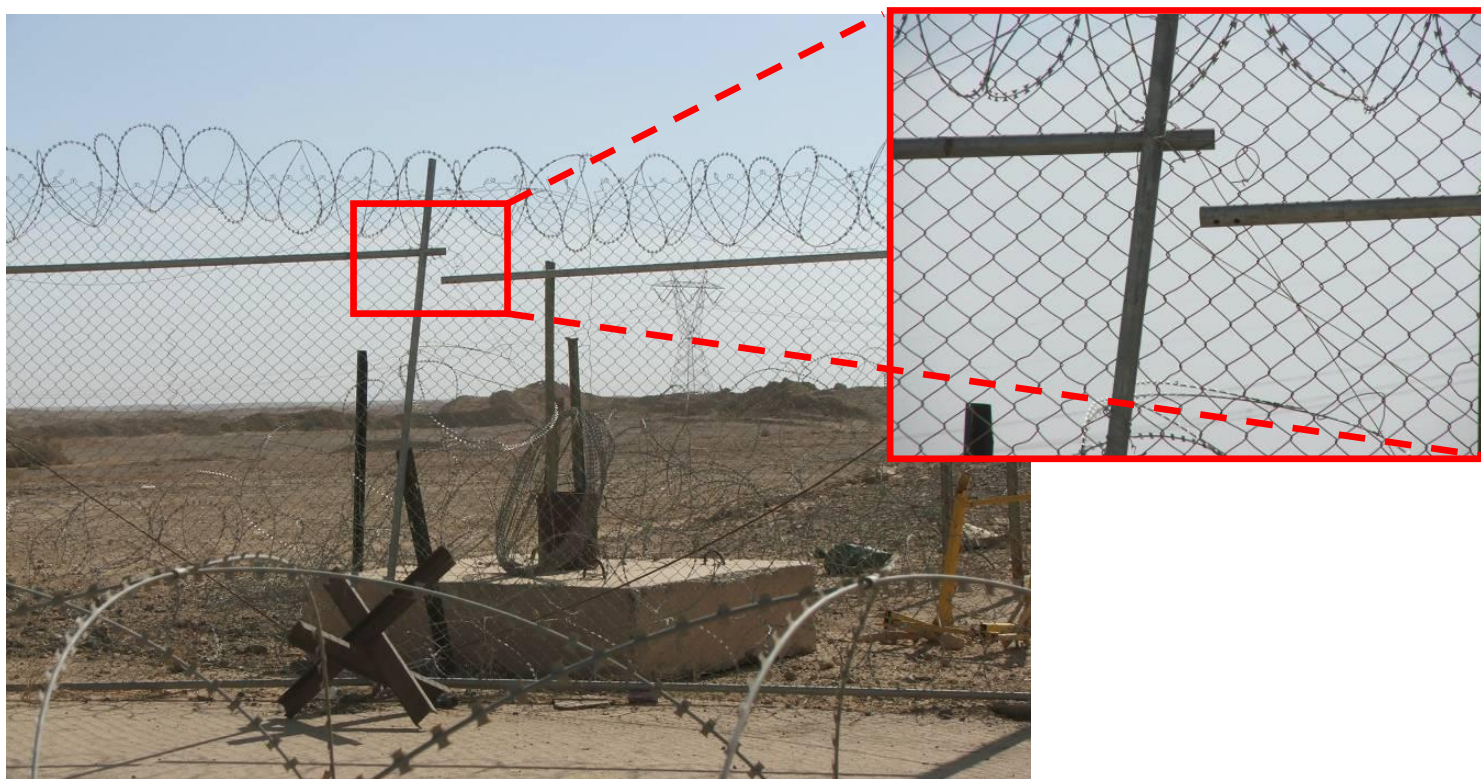
The section of fence adjacent to the gate was broken and was inadequately repaired (Site Photo 12). According to Iraqi Army representatives, the fence fell apart. Iraqi Army representatives attempted to repair the fence with materials on hand.

**Site Photo 12. Broken fence near entry gate**

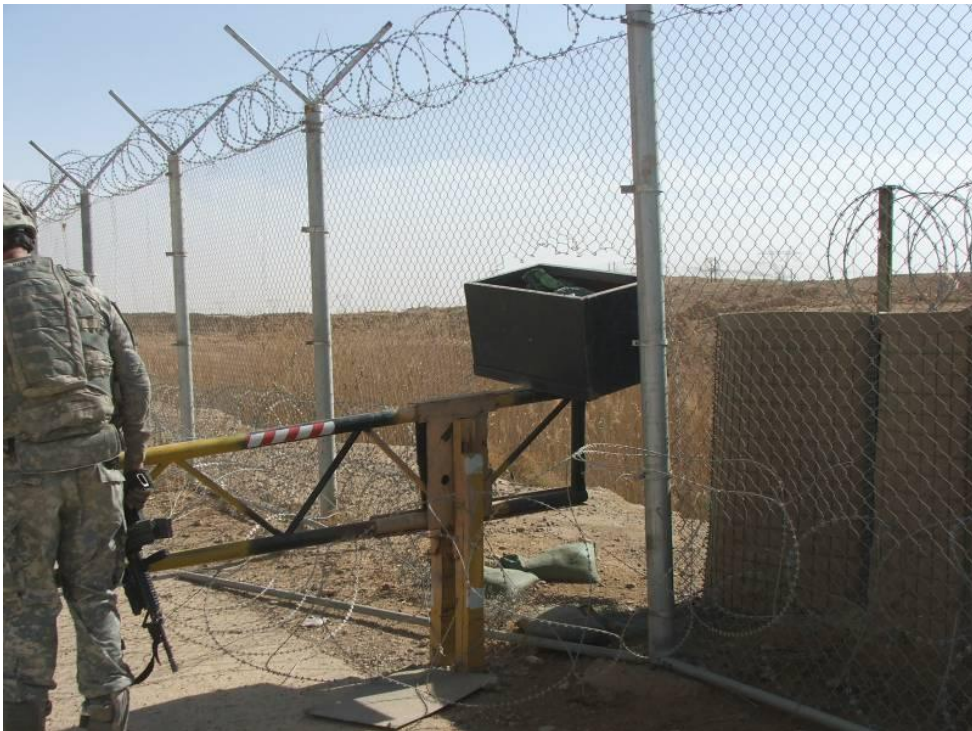
The lifting gate was misaligned and was damaged (Site Photo 13). The location of the lifting gate was poorly planned because the security fence was modified (not in accordance with the design) to accommodate the location of the lifting gate, leaving a significant gap in the chain link fabric (Site Photo 14).

**Site Photo 14. Lifting gate with modified fence**
