**HUMER KWER HEALTH CENTER  
SULAYMANIYAH, IRAQ**

**SUSTAINMENT ASSESSMENT**

**SIGIR PA-09-186  
APRIL 20, 2010**

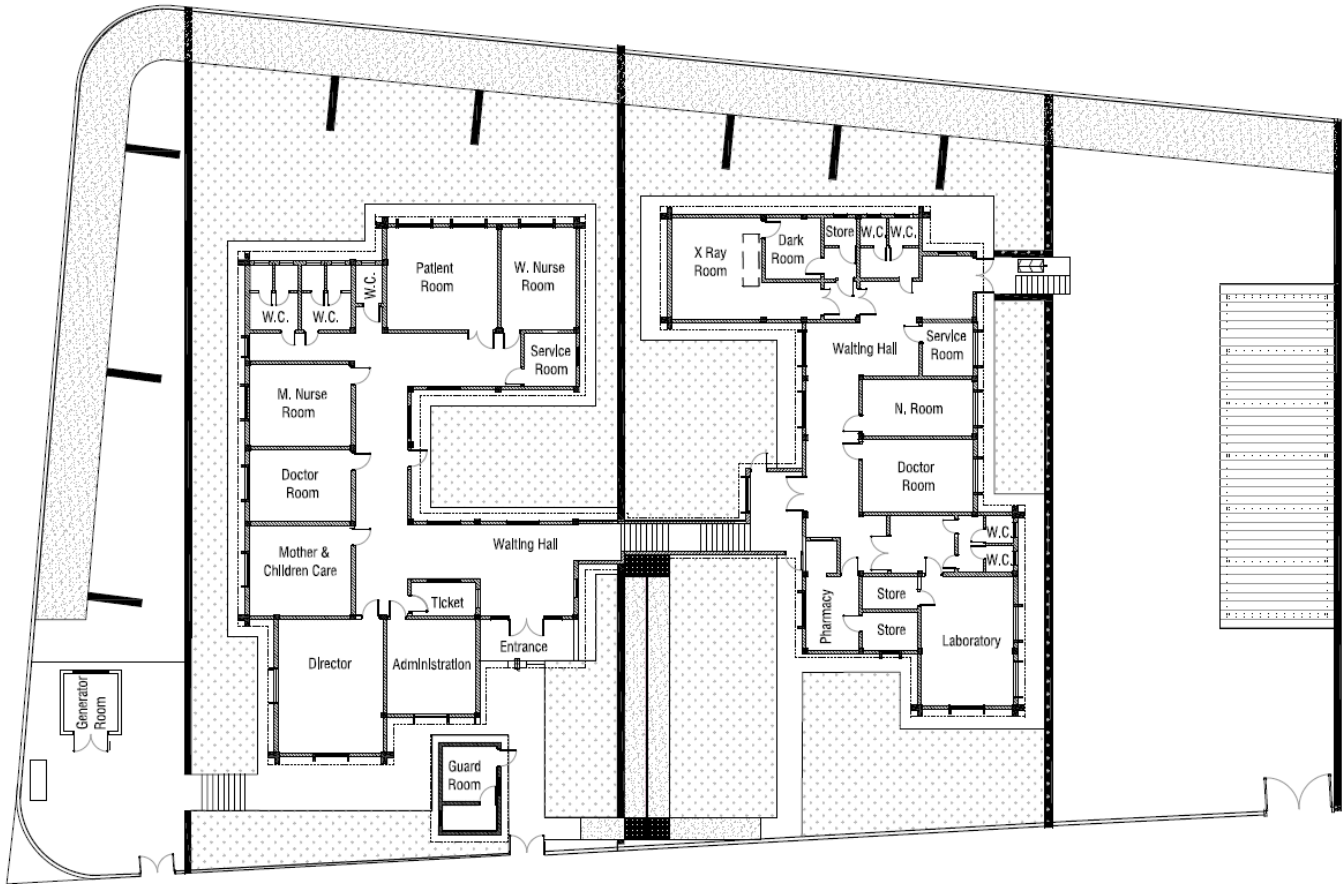
**Figure 1. Humer Kwer Health Center project site plan  
(Courtesy of GRN)**

An exterior ramp is shown connecting the upper and lower levels of the building. The ramp is fairly long, and contains one intermediate landing. The design slope for the ramp is 10%. This is a difficult grade for handicapped individuals to traverse.

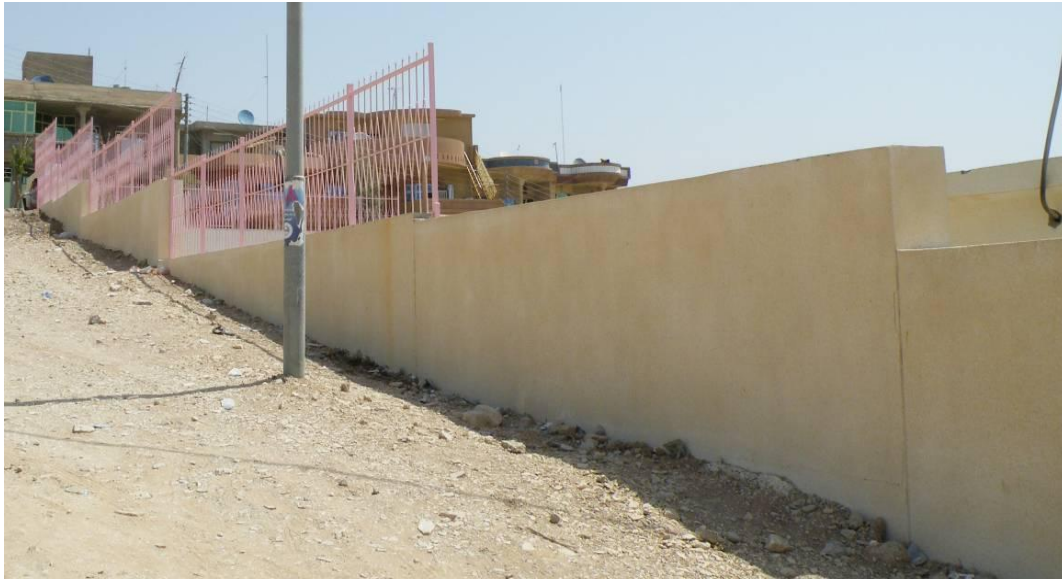
**Site Photo 5. Security fence atop perimeter wall**

(Site Photo 5). The security wall appeared to be constructed plumb and level, and was stepped to accommodate the steep grade. The wall appeared sound with no apparent cracking or settlement. Three entry points to the facility were constructed with locking steel gates placed at each opening.

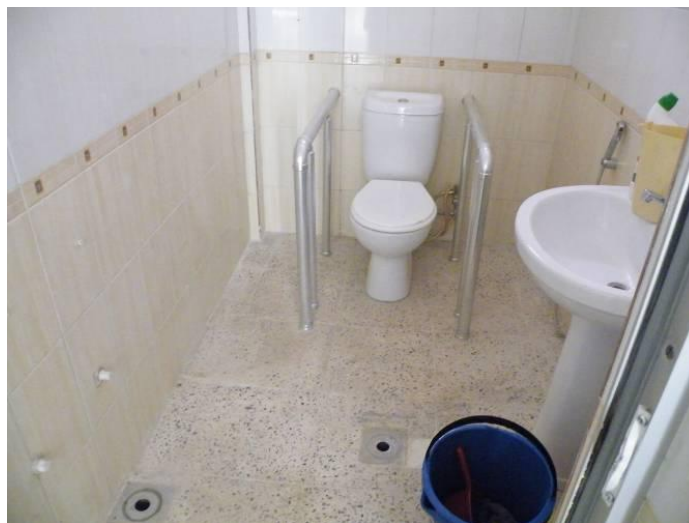
**Site Photo 10. Accessible restroom**

The upper level contained both conventional and physically-challenged accessible restrooms. The restrooms' construction quality appeared good with no cracked, loose, or missing tile (Site Photo 10). All fixtures and grab bars were firmly attached to the structure. At the time of the site assessment, the restrooms were functioning and relatively clean.
