# Inspector General

Public Works Operations  
at U.S. Army Garrison-Yongsan, Korea

| Report Documentation Page | | | | Form Approved<br>OMB No. 0704-0188 | |
|---|---|---|---|---|---|
| 1. REPORT DATE<br><b>04 MAY 2010</b> | | 2. REPORT TYPE | | 3. DATES COVERED<br><b>00-00-2010 to 00-00-2010</b> | |

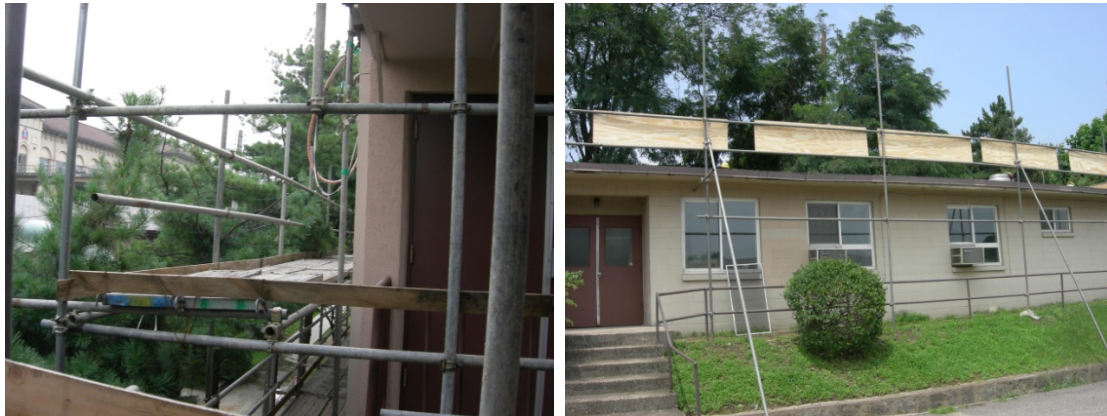
**Figure 1. Scaffolding Around a Building    Figure 2. Fall Protection for Roof Work**

DPW spent \$309,000 (46.5 percent) of the cost of the 27 DOs for “scaffolding” used primarily for fall protection for roofing work. The cost of the scaffolding for this contract was KRW2,050 per square foot, much higher than the IGCE of KRW1,258 per square foot in the existing General Repair Contract. The IDIQ contract for painting had a line item priced at KRW113 per square foot for scaffolding.
