AFRL-RX-TY-TR-2009-4608

## **SMOOTHNESS EVALUATION OF EXPEDIENT REPAIRS AT AVON PARK**

APR Consultants, Inc.  
27 Oaklawn Avenue  
Medway, OH 45341-1117

NOVEMBER 2009

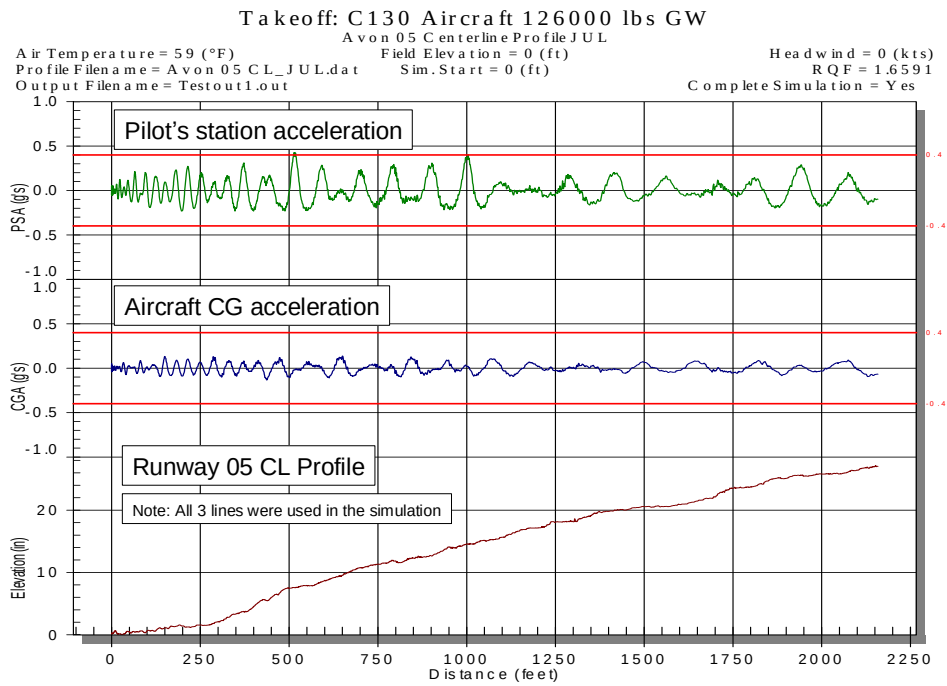
**Figure A-66: C-130 Takeoff on Avon Runway 05 Before Damage**

Figure 68 is a C-130 takeoff on the undamaged Runway 05 profiles. The plotted result is typical for C-130 operations on an aging commercial runway. Full length profiles were simulated for the centerline (CL) and 5 feet left and right of the CL before the crater exercise. Figure 69 is a C-130 takeoff on the same runway after the expedient repairs were made. The takeoff simulation produced moderate aircraft response which was a surprising result. The term moderate is based on the g-level experienced at the cockpit pilot station (PS) and/or the aircraft center of gravity (CG). Moderate, as defined by APR's experience, is multiple events where the acceleration is above .6 g. The C-130 is very capable of rough field operations; consequently, little response was expected on the repaired Avon Park runway. However, the moderate accelerations produced at the cockpit indicate that a resonant loading condition was occurring. This was caused by the fact that multiple repairs were involved. Just as the aircraft was rebounding from one bump, another was encountered. It should be noted that the moderate response predicted for C-130 is not enough to prevent operations, but could reduce aircraft fatigue life and increase operational maintenance.

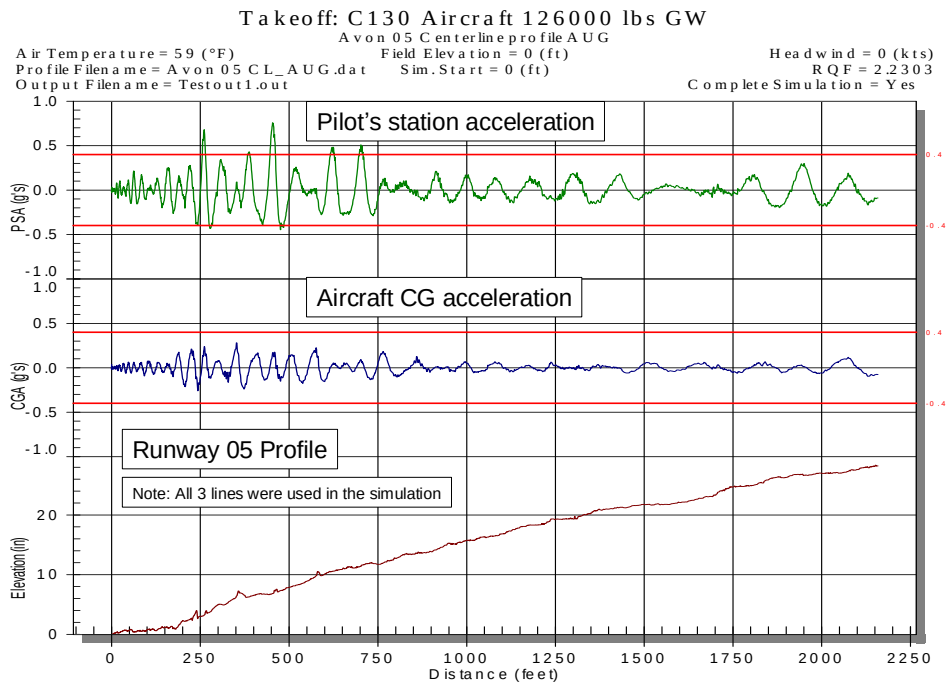
**Figure A-67: C-130 Takeoff on Avon Runway 05 After Expedient Repairs**

The repairs were encountered at a speed that was tuned to the natural frequency of the C-130. The speed that section 1 was encountered began at 30 knots and ended at 43 knots. Had the section 1 repairs been located on another section of the runway, they would not have caused a moderate response. Figure A-68 shows that the response is acceptable if the threshold is displaced just 500 feet.

F-16 and C-130 takeoff, landing and 60-knot taxi simulations were made on the repaired runway. The takeoff simulations showed surprisingly significant aircraft response particularly for the C-130 aircraft which is very capable when operating on rough runways. It became evident that multiple repairs spaced relatively close to each other cause a resonant response with the C-130. This is a significant finding. Landing simulations showed little change between before and after expedient repairs.

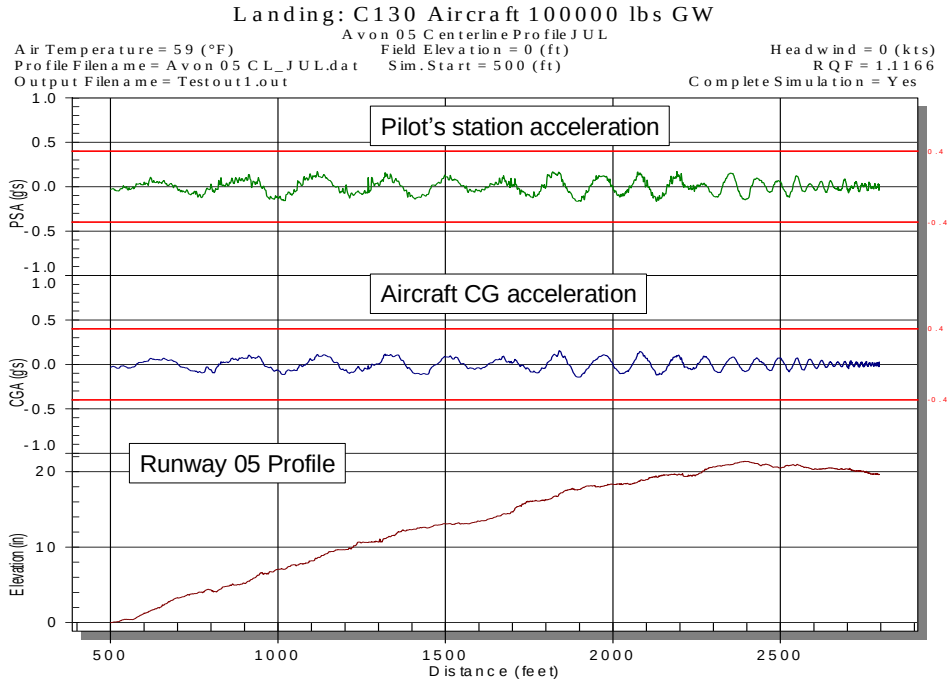
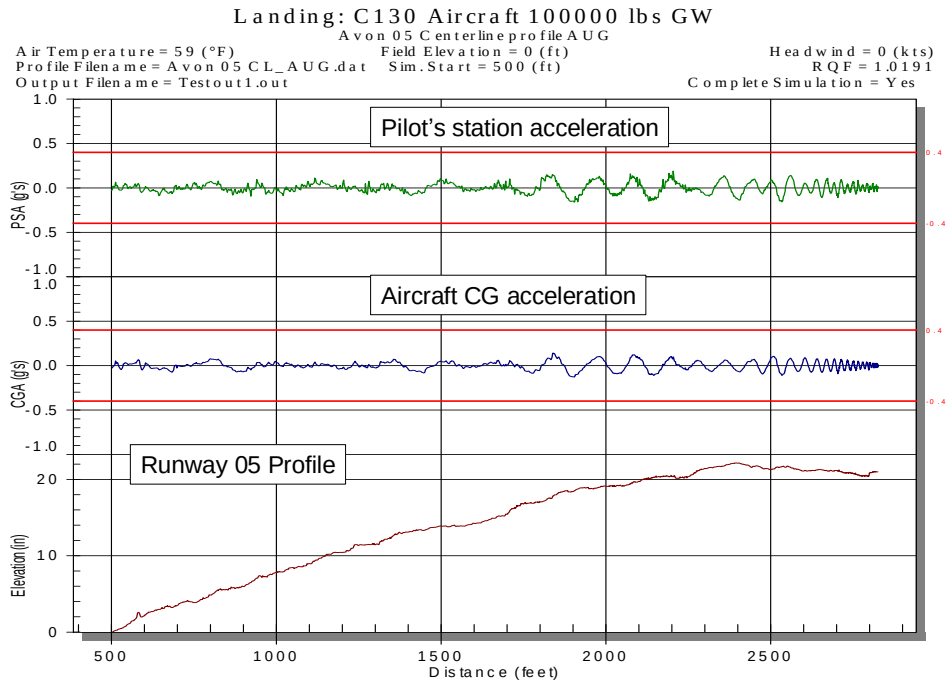
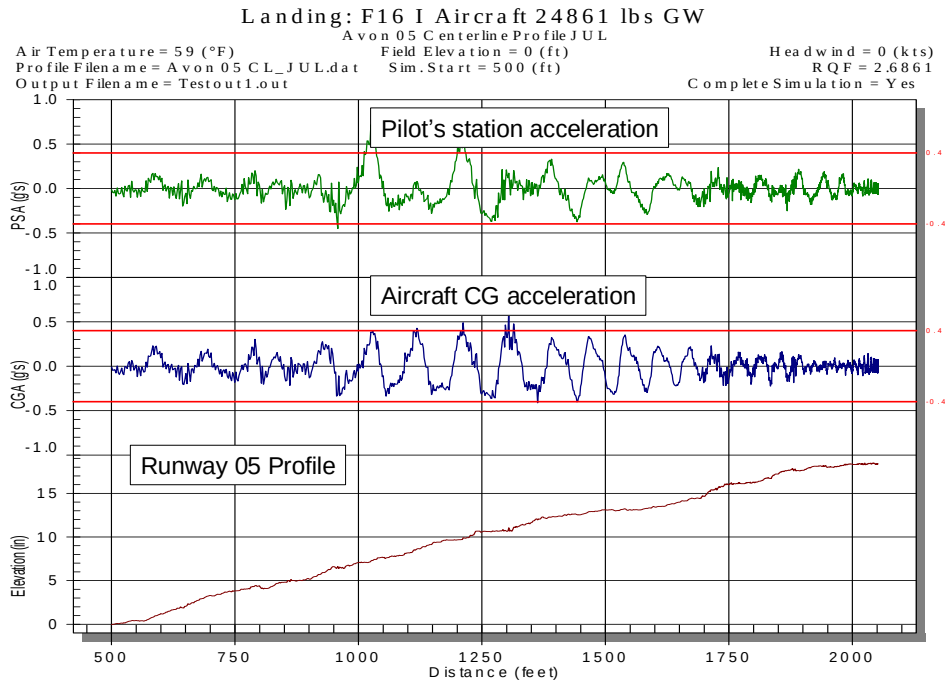
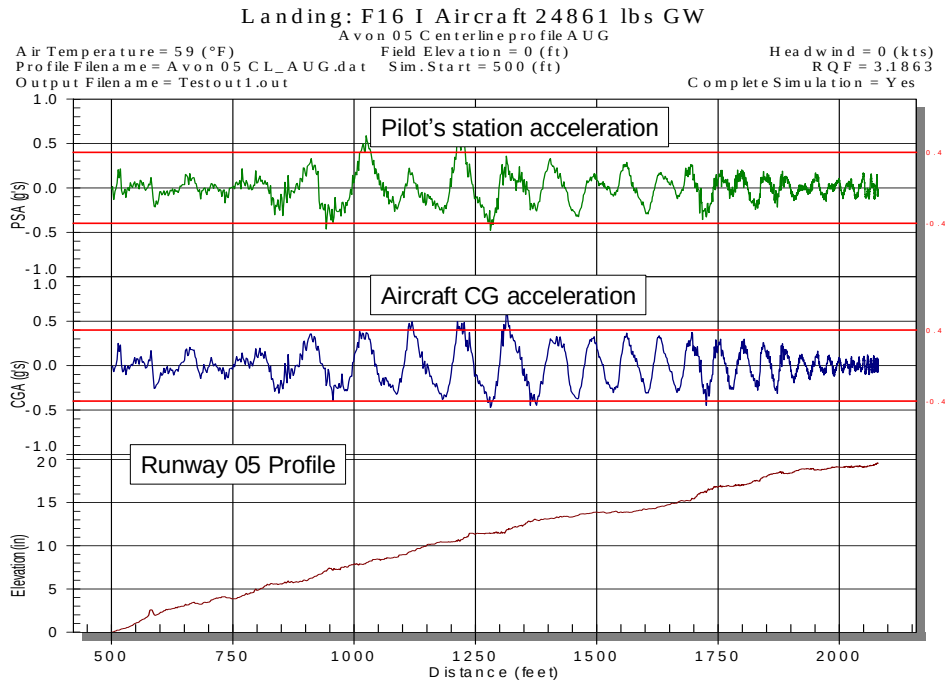
Several landing simulations were also conducted. Figures A-72 through A-75 show that the repairs had very little impact on the F-16 or C-130 response.
