## **Reducing Fracture Tendencies in PCBN FSW Tools**

ONR Contract Number N00014-09-C-0288

### **Base Effort Final Report**

David Marshall  
Teledyne Scientific Co. LLC  
1049 Camino Dos Rios  
Thousand Oaks, CA 91360

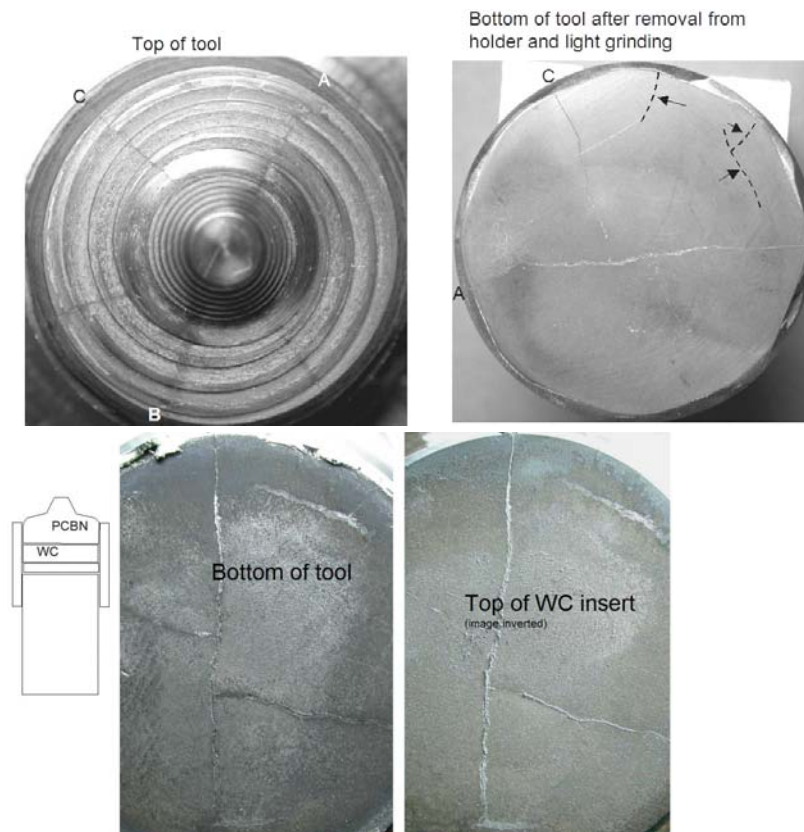
Photos of the top and bottom of the tool are shown in Fig. 10. Several cracks oriented in radial directions are visible on the top surface. One of these (A-B) was continuous around the sides and bottom of the tool insert. The others were continuous around the sides but either ended or followed more irregular paths on the bottom.

The PCBN tool rested on a WC/Co insert in the holder. The top of this insert had ridges that mirrored the pattern of cracks on the bottom of the PCBN tool (Fig. 10).

*Fig. 10. Top and bottom surfaces of PCBN tool and top surface of WC/Co insert after removal from holder.*

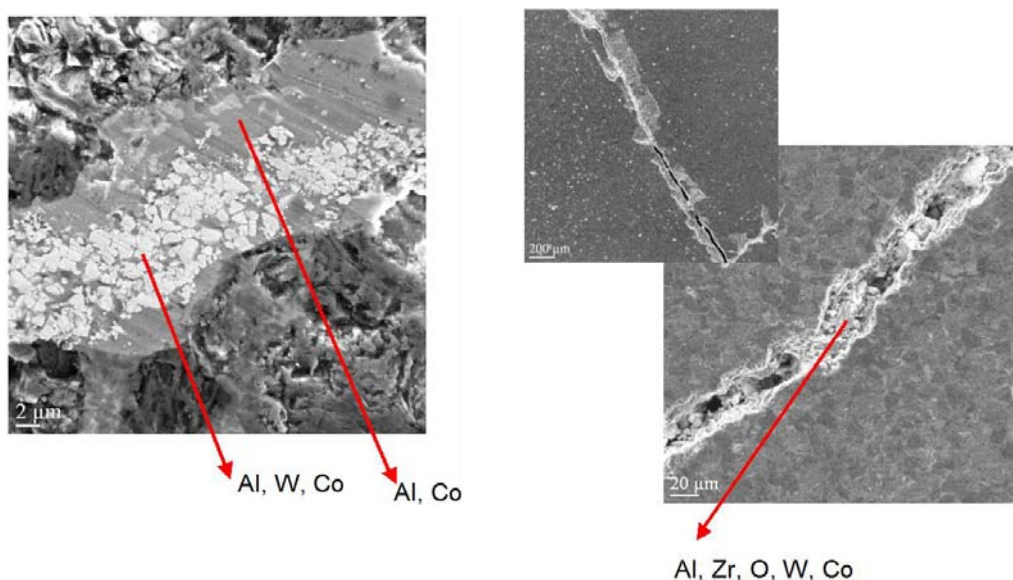
SEM analysis of the WC/Co insert after sectioning indicated that the ridges corresponds to an underlying reaction zone consisting of regions of Co-Al metal and regions with WC particles in a metal of similar composition. Examination of the bottom of the PCBN tool indicated that most cracks were filled, at least near the surface, with metal consisting of regions of C-containing Al surrounding regions of Al-W-Co (Fig. 11). In some regions it appeared that this material had chipped out when the tool was removed leaving an underlying region containing Al., Zr,O,W and Co. The presence of Zr and O is accounted for by a spray coating of  $\text{ZrO}_2$  that was applied to the tool surface before assembly. The only potential source of Al metal is the decomposition of trace amounts of  $\text{AlB}_2$  formed in the PCBN material during its densification:

This reaction indicates that the temperature at the base of the PCBN tool exceeded  $\sim 1000^\circ\text{C}$  during use. At this temperature, an Al liquid phase can contain up to  $\sim 10\%$  Co, consistent with the observed reaction of the Al with the Co grain boundary phase in the WC/Co insert.

*Fig. 11. SEM analysis of material filling cracks in the bottom of the PCBN tool from Fig. 10*

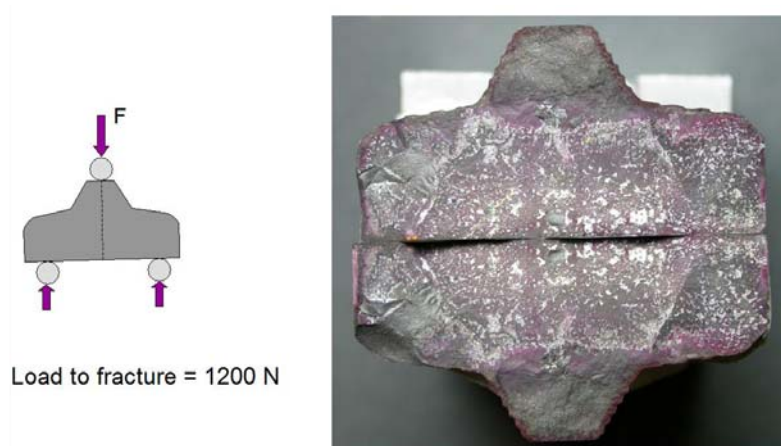
The PCBN tool in Fig 10 was broken apart along crack A-B, as indicated in Fig. 12, after infiltrating the cracks with a dye penetrant. A large force (1200 N) was required to fracture the tool. The force was large for two reasons: (i) although the crack A-B formed a closed path around the outside of the tool, there were intact regions in the interior, near the top of the tool, where the crack had not penetrated (visible in Fig. 12 as gray regions that were not decorated by the pink dye penetrant); (ii) large areas of the cracked region were strongly bonded together with Al metal, as indicated in subsequent SEM analysis, which showed the ductile rupture of Al metal on both sides of matching fracture surfaces (Fig. 13).

Fig. 12. Fracture of the PCBN tool from Fig. 10 along crack A-B

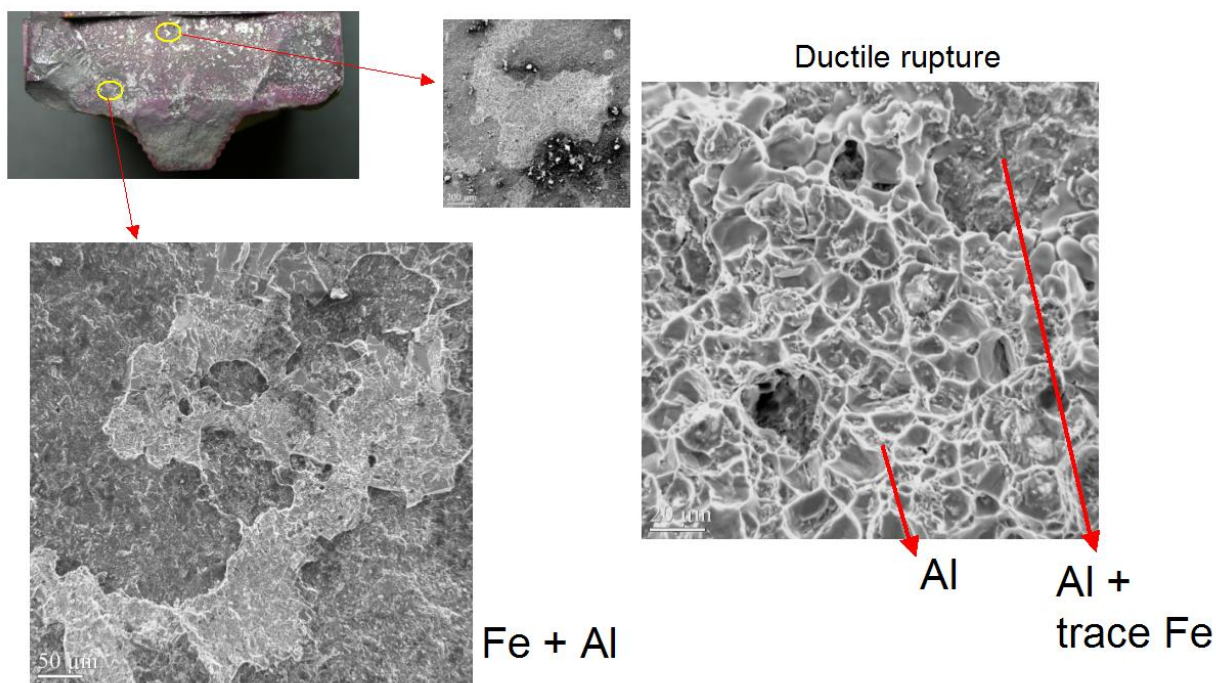
The composition of the metal that filled most of the cracked region varied with location. Near the top of the tool there was a large amount of Fe and Al, the Fe coming from the steel work piece that was used in the FSW and the Al from the decomposition reaction mentioned above. Near the bottom of the tool the metal was mostly Al, with a trace of Fe in local regions.

Fig. 13. SEM analysis of fracture surface of tool in Fig. 12

In summary, these observations indicate that there were at least 6 major cracks in the tool, none of which passed completely through tool. This explains the general observation that these types of tools continue to function surprisingly well in FSW long after they are severely cracked. The observations indicate that crack growth occurs incrementally, likely over many thermal and/or mechanical cycles, rather than by

unstable growth at a critical condition. The presence of Al liquid filling the cracks indicates that the temperature exceeded  $\sim 1,000^{\circ}\text{C}$  throughout the PCBN tool during FSW. Under these conditions diffusion of Fe from work piece occurred into the Al liquid in cracks through most of tool thickness.
