INVESTIGATION OF AN EXPLOSIVE  
ACCIDENT USING SIMULATION AS A TOOL

J.F. DROLET, G. COUTURE AND R. FARINACCIO

DEFENCE RESEARCH ESTABLISHMENT VALCARTIER  
P.O. Box 8800, COURCELETTE  
QUEBEC, CANADA, G0A 1R0

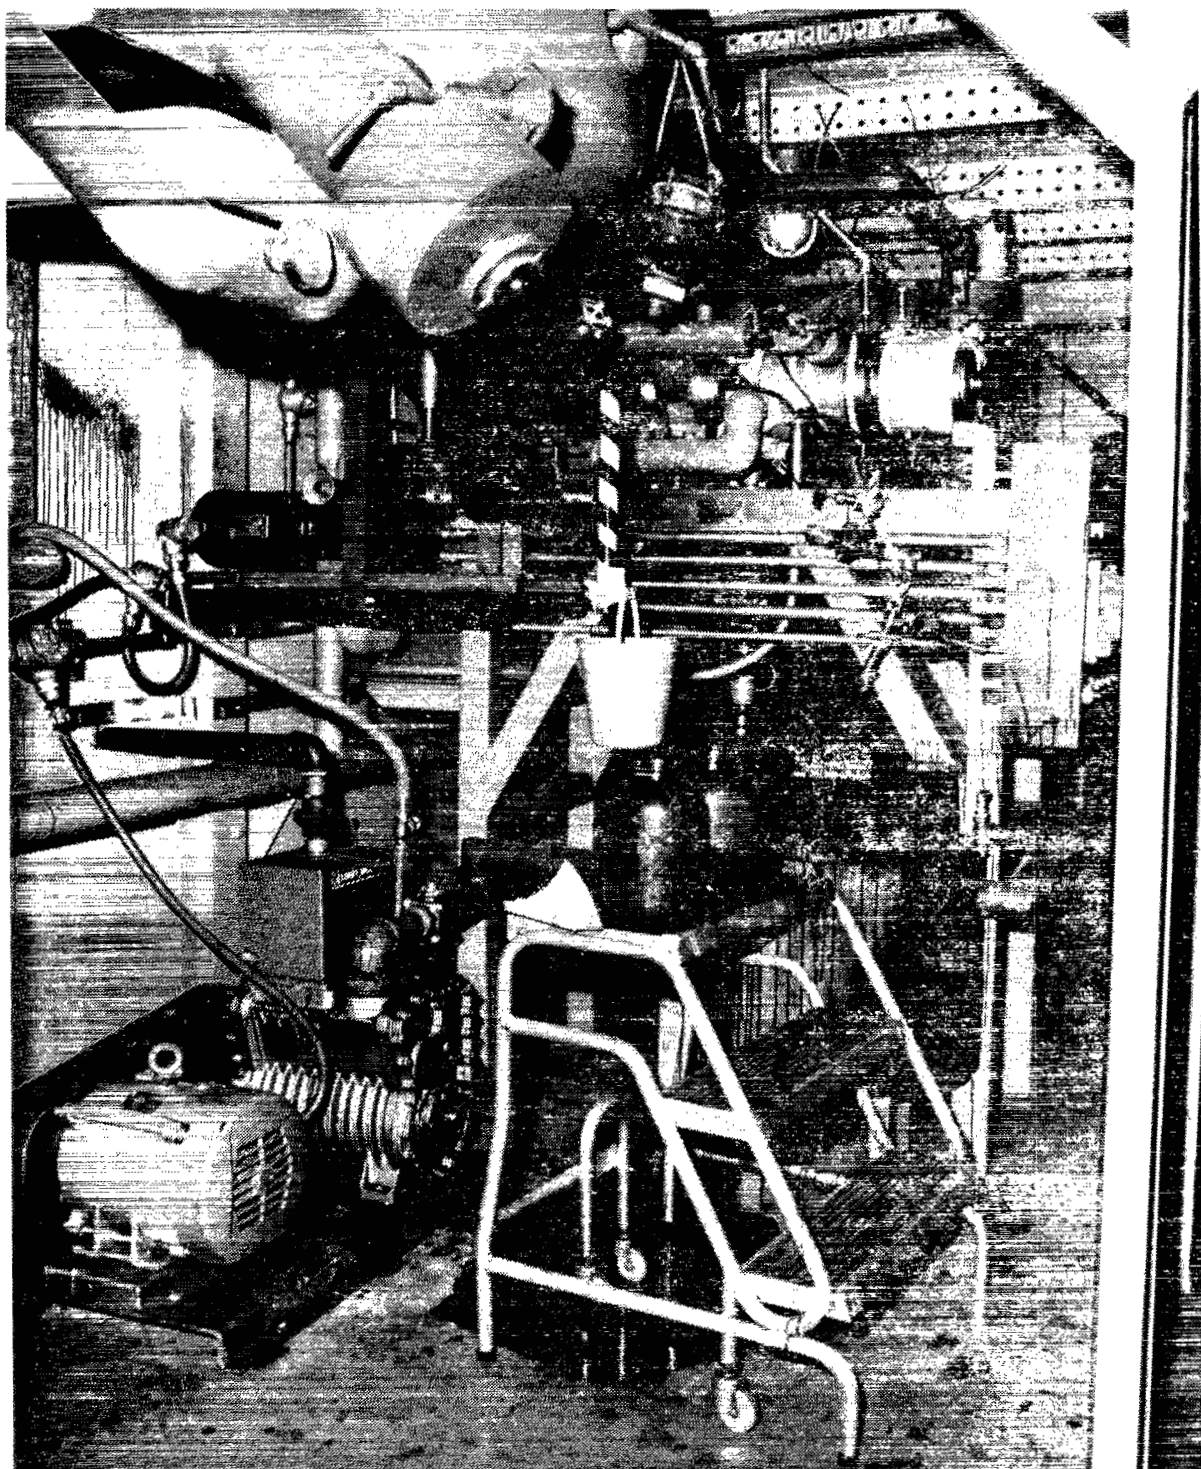
A picture of the equipment is shown in Fig. 2 after the accident. Polymer residues was seen on the walls, the ceiling, the floor and the equipment. Figure 3 shows the polymer reservoir attached to the ceiling and the gear pump in the back with the different valves and piping. Figure 4 shows the remaining part of the pipe that was burst open and the heating tape that was wound around. Finally, Fig. 5 shows the stainless steel elbow where the explosion occurred and some plastic parts that connected the EXP reservoir to the equipment.

FIGURE 2: Overall view of equipment

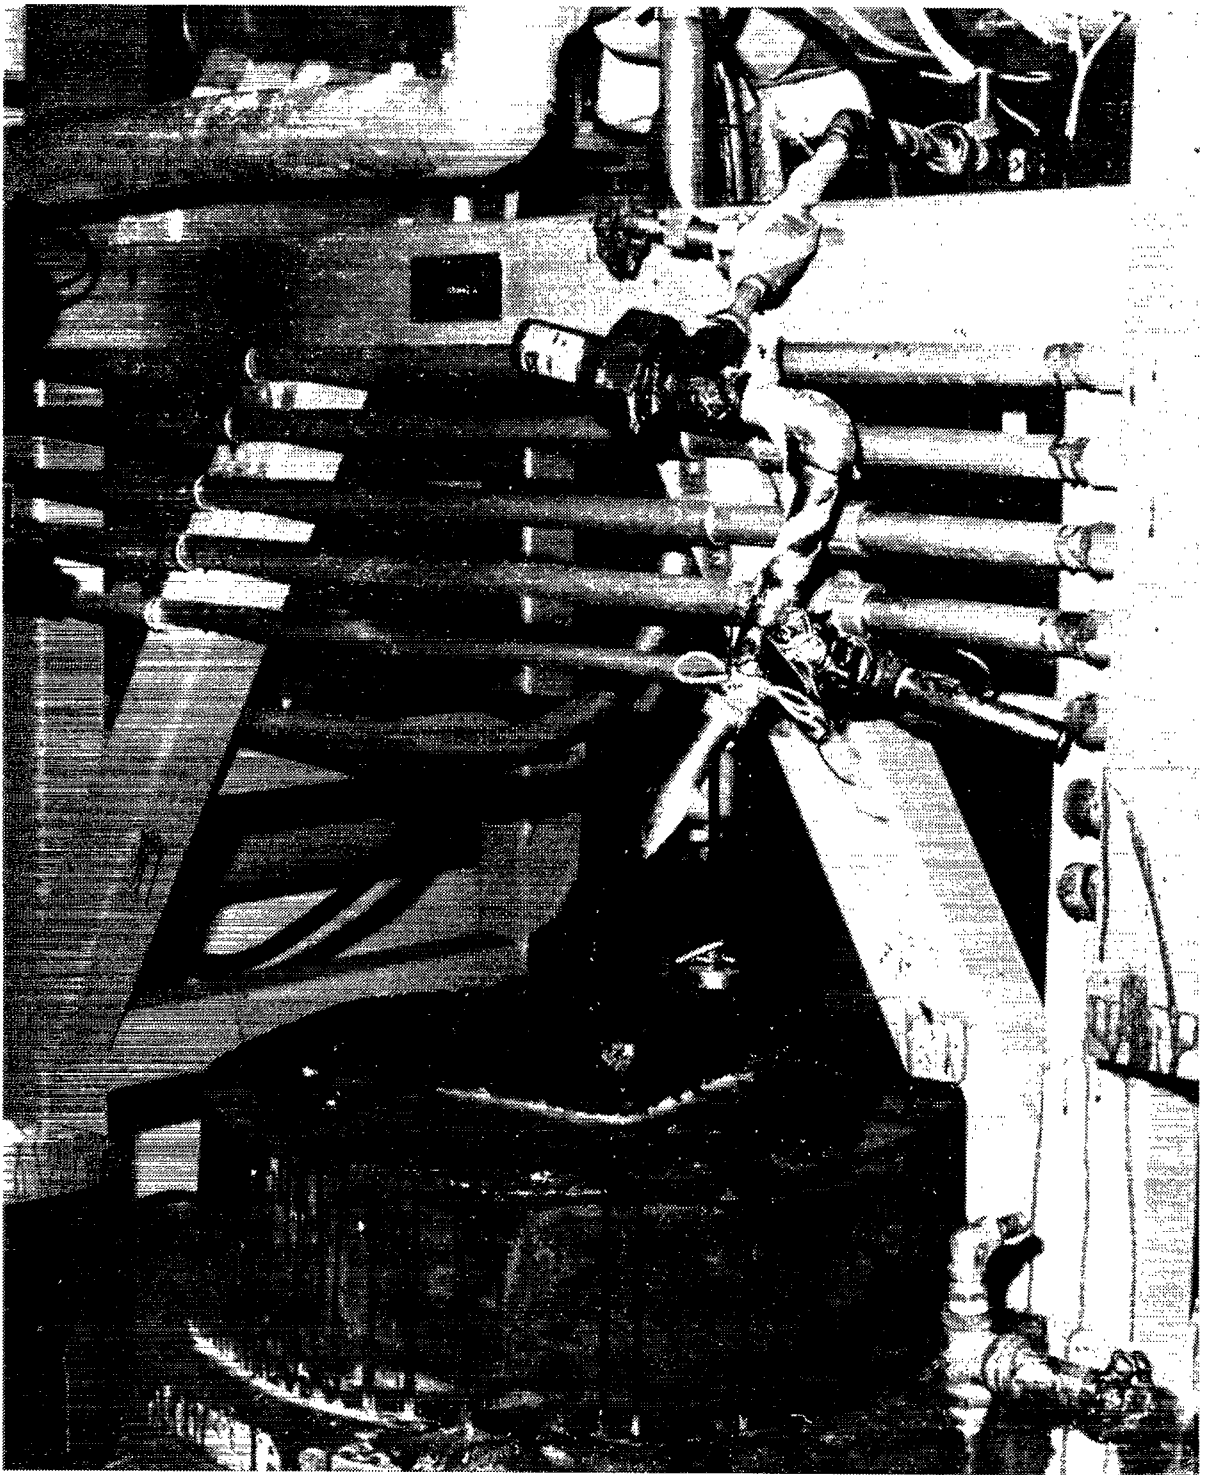
FIGURE 4: Section of Broken piping

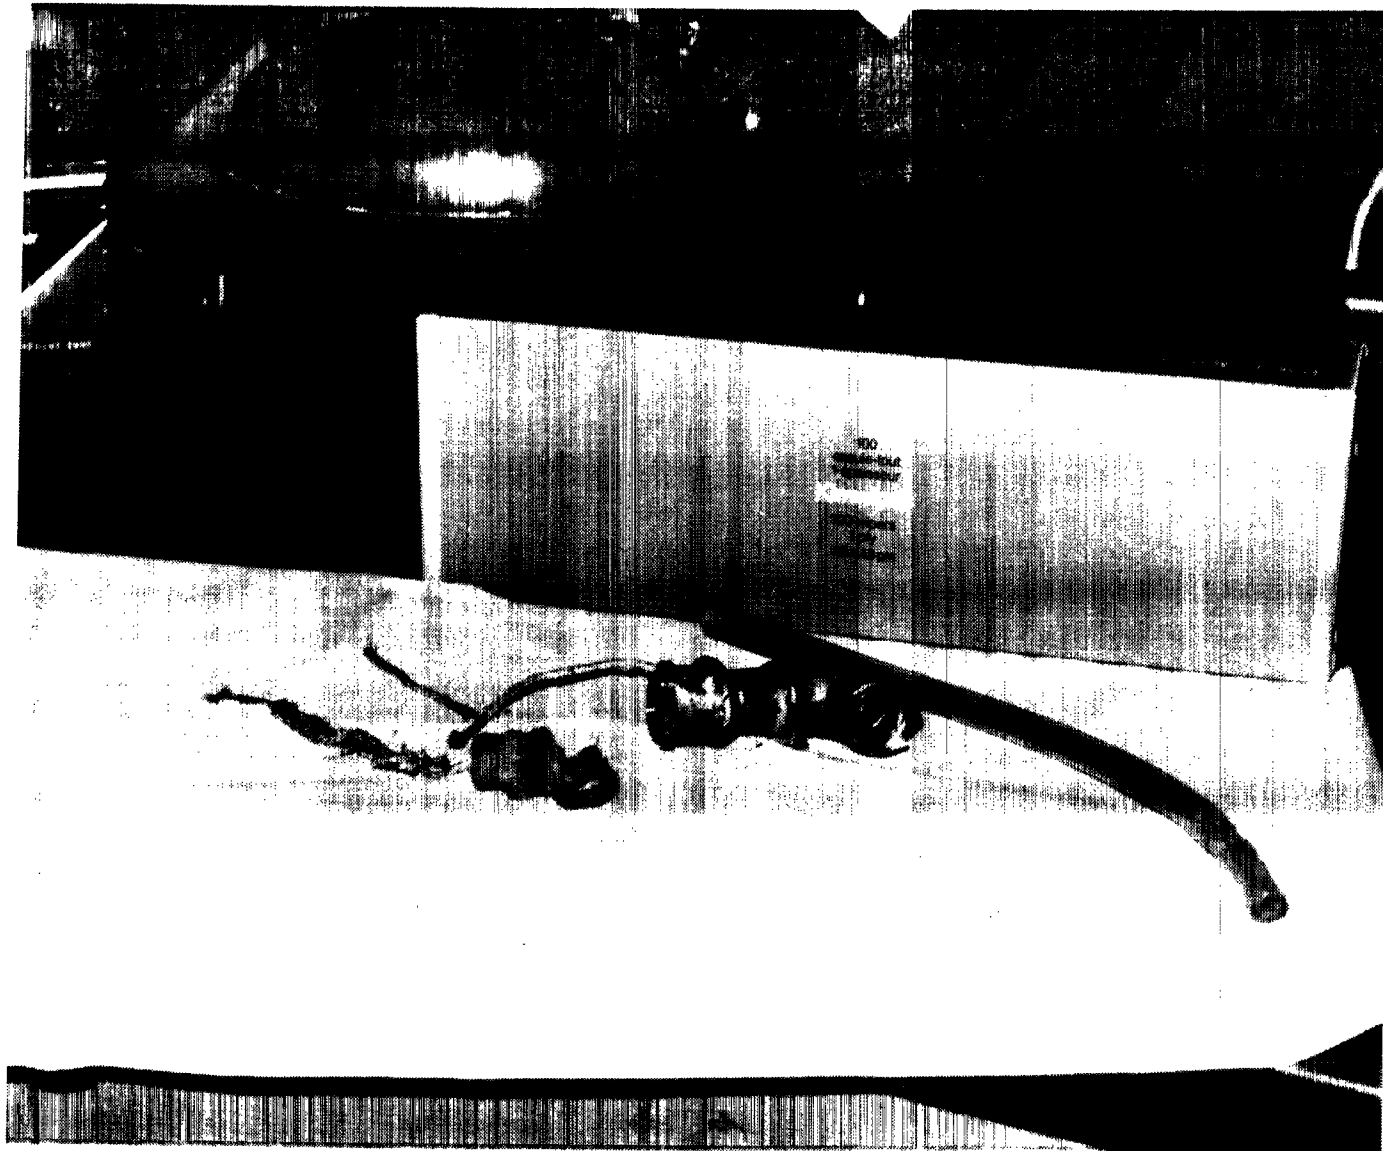
A second simulation similar to the one just described above but with the addition of insulation over the heating tape (see Fig. 8) was prepared. As shown in Fig. 9, this simulation revealed that the temperature inside the piping could have reached, after equilibrium, a temperature as high as 370°C, a temperature more than sufficient to cause the auto-ignition of EXP (auto-ignition of EXP is  $214 \pm 2^\circ\text{C}$ ).

FIGURE 5: Stainless Steel Elbow where explosion occurred

- 1) installation of a safety valve in the equipment;
- 2) not using heating tape as a source of heat in the presence of energetic materials;
- 3) formation of a team of experts to study the risks associated with new processes or new equipment and make the proper recommendations.
- 4) writing of SOPs even for a one time operation when the level of risk is high.
- 5) operation of equipment by remote control whenever possible.

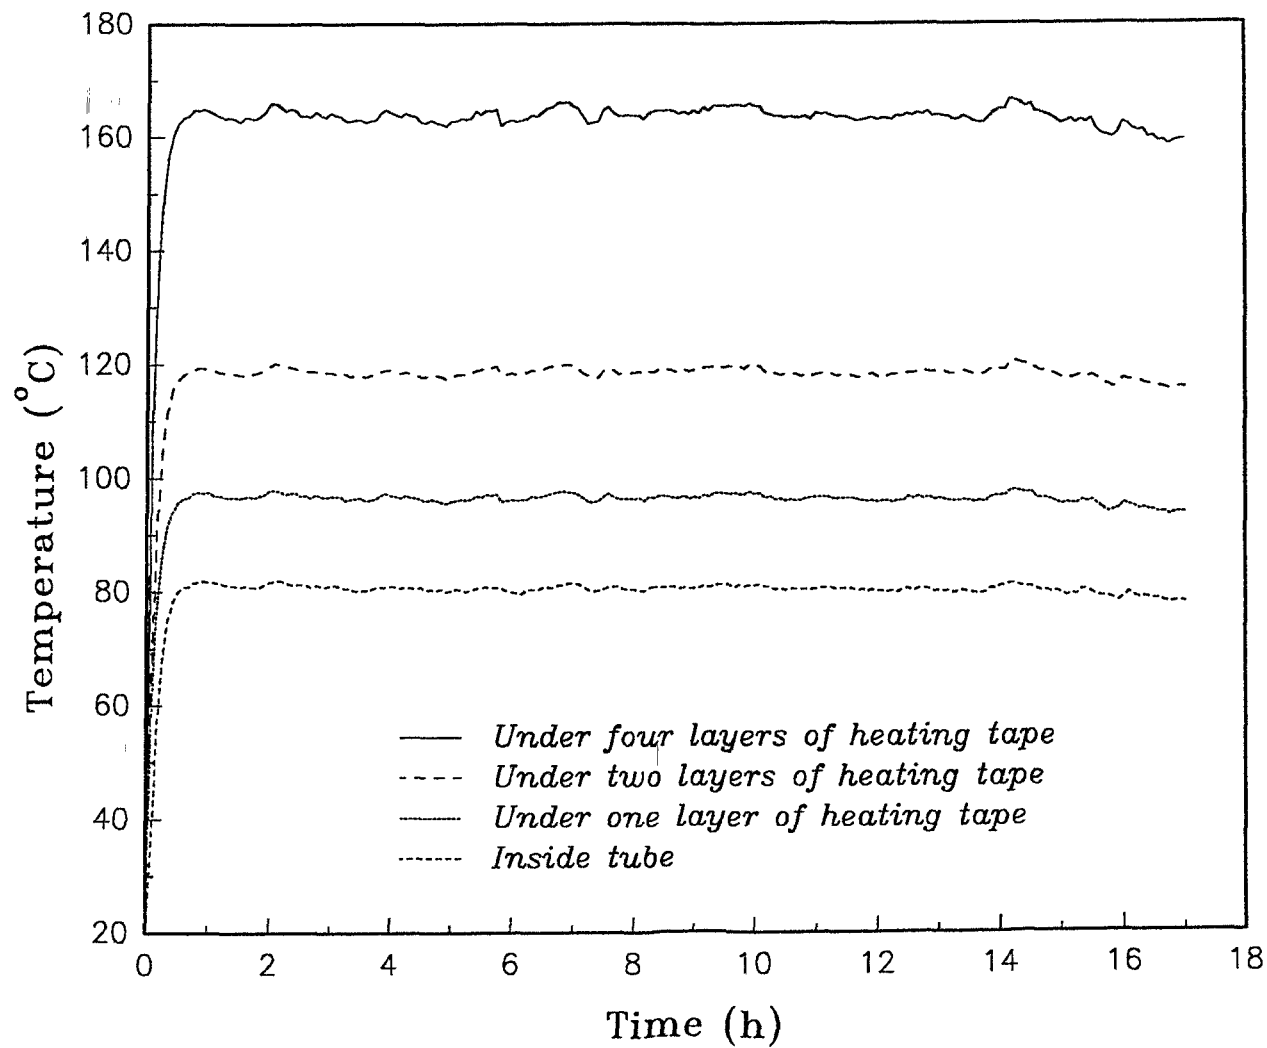
FIGURE 7: Test results from first simulation

A schematic of the simulation test is shown in Fig. 6 and the results appear in Fig. 7. It can be concluded from the results that the number of layers has a strong effect on the temperature of the pipe but in this case, it does not seem to bring it high enough (170°C) to explain the ignition of EXP.
