**REPORT ON THE  
PETERBOROUGH EXPLOSION**

Peterborough, UK; 22 March 1989

**BLAST DAMAGE AND INJURIES**

**Health and Safety Executive  
H M Explosives Inspectorate**

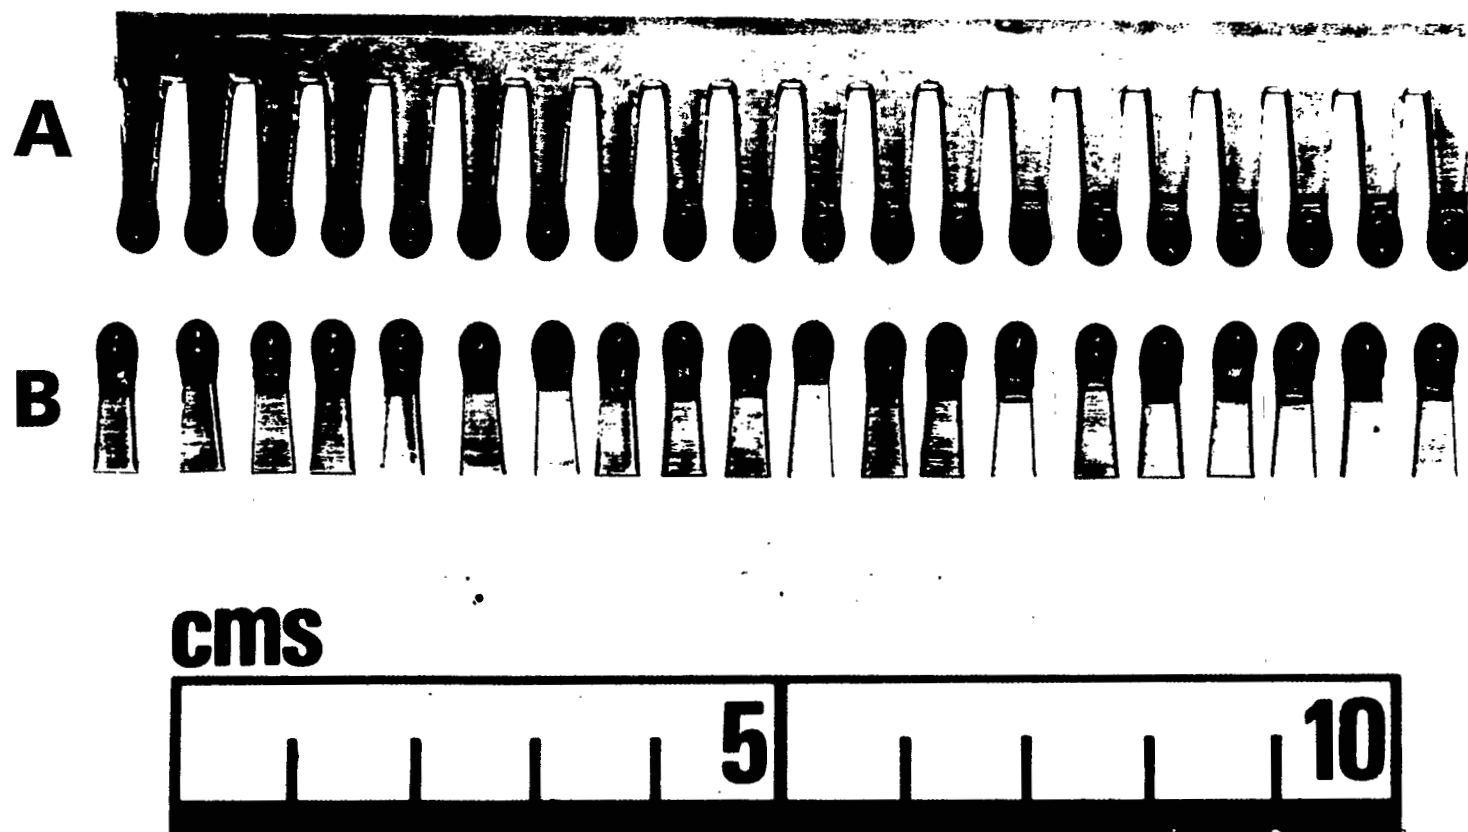
- 14 The Vulcan fuseheads were found to be in a satisfactory condition and properly packed. The Cerium fusehead combs however were found to be packed in unauthorised and unsafe packagings. The type of packaging used was both illegal and dangerous in that there were excessive numbers of fuseheads per box, the packaging was loose resulting in presence of loose composition inside metal boxes, and presence of rust. Fusehead composition was examined and found to be extremely sensitive both to impact and friction. Mixtures with rust (1%) had a 10 fold increase in impact sensitivity. Boxes of combs dropped from a height of 1.2 metres exploded in some tests but not others. Ignition trials on one box of cerium combs produced a fireball approximately 2.5 m in diameter, and lasting 0.3 seconds.

- 16 The initial minor explosion was probably caused by ignition of the Cerium fusehead combs when the vehicle jolted over the speed ramp control. The likely mechanism for ignition being impact or friction of the fusehead debris or loose composition against the metal box packaging. The fusehead composition was probably sensitised by the presence of rust. The fireball which followed threw burning debris around the load compartment, starting a number of fires.

Fig 2 A - Cerium Fusehead Comb. B - Cut Fuseheads.

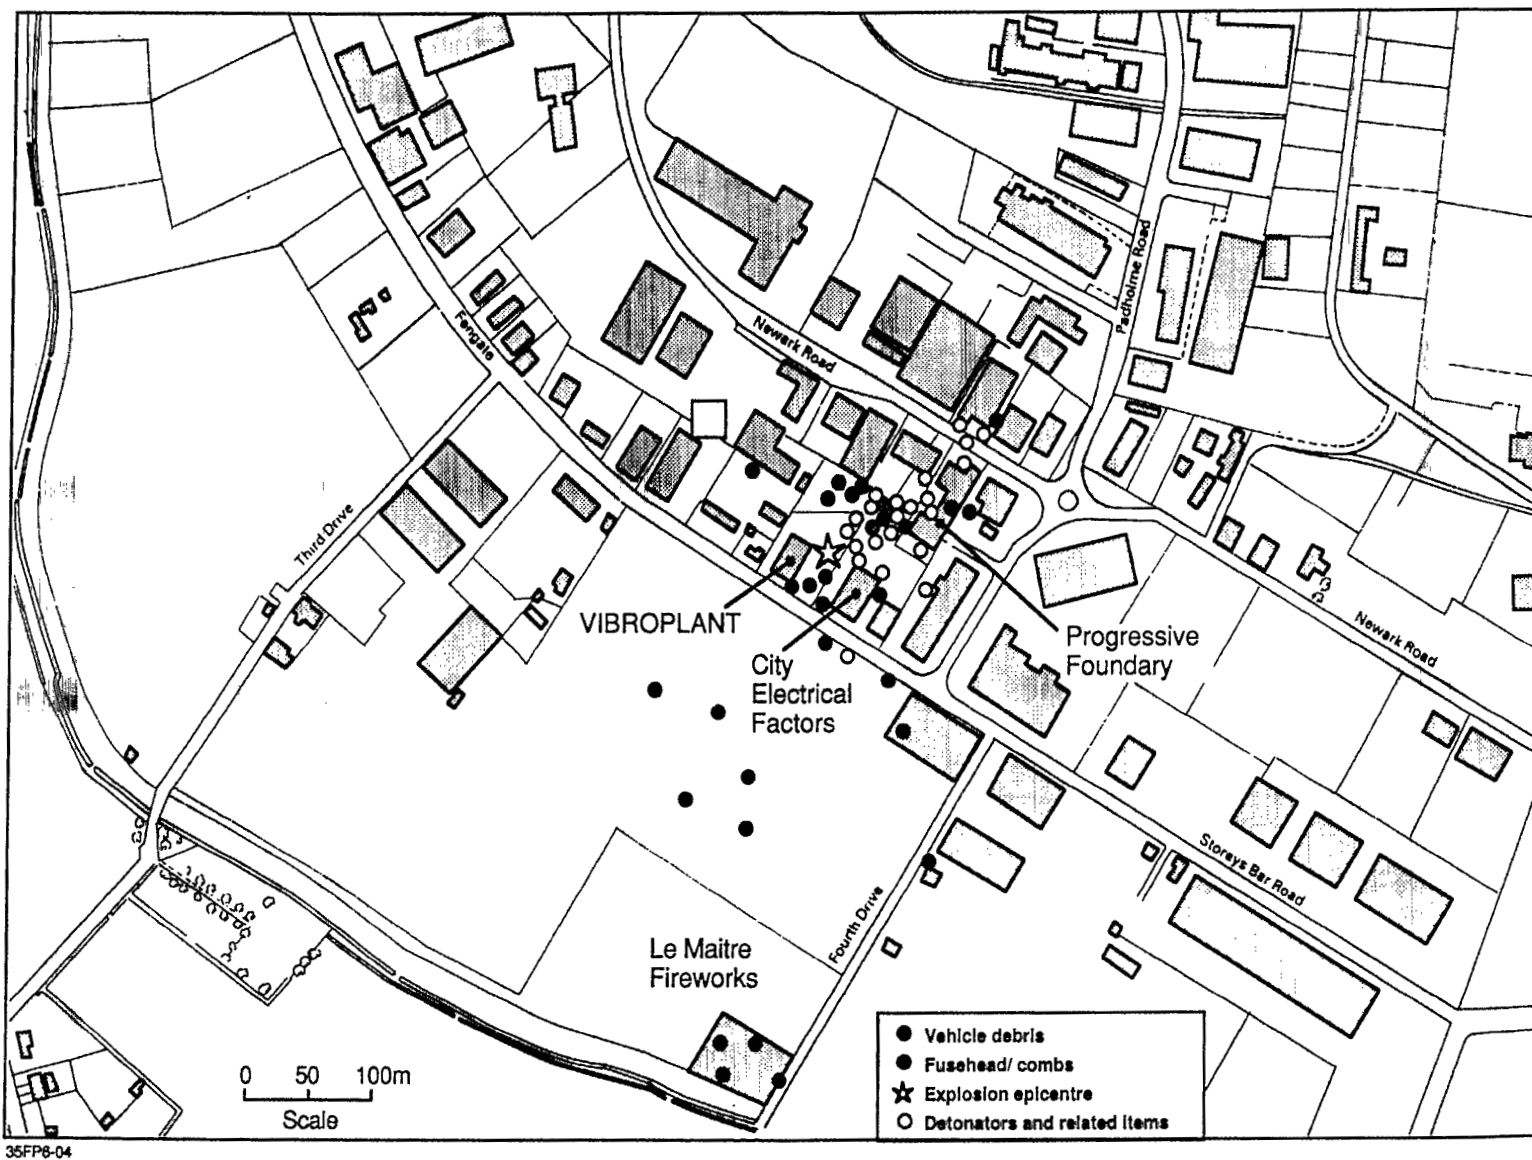
- 27 Fragments were thrown over a wide area - see Figure 7. The prime requirement in the immediate post accident situation was to collect all live pyrotechnic items from the surrounding area. Recognisable pieces of vehicle (except the many small pieces of aluminium from the body) were also collected. The extremity of fragment throw was not accurately determined, but within a licensed fireworks site some 380-400 m away, a number of small items in the weight range 100-3000 grammes were found. Also at approx 470 m a number of cars were allegedly damaged by falling gravel.

Fig 7 Explosion at premises of Vibroplant, Peterborough. Debris plan

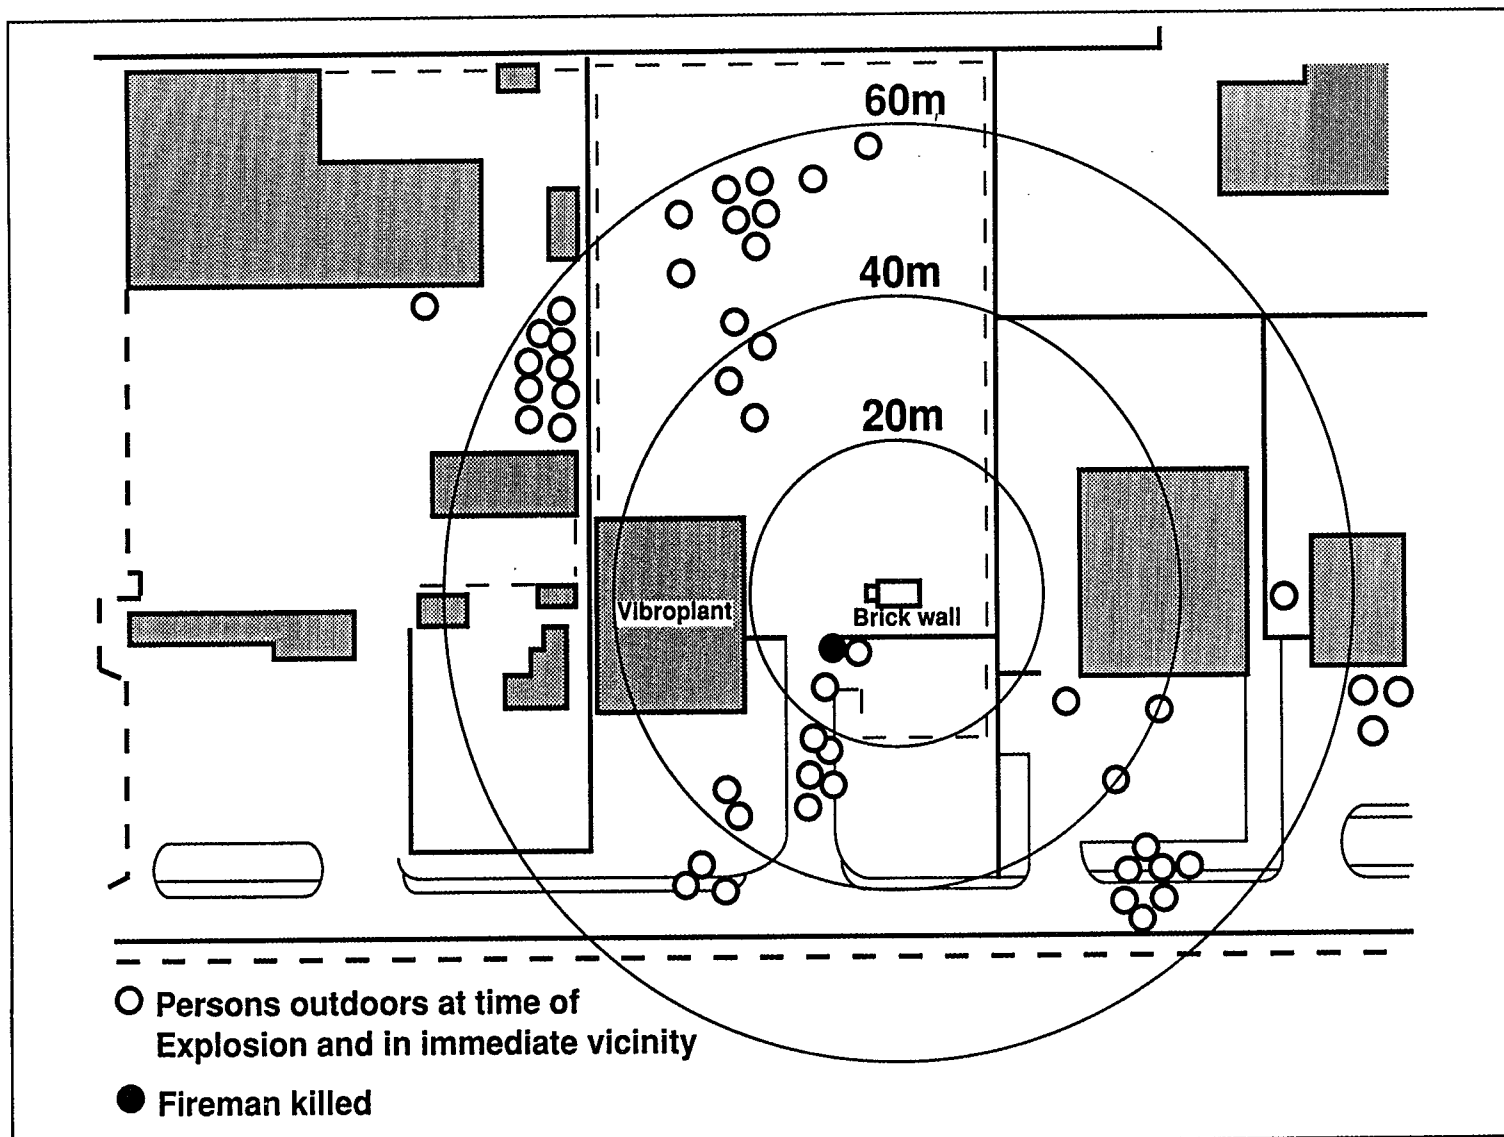
Fig 8

- 31 The fireman killed in the incident was approximately 15 or so metres away from the centre of the explosion and was killed by a fragment (see Figure 8). One of the badly injured persons (burned) was a fireman who had been standing close to the fatality. The other badly injured person was outdoors approx. 40 metres away, and was hit by a fragment. The injury 'contours' are summarised in Table 4.

- 34 In the 12 minute period between the onset of fire and the final explosion, numbers of people congregated both outdoors in close proximity to the van, and against windows which overlooked the Vibroplant yard (see Figure 8). This had the effects of causing persons outdoors to be blown off their feet, sustain hearing damage, and for some to be injured by fragments. Persons indoors sustained serious cuts from flying glass, translational injuries, and injuries from falling

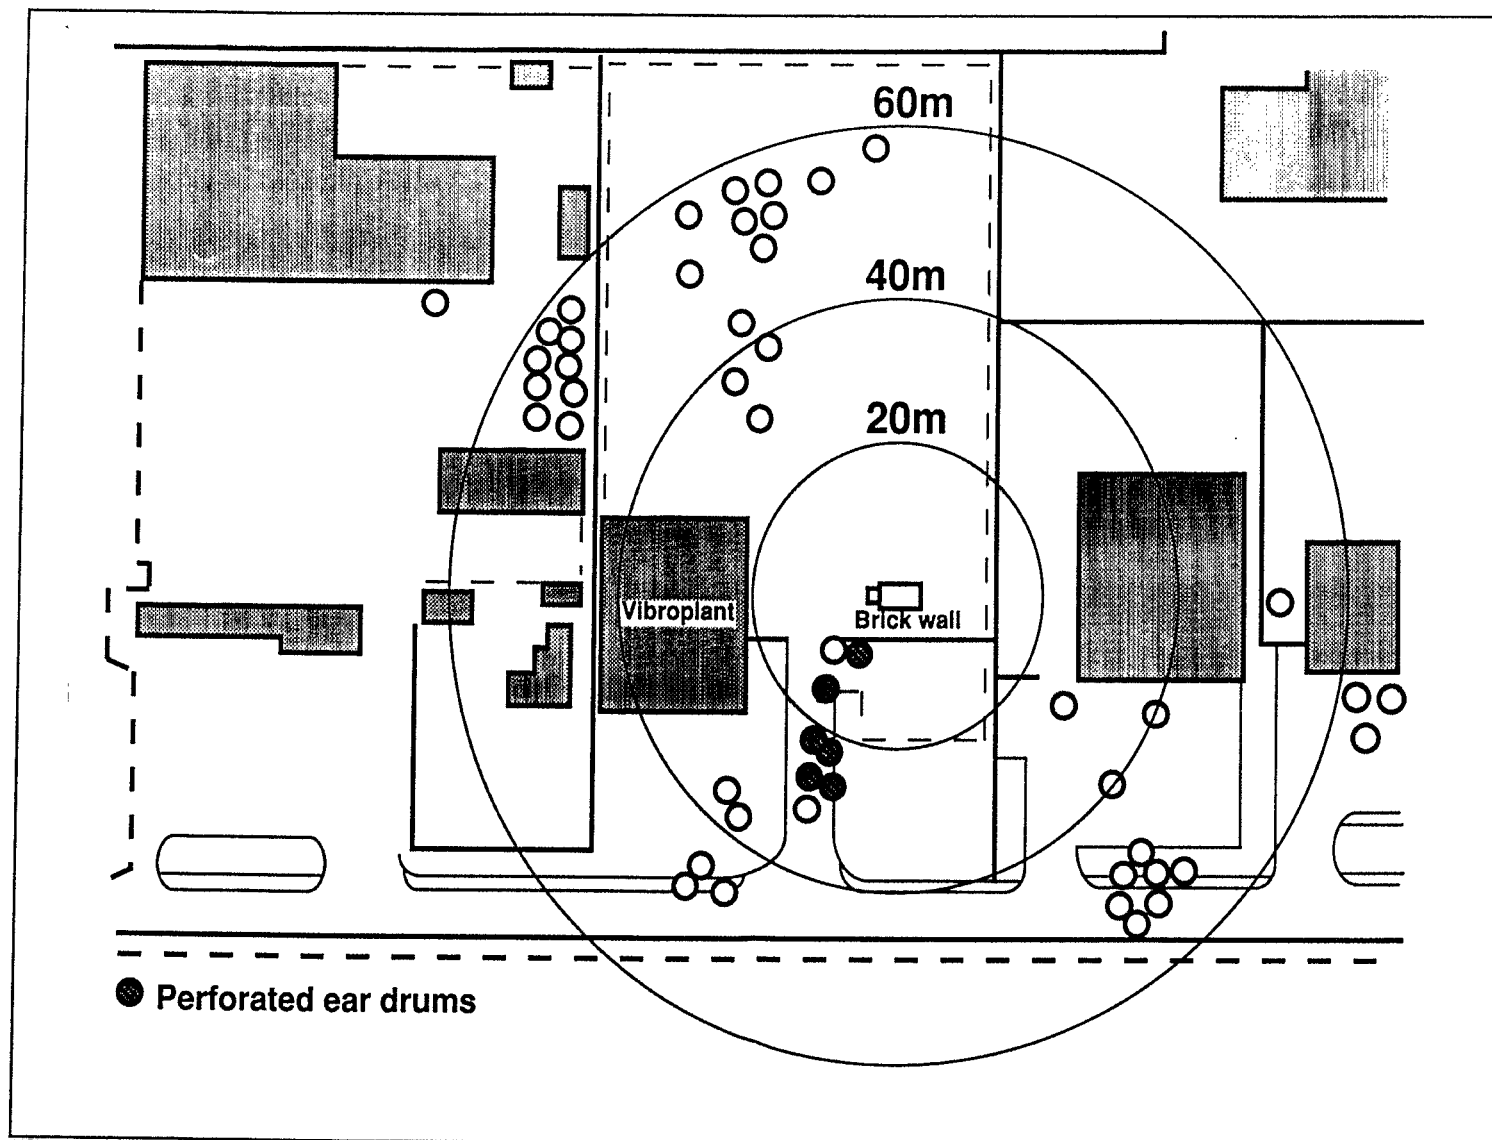
- 32 Persons outdoors and close to the explosion sustained perforated eardrums (see Figure 9), cuts and bruises from flying debris, and were thrown to the ground (see Figure 10). Persons indoors sustained the greatest numbers of injuries from flying glass. Other injuries indoors were due to collapsed ceilings.

Fig 9 Injuries sustained to persons outdoors

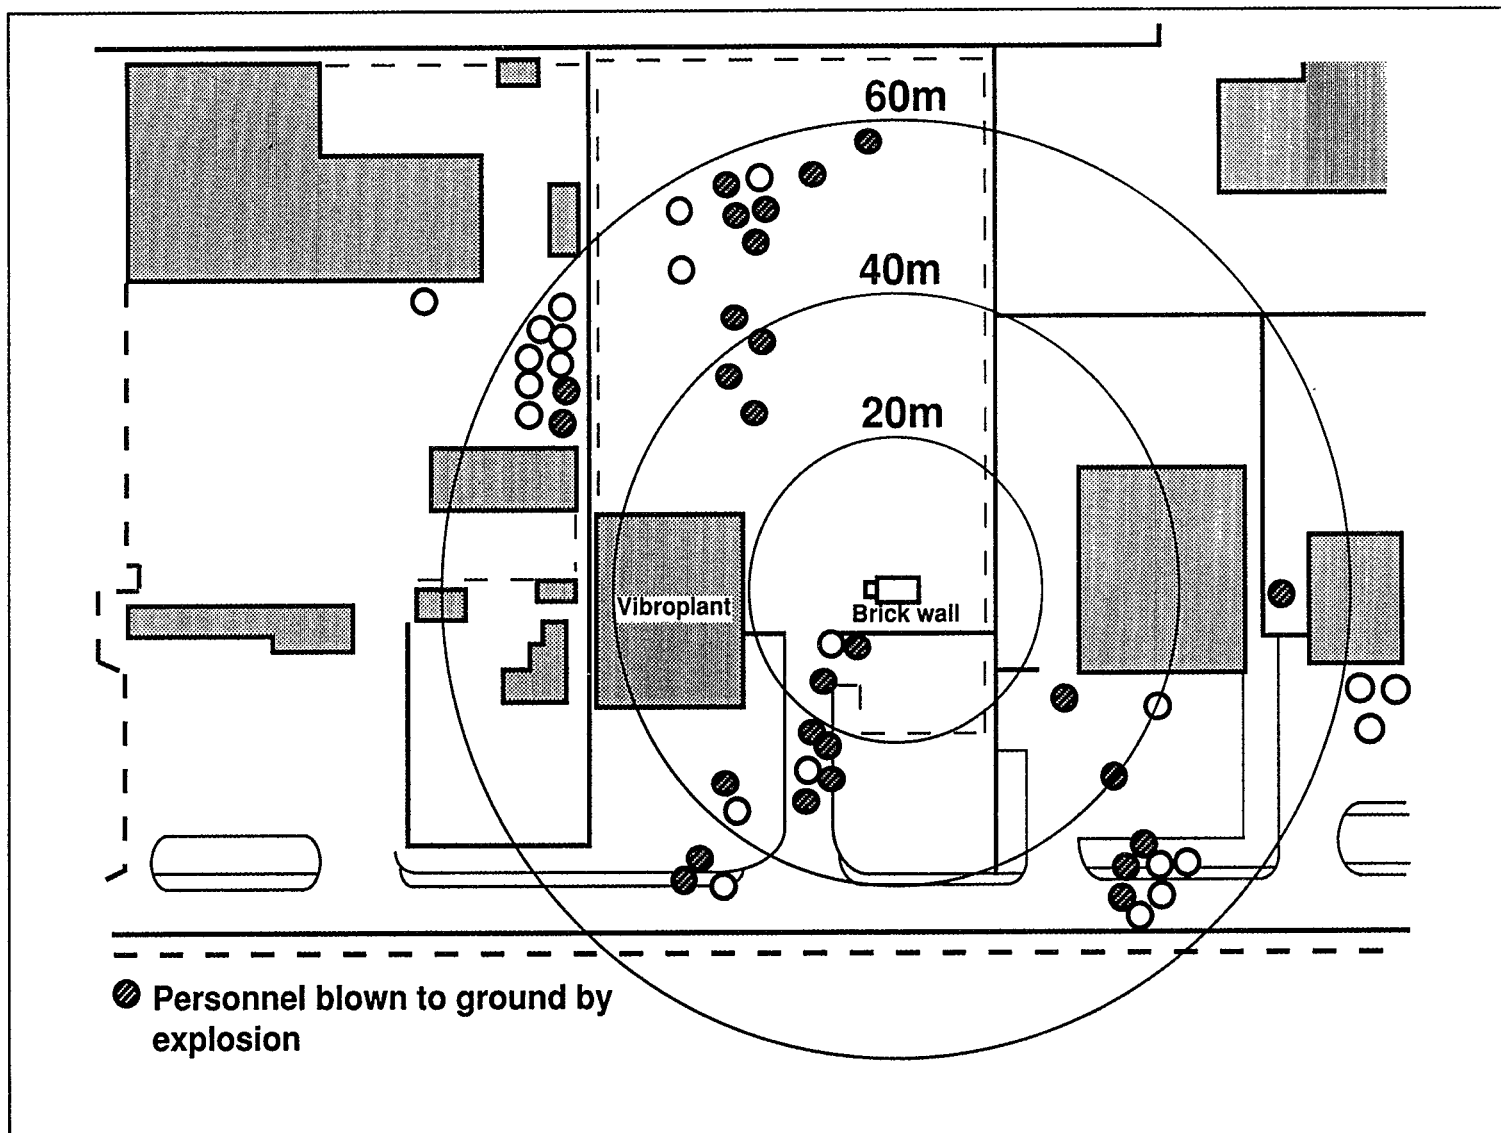
Fig 10 Blown to ground
