ERDC/CERL TR-07-24

Construction Engineering  
Research Laboratory

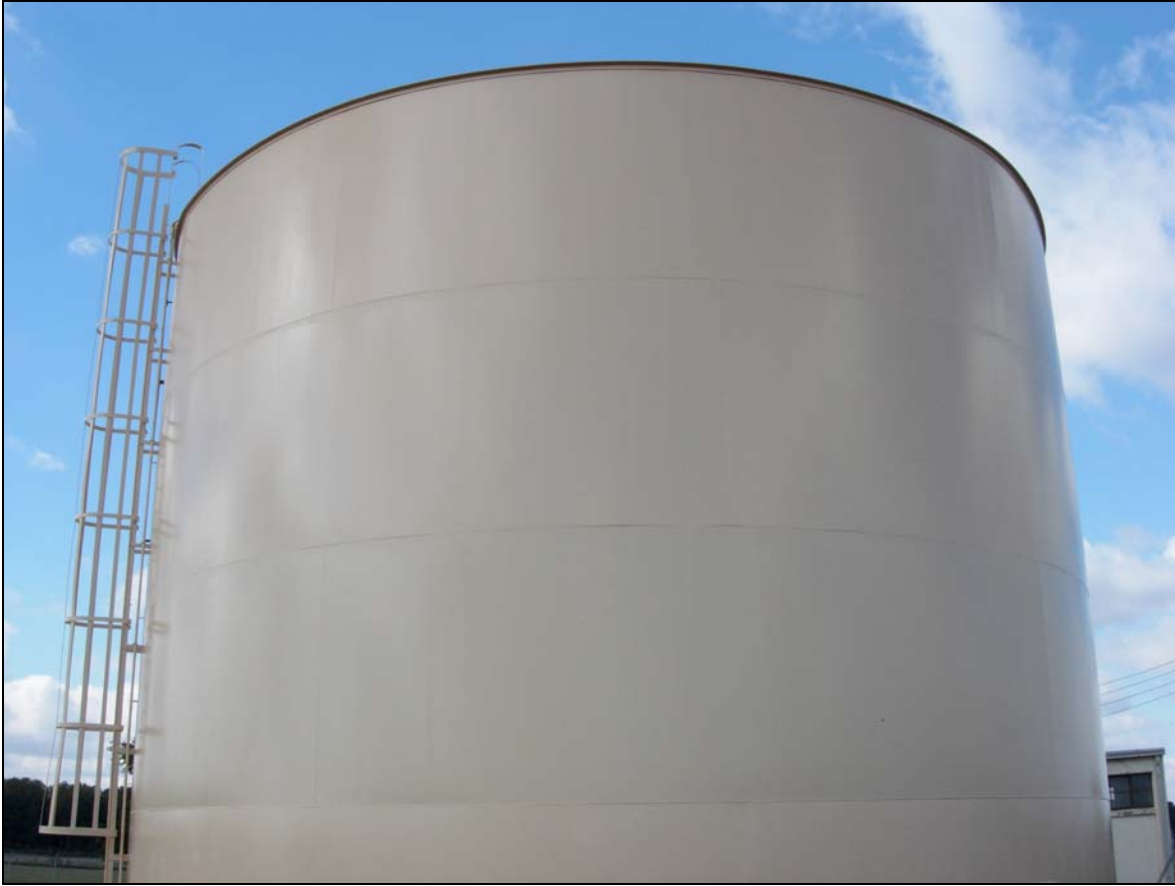
**Figure 1: Destiny Deluge Tank**

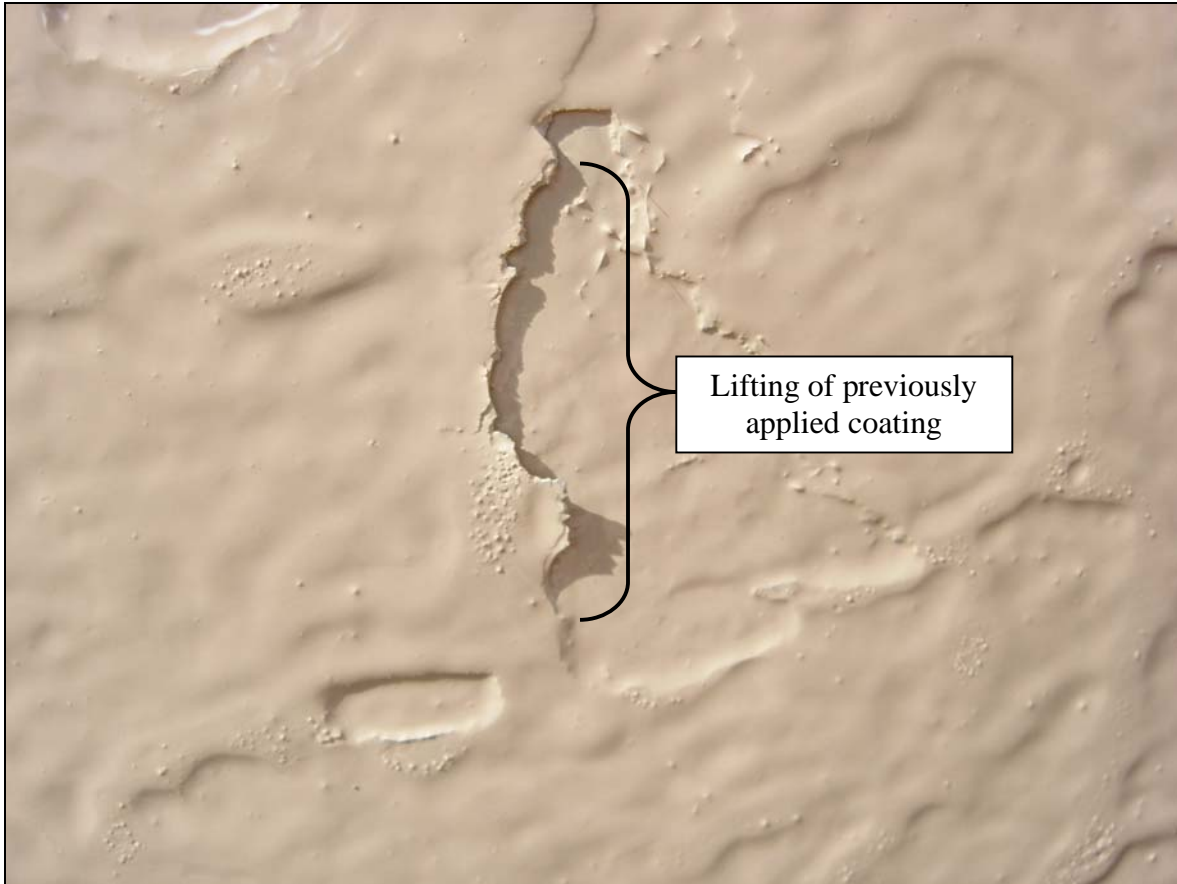
**Figure 3: Lifting of the previously applied coating along the unfeathered edge**

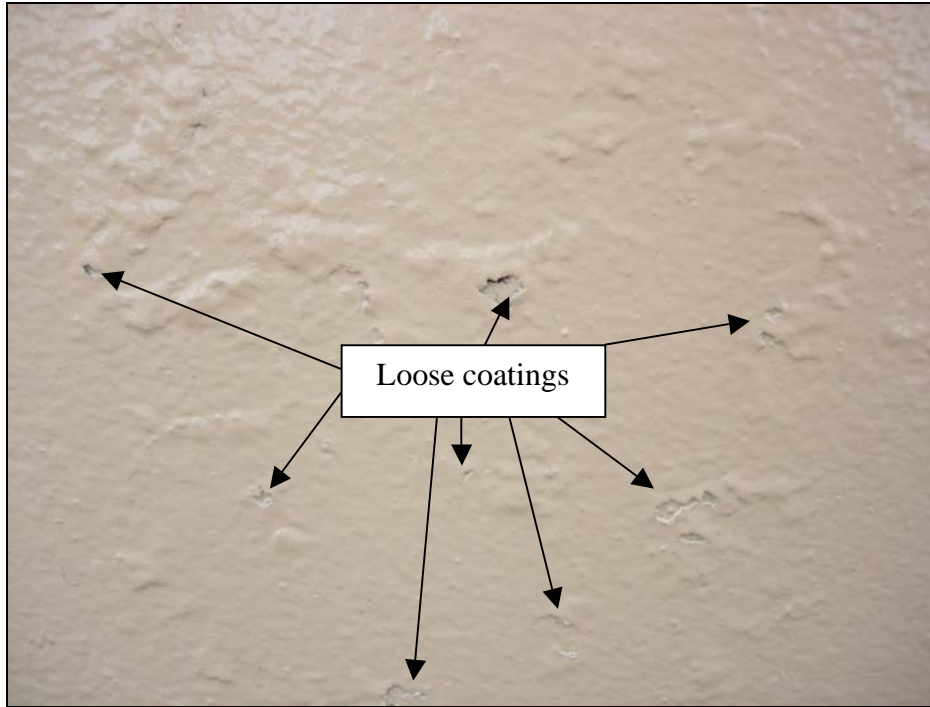
**Figure 4: Loose coatings prior to dull putty knife test**

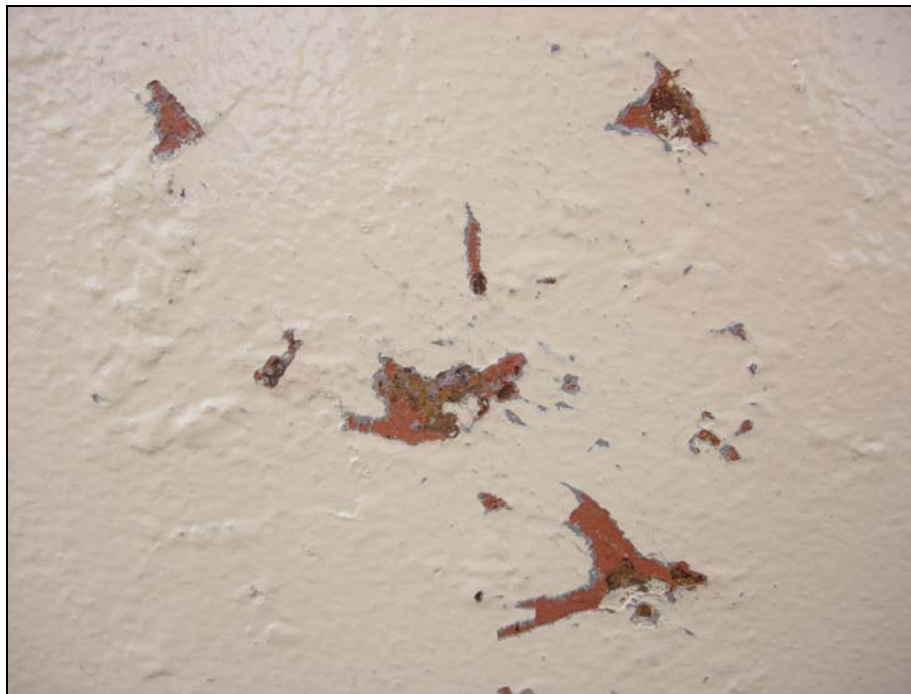
**Figure 5: Loose coatings removed with dull putty knife**

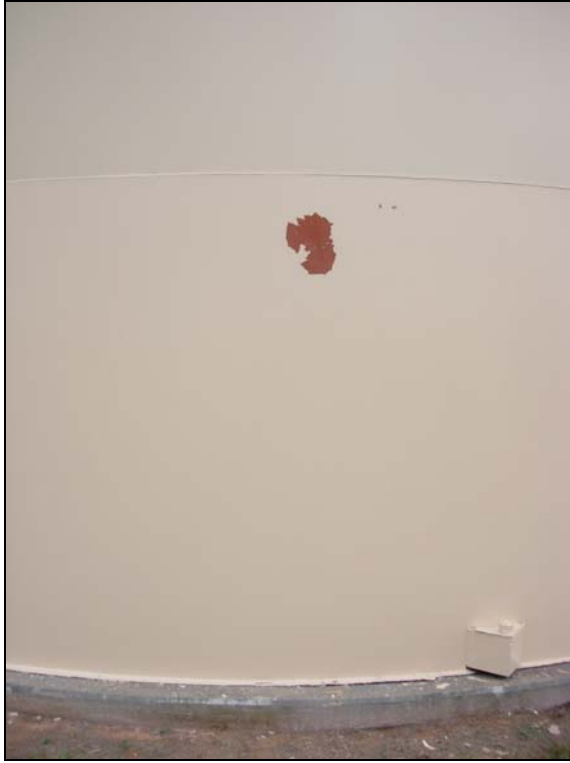
**Figure 6: Long view of delaminating paint**

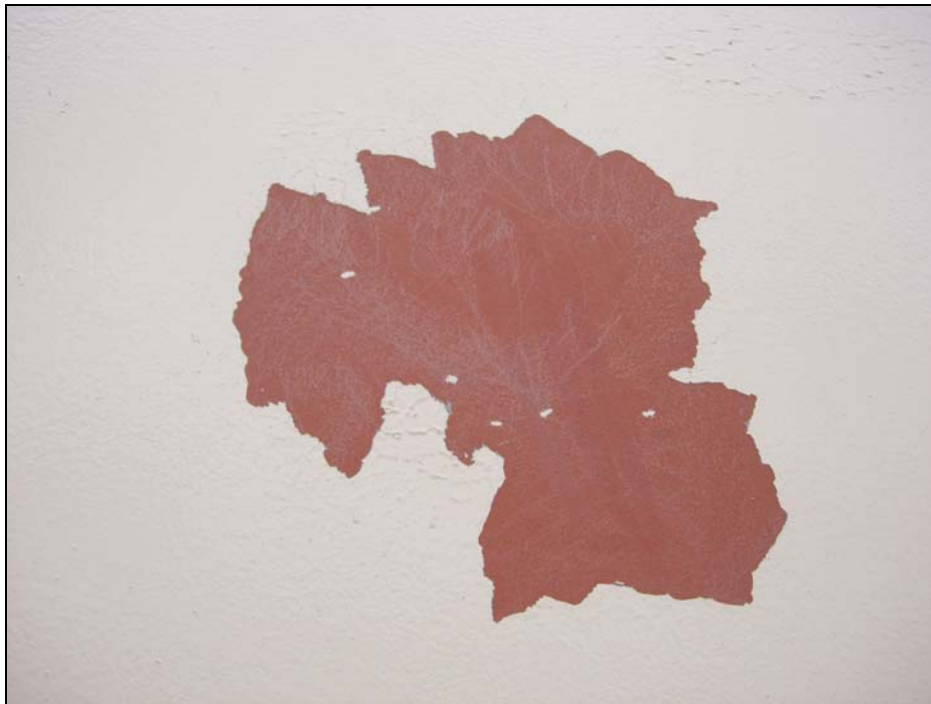
**Figure 7: Close up of area shown in Figure 6**

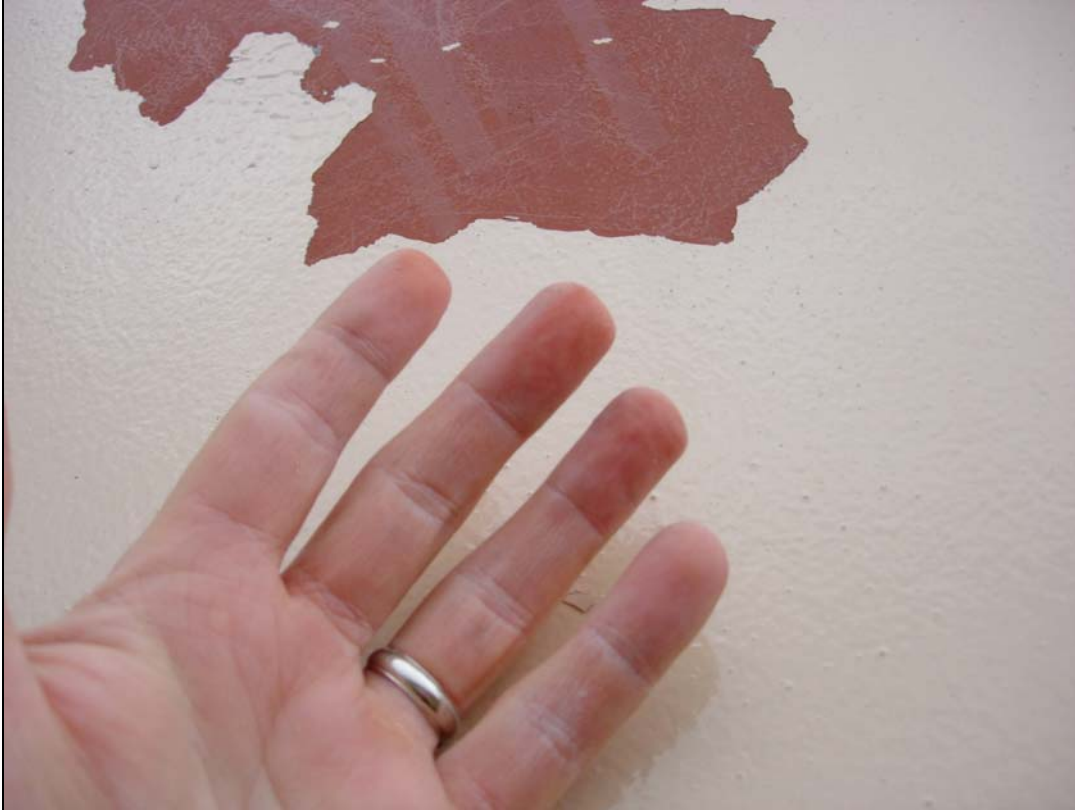
**Figure 8: Chalk seen on fingers after rubbing on coated surface where delamination occurred**

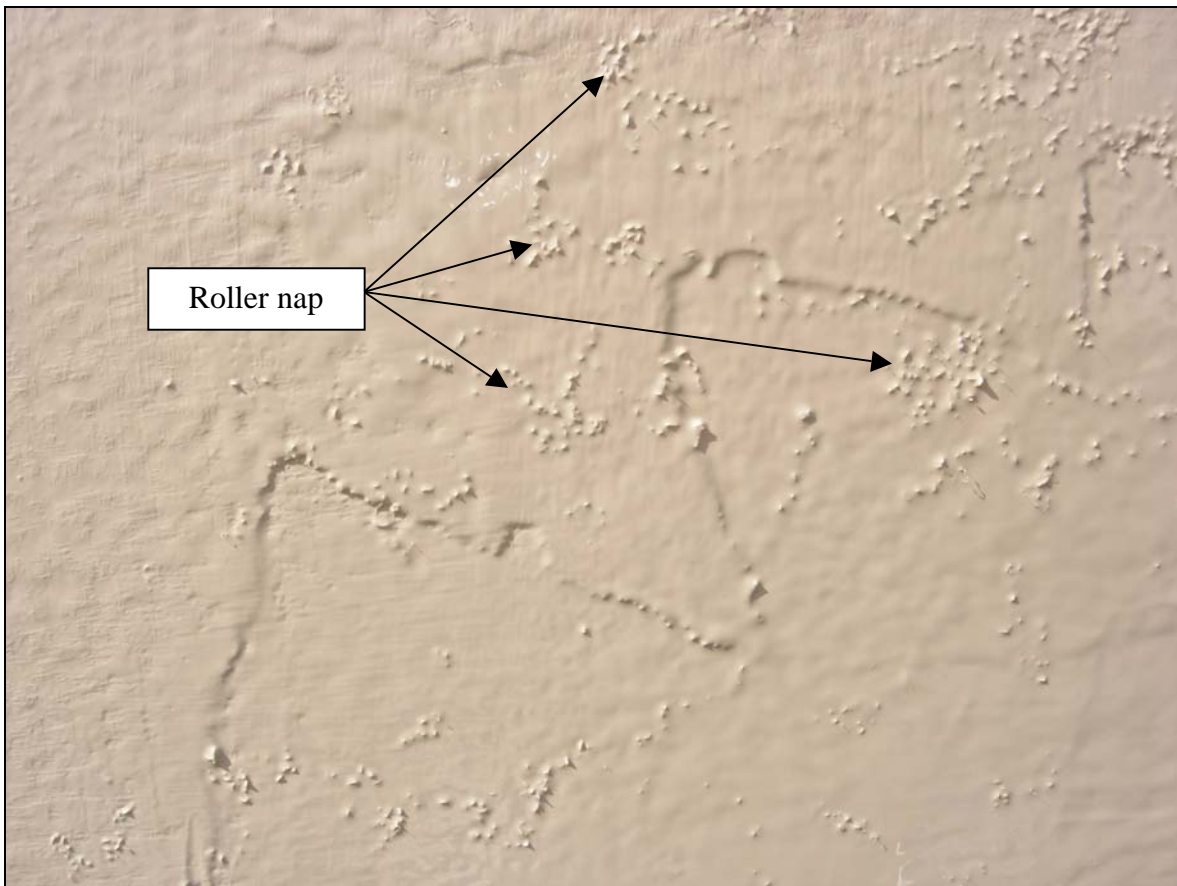
**Figure 10: Small pieces of roller nap embedded within the Corothane I Ironox A finish coat**

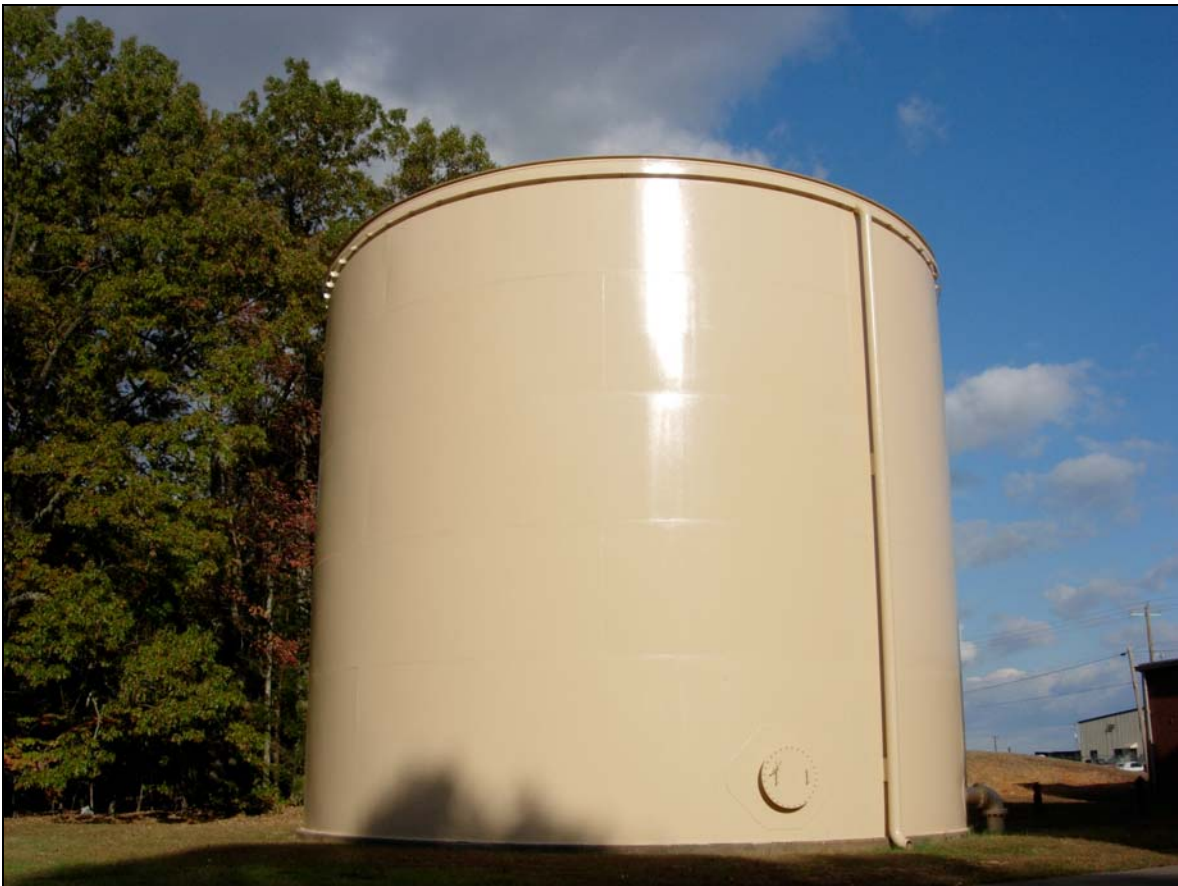
**Figure 11: Sabre Deluge Tank after application of the coating system by MANTA**

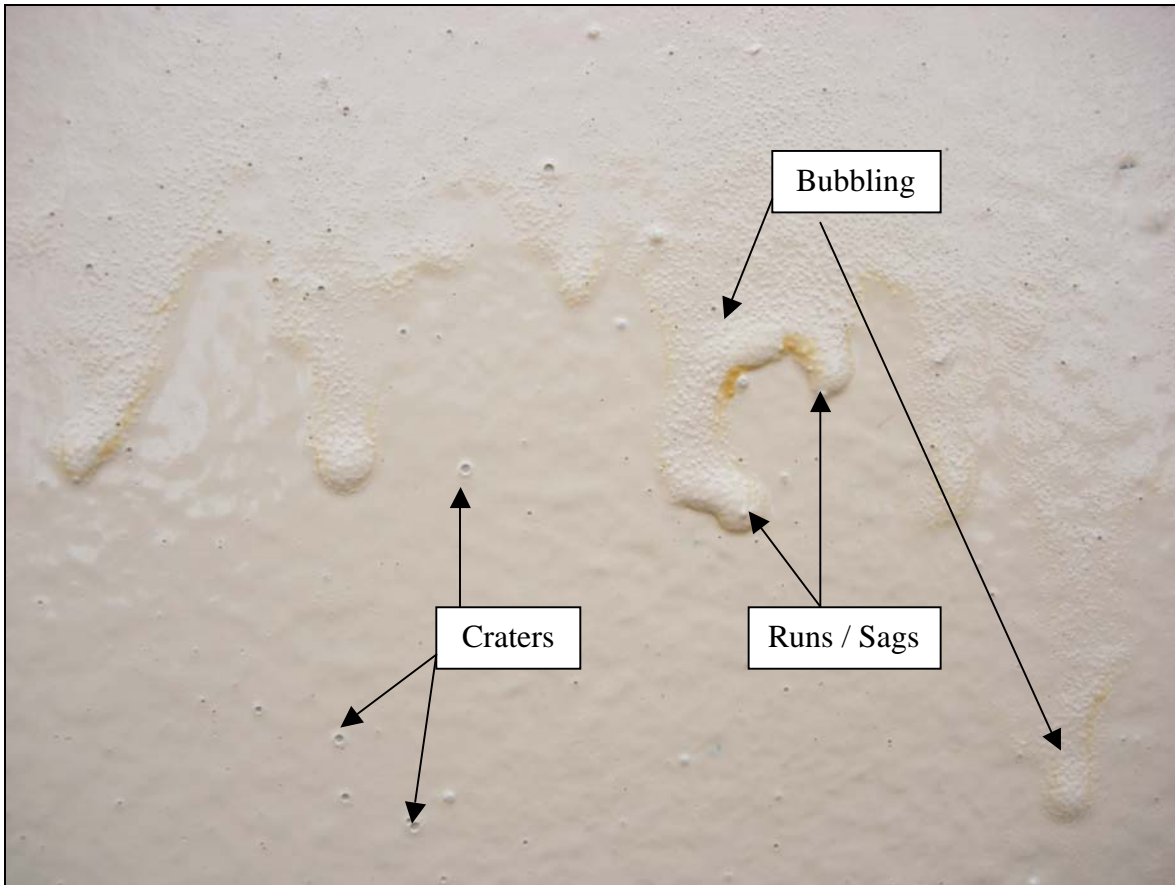
**Figure 12: Foaming, craters, runs and sags in finish coat on Sabre Deluge Tank**

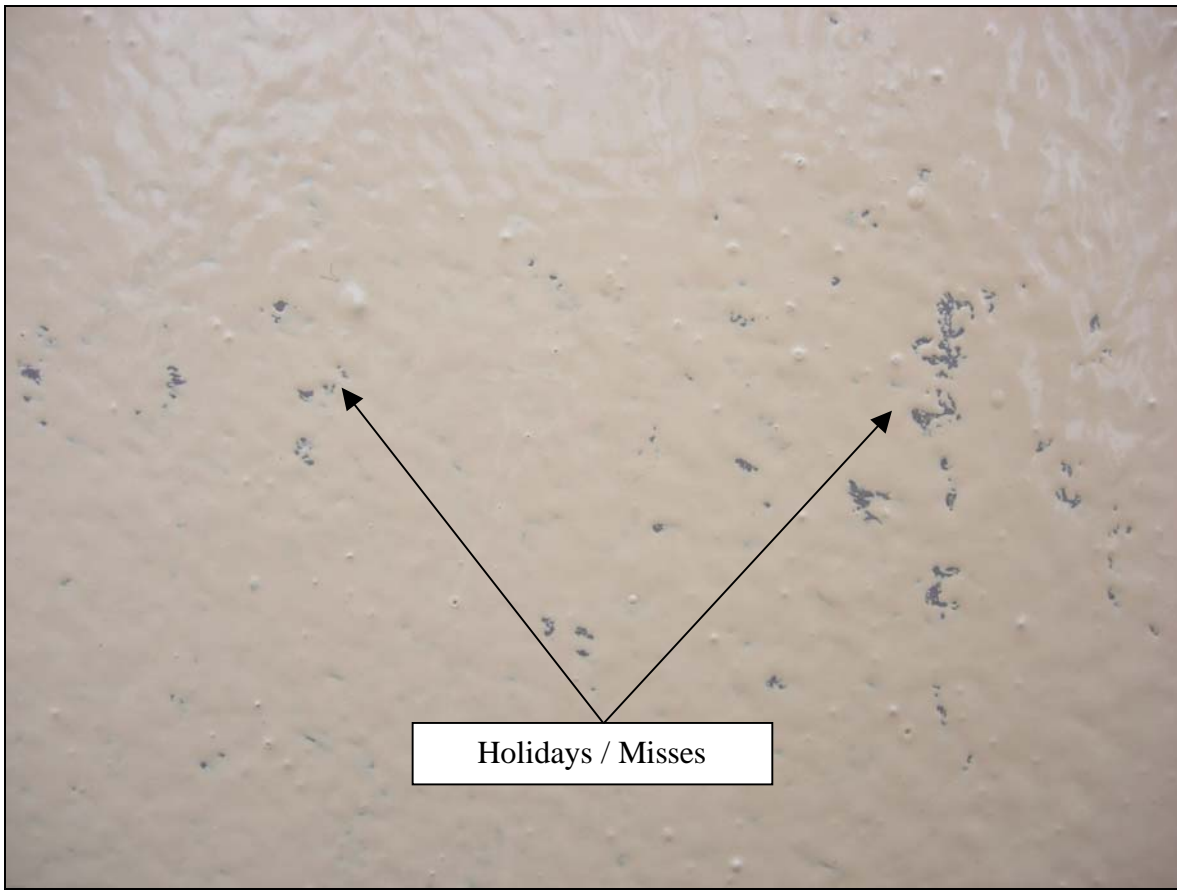
**Figure 13: Holidays / missed areas in the Sherwin Williams Corothane I Ironox finish coat**

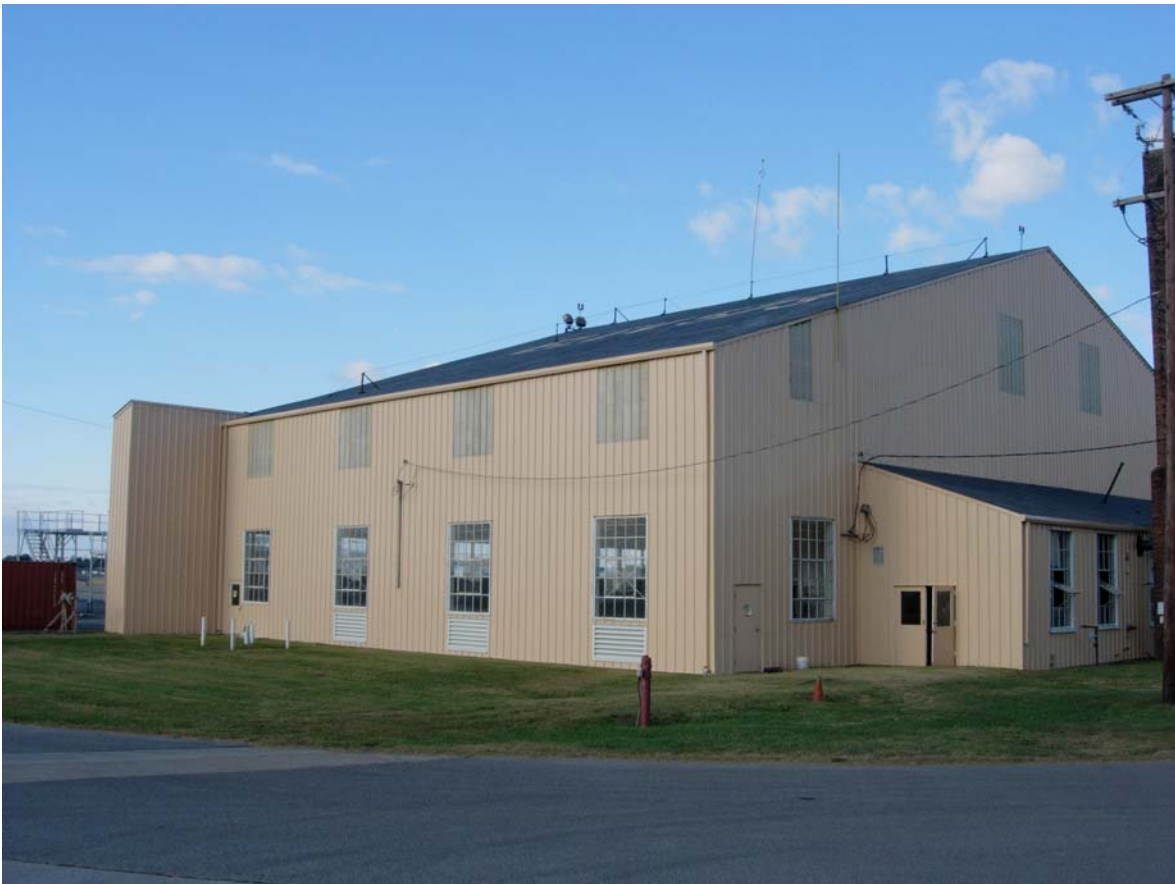
**Figure 17: Hangar #1 upon Completion**

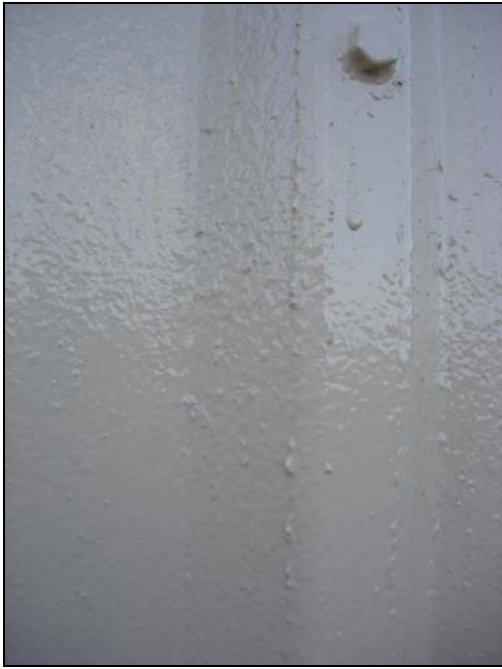
**Figure 18: Final Inspection (Hangar #1)**

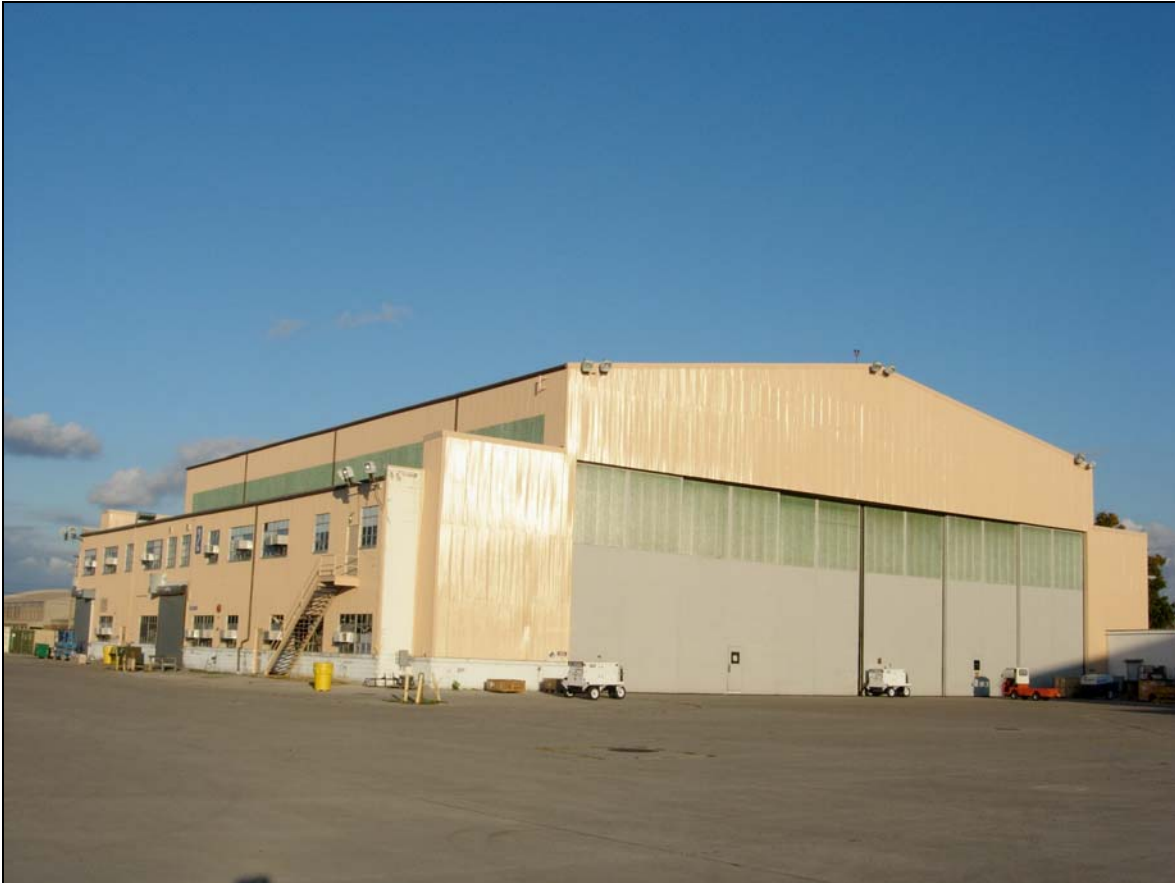
**Figure 22: Hangar #2 Ft. Campbell upon Completion**

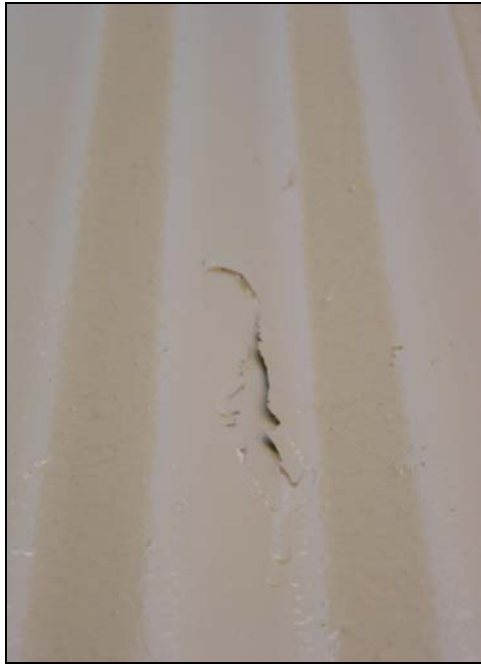
**Figure 23: Loosely adhered coating**

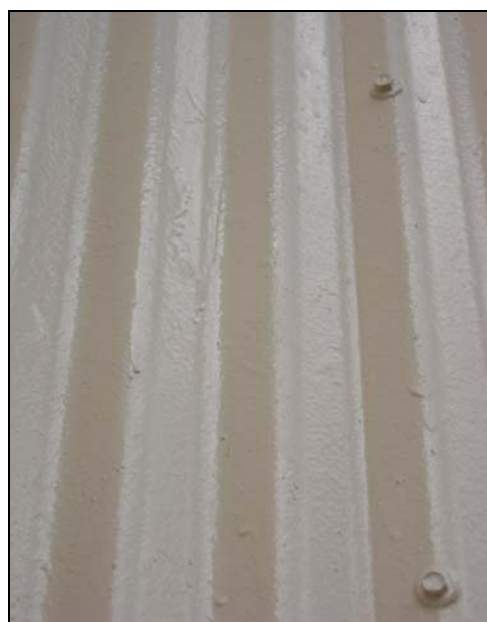
**Figure 25: Close-up after repair**

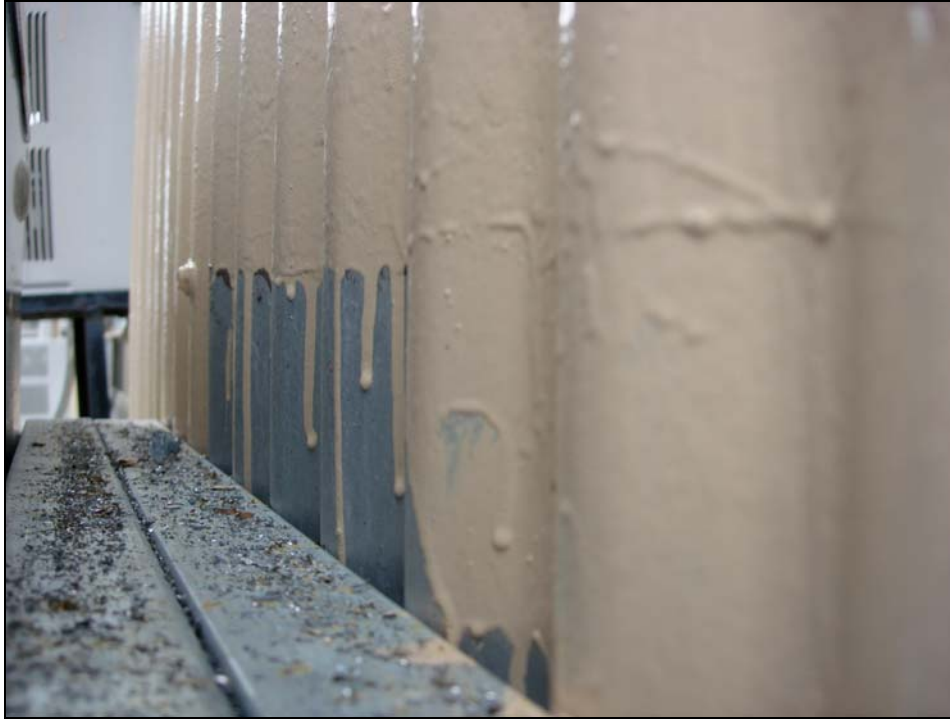
**Figure 27: Difficult to access area that was not primed or topcoated**

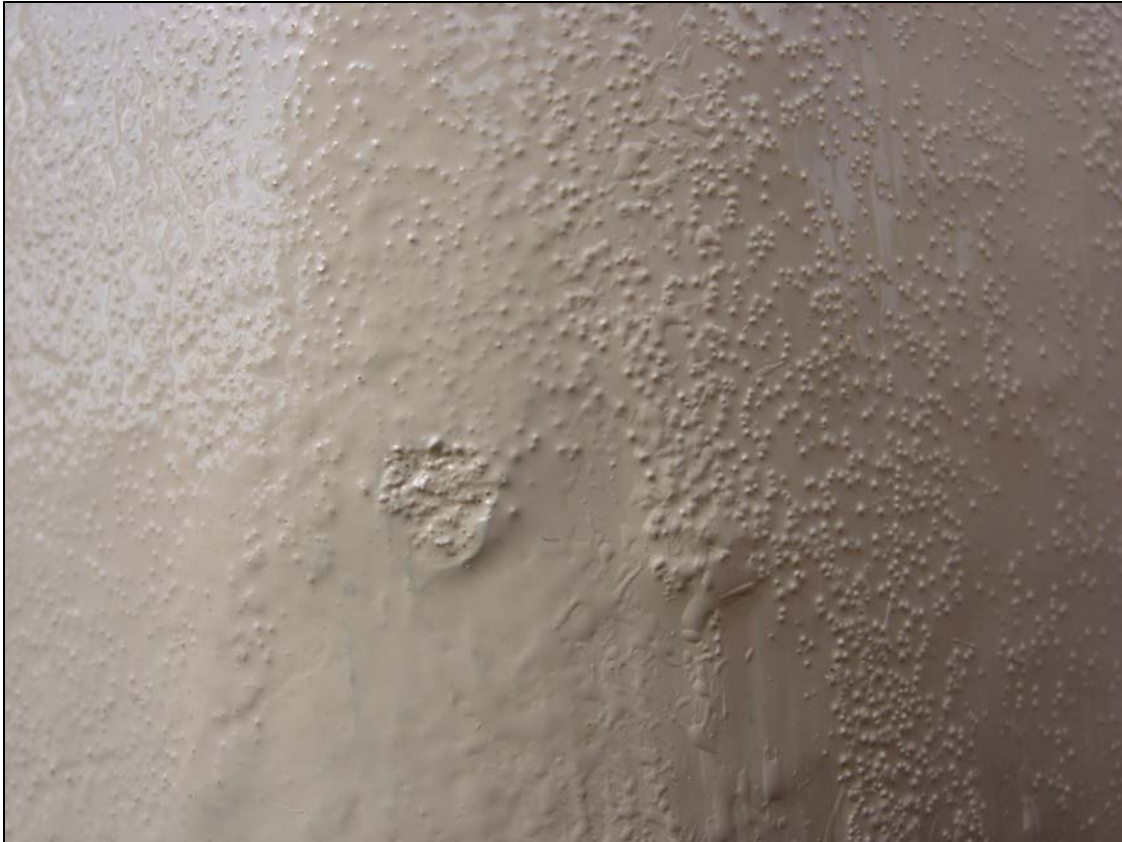
**Figure 32: Small bubbles in the Sherwin Williams Corothane I Ironox topcoat**

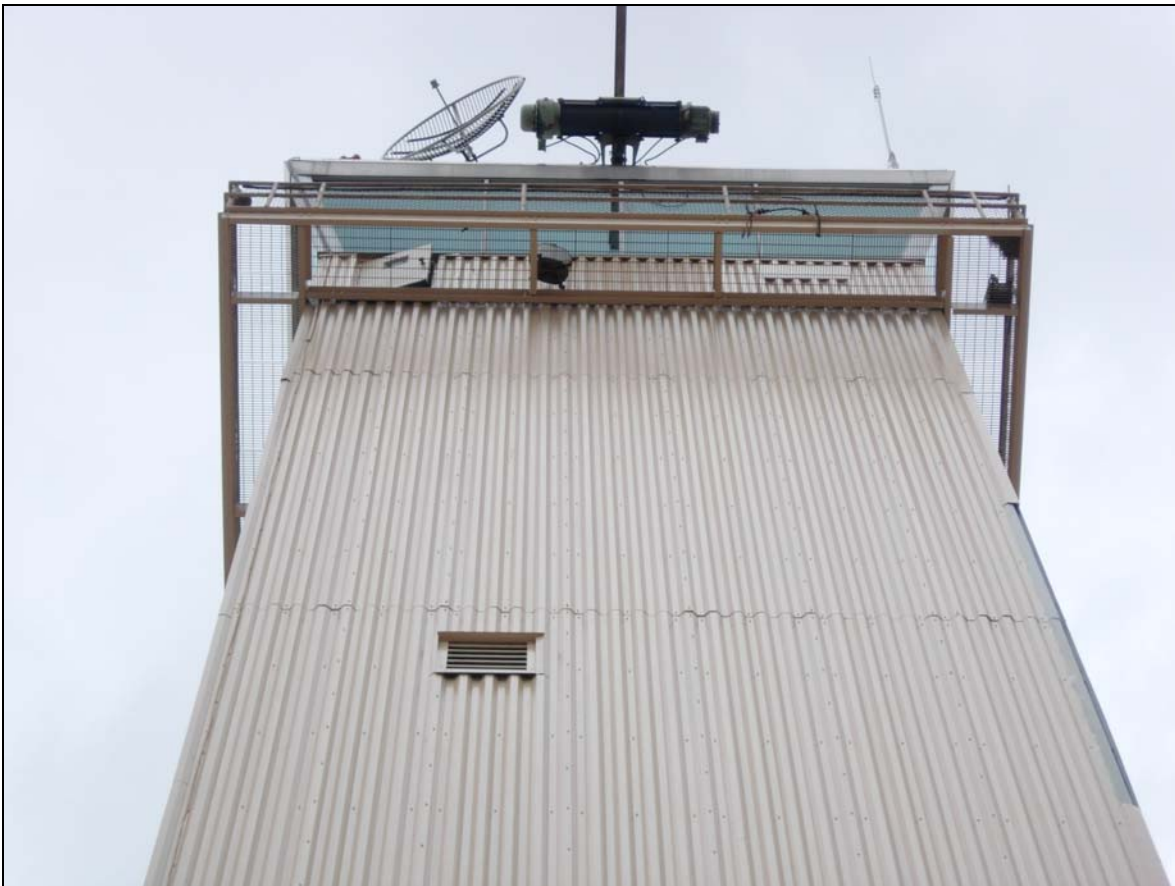
**Figure 33: Close-up of the Flight Control Tower upon Completion**

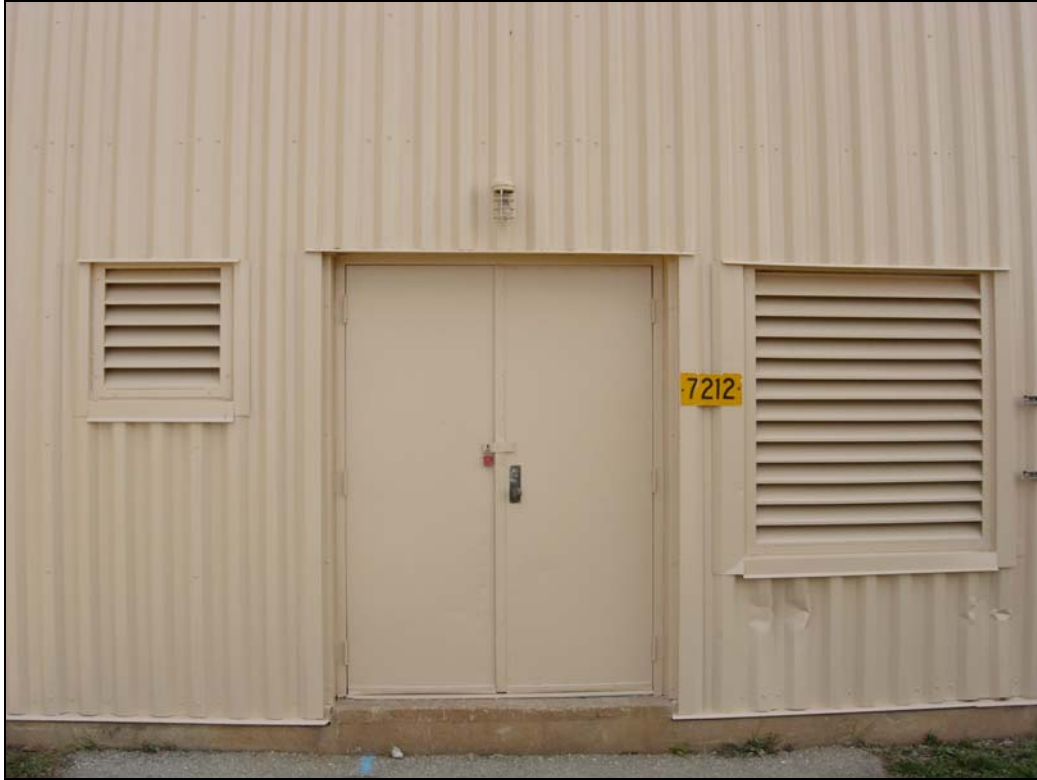
**Figure 34: Dented siding on Flight Control Tower beneath the large vent**

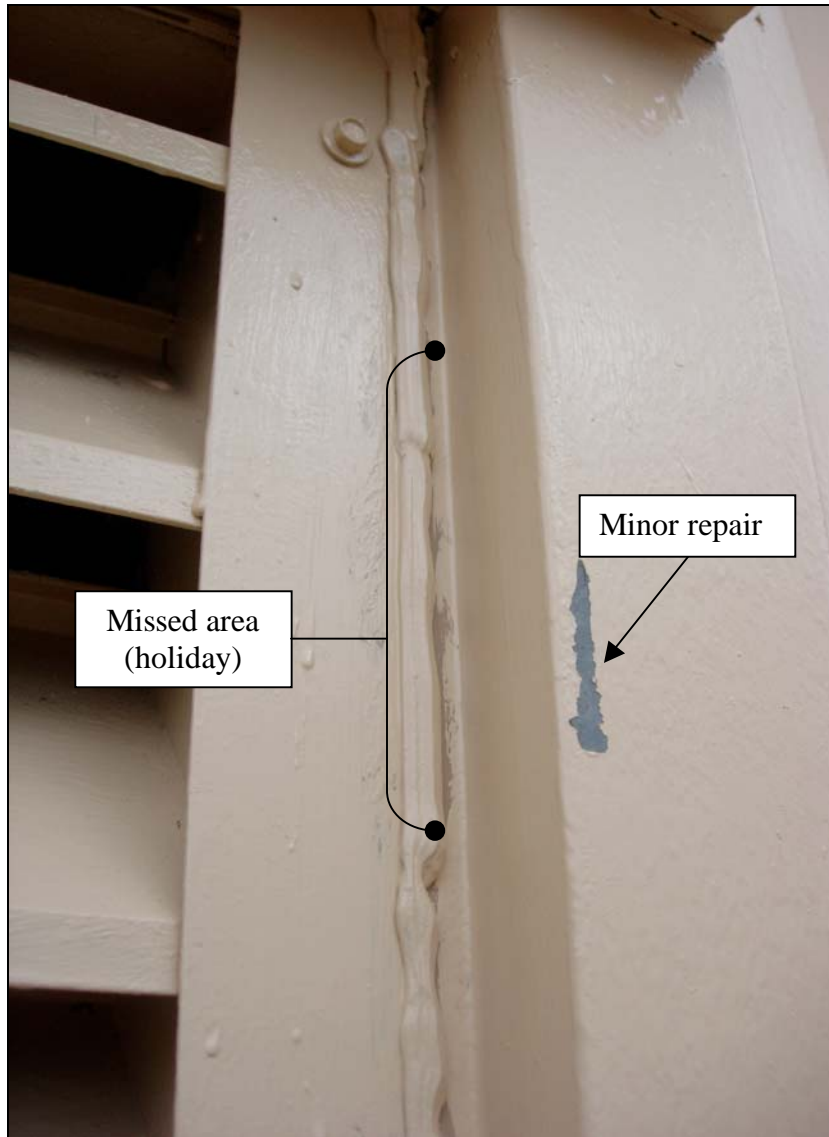
**Figure 36: Area with holiday missed area and minor repair**

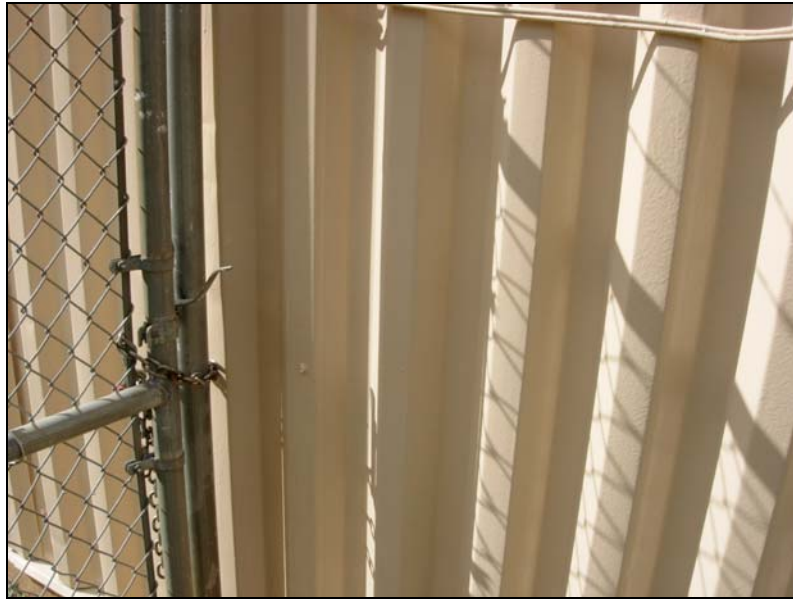
**Figure 37: Close-up of the gate and latching device**

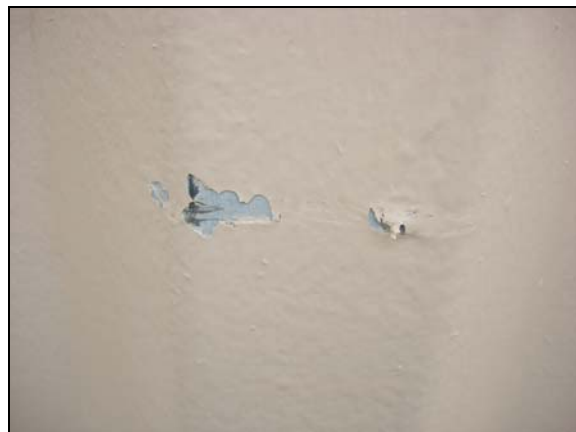
**Figure 39: Damage to paint from gate latch**

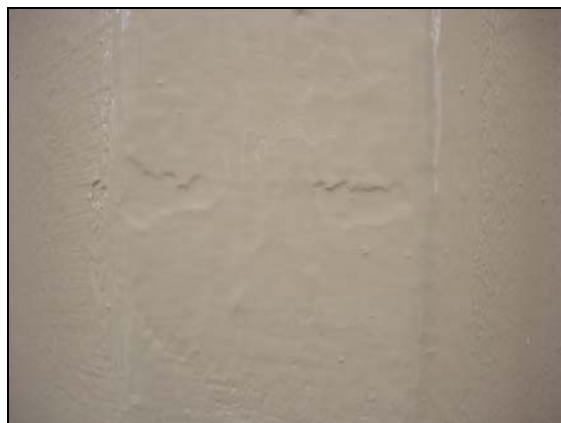
**Figure 40: Area after MANTA repaired damage**
