OFFICE OF THE SPECIAL INSPECTOR GENERAL FOR IRAQ RECONSTRUCTION

HADITHA GENERAL HOSPITAL
UNDER THE ECONOMIC SUPPORT FUND PROGRAM
HADITHA, IRAQ

SIGIR PA-08-132
JANUARY 23, 2009

SUBJECT: Report on Project Assessment of the Haditha General Hospital, Haditha, Iraq
(SIGIR Report Number PA-08-132)

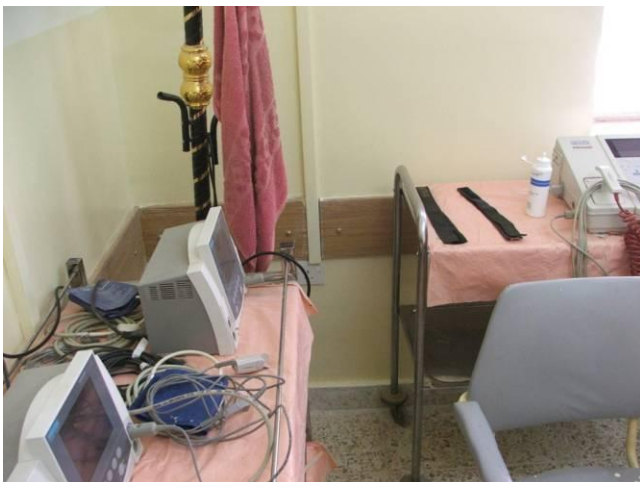
SIGIR noticed a moderate amount of modern medical equipment requiring electricity; specifically, several heart monitors and defibrillator machines (Site Photo 10). This equipment appeared to be supplied with power from the renovated electrical system.

Photos 10 and 11. Heart monitors and defibrillator machines (left) and standing water on the restroom floor (right).

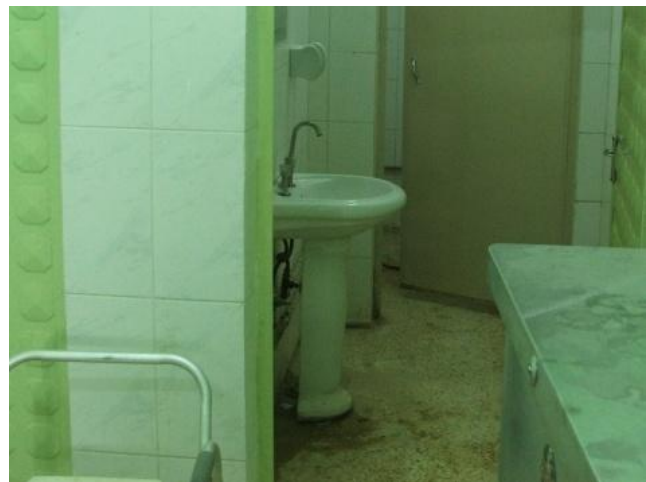
Several of the common restrooms were kept in an unsanitary manner. At least one lavatory in the common restroom between the wards appeared to be leaking and there was standing water on the floor (Site Photo 11). Due to time limitations, SIGIR could not determine if the leak was in a previously renovated area or if the contractor was required to perform additional work, including repair of the lavatory, under the re-scoped portion of the contract. However, there is a significant potential for germs and the spread of disease from the use of the restrooms.

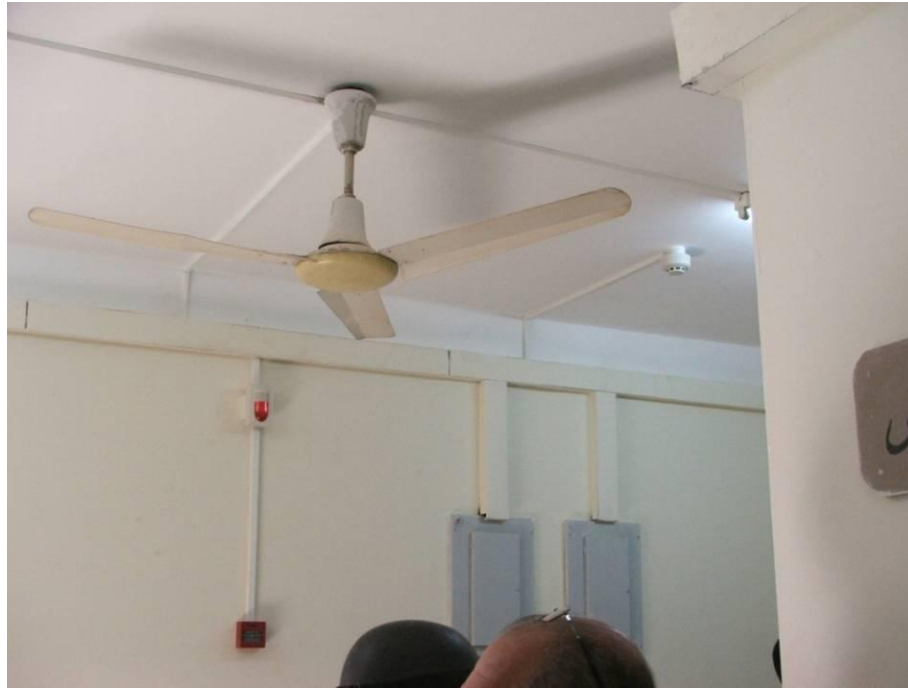
Measures to improve fire safety were included throughout the facility, including in the men's and women's wards and the maternity wing. The contractor installed fire extinguishers, which appeared to be new and fully charged (Site Photo 9). The contractor representative stated a fire alarm system was installed and functioning properly (Site Photo 13).

Site Photo 13. Installation of fire alarm system.

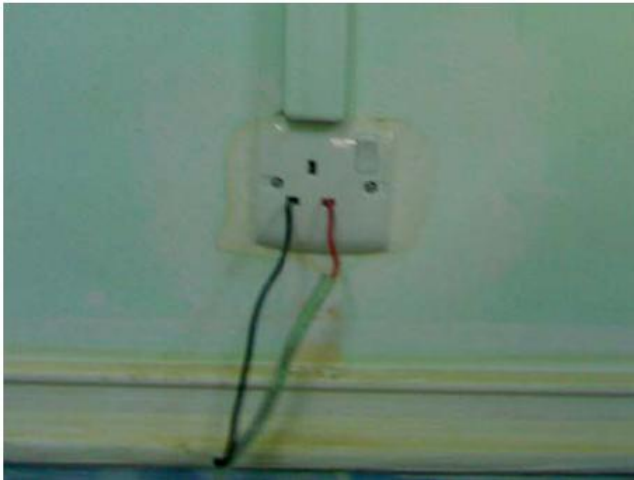
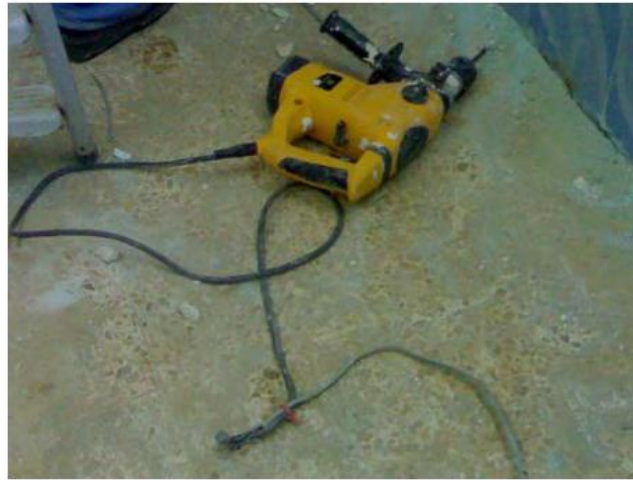
The USACE provided SIGIR with 14 daily QA Representative (QAR) reports from the months of September and October 2008. The reports provided detailed information regarding the progress of renovation and the quality of construction. The QAR provided written reports, including photographs, which documented activities being performed and deficiencies in construction quality or materials. The daily QA reports identified the safety concerns, inferior workmanship, and the progress of construction. For example, the QAR identified potentially dangerous safety concerns with the contractor's use of electrical connections and the corrective actions taken (Site Photos 14-17).

Site Photos 14 and 15. Unsafe electrical practices used by the contractor and captured in daily QA reports (Courtesy of USACE)
