RIGHT BANK DRINKING WATER TREATMENT  
PLANT REHABILITATION

COMMANDER'S EMERGENCY RESPONSE PROGRAM

NINEWA GOVERNORATE, IRAQ

SUSTAINMENT ASSESSMENT

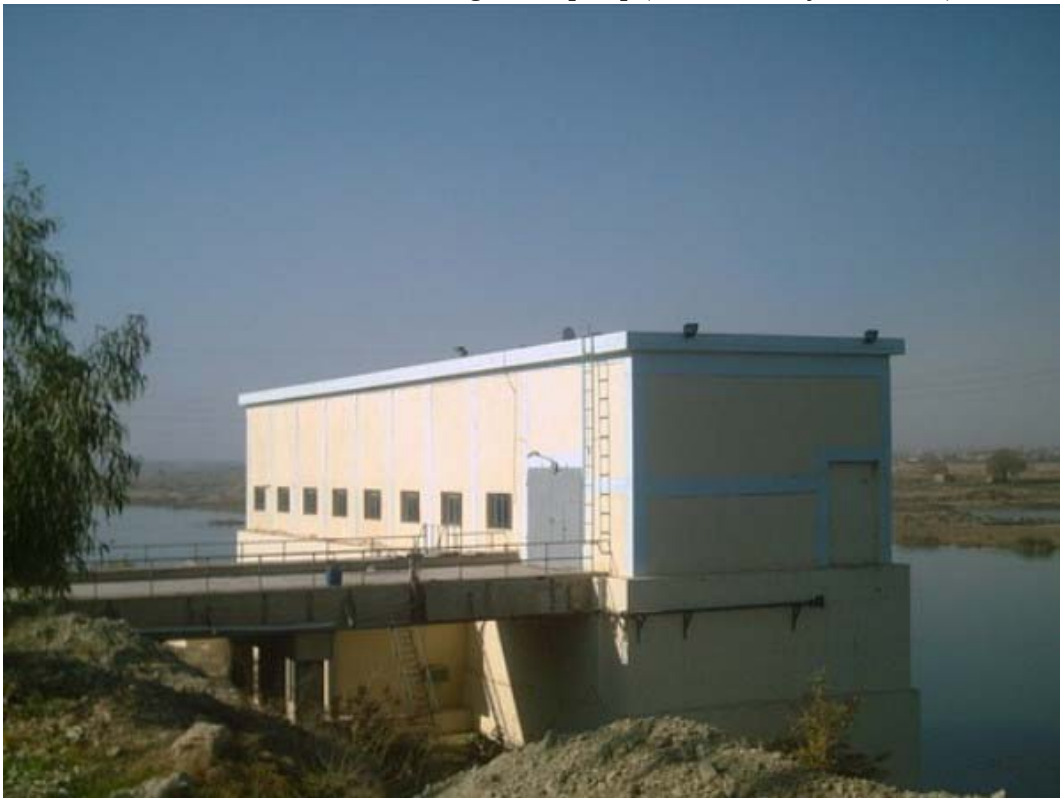
**Site Photo 5. Low- lift pumping station's newly renovated exterior (Photo courtesy of USACE)**

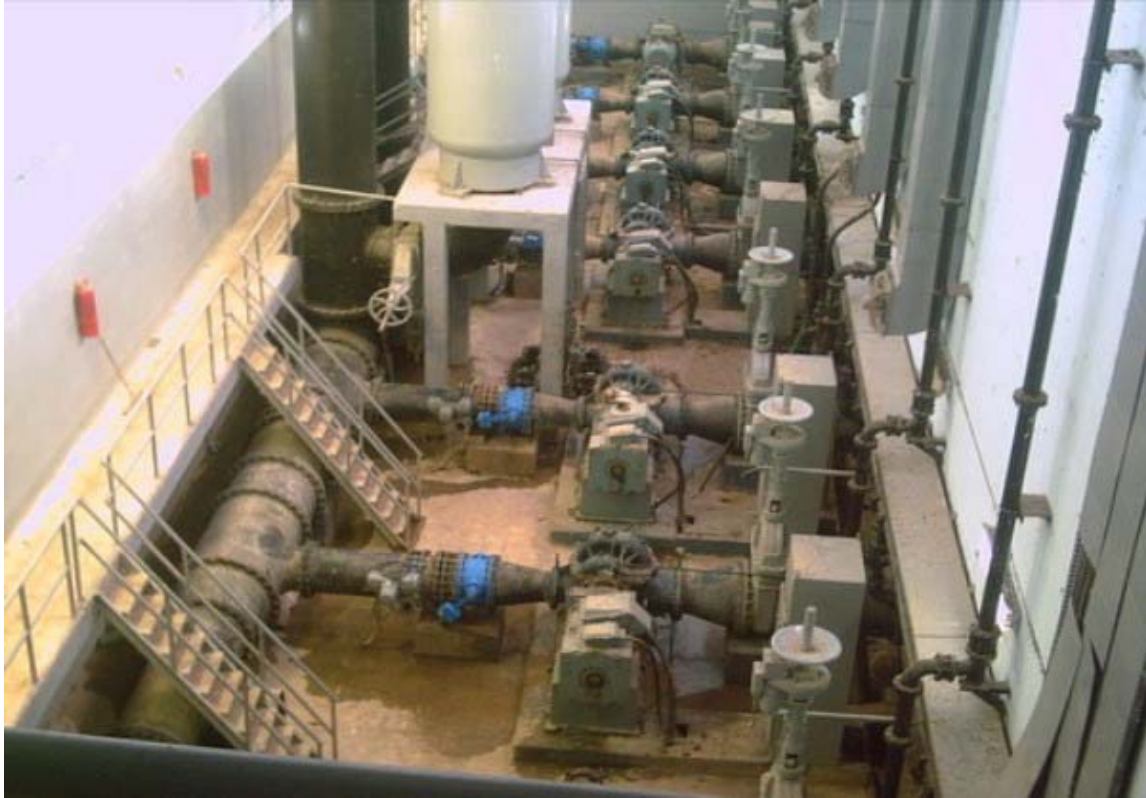
**Site Photo 6. Low- lift pumping station's newly renovated interior (Photo courtesy of USACE)**

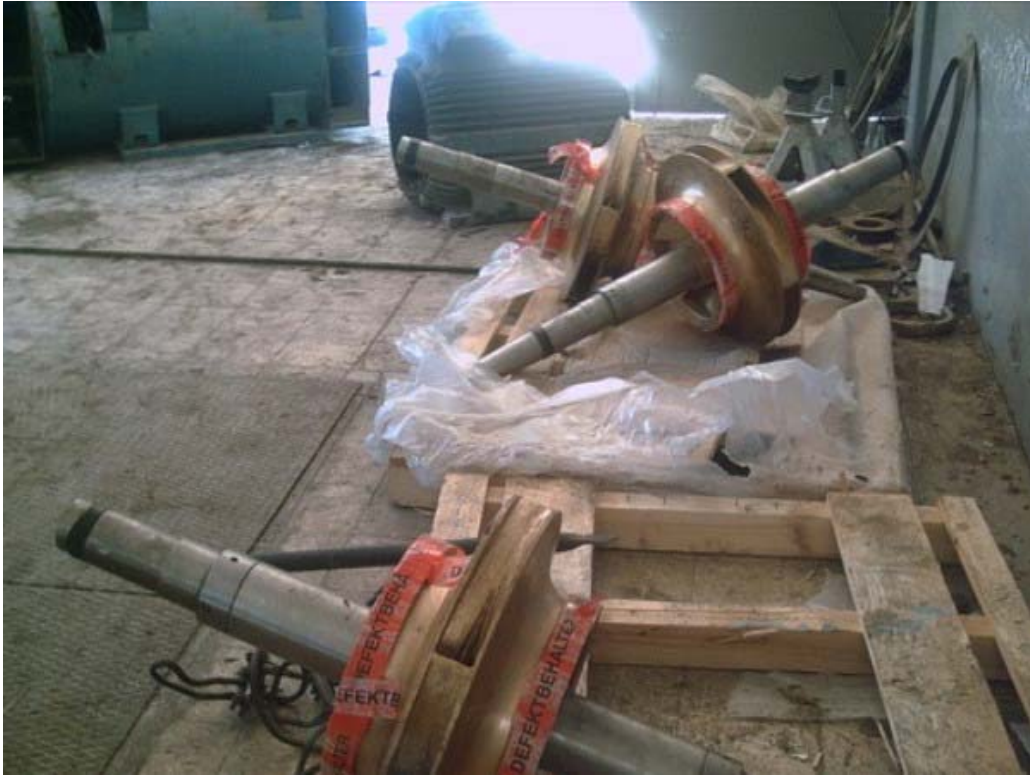
**Site Photo 10. High-lift pumping station's propeller & stainless steel shaft for pumps  
(Photo courtesy of USACE)**

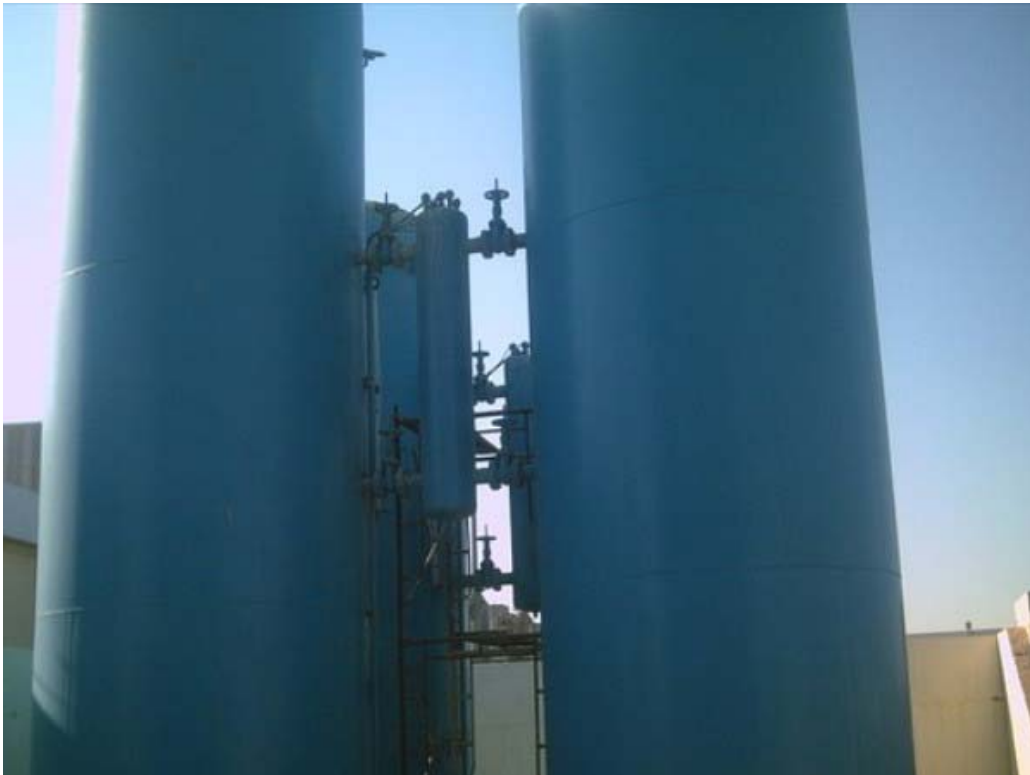
**Site Photo 11. Anti-hammer system (Photo courtesy of USACE)**

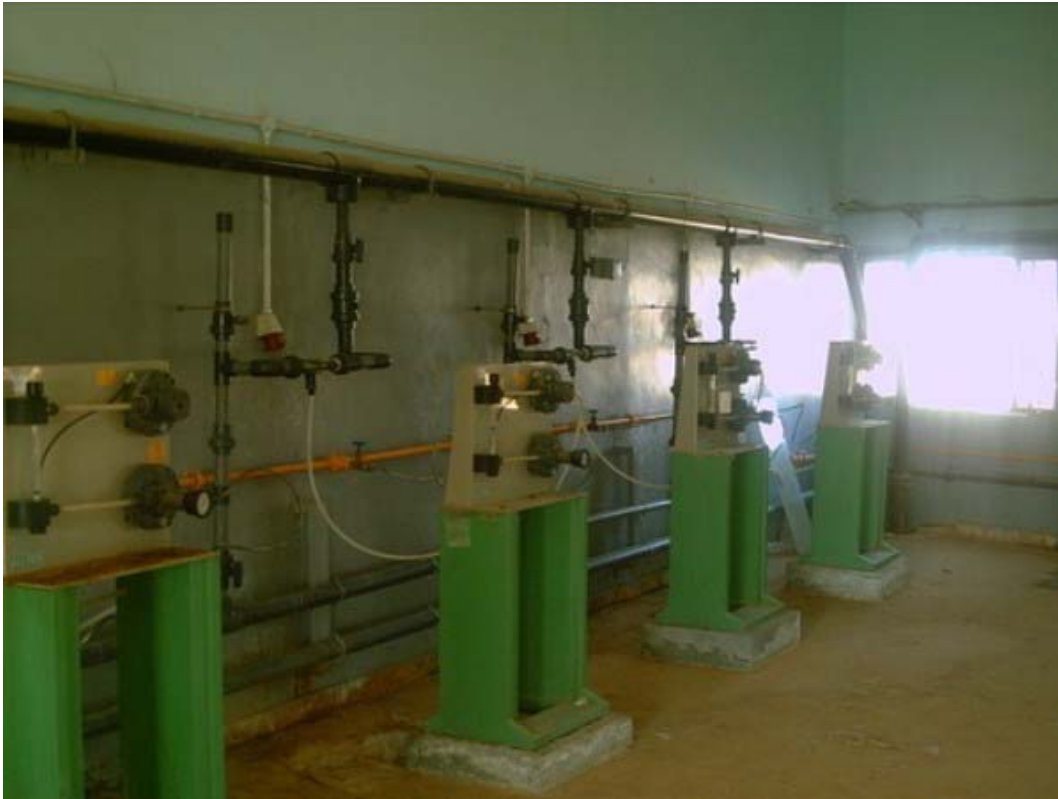
**Site Photo 12. Chlorine dosing sets (Photo courtesy of USACE)**

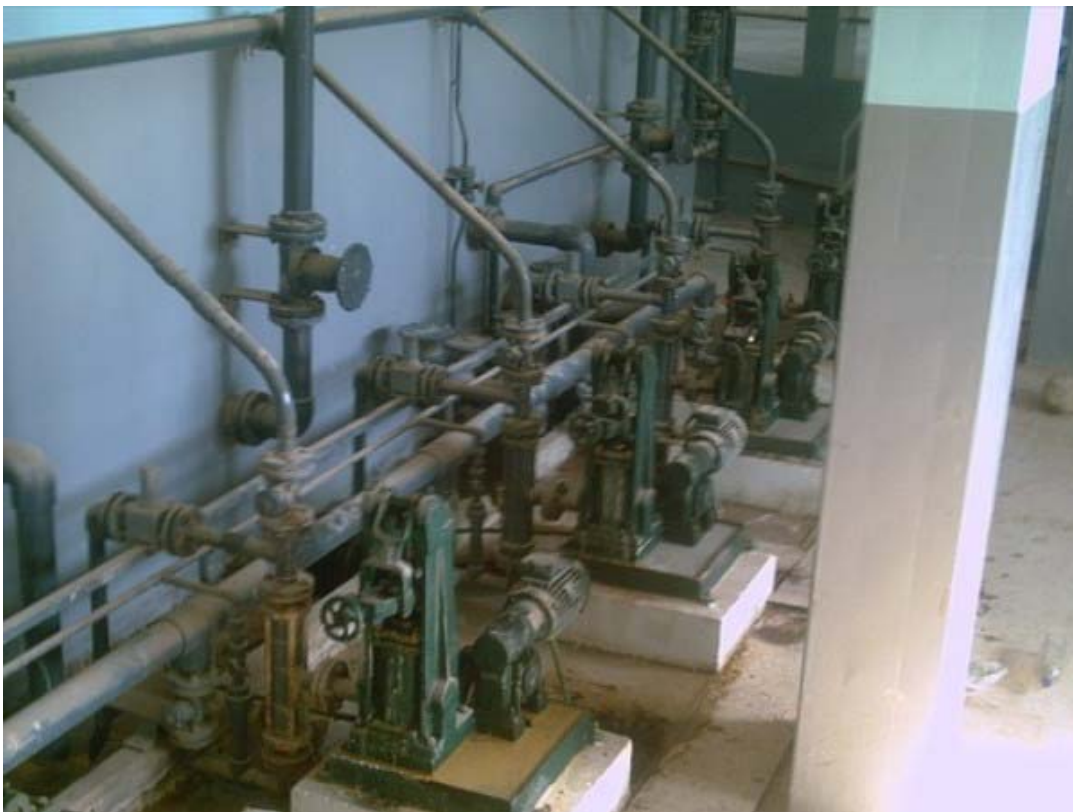
**Site Photo 13. Alum mixers (Photo courtesy of USACE)**

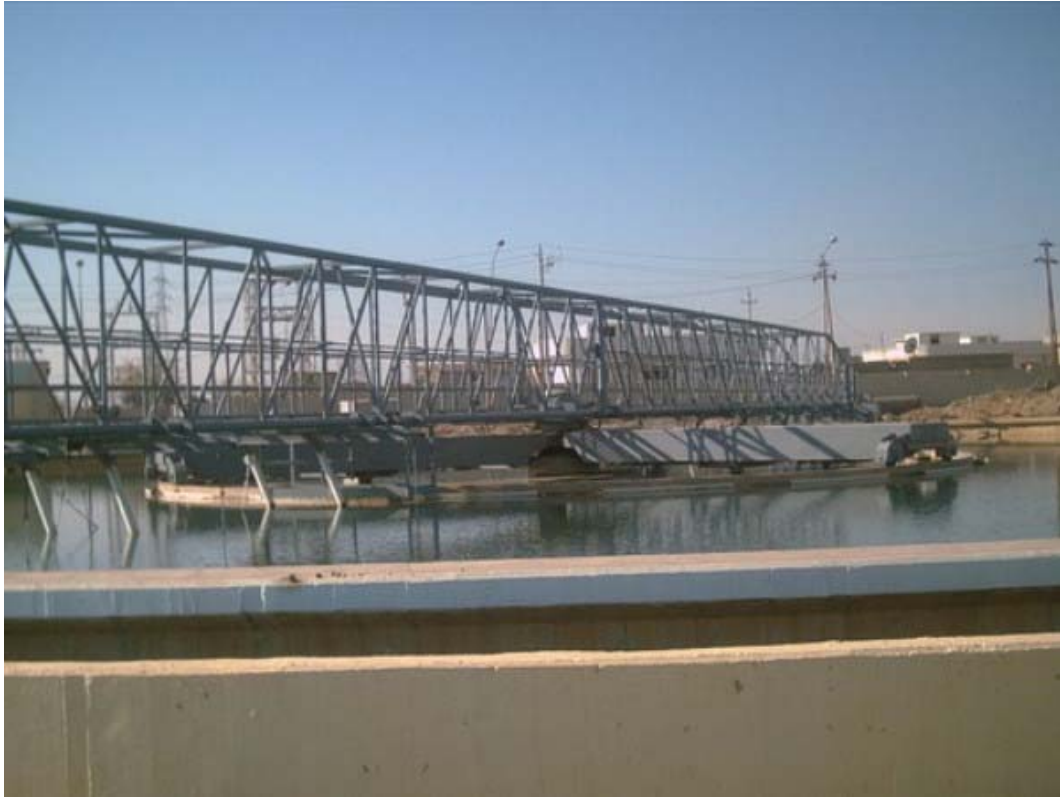
**Site Photo 14. Settling tank (Photo courtesy of USACE)**

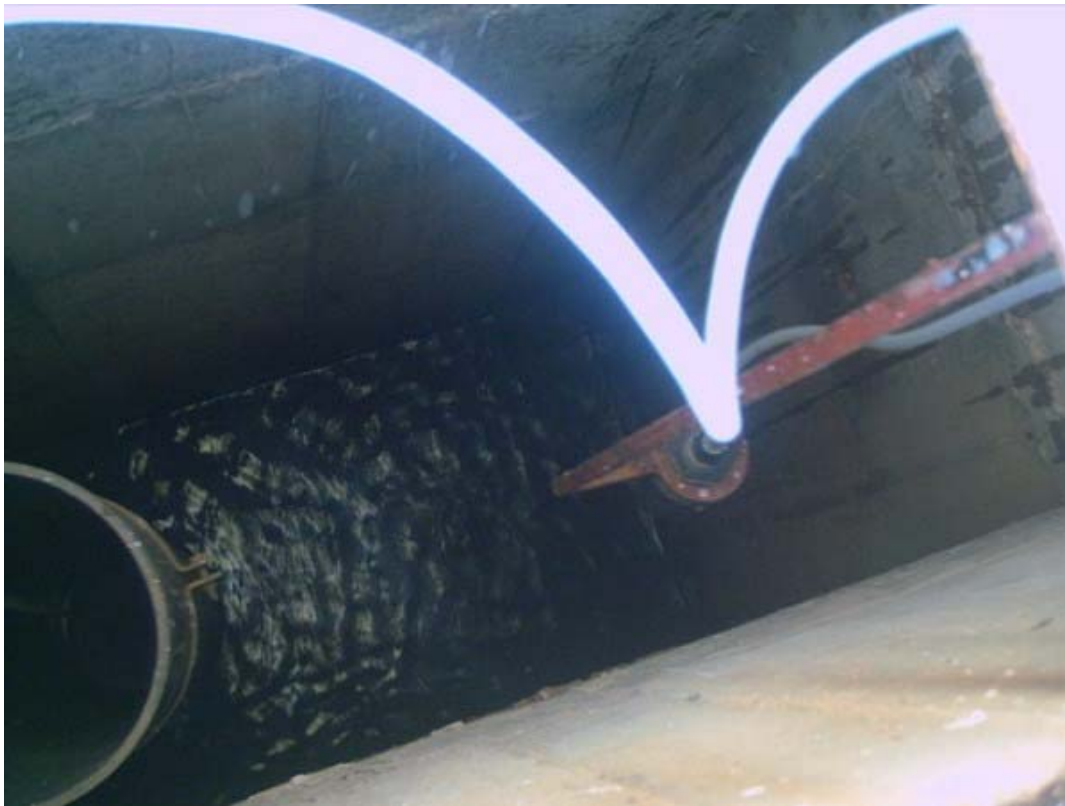
**Site Photo 15. Water level indicator (Photo courtesy of USACE)**
