**BARTILLA BOOSTER PUMP STATION REPAIR**  
COMMANDER'S EMERGENCY RESPONSE PROGRAM  
**NINEWA GOVERNORATE, IRAQ**

**SUSTAINMENT ASSESSMENT**

**SIGIR PA-07-109**  
**OCTOBER 23, 2007**

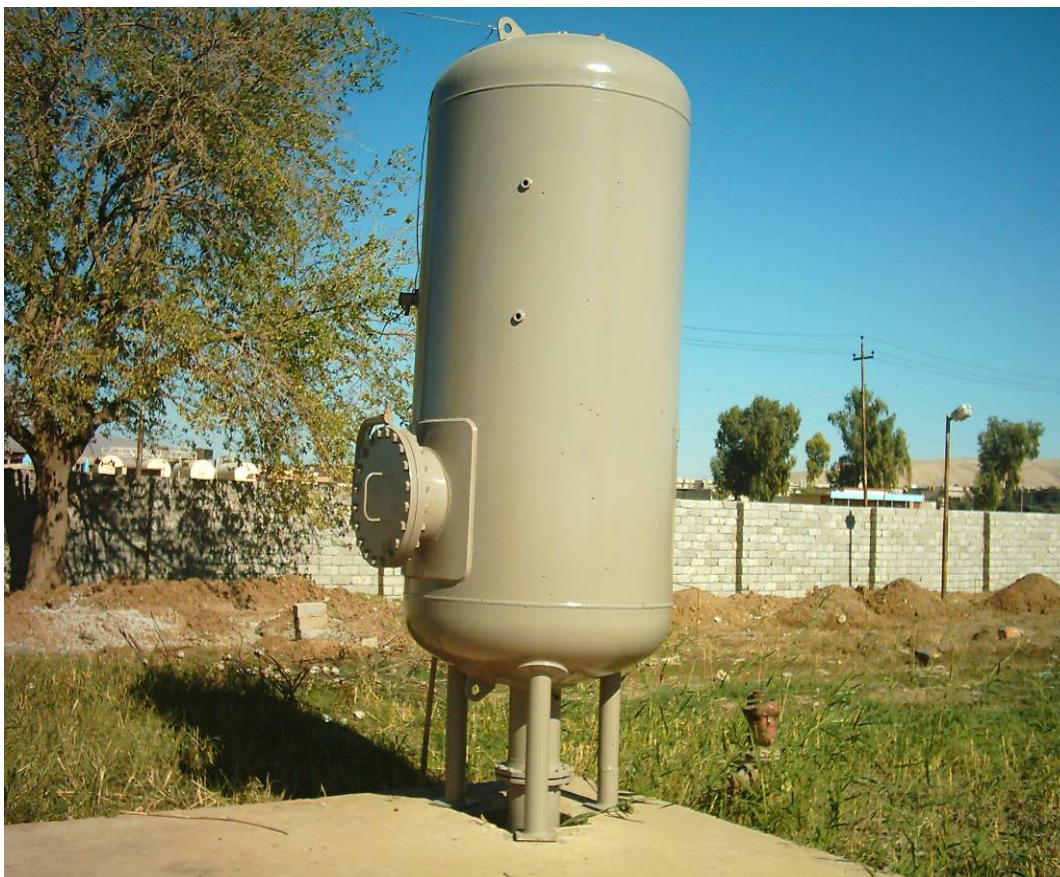
**Site Photo 2. Anti-Hummer system after maintenance (Photo courtesy of USACE)**

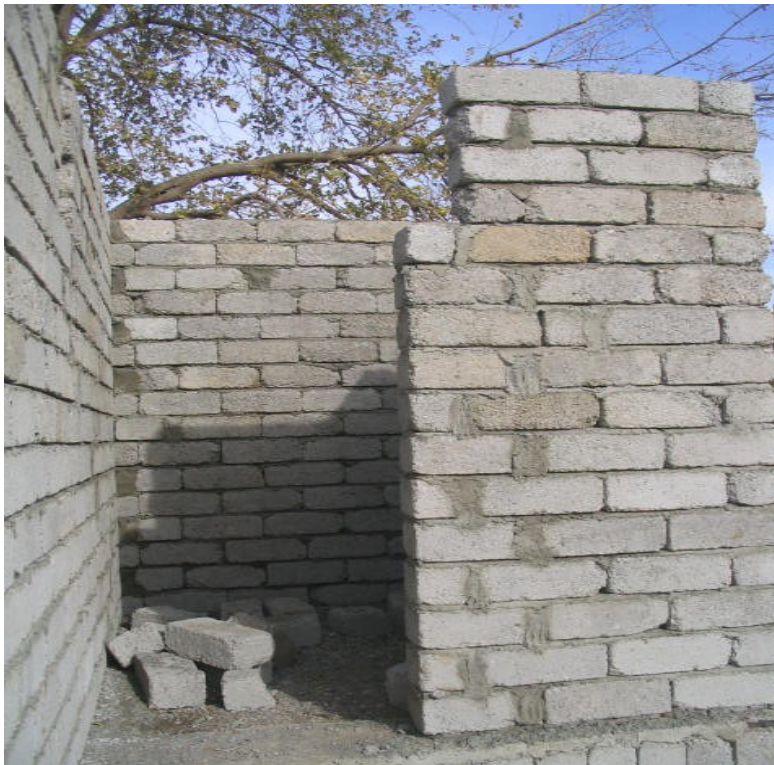
Site Photo 6 displays the new construction of a water closet at the Bartilla Booster Pump Station, and Site Photo 7 documents the completed construction of the water closet.

**Site Photo 6. Construction of a water closet (Photo courtesy of USACE)**

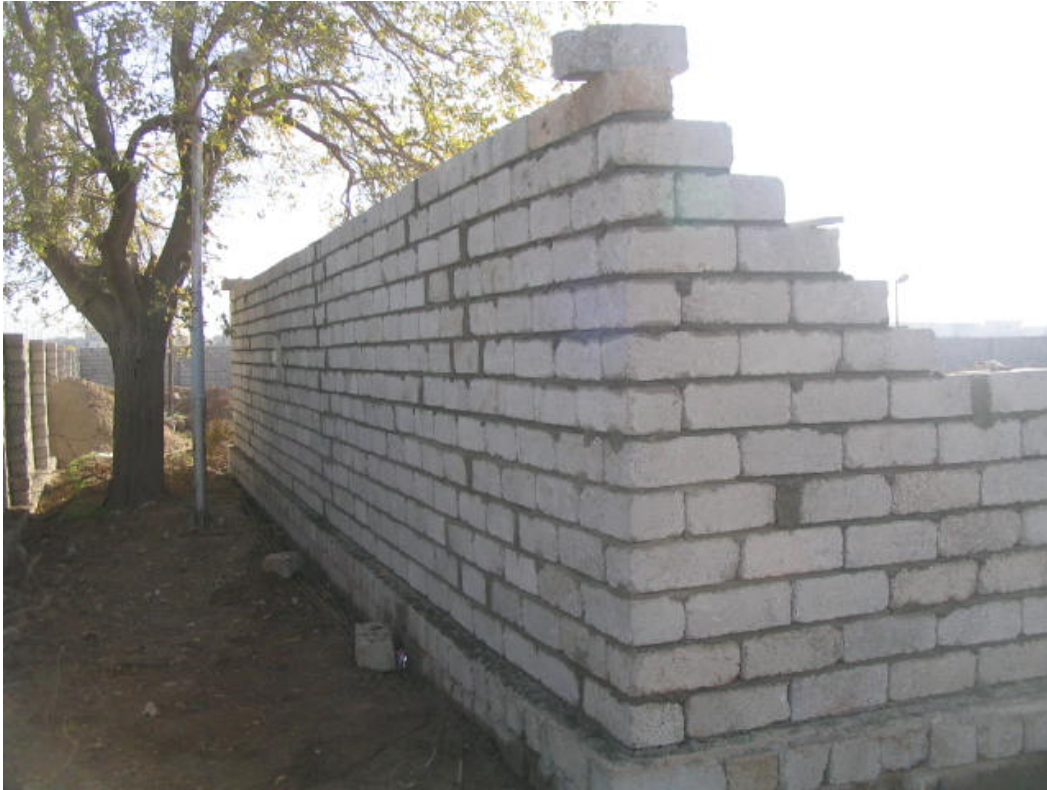
Site Photo 11 documents the construction that occurred for the manager of operations' new office.

**Site Photo 11. Construction of the manager of operations' new office (Photo courtesy of USACE)**

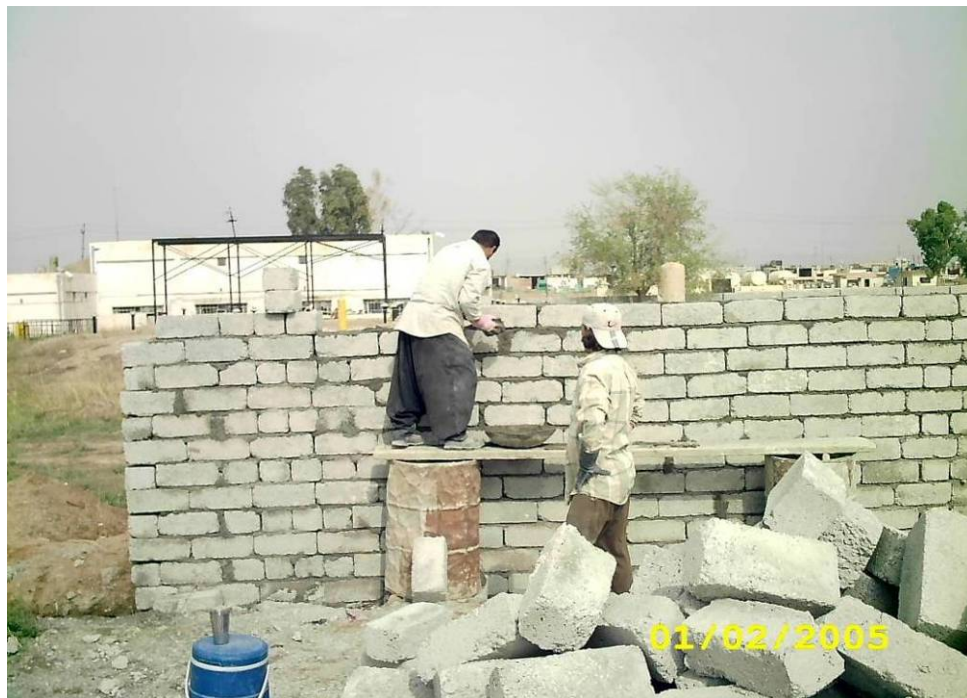
The construction of the two-meter high fence, made from concrete blocks and cement plaster, is shown in Site Photo 12. Site Photo 13 documents the completed construction of the two-meter high fence around the perimeter of the Bartilla Booster Pump Station.

**Site Photo 12. Construction of security wall (Photo courtesy of USACE)**
