## Hatteras Breach, North Carolina

*by Ty V. Wamsley, Kent K. Hathaway, and Michael Wutkowski*

**PURPOSE:** This Coastal and Hydraulics Engineering Technical Note (CHETN) is intended to document the rapid response of the U.S. Army Corps of Engineers to engineer and construct a breach closure and the lessons learned. The note also documents the short-term morphologic evolution and hydrodynamic characteristics of the breach based on an analysis of collected data. Researchers are utilizing this important data set in the development of numerical models of coastal breaching and to further the Corps' understanding of the breaching process.

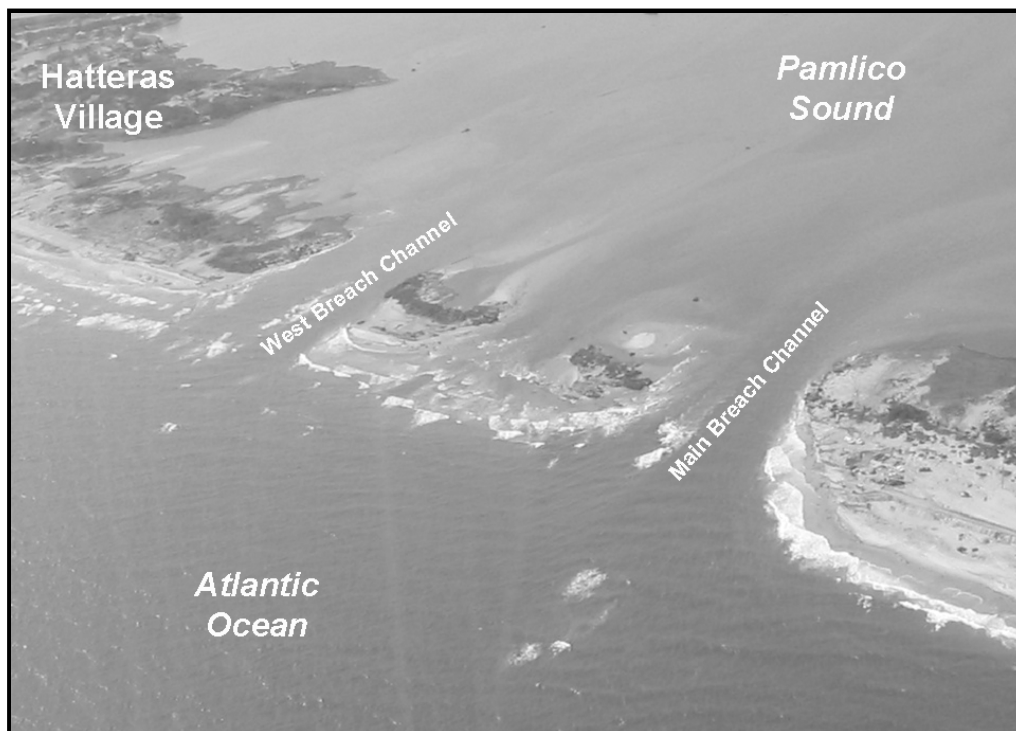
Figure 2. Hatteras breach, 22 September 2003.

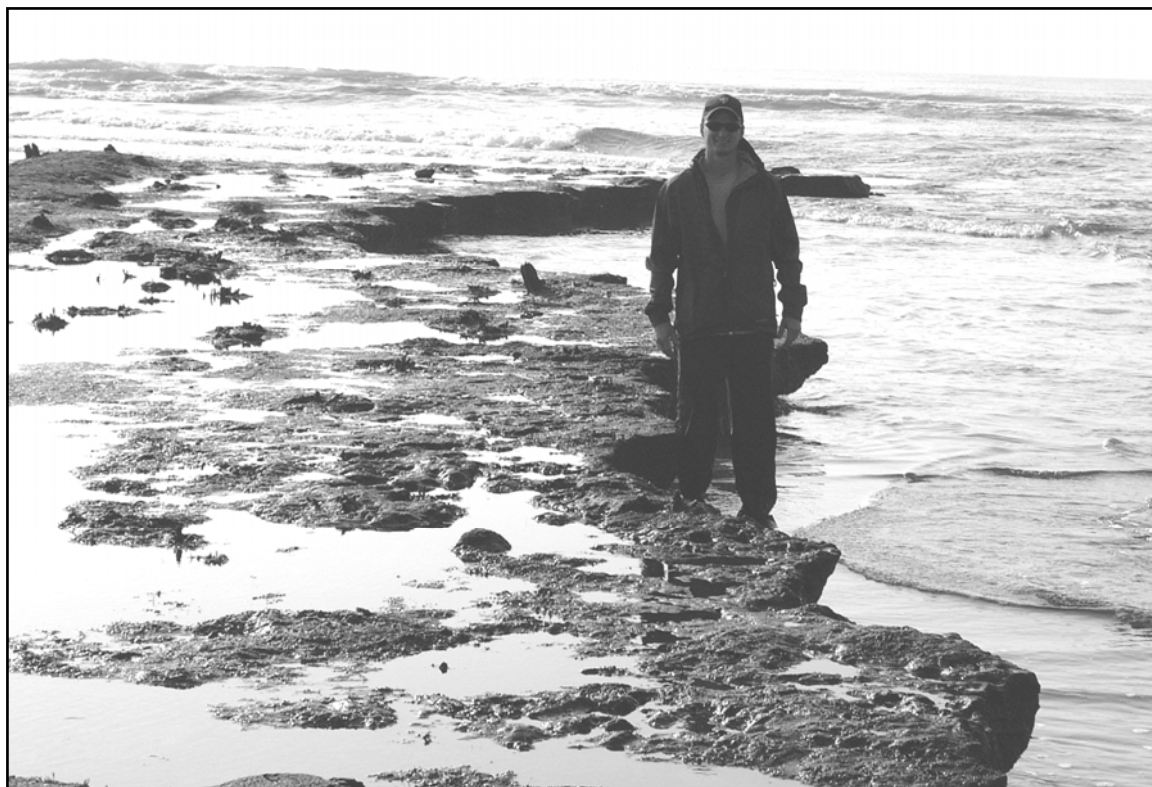
Figure 4. Western edge of peat terrace, looking southeast. Peat extends approximately 1.5 to 2 ft above the adjacent sandy bottom.

The peat terrace restricted flow in the middle breach channel, which was about 225 ft wide. Water flowed through the middle channel and over the peat terrace only at higher tide elevations. The restricted flow resulted in little scour of this channel. Maximum depths in the middle channel were about 5 ft NAVD88 (1988 North American Vertical Datum). The west channel was about 350 ft wide and littered with debris (Figure 6). Pilings from the bridge partially constructed in the 1930s extended across the channel on the ocean side. Large chunks of asphalt and roadbed material were visible at lower tide elevations, particularly on the west side of the channel. Near the center of the channel was a peat outcropping with large chunks of asphalt resting on top. The flow through the west channel was somewhat greater than that of the middle channel. Survey 2 maximum depths in the west channel were 7 to 10 ft NAVD88. The eastern-most breach channel was approximately 325 ft wide on the sound side and 350 ft wide on the ocean side and was the main channel as it captured a majority of the tidal prism. The unrestricted flow through this channel created scour depths down to 20 ft NAVD88.

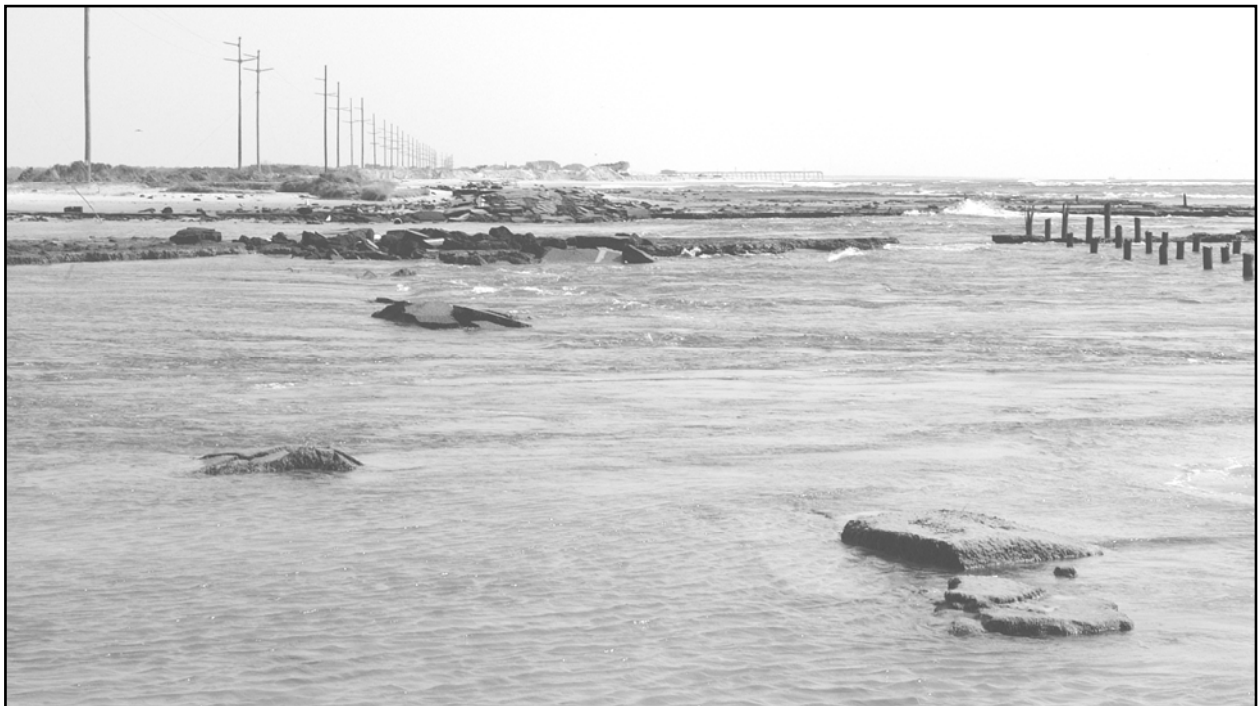
Figure 6. West breach channel, looking east, 5 October 2003. Note old bridge pilings on right and extensive road debris in channel.

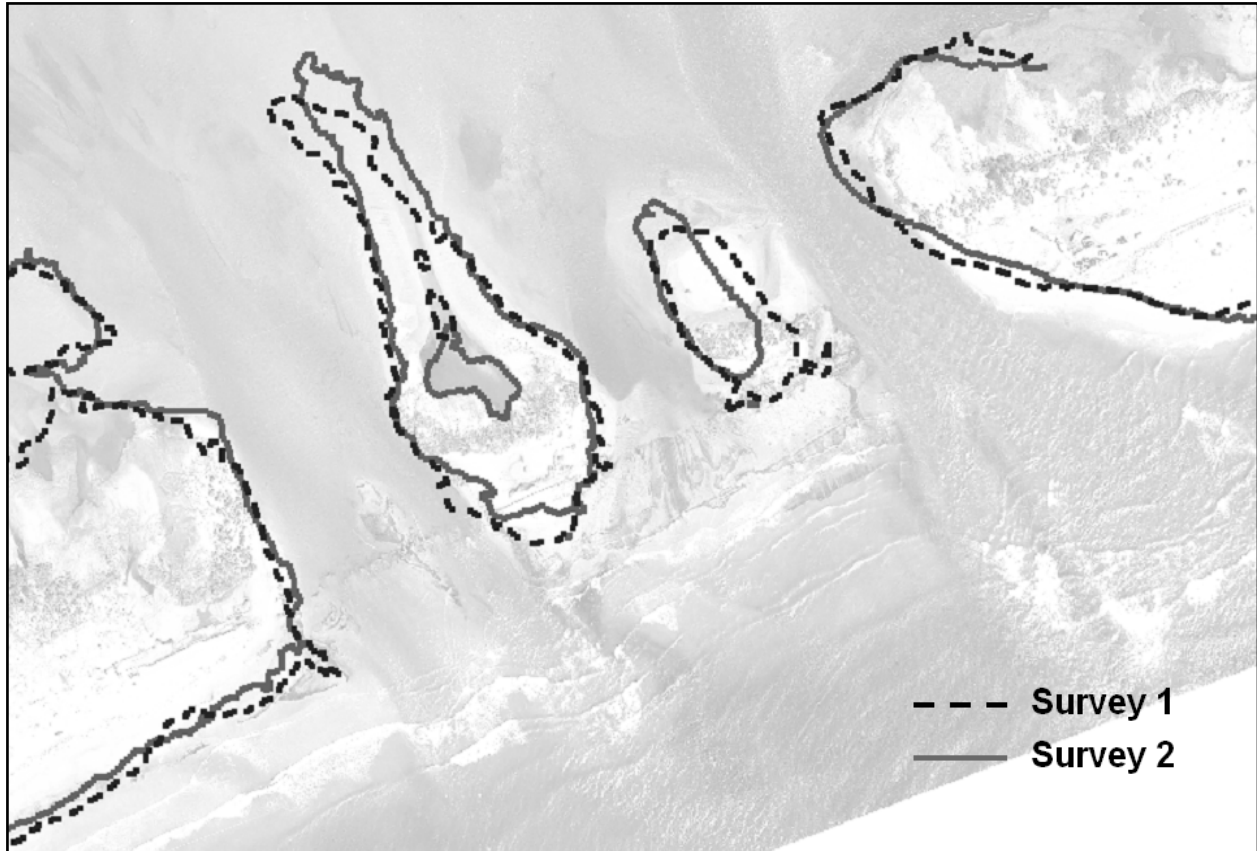
Figure 8 is a comparison of the 0-contour (NAVD88) between Surveys 1 and 2. The recession of both channel banks at the ocean end of the breach is evident. The east bank receded 25 to 45 ft while the west bank moved 40 to 80 ft. On the sound end of the breach channel, the east bank advanced approximately 25 ft, pushing the channel to the west. This end of the channel also continued to widen, however, as the west bank receded about 45 ft.

Figure 8. Comparison of the 0-contour (NAVD88). Aerial photograph was taken on 24 September, tide elevation -1.3 ft NAVD88 (NCDOT photograph).

Figure 8 illustrates the elongation of the margin shoals behind both breach islands. The east island shoal advanced approximately 65 ft. The west island shoal migrated in a northerly direction and also elongated by approximately 65 ft. The 0-contour on the front side of each island receded. This recession, however, was not from erosion of the peat terrace. The peat terrace elevation was below 0 NAVD88, and the sandy material on top eroded during higher tide elevations.

Figure 8 also shows beach shoreline change within about 500 ft of the breach. On the west side, the beach eroded approximately 35 ft. Sediment supplied by longshore transport advanced the

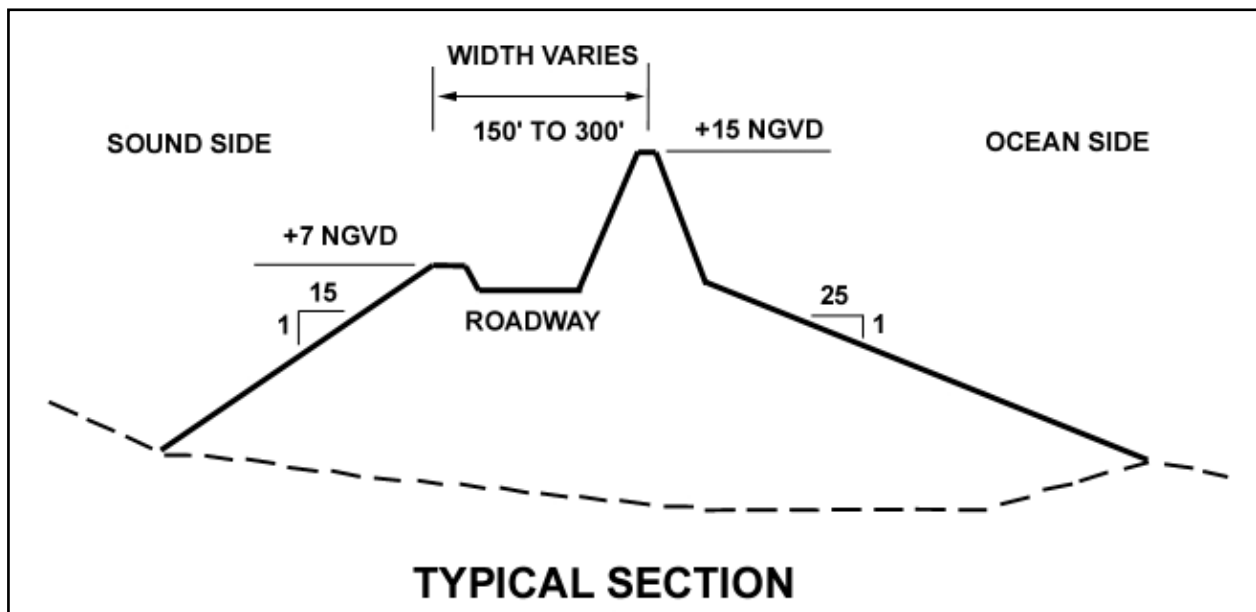
Figure 16. Typical fill cross section.

The design cross section consisted of a berm at elevation +7.0 ft NGVD with a 10-ft-wide dune at +15.0 ft NGVD (Figure 16). The berm and dune elevations were chosen to be consistent with the pre-breach elevations. The pre-breach berm elevation was +6.0 ft NGVD and the average pre-breach dune elevation was +15.0 ft NGVD. Factors influencing the width of the berm were that the berm had to contain enough sand to fill the scour channels formed by the breach, the width of the berm had to be at least 100 ft after waves and currents adjusted the fill profile, and the fill had to transition into the adjacent shoreline. To determine the design berm widths, a design template with a berm width of 100 ft was superimposed on a digital terrain map that was generated from surveys. The volume to construct the design template and fill the scour channels was calculated. Construction berm widths that contain the calculated volume of sand were determined and then the widths were adjusted to transition into the adjacent shorelines. The width of the berm varied from 150 ft in the center breach channel to 300 ft in the main breach channel.

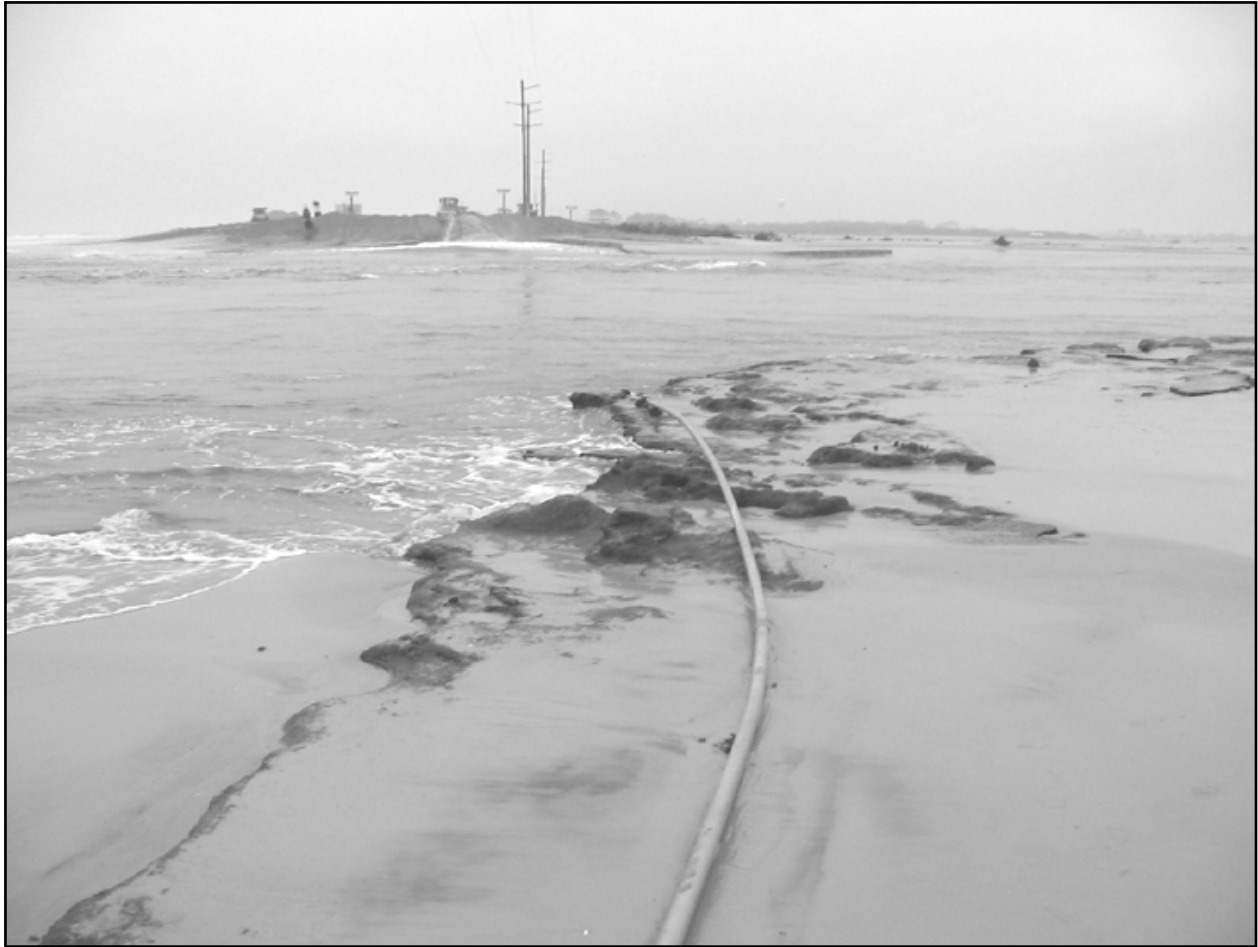
with an erosion resistant peat layer at the eastern bank of the breach allowed the design to omit armoring there. The peat layer was 3 to 4 ft thick, several hundred feet wide, and was exposed at low tide as shown in Figure 17. There was broken asphalt near the high-water line of the east bank of the breach, the peat layer extended 20 ft further into the breach than the broken asphalt and did not appear to erode.

Figure 17. Exposed peat layer on eastern bank of breach.

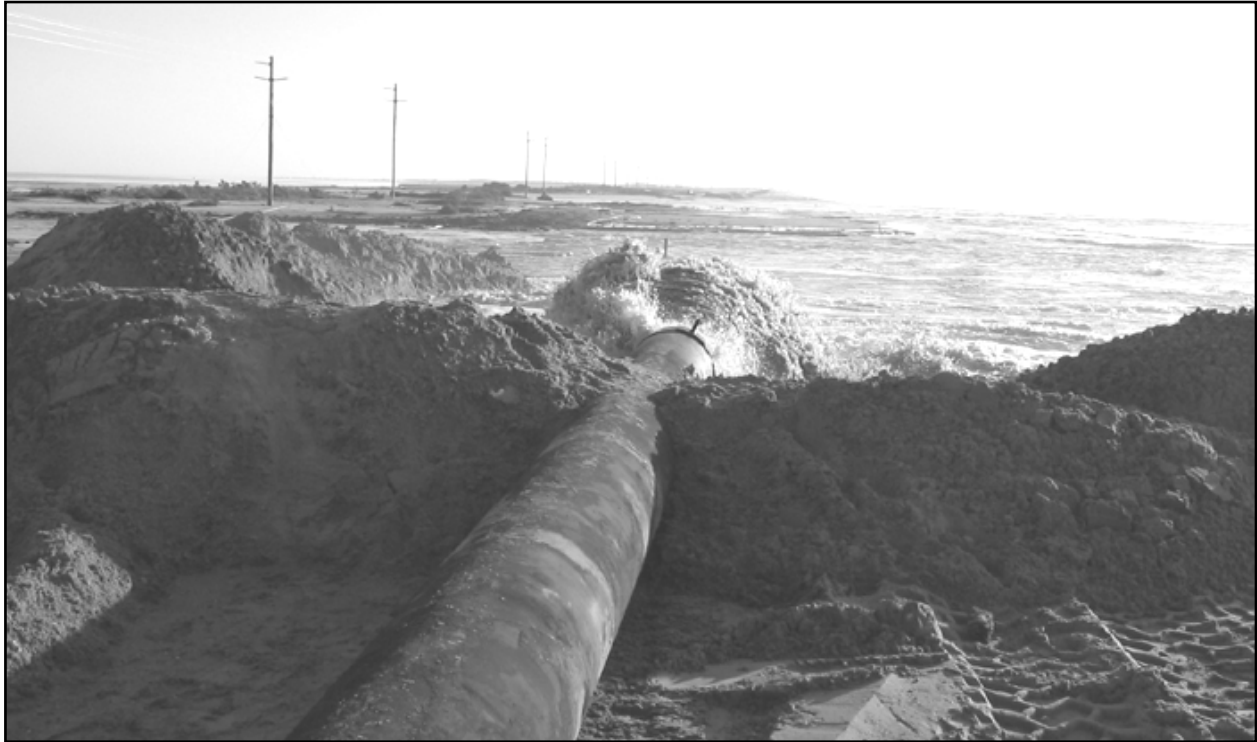
Figure 18. Discharge at western shoulder of breach. View is towards northeast. Island dividing west and center breach channels is in background.

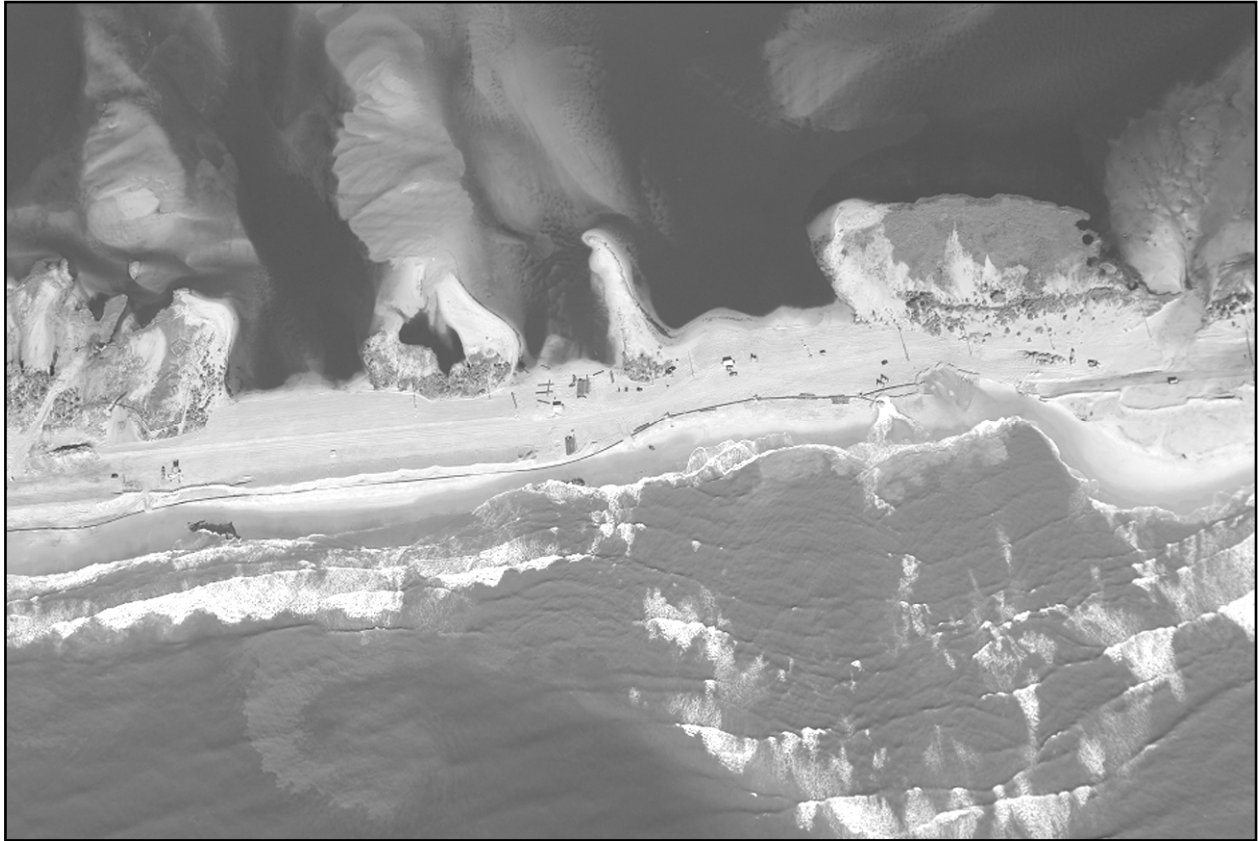
Figure 20. Aerial photo of closed breach on 3 November 2003.

Applying the new procedure, the remaining breach was narrowed to approximately 50 ft in 1.5 hr when at 11:00 a.m. the shaft on the booster failed. The booster was repaired by 4 p.m., but during the 5 hr of inactivity, the dikes, which were as long as 50 ft, were now 10-ft stubs. At 4 p.m., the slack of high tide, another attempt was made to close the breach with the same procedure. At 5:30 p.m., the two dikes were again approximately 50 ft long. This was a sufficient dike length to protect the discharge area from waves and currents and only one of the dikes was extended further to close the breach. As the tide fell and the ebb currents increased through the breach, progress slowed but, at 8:40 p.m., on 1 November 2003, the breach was closed. Throughout the night, the narrow section of the berm was widened to prevent it from breaching during the next high tide. At closure, approximately 300,000 cu yd had been dredged (Figure 20).
