AL SUMELAT  
WATER NETWORK  
VILLAGE OF AL SUMELAT, IRAQ

**SIGIR PA-05-004**  
**MARCH 15, 2006**

## Al Sumelat Water Network Village of Al Sumelat, Iraq Synopsis

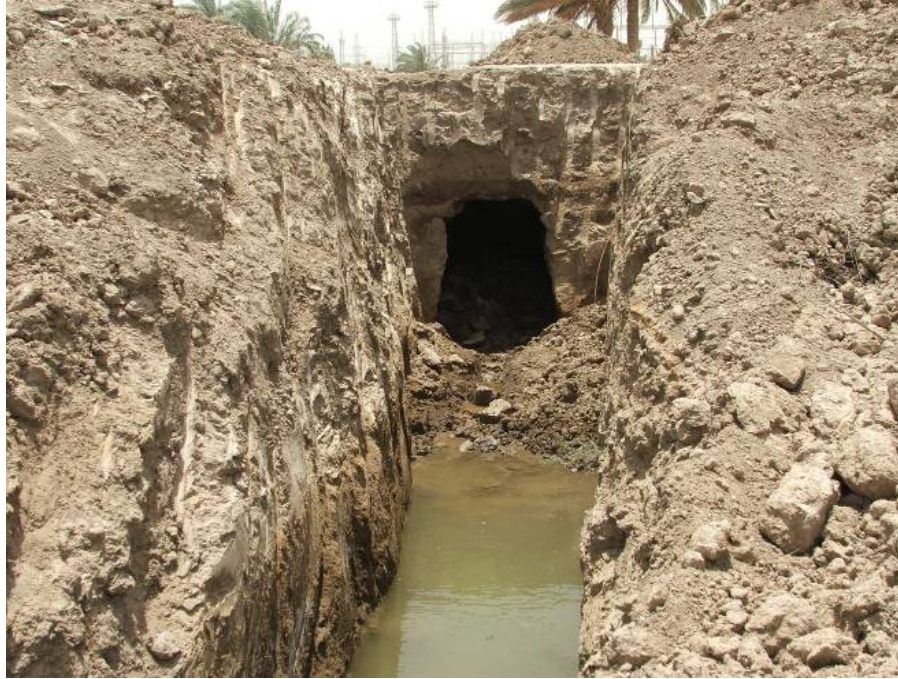
**Point B:** Point B on the locator map in Figure 1 on page 4 is the point at which the pipeline route crosses underneath an irrigation canal. A recently excavated tunnel approximately 1 meter by 1/2 meter was observed underneath the irrigation canal. The pipeline was not visible leading into (Site photo 4) or exiting the

tunnel. The bottom of the tunnel excavation appeared to be undisturbed soil. Consequently, no evidence that the pipeline had been installed beneath the irrigation canal was found.

**Site photo 4: Point B excavated tunnel under irrigation canal**

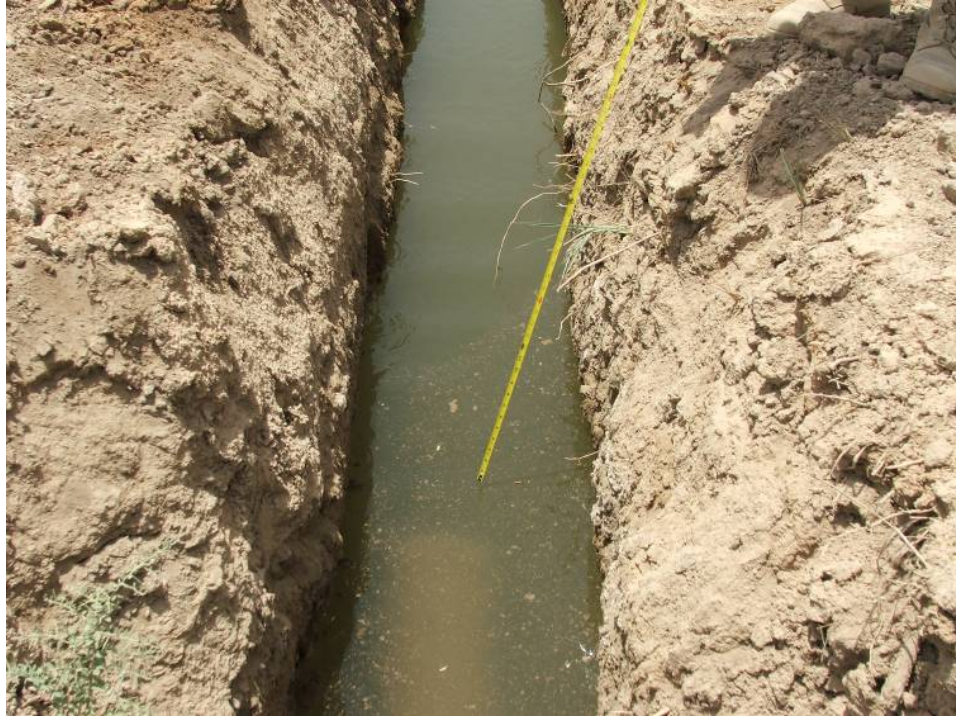
**Point B to C:** The approximate length of the pipeline from point B to point C (see the locator map in Figure 1 on page 4) is 1,495 meters. Uncapped endpoints of the pipeline were observed at both points B and C (Site photos 5 & 6). The pipe diameter looked to be approximately 225 millimeters, but accurate measurements were not obtained at this location. Disturbed surface soil was observed continuously between points B and C along the proposed pipeline route. The disturbed soil appeared to be the result of a recent trench excavation and subsequent backfilling of the trench. A sand base was not present at the endpoints of the pipeline. A significant amount of unconsolidated soil was observed above grade along the pipeline path. Lack of compacting during backfilling operations would result in the presence of the observed excess soil. The surface of the disturbed soil was uneven with several feet variation in height along the pipeline route. This indicates that final surface grading was not completed. It appeared, based on site assessment observations, that the pipeline had been installed between points B and C, but the pipeline installation was not consistent with contract requirements.

**Site photo 5: Uncapped submerged pipe end at point B**

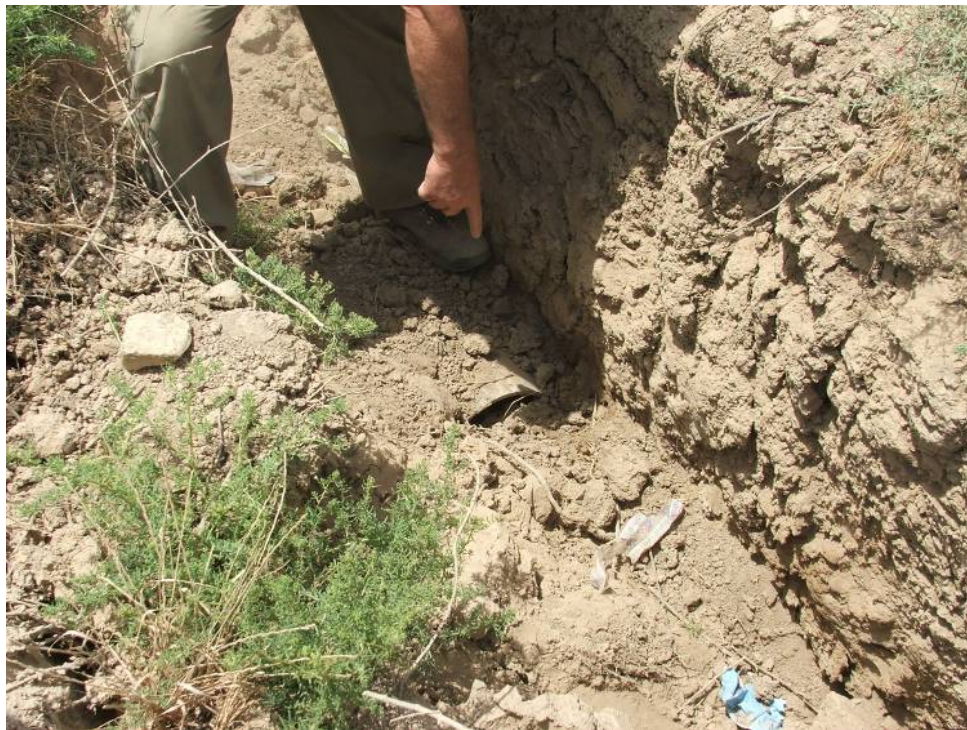
**Site photo 6: Uncapped pipe end at point C**
