POLICE STATION – SAFWAN IHP  
404  
BASRAH, IRAQ

**PROJECT NUMBER SIGIR-PA-06-051**  
**JULY 24, 2006**

SUBJECT: Report on Project Assessment of the Safwan Iraqi Highway Patrol  
Construction, Safwan, Iraq (Report Number SIGIR-PA-06-051)

## Police Station – Safwan IHP 404, Basrah, Iraq

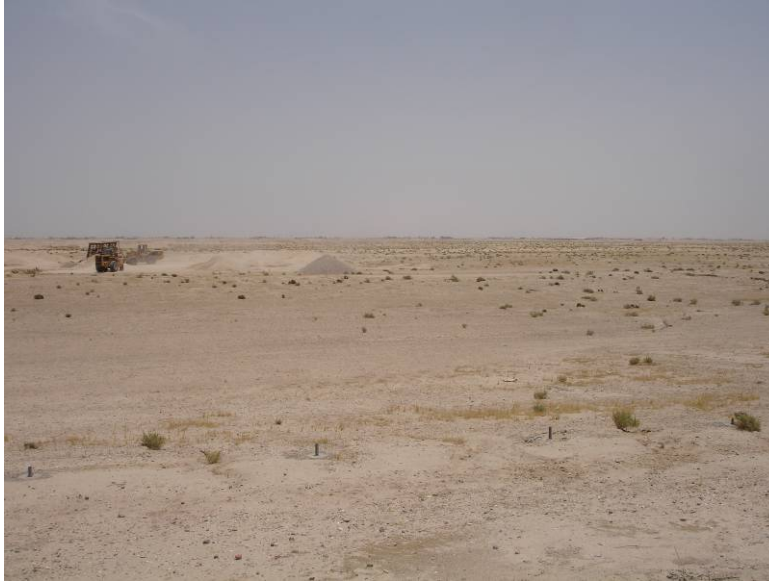
**Site Photo 1: IHP Barracks project site during initial construction (Photo courtesy of the USACE)**

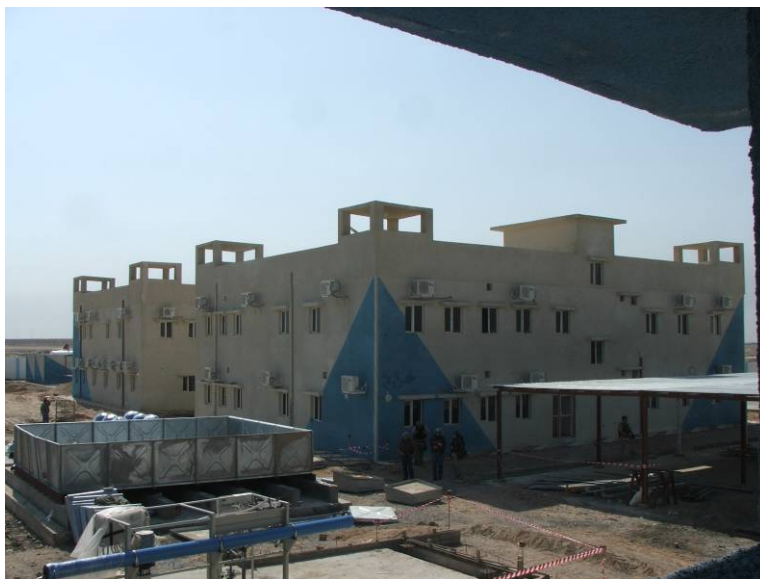
Site Photo 2 shows the exterior of the two barracks buildings and Site Photo 3 shows the interior of the dining facility. Site Photo 4 shows the barracks bathroom and Site Photo 5 shows the interior of a billeting area. All work appeared consistent with the contract and design requirements.

**Site Photo 2: Exterior view of both barracks buildings**

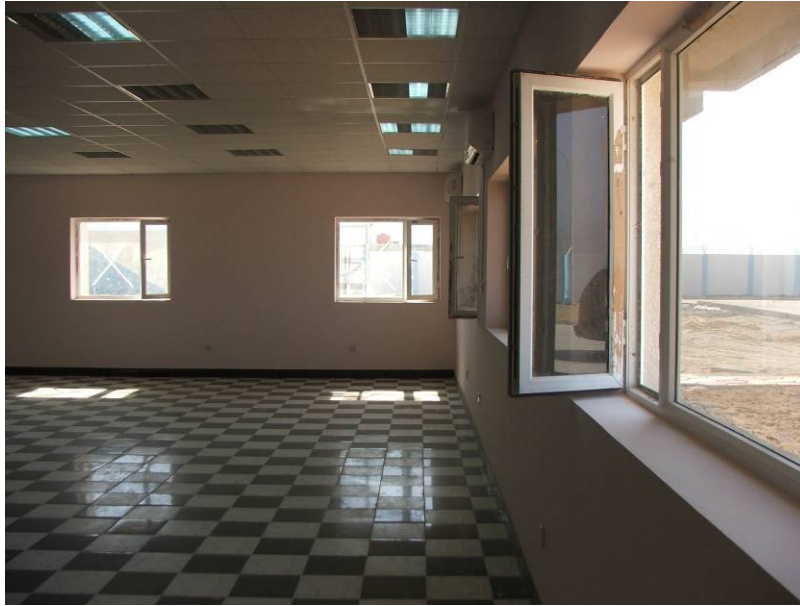
**Site Photo 3: Dining facility**

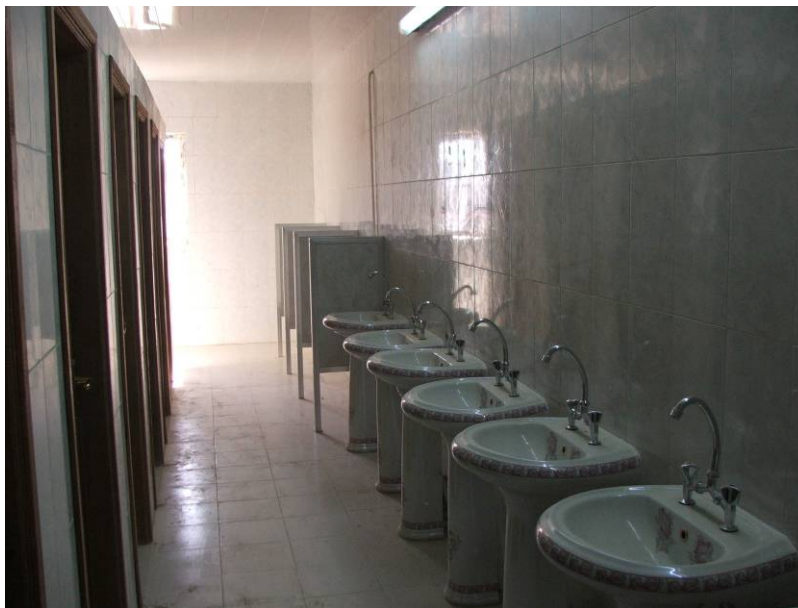
**Site Photo 4: Bathroom facility**

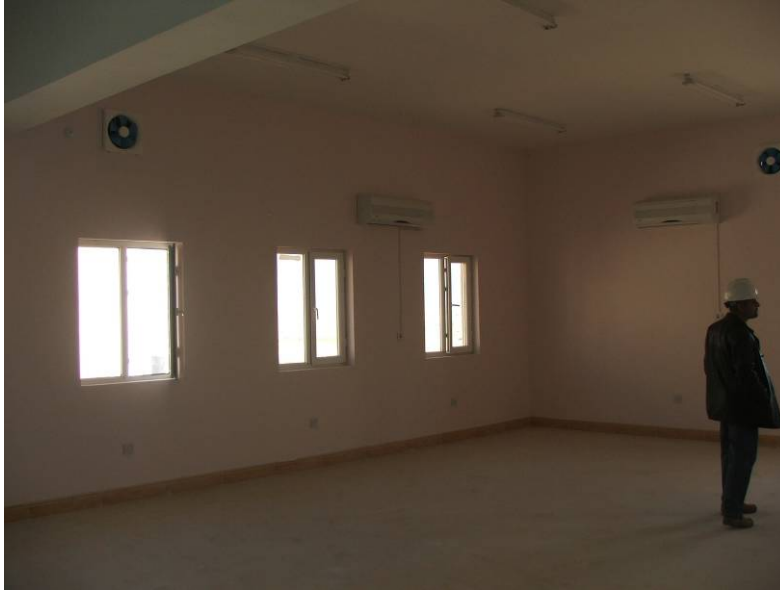
**Site Photo 5: Billeting room**

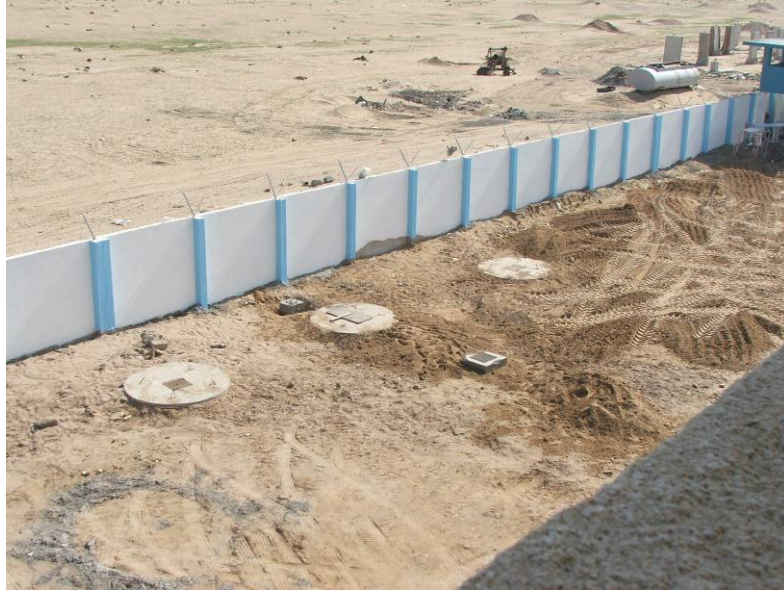
At the time of the site visit, the perimeter security wall was nearly complete and the front and rear gates were installed. The construction of the perimeter walls were consistent with the design requirements and included exterior plaster and paint. The razor wire was observed placed onto the mounting brackets, although the single roll of concertina wire along the entire length of the perimeter wall had not been installed at the time of the site visit. Front and rear entry gates were metal and installation was complete. Site Photo 6 shows a completed section of the perimeter wall, Site Photo 7 shows finishing work being completed on a section of the perimeter wall, and Site Photo 8 shows the rear entrance gate.

**Site Photo 6: Completed section of perimeter wall**

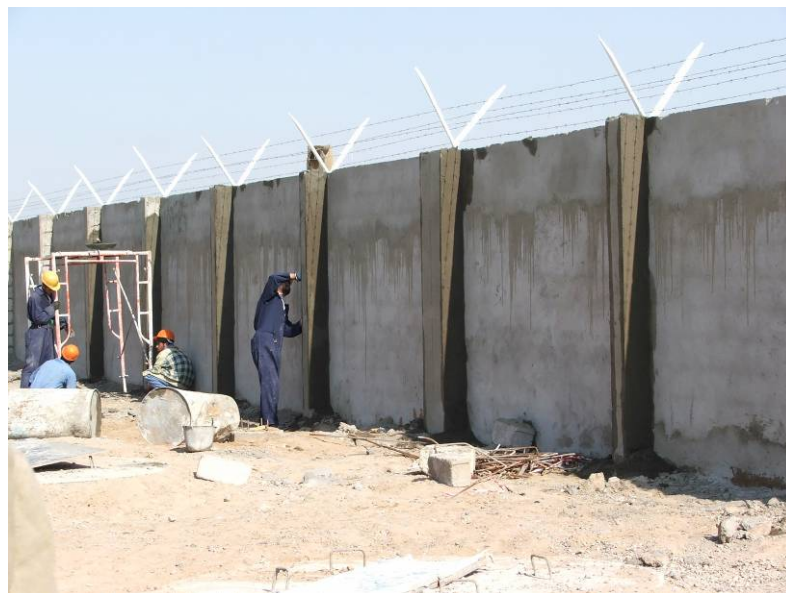
**Site Photo 7: Finishing work of section of perimeter wall**

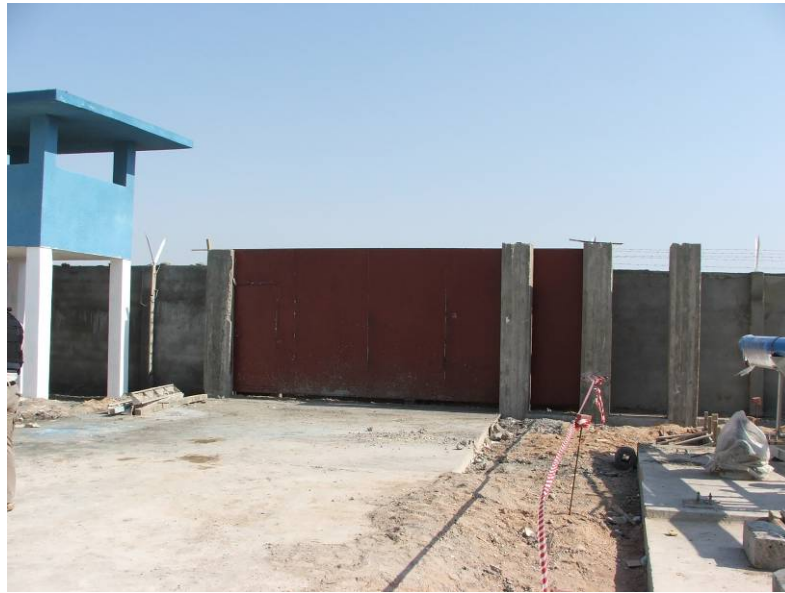
**Site Photo 8: Rear entrance gate**

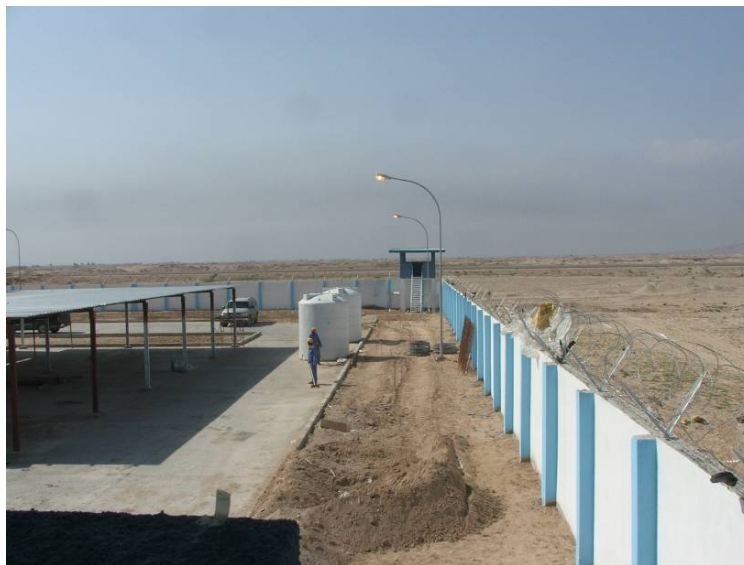
At the time of the assessment, three 8-meter light poles and none of the 4-meter light poles were observed installed. During the site visit electrical testing was being conducted with the use of a portable generator and the light poles were observed to be operational. Exterior building wall mounted lights were observed at entry ways. The guard tower outward orientated lights were not evaluated. Site Photo 9 shows installed 8-meter light poles with the lights illuminated, and Site Photo 10 shows the installed exterior building lights.

**Site Photo 9: 8-meter light poles**

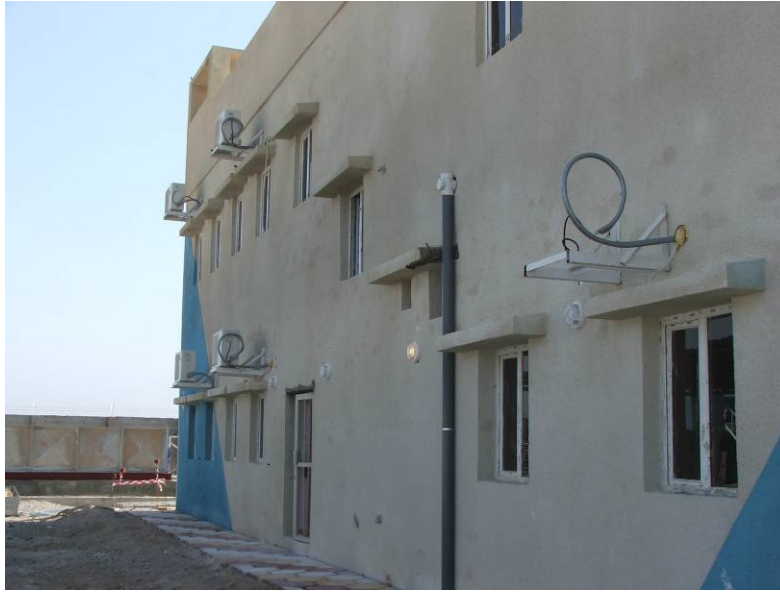
**Site Photo 10: Exterior building light**

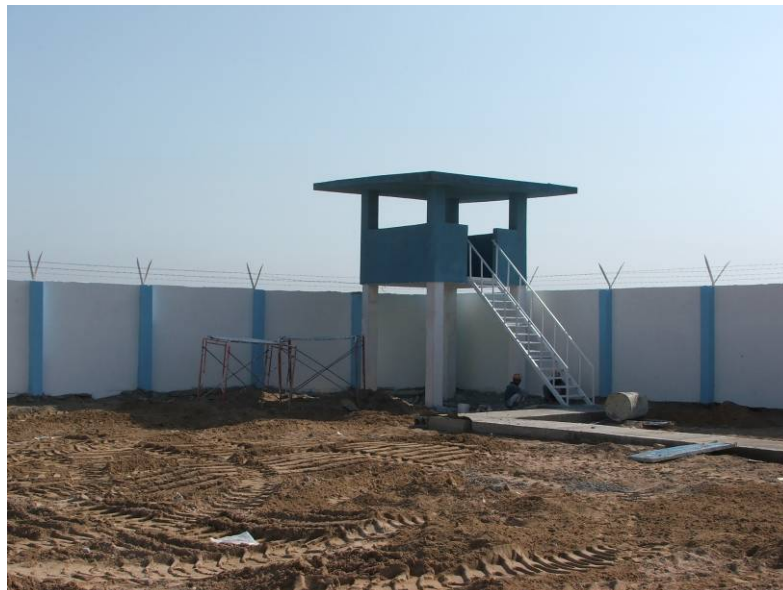
**Site Photo 11: Exterior view of corner guard tower**

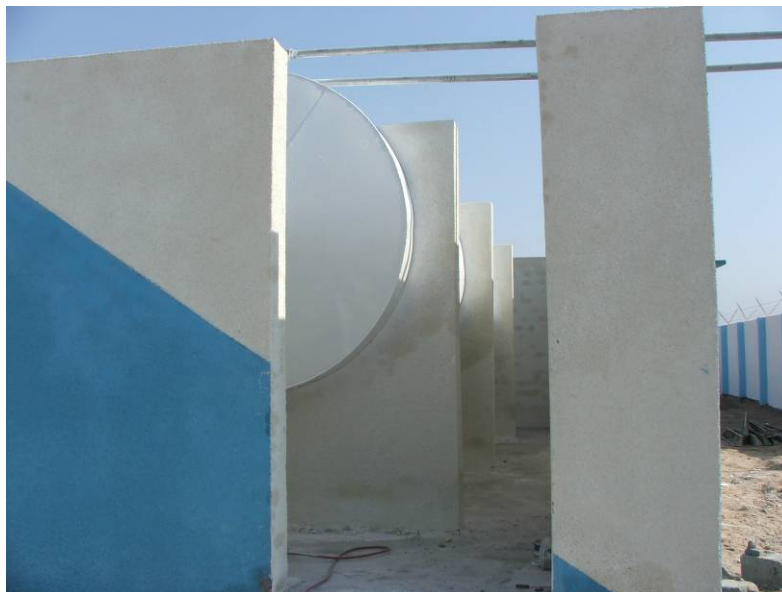
At the time of the assessment, the fuel tanks and the fuel dispensing units were in place, although these items had not been completely tied in. Two steel horizontally mounted fuel tanks were observed located within an enclosed wall system. The fuel tanks were supported by a concrete cradle system and also by steel supports. Piping had been installed and two fuel dispensing units were located on a concrete pad. The framework for a steel framed cover was complete over the fuel dispensing units, although the roof had not been installed. The fuel tanks and piping were consistent with the contract and design requirements. Site Photo 12 shows the end of one of the fuel storage tanks and wall enclosure, and Site Photo 13 shows the fuel dispensing units.

**Site Photo 12: Fuel storage tank with wall enclosure**

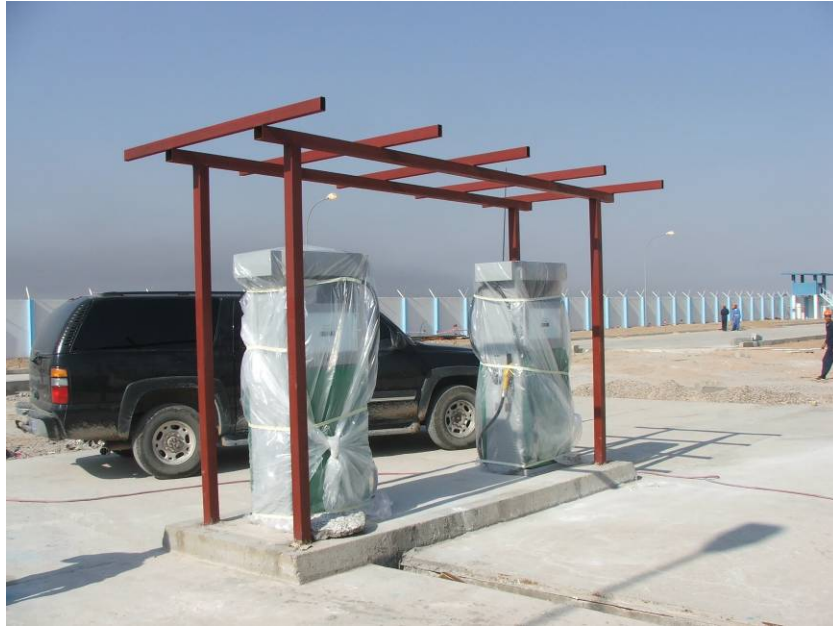
**Site Photo 13: Fuel dispensing units**

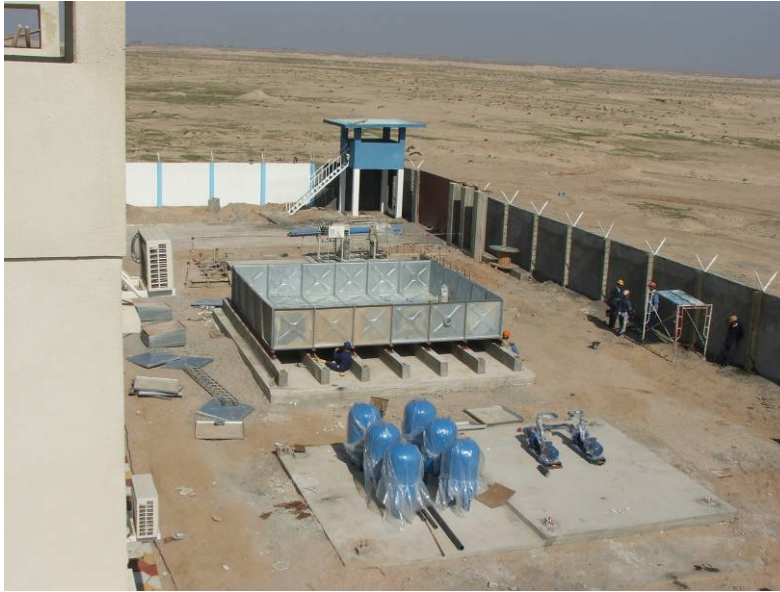
At the time of the assessment, the water system was being installed. The concrete pads had all been constructed, although footings for the filtration system were not complete. The reverse osmosis filtration system was in place, the storage tank was under construction, and both the distribution pumps and hydropneumatic pressure vessels were installed. Piping and connections were partially complete. All system components were observed to be consistent with contract and design requirements. Site Photo 14 shows the six hydropneumatic pressure vessels, two water distribution pumps, and single water storage tank (under construction). Site Photo 15 shows the reverse osmosis water filtration system during installation.

**Site Photo 14: (6) hydrophumatic pressure vessels (left foreground), (2) water distribution pumps (right foreground), and single water storage tank**

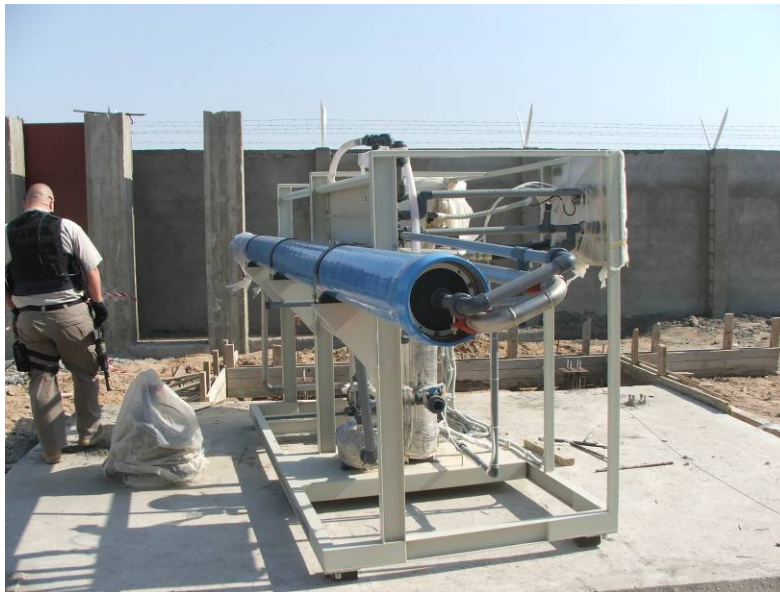
**Site Photo 15: Reverse osmosis filtration unit**

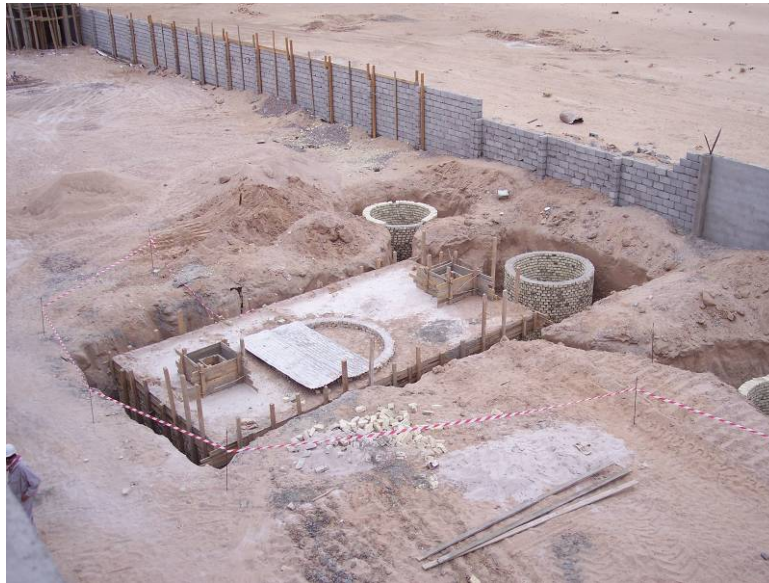
surface where the septic system was installed. Site Photo 16 shows the septic system during installation (courtesy of USACE) and shows tank and leech pits.

**Site Photo 16: Septic system during installation (Courtesy of USACE)**

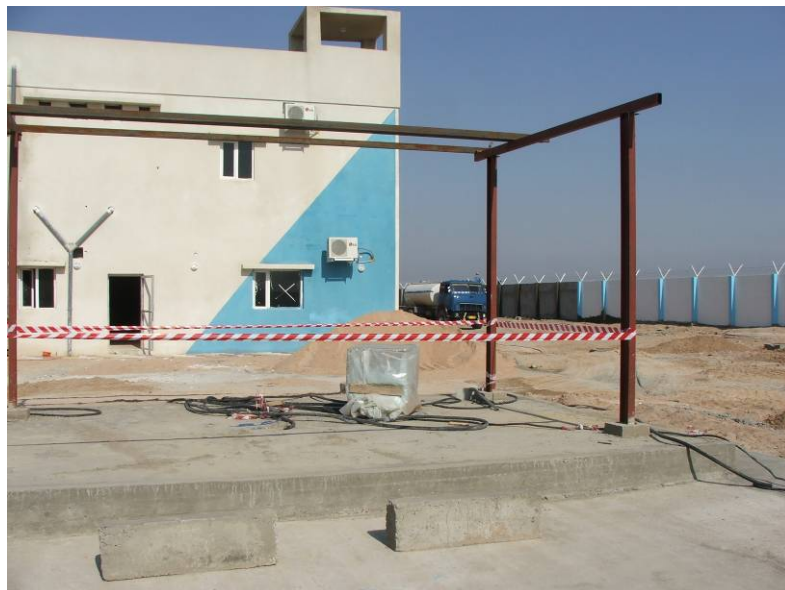
**Site Photo 17: Concrete pad for generator unit**

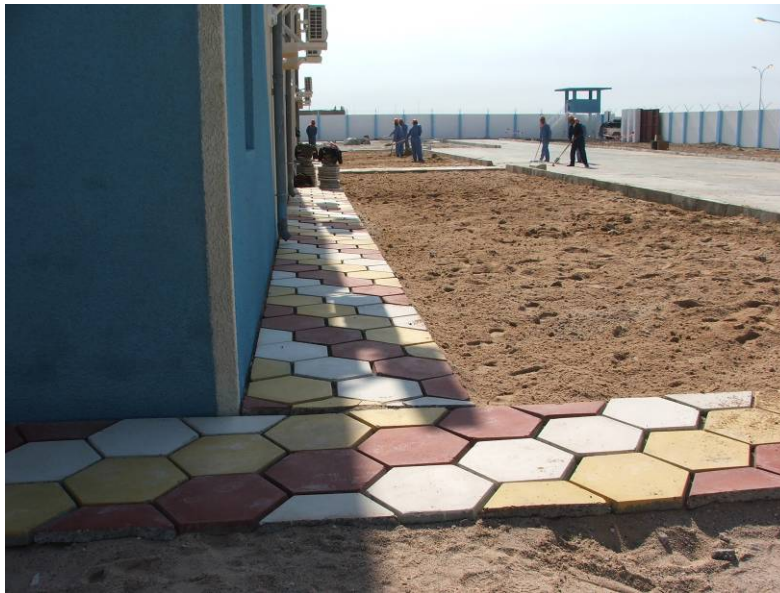
At the time of the site visit, the roadways were constructed and sidewalks installed. Site Photo 18 shows the sidewalks along the perimeter of the barracks facility and roadway. The sidewalks appeared to be consistent with contract and design requirements. Although tile on the walkway was not included in the original design, the substitution enhanced the appearance of the facility. The roadways were constructed of concrete and were complete at the time of the site visit.

**Site Photo 18: Sidewalks along the perimeter of the barracks facility (foreground) and roadway (background)**

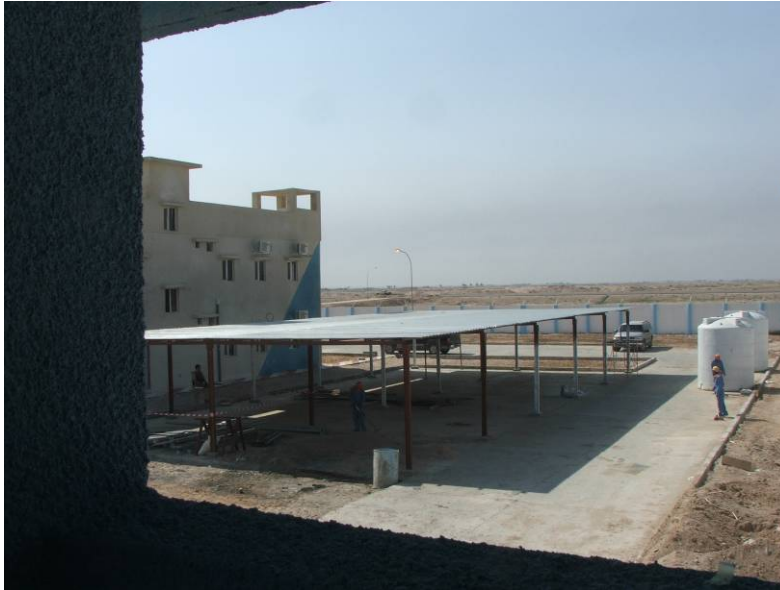
At the time of the assessment, the uncovered parking area was complete and the covered parking area was under construction. The covered parking area design required steel I-beam columns and I-beam cross members. Although steel I-beams

**Site Photo 19: Covered parking area**

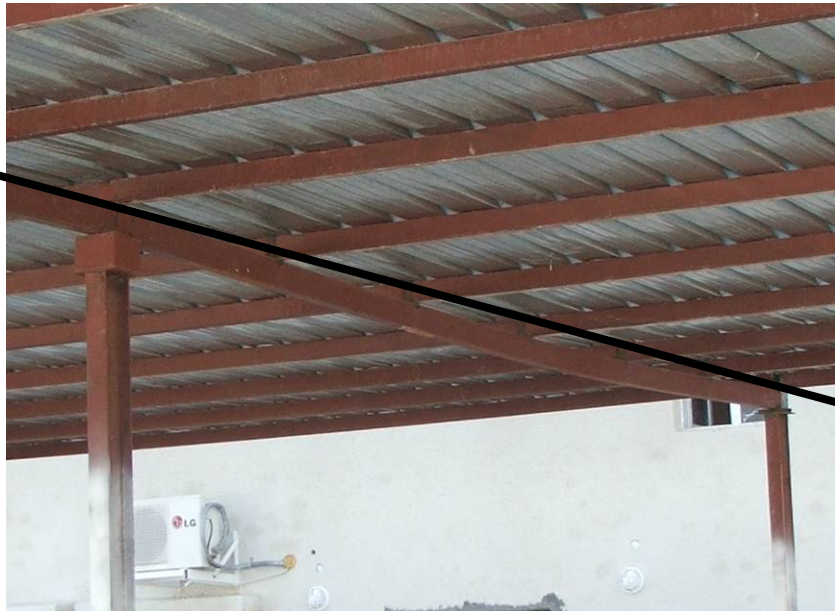
were used for the columns, rectangular tubular steel was used for the cross member supports. The cross members were noticeable deflecting under the weight of the roof. The USACE project manager and contractor were aware of the deflection. The USACE project manager stated that he has coordinated with the contractor to install additional columns to correct this issue. Site Photo 19 shows the covered parking area. Site Photo 20 shows the deflection of the rectangular tubular steel cross member supports in contrast to a straight line between support points.

**Site Photo 20: Deflection of the rectangular tubular steel cross member in contrast to a straight line between support points**
