SUMMARY REPORT  
GROUND PROJECT SURVEYS  
FOR THE QUARTER ENDED  
MARCH 31, 2006

**SIGIR PA-06-052**  
**JULY 31, 2006**

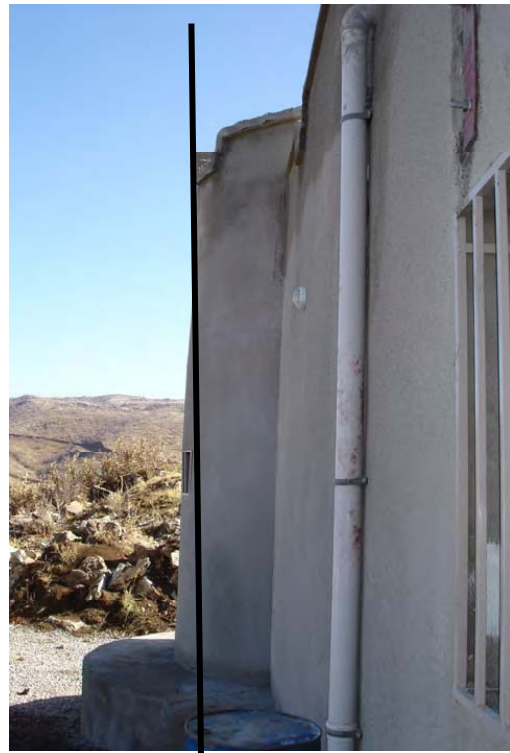
- Spot welds on the generator roofing appeared to be poor quality.
- Insufficient mastic in voids between roof tiles was noted.
- Surface of exterior walls was not straight (inward curvature) and poor finishing was observed. Site Photo 14 shows the exterior wall with a straight-line superimposed on the picture.

**Site Photo 14: Front exterior view showing inward curvature of wall (Project 12831)**

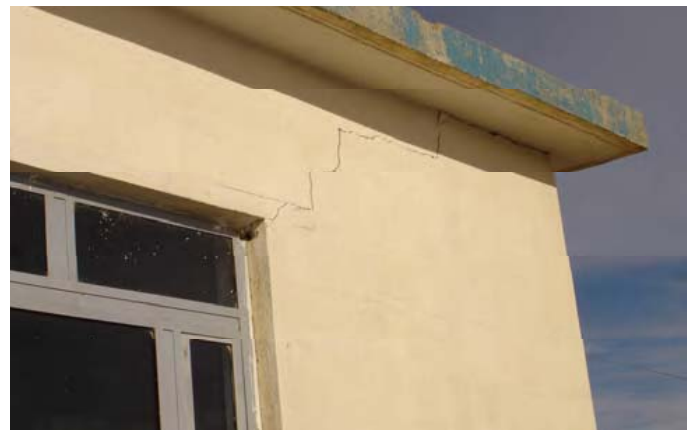
**Site Photo 33: Cracks in exterior wall (Project 20572)**

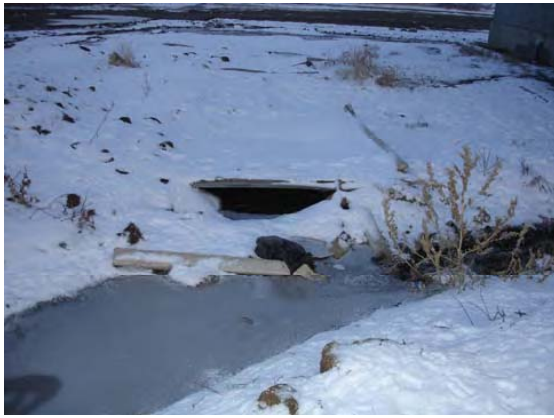
**Site Photo 37: Sewage overflow area (Project 20575)**

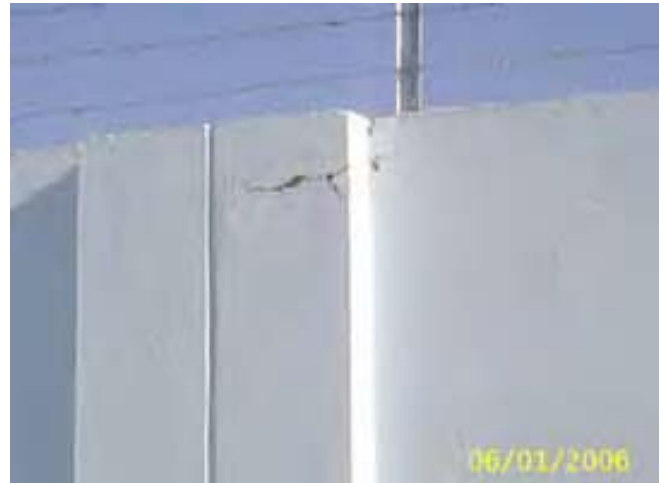
The IRMS database listed the project as 100 percent complete on 30 August - 2005. The project was new construction and included perimeter security walls, entrance gates, guard towers, and a nine-room building. Site Photo 62 shows the exterior of the building. A generator and covered parking area were also located within the perimeter walls. A crack was observed in the perimeter wall, although no other discrepancies were noted. Site Photo 63 shows the crack in the exterior perimeter wall.

**Site Photo 63: Crack in perimeter wall (Project 19111)**

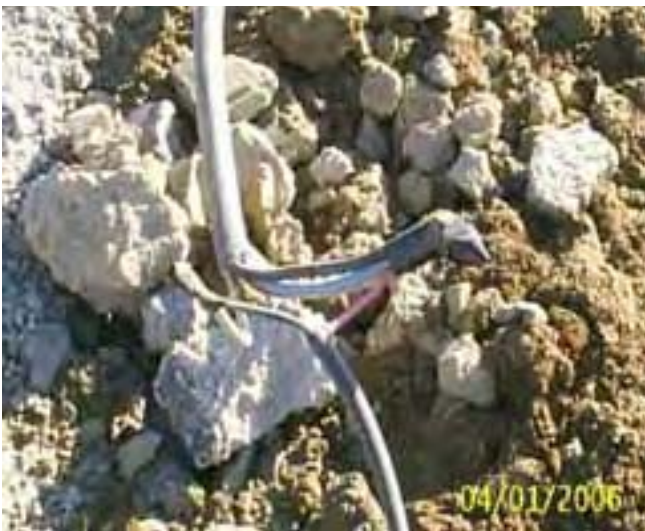
improper electrical connections. Site Photo 72 shows exterior electrical wiring located on the ground surface and Site Photo 73 shows interior lights with possible fire damage.

**Site Photo 72: Exposed electrical wirings (Project 19179)**

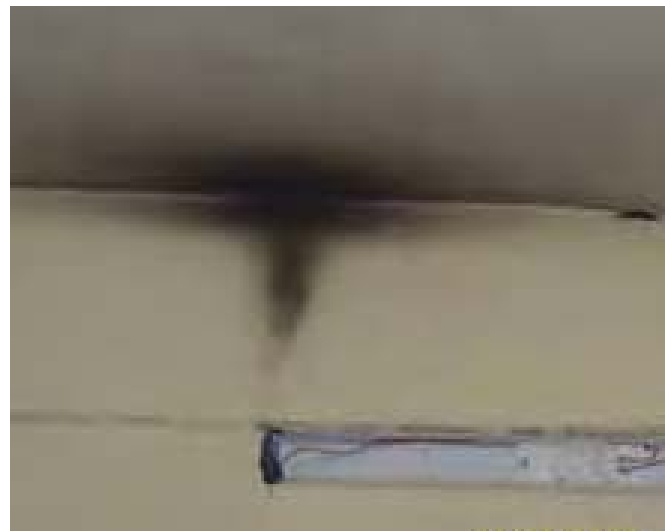
**Site Photo 73: Interior electrical light with smoke damage (Project 19179)**

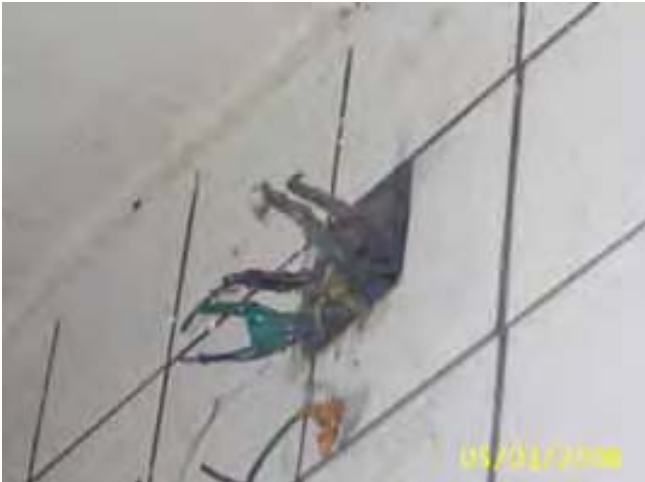
Site Photo 74: Exposed electrical wirings (Project 19181)

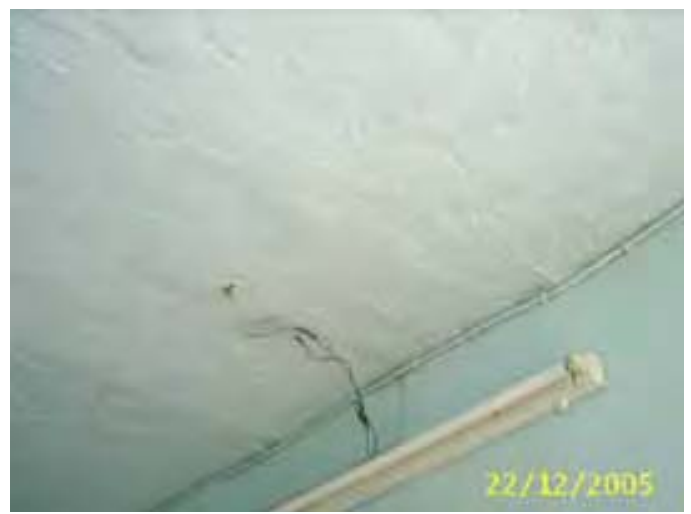
- Electrical systems had exposed wiring and improper connections at numerous locations in the police station. Site Photo 76 shows an example of the electrical wiring.
- Interior walls and ceilings had rough surfaces and inconsistent finishing. Site Photo 77 shows the surface of an interior ceiling.

**Site Photo 77: Roof and inconsistent ceiling texture (Project 19189)**

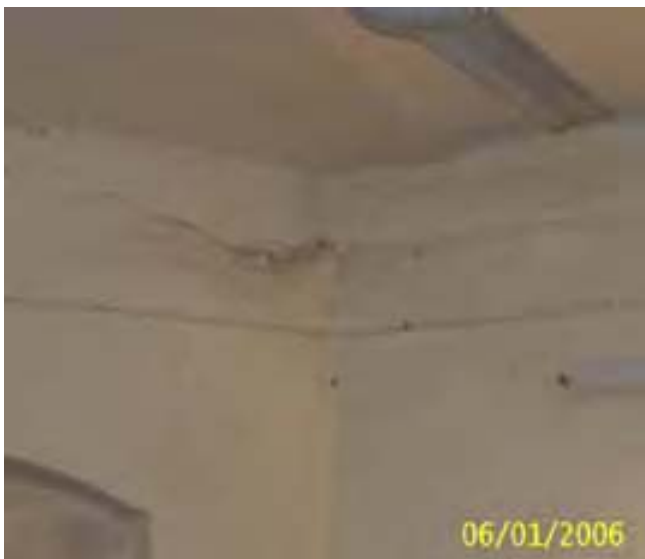
**Site Photo 78: Cracks and peeling paint in walls and ceiling (Project 19227)**

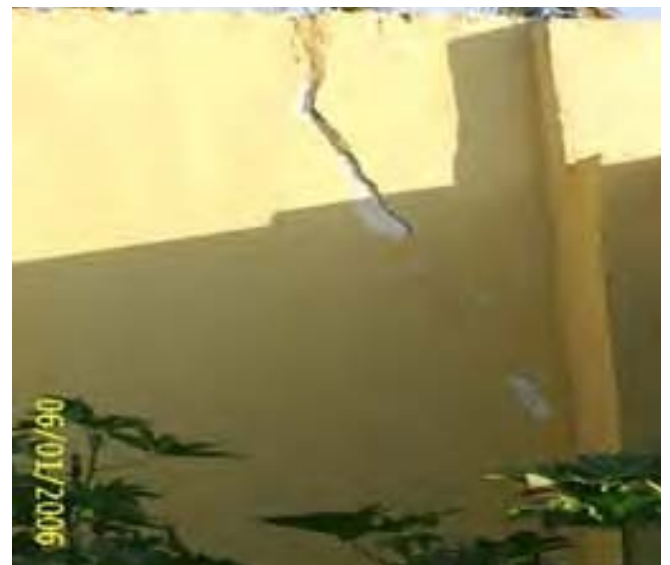
**Site Photo 79: Crack in perimeter wall (Project 19227)**
