DAHUK REHABILITATION CENTER
DAHUK, IRAQ

SIGIR PA-06-070
JANUARY 08, 2007

SUBJECT: Report on Project Assessment of the Dahuk Rehabilitation Center, Dahuk,
Iraq (Report Number SIGIR-PA-06-070)

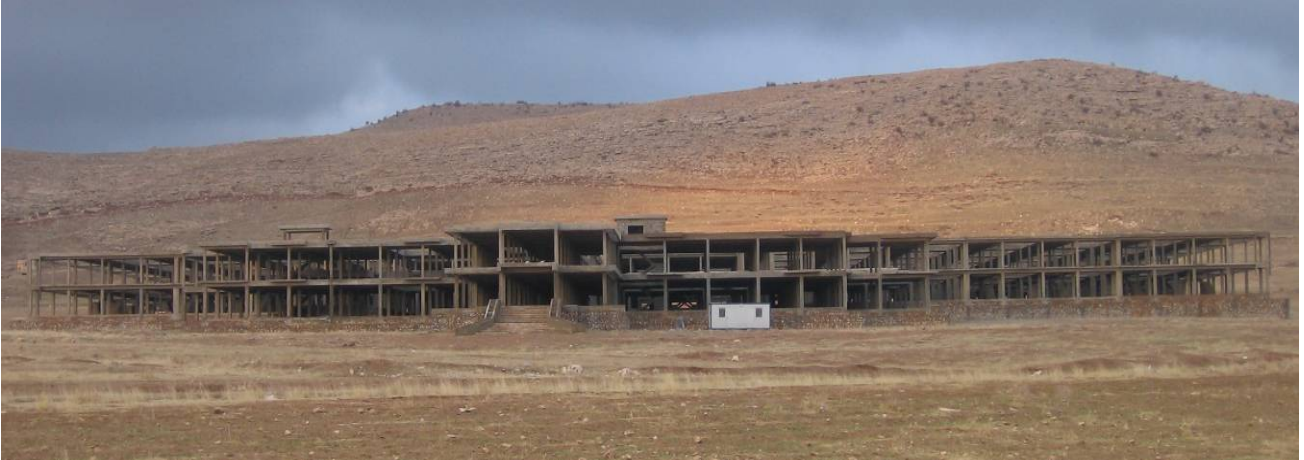
At the time of the site assessment, the project was reported as 60% complete. The facility’s structural concrete framework was completed before the project was halted in 2001. Accordingly, the concrete skeleton from the previous work served as a starting point for new construction covered by the current contract. The photo below, courtesy of the U.S. Army Corps of Engineers (USACE) dated 26 December 2005, shows the concrete framework previously completed.

**The Dahuk Rehab Facility at the pre-construction stage for the current contract.
(Photo courtesy USACE.)**

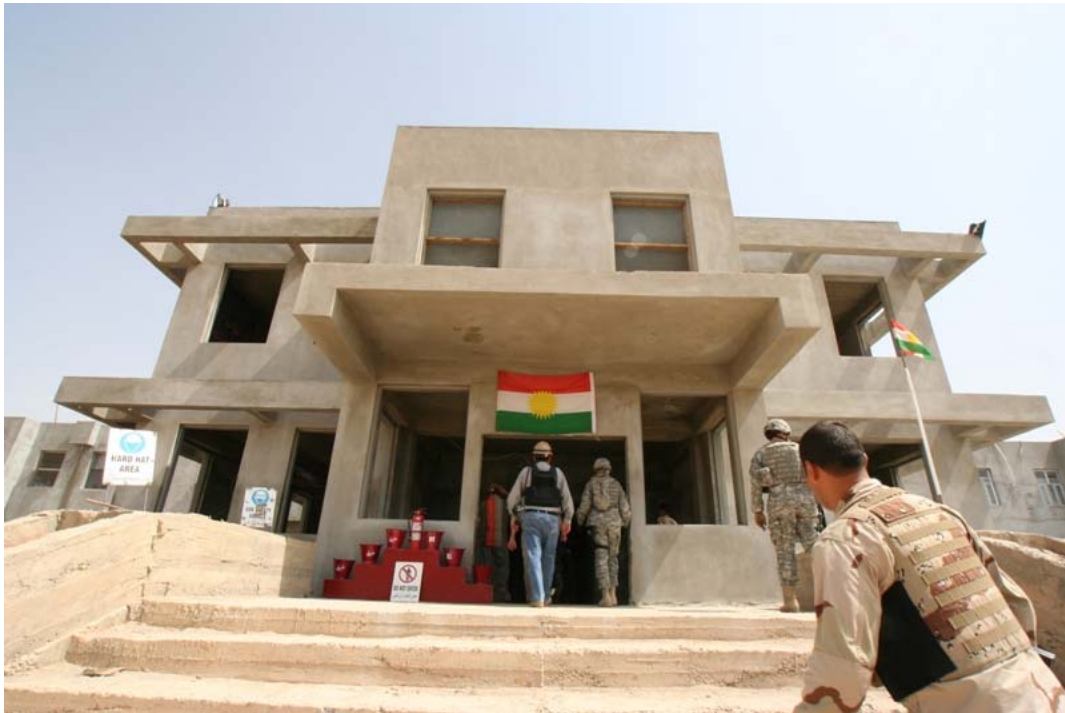
Site Photo 1. Main entrance to the Dahuk Rehabilitation Facility.

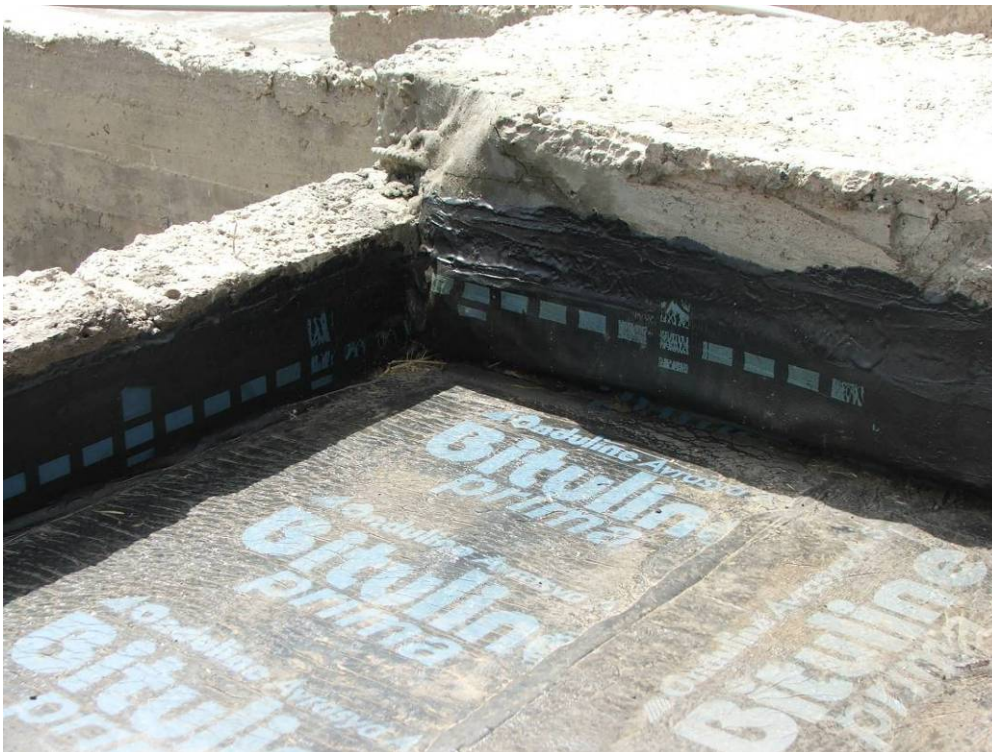
Application of the bituminous waterproofing membrane was applied as the last step in the process. The roll material membrane, approximately a meter wide, was applied using a “torch-on” hot material technique to securely attach the membrane to the roof surface. Site Photo 3 shows the evenness of the overlapping seam and the flat lie of the membrane. In addition, the membrane material appeared free from voids and pockets, and was cleanly attached to the geometry of the inner roof corner.

Site Photo 3. Bituminous waterproofing membrane.

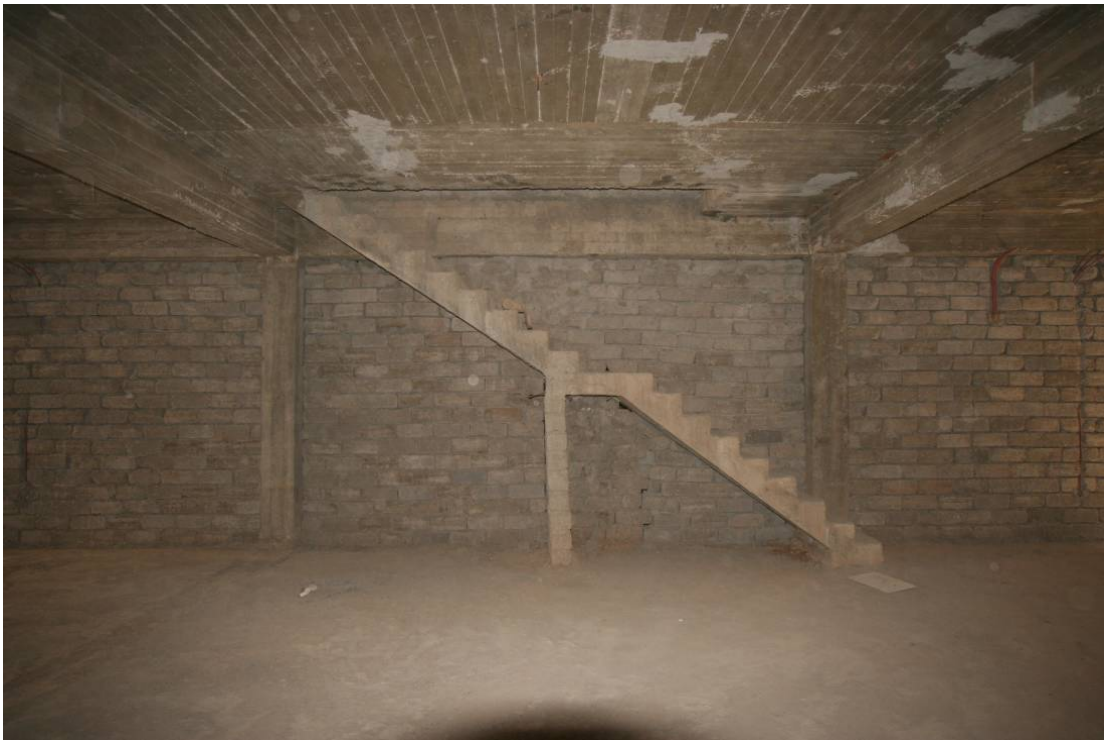
Site Photo 9. Pre-finish side view of poured concrete stairs.

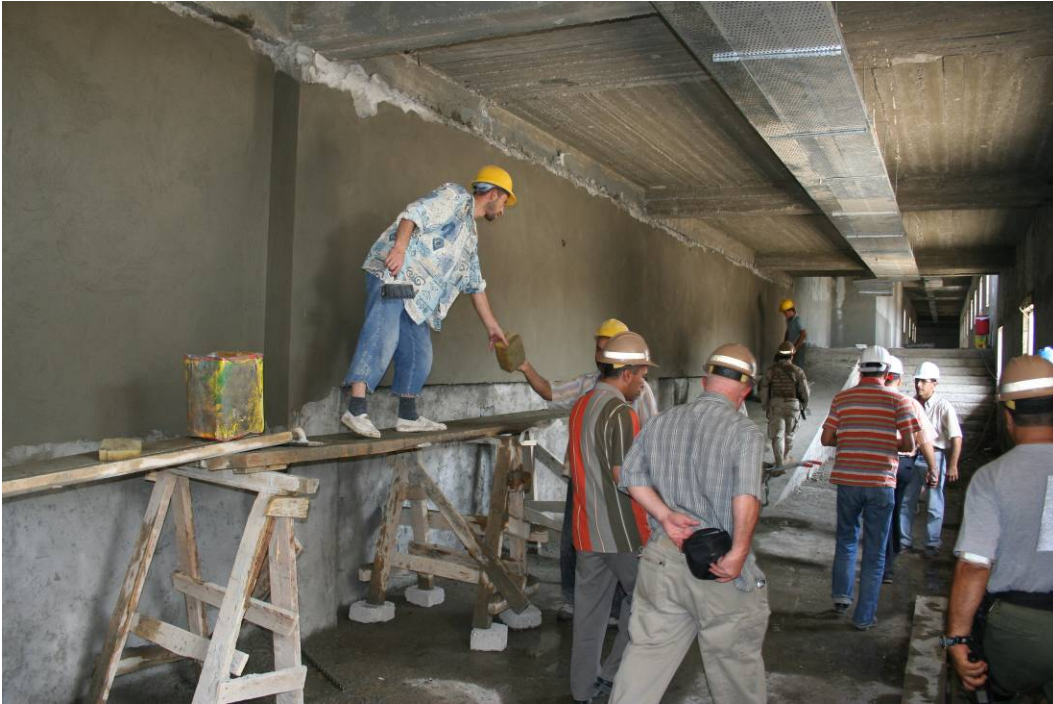
Site Photo 10. Workers finish an interior wall with a thin layer of concrete (plaster).

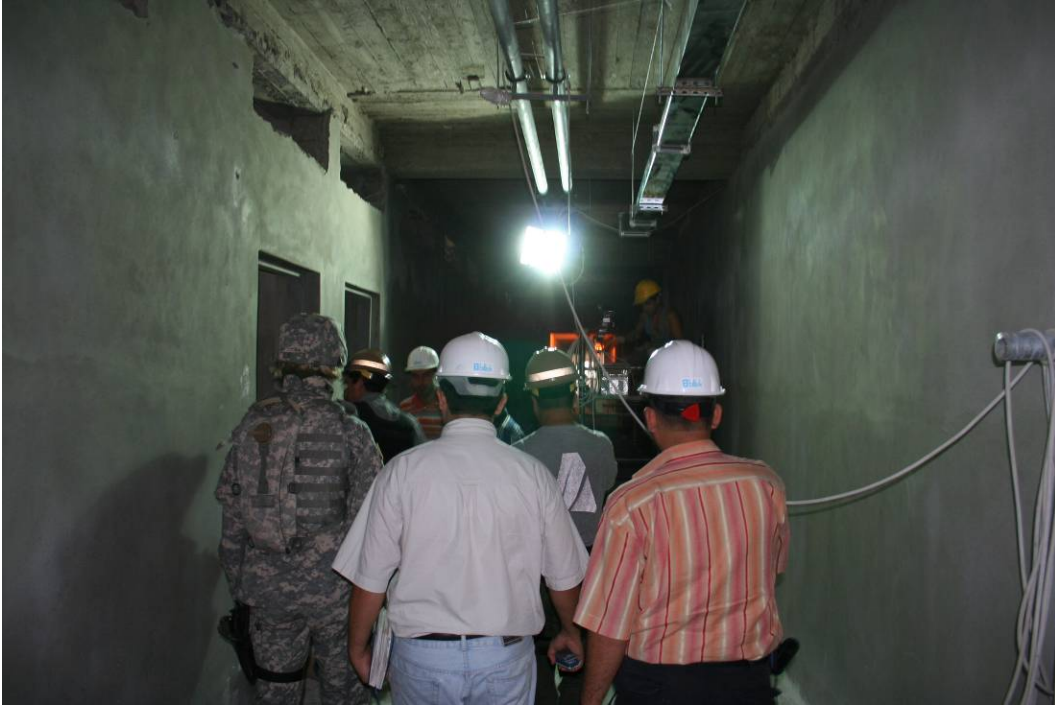
Site Photo 11. Concrete finished interior walls.

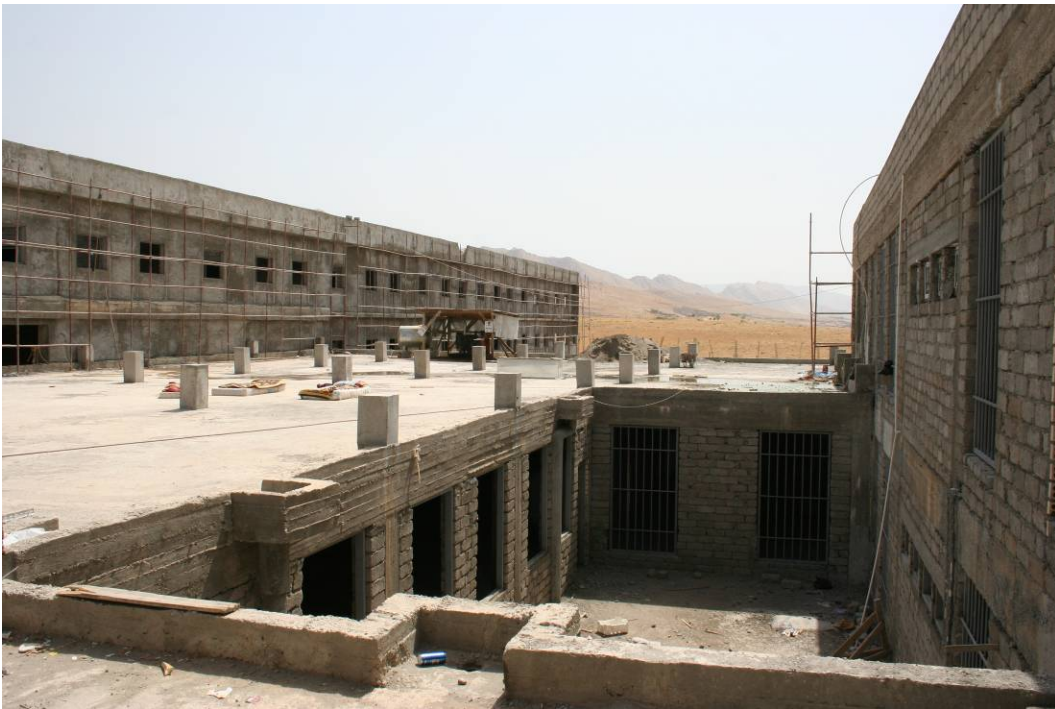
Site Photo 12. Left side of photo shows completed exterior finish work, while right side shows an unfinished wall.

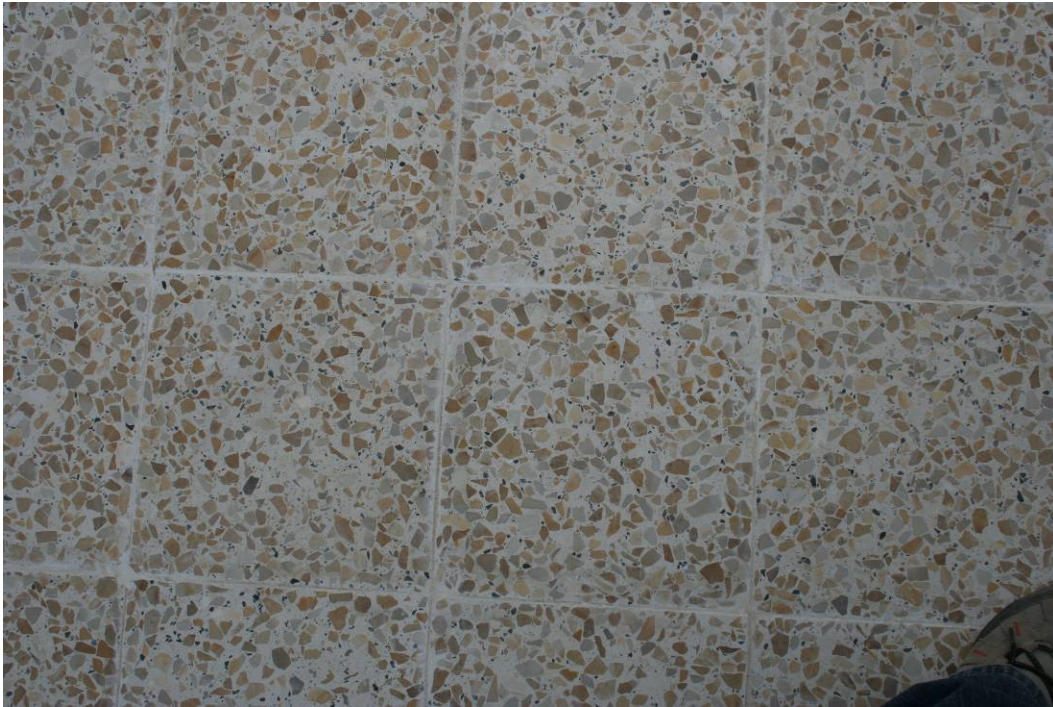
Most interior floors were to be finished with terrazzo tile. Although not complete, floor tiling was progressing at the time of our site visit. Site Photo 13 shows a section of the floor finished with terrazzo tile that appeared to be properly installed.

Specifically, all tiles observed by the assessment team were aligned, uniformly spaced, and level.

Site Photo 13. Terrazzo floor tile was used to finish most floors in the facility.

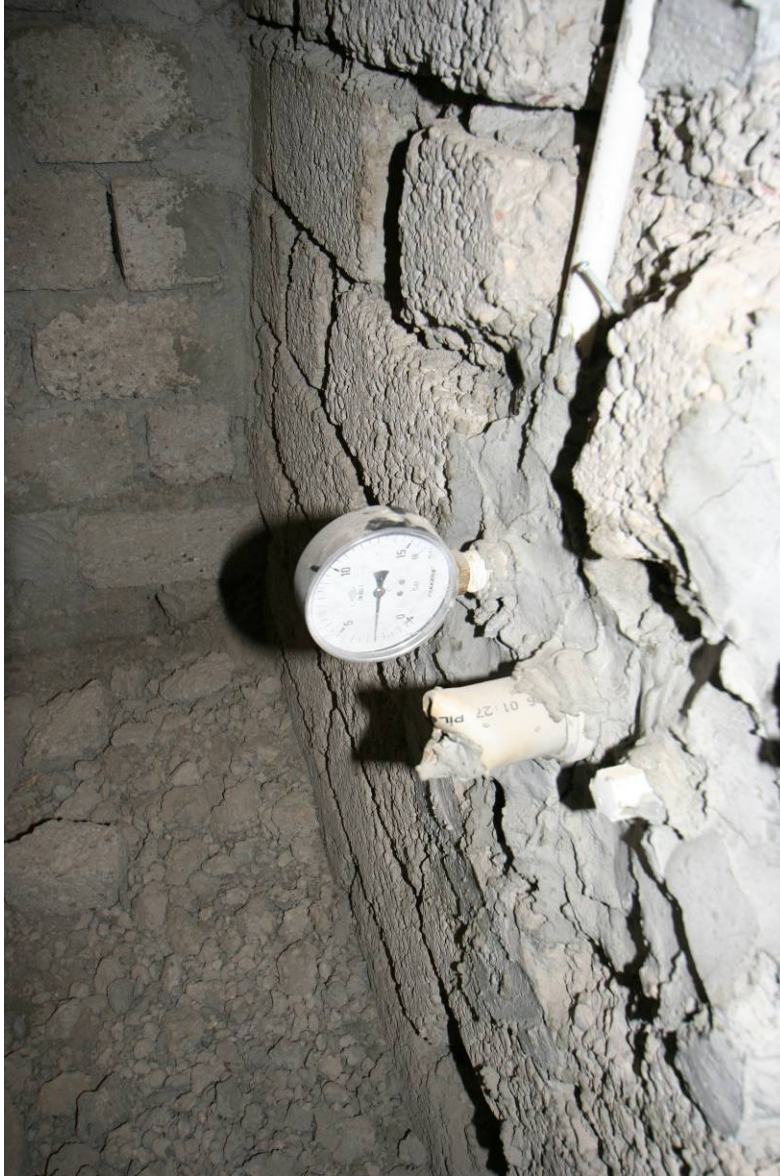
At the time of the assessment team's visit, the installation of the wastewater pipes, rainwater pipes, and domestic water supply system pipes were complete. The contractor was in the process of conducting pressure tests on the domestic water supply system pipes. In Site Photo 18, a pressure meter is attached to a pressurized domestic water line.

Site Photo 18. Domestic water line pressure test was in progress.

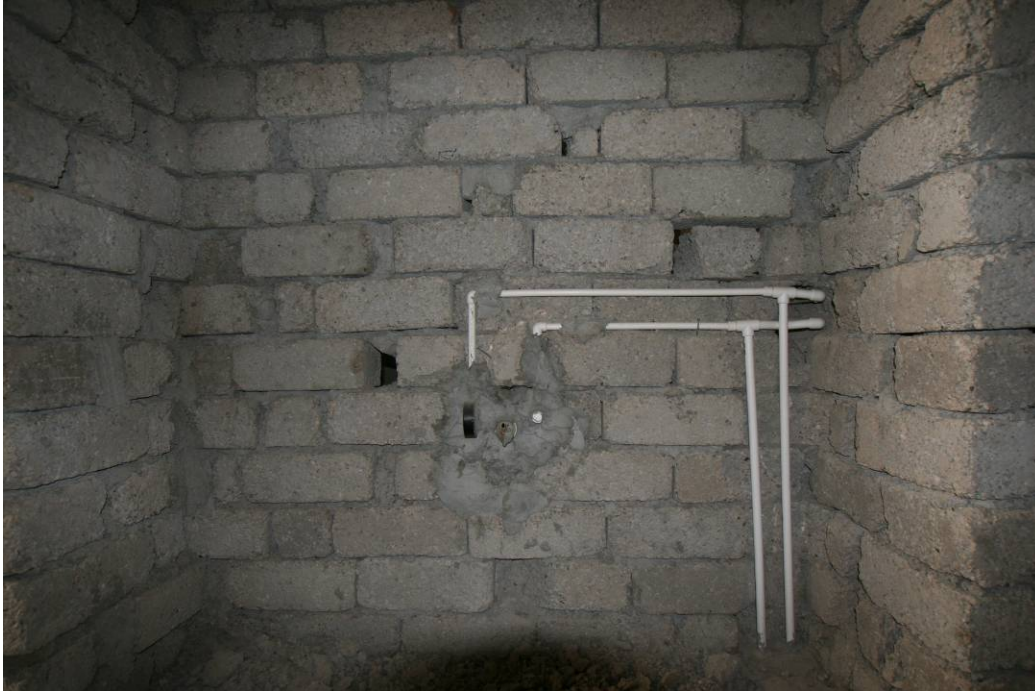
Site Photo 21. Wall installation of bathroom area domestic water pipes before finishing.

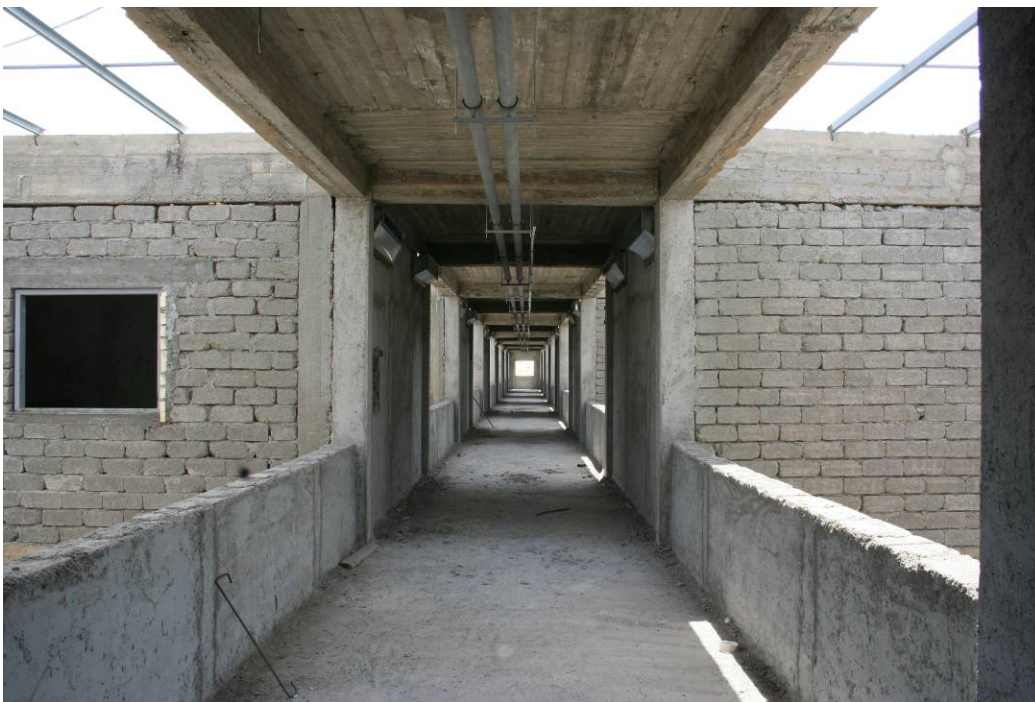
While not completed at the time of the assessment team's visit, pipe work installation for a firefighting system was in progress. In Site Photo 22, piping for the firefighting system was hung from a corridor ceiling. As with the cable trays and ductwork, firefighting piping was placed in parallel on evenly spaced hangers.

Site Photo 22. Corridor contains firefighting system piping.

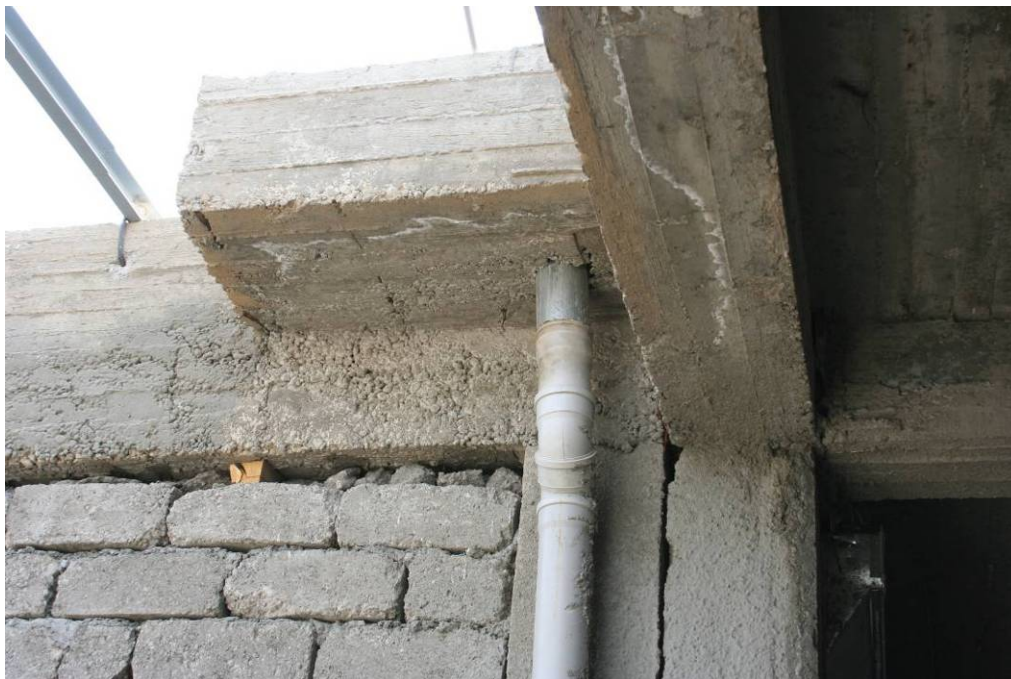
Site Photo 24. Bottom side view of collection basin showing positive rainwater drain piping.
