AL KASIK WATER STORAGE TANKS  
AL KASIK MILITARY TRAINING BASE  
AL KASIK, IRAQ

**SIGIR PA-06-071**  
**JANUARY 08, 2007**

SUBJECT: Report on Project Assessment of the Al Kasik Water Storage Tanks, Al Kasik  
Military Training Base, Al Kasik, Iraq (Report Number SIGIR-PA-06-071)

## Al Kasik Water Storage Tanks Al Kasik Military Training Base, Iraq

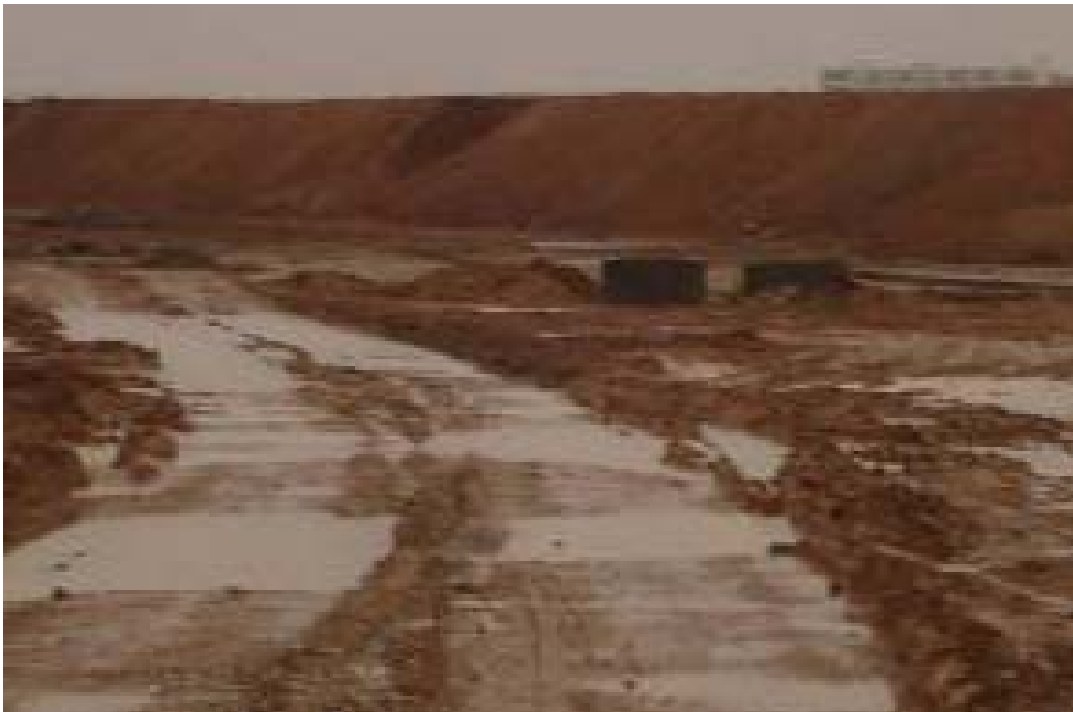
At the time of the assessment team's site visit, the project was reported as 57% complete by the AFCEE/VIAP<sup>1</sup> Quality Assurance Representative (QAR). Although the TO's Field Period of Performance (POP) had been extended to 19 September 2006, the contractor's construction manager stated that the WST project would likely not be completed by then. QA reports confirmed that substantial rain in January, February, and March 2006 contributed to delayed WST project progress (Site Photo 1). In addition, the contractor's construction manager stated that there had been unspecified delays attributable to equipment and material unavailability. At the time of the assessment team's site visit, the sub-contractor was waiting for a sand blaster needed to clean all steel before a protective/finish coating (epoxy paint) could be applied. In addition, the contractor's construction manager stated that a shortage of welders skilled enough to pass a welding test administered by the contractor's QC manager had been a persistent problem.

**Site Photo 1. WST site conditions following overnight rain.  
(Photo from QA Report dated 3 Feb. 2006)**

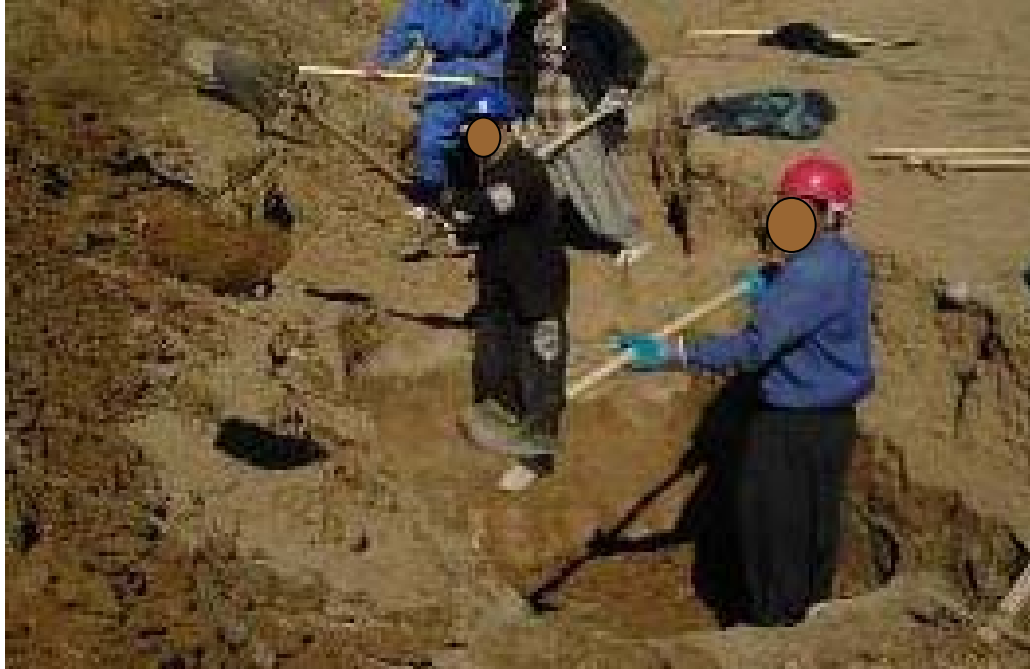
**Site Photo 2. Workers have to re-dig footings after heavy rains.**  
(Photo from QA Report dated 17 Mar 2006)

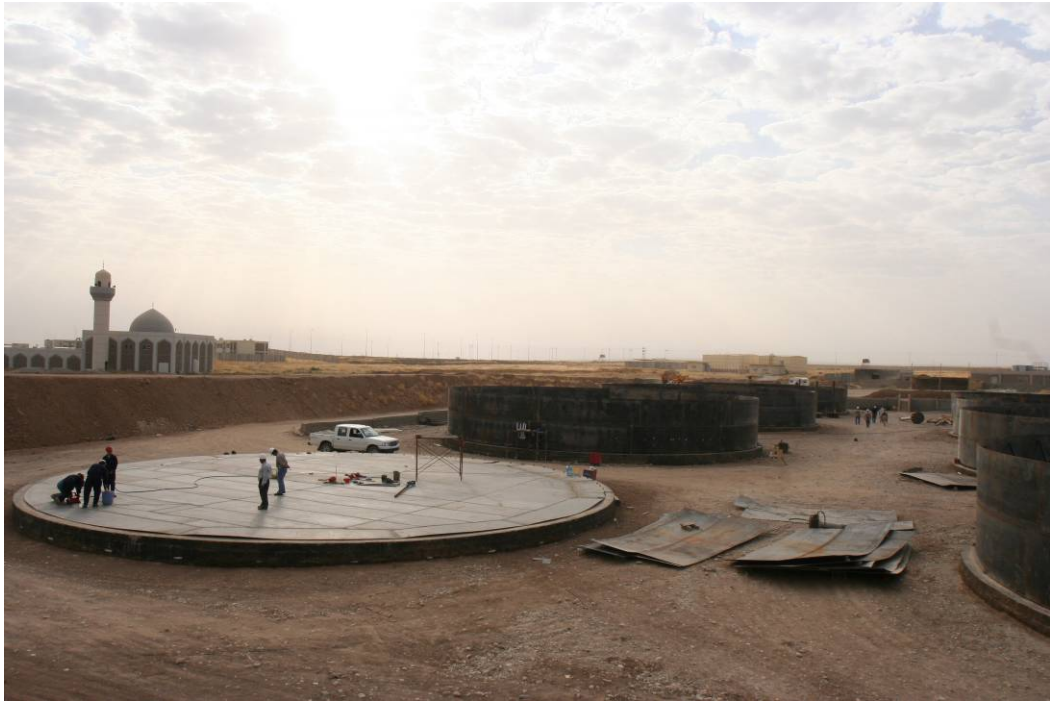
Tank foundation construction started with a concrete foundation, shown in Site Photos 3 and 4. Crushed course aggregate shown in Site Photo 5 was used for on-site production of foundation concrete. To conform to design standards, on-site concrete mixing included the aggregate in a prescribed combination with cement and water. The course aggregate used varied in size from small stone to larger stone, up to approximately 30 mm in diameter. In addition, the crushing process created aggregate with rough asymmetrical surfaces to facilitate effective binding in the concrete when combined with proper amounts of cement and water. We reviewed laboratory tests and confirmed that the concrete met or exceeded strength standards.

**Site Photo 3. Steel floor placed on concrete foundation.**

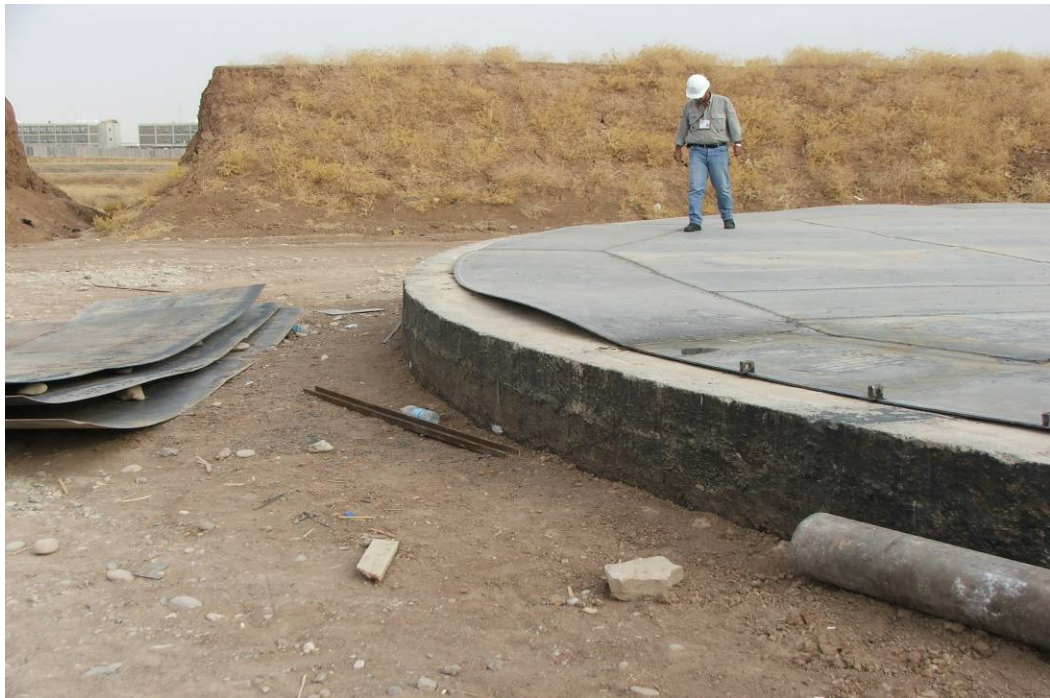
**Site Photo 4. Steel floor placed on concrete foundation**

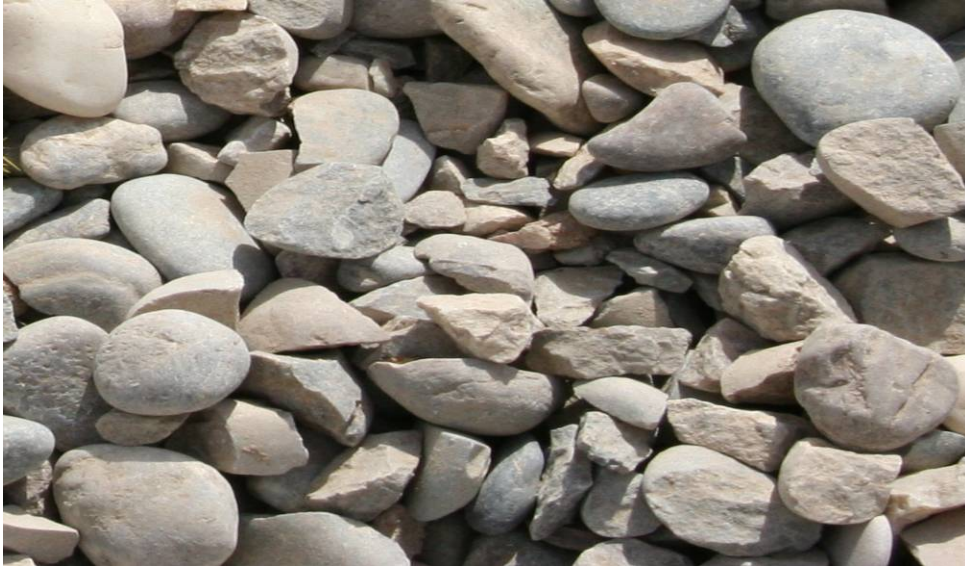
**Site Photo 5. Crush aggregate used in concrete mix for tank foundation.**

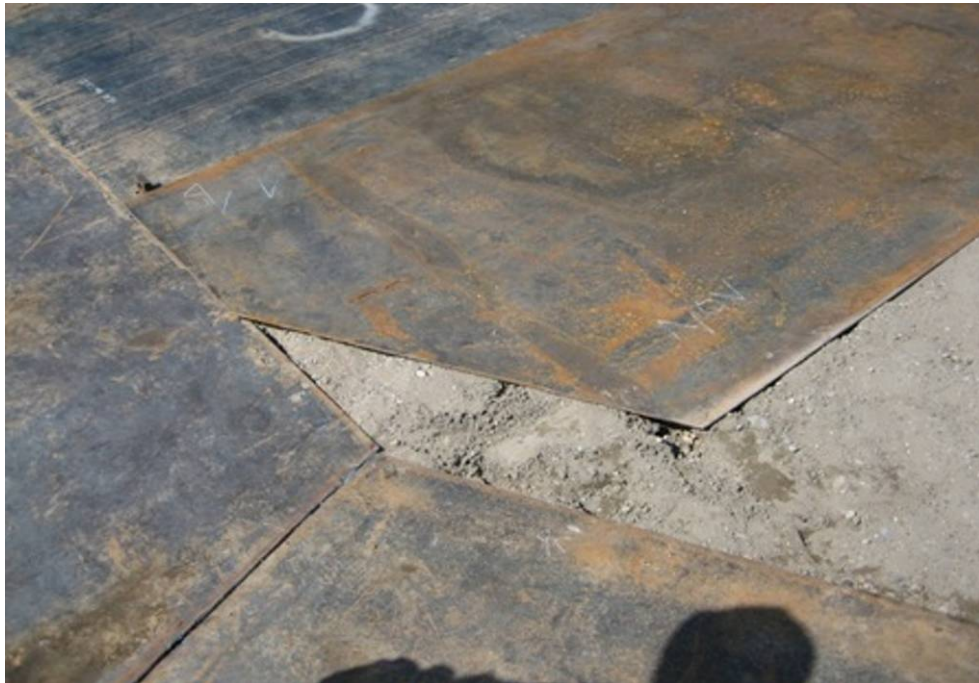
**Site Photo 6. Sheets of steel were fitted together prior to welding.**

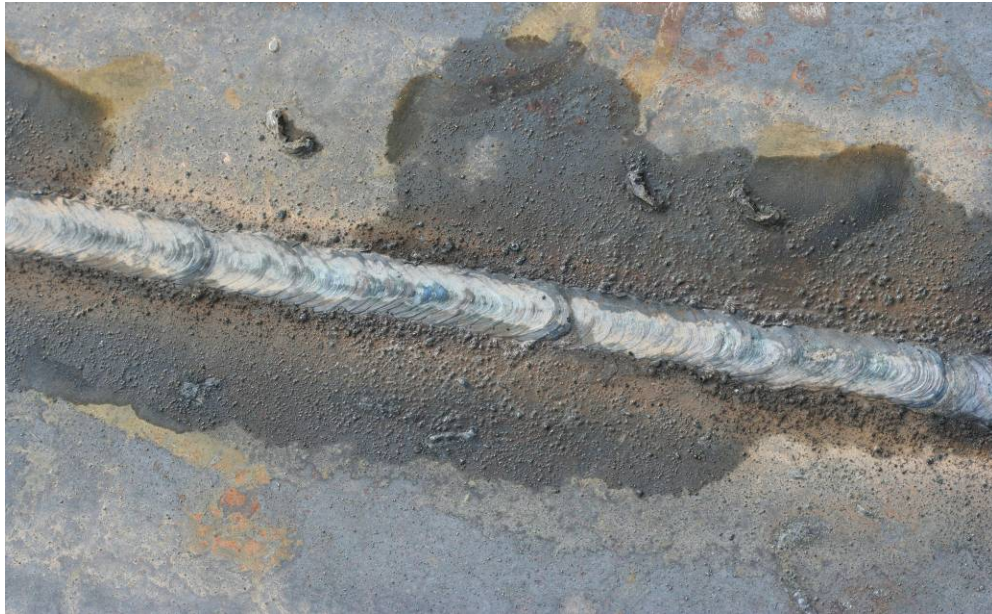
Site Photo 9 displays a successful annular plate weld that passed the vacuum test. Visual inspection by the QC manager pointed out that the uniform thickness, adequate penetration, and uniform rounded swirls of the bead indicated a good weld.

**Site Photo 9. High quality annular plate weld.**

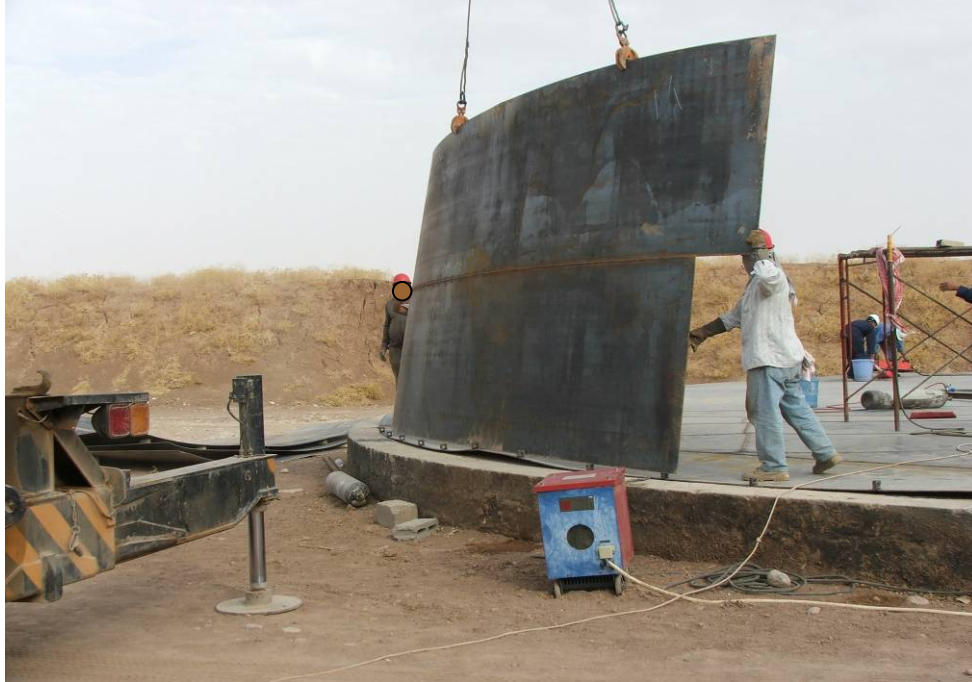
After fabricating and successful testing of the annular plating welds, the tank walls were installed. The contractor fitted an 18 inch overlap on two sections of steel shell plates. The tank walls were being built from sheets welded in place. Site Photo 12 shows workers positioning the first steel plate section to form the tank wall. Also evident in Site Photo 12 is the 18 inch overlap of shell plates.

**Site Photo 12. Steel plates were fabricated and placed on the base plates to form the tank's wall.**

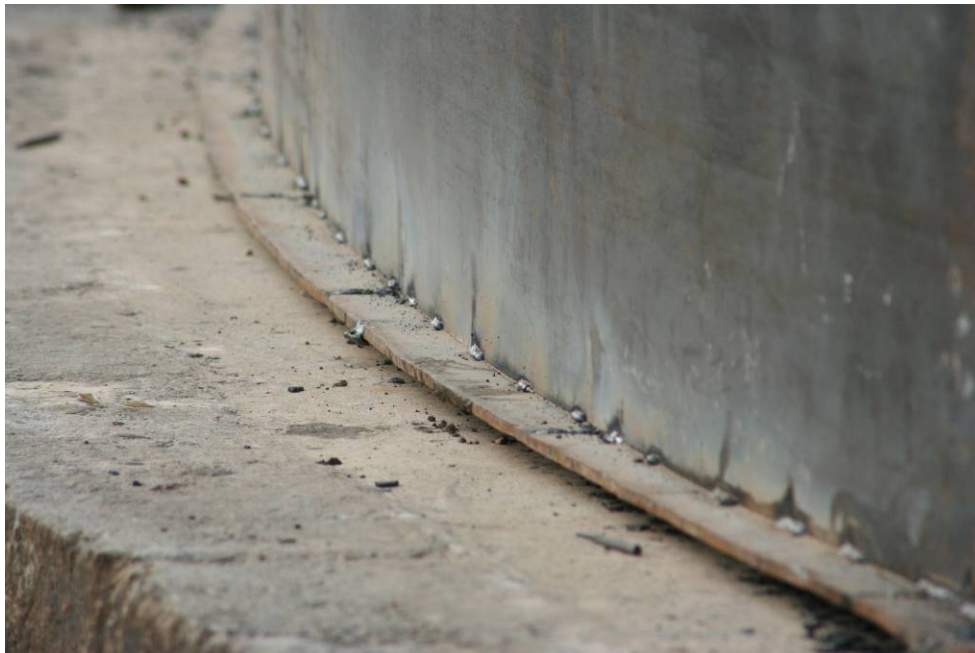
In order to anchor the sheets to the base and fasten adjacent sections, tack welds were utilized. Site Photo 13 shows tack welds along the base of the tank while Site Photo 14 shows the initial fastening of adjacent steel section of wall plating.

**Site Photo 13. Tack welds temporarily attach wall plate to floor.**

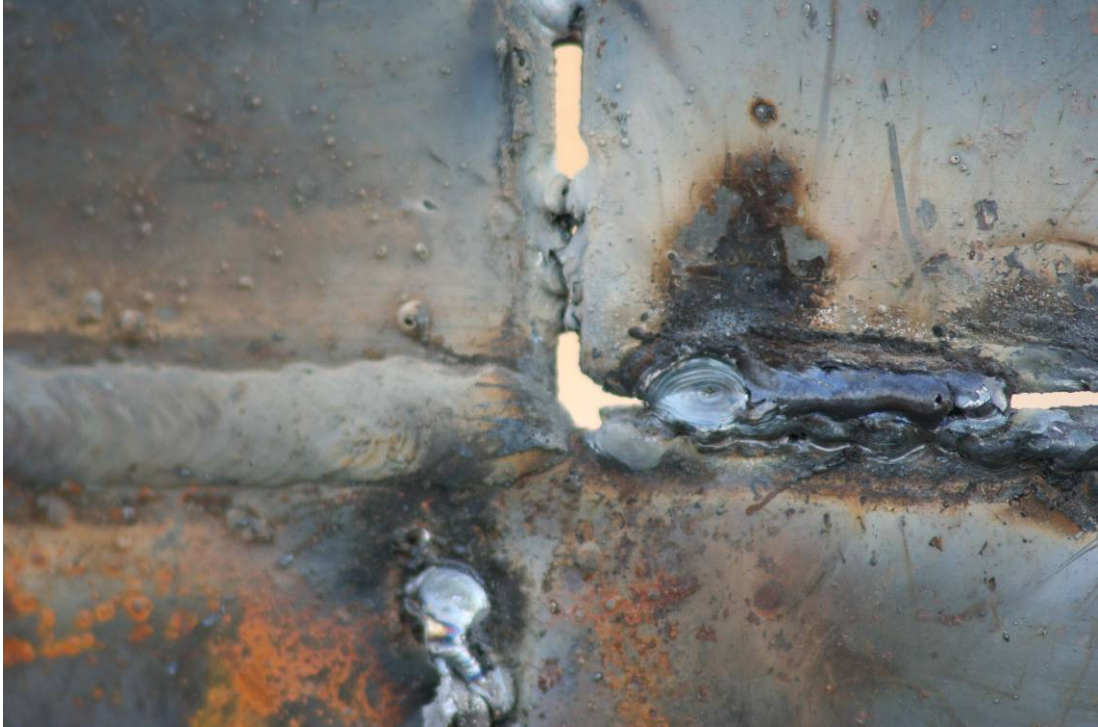
**Site Photo 14. Tack welds temporarily attach wall plates together.**

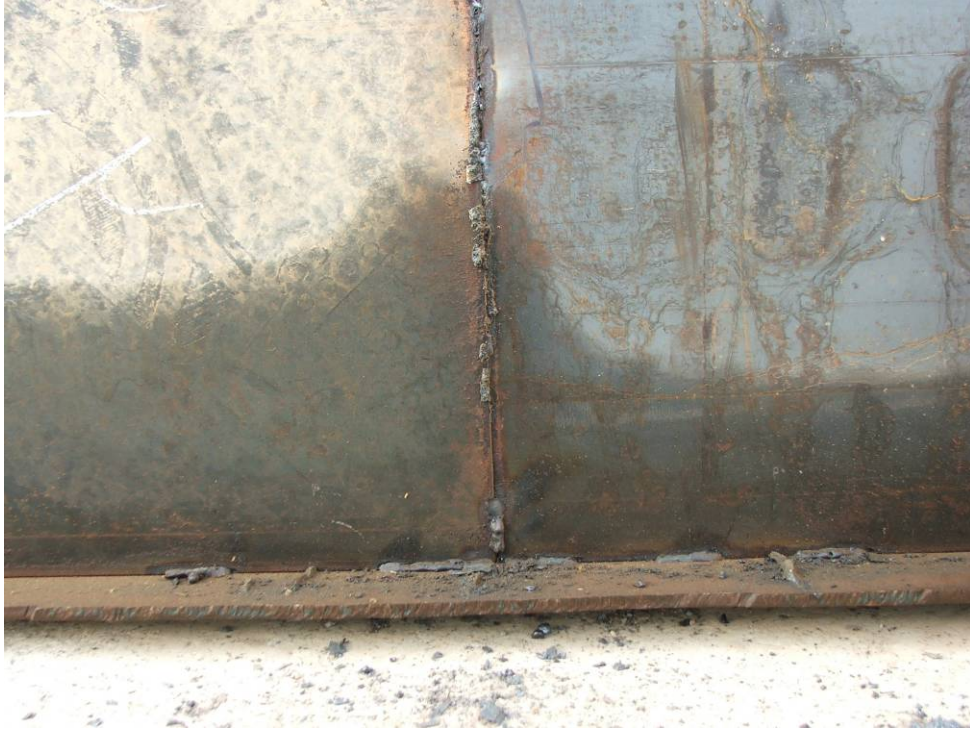
After the first two runs were completed, a diesel penetrant test was performed to determine if the welds held a seal. That test consisted of application of light diesel fuel (kerosene) to the weld's surface. Penetration of diesel through the weld indicated failure or leakage. Procedures dictated that all leaks would be repaired and retested. Site Photo 15 shows where the diesel fuel passed through the weld after a 24-hour dwell<sup>2</sup> period on the outside of the tank. Site Photo 16 reveals a leak in the inner weld of the after the 24-hour dwell period.

**Site Photo 15. Diesel penetrated the welds within 24 hours of test.**

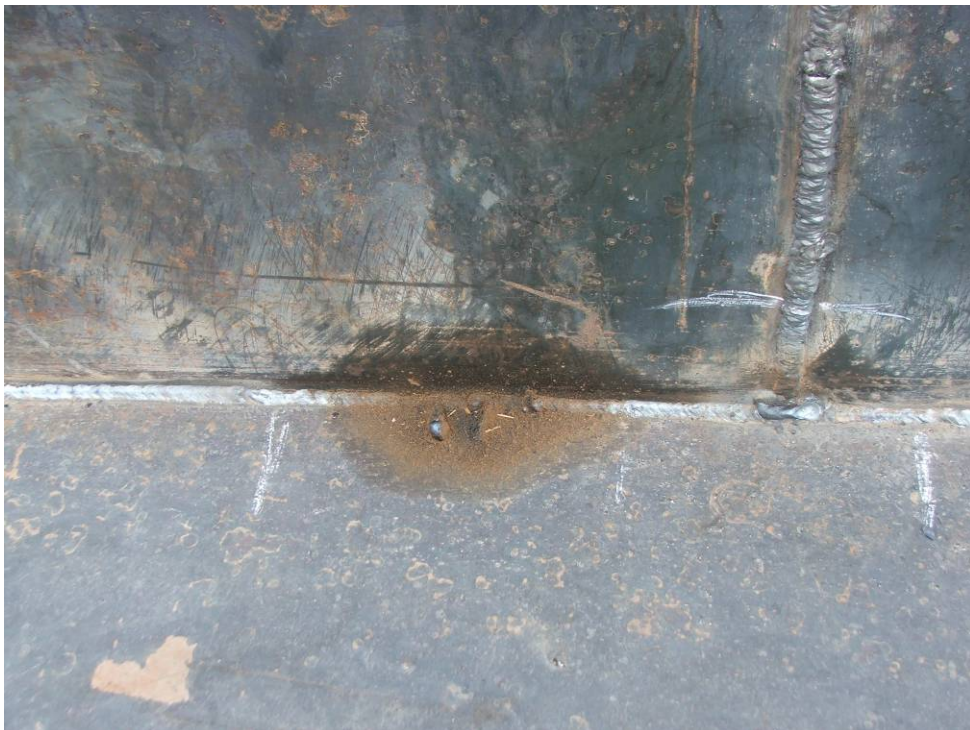
**Site Photo 16. Diesel penetrated the welds within 24 hours of test.**

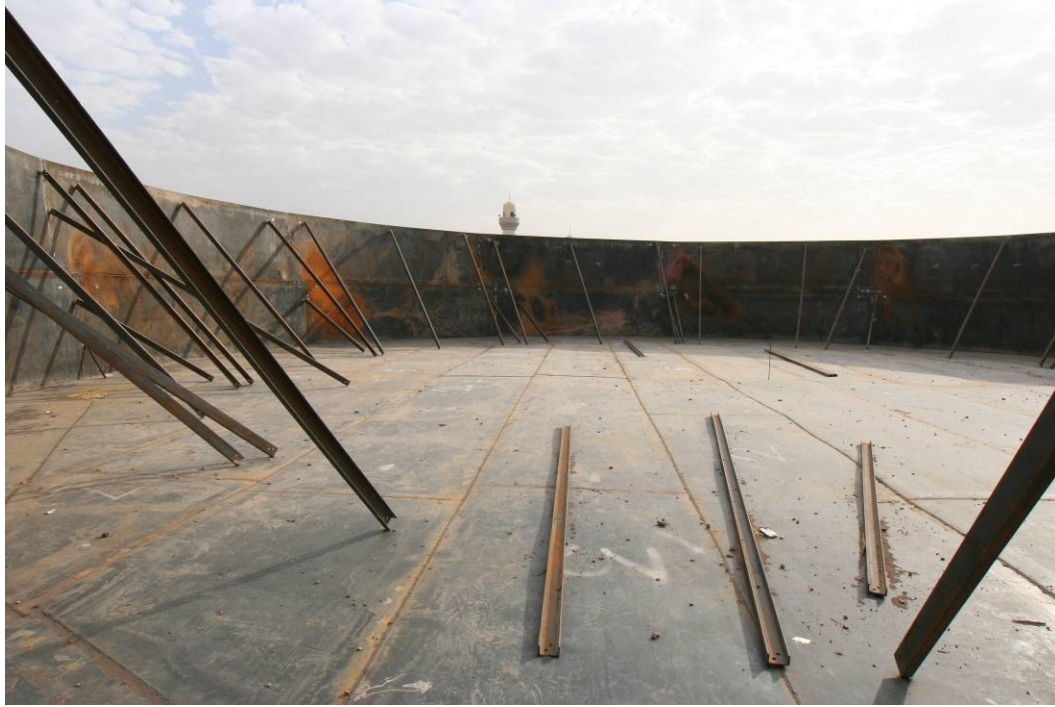
unwelded sections of the steel sheets. An example of the internal bracing supporting the tank wall sections is shown in Site Photo 17.

**Site Photo 17. Inner tank bracing supports the attached steel shell plates.**

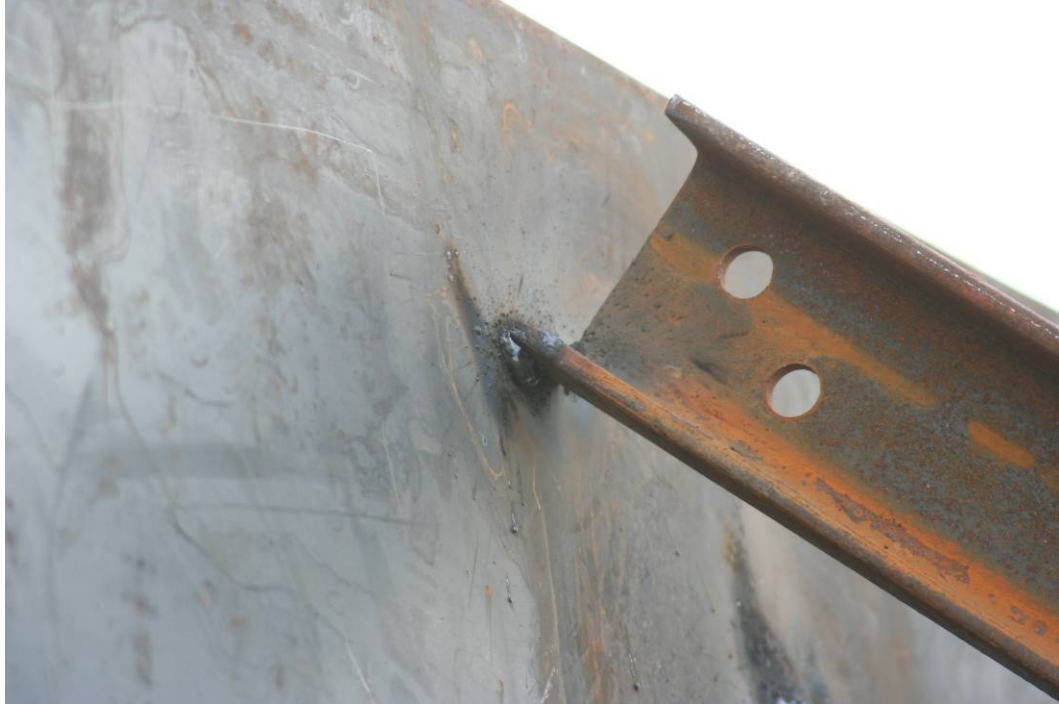
The contact edges of the steel beams were tack welded to the adjacent plates. Site Photos 18 and 19 show the top and bottom tack welds used to attach the steel supports to the tank base and walls. Vertical and horizontal runs (welded seams) were required to attach the plates that make-up the tank's walls. Supporting steel beams were removed once support was no longer needed and welds were secure.

**Site Photo 18. Top ends of steel beams are tack welded to the wall plates.**

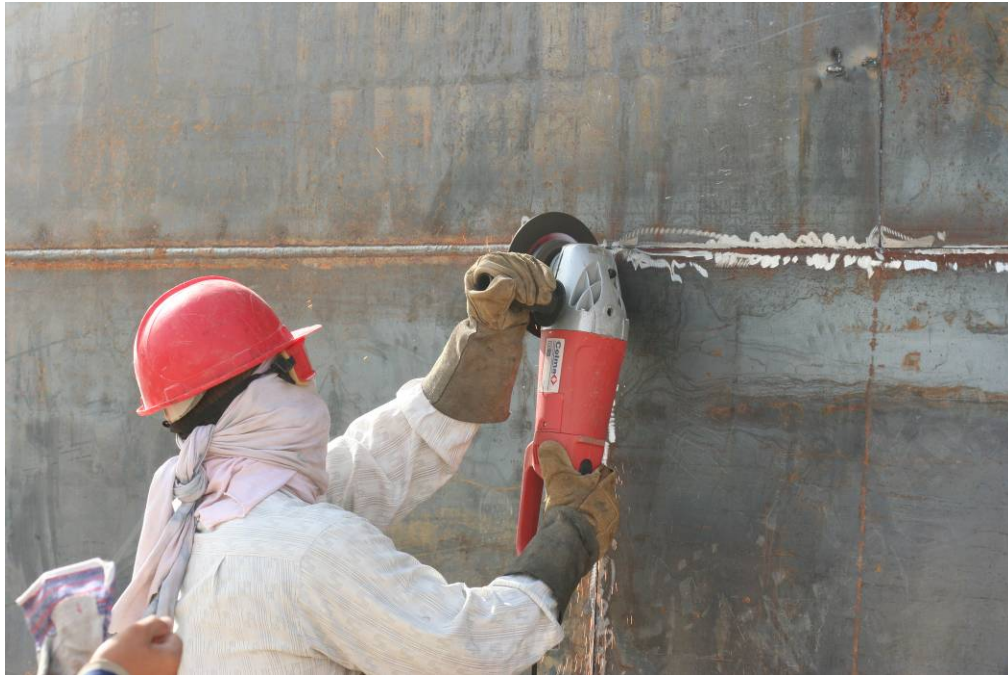
beads were “back ground” to the plate metal. Site Photo 20 shows the back grinding process while Site Photo 21 shows a weld grounded flush with the plate steel.

**Site Photo 20. Grinding the outside weld back to the shell plating.**

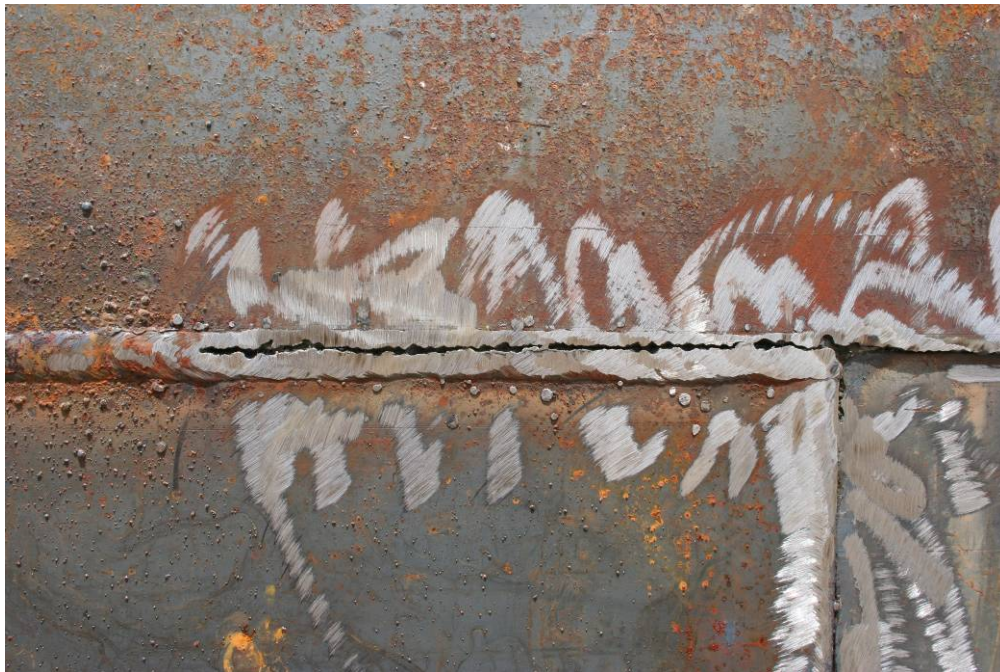
**Site Photo 21. Close-up of bead ground flush with plate steel.**

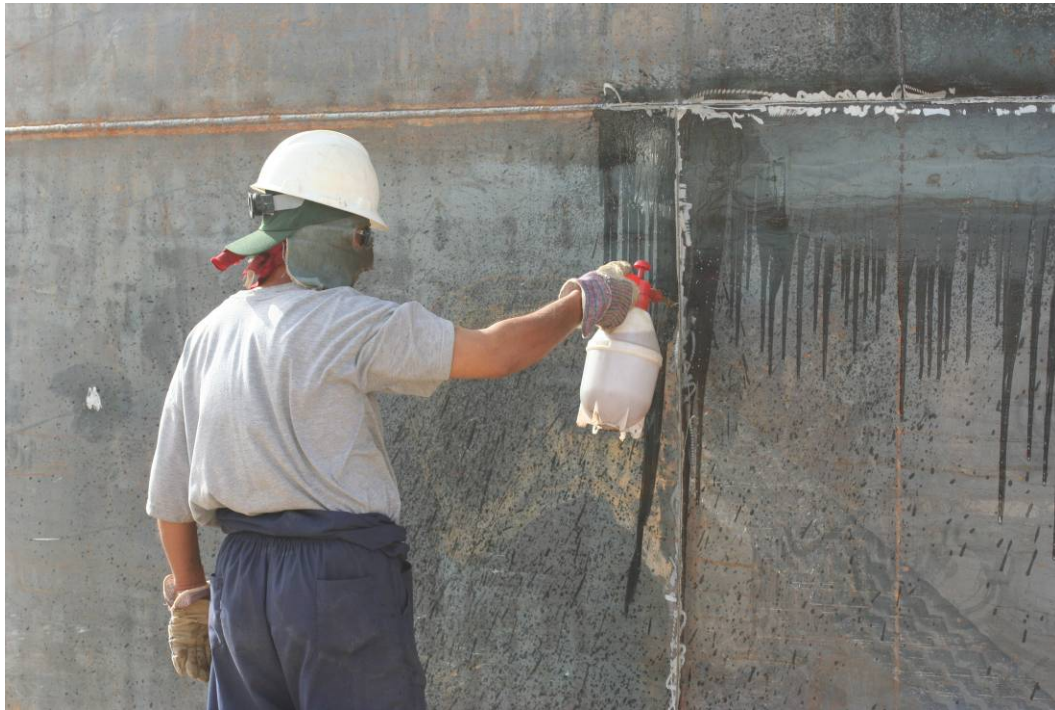
the weld, the failed weld area was marked and subsequently rewelded and retested. Site Photo 22 illustrates how workers applied/sprayed the light diesel penetrant to a welded seam.

**Site Photo 22. Diesel was sprayed on horizontal and vertical welds to conduct a penetrant test.**

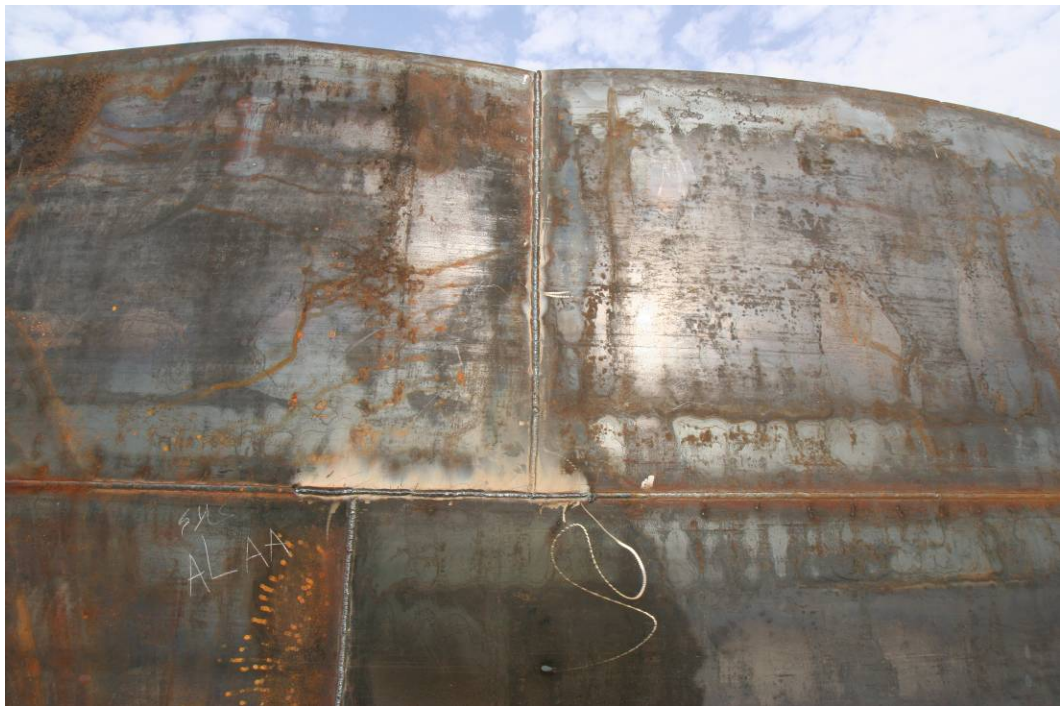
**Site Photo 24. Completed second run on a vertical weld of a shell plate.**

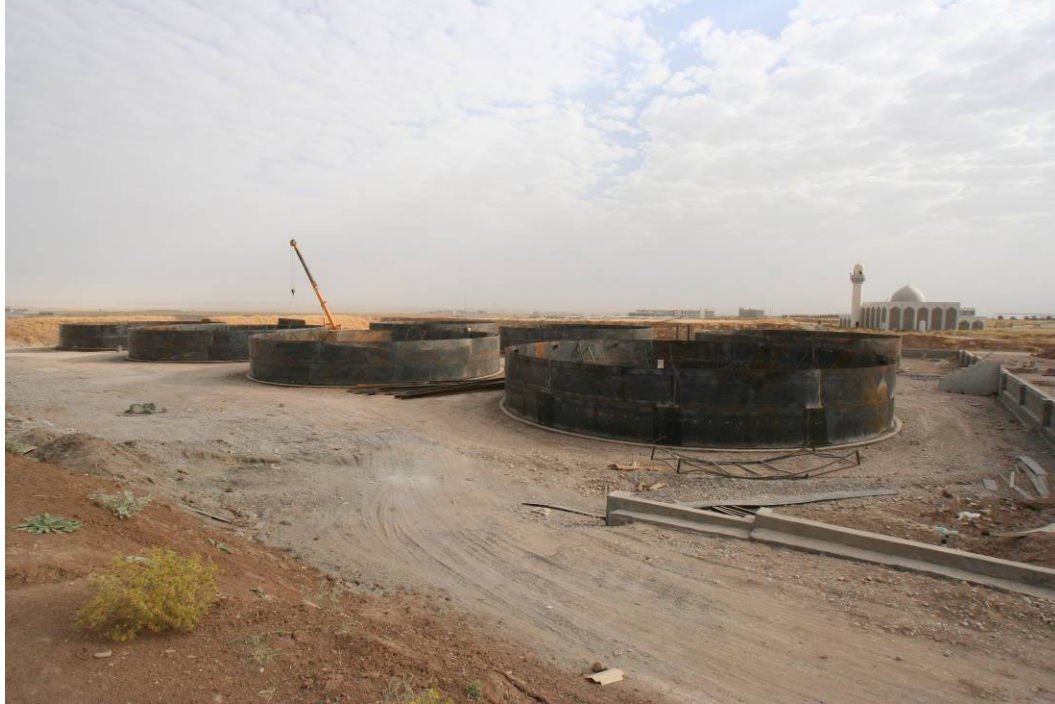
Based on a review of contract requirements and final design drawings, discussions conducted with contractor personnel and our on-site visit conducted on 1 August 2006, the assessment team found that construction was based on adequate design and work completed at the time of our site visit conformed to design requirements. Overall progress at the time of the site visit is shown in Site Photo 25.

**Site Photo 25. Overall construction progress as of 1 August 2006.**
