RECRUITING (BABIL VOLUNTEER)
CENTER
AL HILLA, IRAQ

SUSTAINMENT ASSESSMENT

SIGIR PA-06-089
APRIL 17, 2007

Recruiting (Babil Volunteer) Center Sustainment Assessment Al Hilla, Iraq

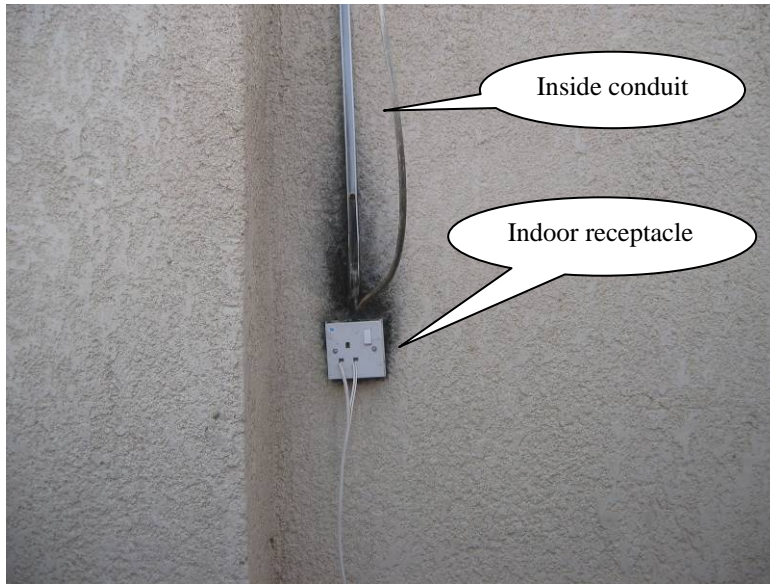
Our inspection noted that indoor electrical wiring, receptacles and junction boxes were used to power a water pump used in outdoor applications. The wiring appears to have shorted and ignited the electrical box, which has been replaced. A second water pump also used indoor electrical wiring but was not connected to a power source. The wiring, junction box, receptacle and pumps were left unprotected from the outside elements.

Site Photo 4. Indoor wiring and electrical box connecting to water pump

3. It is uncertain who is responsible for the unprotected water pumps and inferior wiring. Action should be taken to insure that outdoor wiring is installed, the water pumps are protected from the elements and the disconnected pump is connected to a power source.

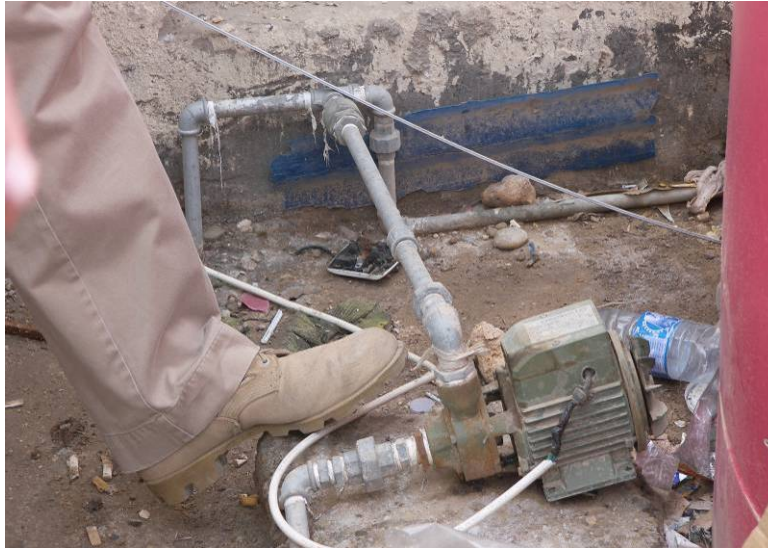
The contractor stated that the pumps were originally installed on the building roof but the current user moved them to the ground after occupying the facility. The contractor noted that all of the defects associated with the pumps' current condition are attributable to the end user relocating them from their original rooftop location. The contractor was unable to provide pictures or other evidence demonstrating the pumps were originally installed on the roof. Site Photos 4, 5, and 6 show the indoor wiring and electrical box, exposed water pumps, and disconnected wiring.

Site Photo 5. Water tank pump exposed to the outside elements

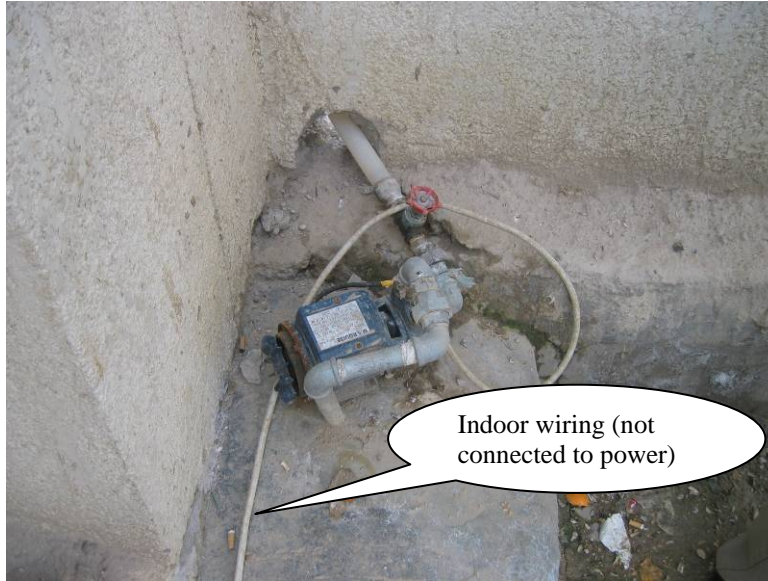
Site Photo 6. Exposed water pump connected to the main water supply line using indoor wiring. (Wiring is not connected to electrical power.)

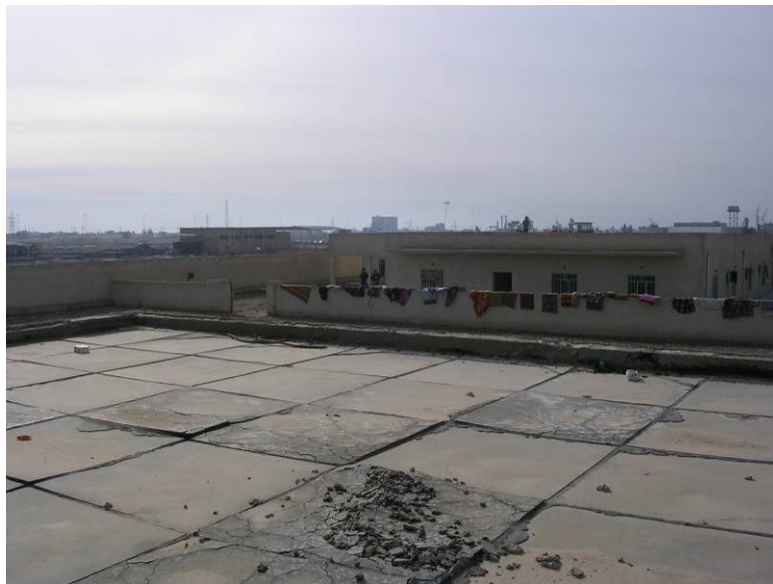
The guard house roof deteriorated prematurely and the water tank on the roof apparently overflowed causing damage to the interior walls. After being notified of the problem, the contractor visited the site and repaired the roofs at the guard house and the main building. Site Photo 7 shows the deteriorated roof tiles and Site Photo 8 provided by the contractor on 17 February 2007 shows the repair work on the roof.

Site Photo 7. Deteriorated roof tiles on the guard house

1. Upon hearing about the deficiencies the subcontractor visited the site, made an assessment of the deficiencies and repaired the guard house roof as a warranty item.

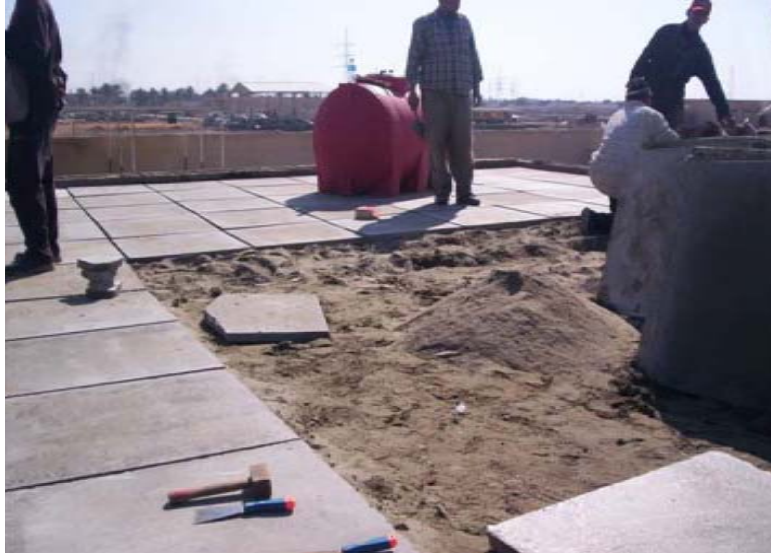
**Site Photo 8. Contractor repairing the guard house roof after being notified by SIGIR
(From Weston photo log)**

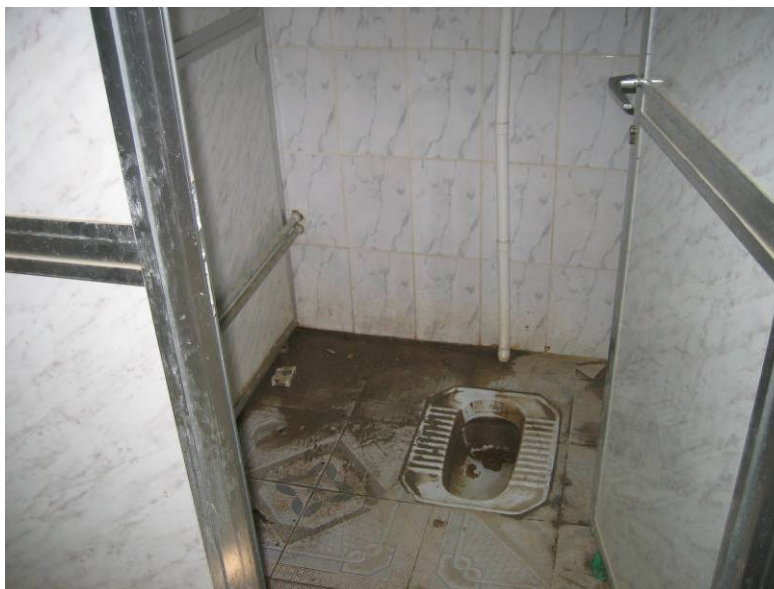
Our inspection disclosed that bathrooms were not clean, there were no beds for the Iraqi soldiers stationed at the facility, and electrical wiring had been “jerry rigged” to either repair burned out circuits or to add lighting. Also, as previously mentioned, the waste water holding tank was full and channeling raw sewage onto the adjacent property which eventually drains into the Hilla River. If maintenance continues at its current level, SIGIR believes that the useful life of the facility will be significantly shortened. Also poor O&M practices such as “jerry-rigged” wiring and draining raw sewage into the Al Hilla River create fire and community health hazards. Site Photos 9 through 14 illustrate these conditions at the time of our assessment.

Site Photo 9. Example of an eastern style toilet that had not been maintained

4. The GoI should be notified that the facility is not being maintained adequately and they should be encouraged to allocate funds from the Base Support program to provide appropriate operation and maintenance at the center.

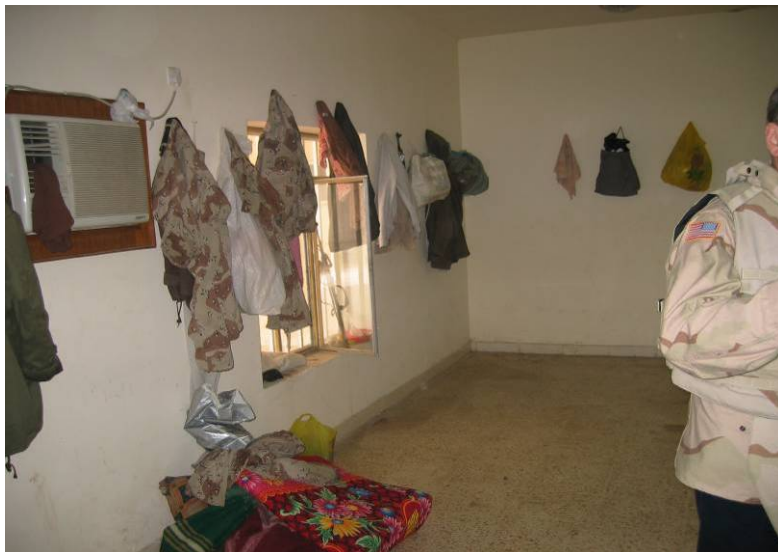
Site Photo 11. Bedless sleeping quarters for the Iraqi soldiers assigned to the facility.

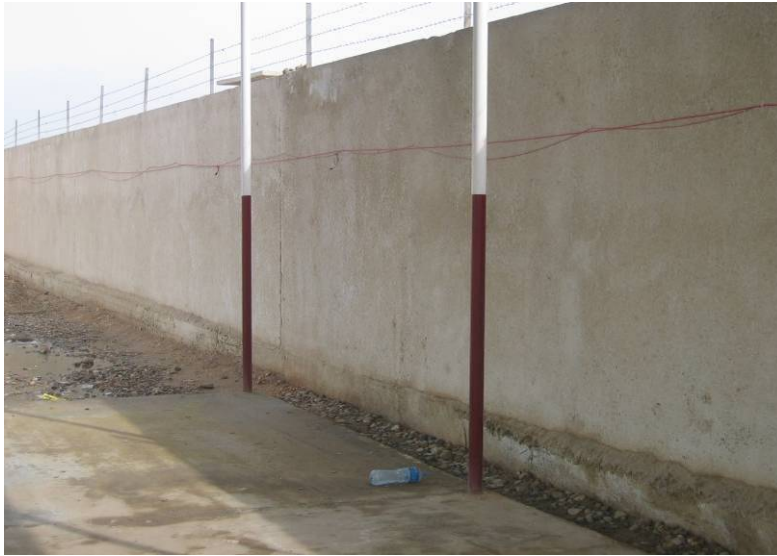
Site Photo 12. Post construction indoor wiring added to power the lighting for the outside staging area.

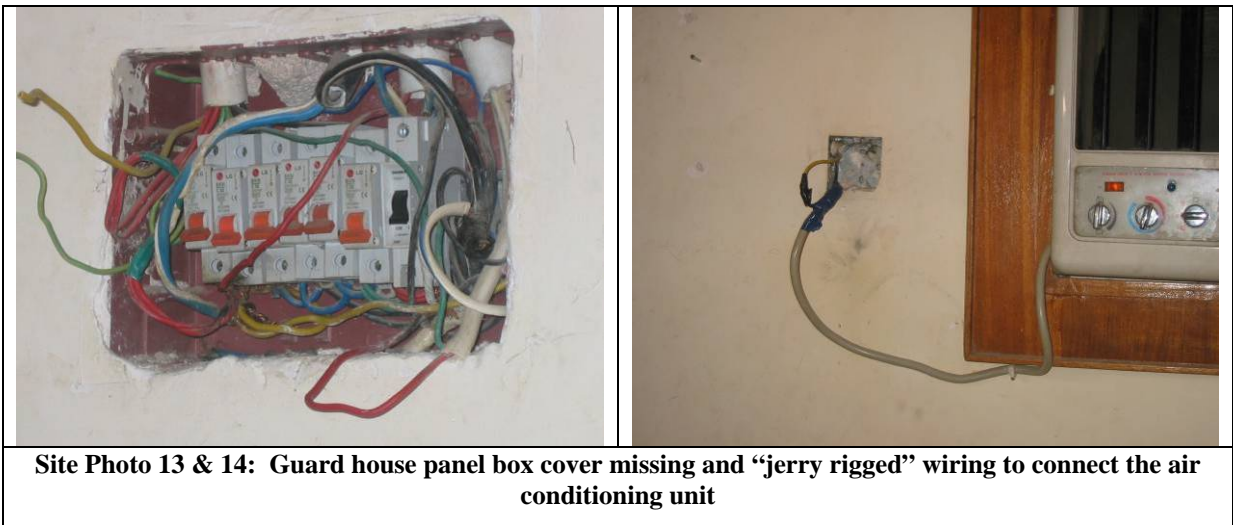
Site Photo 13 & 14: Guard house panel box cover missing and “jerry rigged” wiring to connect the air conditioning unit
