IRAQI C-130 BASE
BAGHDAD, IRAQ

SUSTAINMENT ASSESSMENT

SIGIR PA-07-099
JULY 24, 2007

SUBJECT: Report on Sustainment Assessment of the Iraqi C-130 Base, Baghdad, Iraq
(Report Number SIGIR PA-07-099)

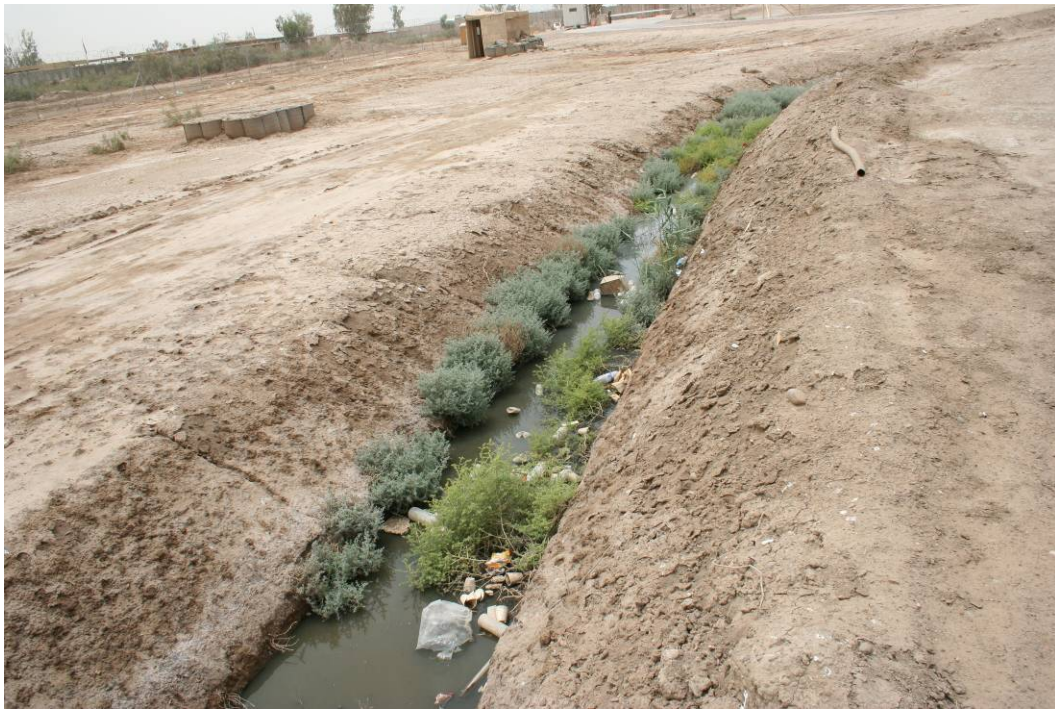
Raw sewage filled the storm drainage collection pit (Site Photo 14) and connecting drainage ditch (Site Photo 15). A small wet soil trail was evident in the soil in front of the sewage tanks to the drainage ditch, where it appeared that a hose leaked. The holding tank design only allows sewage removal by pump. Waste removal required a pump truck to transfer sewage from the collection tanks to the drainage ditch. From the evidence on site, the inspectors concluded that the pump trucks were used to pump the holding tanks into the drainage ditch.

Site Photo 15. Raw sewage is pumped from sewage holding tanks into storm water runoff ditch
