51<sup>ST</sup> BRIGADE IRAQI ARMY BARRACKS  
AL HILLAH, IRAQ

**SIGIR PA-06-075**  
**JANUARY 29, 2007**

SUBJECT: Report on 51st Brigade Iraqi Army Barracks, Al Hillah, Iraq  
(Report Number SIGIR PA-06-075)

## 51st Brigade Iraqi Army Barracks, Al Hillah, Iraq

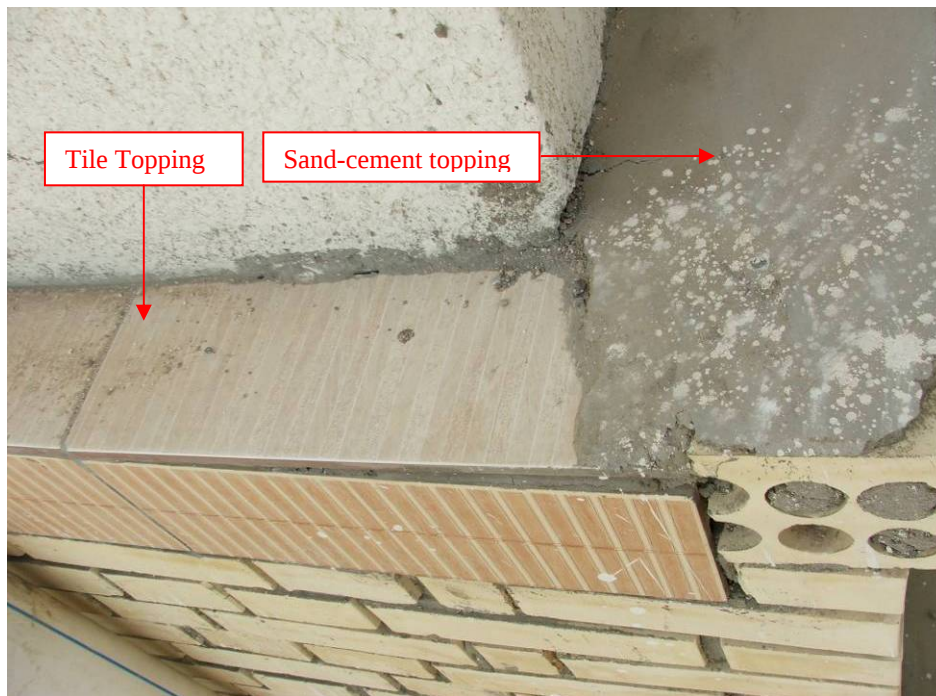
The dining facility floor plan included a 100-person dining room, a kitchen, a hand wash room, and three separate food storage rooms (dry storage, a chill box, and a frozen box). The design called for the base of the exterior walls to be covered with brick to a height of about 1 meter (m), and the upper portion of the walls covered with a ceramic type tile matt. Site Photo 1 shows the exterior of the dining facility. The contractor had constructed the brick facing along the bottom 1 m of the exterior; the upper portion of the walls were plastered, textured, and painted. We did not find any significant deficiencies with the exterior construction, except the top of the 1 m brick face on one side of the building. The contractor, on three sides of the building, had placed a ceramic tile cover over the top course of the brick face. However, on the front side of the building, the contractor had only placed a sand-cement topping, as shown in Site Photo 2. The USACE GRS Babil Resident Office PE informed us the contractor would make the necessary corrections.

**Site Photo 2. Brick face finish**

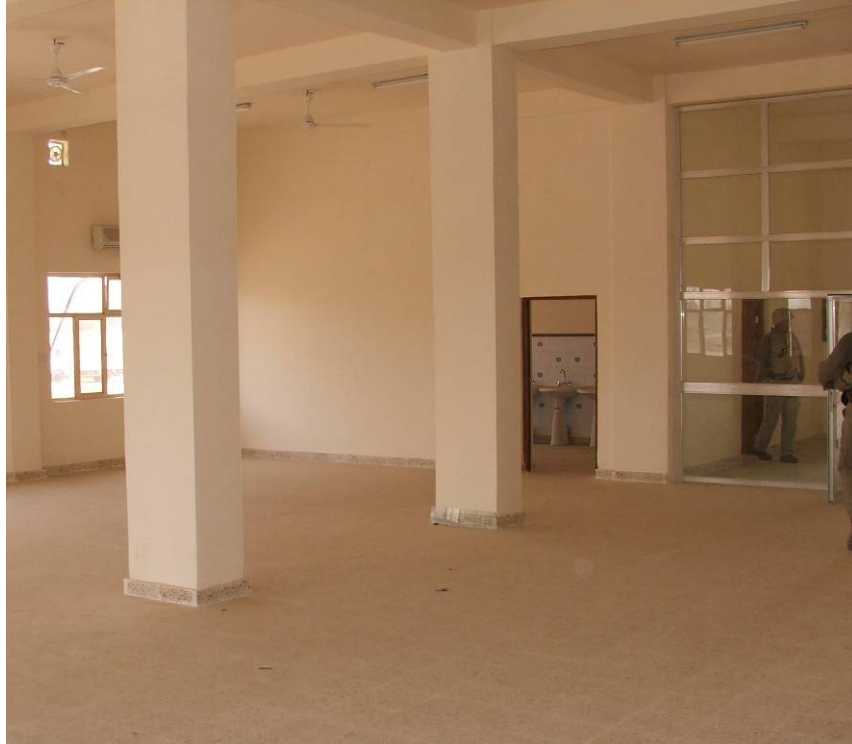
The interior walls of the dining facility were plastered and painted and the flooring included mosaic tiles. Site Photo 3 shows part of the interior finishes in the dining room.

**Site Photo 3. Dining room interior**

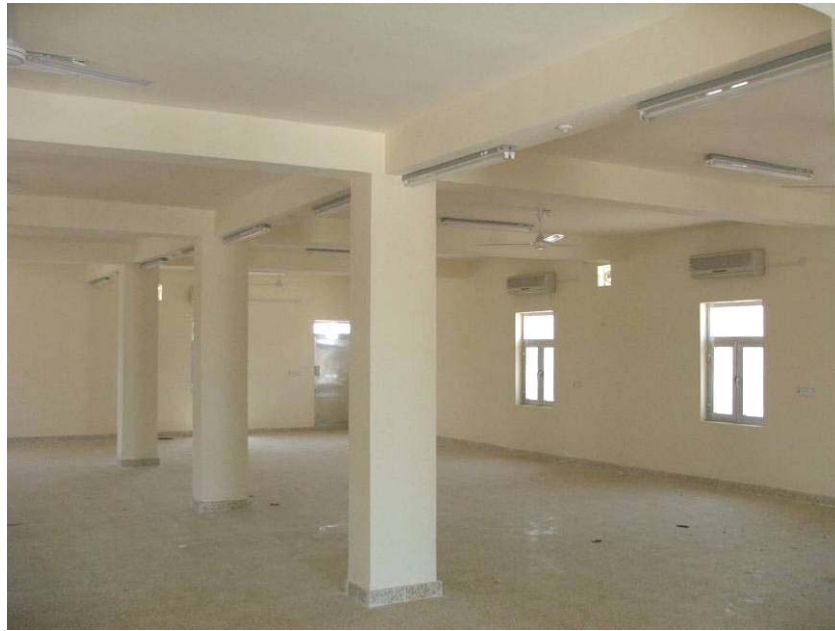
**Site Photo 4. Interior in one of the barracks sleeping quarters**

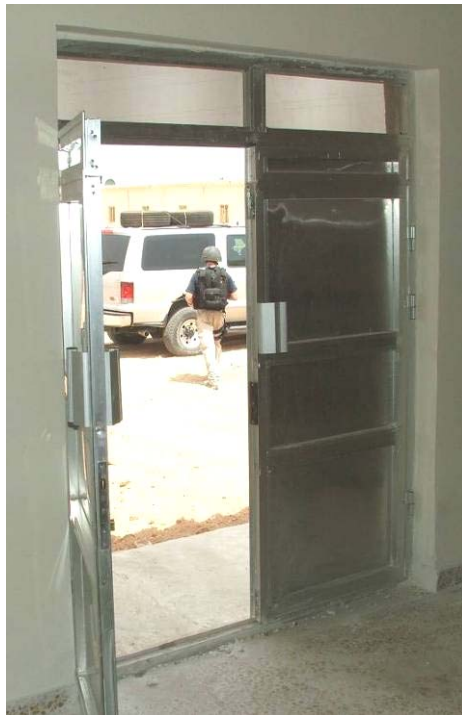
The SOW also required “good quality” aluminum windows and aluminum doors in the barracks sleeping quarters. In our inspection, we observed two sets of aluminum entry/exit doors in the sleeping quarters, one set of double doors serving as the front entrance, and a single door in the rear of the building. These doors did not appear to be “good quality,” especially considering the high traffic that a 75-man barracks will receive. Site Photo 5 shows the aluminum doors used for the entrance to the barracks sleeping quarters, and Site Photo 6 shows the rear entrance/exit door in one of the two barracks.

**Site Photo 5. Aluminum doors at front entrance to the barracks sleeping quarters**

In addition, we also identified the poor quality aluminum doors in the barracks sleeping quarters. As with the ablution buildings, considering the heavy traffic expected with a 75-man barracks, a higher quality type door was needed. Another concern is that during a strong windstorm, the aluminum doors may fly off.

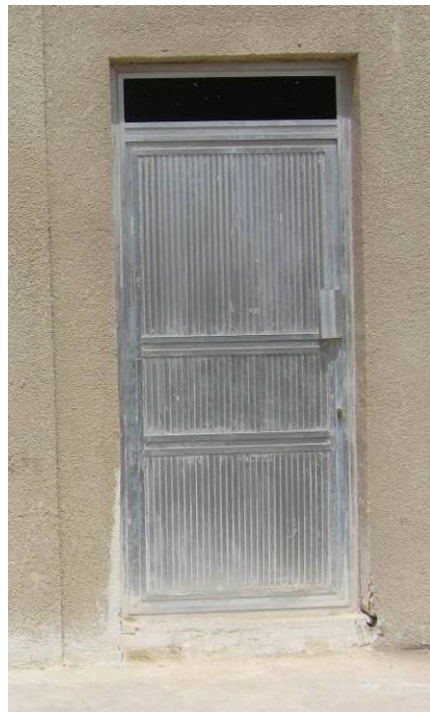
**Site Photo 6. Aluminum door at rear entrance to the barracks sleeping quarters**

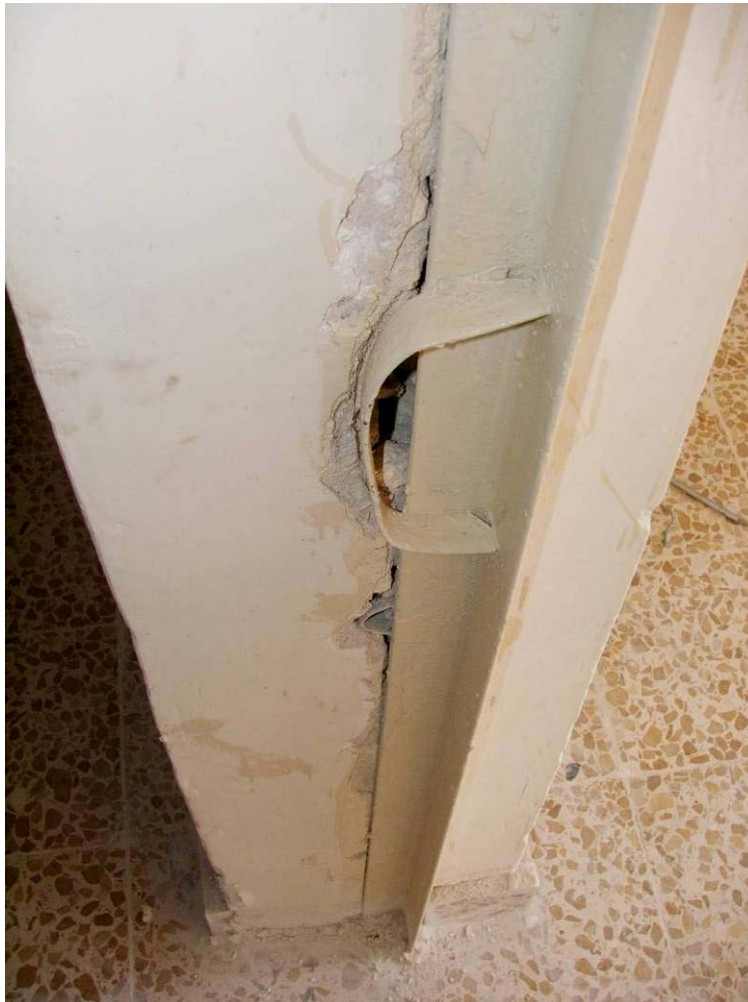
In the barracks' issue room and arms room, the design required metal doors. These doors appeared to be satisfactory in quality and adequately installed. We did notice on one of the door frames (Site Photo 7), the wall around the frame needed patching and painting.

**Site Photo 7. Arms room wall requiring patching in door frame**

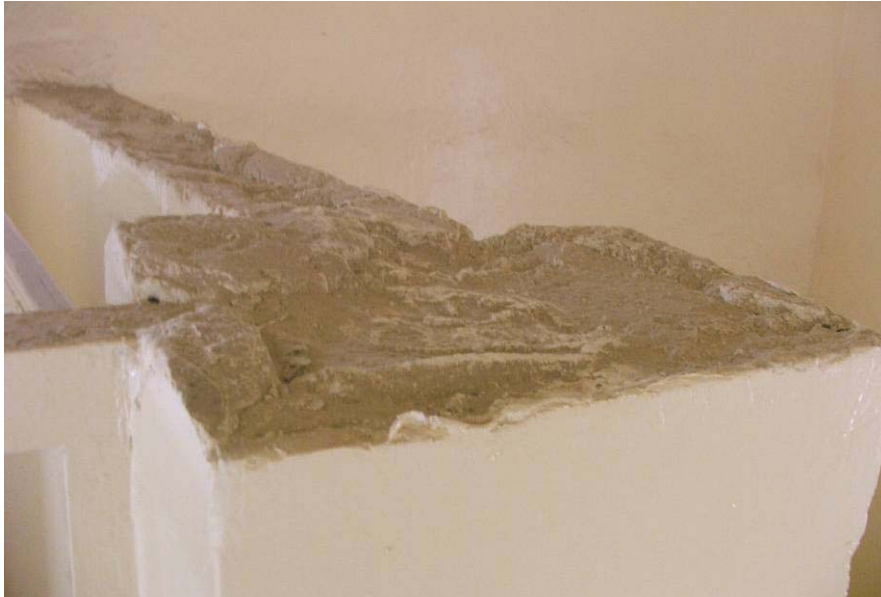
Although the walls and ceiling appeared to be finished properly, we did observe the top of the privacy walls constructed between showers and water closets were not finished in

the same manner as the walls and ceiling. The design contained no information regarding the finish requirements for the top of these walls. Site Photo 8 shows an example of the unfinished portion of the privacy walls. Aside from the ascetics, the rough surface will pose a problem for cleaning, and will trap moisture and dirt.

**Site Photo 8. Top of privacy walls constructed in ablution buildings**

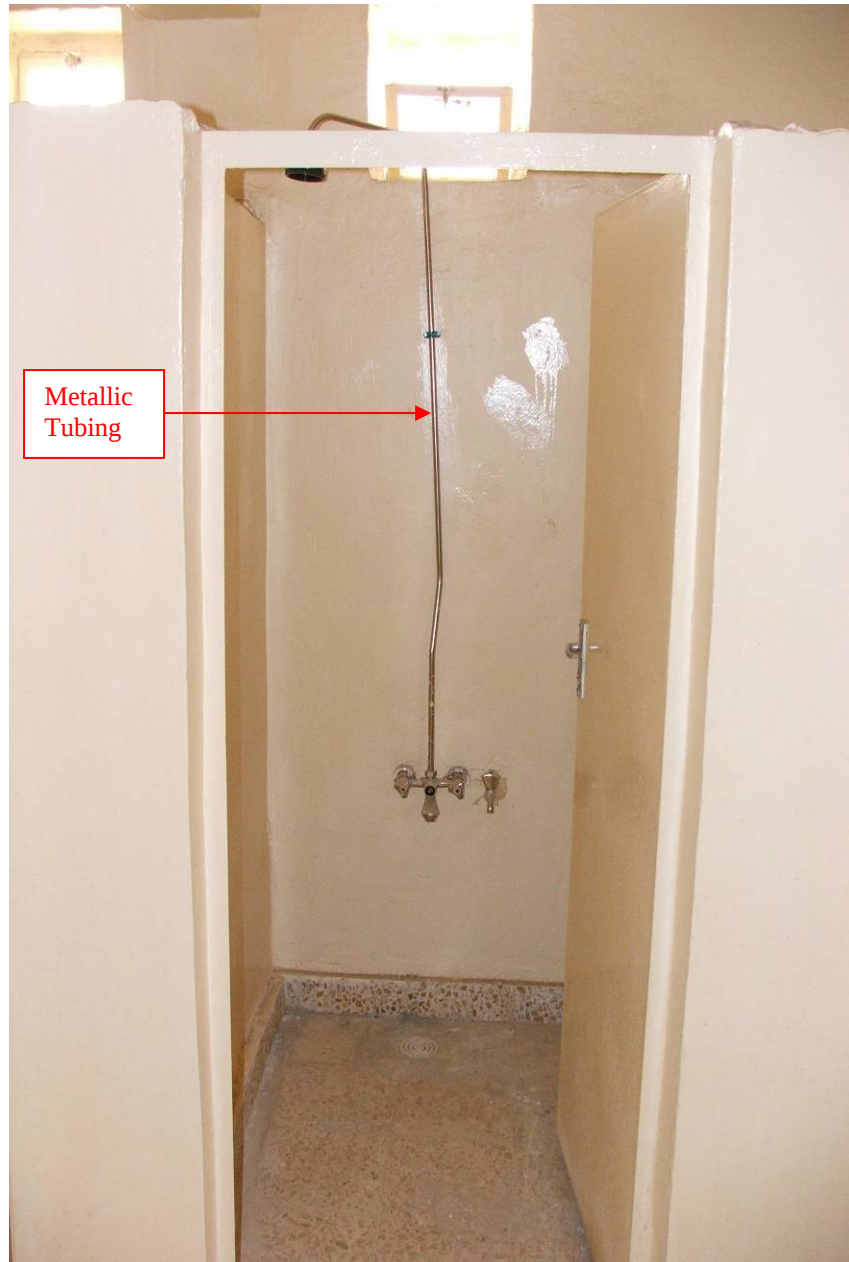
Regarding the plumbing fixtures used in the ablution buildings, we did observe what appeared to be low quality fixtures (shower heads, water supply lines, faucets, drain covers, etc.) installed in the showers, wash stations, and water closets. Site Photos 9 and 10 show the shower fixtures, including the shower head and the thin metallic tubing used to supply water to the shower head. Site Photos 11 and 12 show the type of plumbing materials used in the water closets, which includes flexible water hoses, plastic supply tanks, and thin wall plastic tubing supplying water from the tank to the toilet. Considering the ablution buildings will receive heavy usage, we believe the low quality plumbing fixtures will pose continual maintenance problems for the Iraqi Army.

**Site Photo 9. Shower in ablution buildings**

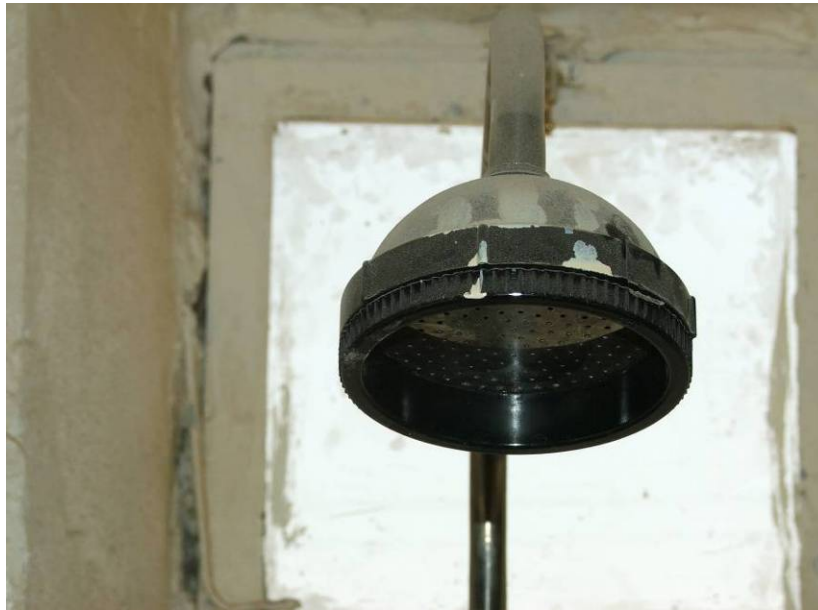
**Site Photo 10. Shower head in ablution building**

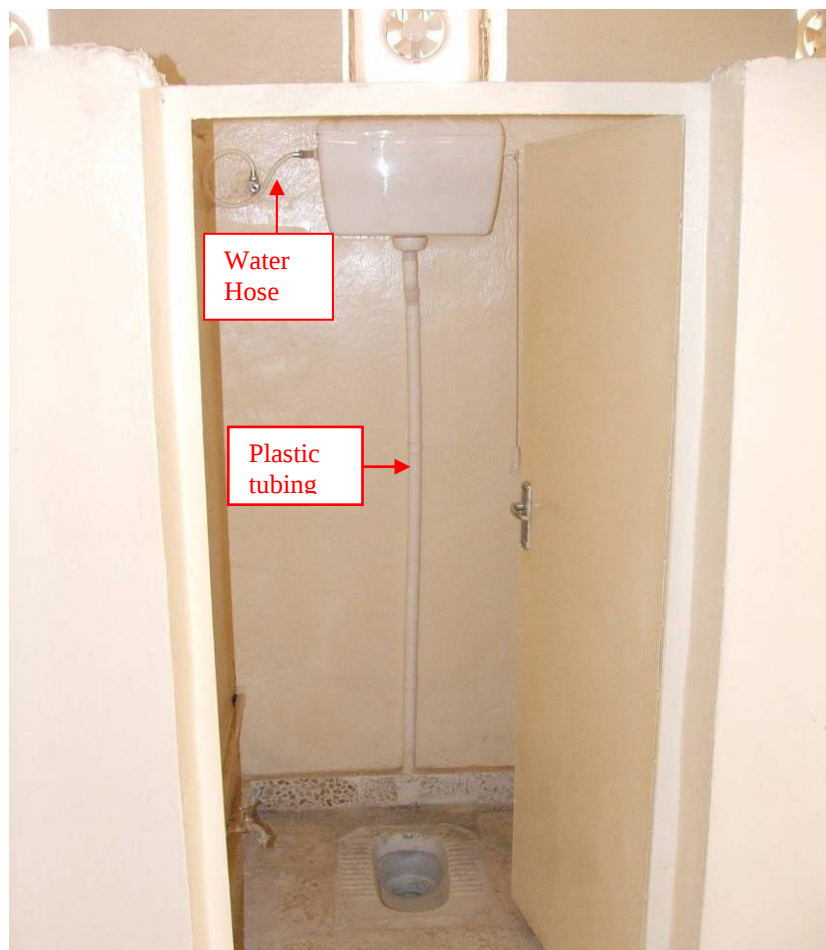
**Site Photo 11. Water closet in ablution building**

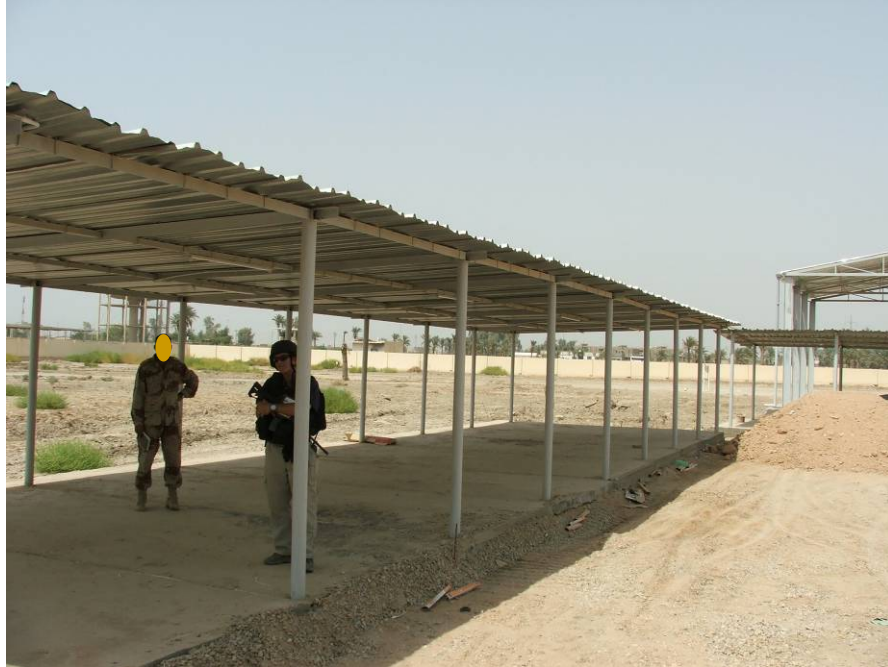
Site Photo 13 shows one section of the 40 vehicle sunshade. We did note that many of the four inch tubular columns consisted of spliced sections of pipe welded together to form one tubular column. The design did not provide any details as to whether or not welded pipe columns were allowed.

**Site Photo 13. 40- vehicle parking sunshade**

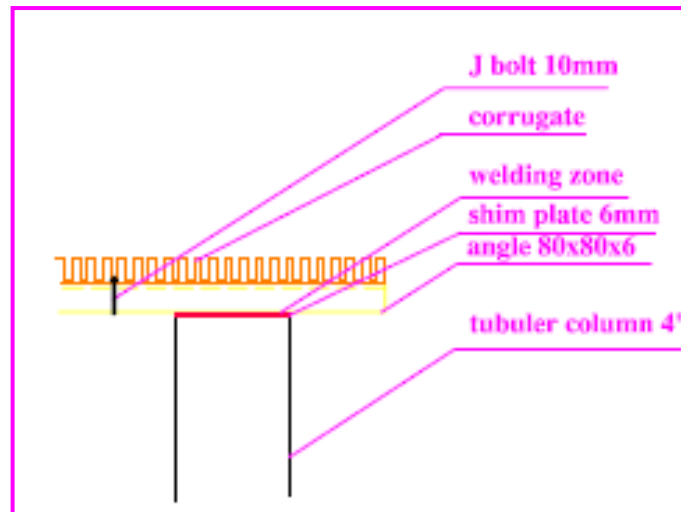
The design detail for the structural frame supporting the corrugated roof sheeting (Figure 1) showed an 80 x 80 x 6 angle supporting the roof sheeting. No units were provided for the angle, although it is assumed the dimensions are in millimeters. Figure 1 also shows the angle welded to a shim plate at the top of the column. There were no details provided on the type or size of weld or the type and thickness of the corrugated roof sheeting. The design also did not show any lateral cross bracing perpendicular to the angle support shown in Figure 1.

**Figure 1. Design detail for covered parking (sunshade)**

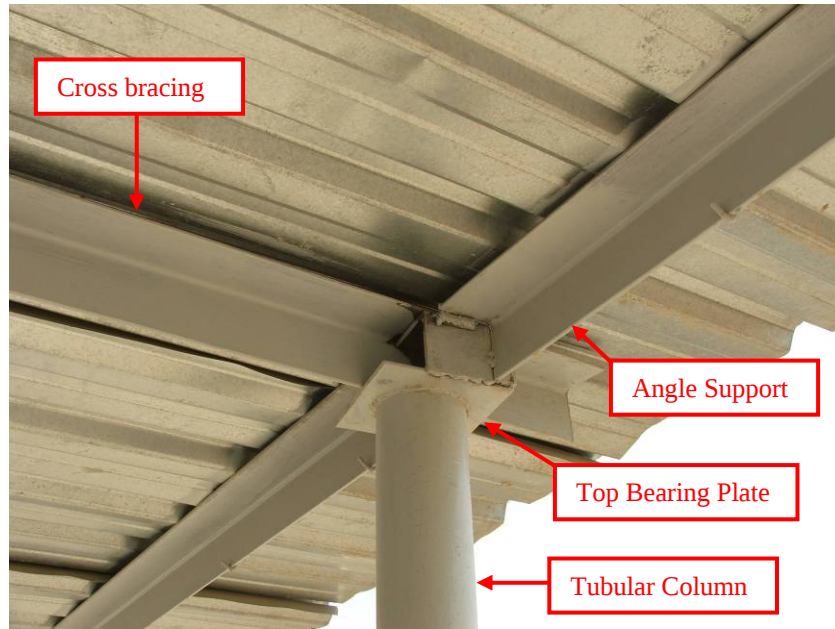
Site Photo 14 shows the actual welded angle connections at the bearing plate (i.e., shim plate) at the top of each tubular column, as well as, the lateral cross bracing. The roof sheeting material appeared to be a thin gage sheet metal, connected to the frame with J-bolts, as depicted in Figure 1.

**Site Photo 14. Typical column support for covered parking (sunshade)**

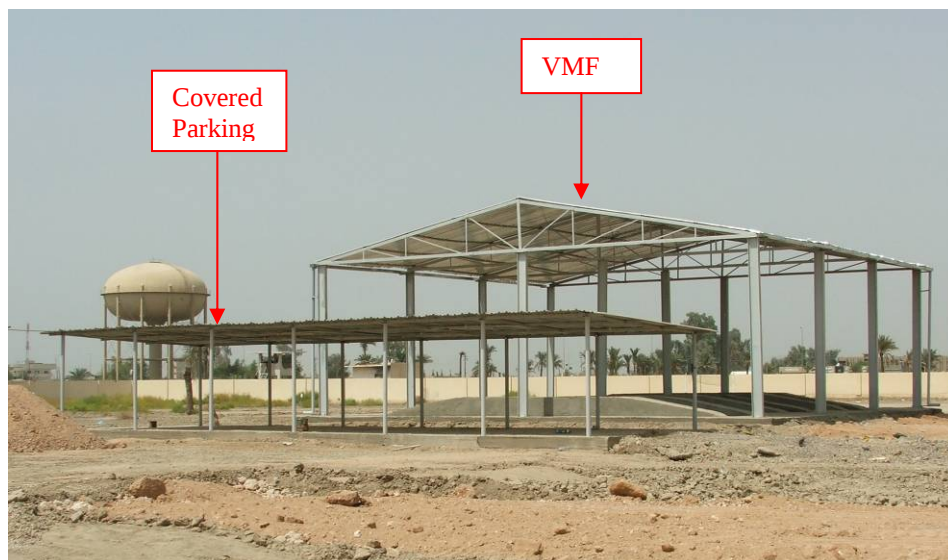
**Site Photo 17. Vehicle maintenance facility (VMF) next to a covered parking sunshade**

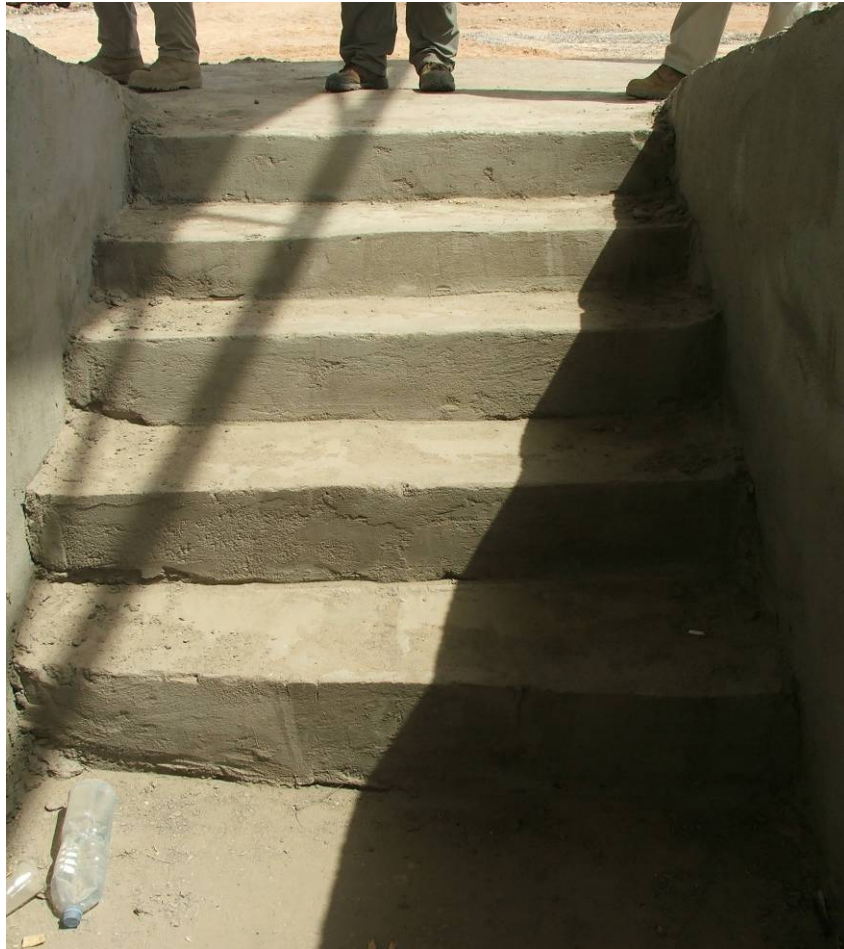
We observed poor workmanship associated with the concrete stairs accessing the maintenance pits. The stairs did not appear to be aligned properly or uniform or level. In addition, there were also voids in the concrete along the rise of the steps. Site Photo 19 shows one set of steps to illustrate the poor workmanship.

**Site Photo 19. Concrete steps into the maintenance pit**

We recommend the Commanding General, Gulf Region Division, U.S. Army Corps of Engineers should assess the adequacy of the motor pool facility's concrete vehicle ramps and the structural steel frame supporting the roof.

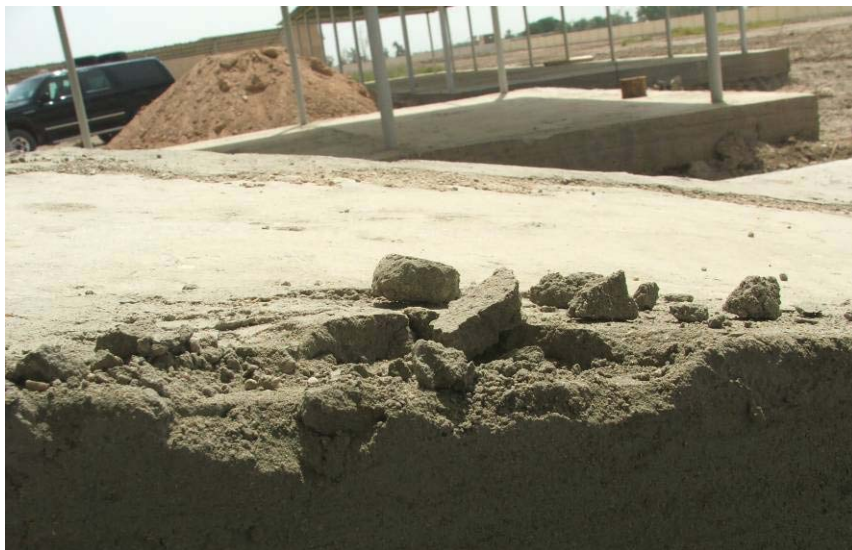
We also found the contractor had patched the ramp surface with a sand-cement mortar. There was no explanation for the need for patching; however, in several areas, the patch was crumbling. Site Photo 20 shows the crumbling material along the top of the ramp.

**Site Photo 20. Crumbling mortar at the surface of the vehicle ramp**

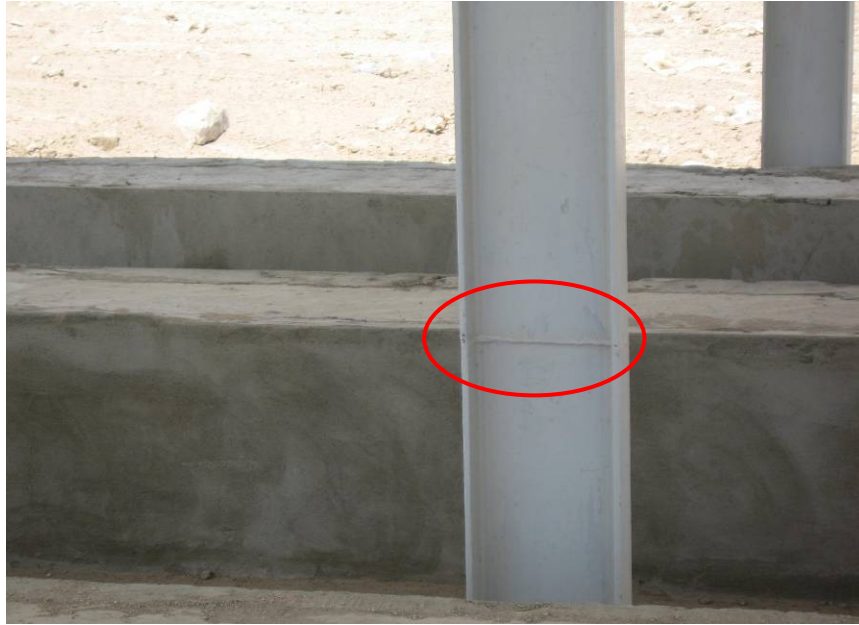
We also observed one of the H-columns consisted of two sections, butt welded together to form the column (Site Photo 21). In addition, in two of the 12 columns, we observed four bolt holes in the flange section of the column (Site Photo 22).

**Site Photo 21. Spliced steel H-column at the motor pool**

Our concerns about the motor pool noted above should be reviewed by a USACE GRS structural engineer, particularly since there were no structural design drawings for the facility.

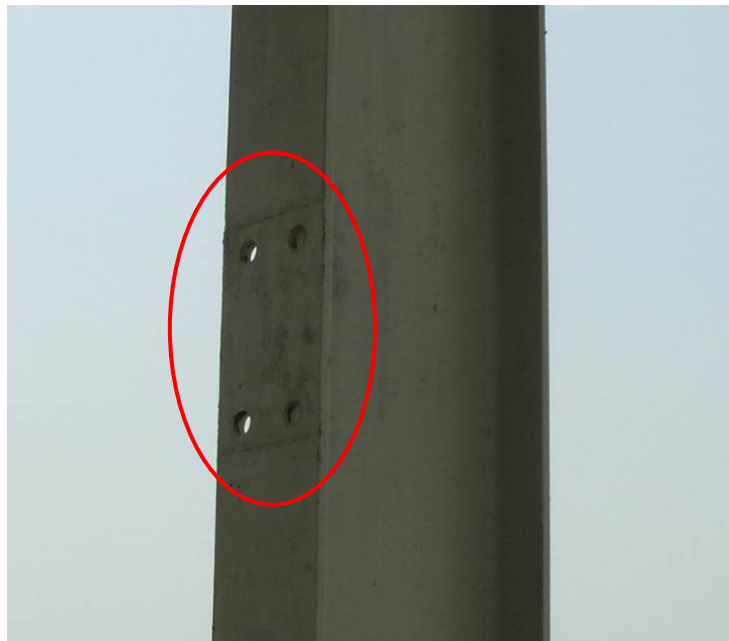
**Site Photo 22. Bolt holes in flange of a steel H-column at the motor pool**

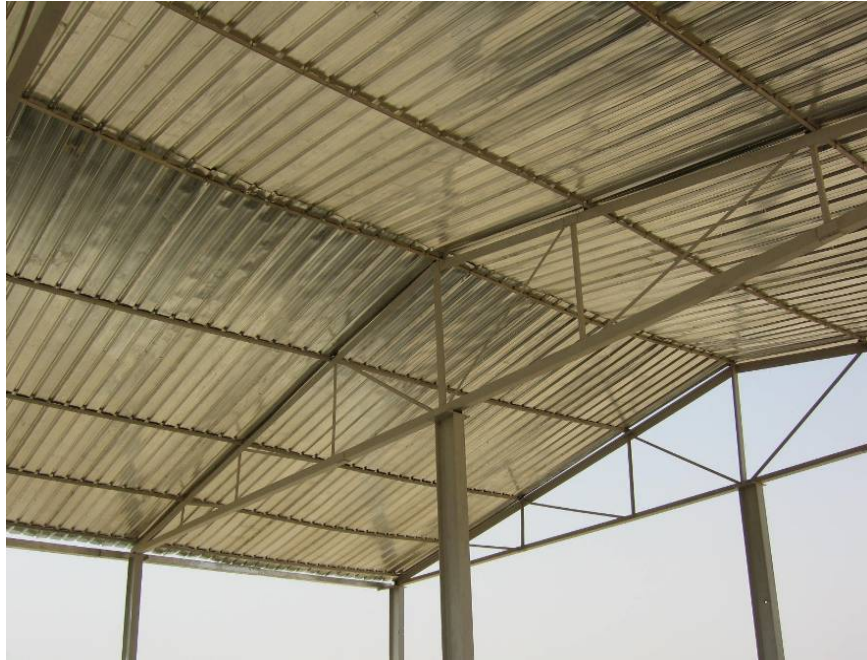
The motor pool's sheet metal roof was supported by four trusses consisting of steel angles. Each truss was supported by three H-columns, one at each end, and one at mid-span. Site Photo 23 shows two of the roof trusses.

**Site Photo 23. Roof truss system supporting the motor pool roof**

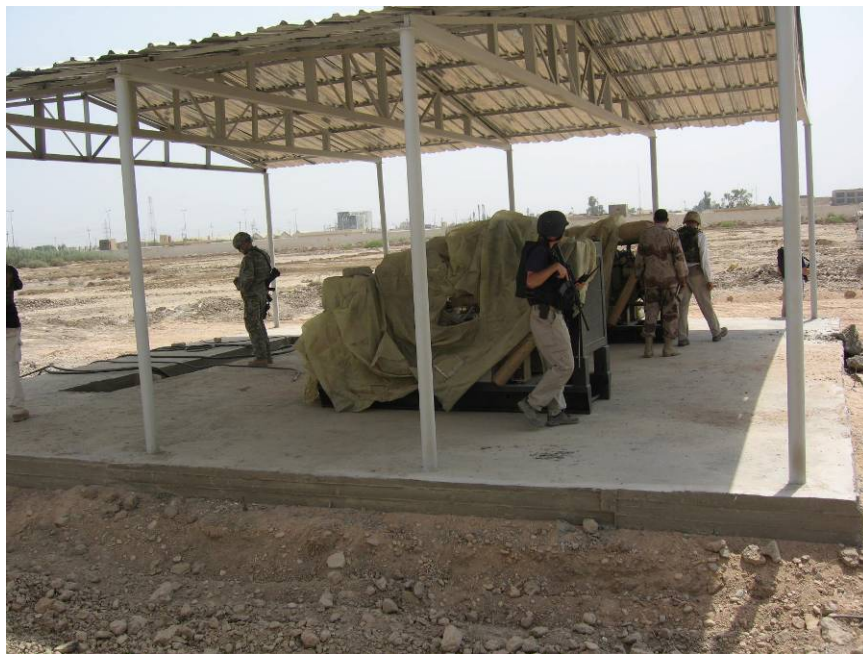
The SOW required the contractor to install two, 200 kilo-volt-amps (kVA) diesel generators in a new generator shed. The SOW also required a fuel tank for the generators (no size provided), manual change-over switch, synchronous panel for 2 generators, and 400 ampere switchgear. We found during our inspection the two new 200 kVA generators covered with tarps and resting on a concrete slab. The generator shed was also constructed, but the switchgear, electrical panel, and external fuel tank had not been installed. Site Photo 25 shows the generators in place under the metal shed.

Site Photo 25. Generator shed and two generators (covered with tarps)

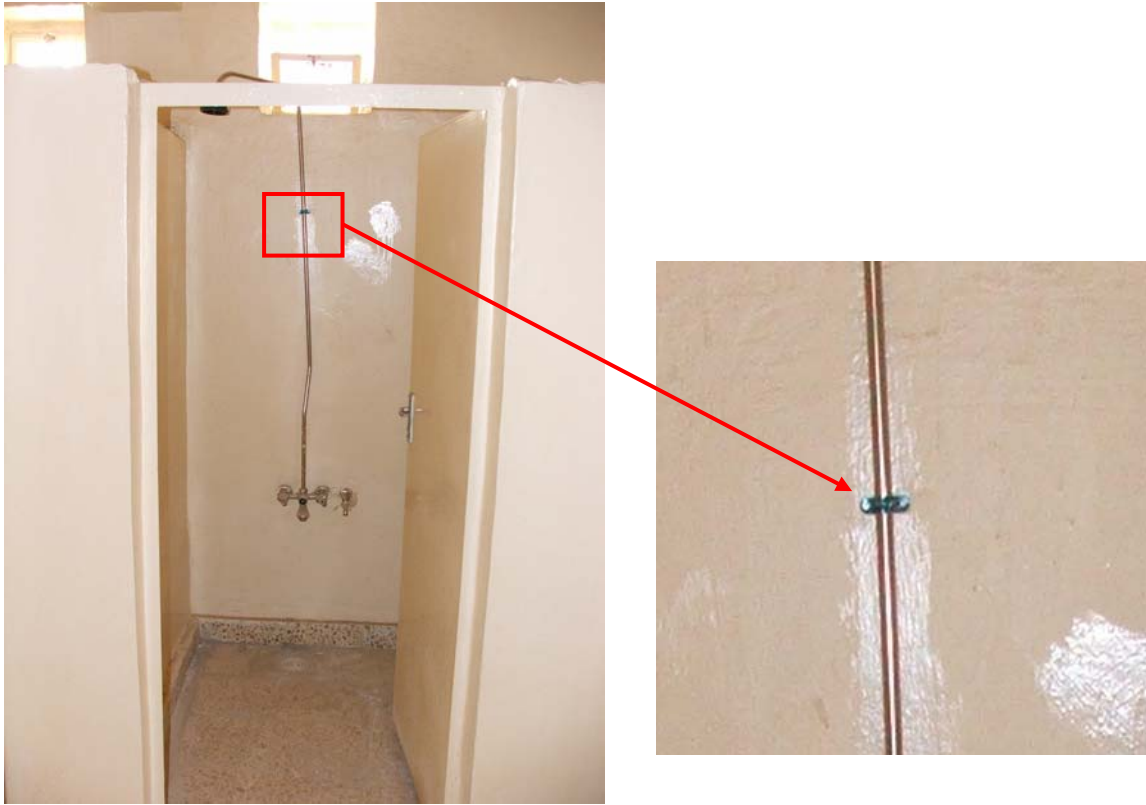
Earlier in this report, we identified potential sustainability issues with the low quality plumbing fixtures in the ablution buildings. For example, the plumbing materials used in the water closets were flexible water hoses, plastic supply tanks, and plastic tubing from the tank to the toilet; while in the showers, the water faucets are susceptible to breaking off and the thin metal water pipe to the shower head is connected to the wall with a one screw clamp (Site Photos 26 and 27). Over time, the clamp will dislodge from the wall and the shower water pipe will dangle. Considering the heavy usage the ablution buildings will receive, the low quality material will pose continual maintenance problems for the Iraqi Army.

**Site Photos 26 and 27. Single screw clamp holding the thin metal water pipe to the wall.**
