ELECTRICAL SUBSTATION  
SUSTAINMENT  
BASRAH, IRAQ

**SIGIR PA-06-082**  
**SIGIR PA-06-083**  
**SIGIR PA-06-084**  
**SIGIR PA-06-085**  
**SIGIR PA-06-086**  
**JANUARY 10, 2007**

SUBJECT: Report on Electrical Substation Sustainment, Basrah Iraq  
(Report Numbers SIGIR PA-06-082, 083, 084, 085, and 086)

## Electrical Substation Sustainment Basrah, Iraq

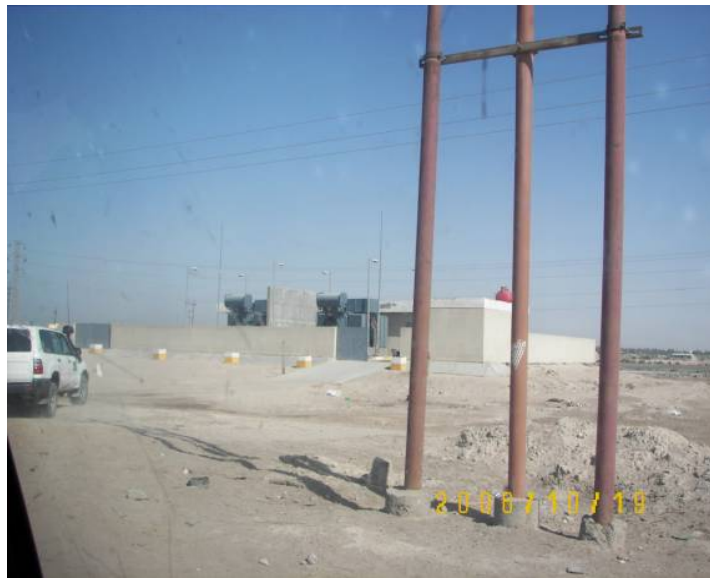
The current sustaining assessment of the Al Seraji and Al Hamdan substations showed that the substation buildings, guardhouses, and perimeter walls remained in good repair. Each substation was secured by security guards and two substation operators, who were present at the time of our visit. Site Photo 2 illustrates the condition of the exterior perimeter of the Al Hamdan substation at the time of our visit. Site Photo 3 illustrates the condition of the interior perimeter walls and transformers at the Al Seraji substation.

**Site Photo 2. Al Hamdan substation perimeter walls**

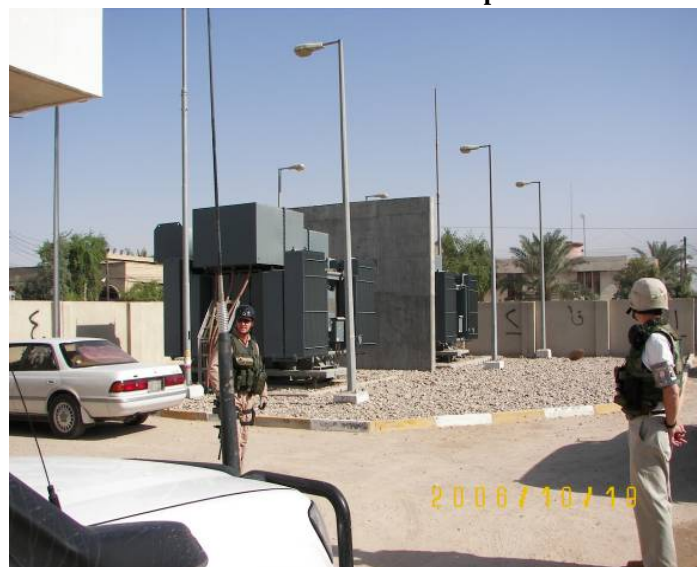
**Site Photo 3. Al Seraji substation view of internal walls**

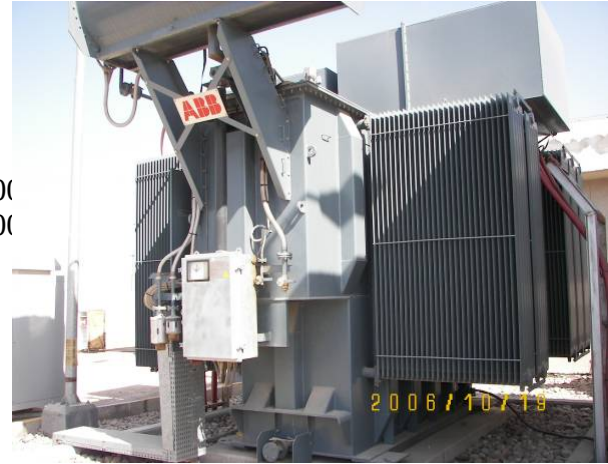
were installed on concrete pads with firewalls. The current assessment confirmed that the transformers remained in good repair and three of the four were operational. The fourth transformer, located at Al Hamdan was connected to the transmission feeder but was not operating because of maintenance being performed at the upstream transmission substation. Site Photos 8 through 11 shows no significant change in the transformers' condition between the first and second assessments.

**Site Photo 9. Al Hamdan 33/11kV transformer at the second assessment**

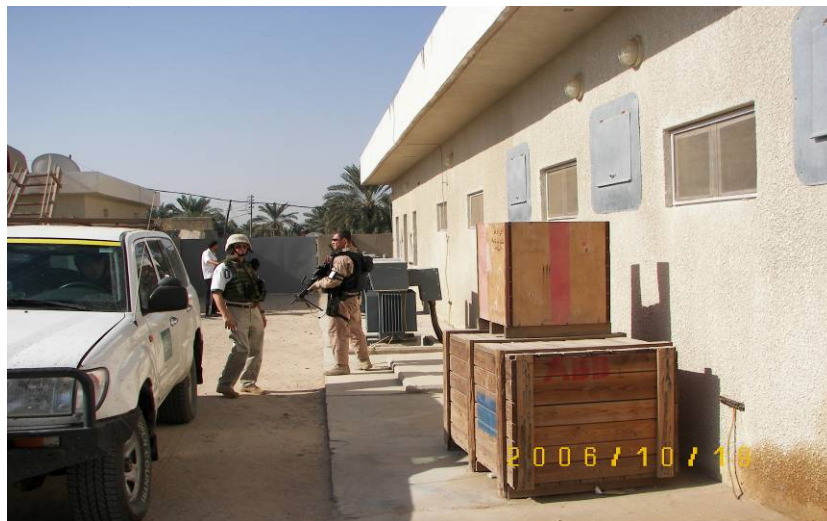
The contractor delivered manuals, drawings, and spare parts required by the contract to each substation. We observed two unopened wooden boxes on the sidewalk perimeter at the Al Seraji substation building during our site visit. During a follow-up discussion, we learned that these boxes probably contained the spare parts delivered by the contractor. The SDC officials responsible for operating the substation said the spare parts are not officially delivered until they are opened and the contents inventoried in the presence of a contractor or government representative. The GRS resident engineer was unaware that the boxes were not opened and agreed to work with the MOE to open them, observe the contents and secure them in the SDC warehouse. Site Photo 12 shows the boxes thought to contain the spare parts delivered to the Al Seraji substation.

**Site photo 12. Boxes thought to contain the spare parts delivered to the Al Seraji substation**

3. Spare parts, drawings, and operating manuals were provided as required by the contract. However, confusion over the official acceptance process appears to have caused spare parts to be left in unopened boxes next to at least one substation for over one year. Neither the contractor nor the GRS Resident Engineer was notified by SDC that the spare parts boxes had not been opened.
