QUICK REACTION REPORT ON THE  
BAGHDAD POLICE COLLEGE  
BAGHDAD, IRAQ

**SIGIR PA-06-078.1**

**SIGIR PA-06-079.1**

**SEPTEMBER 27, 2006**

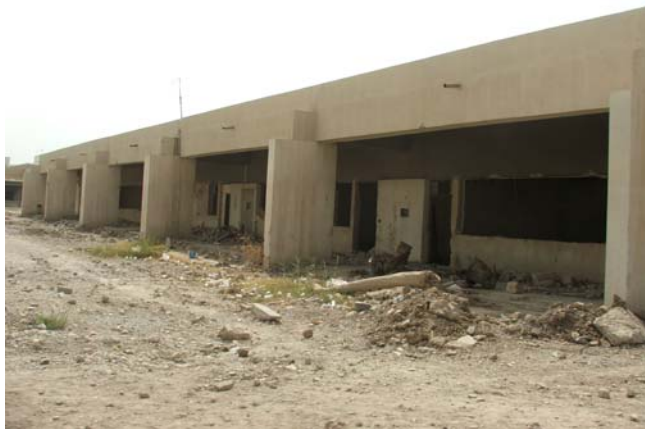
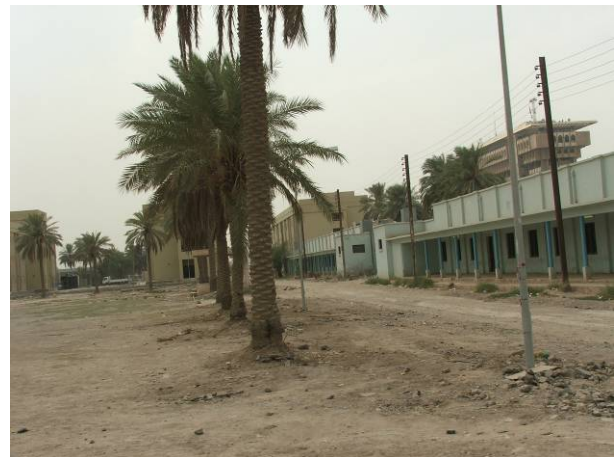
The description of the facility (pre-construction) was based on information obtained from the contract, the U.S. Army Corps of Engineers (USACE) project file, and Baghdad Police College personnel. The project site is located at the existing Baghdad Police College, in Baghdad, Iraq. The Baghdad Police College previously was a three year officer training facility. However, with an emphasis of providing a large number of cadets thorough Basic Police Training, this facility was determined to be insufficient. The existing facility consisted of a number of buildings, constructed approximately between 1935 to 1940. The existing buildings were in various stages of decay (Site Photos 1 and 2).

Site Photos 1 and 2. Existing buildings at the Baghdad Police College

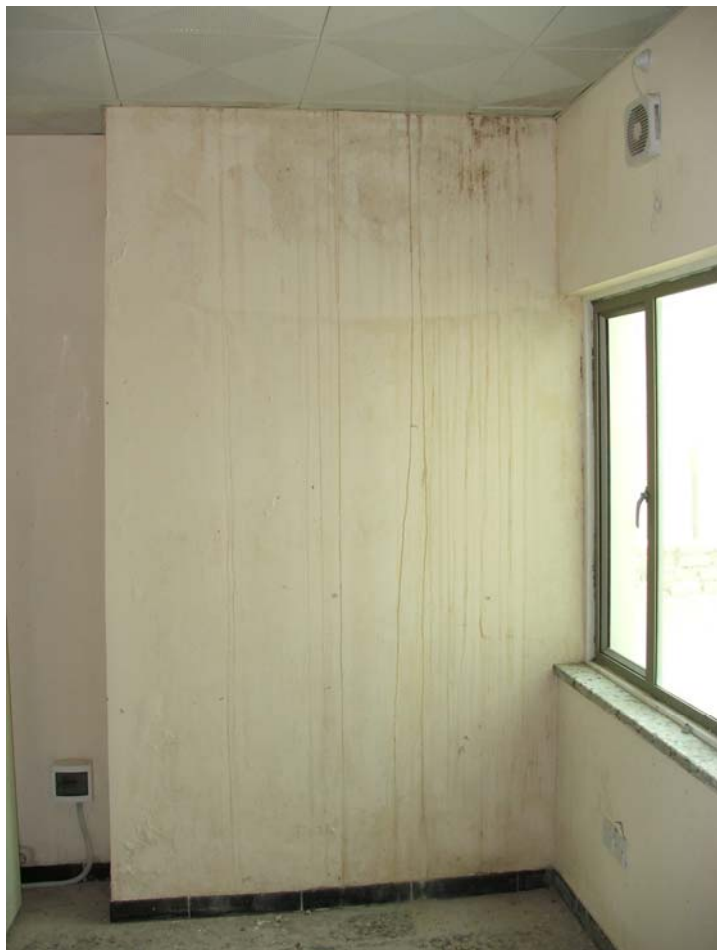
During our site visit, we immediately identified water damage and staining on the ceiling and walls of the ground floor (Site Photos 4 and 5). We toured the second floor bathroom and saw evidence of similar water damage and staining on the ceiling (Site Photo 6).

**Site Photo 4. Water damage to wall**

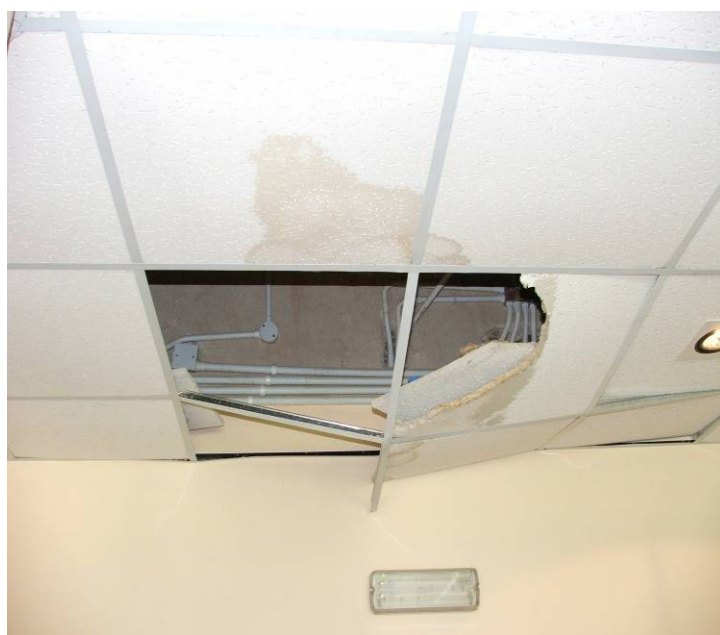
**Site Photo 5. Water damage to ceiling**

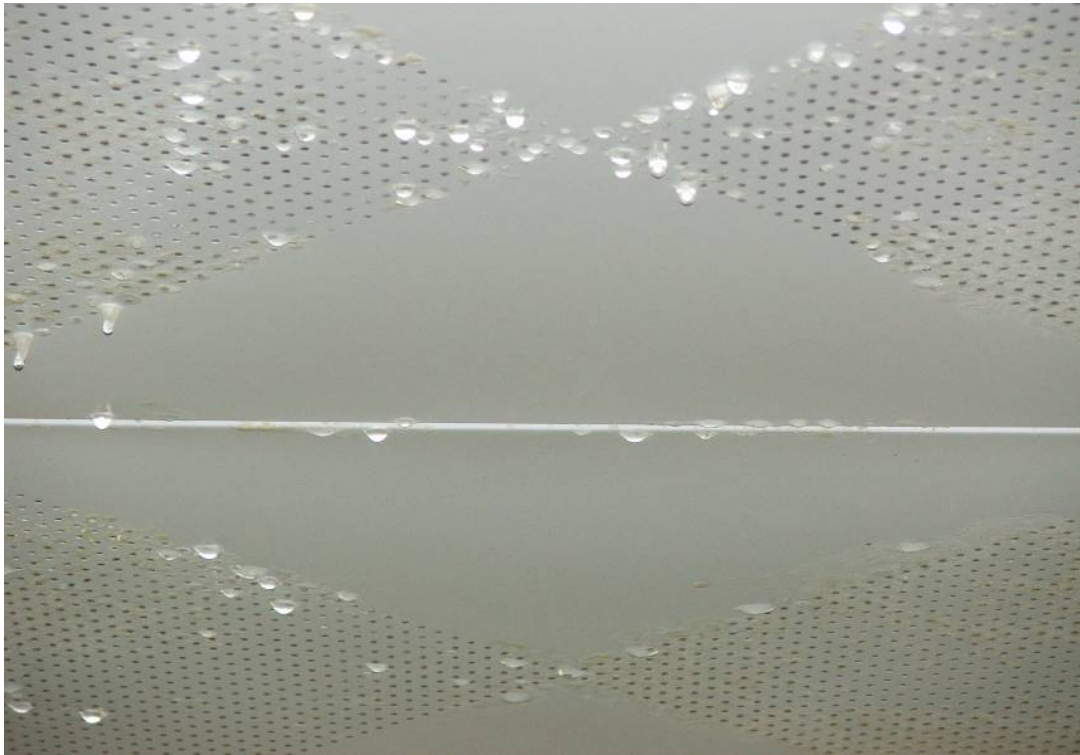
We visited another cadet building and, while on the ground floor, we witnessed firsthand the leaking of water and the residue of dissolved minerals and materials that had been transported by the water from the second floor (Site Photos 7-11). The water has been dripping at such a rapid rate that the Baghdad Police College Director refers to this room as the “Rain Forest.”

**Site Photo 9. Close-up view of leaking ceiling**

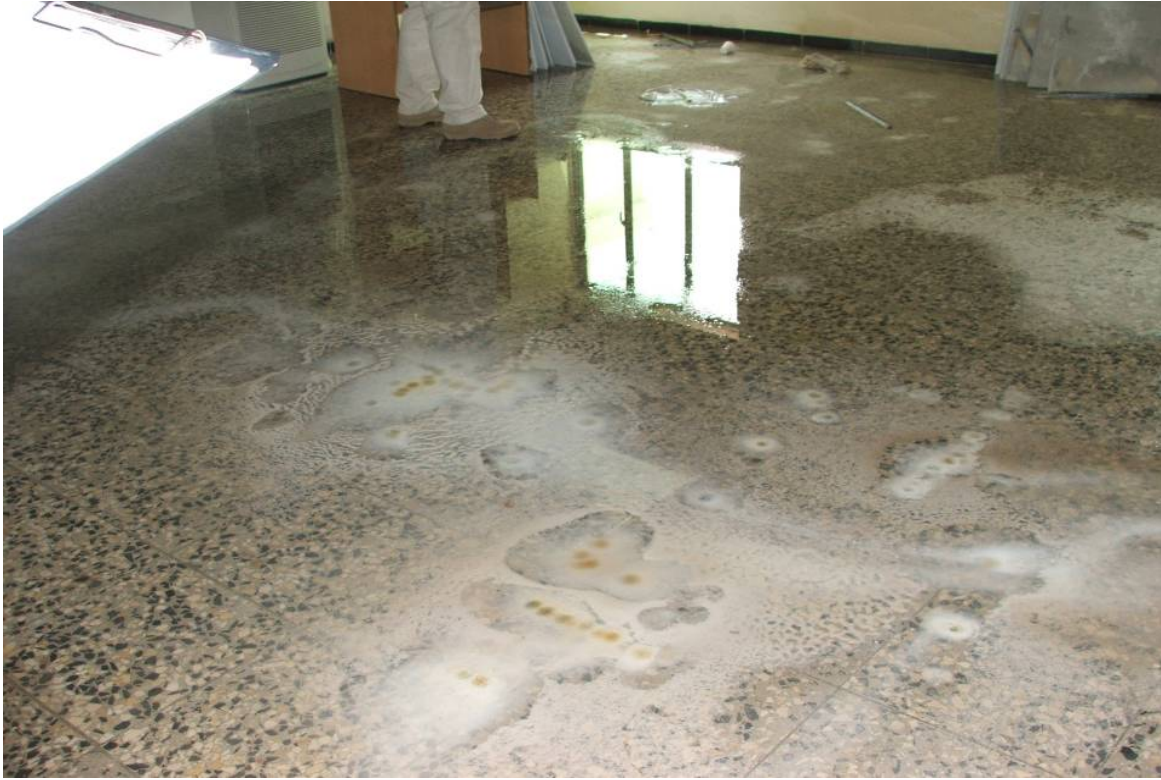
**Site Photo 11. Additional view of water damage and residue from dissolved minerals and materials in the water from leaking ceiling**

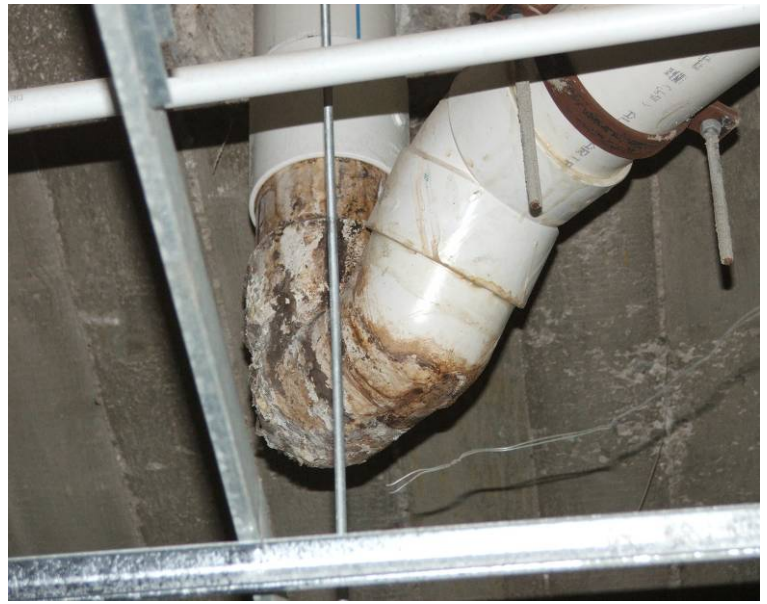
- Floor drains are not adequately sealed to the floor surface and/or properly affixed to adjacent fittings with the proper adhesive or sealant, which causes water to drain outside rather than inside the drain collectors (Site Photo 12 and 13)
- Drains were assembled without the specified molded plastic fittings, which resulted in water and waste materials flowing from the collection trees through the improperly fabricated joints directly into the concrete floors. The contractor used pipes with holes that were hand cut with secondary pipes inserted (Site Photo 14) rather than the appropriate type of pipe (Site Photo 15).

**Site Photo 13. View of another pipe leaking wastewater**

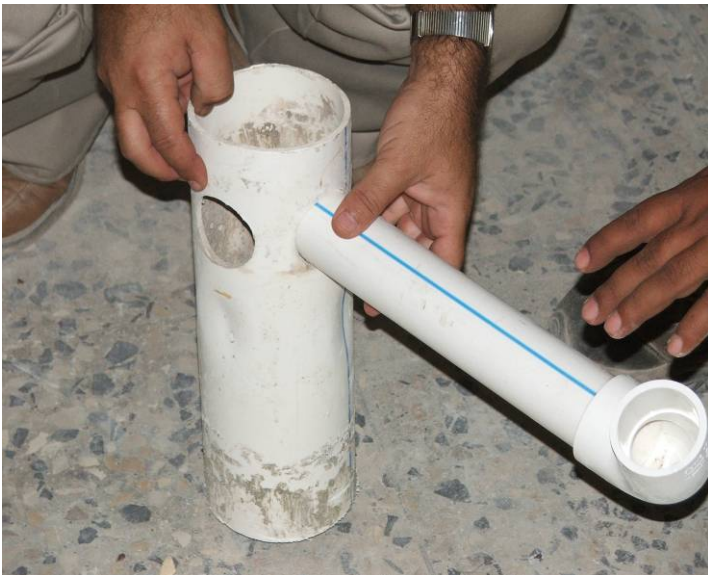
**Site Photo 14. Typical contractor built wastewater pipe connection method**

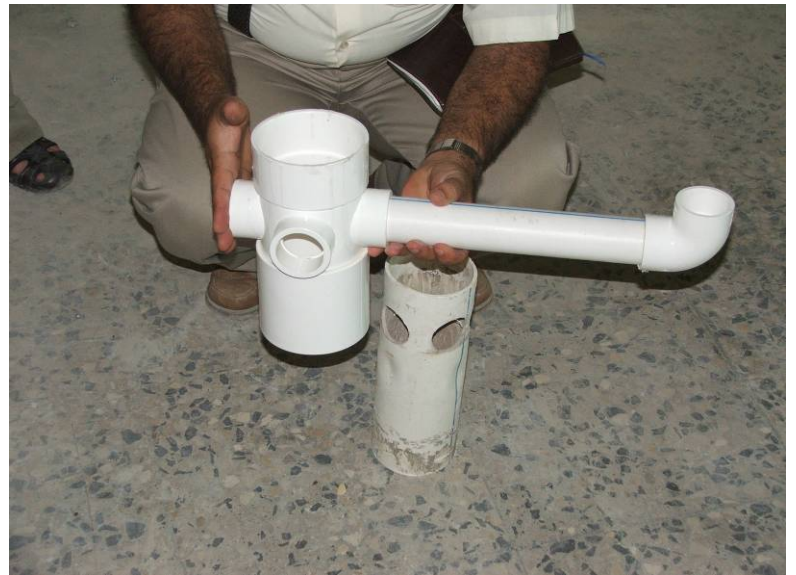
**Site Photo 15. Contract specified wastewater pipe connection method**

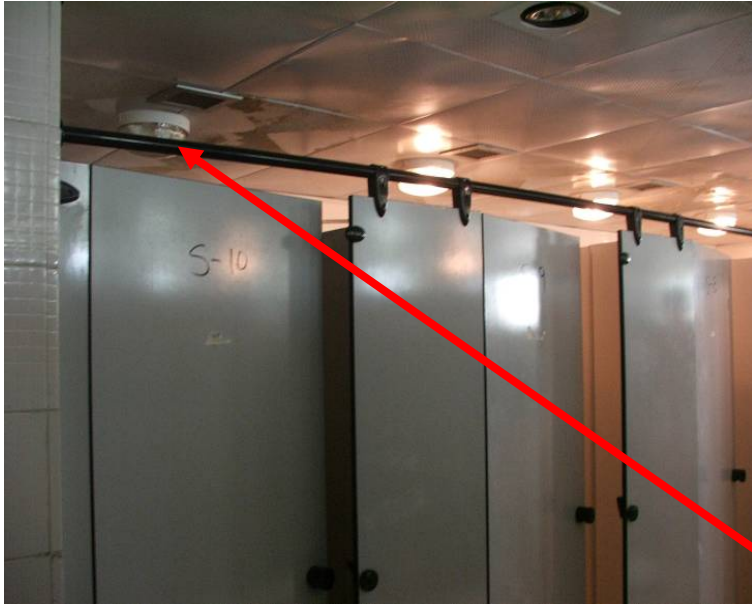
As a result of the inferior plumbing techniques, methods, and bonding materials used by the contractor to join the wastewater pipes, water and other waste materials from showers, wash basins, and toilets are continually draining through the reinforced concrete floors, from the top floor to the second floor to the ground floor, permeating and filling light fixtures, showers, and toilet areas, with liquids, including diluted urine and fecal matter. For example, we witnessed a light fixture so full of diluted urine and feces that it would not operate (Site Photos 16 and 17). As we continued

**Site Photo 16. Bathroom lights on second floor**

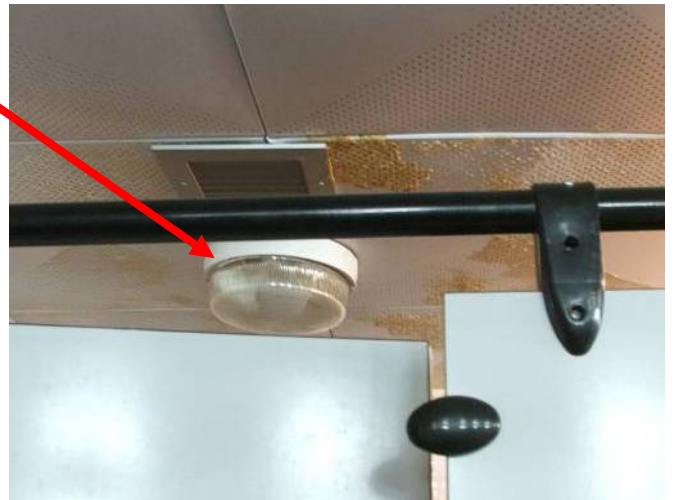
**Site Photo 17. Close-up view of far left bathroom light not operating because it is full of diluted urine and fecal matter**

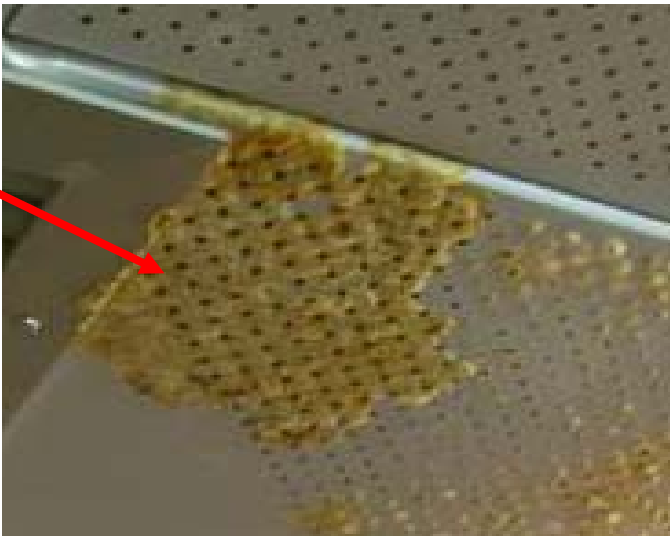
our assessment throughout the second floor bathroom, we identified evidence of large quantities of diluted urine dripping from the top floor down through the ceiling. The urine was so pervasive that it had permanently stained the ceiling tiles (Site Photos 18 and 19). During our visit, a substance dripped from the ceiling onto an assessment team member's shirt (see Site Photos 20 and 21).

Site Photo 19. Enlarged picture of urine stain

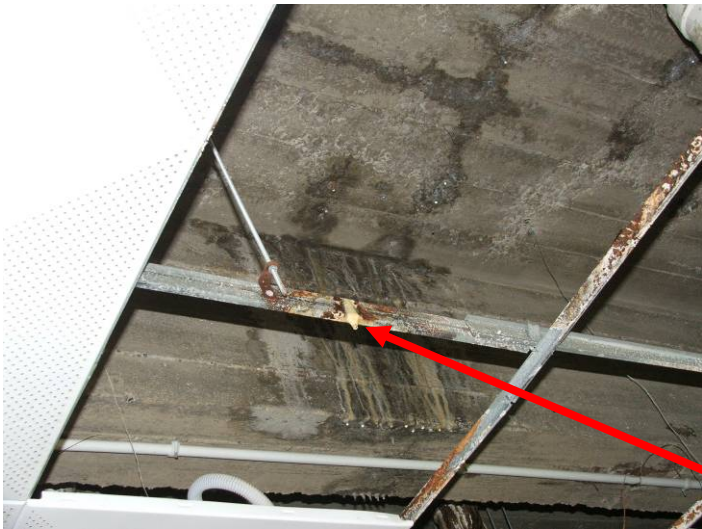
Site Photo 20. Ceiling Dripping

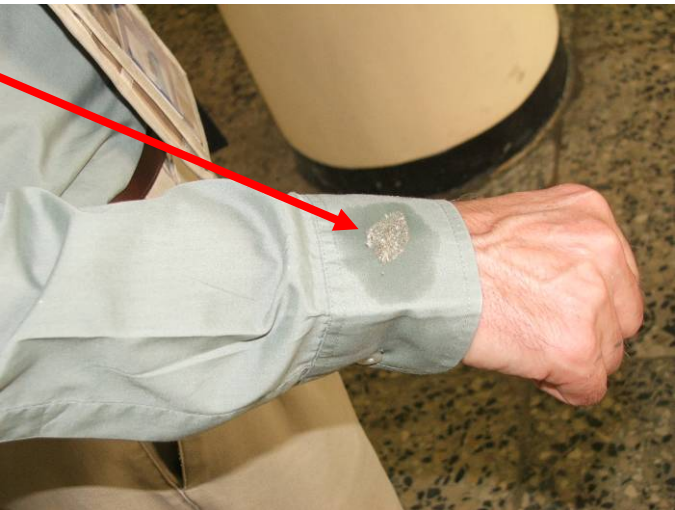
Site Photo 21. Substance on engineer's shirt

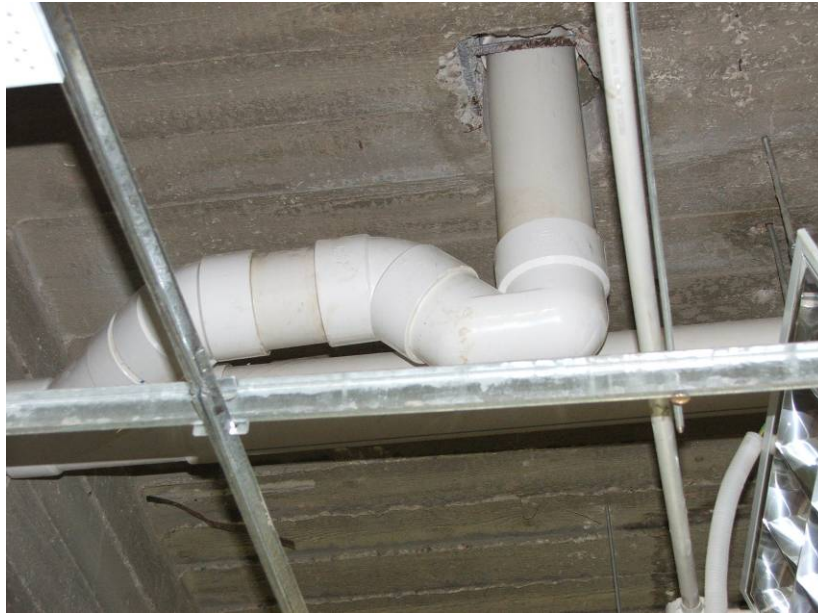
**Site Photo 22. New pipe installed to correct the leak**

As soon as the buildings started to leak from the top floor to the ground floor, the Director of the Baghdad Police College contacted the contractor. Parsons directed the subcontractor who performed the original work to correct the problem. The subcontractor is currently changing out the pipes that contributed to the leaks. For example, Site Photo 22 shows new pipe installed to correct the leakage problem identified in Site Photos 12 and 13, respectively. The subcontractor also plans to use the pipes with molded plastic fittings, such as the one identified in Site Photo 15, which should eliminate water and waste materials from flowing directly onto the concrete floors in the future.

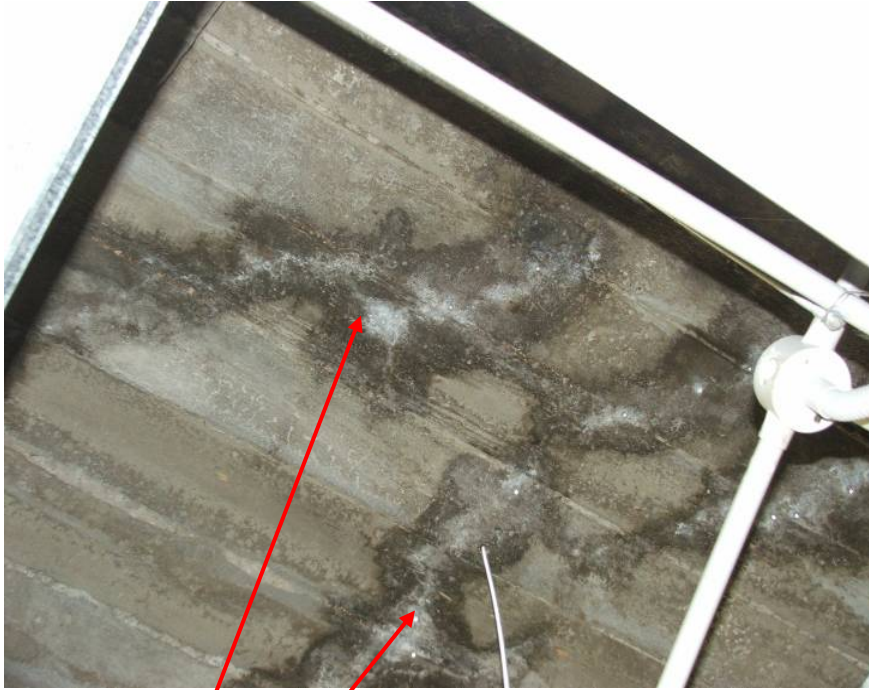
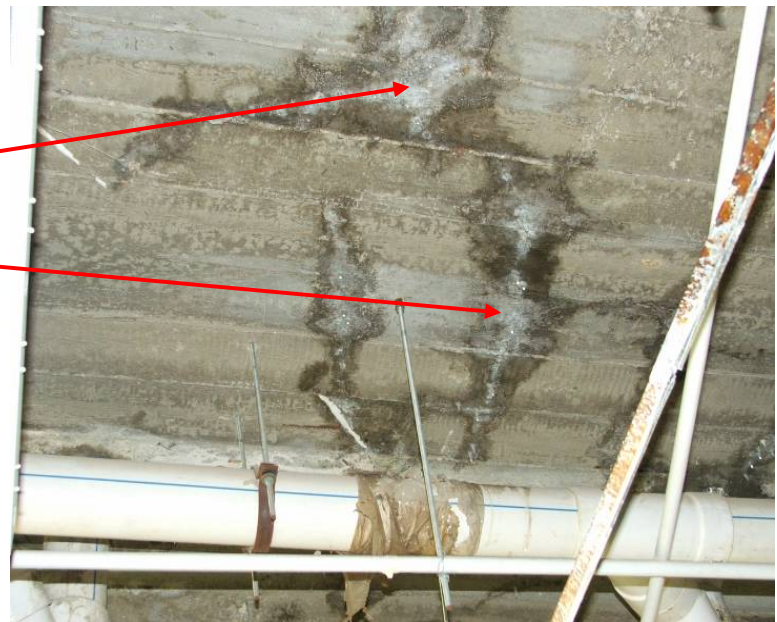
Even though the subcontractor is taking steps to correct the problem, the Baghdad Police College staff and students still have to deal with the damage caused by the poor subcontractor workmanship. In addition to water and waste materials soaking and filling light fixtures, showers, and toilets on the ground and second floors, the amount of material was so pervasive that it has soaked through the reinforced concrete floors causing deterioration of the reinforcing steel, and leaching of the chemical salts that are necessary for the proper strengthening of the concrete. The visible salt deposits, known as efflorescence, are readily apparent on the underside of the slabs (Site Photos 23-26). The subcontractor is making the corrections needed to fix the original problem; however, the subcontractor did not make any assessment of the damage already done including the structural integrity of the reinforced concrete slabs for each floor of the building. The Director of the Baghdad Police College is also concerned that the rust, mold, and presence of urine and fecal matter caught within the concrete floors presents a serious threat to the health of all Baghdad Police College students and staff. Further, if an environmental and/or health hazard is present at the Baghdad Police College, the number of basic recruits graduating through the facility will be impacted.

**Underside of 2<sup>nd</sup> floor  
Concrete slab cracks with  
soaked through with urine,  
fecal matter and efflorescence.**

1. Perform an assessment of all wastewater plumbing installations in all newly constructed buildings, both single and multiple storied, sponsored under this contract. This assessment will be to determine if similar methods of inadequate plumbing techniques were utilized in other project locations as were discovered in the cadet barracks buildings.
2. Perform a critical technical study of the structural integrity and load carrying capacity, as well as the potential environmental and health hazards posed by the rust, mold, and presence of urine and fecal matter within the concrete floor slabs of the cadet buildings to the Baghdad Police College students and staff.

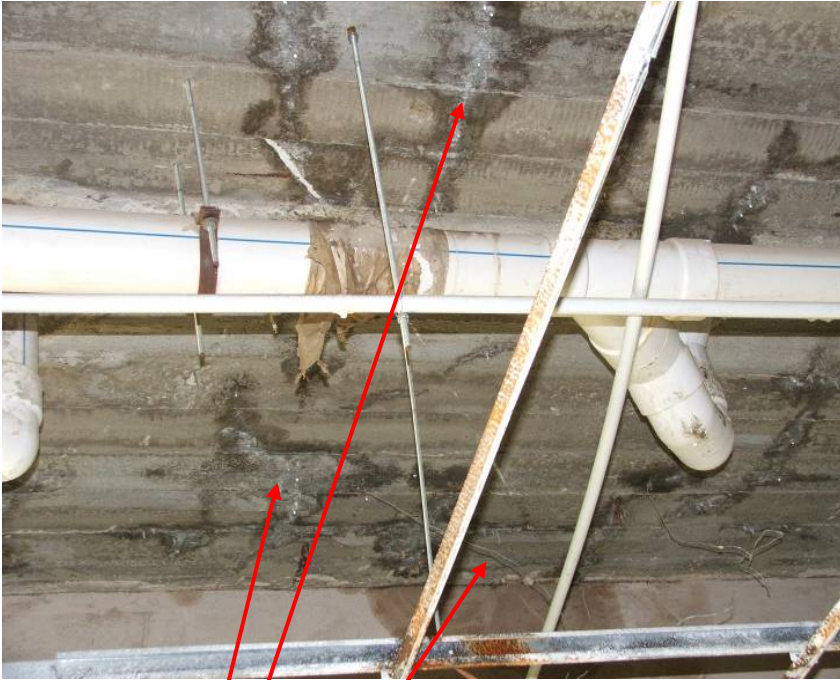
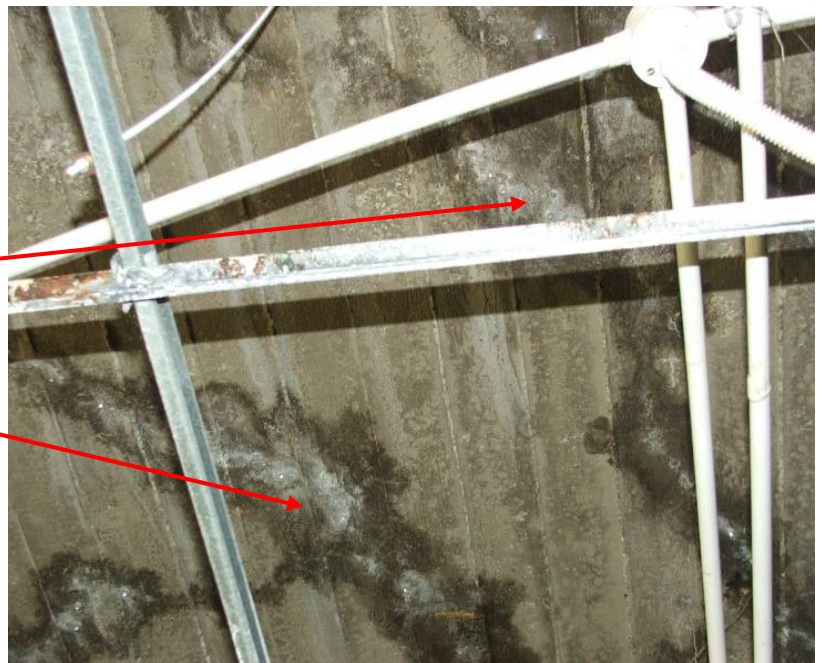
**Underside of 3<sup>rd</sup> story Concrete floor slab cracks soaked through with extensive urine, fecal matter and efflorescence.**
