**OFFICE OF THE SPECIAL INSPECTOR GENERAL  
FOR AFGHANISTAN RECONSTRUCTION**

**INSPECTION OF HABIB RAHMAN SECONDARY SCHOOL  
CONSTRUCTION PROJECT IN KAPISA PROVINCE:  
DESIGN AND SAFETY ISSUES REQUIRE ATTENTION**

**October 26, 2009**

SUBJECT: SIGAR Inspection Report 10-3: Inspection of Habib Rahman Secondary School  
Construction Project in Kapisa Province: Design and Safety Issues Require Attention

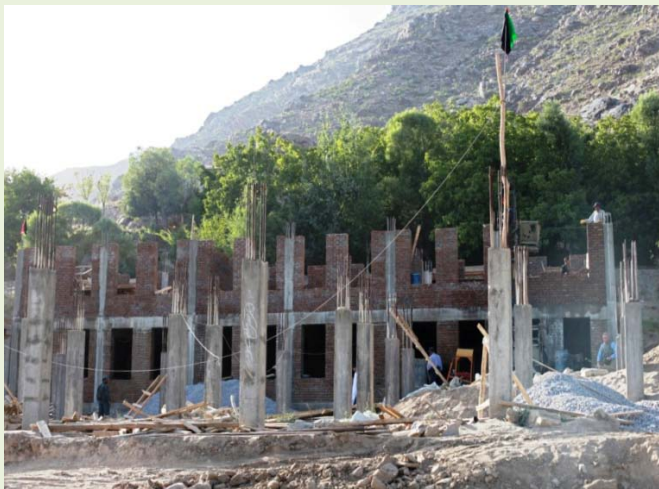
- Unfinished work left over from earlier construction at the site continues to cause major design and safety issues. The contract does not require the removal of this unfinished structure and currently there are no plans to have it demolished. SIGAR believes this abandoned construction site occupies valuable space which could be used for a number of other purposes. Additionally, it presents an unsafe environment for school children.

View of new school construction obscured by the unfinished and unusable structure of a previous construction project. (Photo provided by SIGAR)

That the Commander, U.S. Forces-Afghanistan and Commander, Kapisa PRT initiate a follow-on CERP project to correct the design and safety deficiencies noted in this report.

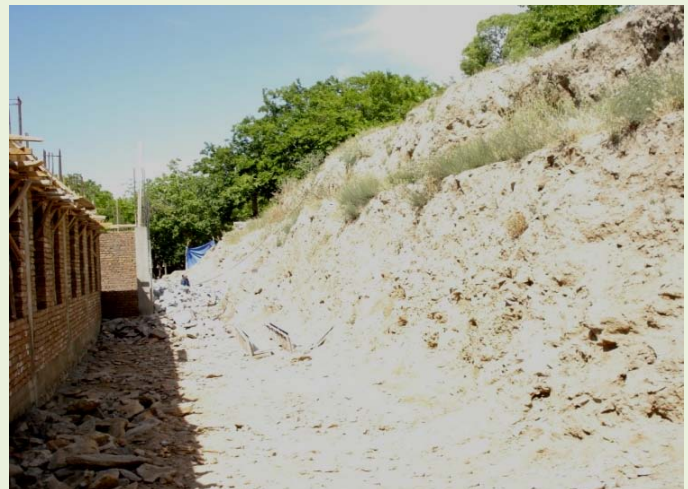
- The lack of a reinforced retaining wall and the associated earth removal work needed in the rear of the school which is adjacent to the base of a hill could pose a hazard to building occupants from potential rock and mud slides. This problem resulted from the decision to build the new school behind the unfinished work site which required the contractor to excavate a portion of the hill to make room for the new construction. The existing masonry security perimeter wall is insufficient to protect the school from debris falling from the hillside.

View of the limited offset distance from the base of a hill which could be subject to rock and mud slides. (Photo provided by SIGAR)

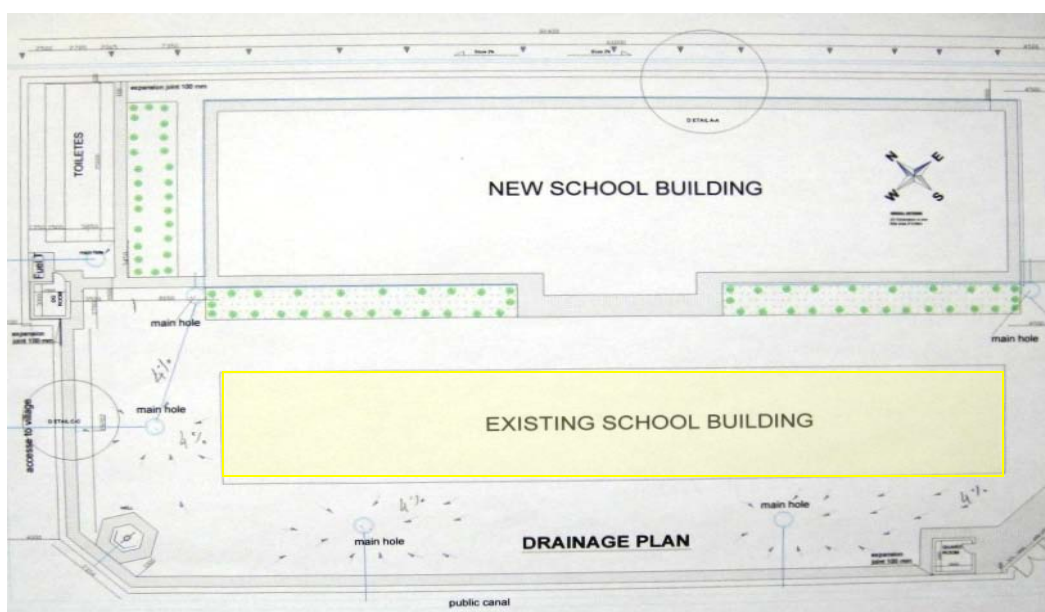
**Figure 2: Design Plan for the Habib Rahman Secondary School which builds around a previously built, unfinished structure (shaded in yellow) rather than demolishing it. (Illustration provided by Kapisa PRT)**
