**OFFICE OF THE SPECIAL INSPECTOR GENERAL
FOR AFGHANISTAN RECONSTRUCTION**

**INSPECTION OF FARUKH SHAH SCHOOL CONSTRUCTION
PROJECT IN KAPISA PROVINCE:
PROJECT COMPLETION APPROVED BEFORE ALL
CONTRACT REQUIREMENTS MET**

October 26, 2009

SUBJECT: SIGAR Inspection Report 10-1: Inspection of Farukh Shah School Construction Project, Kapisa Province: Project Completion Approved Before All Contract Requirements Met

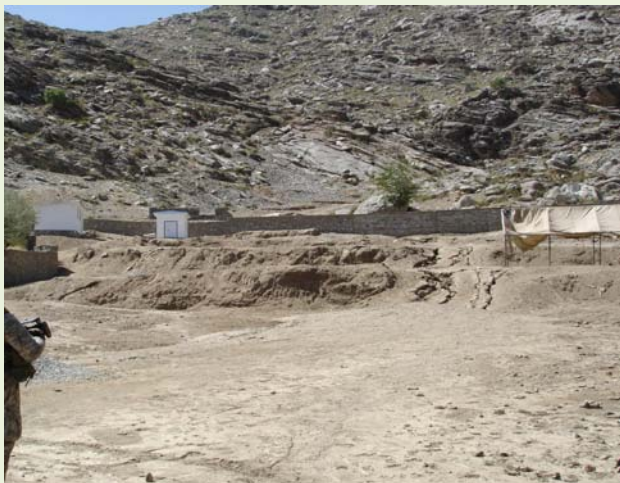
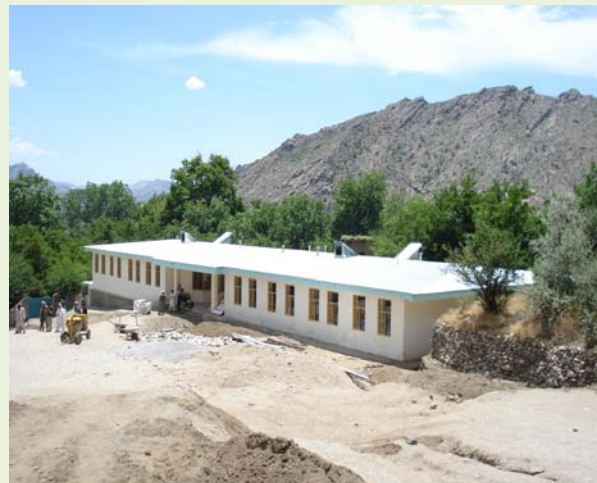
- *Design Deficiencies:* SIGAR also found two project flaws that could affect the long-term viability of the school infrastructure. Improper grading, including a lack of terracing to mitigate the effects of soil erosion, and the absence of a retaining wall increases the risk that landslides will eventually damage structures on the school compound. SIGAR believes both these items should have been anticipated and included in the project's scope of work.

Views of the rear portion of the perimeter wall which is inadequate to protect the Farukh Shah School compound from rock slides on left, and improper grading on right that places the school compound at risk. (Photos provided by SIGAR).

- Issue a follow-up contract to address the construction deficiencies noted in this report.
- Place greater emphasis on developing detailed scopes of work which anticipate and address critical design issues that are particular to each construction project rather than relying solely on standard design plans.

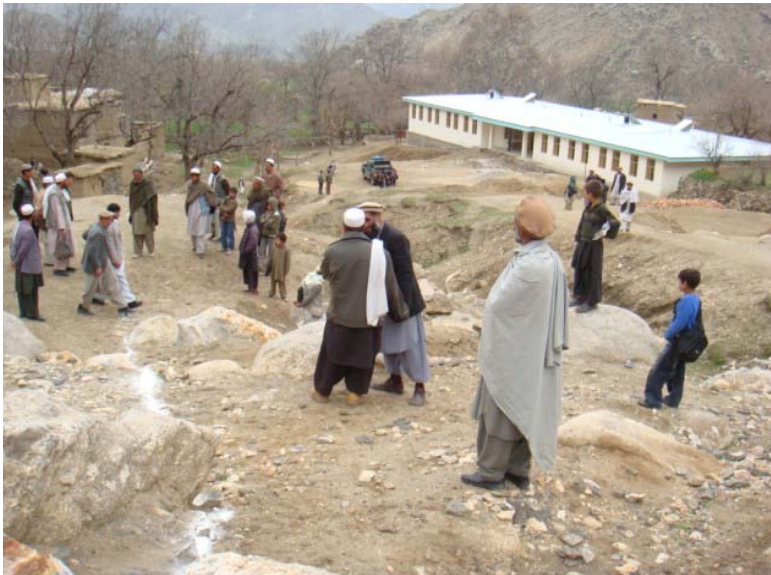
Site Photo 1: View of school house taken in April 2009. (Photo provided by Kapisa PRT)

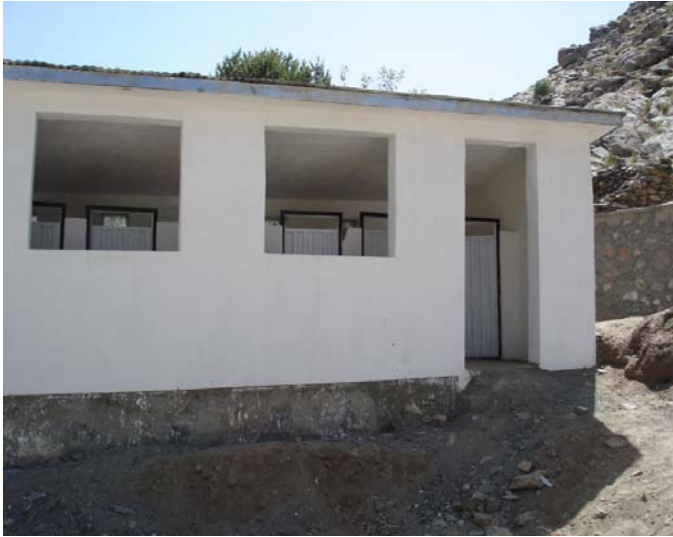
During our June inspection visit, SIGAR observed portions of the latrine concrete walls that were severely cracked and a defective roof that allowed wind and moisture to enter the structure that had to be removed. SIGAR also observed refuse removal openings in the rear base of the latrine structure that

were too small to adequately remove the human waste that will accumulate in these locations. During SIGAR's follow-up site visit in August, we found that although some improvements were made to the latrine building, including the installation of the new roof, other deficiencies, such as the inadequately sized openings for refuse removal, remained.

Site photo 2: View of the latrine containing inadequate opening sizes for refuse removal. (Photo provided by SIGAR)

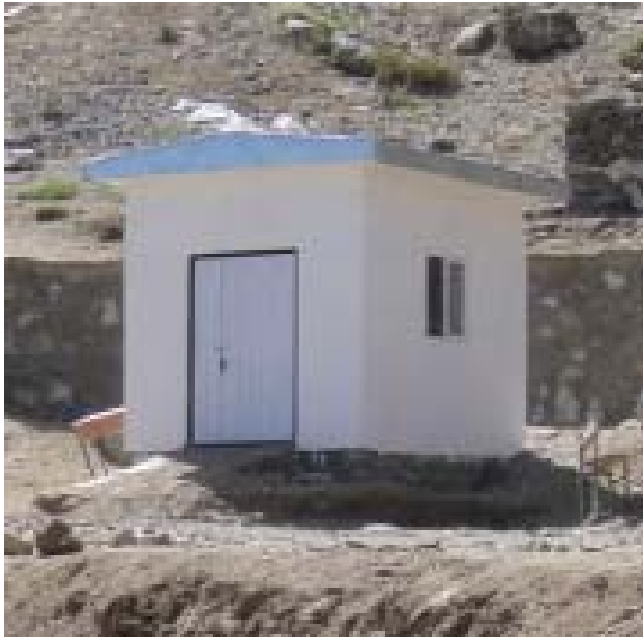
SIGAR found that the power plant building was adequately built following the replacement of the original roof that had to be removed due to defective construction methods we identified in June 2009. Additionally, during the August onsite visit the SIGAR inspection team had the opportunity to examine the 10 kilowatt generator. SIGAR found that the generator had not been permanently installed. No venting pipes or vent openings were installed, as required by the statement of work, to properly allow vent fumes produced during generator operations to escape the building. Additionally, the building lacked a concrete walkway and no fuel tank was installed at the time of SIGAR's June inspection. During the August onsite visit SIGAR noted that although some improvements were made, such as a newly installed roof, several items required by the statement of work had yet to be accomplished. These items include venting pipes for generator exhaust and concrete walkways leading to the school. During

SIGAR's second site visit, we also learned that no individual had been designated or trained to serve as the generator operator and electrician to handle power issues for the school.

Site Photo 3: View of generator house which lacks proper exhaust venting as required in the statement of work. (Photo provided by SIGAR)

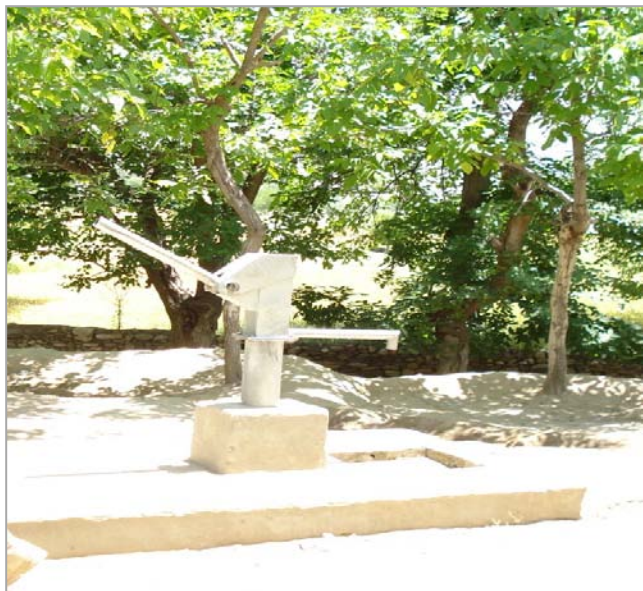
During both the June and August onsite visits, SIGAR inspectors found the hand operated water pump to be inoperable. SIGAR could not determine whether the well was placed in a location that no longer had the capacity to bring water to the surface, or whether the internal mechanisms of the pump were at fault.

Site Photo 4: During the onsite visit to the school, SIGAR inspectors found that the water pump installed 3 months earlier was not operable. (Photo provided by SIGAR)

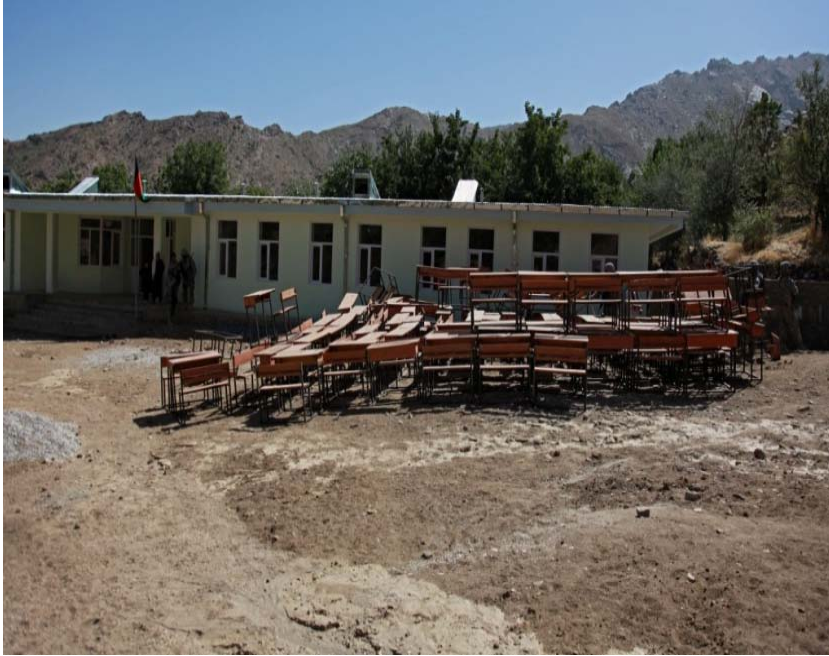
SIGAR noted that the school compound had not been adequately cleared of debris and rubbish left over from construction activities. Additionally, old student desks that were apparently not needed by the school administration were placed in two large piles on either end of the school. It is unclear when or if these materials will be removed.

Site photo 5: View of discarded old school desks outside of the main school building. (Photo provided by SIGAR).

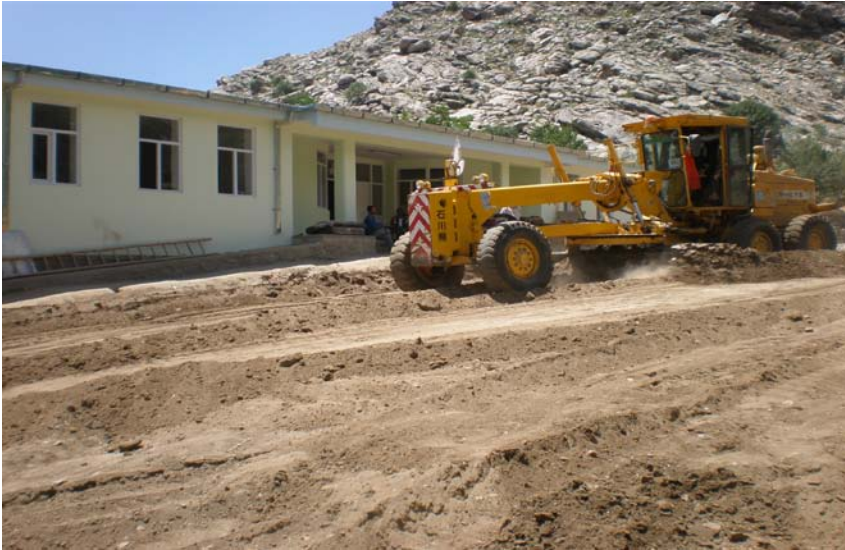
SIGAR found two serious project design flaws. First, instead of properly grading the site and compacting the construction site's soil, the excavated material was placed in the lower portion of the school grounds. This area is subject to severe erosion which creates a potential threat to the integrity of the various buildings on the school grounds (see Site Photos 6 and 7).² SIGAR believes that the absence of adequate earthwork provisions in the contract's scope of work led to this condition. The only practical solution to this serious design problem is to conduct another topographic survey and develop an effective grading plan that will prevent erosion from undermining the foundations of the various structures on the site. SIGAR noted in discussions with PRT and school officials that there is interest in developing a plan that can best utilize the newly leveled land for other purposes such as a soccer pitch and play ground.

Site Photo 6: View of grader attempting to level the ground in front of the school house in mid- July. This grading improved, but did not solve, the ground erosion problem because there was no follow-up compaction of the soil. (Photo provided by Kapisa PRT)

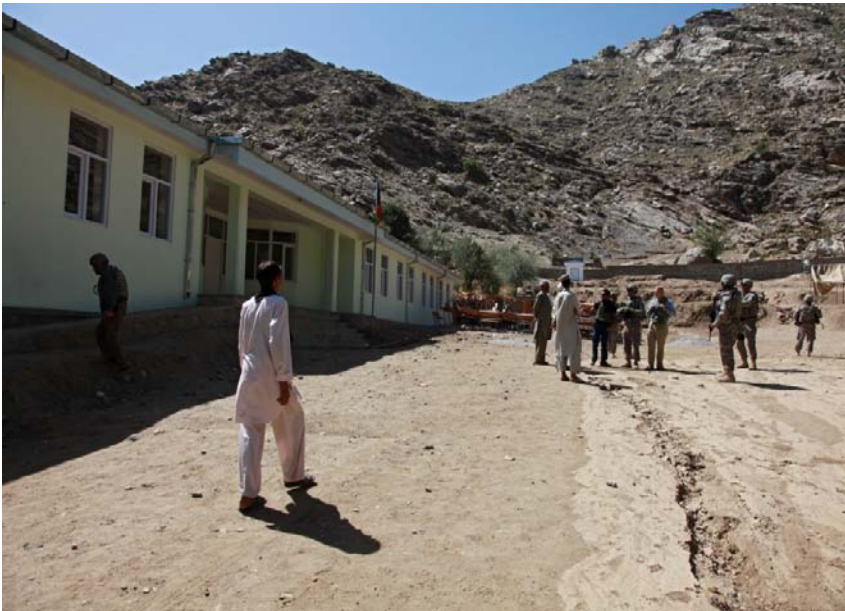
Site Photo 7: View of school grounds less than one month after grading work was completed showing signs of site erosion. (Photo provided by Kapisa PRT)

Second, SIGAR also found that although the perimeter wall appeared to be solidly built and in accordance with the statement of work, it mostly serves as a retaining wall due to the nature of the school grounds topography. SIGAR notes this is potentially dangerous since the perimeter wall was not built to retaining wall standards which require a much larger and stronger foundation base. Given the nature of the area's topography with evidence of recent rockslides and erosion, the possibility exists that areas of the perimeter wall may suffer washout and collapse unless it is further reinforced. (See Site Photos 7 and 8).

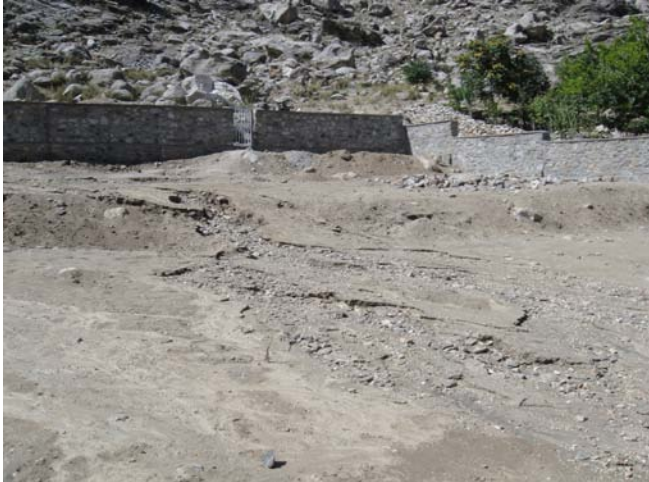
Site Photo 8: View of 2 meter high stone masonry perimeter wall at the rear of the school compound. The significant level of erosion can be seen. The perimeter wall parallel to the slope can be seen on the right. (Photo provided by SIGAR)

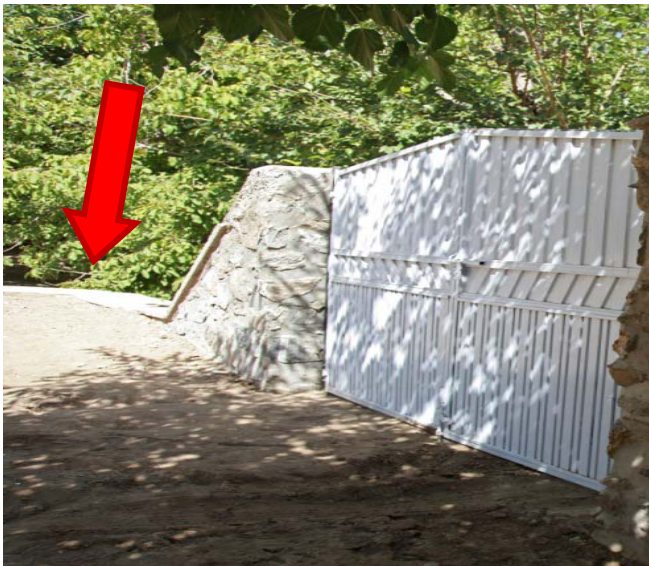
Site Photo 9: The top of the 2 meter perimeter wall can be seen (indicated by red arrow). During the site grading, soil was placed against the perimeter wall, bringing the grade elevation up to the top of the wall in some areas. (Photo provided by SIGAR)
