## Aging Weapons Systems Repair using Friction Stir Welding

Bryan M. Tweedy<sup>1</sup>, William A. Arbegast<sup>2</sup>, Robert H. Hrabec<sup>1</sup> and James M. Hutto<sup>1</sup>

Keywords: Friction stir, repair, aging aircraft, FSW

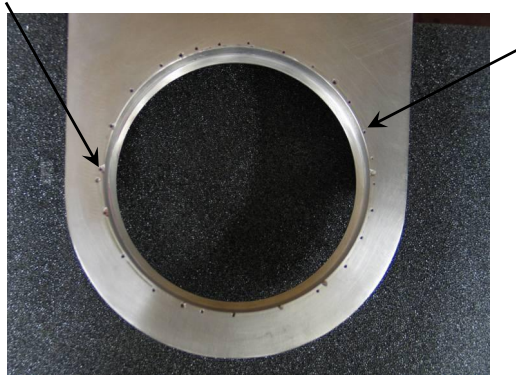
The purpose of this FY07 Aging Aircraft Study [1] was to investigate the use of advanced processing technologies such as friction stir welding and processing, laser deposition and cold spray in repair/remanufacturing applications of aging weapons systems. In particular, friction stir welding and processing presented some unique opportunities to repair worn or cracked components. One of the chosen parts for this remanufacturing study is the ruddervator fitting for the KC-135 re-fueling boom (Figure 1). This structural component is responsible for connecting the re-fueling boom to the rudder shaft. The component has two ears, each with a bearing race. When the bearings are installed, it is common to use a punch and hammer to deform the part and stake the bearing in place. Unfortunately, these stake marks are stress concentration points and form fatigue cracking when placed into service. A picture of the typical stake marks in the ruddervator fitting is shown in Figure 2.

Figure 2: Typical Stake Damage to a Ruddervator Ear

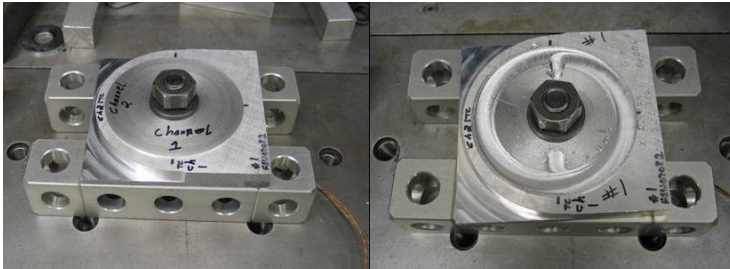
Parts were fixtured on the FSW table and were elevated on 1.5" tubing from a tooling system from Marino Gauge. The only clamping holding the parts in position was a single 5/8" bolt through the center of the plug (Figure 7). To test the weld program, a 4-pass test-weld was made on a piece of 0.25", 6061-T6 aluminum fixtured in a similar manner to the surrogate parts. A two-pass weld (Figure 8) was completed on the first surrogate part with success. On the exit radius however, a lack of consolidation (LOC) defect formed through the radius (Figure 9). A four-pass weld (Figure 10) was completed on the second surrogate part with success. The travel speed was reduced through the exit radius, which reduced the LOC defect, but did not totally eliminate it.

Figure 8: Surrogate 1 (2-Pass Weld)

this indication was not present. The exit radius LOC seen in the first surrogate part was lessened in the second article by utilizing a reduction in the programmed travel speed in the transition zone to the termination of the weld. The article with four passes was only slightly hotter than the article with two passes. It is possible that steady state temperature was reached and that peak temperatures will not exceed 600°F with more than four passes.

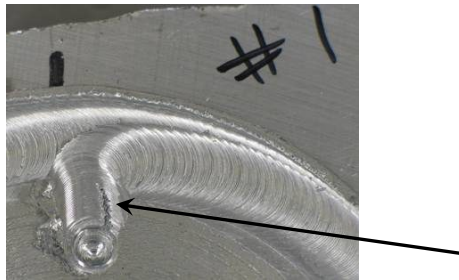
Figure 9: Lack of Fill on Exit Radius

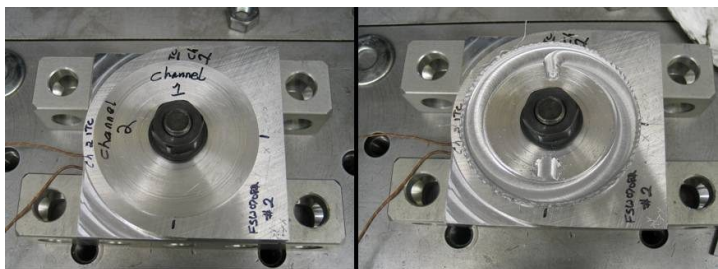
Figure 10: Surrogate 2 (4-Pass Weld)

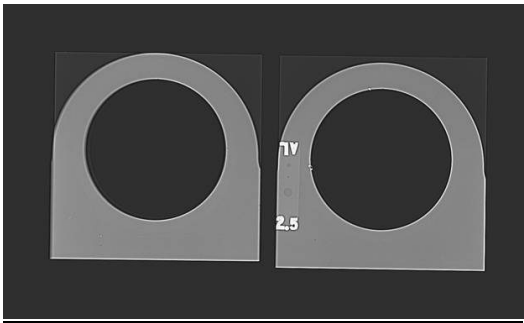
Parts were re-machined to remove the plugs from the bearing bores and radiographically inspected at Ellsworth AFB, Rapid City, SD (Figures 11-12).

Figure 12: X-ray Inspection of Surrogate Parts

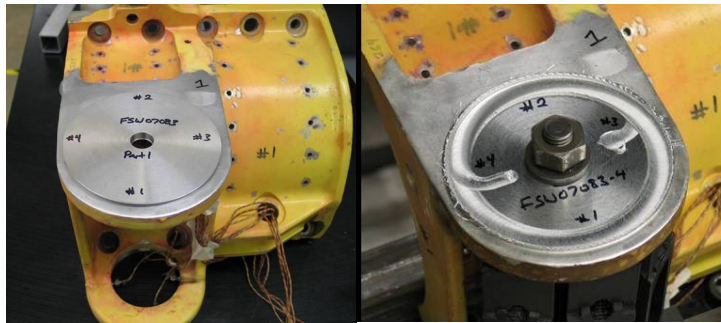
The prototype ruddervator fitting was cleaned with a solvent wipe and the machined plugs were pressed into place (Figure 14). Standard tooling was used and was similar to the setup used in welding the surrogate parts in the previous section. This was important to avoid differences in the thermal and mechanical conditions used in the development of the repair process to aide portability between surrogate and prototype production. Welds were made using the parameters developed in the previous section (800 rpm, 8 ipm) while thermal data was being collected via a data acquisition system. Welds were made counter-clockwise about the center of the plug, with two inner passes followed by two outer passes. Following welding, the resultant plugs were machined from the ruddervator fittings and the repaired part was radiographically inspected which revealed that no volumetric defects remained in the part.

Figure 14: Dry-fit of Repair Plug (left) and Post Weld Repair (right)

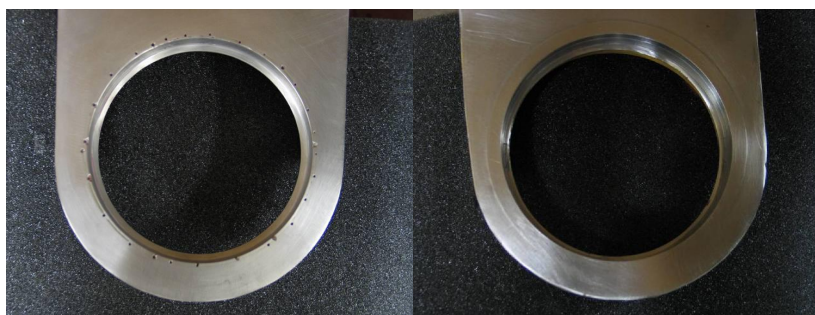
Utilizing the information and procedures developed in the defect processing study and the surrogate parts welding, the prototype production parts were processed with some confidence in the quality of the repair. A LOC indication was still present even with the increased radii employed for the exit procedure. The stake defects were observed to be successfully processed from the part once the plug was machined from the bore (Figure 15). The plug machined out of the ruddervator part, however, slight concentricity issues exist between the re-machined bore and the pre-welded bore. The radiographic inspection of the part showed no remaining volumetric defects. The maximum temperature for both the surrogate and prototype part as measured by the thermocouples was approximately 550°F.

Figure 15: Pre and Post Repair of Ruddervator staking damage
