BAGHDAD AL KARKH
COURTHOUSE
BAGHDAD, IRAQ

SIGIR-PA-06-058
OCTOBER 10, 2006

SUBJECT: Report on Project Assessment of the New Al Karkh Courthouse,
Baghdad, Iraq (Report Number SIGIR-PA-06-058)

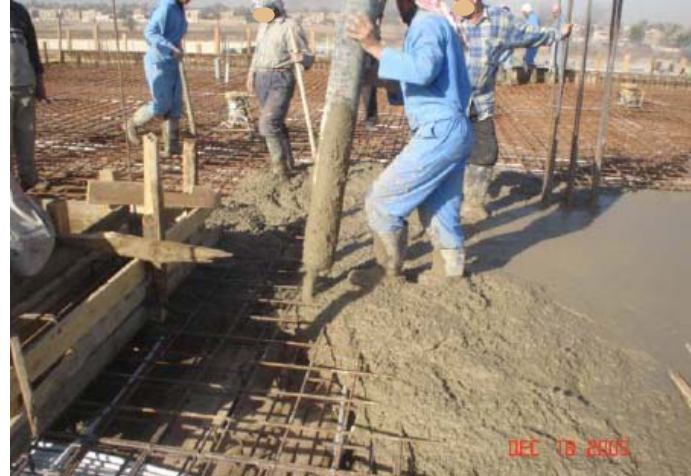
Site Photo 3. Concrete placement for roof slab pour (Photo provided by USACE)

In our review of the progress photos and QA reports we did not find any evidence of problems with the quality of the concrete, such as honeycombing, segregation, or exposed reinforcing steel. Additionally, our review of the QAR reports did not indicate any problems with the concrete achieving required compressive strengths.

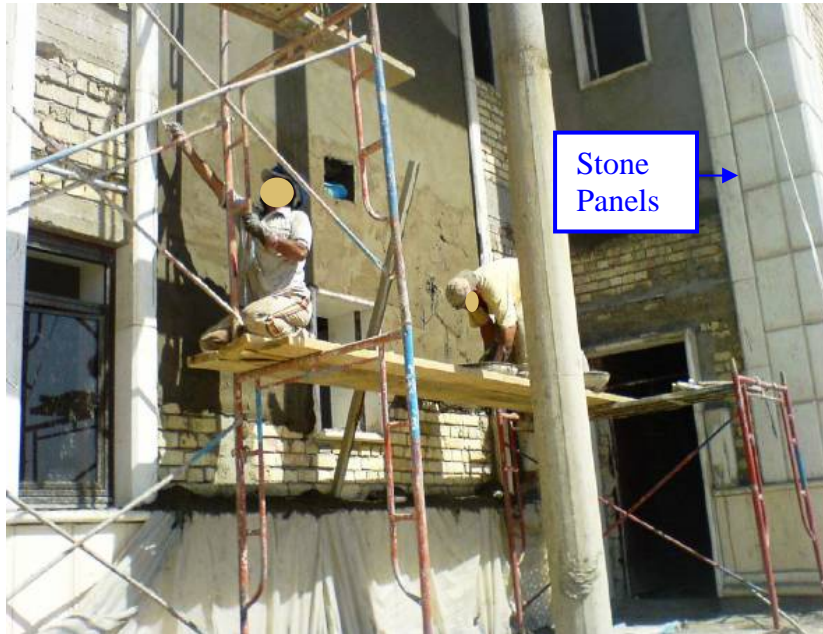
Site Photo 4. Plastering exterior wall between windows (Photo provided by USACE)

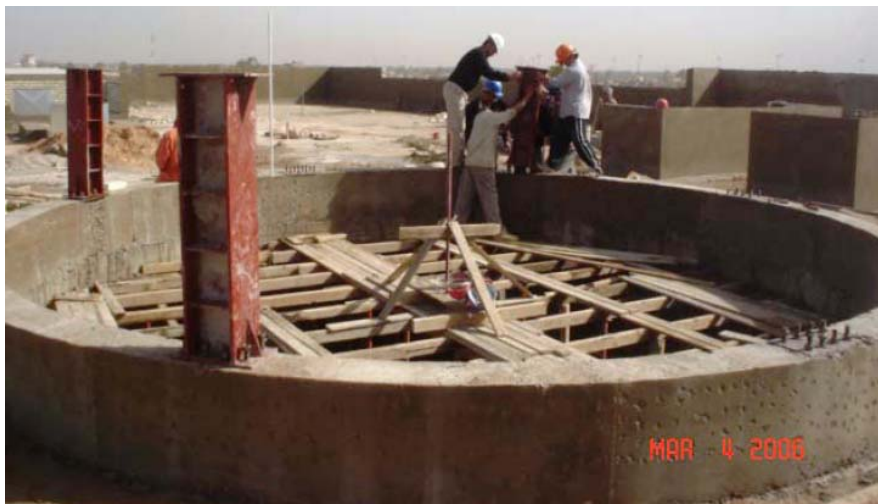
Site Photo 9. H-Columns anchored to dome concrete base (Photo provided by USACE)

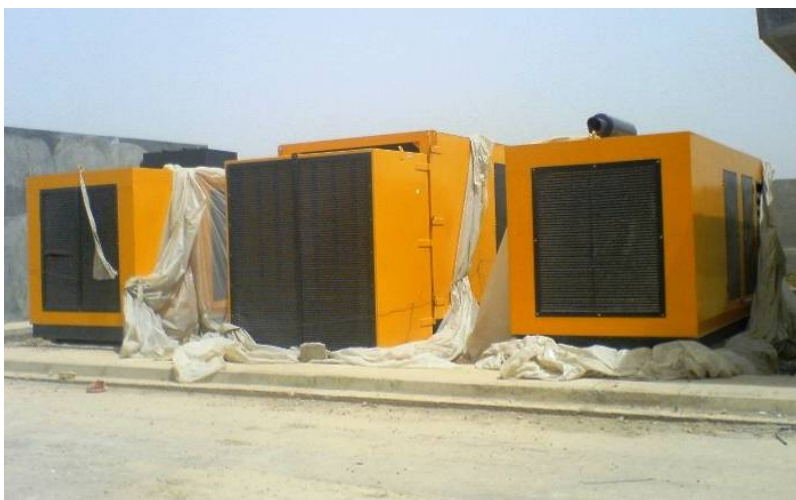
**Site Photo 13. Generators for the courthouse (2) and the annex (1)
(Photo provided by USACE)**

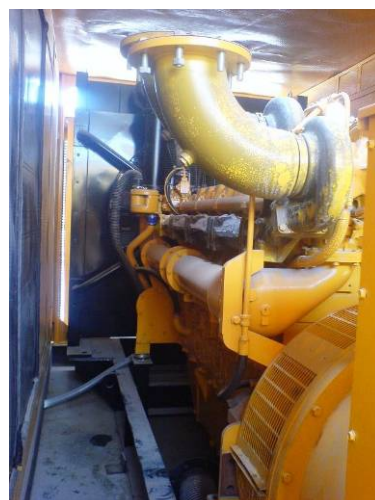
**Site Photo 14. Interior of the generator enclosure
(Photo provided by USACE)**

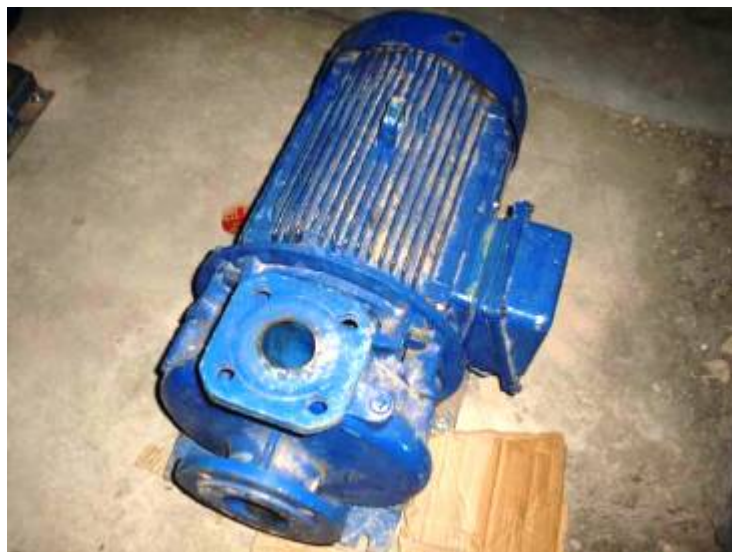
Site Photo 15. Domestic water circulation pump (Photo provided by USACE)

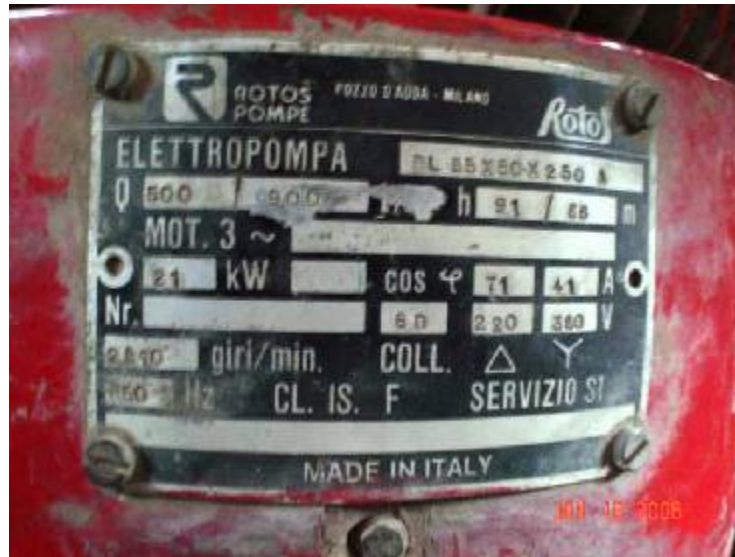
The design required four water circulation pumps, three for domestic water and one for the fire hydrant system. The capacity of the pumps according to the design was 18 m³/hour (hr) at 25 m head for the domestic water pumps and 18 m³/hr at 25 m head for the fire hydrant system pump. The contractor supplied and installed four circulation pumps. The pumps, based on our review of the QA report photos, do not appear new. We observed photos showing rust and dirt on the pump and motor housings. Site Photo 15 shows the condition of one of the pumps. In addition, the face plate on the fire hydrant pump system appears to have been altered because there are scratches in the entries for flow capacity.

Site Photo 16. Factory plate for fire hydrant system pump (Photo provided by USACE)

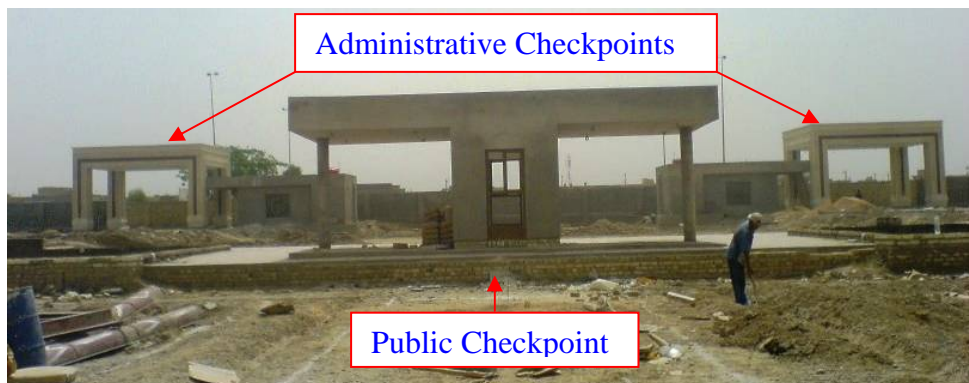
Site Photo 18. Administrative and public checkpoints (Photo provided by USACE)

Based on our review of the QA reports, there were no reported deficiencies associated with the checkpoints' construction. The 3 July 2006 report lists the three checkpoints shown in Site Photo 18 as 95% complete.

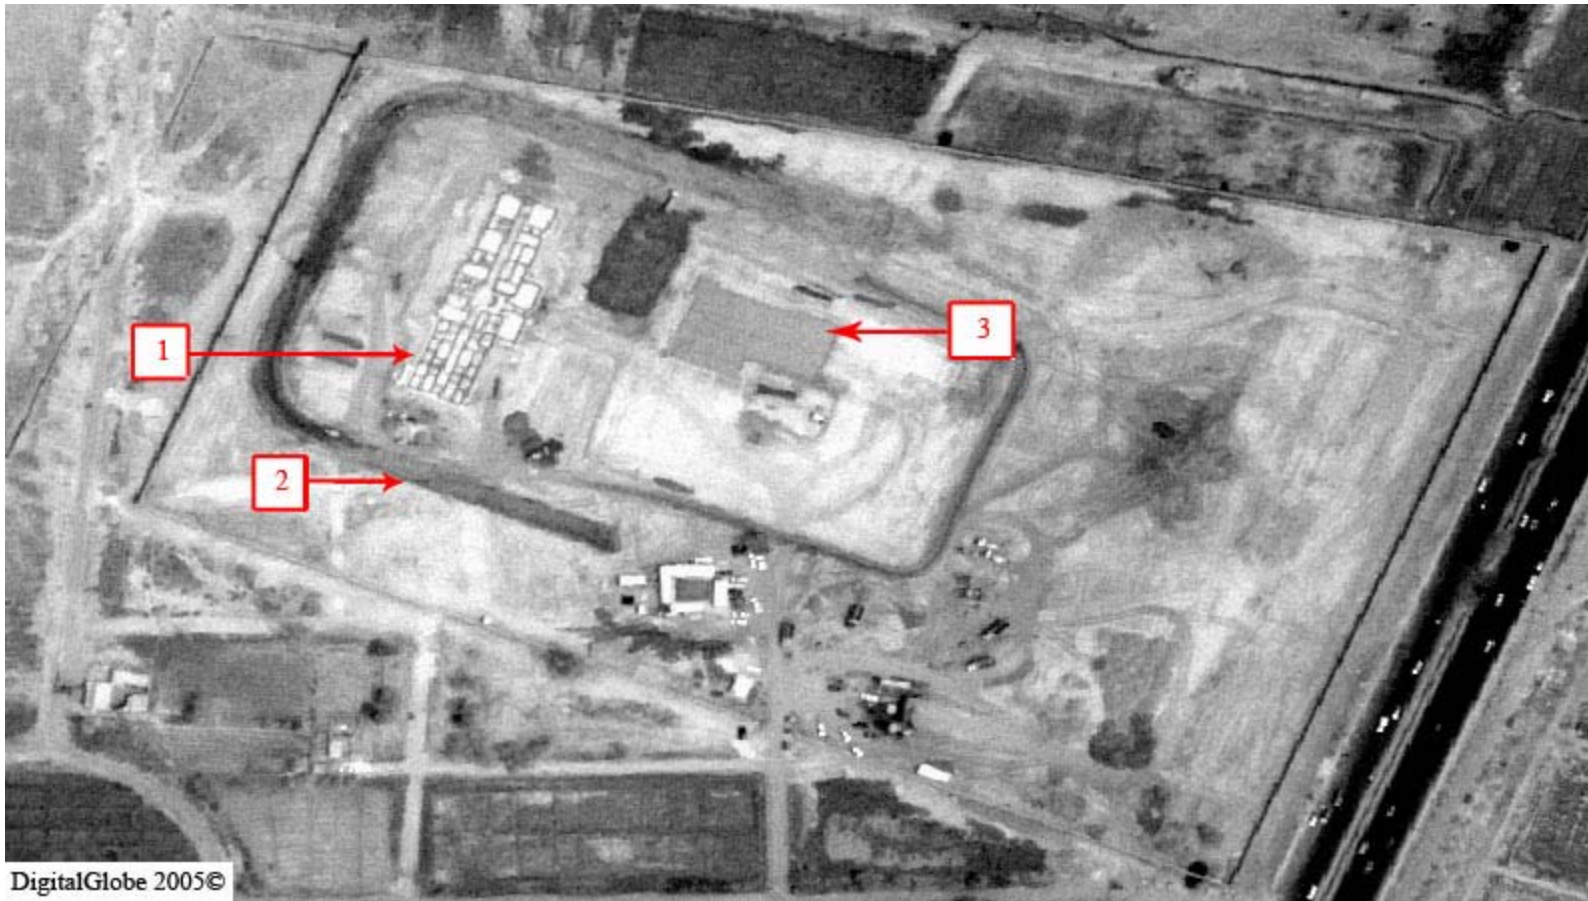
Since the assessment team was not able to travel to the site, we reviewed commercially available satellite imagery of the courthouse site to independently verify the construction progress. Aerial Image 1 shows the site on 10 August 2005 in the initial stages of construction. Item 1 is the annex building under construction. Item 2 is the road during the early stages of construction. Item 3 is the courthouse site. The darker area depicts the reinforcing steel placement for the raft foundation.

Aerial Image 1. Courthouse site on 10 August 2005

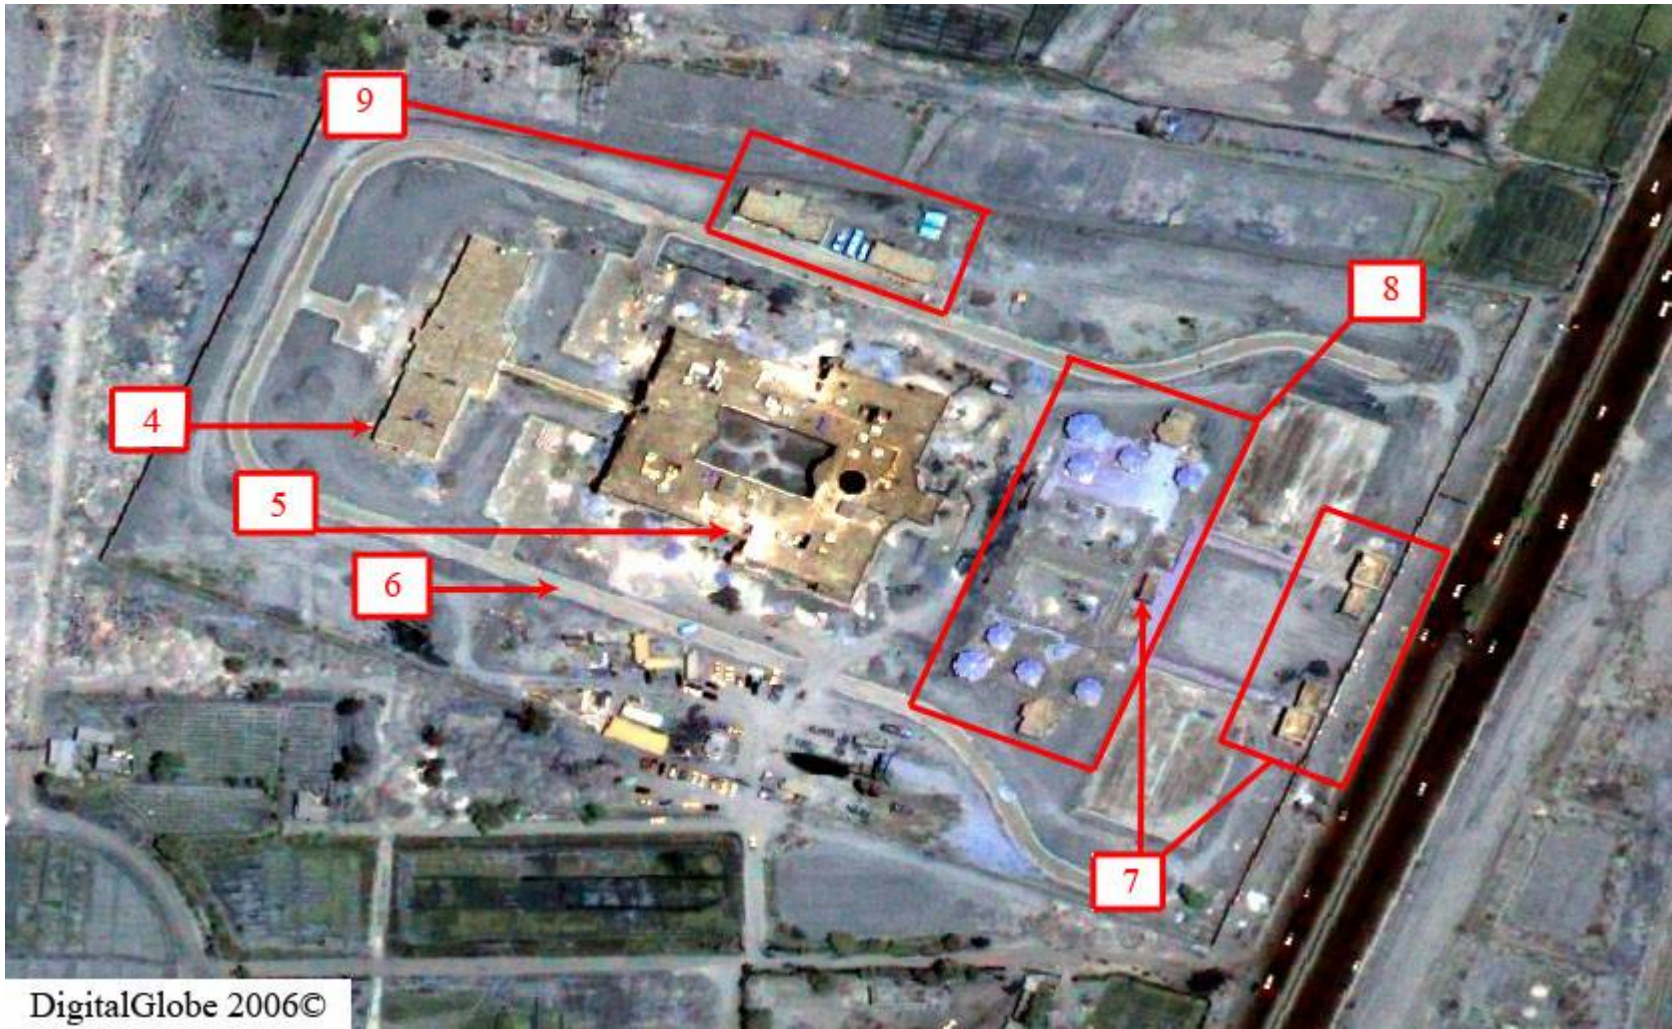
Aerial Image 2 shows the courthouse site on 16 May 2006. Item 4 shows the Annex building nearing completion. Item 5 is the substantially completed courthouse. Item 6 is the perimeter road including curb and gutter. Item 7 points to the two administrative checkpoints at the entrances and the public checkpoint within the compound. Item 8 depicts the two sets of kiosks, cafeterias, and bathroom buildings flanking the front side of the courthouse. Item 9 highlights the electrical transformer building, generators, and maintenance/water storage building.

Aerial Image 2. Courthouse on 16 May 2006
