BAGHDAD RAILWAY STATION  
REHABILITATION  
BAGHDAD, IRAQ

**SIGIR PA-06-057**  
**JULY 25, 2006**

SUBJECT: Report on Project Assessment of the Baghdad Railway Station  
Rehabilitation, Baghdad, Iraq (Report Number SIGIR-PA-06-057)

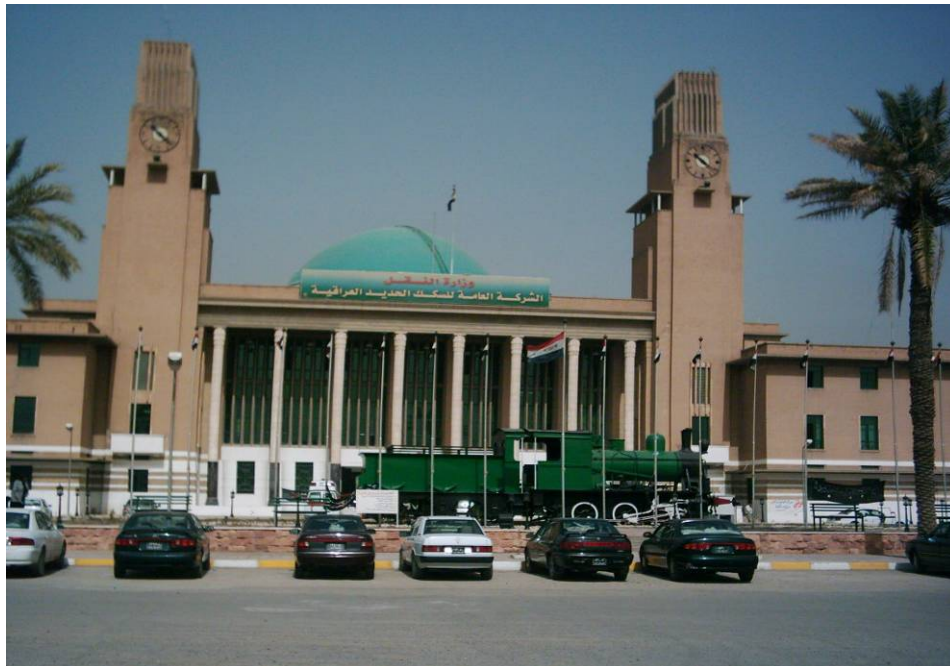
Site Photo 1. View of outside of Baghdad Railway Station (Photo provided by USACE)

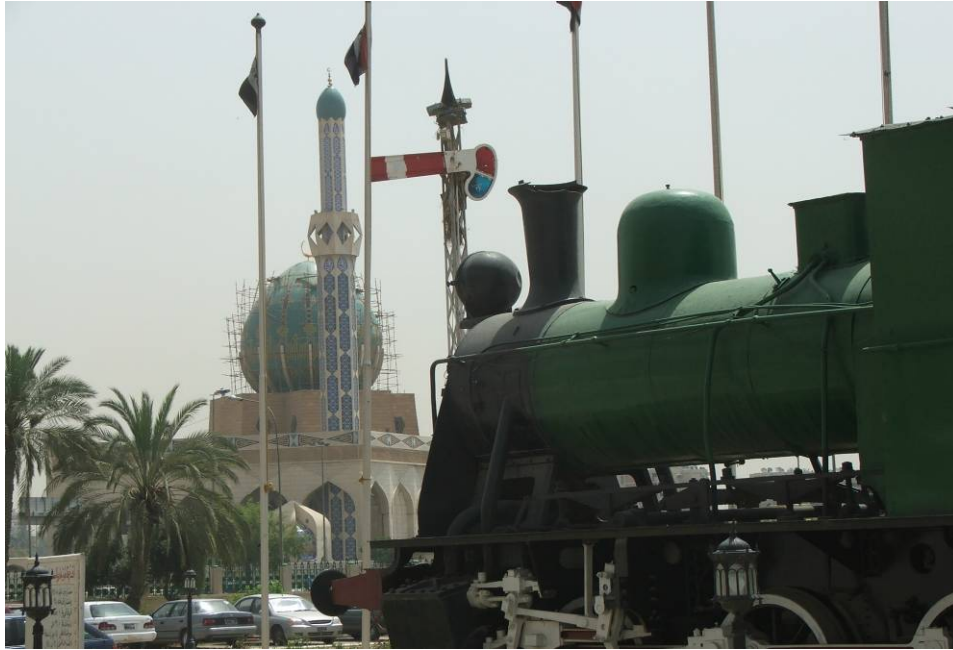
**Site Photo 2. View of original railway car displayed in front of Baghdad Railway Station**

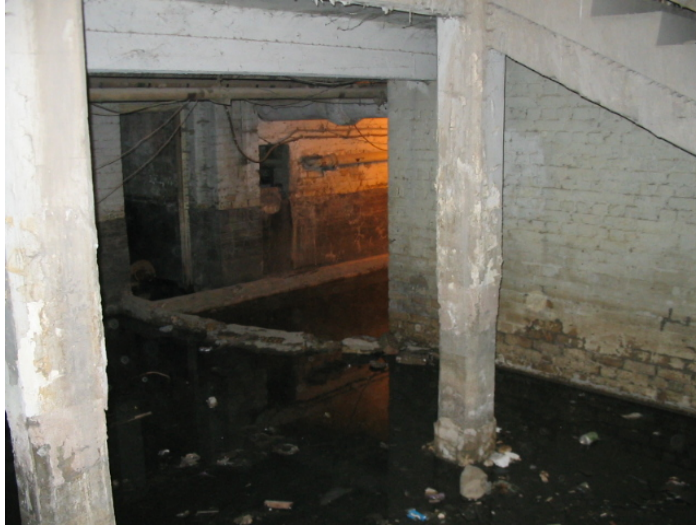
According to the USACE and IRR personnel, prior to the rehabilitation project, the basement was full of raw sewage and ground water to a height of four feet (Site Photo 3). The basement had been flooded for about 10 years. The sewage contaminated water had to be drained prior to any rehabilitation to the basement. After draining the sewage, the BOQ required the contractor to clean the basement and water proof the basement flooring, joints, walls, windows. The BOQ also required the repair and painting of existing steel windows and partitions including all hardware and accessories.

**Site Photo 3. View of basement prior to rehabilitation and drainage of sewage  
(Photo courtesy of the USACE)**

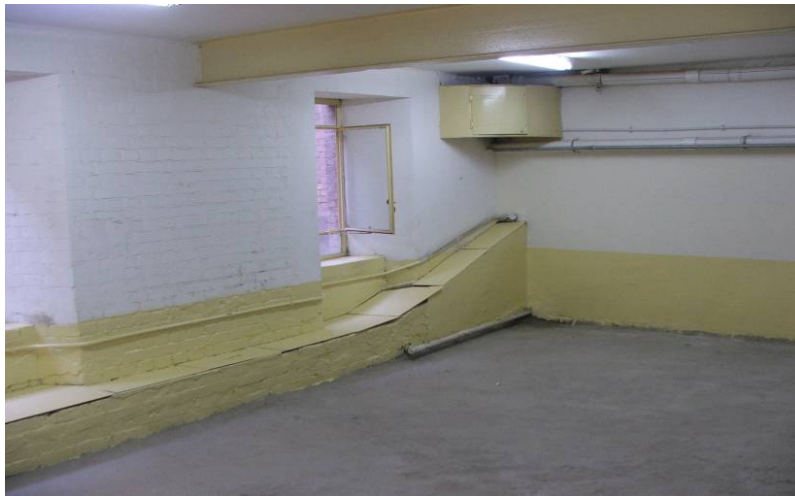
After draining the basement, the contractor then removed the utility piping, valves, fittings and pumps from the basement as well as the electrical distribution boards, conduits and cables. The contractor waterproofed the basement walls, ceiling, and floor. The contractor repaired or replaced windows, doors, and partitions, and painted the walls, ceiling, doors, window frames, and ductwork (Site Photo 4). The assessment team walked through the basement and observed the completed repairs. The required repairs as described in the SOW and BOQ appeared to be complete. However, according to IRR personnel, the basement leaked (after repairs were completed) during the past winter's rainy season. We brought this point to the attention of the USACE personnel, and were told the issue, if true, would be dealt with as a warranty item.

**Site Photo 4. View of basement after drainage, waterproofing, and painting**

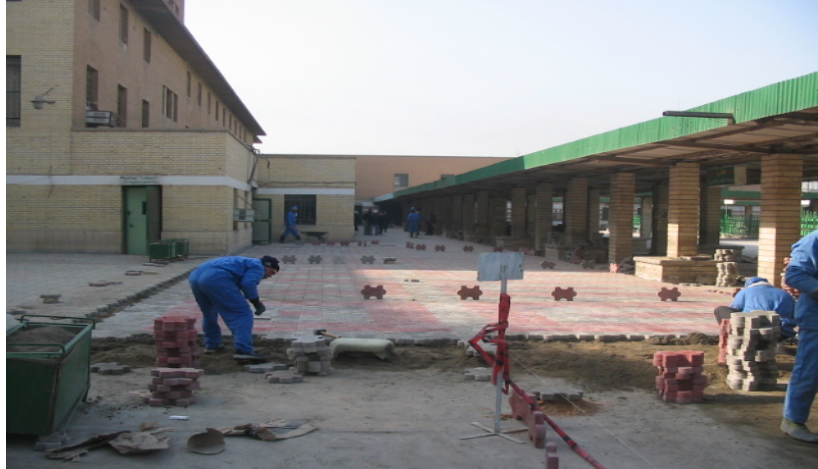
The design drawings and BOQ required the removal and replacement of the existing stone pavers with interlocking concrete block pavers for the passenger waiting platform. The USACE personnel provided photographs of platform work in progress (Site Photo 5). The assessment team observed the completed platform as shown in Site Photo 6. The team did not observe any noticeable defects in the concrete pavers. They appeared to be level and evenly joined and placed in the areas required by the design.

**Site Photo 5. Work in progress on passenger waiting platform  
(Photo courtesy of the USACE)**

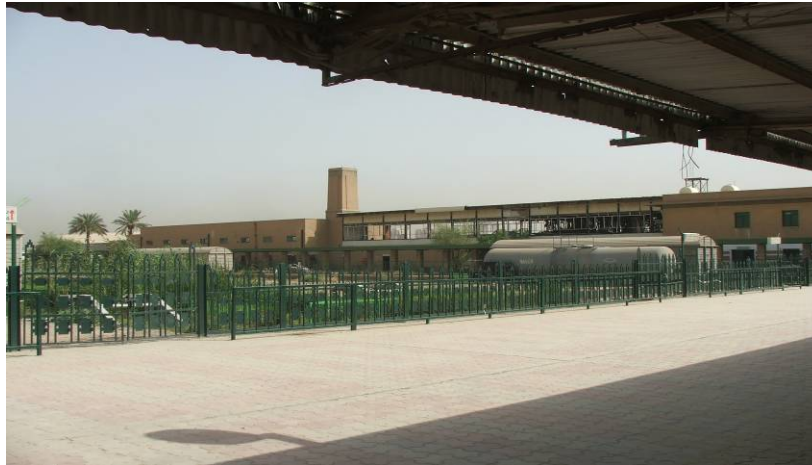
**Site Photo 6. Completed concrete pavers on the platform**

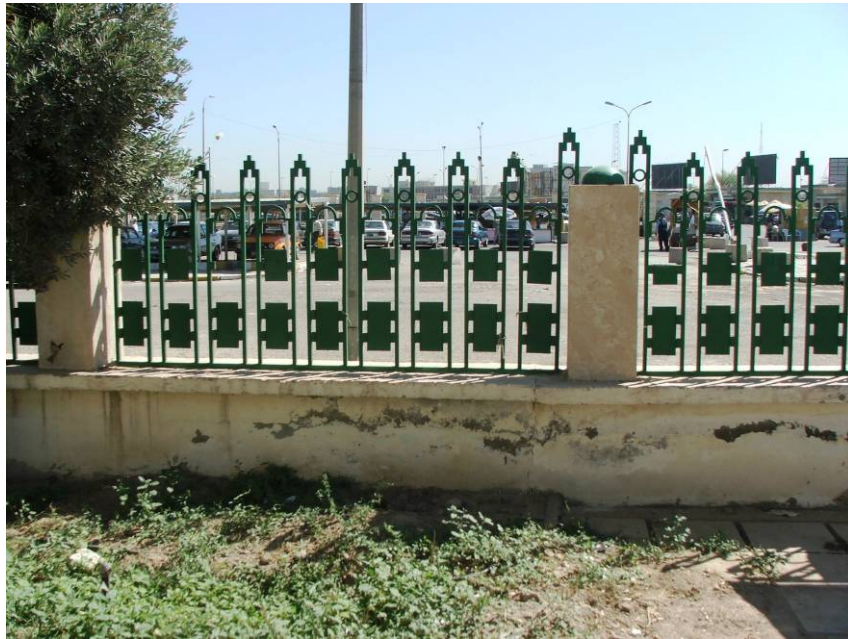
The BOQ and design required the contractor to repair and paint the existing fences and gates. The BOQ listed 785 linear meters (lm) of steel fencing to be repaired and 1,850 lm of brick fencing to be installed. The steel fence was actually a composite fence consisting of a plastered brick base and support columns and a steel lattice and rails between the columns. The assessment team did not verify quantities nor inspect the entire fence. The completed fencing in the areas we inspected did not have any noticeable defects, although we did observe some chipped paint on the base of the steel fence adjacent to the east side garden area as shown in Site Photo 7. The final punch list did not contain any items relating to the fence, so we informed the DRE about the chipped paint on the fence. The DRE directed the on-site USACE Quality Assurance Representative to inspect the entire length of the perimeter fence and document any defects in order to provide them to the contractor for corrective action.

**Site Photo 7. Fence on east side of station near garden area**

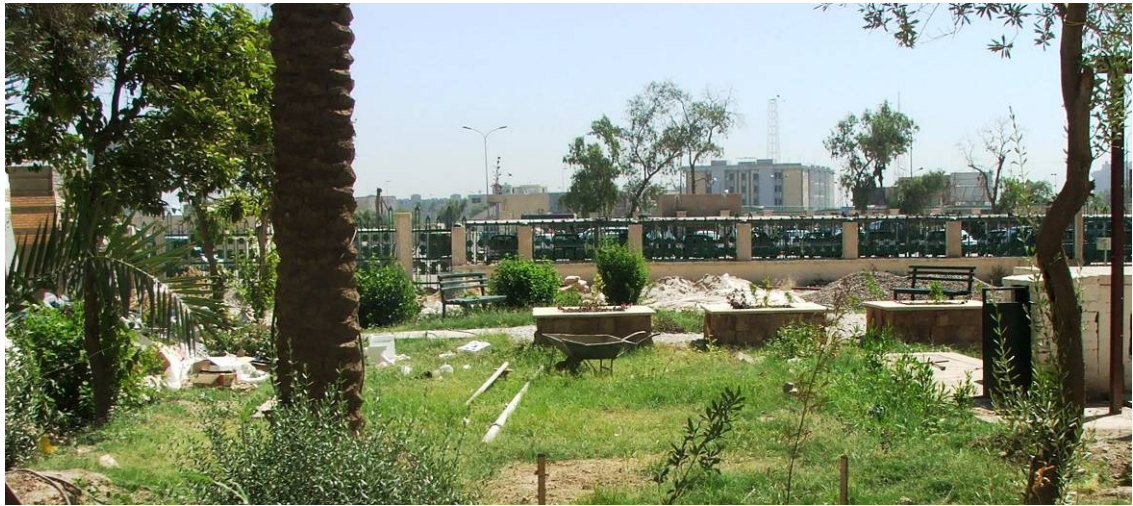
During the on-site assessment, we walked through the gardens in the front of the railway station opposite the main entrance and at the northeast side of the station. We found the gardens inadequately maintained as shown in Site Photo 8. According to the DRE, the gardens were not being maintained by the contractor because the contractor believed they were the IRR’s responsibility. However, the IRR believed the on-going maintenance of the gardens remained a contractor responsibility. At the time of the assessment, the issue had not been resolved, but the DRE, PCO, and representatives of IRMO were meeting to address punch list items, the pending modification work, and the responsibility for garden maintenance.

**Site Photo 8. Garden area on east side of the railway station**

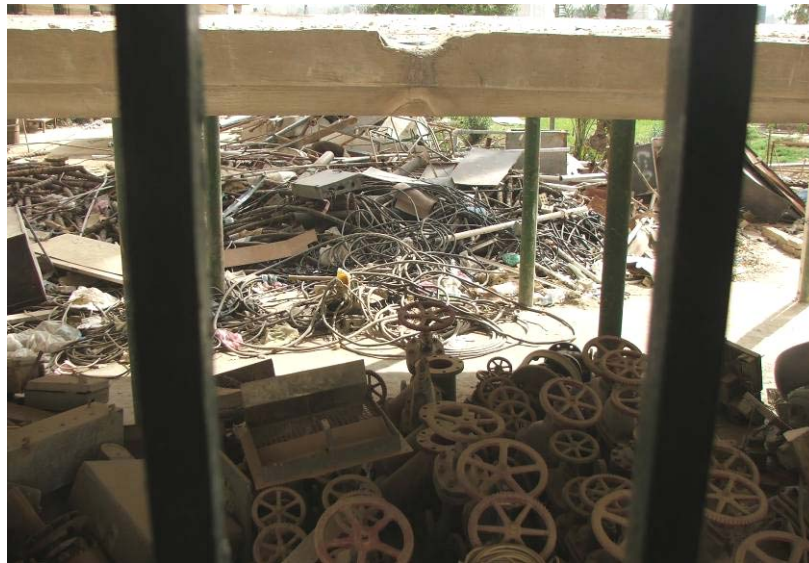
The demolition and clean-up portion of the contract was de-scoped. During our site visit, we identified old parts and miscellaneous equipment that were removed from the basement (e.g., valves and electrical cable) and stored on site adjacent to the east side garden area. According to the USACE DRE, the IRR wants to retain the equipment to resell it for revenue at a future auction. Site Photo 9 shows the excess material.

**Site Photo 9. View of old parts located on site**

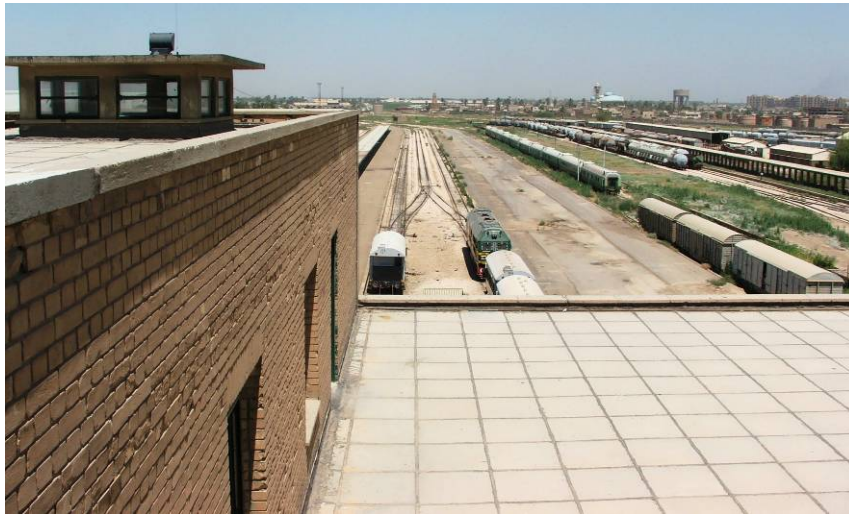
The existing roof prior to construction had been neglected and not properly maintained. The USACE DRE indicated that parts of the roof had been used by the previous regime for anti-aircraft batteries. The BOQ and design requirements included removal of the mastic joint between tiles, supply and installation of new mastic, removal and replacement of damaged concrete tiles and concrete covers with new ones, and the repair of damaged expansion joints on the 8,850 square meter (m<sup>2</sup>) roof. Based on our observations and a review of the project progress photos

provided by the USACE DRE, we did not see any problems associated with the workmanship or final product. Site Photo 10 shows the roof after repairs.

**Site Photo 10. One section of the repaired roof**

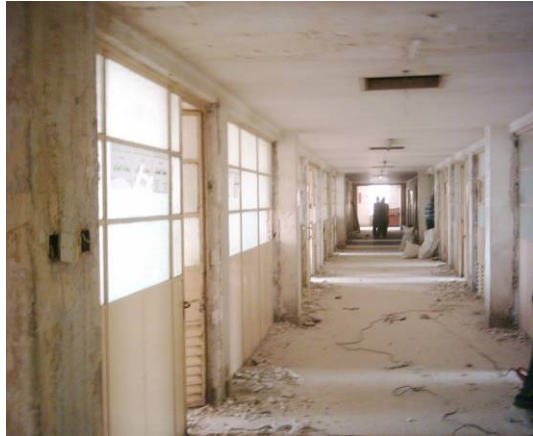
**Site Photo 11. View of existing interior partitions**  
(Photo courtesy of USACE)

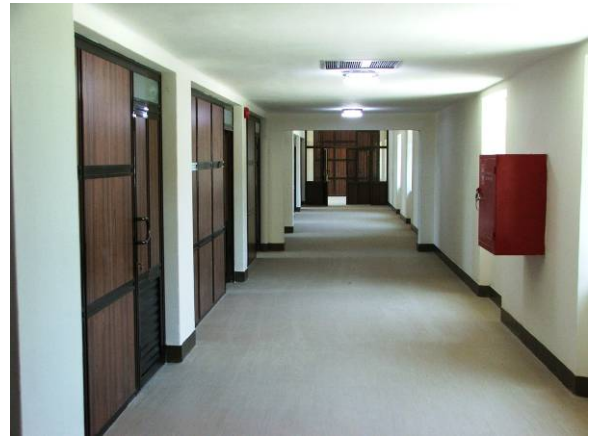
interior partitions with aluminum partitions consisting of MDF and reinforced glass. The observed partitions appeared to meet the standards of the design.

**Site Photo 12. View of new interior partitions**

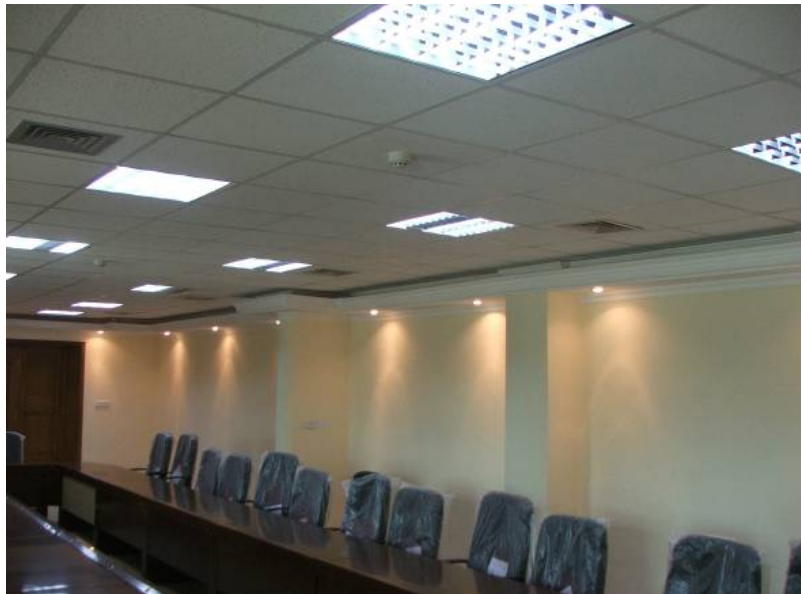
**Site Photo 13. Conference room with suspended acoustical ceiling**

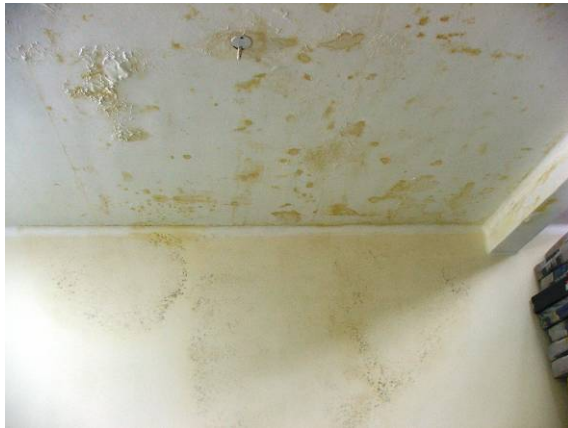
During the first site visit, we observed water damage (blistered and peeling paint as seen in Site Photo 14) on the concrete ceiling in one of the ground floor offices. The DRE informed the assessment team that the water damage occurred because the floor

**Site Photo 14. Water damage to ceiling caused by rainwater leakage from above**

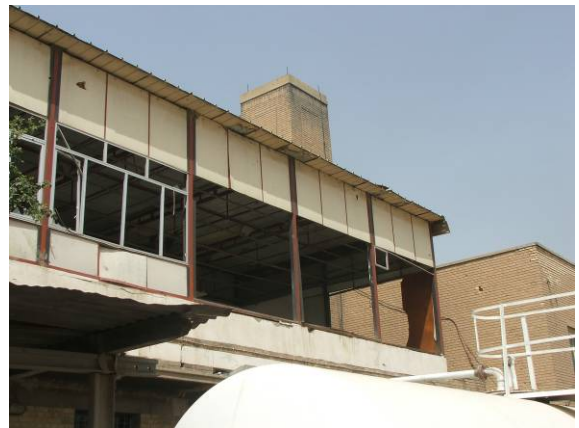
above contained a restaurant (Site Photo 15) that had been looted prior to the project and was exposed to the elements. Thus, rainwater trapped in the old restaurant leaked into the room below. The renovation scope of this project did not include the restaurant.

**Site Photo 15. Old restaurant exposed to weather resulting in leaks below**

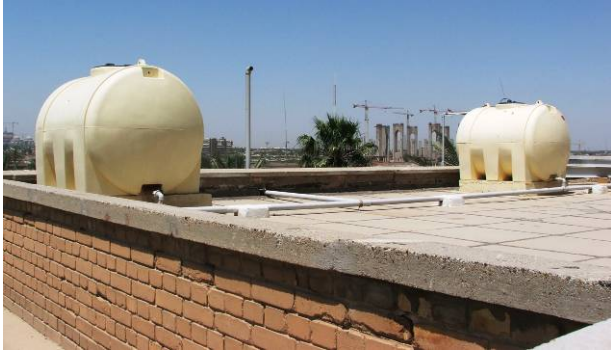
**Site Photo 16. Roof top polyethylene water tanks**

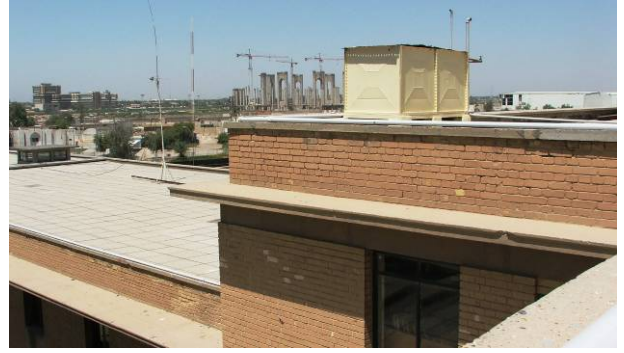
**Site Photo 17. Roof top galvanized water tank**

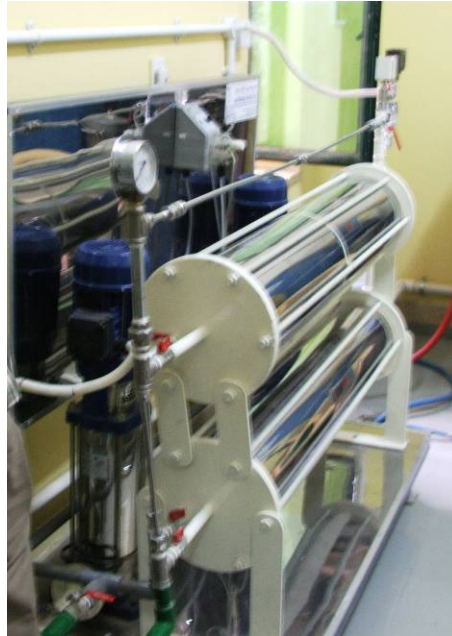
For drinking water, the contractor installed drinking water dispensers in every floor in each wing. To treat the drinking water, the contractor installed a reverse osmosis (RO) purification system in a utility room on the ground floor. The BOQ included a requirement for one RO purification system for drinking water. However, the design did not show the RO system location or piping diagrams from the system to the drinking dispensers. Site Photo 18 shows one part of the RO system, the pressure vessels containing the thin film membrane elements.

**Site Photo 18. Pressure vessels containing filtration units on the RO system**

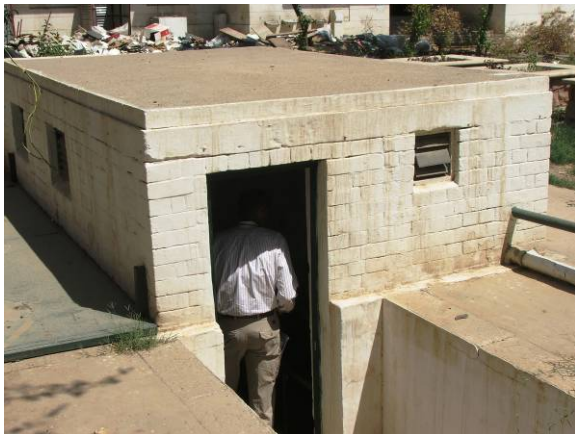
The IRR has issues with the pumps as noted in a letter to the contractor dated 14 June 2006, indicating the pumps (item 2) need to be heavy duty. The contractor responded that the pumps comply with the submittal requirements that had been approved by the IRR.

**Site Photo 19. One of the two sewage pump houses**

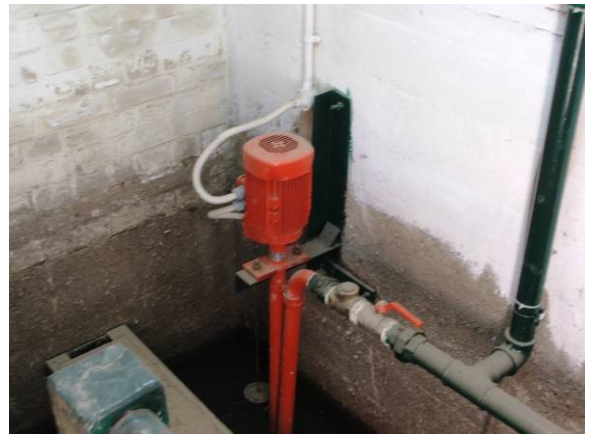
**Site Photo 20. One of two electrical sewage pumps in the pump house**

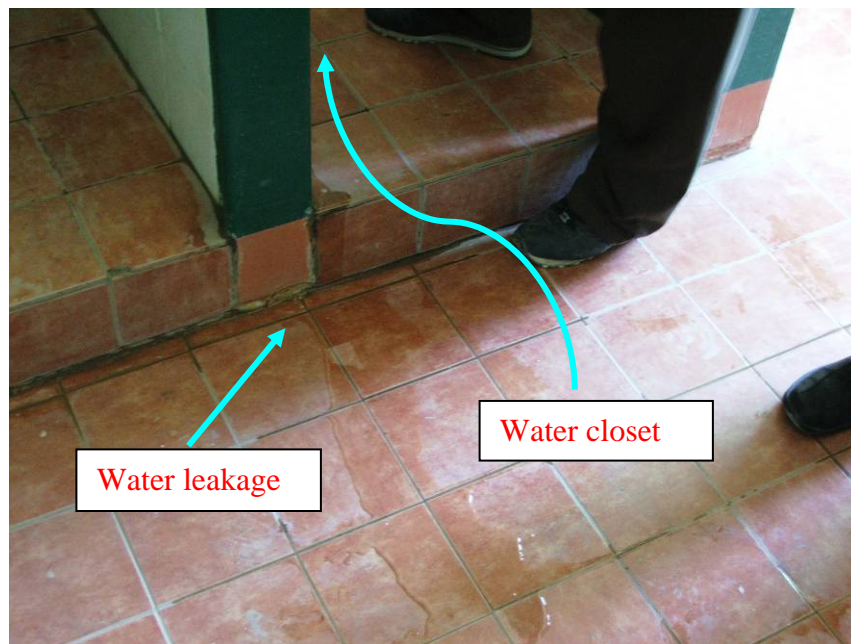
Bathrooms included a floor drain near the middle of the floor. On some of the bathrooms, water faucets were adjacent to the toilets to facilitate cleaning. The bathrooms were renovated according to the design. However, based on information provided to us by the USACE DRE, in three of the bathrooms, because of space constraints, the floor's slope was not enough to adequately drain the water to the

floor drain and to the toilets within the water closets. Thus, water continually ponds and has eventually permeated along the interface between the bathroom floor and the step into the water closet as shown in Site Photo 21.

**Site Photo 21. Standing water in one of the station's bathrooms**

At the time of the assessment, the USACE DRE and contractor were working to develop a solution that would eliminate the standing water while satisfying the requirements of the IRR.

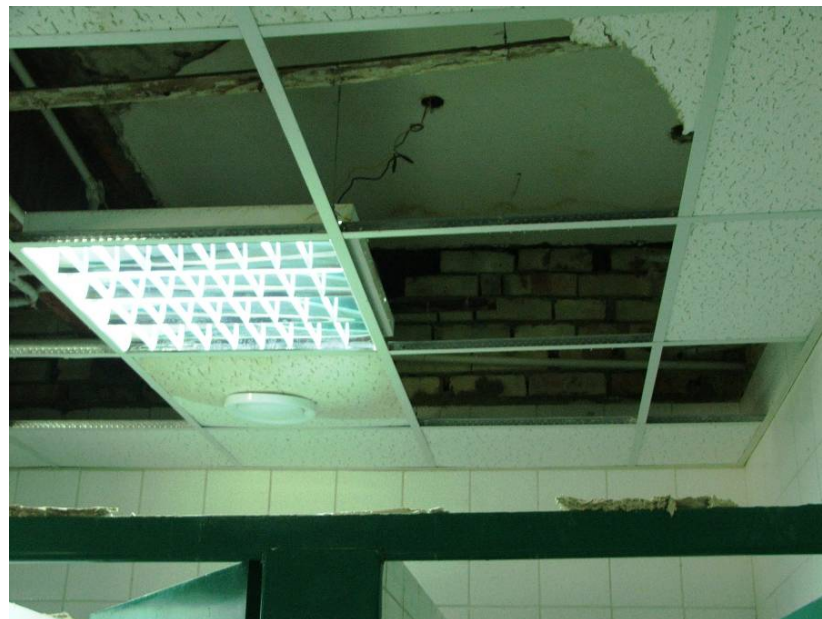
As a result, water has leaked into the bathroom on the floor below, causing damage to the suspended acoustical ceiling. Site Photo 22 shows some of the damage that occurred in the bathroom below.

**Site Photo 22. Water damage to the suspended ceiling**

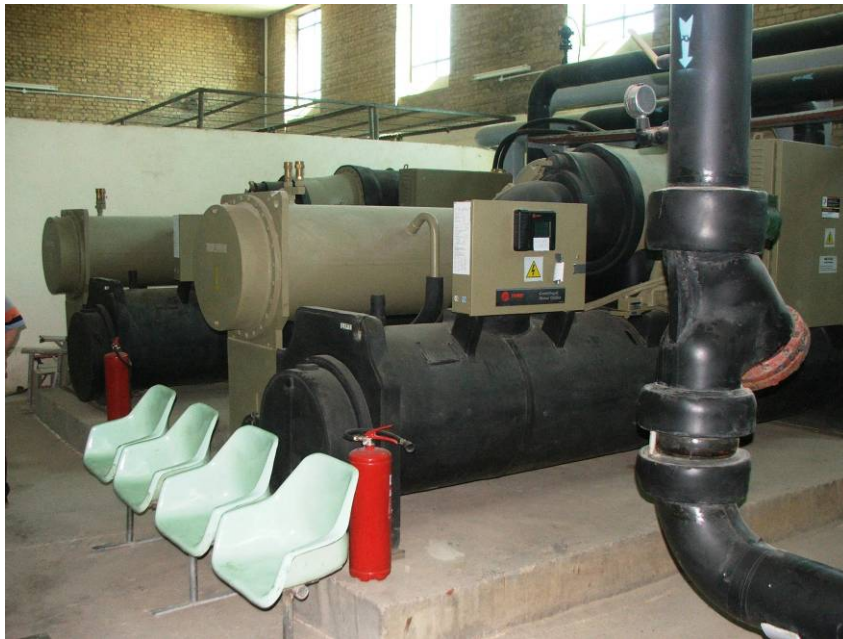
The design specifications required two packaged 500 ton centrifugal liquid chillers for air conditioning. The DRE provided the assessment team with the chiller submittal containing the factory information for Trane® 500 ton chillers. According to the DRE, one chiller could meet the air conditioning demands of the entire rail station. The second chiller served as a back-up. The assessment team verified during its inspection the installation of two, 500 ton, Trane® chillers as shown in Site Photo 23. On our first site visit, neither chiller was operating, because of a power outage. On the assessment team's second and third visit, the chillers were operating.

**Site Photo 23. Two, 500 ton chiller units**

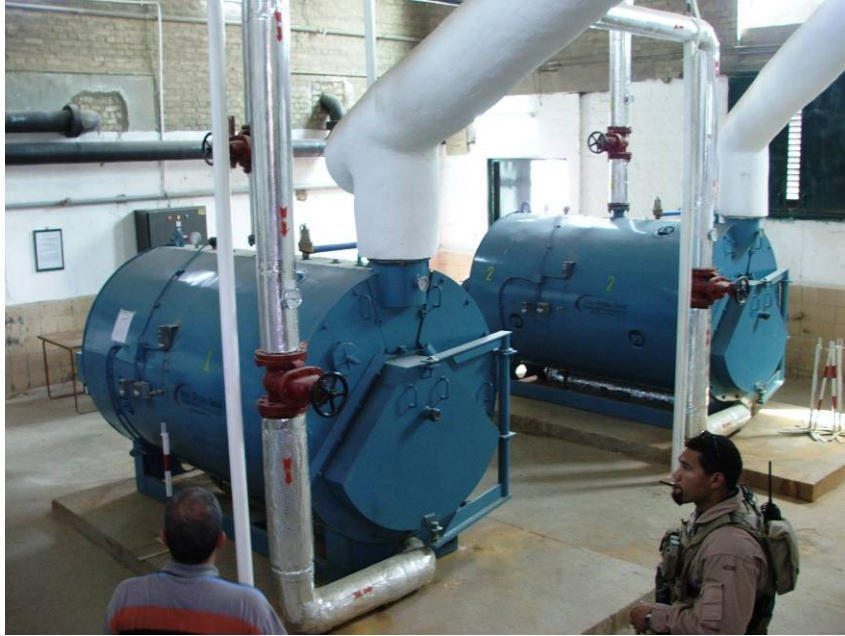
In addition to air conditioning, the design required the installation of two packaged hot water boilers for heating in the winter time, each with a heating capacity of 1,000 kilowatts (kW). The BOQ listed a requirement for two, hot water boilers (950 – 1000 KW) capacity, western source, diesel fuel with accessories for operating with a water softener. The contractor installed two York-Shipley boilers, each with a listed capacity (based on the York-Shipley submittal) of 981 KW, as shown in Site Photo 24.

**Site Photo 24. York Shipley hot water boilers**

The assessment team verified their installation as well as the required water softener, and hot water circulation pumps. We did not notice any apparent defects with the boilers or the supporting equipment, including evidence of prior leaks. The insulation on the hot water pipes also appeared adequate, with no noticeable defects.

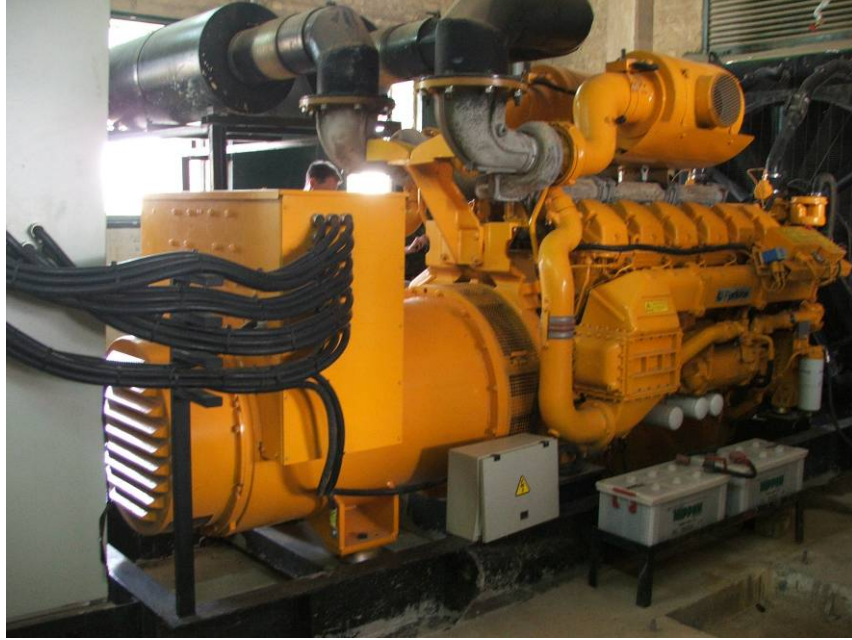
The design required two 1,250 KVA generators. The BOQ lists a requirement for one generator, although the DRE indicated an identical second generator was government furnished by PCO. While on site, the assessment team verified the contractor installed two 1,250 KVA Perkins generators in the powerhouse location shown on the design. Site Photo 25 shows one of the two Perkins generators.

**Site Photo 25. One of two Perkins 1,250 KVA generators**

We did not observe the generators operating on either of the two site visits when we toured the powerhouse. However, power from the city grid is not reliable, and the generators have operated on a routine basis since their installation. The final punch list does not list deficiencies associated with the generators themselves, although there remain some issues associated with how they are operated.

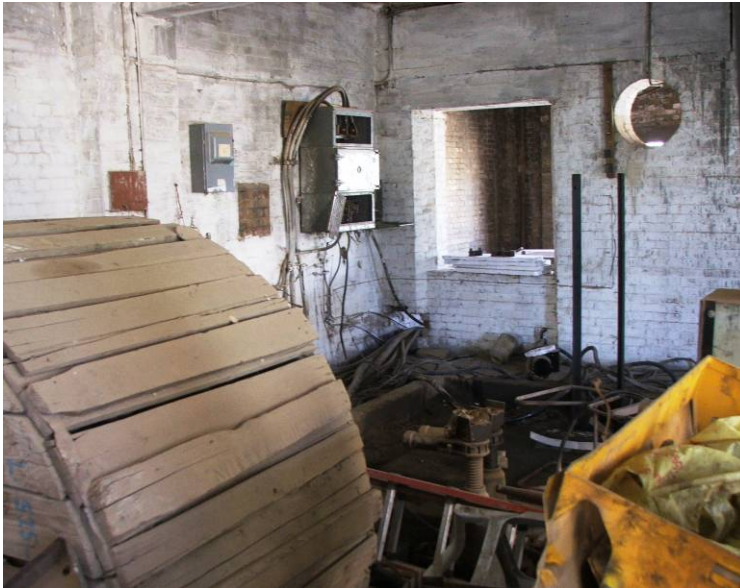
Although not part of the contract work, the assessment team toured the substation to gain a better understanding of how the railway station currently switches over to the existing second feeder. The existing substation building and facility switchgear appeared to be in substandard condition. Site Photo 26 provides an interior view of one of the two rooms in the substation.

Site Photo 26. Substation building on east side of rail station

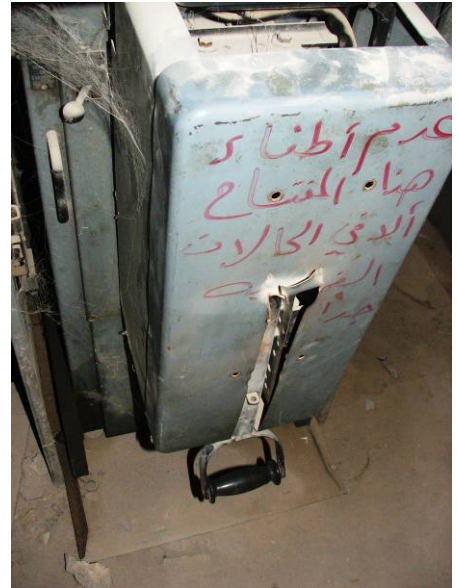
When the primary feeder to the station's powerhouse goes down, the railway station utilizes the second feeder. To connect the second feeder to the railway station, one of the station's employees operates a switch manually. Site Photo 27 shows the manual throw switch shown in the open position. A new second feeder (in the pending modification) would bypass the old substation all together and be routed from the west side of the station, through the utility tunnels into the powerhouse on the east side of the station.

Site Photo 27. Manual electrical switch

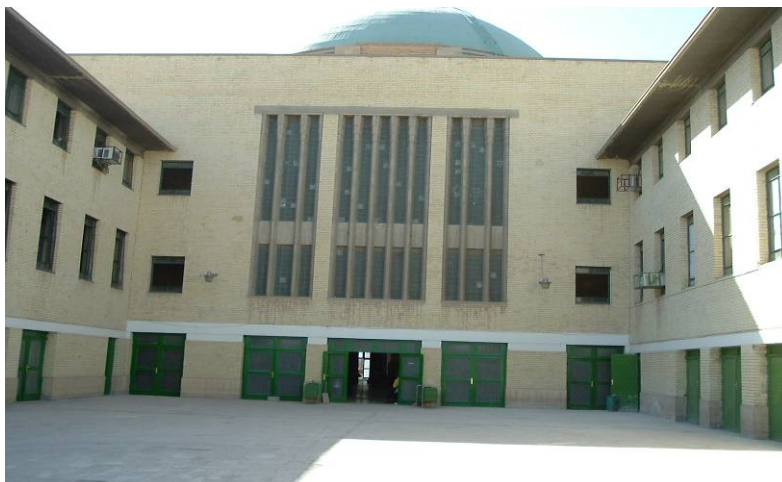
There is a pending modification to add the following: a Reverse Osmosis water purification unit for the chillers; install a canopy in the rear of the station (Site Photo 28); install drainage piping for the passenger platform area; demolish two damaged cafeterias; and install an incoming 11 kV feeder from the Iraq National Grid to serve as a redundant feeder. In addition, as mentioned earlier, discussions are still ongoing between the Resident Office, IRMO and GRD/PCO officials regarding the new sewage station pumps, maintenance of the gardens, and other items that the IRR

Site Photo 28. Rear view of railway station – site of future canopy
