Defence Science and  
Technology Organisation

# **Non-destructive Evaluation of Aircraft Structural Components and Composite Materials at DSTO Using Sonic Thermography**

**DSTO–TN–0986**

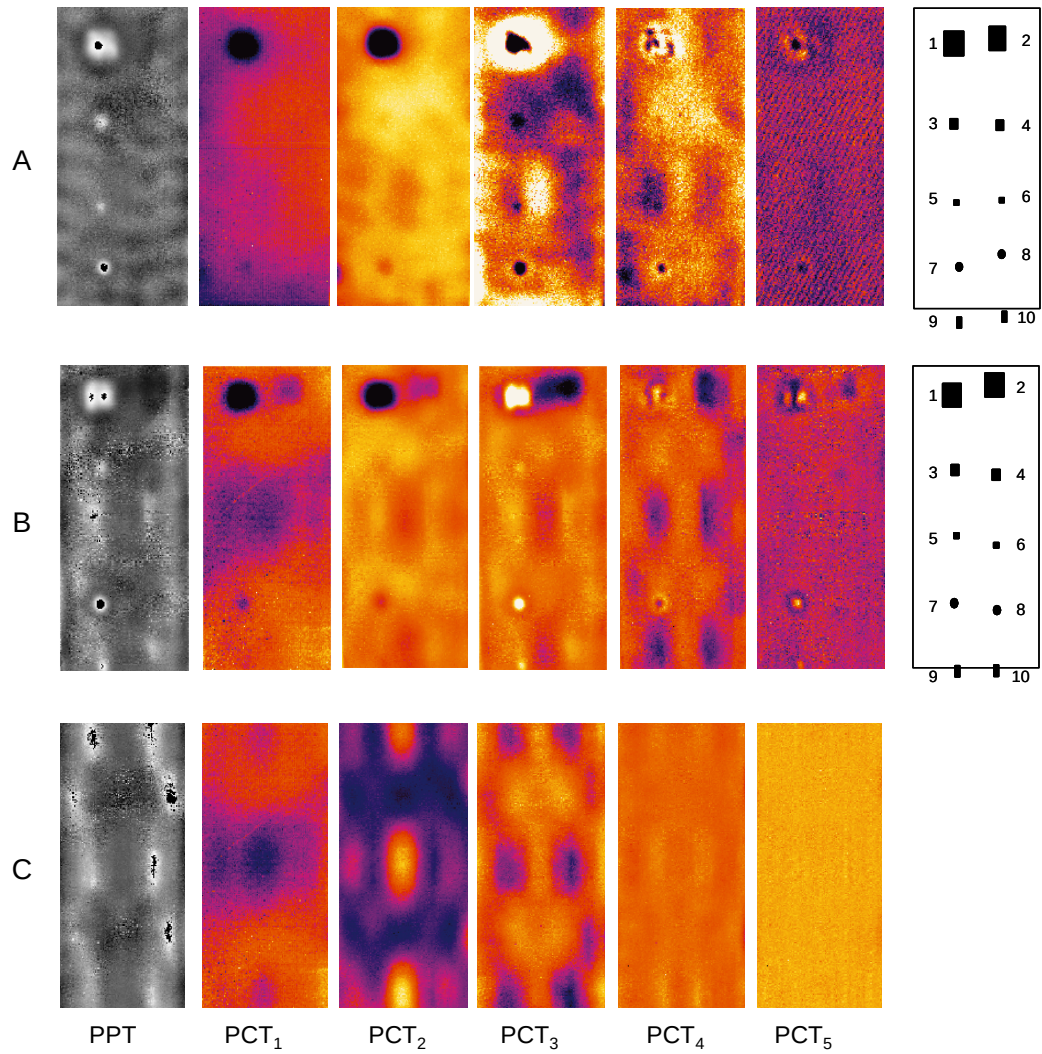
Figure 5 shows the PPT and PCT results for the ST inspection of specimens A, B and C. The PCT results show the first five modes. The PPT results for specimens A and B show strong indications for inserts located at a depth of 15% below the surface. For both specimens A and B, all modes show indications of inserts 1 and 7. Modes 2, 3, and 4 (PCT<sub>2</sub>, PCT<sub>3</sub> and PCT<sub>4</sub>) show indications of the inserts embedded at 15%. For the inserts embedded in the midplane, there appears to be no indication for specimen A, however for specimen B defects 2, 4 and 8 are observable in PCT<sub>5</sub>. Specimen C shows vibration modes set up within the specimen due to the acoustic excitation. These are distinguished from structural defects by the distinctly periodic pattern of the signature, which effectively maps the anelastic strain amplitude in the specimen. Interestingly, while specimen B produces a modal pattern similar to that of specimen C, specimen A yields a different pattern. This could be a result of slight variations in laminate thickness, variations in the defect geometry or acoustic horn position during insonification.

The difficulty in detecting the smaller inserts at a depth 15% below the surface (5, 7 and 9) and the majority of the inserts embedded in the midplane of the specimen (4, 6, 8 and 10) is due, in part, to the fundamental sensitivity limitations of thermographic techniques. According to Maldague [14], a rough rule of thumb for a defect to be detectable using active thermography is that its effective radius should be at least as large as its depth beneath the surface. A summary of the insert sizes for the case in hand, based on this general rule, is shown in Table 2, where the relevant lateral dimension is taken to be the effective radius. The ‘depth’ shown in Table 2 gives the minimum depth at which the inserts in these specimens should be detectable. Based on these results, it can be seen that the inserts embedded at a depth of 15% below the surface should be detectable, and the PPT results for the ST and FT inspections substantiate this. For an embedment depth of 50%, the two largest defects (2 and 4) should be observable, whilst the rest of the defects are below the detection limit. In the ST inspections of specimen B it is possible to detect insert 2, as can be observed in the PPT result and all modes of the PCT results, and insert 4 is observable in the PCT<sub>5</sub> result. Interestingly, insert 8 is just observable in PCT<sub>5</sub>, even though it is below the minimum detectable limit given by Maldague [14].

**Figure 5:** ST inspection of the thin film insert specimens from front face. Specimens A, B and C are indicated, and the PPT and PCT<sub>1-5</sub> results, are shown. The defect positions for specimens A and B are shown to the right of the thermographs.

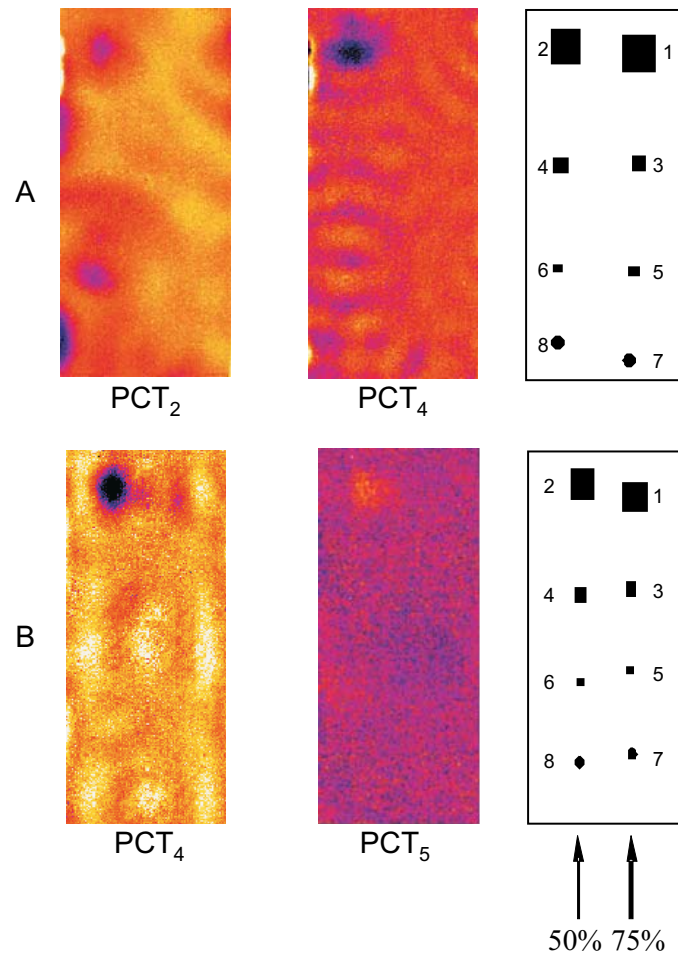
Figure 7 shows the ST inspection of the reverse side of the specimens, in which defects located 0.9 mm beneath the surface are now located at 5.1 mm below the surface. Only PCT<sub>2</sub> and PCT<sub>4</sub> for specimen A and PCT<sub>4</sub> and PCT<sub>5</sub> for specimen B are shown. From these results it can be observed that for specimen A, defects 2 and 6, in the midplane, which were previously not observable, are now detectable in PCT<sub>2</sub> and defect 2 alone in PCT<sub>4</sub>. For specimen B, defect 1, at 5.1 mm and defect 2, at 3 mm below the surface, are observable in the PCT<sub>4</sub> and only defect 2 is observable in the PCT<sub>5</sub> results.

**Figure 7:** ST inspection of the reverse face of the thin film delamination specimens showing PCT<sub>2</sub> and PCT<sub>4</sub> results for specimen A and PCT<sub>4</sub> and PCT<sub>5</sub> results for specimen B as indicated. The defect positions for specimens A and B are shown to the right of the thermographs.

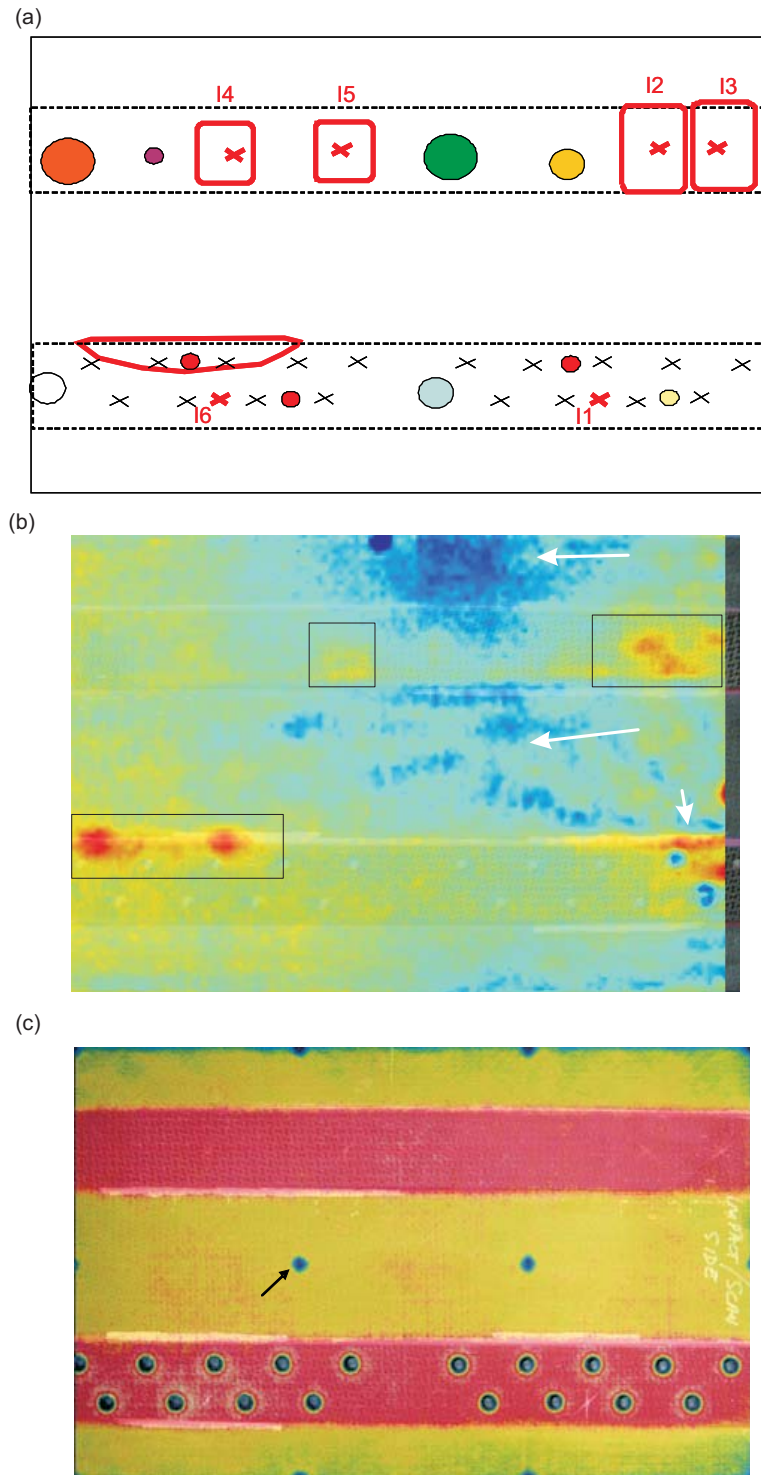
In Figure 10(b) the ST result for specimen 2 indicates significant damage in the I6 impact region. The insonification was applied to the central right of this specimen. The thermal signatures correspond to the edge of the damage area, which is, evidently, in compression. Faint indications of the impact damage caused by I2, I3 and I5 were detected, however these are difficult to distinguish from the modal vibration patterns (indicated by the arrows). In a blind test it would be difficult to conclusively determine that these areas corresponded to damage. None of the vaseline inclusions were detected, partly for the reason stated previously, and also because the detection of defects is hindered by the Cu mesh/ fibreglass finish, which acts to diffuse heat in the lateral or in-plane direction. The extra plies also increase the diffusion length, resulting in a reduction in the thermal signature. FT was unable to detect any damage or inclusions (Figure 10(b)).

**Figure 10:** (a) Damage map, (b) ST result (phase) and (c) FT result for specimen 2. The results shown in (b) and (c) are of the respective thermographs which have been superimposed with a photograph of the panel. In (a) the coloured circles correspond to the vaseline contamination in the bondline, red crosses indicate impact fractures and areas marked by the red outline indicate damage disclosed by C-scans. In (b) the arrows indicate vibrational mode patterns due to anelastic heating. Note that the blue circles in (c) (an example of which is indicated by the arrow) are markers used for alignment of the thermographic images.

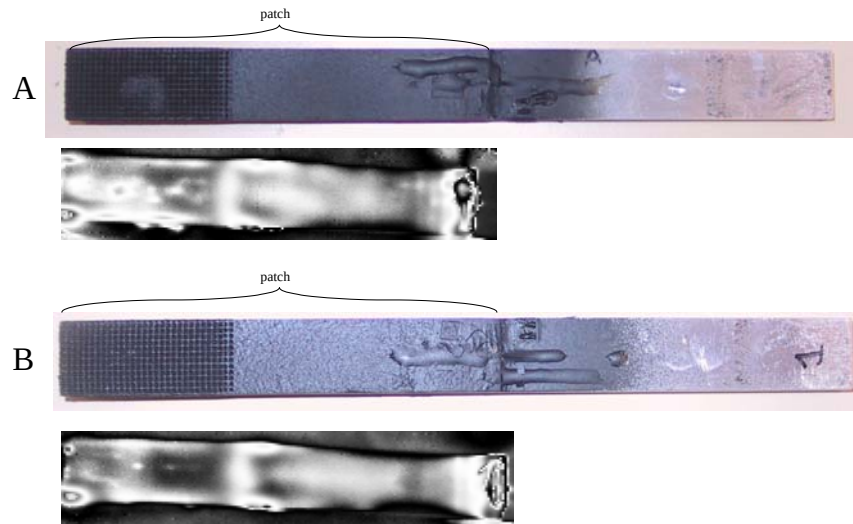
Figure 13 shows photographs of sides A and B of the lapjoint and the corresponding PPT results for each side during insonification. The PPT results for both sides clearly show a bright vertical band mid way through the patch. This corresponds to where the specimen was gripped in the tensile machine and is likely to indicate localised sub-surface damage caused by the grips. On the far right of both thermographs there is an indication of a strong heat source corresponding to the disbonded patch edge. Heat production occurs due to frictional heating between the disbonded patch and the aluminium face. There are

**Figure 13:** From top to bottom, photograph of lapjoint side A, corresponding PPT result, photograph of lapjoint side B and its corresponding PPT result.

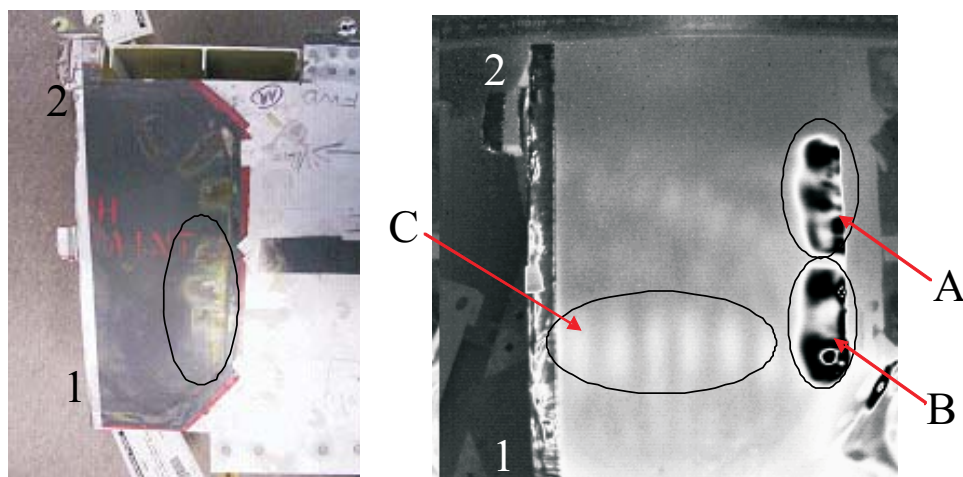
**Figure 15:** (a) Photograph of the LWS fragment 12W951A1 indicating region of interest. (b) Raw ST image showing darkened regions indicating elevated heat production and possible disbands.

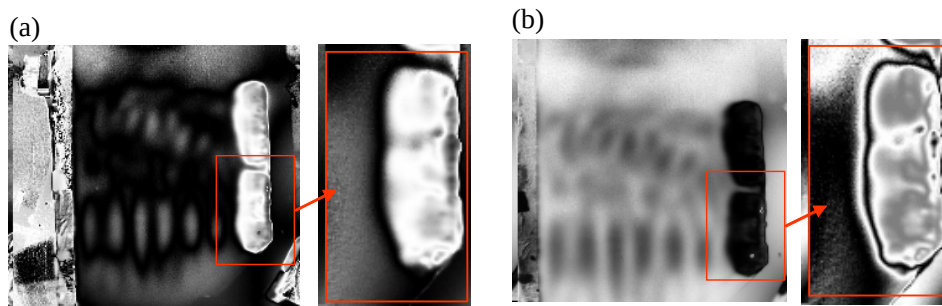
**Figure 16:** (a) PPT and (b) PCT results elucidating the disbond in regions A and B. Different grey scales were used in order to accentuate the flaw regions.

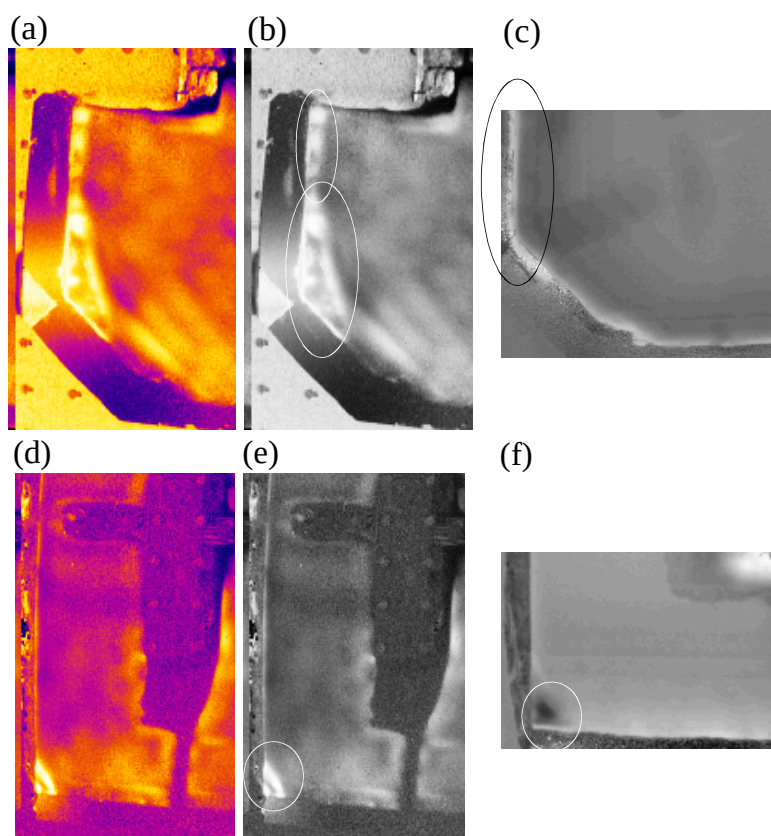
A photograph of the other LWS fragment, 12W951X, is shown in Figure 18 and Figure 19 shows the PCT results (a, b, d and e) and corresponding flash thermographs (c and f) for regions D and E, as indicated. It is noted that a non-grey colour map is used in this case merely to accentuate indications, and does not indicate relative temperature; that is whether a region is hotter or colder. The PCT results show clear indications of disbonding (circled) which are not as strong in the FT results (c and f). Once again the spatial detail is superior in the ST results.

**Figure 19:** (a) and (b) are the sonic PCT<sub>2</sub> results of region D and (c) the corresponding flash PPT result of the same region (circled) and (d) and (e) are the sonic PCT<sub>2</sub> results of region E and (f) the corresponding flash PPT result.

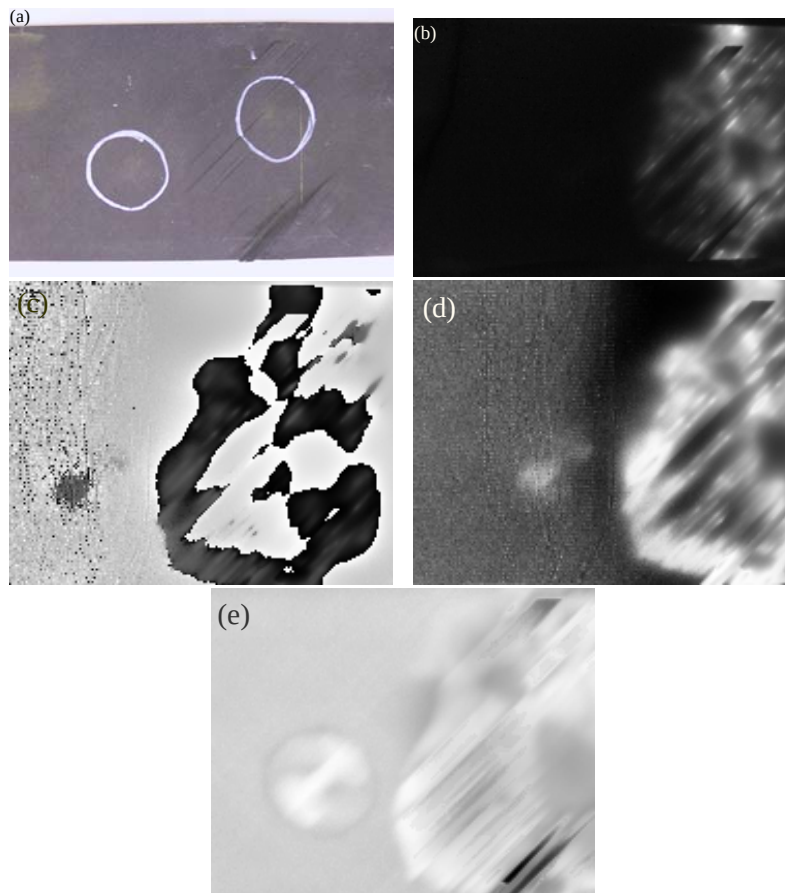
**Figure 23:** (a) Photograph of the impact damaged regions of the composite specimen; impact regions are indicated by the circles. ST (b) raw, (c) PPT and (d) PCT<sub>2</sub> results and (e) flash PPT result of the impact damaged regions of the composite specimen.

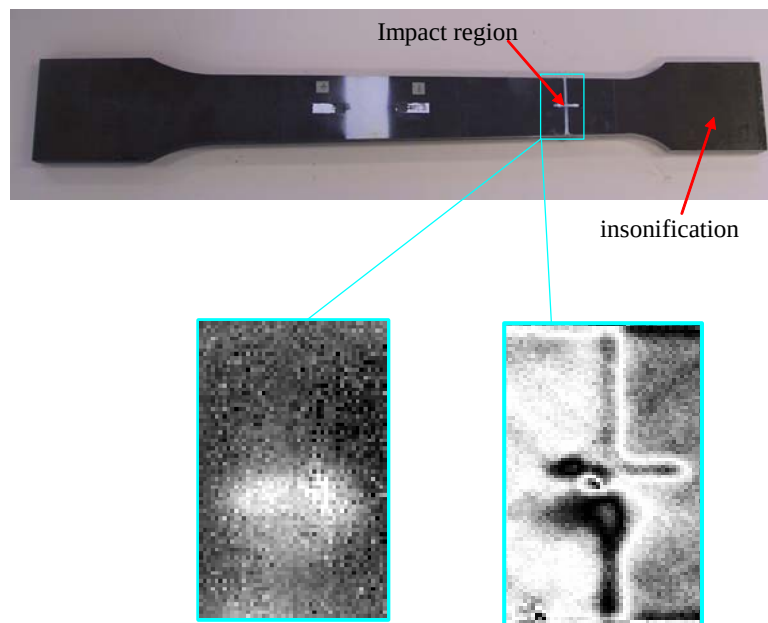
A step lapjoint was manufactured [22] in order to study the effect of BVID on the structural integrity of metal to composite joints. The ‘final wing root joint’ coupon investigated is detailed in Van Blaricum [22]. It consisted of AS4/3501-6 C/Ep laminate bonded to 6A1 - 4V titanium using FM300K adhesive. After being impacted on both sides with a 12 mm diameter spherically tipped impactor, the specimen was loaded under compression in a 500 kN servo-hydraulic test machine in order to determine whether the specimen would undergo delamination failure. The specimen was insonified for 5 s, the acoustic horn set to 500 W, and a frame rate of 10 Hz over 300 frames was used. Figure 26 shows the specimen; the impact region is at the centrepoint of the white cross and the region of interest is outlined by the square. The sonic PCT<sub>2</sub> (left image) and FT PPT (right image) results are also shown. Both results show that the damage is slightly off centre, located below and to the left of the impact.

**Figure 26:** Photograph of the step lapjoint specimen showing the impact region and the insonification point. The bottom left image is the sonic  $PCT_2$  result and the bottom right image is a flash PPT result of the damaged region.

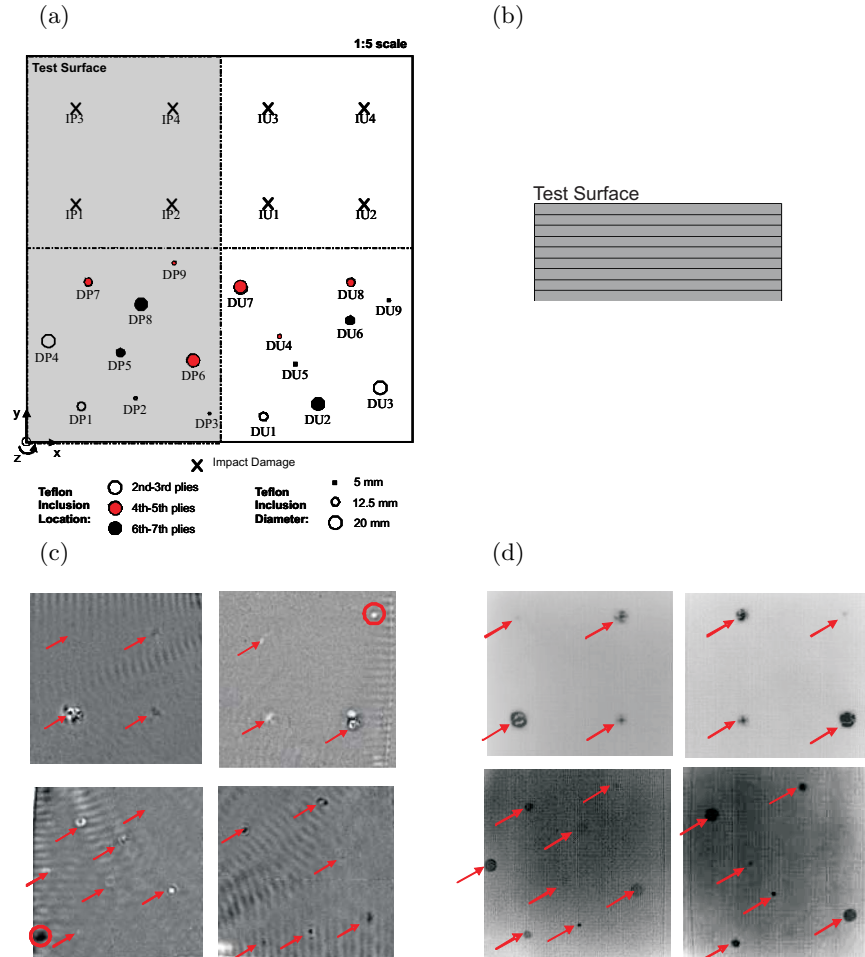
map. The detected damage is highlighted by the red arrows. DP1, DP4, DP5 and DP9 show very faint thermal indications and DP6 shows a clear indication in comparison to the FT of the same defect. This may indicate higher contact stress of the faces of this defect compared to others. The circled regions, at the top right and bottom left of the thermograph, show thermal indications from lead targets situated on the back of the specimen. Based on the rule of thumb described in section 3.2 and the known skin thickness given the diffusion length, all disbond defects should have been observable. None of the 5 mm diameter inclusions and some of the 12.5 mm inclusions were detected using ST, whilst all but DP3, DU6 and DU9 were detected using FT. As a general rule a Teflon insert is a poor approximation to a disbond for a ST procedure since the coefficient of friction is low between the Teflon and the laminate, thus producing a lower amount of heating than would be expected for a real disbond. A closer examination of the ST images of the inclusions that were detected reveals a ring like appearance, similar to that observed for impact damage. This suggests that anelastic heating of the composite due to higher strains at the edges of the inclusions may be contributing significantly to the thermal signature observed.

**Figure 28:** (a) Damage map, (b) profile image of layup, (c) sonic and (d) flash thermographs showing the four quadrants of specimen 1A and the corresponding damage locations. The 'U' and 'P' refer to the damage locations on the unpainted and painted side of the specimen, respectively. (Specimen layout courtesy CRC-ACS.)

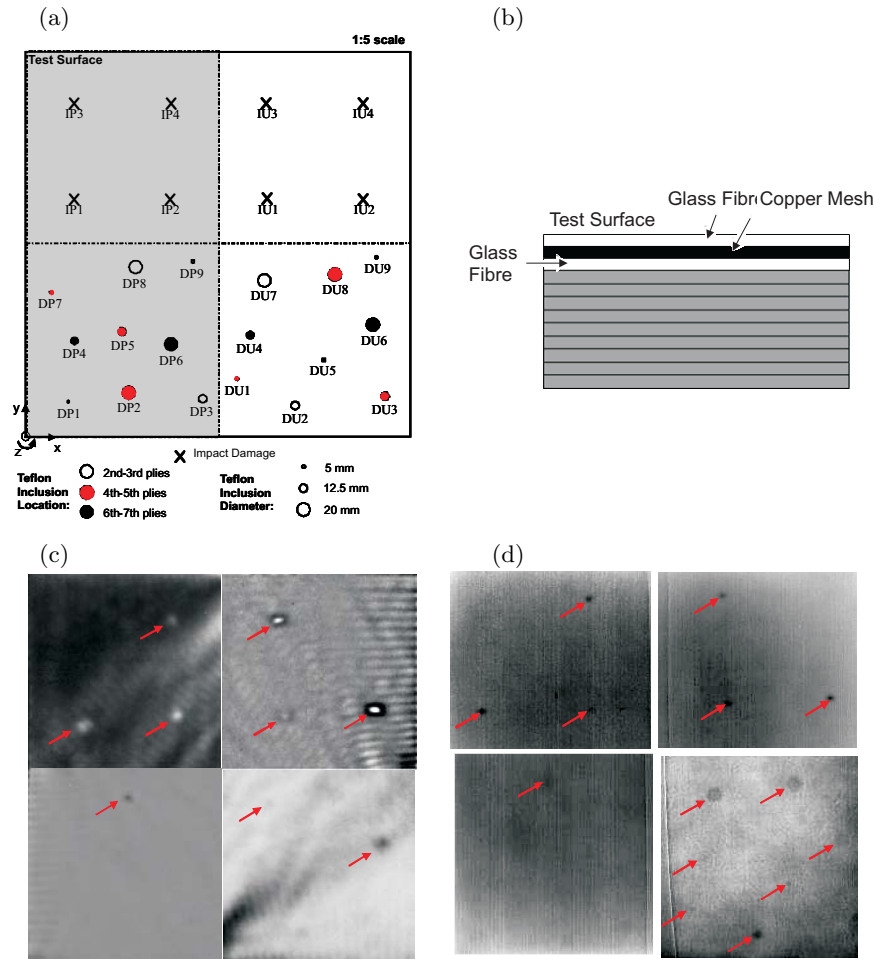
Figure 29 shows the ST and FT results for specimen 1B and the corresponding damage map. The presence of the glass fibre/ copper mesh layers significantly reduces the effectiveness of both ST and FT. This can be attributed to a number of factors. Specimen 1B is 3 plies thicker than specimen 1A, thus increasing the defect depth, resulting in a fainter signature. Also, if only the edges of the inclusions are contributing to the heating, as was speculated for specimen 1A, the area of the defect which contributes to heating is smaller than the defect itself, reducing its detectability. The existence of the copper mesh layer also has a deleterious effect by increasing the amount of lateral diffusion. The effect of the copper mesh on the thermal signature can be observed in the impact damage signatures of the two specimens (with and without mesh). The sonic thermographs of the impact damage in specimen 1A shows distinct detail, particularly for the high energy impacts (12.5 J) of IP1 and IU2. In comparison, the equivalent impacts in specimen 1B are detected, however the signatures appear smeared, and lack the detail seen for specimen 1A.

**Figure 29:** (a) Damage map, (b) profile image of layup, (c) sonic and (d) flash thermographs showing the four quadrants of specimen 1B and the corresponding damage locations. (Specimen layout courtesy CRC-ACS.)

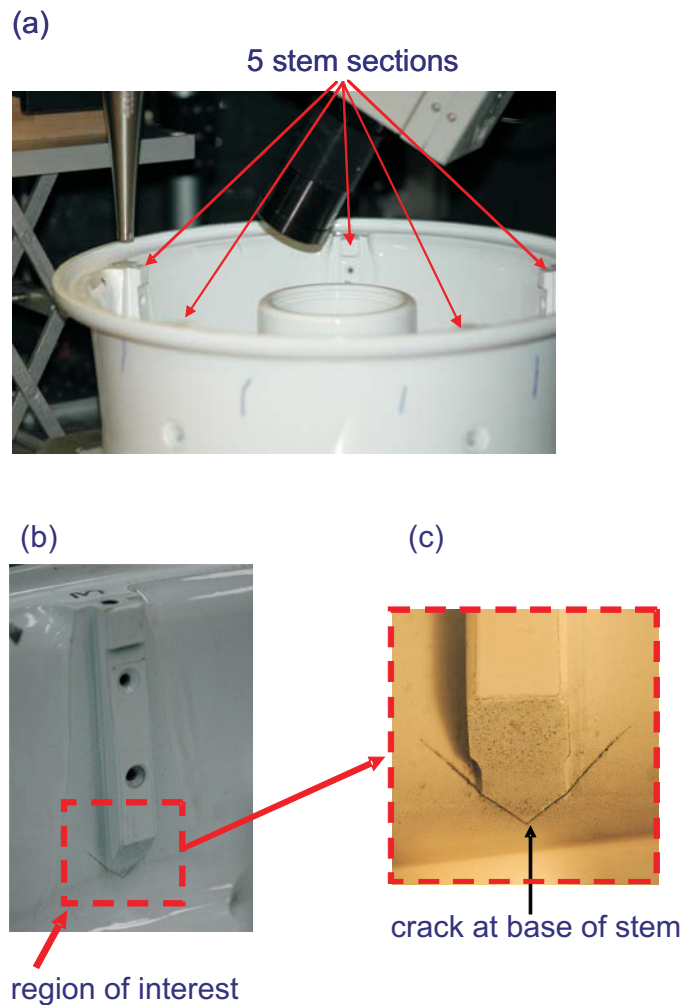
**Figure 42:** Photograph of (a) F-16 main wheel rim, the five stems to be inspected are indicated, (b) one of the stems, with the region of interest highlighted by the box and (c) a close up view of the area to be inspected. For this case a visible crack is observable.
