Engineering Assessment of Big House at Summit Station, Greenland

Final Report

April 2011

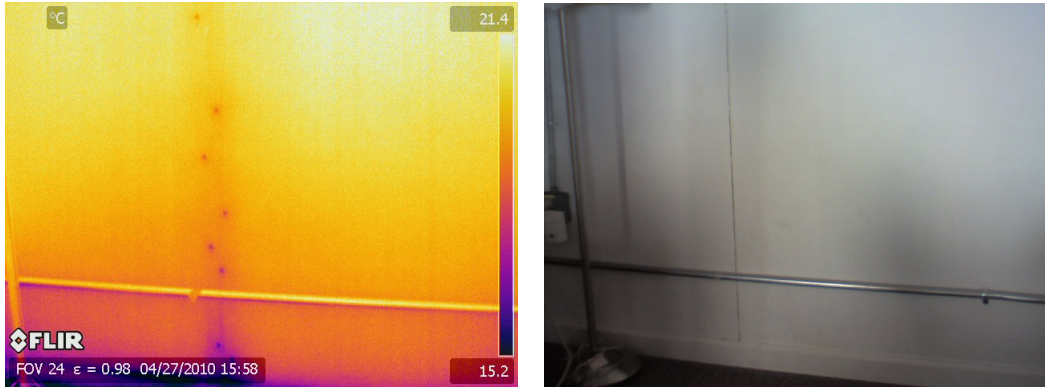
Significant impacts from the periodic lifting of the building were not observed in the IR imagery. As an example, separation between seams in abutting structural insulated panels (SIP) in the walls was minor. A typical

seam is shown in Figure S-2. The IR and visual images are of the north interior wall in the dining area.

Figure S-2. Vertical seam between SIPs does not show separation (north interior wall in dining area).

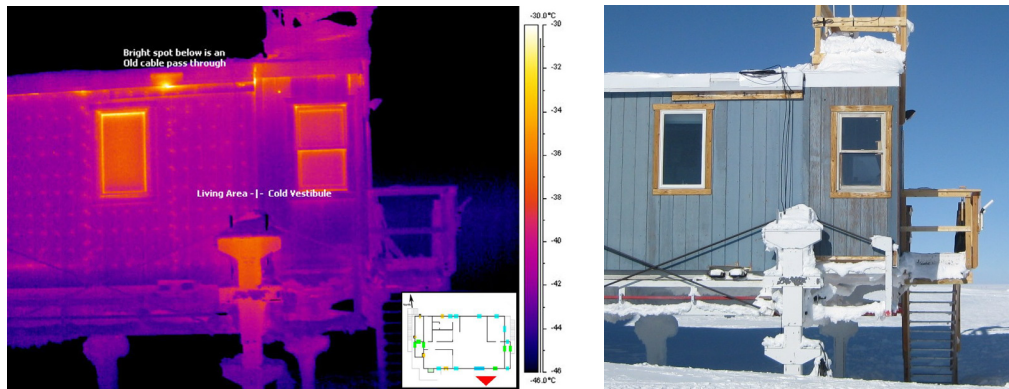
The access hatch to the roof penetrating the ceiling in the unheated east vestibule is a source for heat loss and creates a buildup of frost along the interior of the opening. Heat sources are the shared wall with the main room, and the sunlight that comes through the southern window.

Similarly, more heat loss was observed along the south side fascia, particularly toward the eastern end of the building, where instruments had previously been installed and in locations where repairs had been made to the metal flashing. Figure S-4 illustrates the heat loss observed in the IR imagery from the south side eastern end of the building. The cable pass-through to the radome (Fig. S-5) is an example where the cable pass-through is well insulated and little heat loss occurs.

Figure S-4. Difference in thermal envelopes between heated main room and unheated east vestibule, and heat loss along fascia (exterior south side).

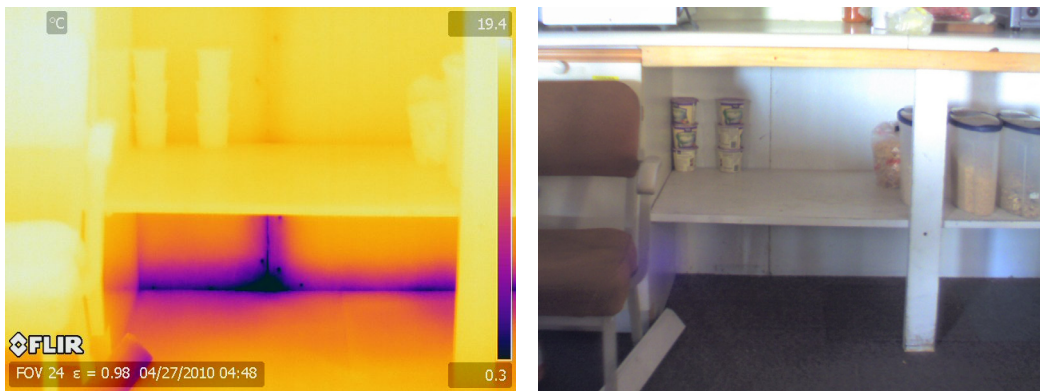
On the main floor, where the wall is joined to the deck, several areas were identified. Locations that appeared to have more heat loss included a cold spot under the counters in the main room, as shown in Figure S-6 (which was immediately caulked), an area in the northeastern corner of the office (which may not be noticeable owing to storage under the desk), and a location in the bathroom along the baseboard where frost had developed.

Figure S-6. Cold spot under the counter in the south wall of the main room.

- Continue to periodically locate and seal up areas where cold air infiltrates into the building.
- Prevent cold air leakage into the building via the stove vents, so appropriate dampers for them should be explored.

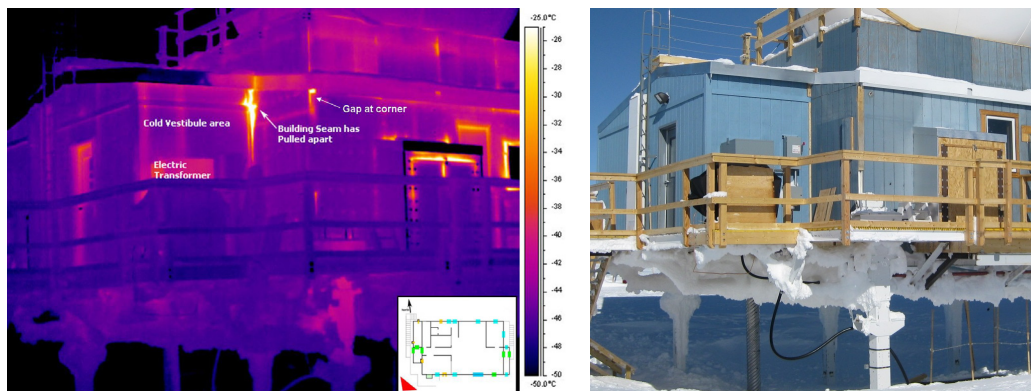
Very high heat loss was observed at the southwestern corner of the structure where the west vestibule connects to the main building (Fig. S-7). This location was identified and noted for repair when the penetration survey was conducted by CPS.

Figure S-7. Excessive heat loss at a gap located in the southwestern corner.

- Repair the two gaps on the southwestern side of the building, at the interface where the west vestibule connects to the main building and the gap at the southwestern corner.

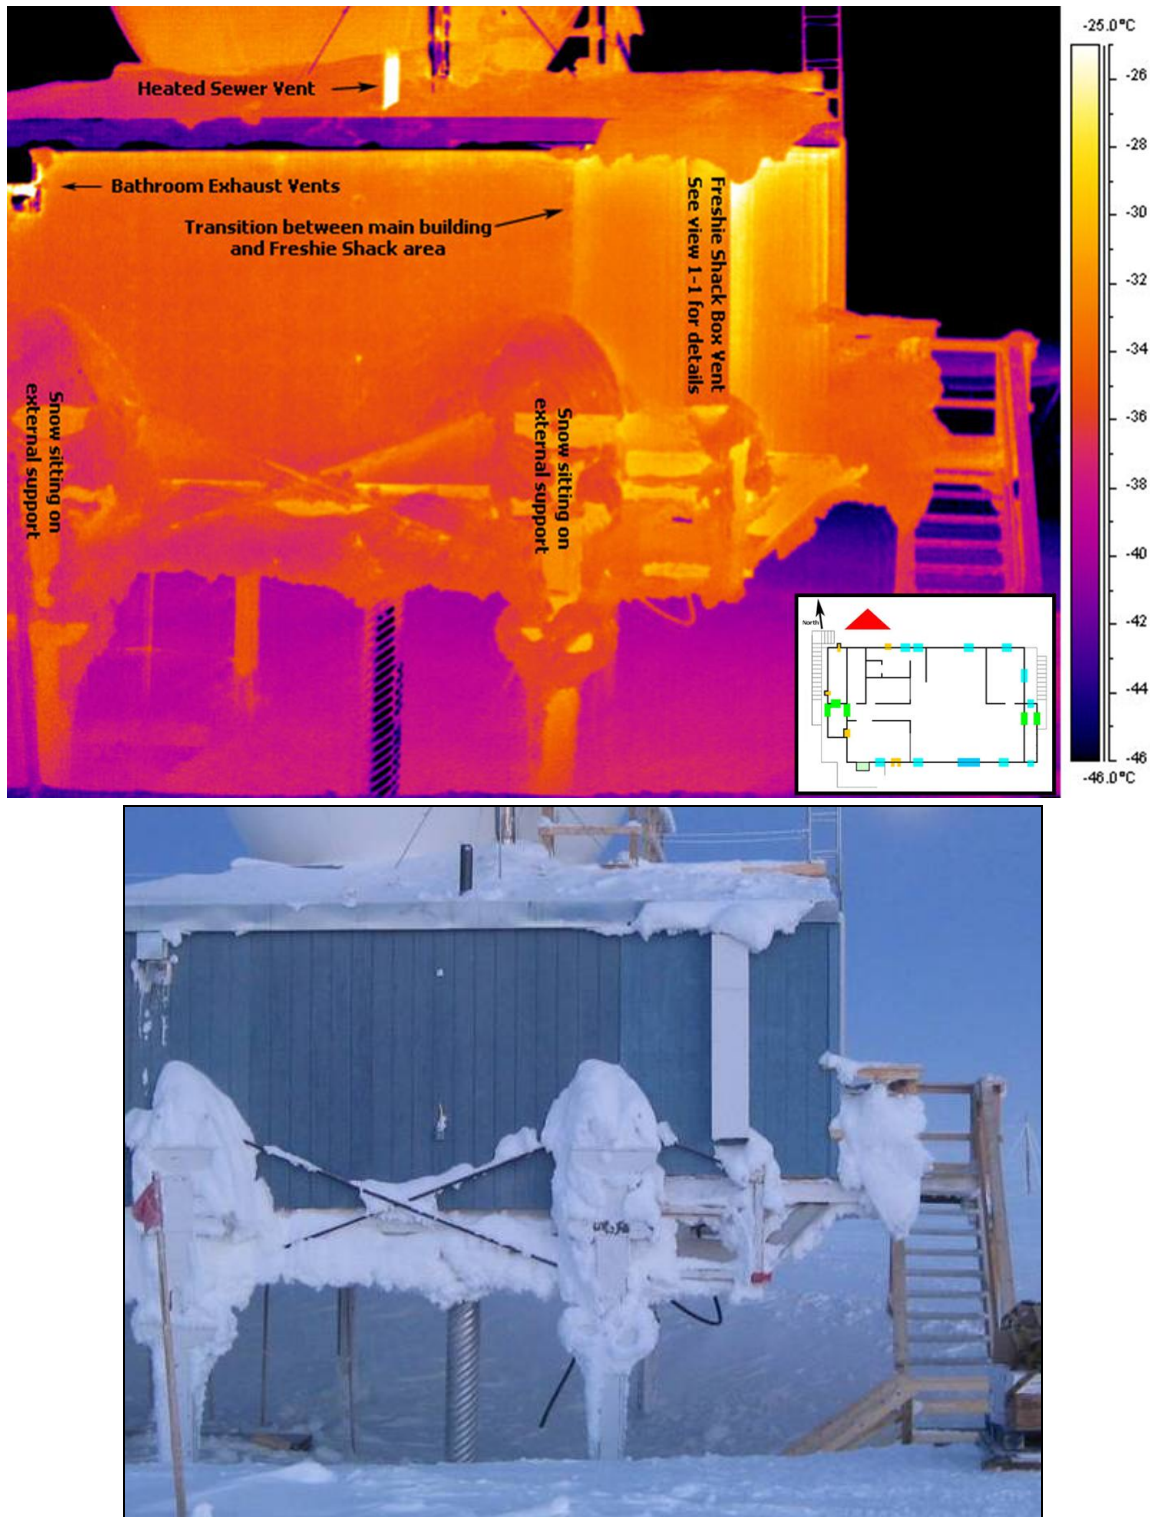
Beginning on the north side western end of the Big House, **View 1** (Fig. 14) includes the exterior wall of the mechanical room, freshie shack, and access stairway of the west entrance. The west vestibule (with dimensions of 2 m wide \times 6.8 m long) was added to the main structure in 2006 (CPS and NSF 2009). There is a slight amount of frost buildup at the bottom of the fresh air vent to the freshie shack. The bright spot on the roof is the heated vent pipe for the sewer in the mechanical room. The transition between the original construction and the freshie shack shows some heat loss at the common wall between them. The bright area along both the sides and bottom of the fresh air vent indicates heat loss out of the freshie shack, although the vent on the inside was covered with cardboard. The freshie shack consists of a 100-mm SIP, covered with an interior metal skin commonly used for food storage. The exterior of the west vestibule is 12.5-mm T-111 siding and, on the north side of the building, is aligned flush with the existing T-111 siding.

Figure 14. View 1 showing location (inset), thermal, and visual image of the exterior North side West end.

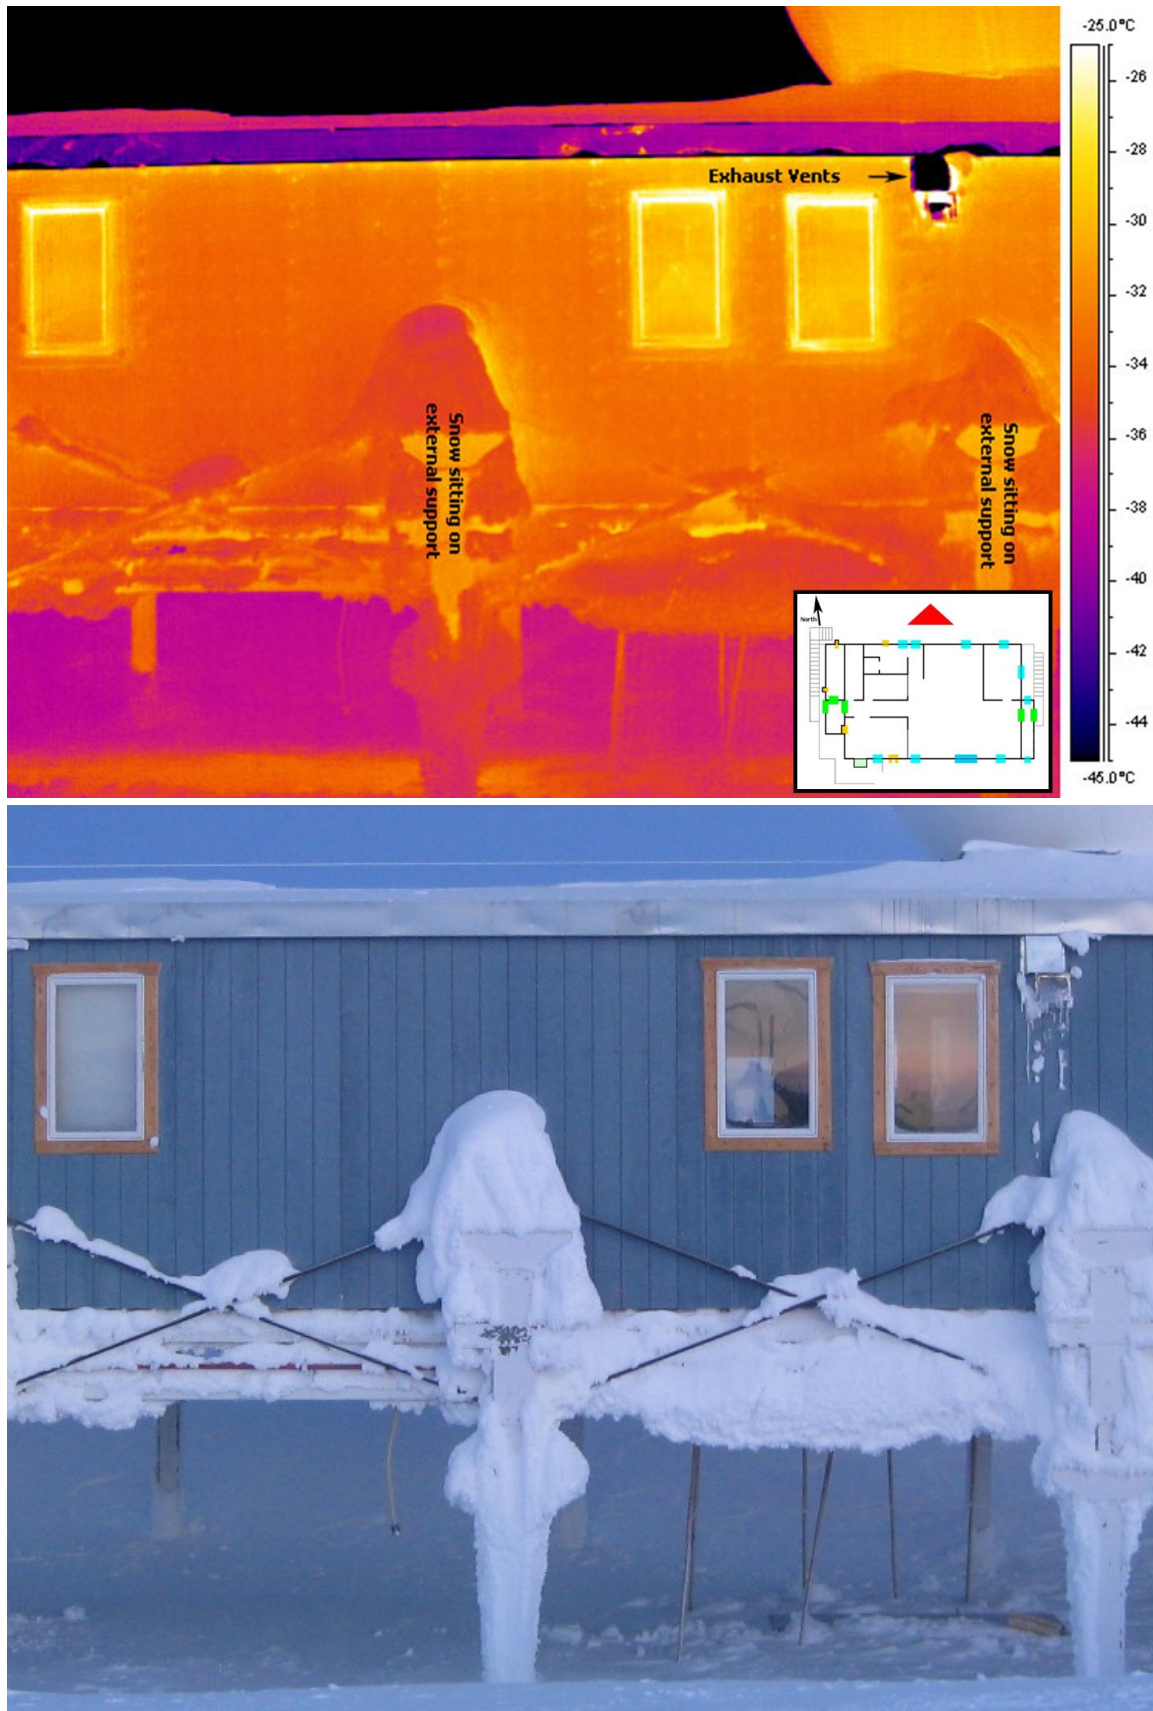
The set of images in Figure 15 are from **View 2** in the mid-section of the north exterior wall. The main room window is on the far left and the windows to the right are those in the hallway and laundry room/bathroom.

Figure 15. View 2 showing location (inset), thermal, and visual image of the mid-North exterior wall in the vicinity of the laundry room and main room.

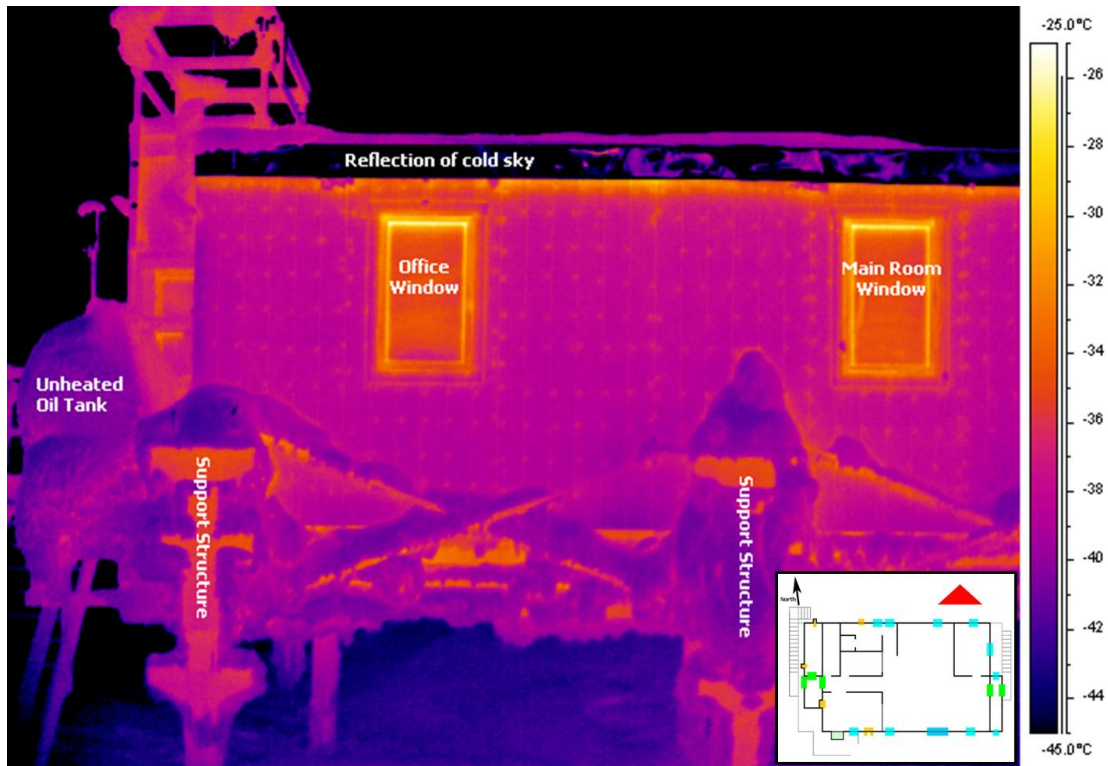
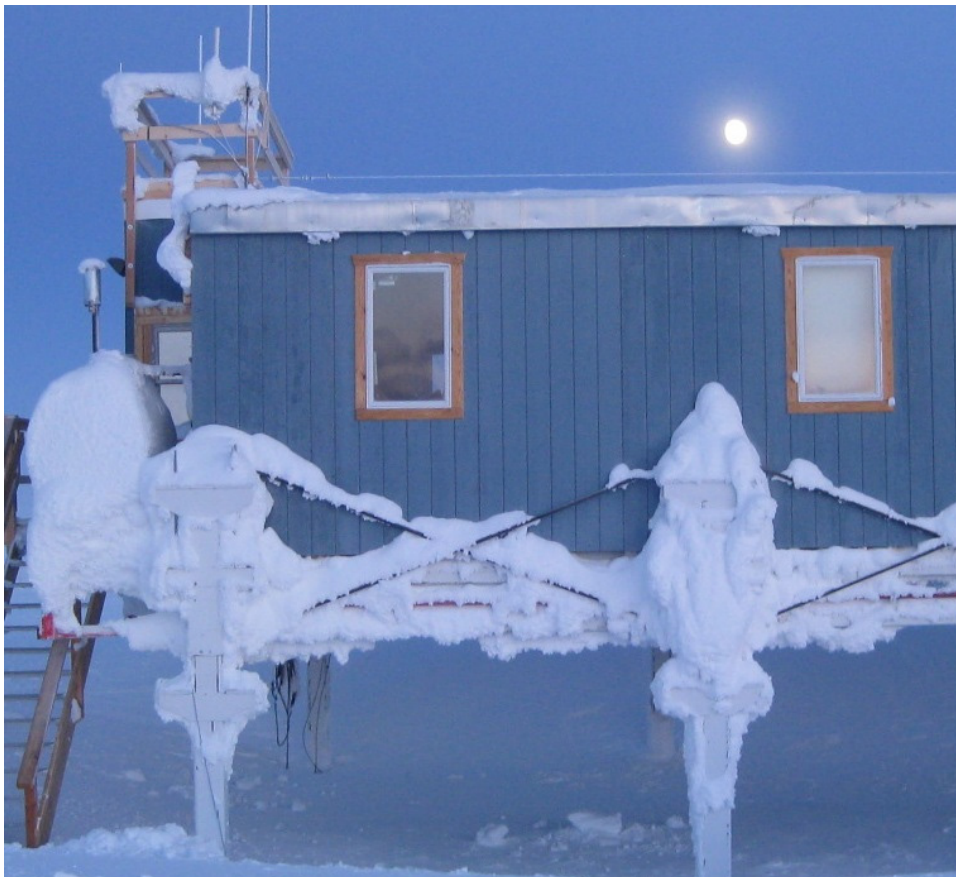
The images at the eastern end of the north wall, as shown in **View 3** (Fig. 16), include the office window (left) and the main room window (right). Both windows are wood frame, double-pane casement. The fuel tank on the deck is the round, snow-covered object located on the far left in the image. Consistent with the windows in **View 2**, the headers at the top of both windows have a brighter area in the IR image, indicating heat loss, and there is more heat loss through the window pane compared to the wall. Heat loss at the top of a window is common as this is a discontinuity within the wall system, and there may be a gap between the wall and the window frame.

Figure 16. View 3 showing location (inset), thermal, and visual image of the eastern end of the North exterior wall in the vicinity of the office and main room.

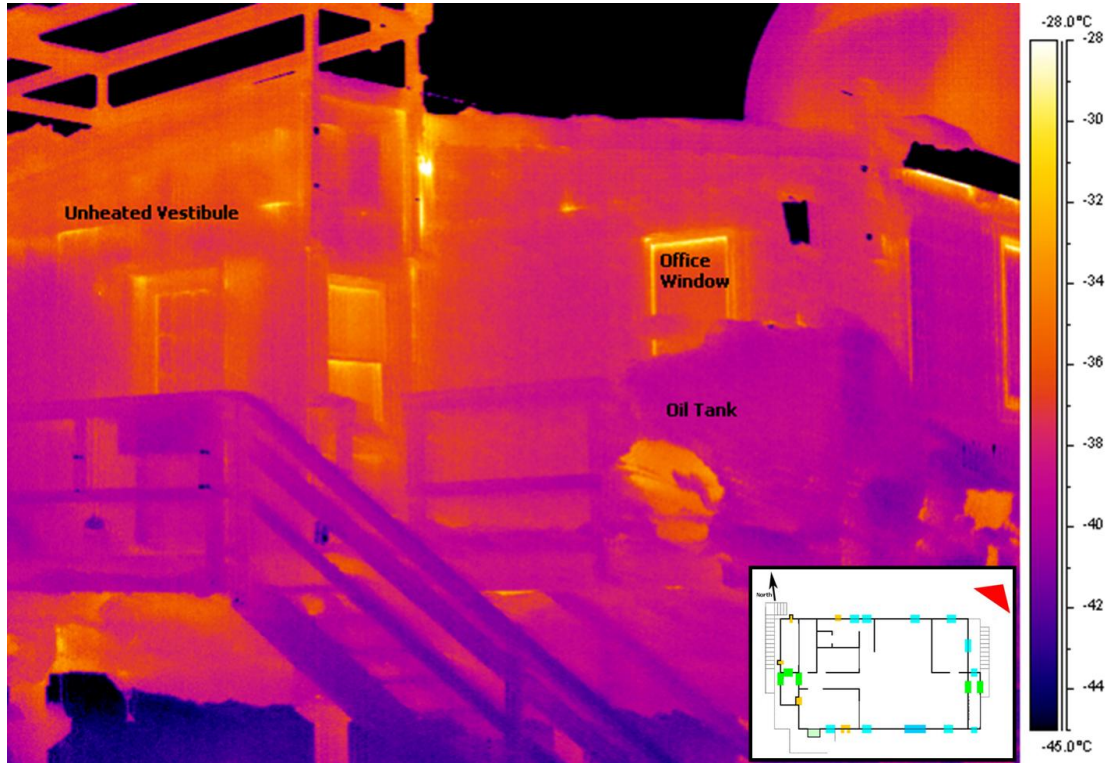
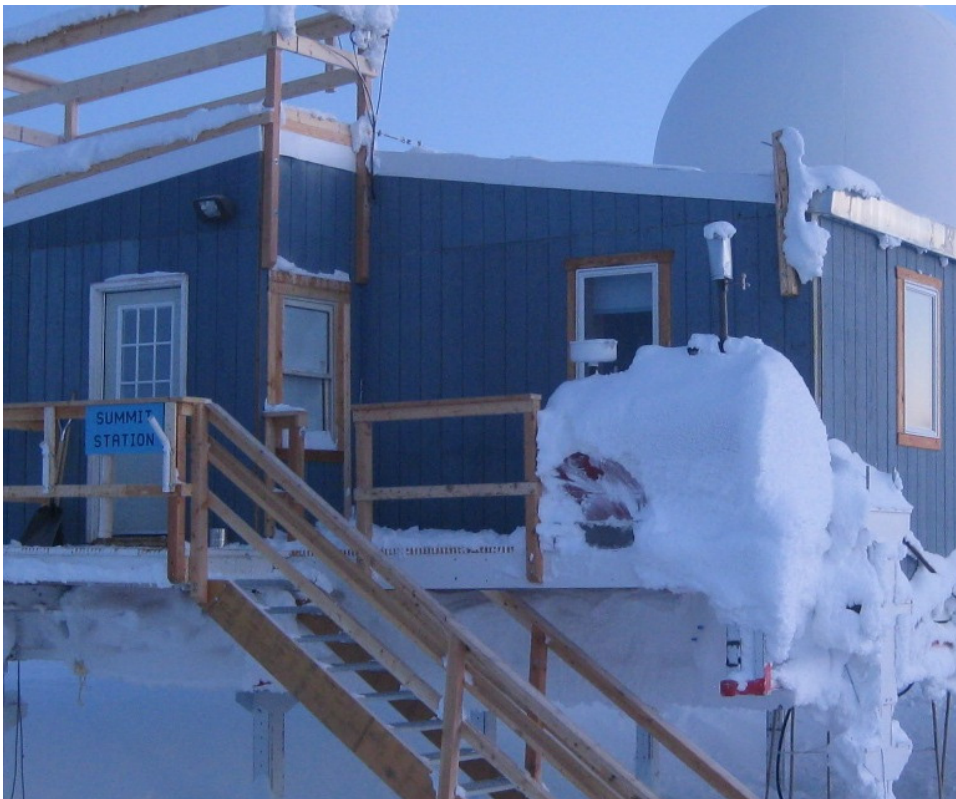
horizontal line above the doorway in the vestibule shows heat loss through the seam where the ends of the T-111 sheathing butt together. This is also clearly visible in the next IR image.

Figure 17. View 4 showing location (inset), thermal, and visual image of the northeastern corner including the office and eastern unheated vestibule.

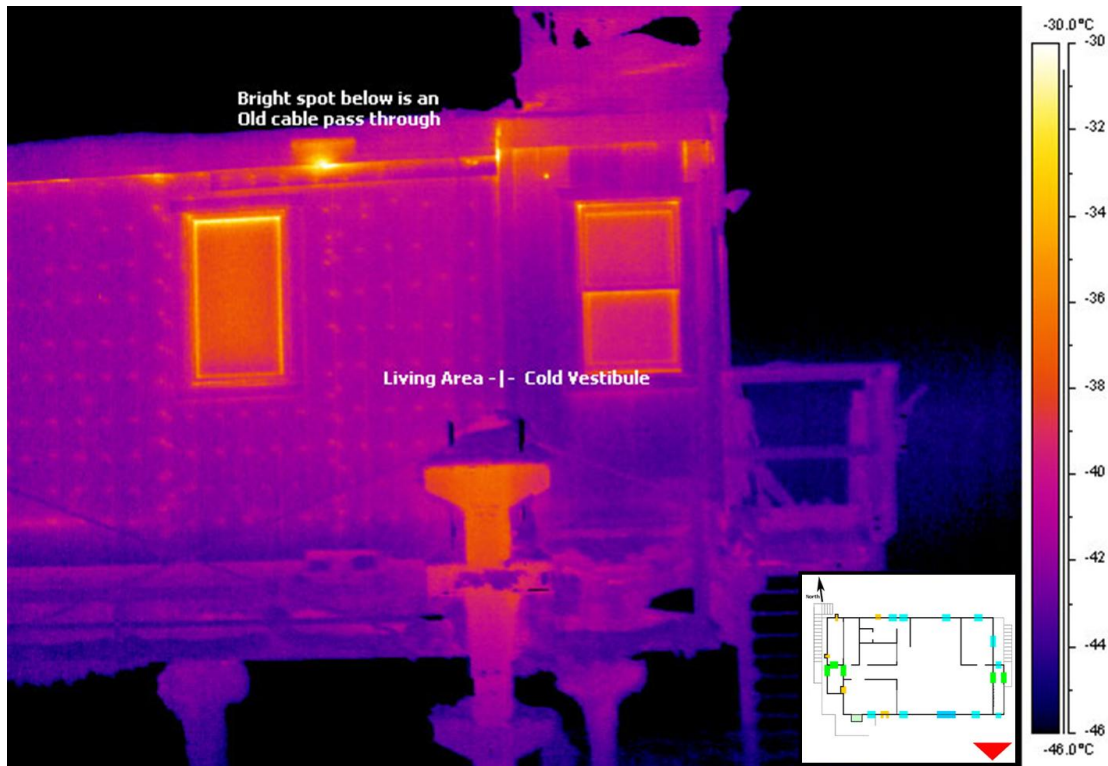
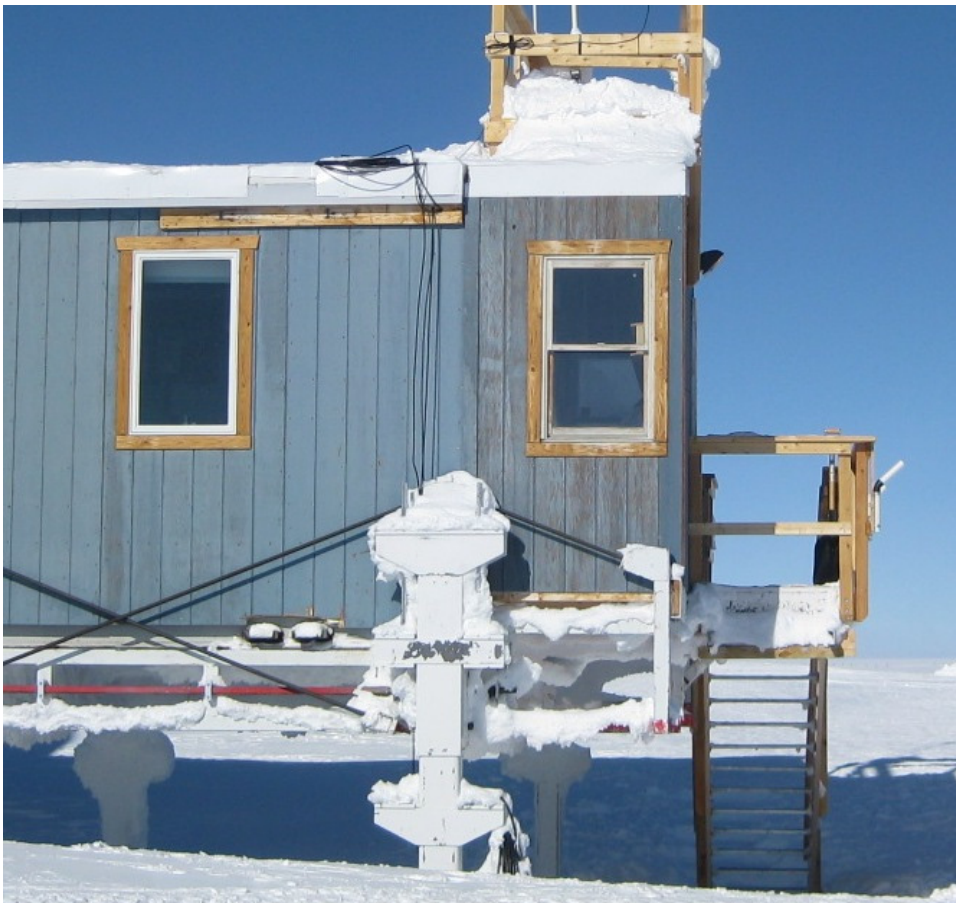
Along the eave are two bright spots showing heat loss from penetrations where previous instrumentation was mounted to the exterior (to the right of the main room window) and existing cables' pass-through to the roof (at the common wall between the main room and vestibule). The area on the right was sealed from the interior prior to the ERDC-CRREL field visit. Re-insulating the empty cavity through the wall should be considered to completely seal the opening and reduce heat loss. Designated cable conduits through the building envelope should be considered to decrease the number of penetrations for cables. This also ensures that the opening can be properly insulated.

Figure 19. View 7 showing location (inset), thermal, and visual image of the eastern end of the South exterior wall in the vicinity of the main room and east vestibule.

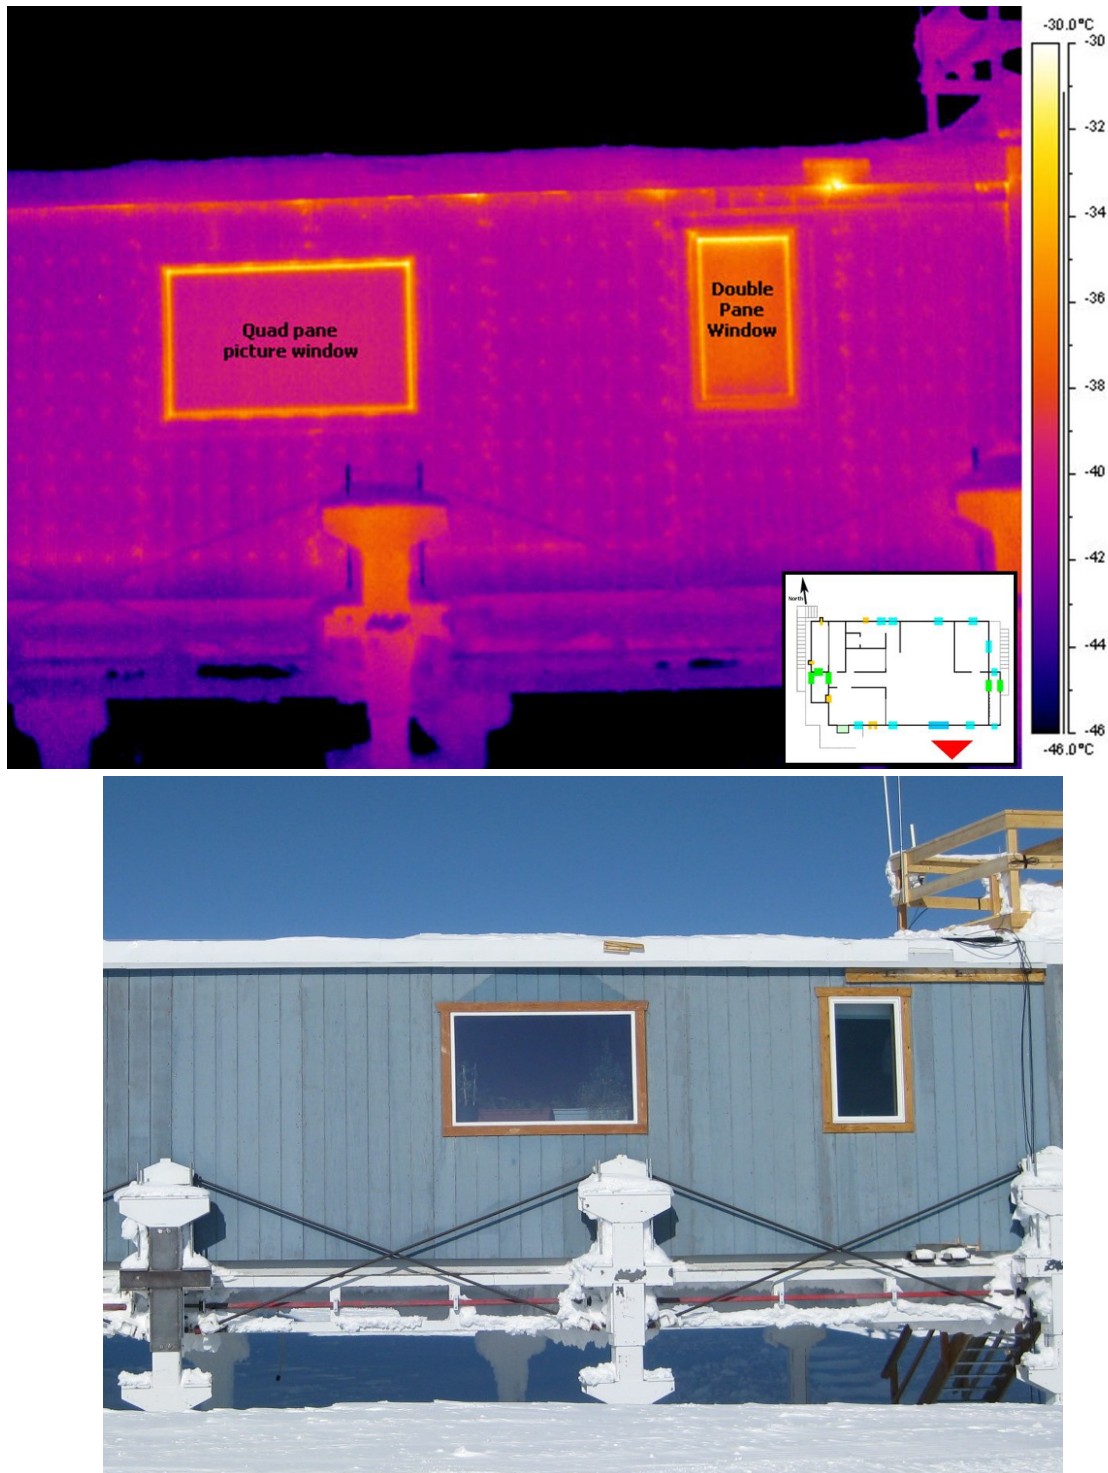
Both windows are the same type as the other casement windows previously mentioned and show similar characteristics in the IR image, with heat loss at the window header. The window on the right in the main room shows additional heat loss, and has about a 5°C temperature difference at the four bright spots under the window. This heat loss may be associated with the installation of the window, possibly ascribable to the counter on the interior that blocks the very bottom portion, or degradation of the window over time from moisture.

Figure 20. View 8 showing location (inset), thermal, and visual image of the South exterior wall in the vicinity of the main room.

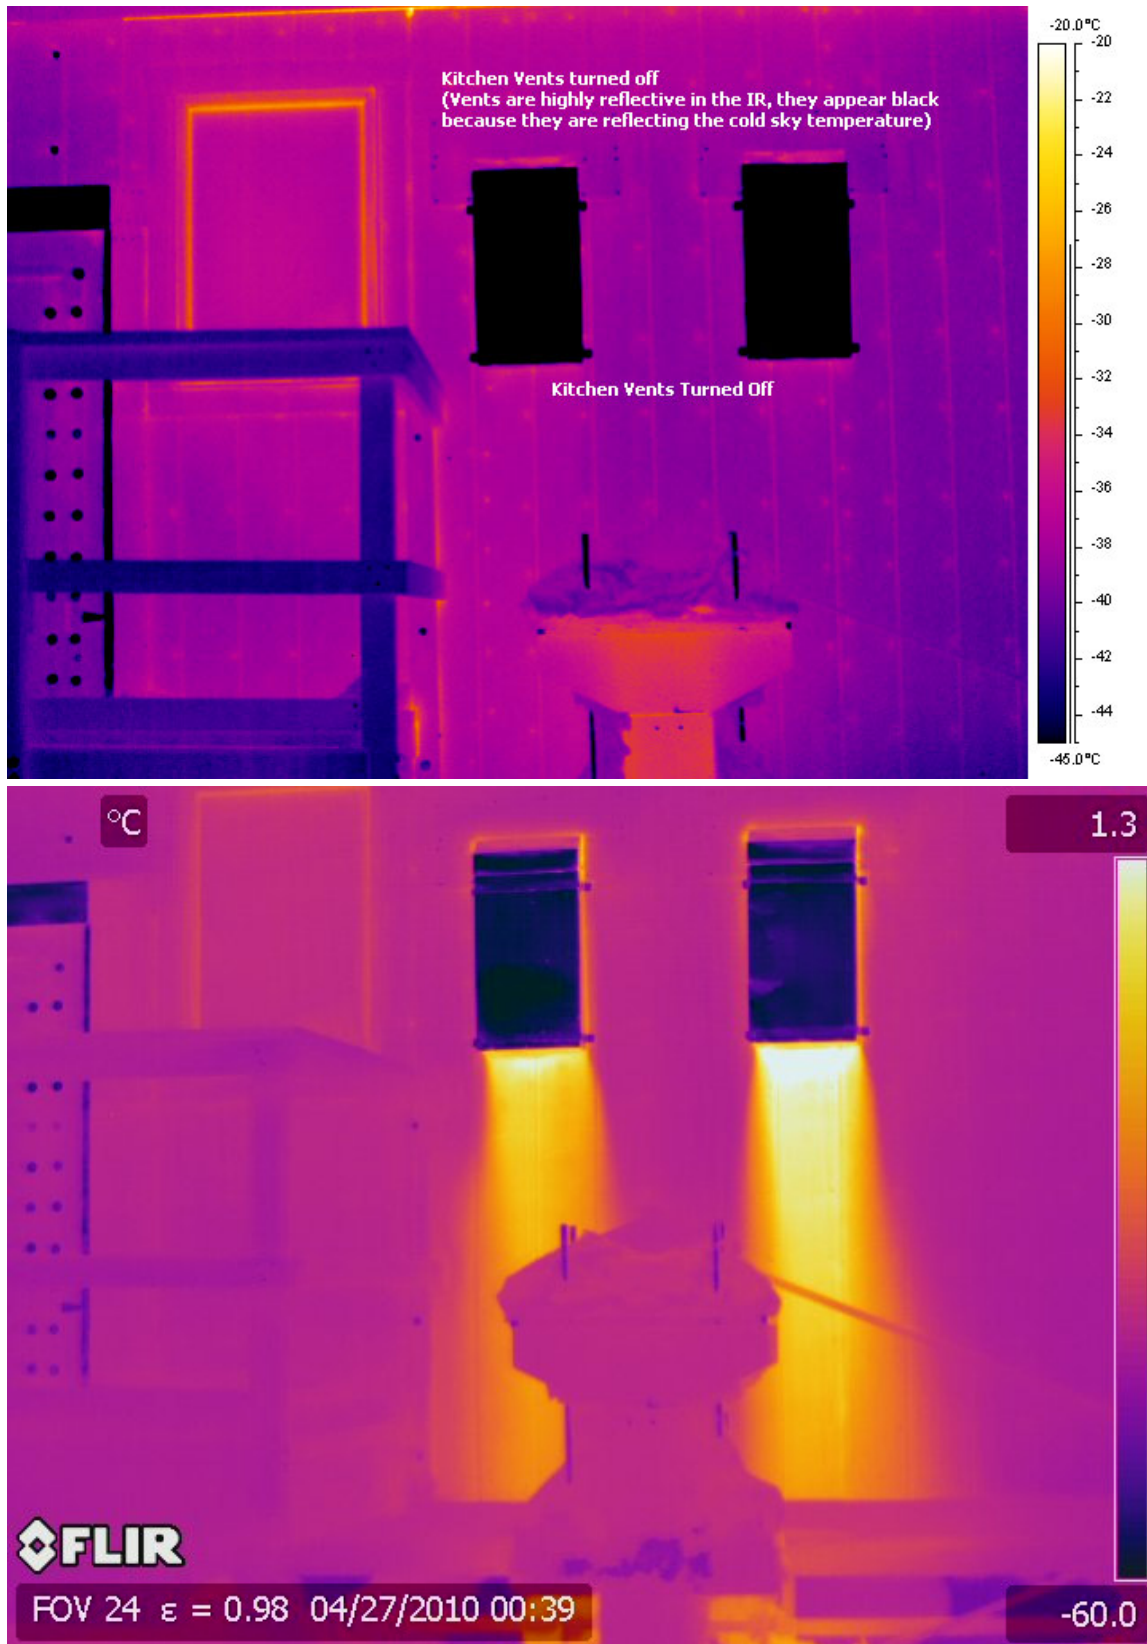
IR imagery taken from the outside of the Big House shows the impact of stove vents expelling warm air to the outside. Conversely, when the vents are not in use, cold air infiltrates the building through the vents.

Figure 22. Thermal image taken before and during stove vent operation.

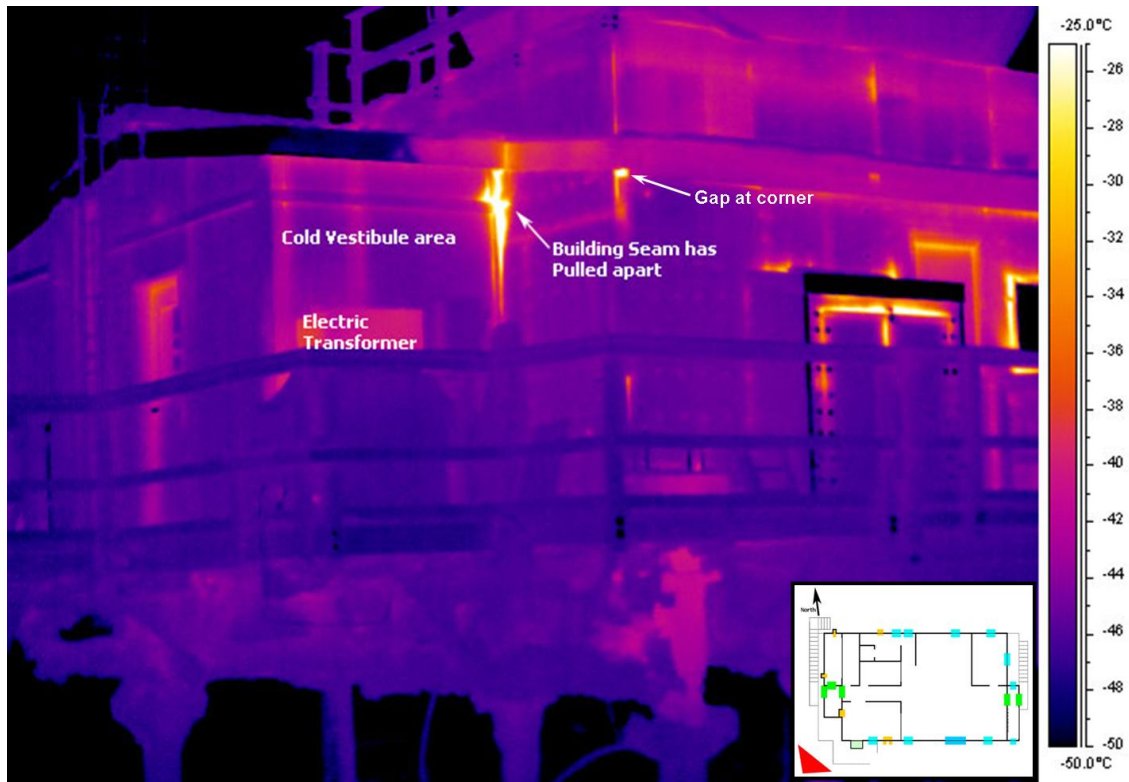
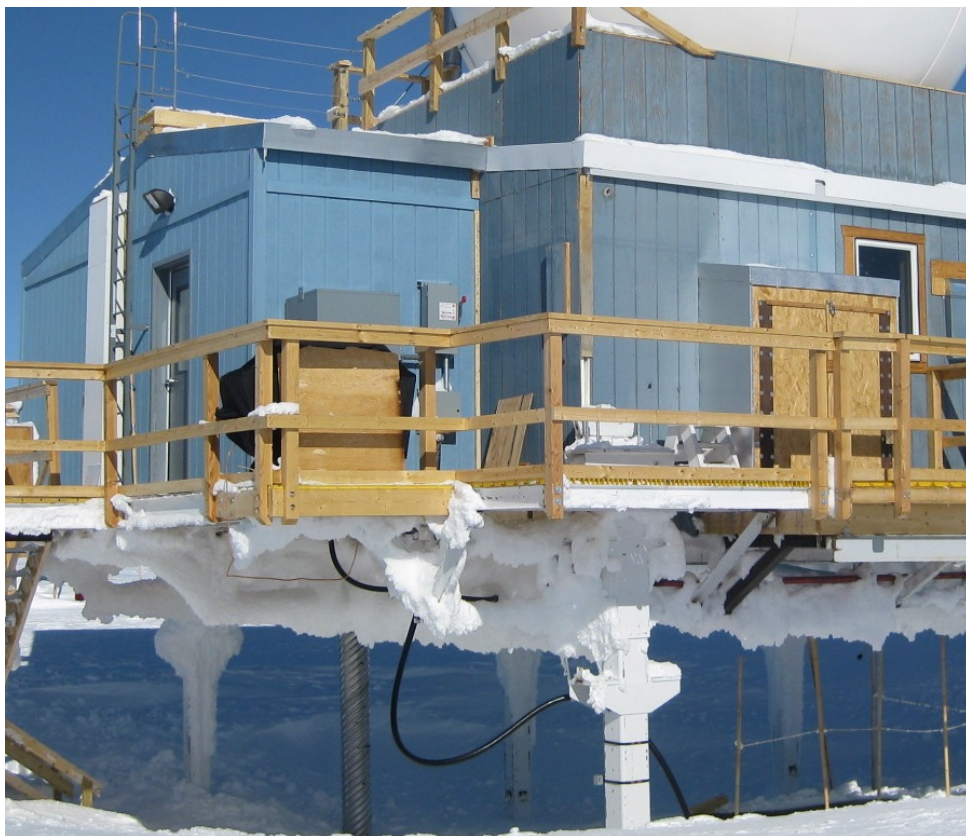
The southwestern corner of the building is shown in **View 12** (Fig. 24) where the west unheated vestibule connects to the main building. The southern portion of the vestibule contains shelving for dry goods and also houses the 600- × 600-mm fresh air intake into the kitchen. The very bright spot at the interface between the main building and the vestibule is a gap indicating excessive heat loss. Further to the right, at the corner of the main building, the bright spot there is from a gap at the eave created when the building was re-sheathed (Fig. 25).

Figure 24. View 12 showing location (inset), thermal, and visual image of the of the southwest corner where the west vestibule connects to the main building

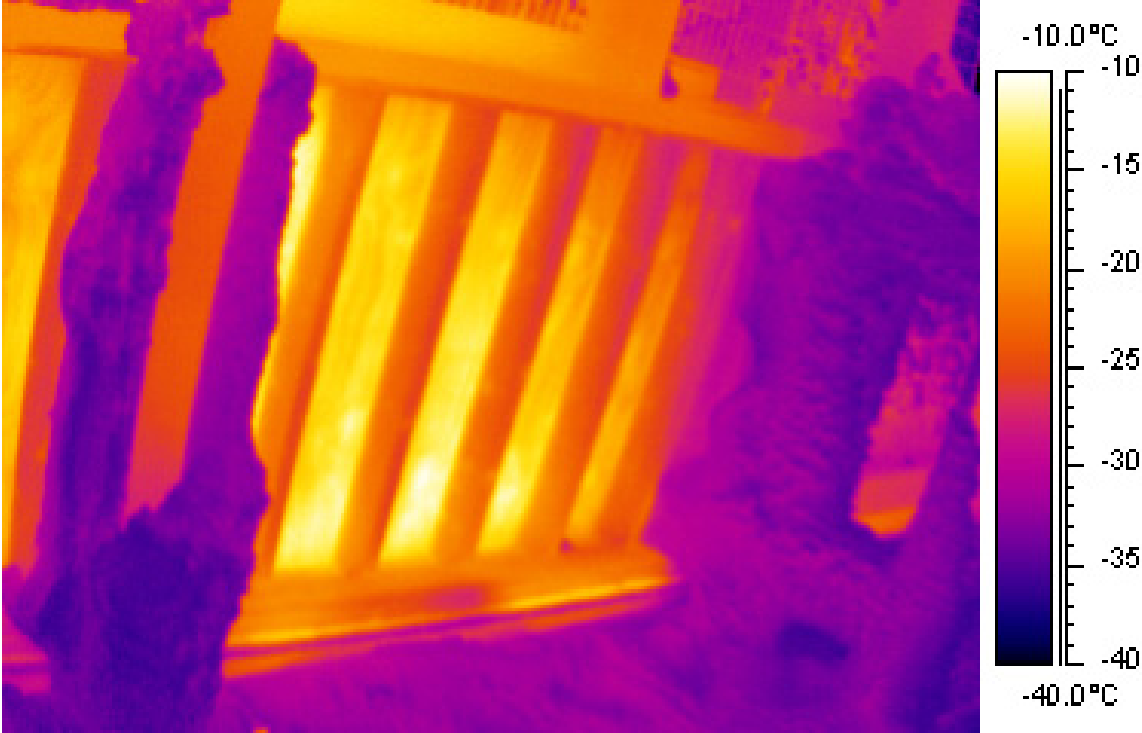
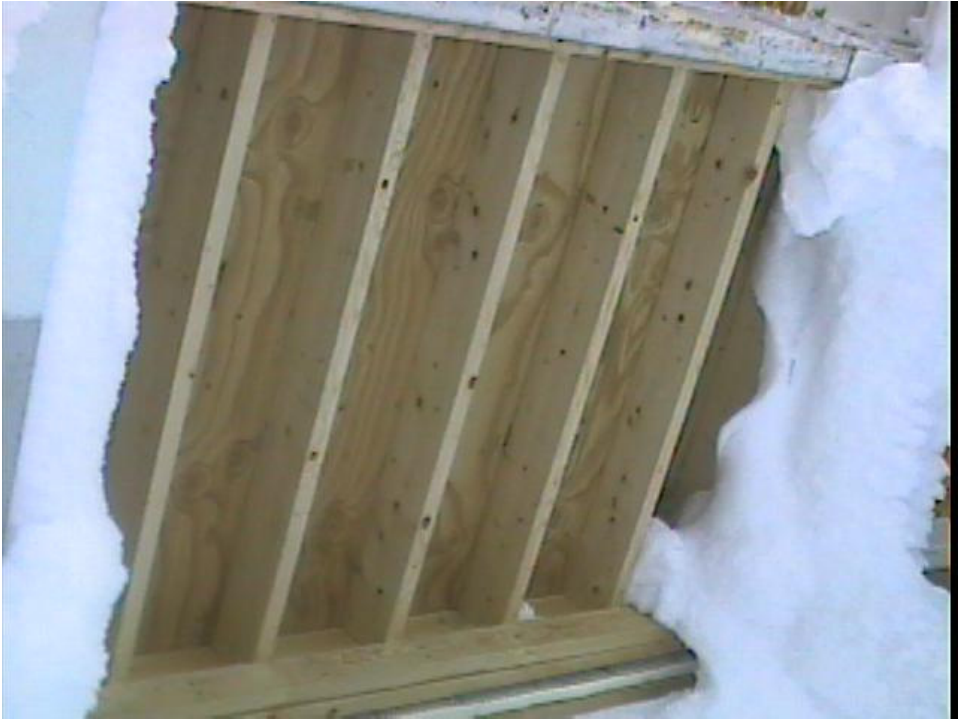
Figure 29. View showing thermal and visual image of heat loss through base of unheated eastern vestibule.

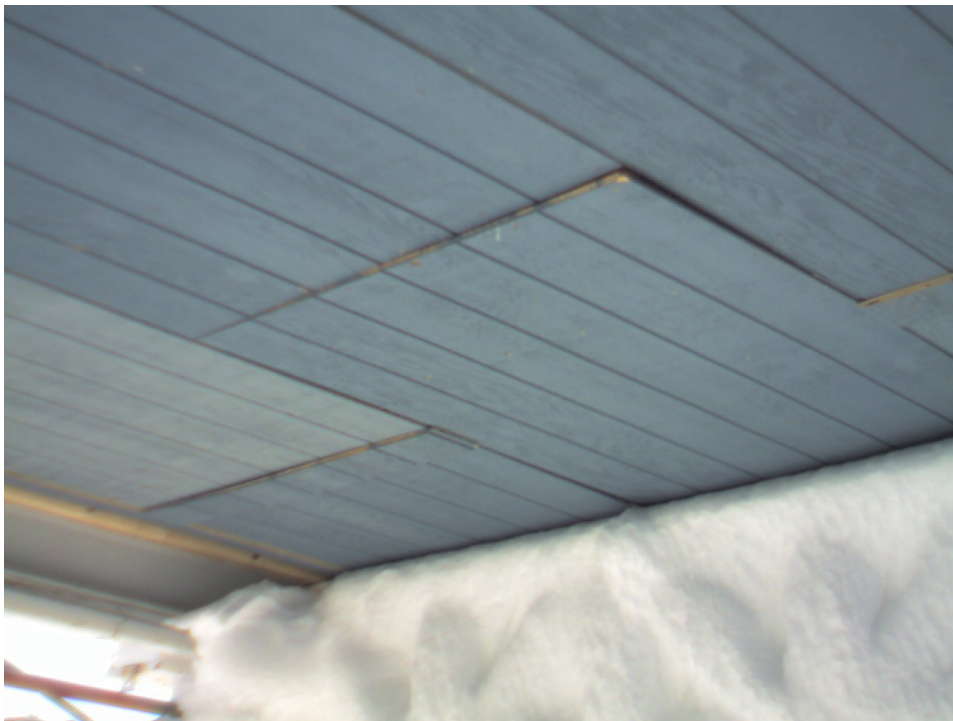
The IR imagery of the exterior base of the structure did not show significant heat loss through the floor. Other than open active vents, the blocked-off vent in the floor of the mechanical room was the only bright spot in the IR imagery. Several pieces of loose sheathing on the underside of the building should be reattached.

Figure 30. View showing thermal and visual image of unsecured sheathing on base of building.

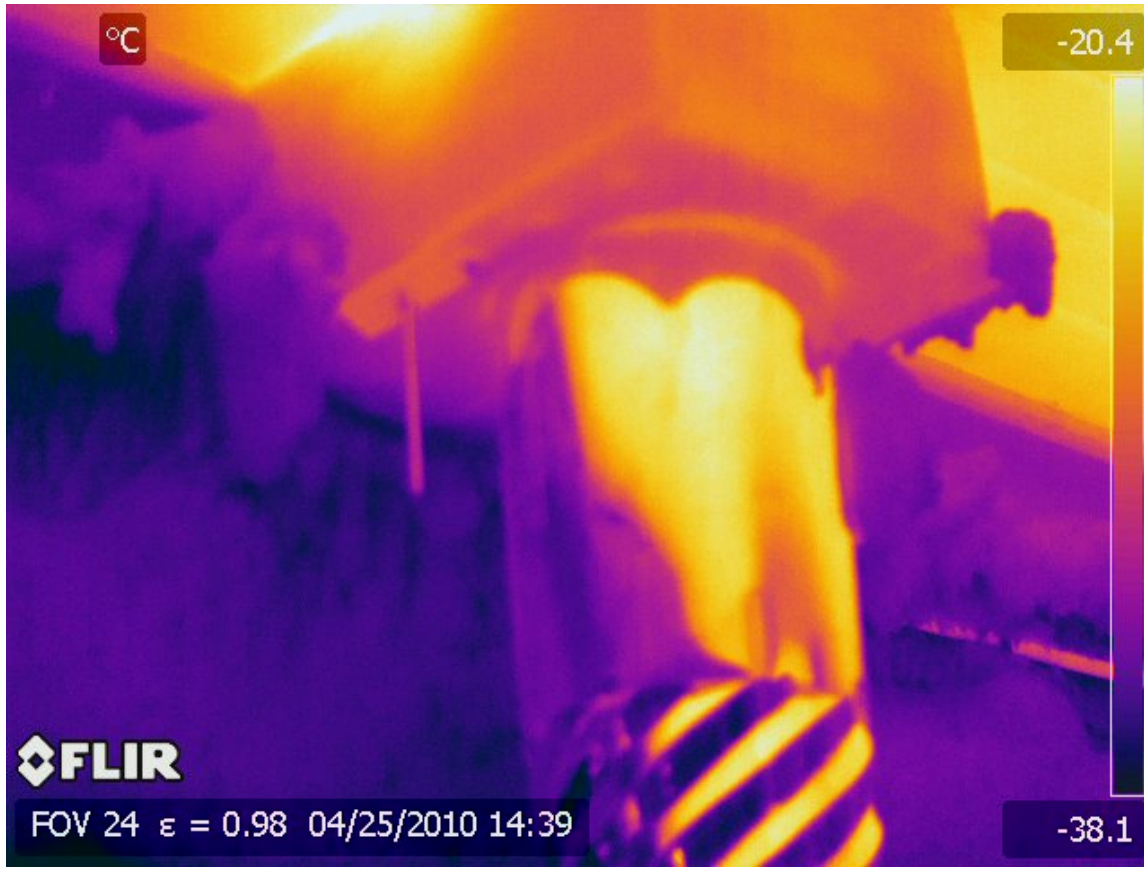
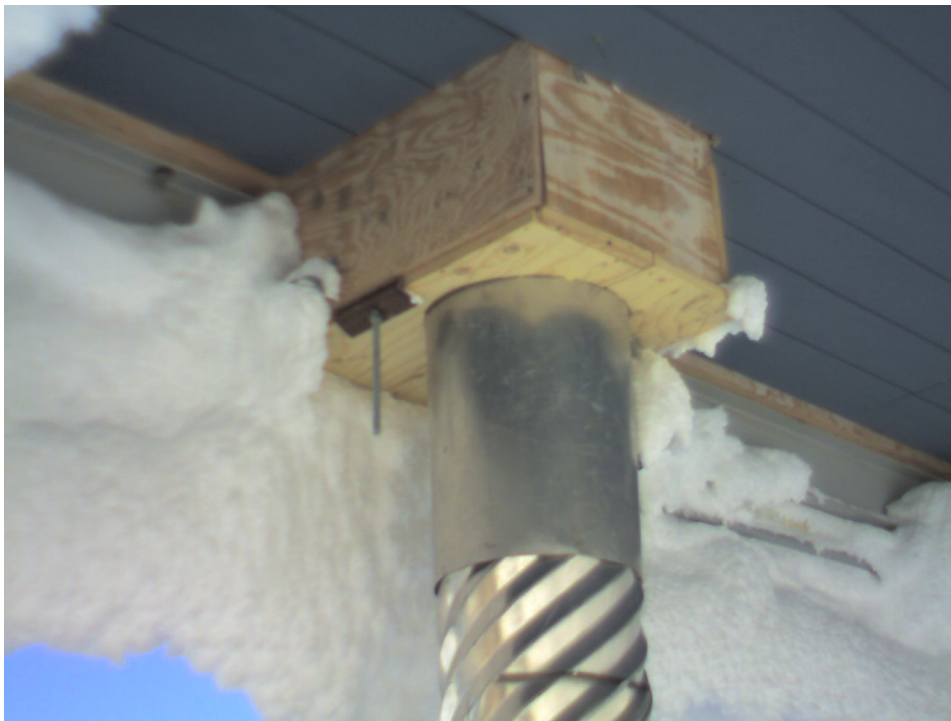
Lastly, Figures 31 and 32 show IR and visual images of the sewer outfall pipe and the opening of the fresh air intake vent in the kitchen, respectively. The sewer outfall pipe shows some heat loss at the interface between the housing around the pipe and the base of the building. Likewise, there is heat loss from the kitchen through the air intake vent.

Figure 31. Base of the building, IR and visual images of the sewer outfall pipe.
