Engineering Assessment of Big House at Summit Station, Greenland

Final Report

April 2011

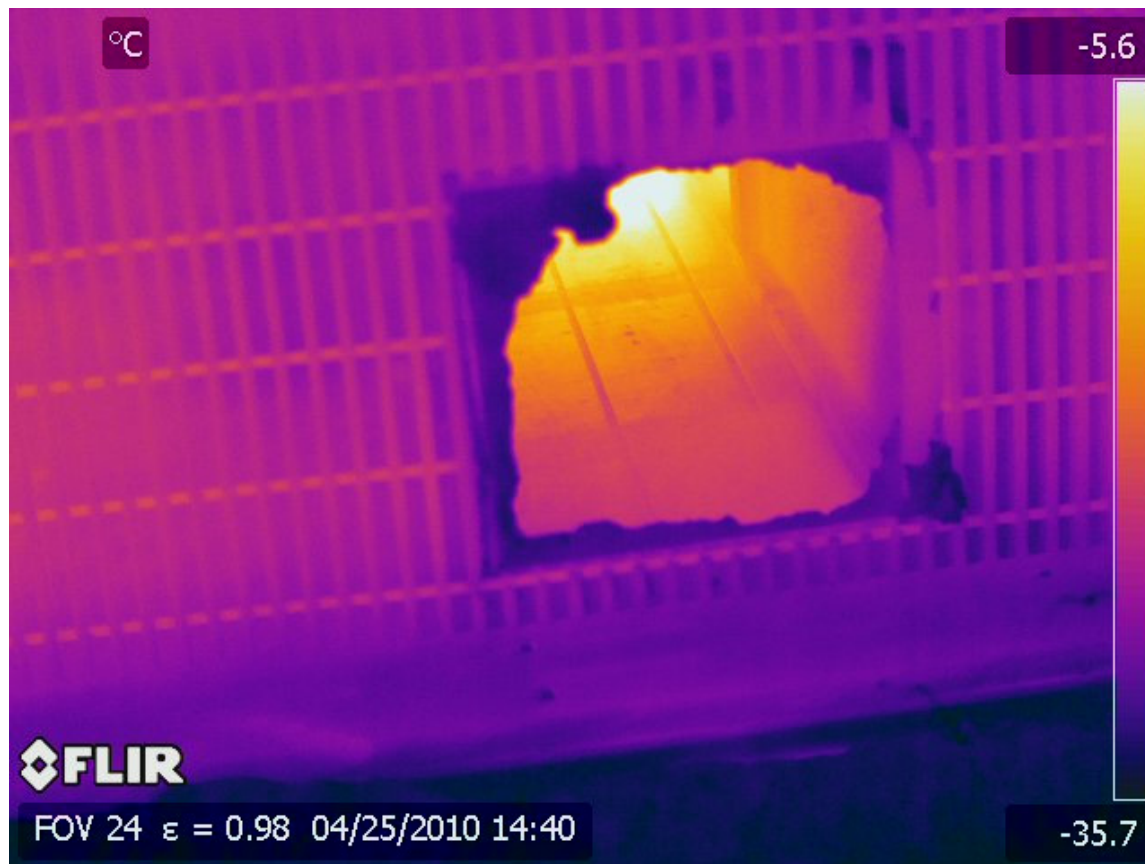
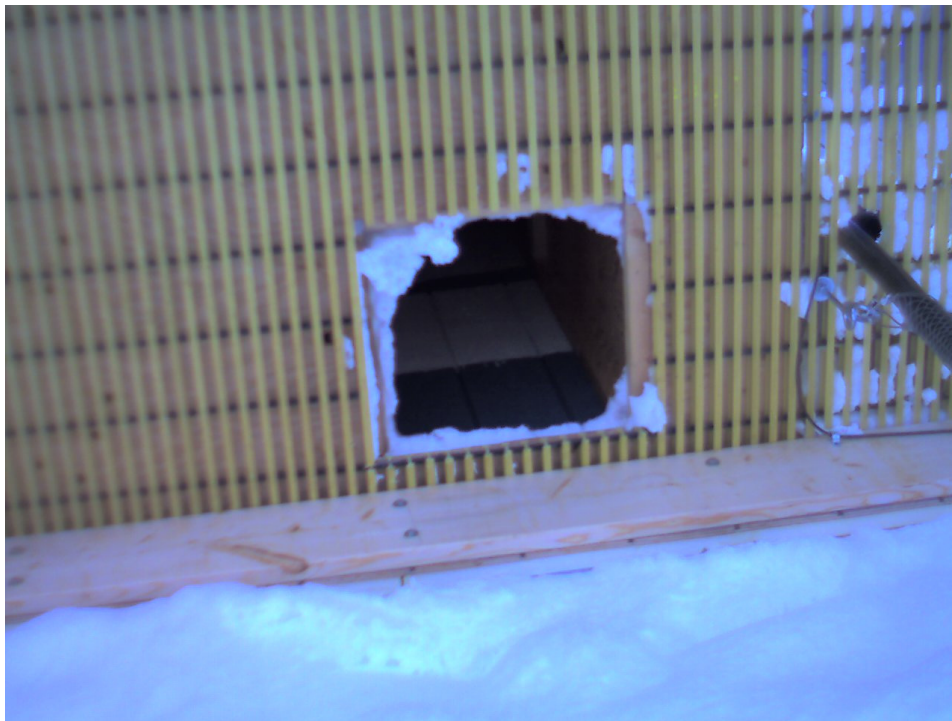
Lastly, Figures 31 and 32 show IR and visual images of the sewer outfall pipe and the opening of the fresh air intake vent in the kitchen, respectively. The sewer outfall pipe shows some heat loss at the interface between the housing around the pipe and the base of the building. Likewise, there is heat loss from the kitchen through the air intake vent.

Figure 32. Base of the building, IR and visual images of the kitchen air intake vent.

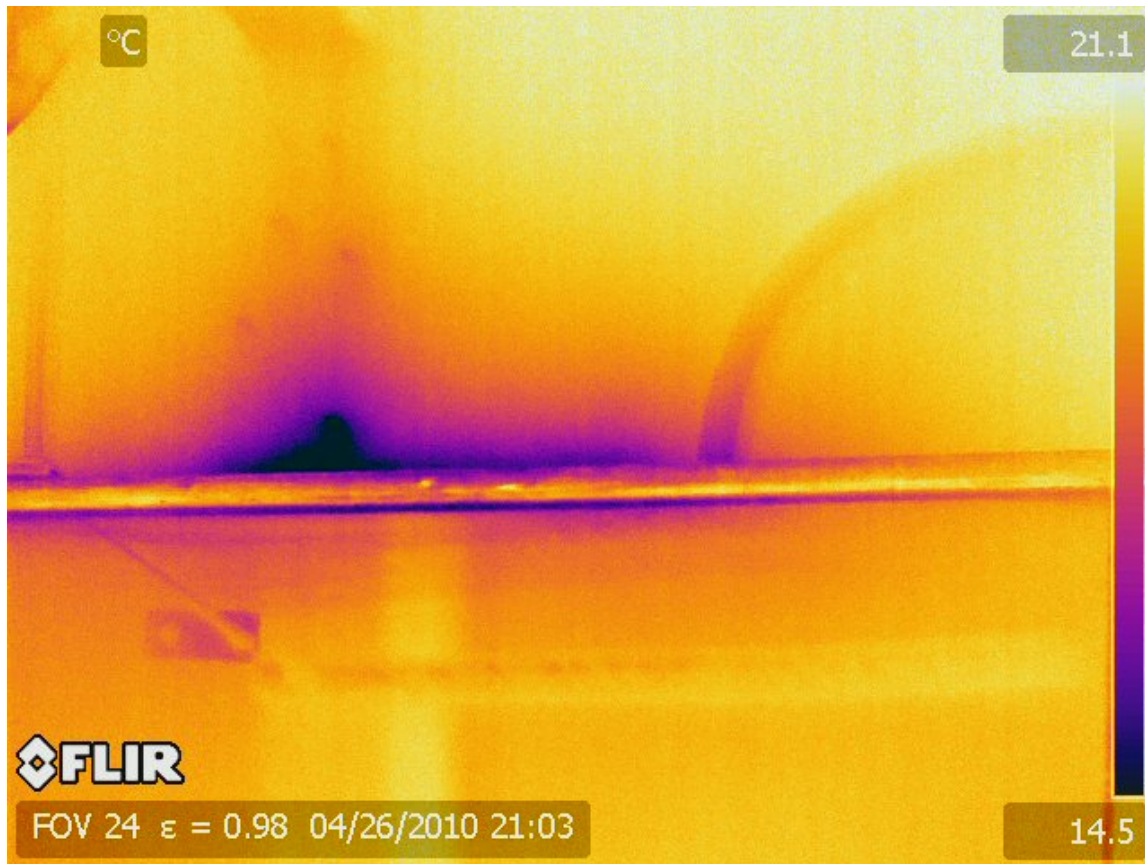
Also seen in Figure 35 is the sealant used around roof beams and along the roof-wall interface. This keeps the moisture from migrating through the wall.

Figure 35. IR and visual images of the roof-wall interface behind the stove in the kitchen.

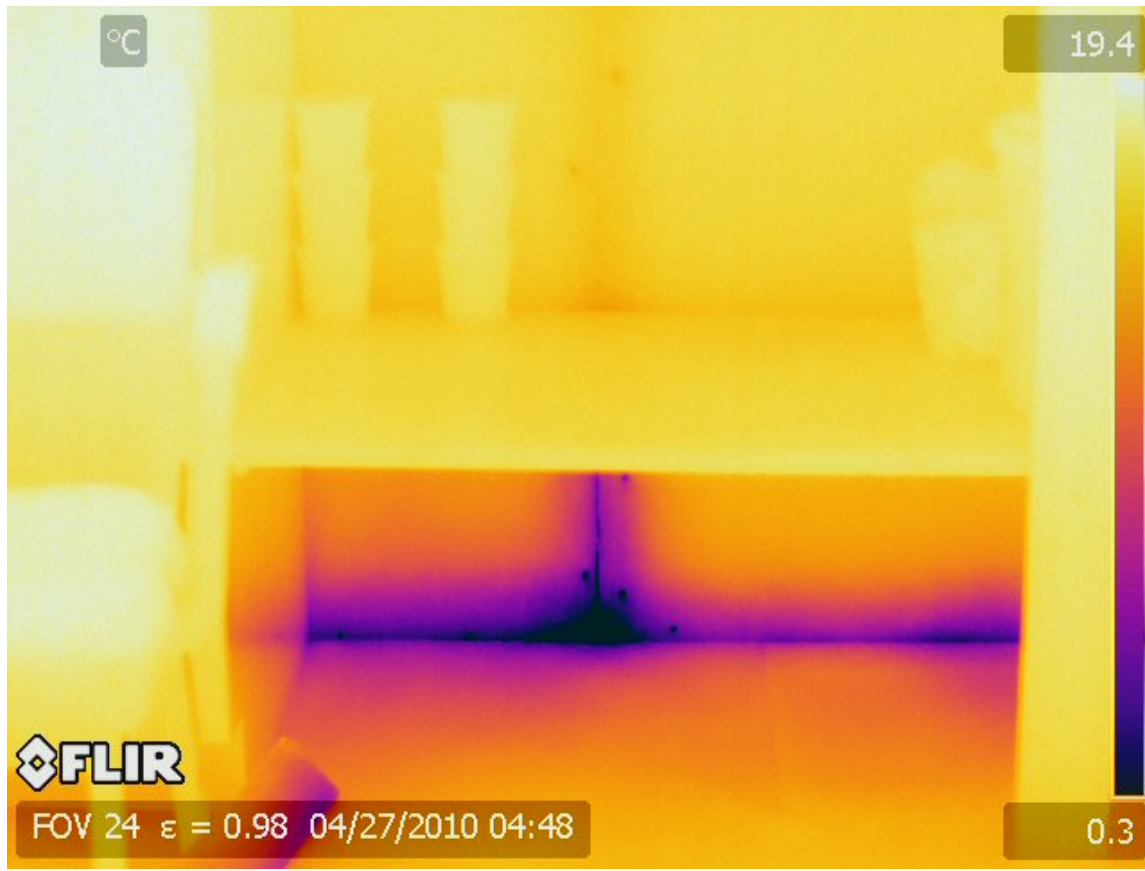
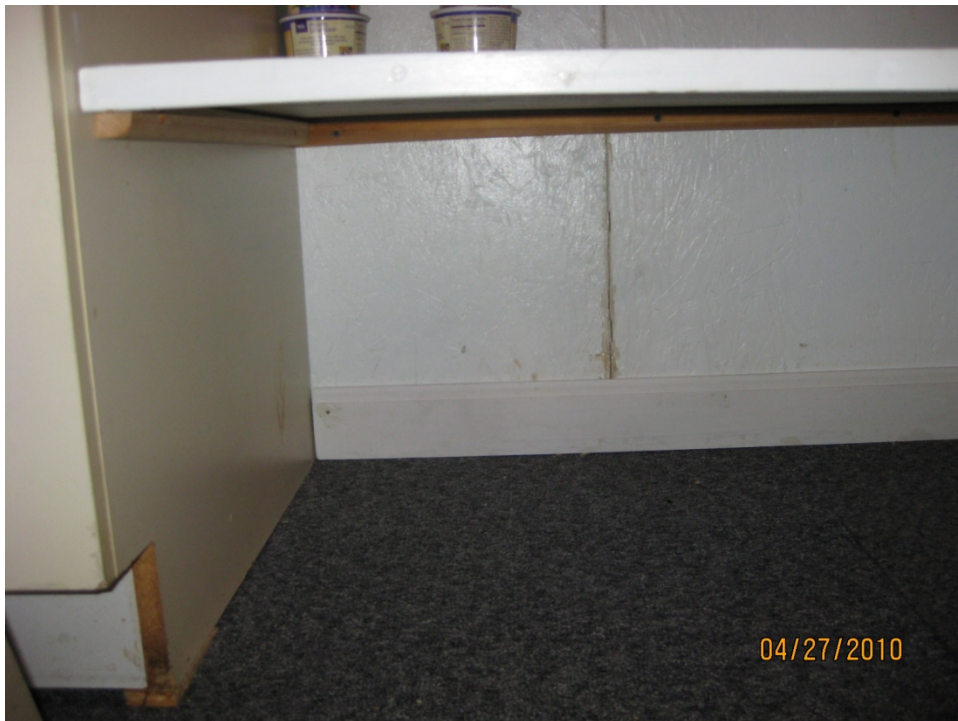
Figure 36. IR and visual images of the cold location under the counter in the main room before it was sealed.

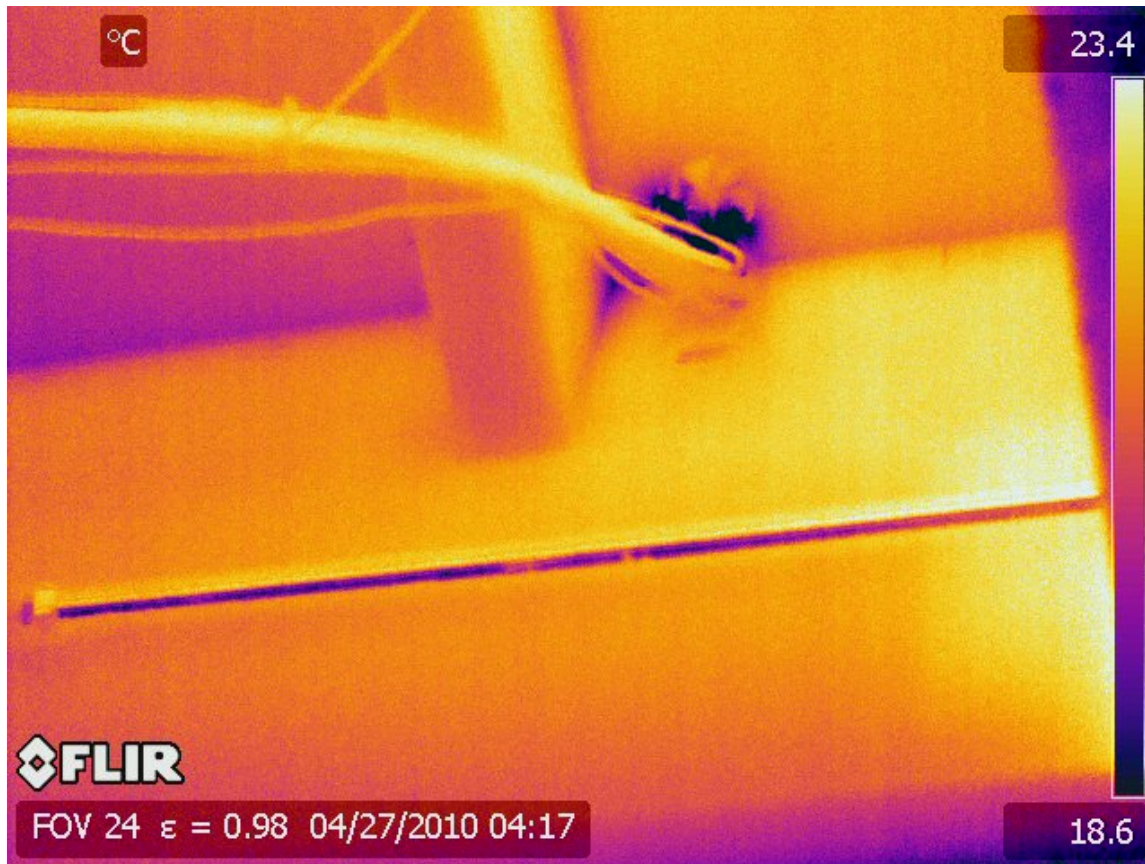
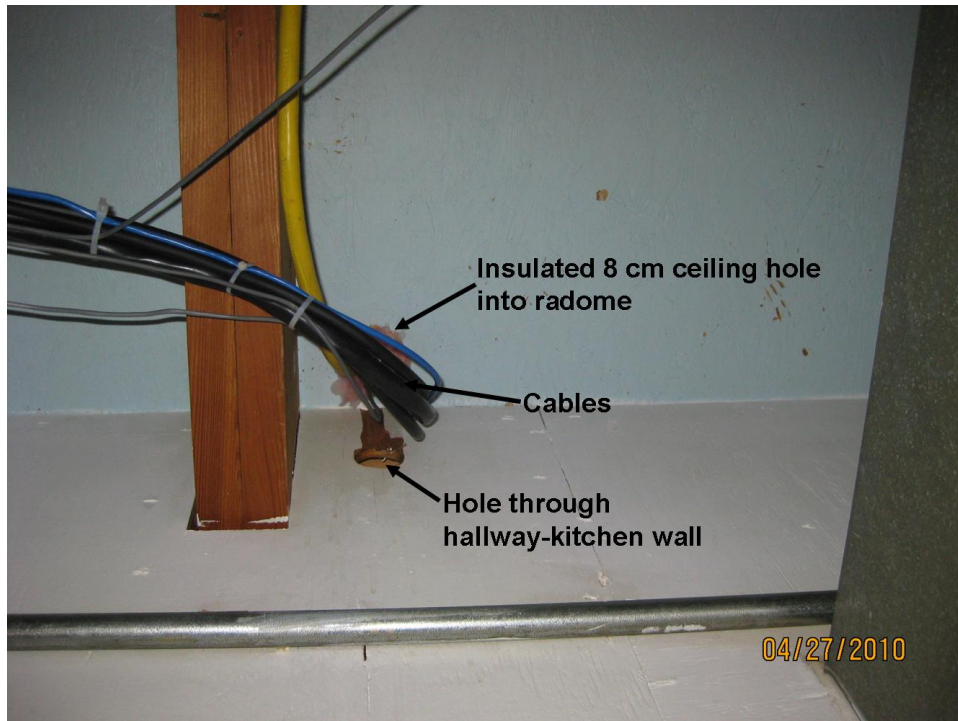
The radome on the roof was not observed to be a significant contribution to heat loss. However, there is some heat loss from the inside of the Big House where the cables run through the ceiling up into the radome.

Figure 38. IR and visual images of the ceiling in the hallway where cables pass through into the radome.

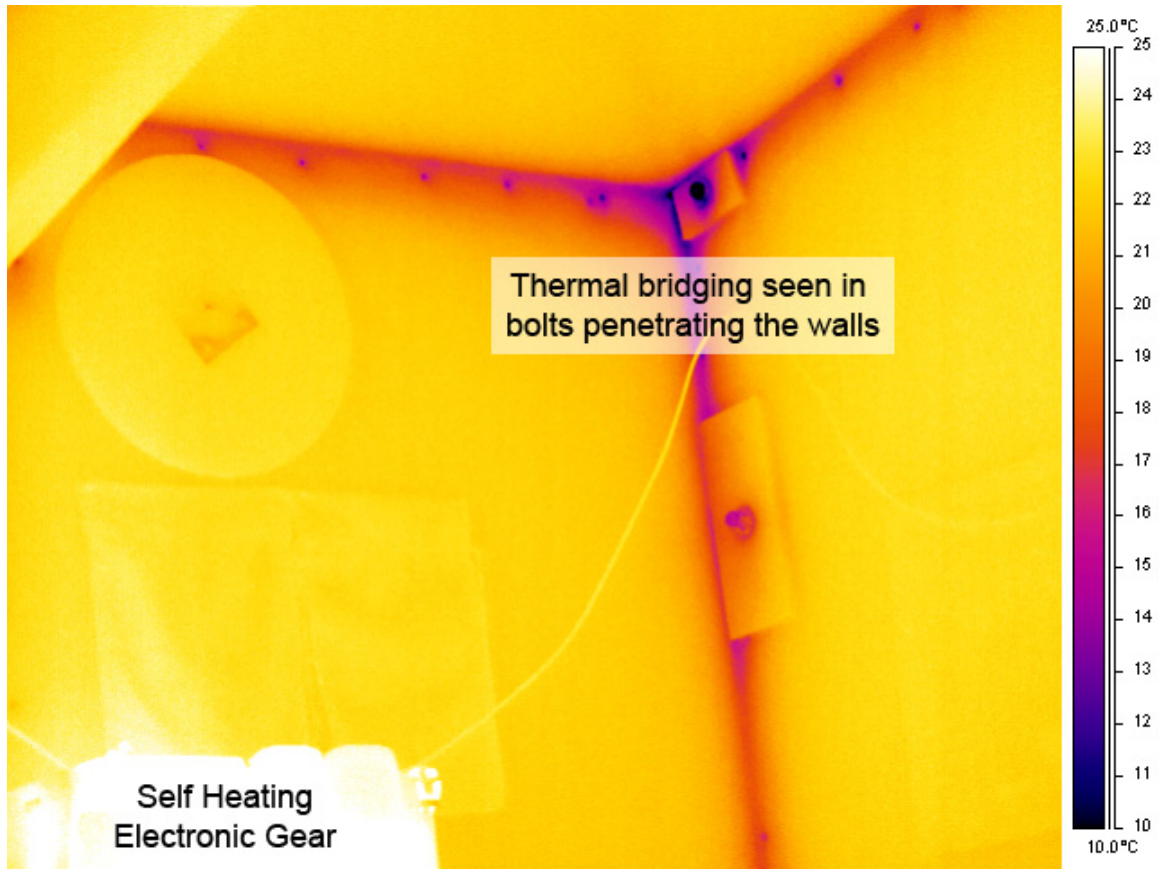
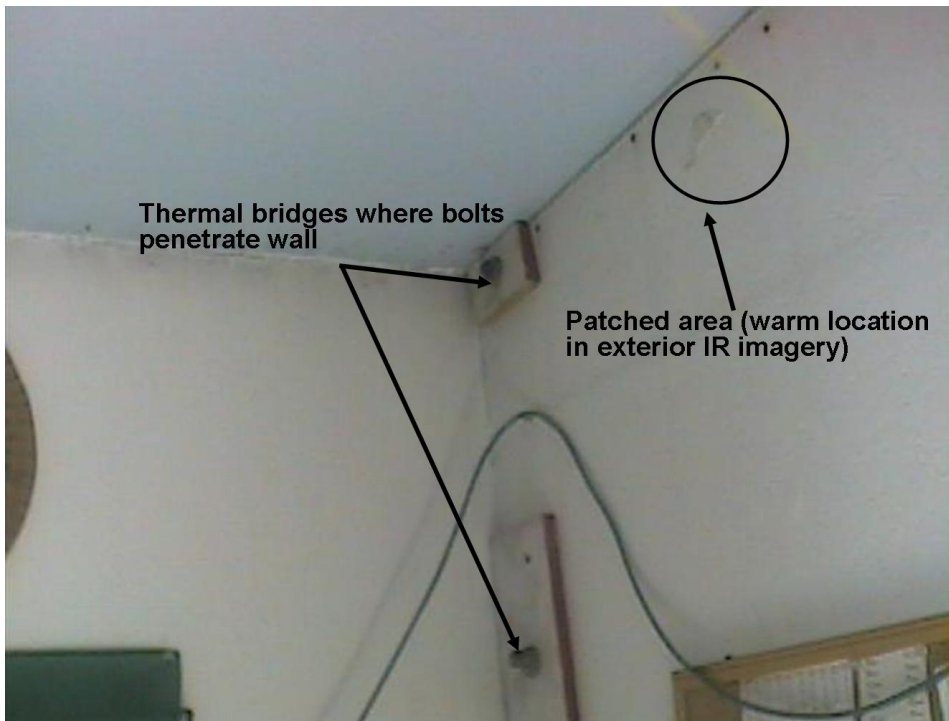
There are leaky locations that run the length of the northeastern corner in the office and also where there are bolts coming through the envelope attached to a piece of lumber on the outside (Fig. 39). Similar to the bolts through the ceiling in the kitchen, the bolts through the wall in the office are thermal bridges. Not visible on the interior is a warm spot on the wall (the location is noted on the visual image) that was visible in the exterior IR imagery.

Figure 39. IR and visual images of the northeastern corner in the office.

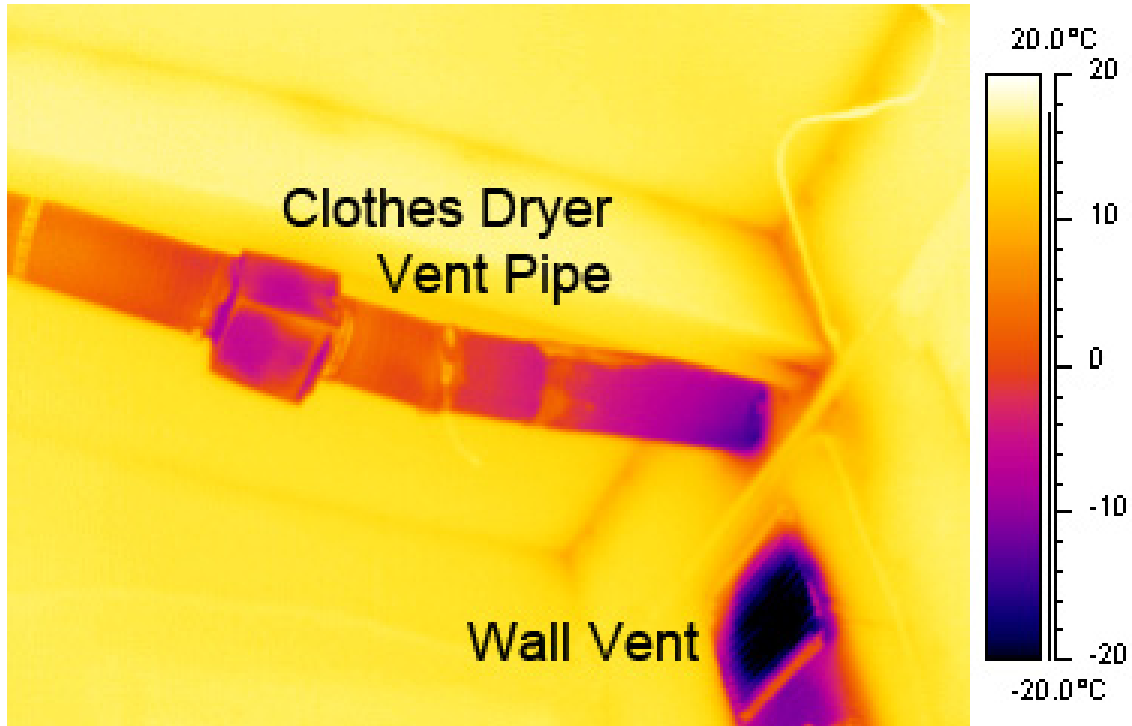
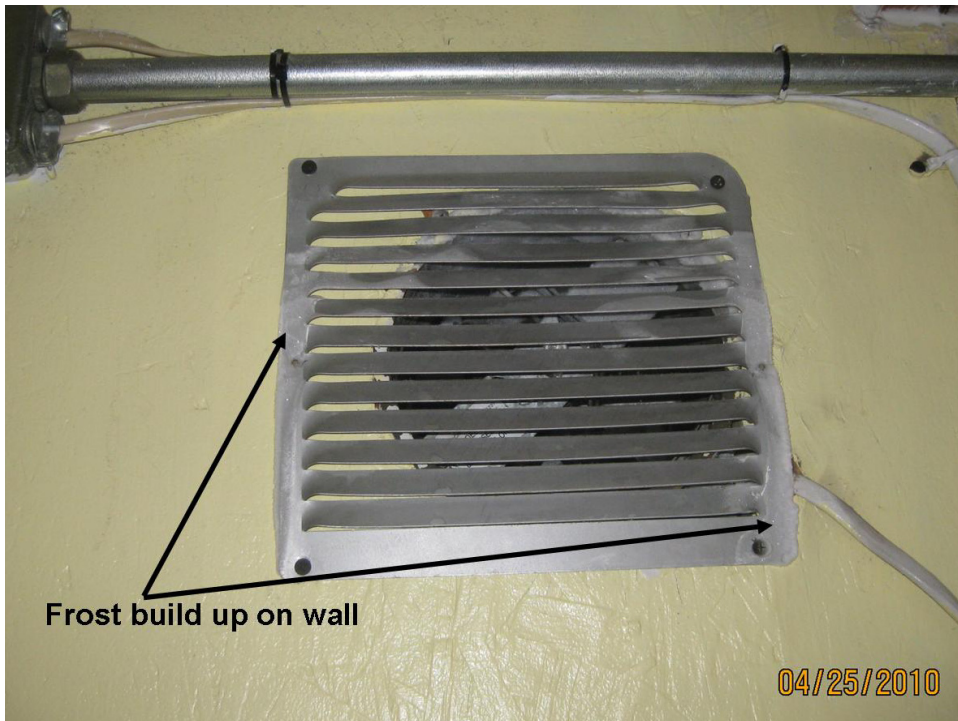
At the time of the IR survey, an air vent centrally located on the north wall in the laundry room was a direct pathway for cold air to infiltrate into the building. This through-the-wall vent is no longer an issue as it was removed later during the 2010 summer season. The hole was insulated and sealed (CPS 2010). Another possible solution would be to relocate this vent to an internal location, such as the wall between the laundry room and scullery, or the wall between the laundry room and hallway. Moving this warm, moist air within the Big House would serve to disperse the humidity where it is needed into the main room. This would also alleviate the ice buildup on the north exterior wall.

Figure 41. IR image of both the clothes dryer and through-wall vent in the laundry room/bathroom. The visual image is a closeup of the through-wall vent noting frost buildup from cold air infiltration.

- Repair the vent in the laundry room to operate effectively, possibly through the use of an automated system, in removing warm moist air from the clothes dryer from inside. Yet, when it is not in operation, it is securely closed with cold climate dampers.

- Use durable exterior hardware should to ensure a proper seal. A direct vent in the north wall of the laundry room created a pathway for cold air infiltration. This vent was removed and the hole insulated and sealed during the 2010 summer season. For through-wall vents, durable exterior hardware should be used to ensure a proper seal when the vent is not in use. Another possible solution would be to relocate this vent to an internal location, such as the wall between the laundry room and scullery, or the wall between the laundry room and hallway. Either of these locations would serve to move this warm, moist air within the Big House to disperse the humidity where it is needed into the main room, and this would also alleviate the ice buildup on the north exterior wall.

Another possible solution would be to remove and seal up the direct vent hole in the north wall and move this vent to an internal location, such as the wall between the laundry room and scullery, or the wall between the laundry room and hallway. Moving this warm, moist air within the Big House would serve to disperse the humidity where it is needed into the main room. This would also alleviate the ice buildup on the North exterior wall.

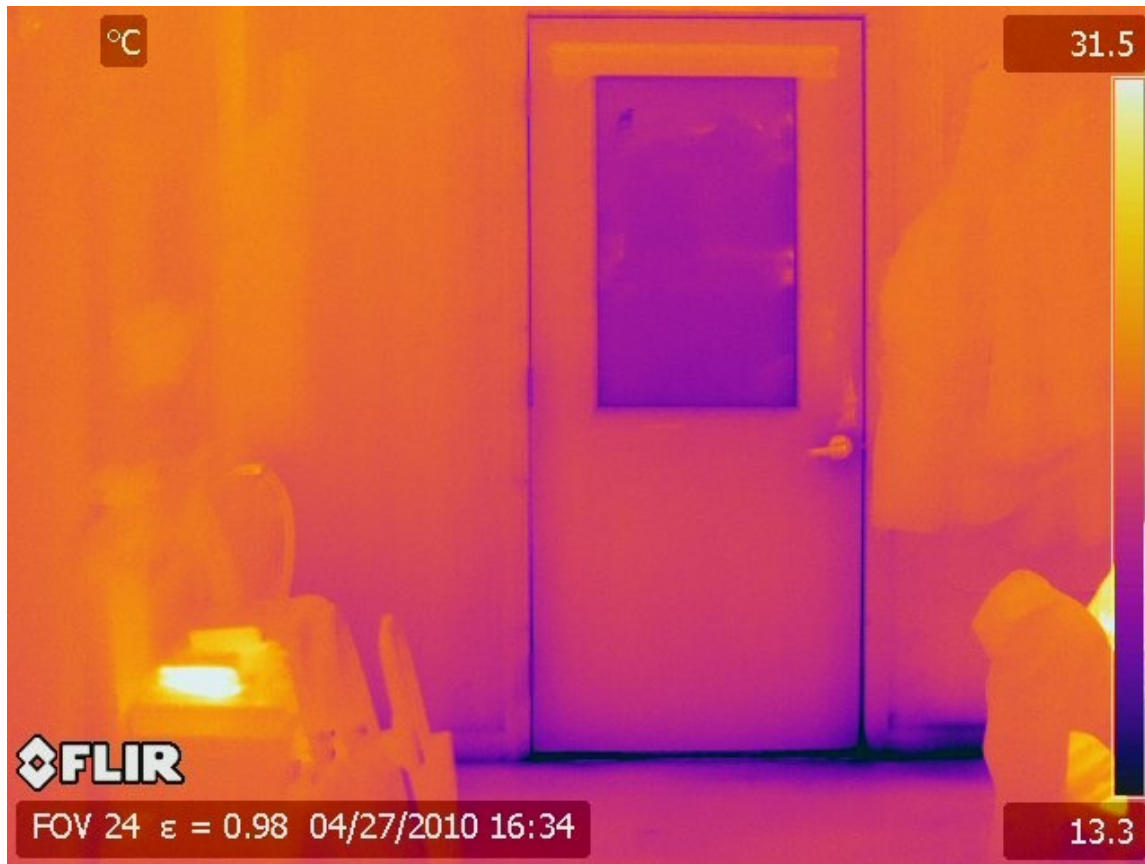
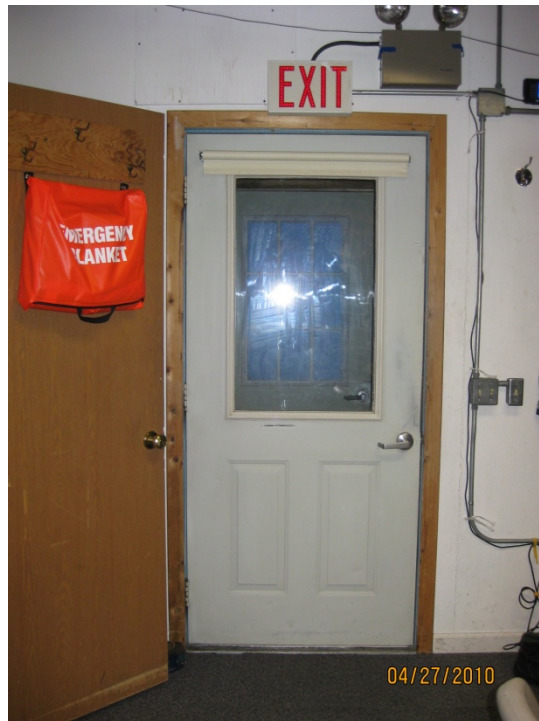
The IR imagery shows heat loss around both the east and west vestibule exterior doors, likely from wear on the door seal, as well as through the window. Both of these doors are insulated residential doors with a viewing window in the upper half of the door.

Figure 42. IR and visual images of the main entrance door in the east vestibule.

- Reduce heat loss around the exterior doors in both the east and west vestibules by replacing the seals.
- Remove the windows in the east vestibule if they are not necessary. This will reduce moisture buildup. Another method to reduce the amount of moisture buildup in arctic entryways is to maintain a constant low temperature (between 2 and 5°C) to mitigate the large temperature swings in an unheated vestibule.

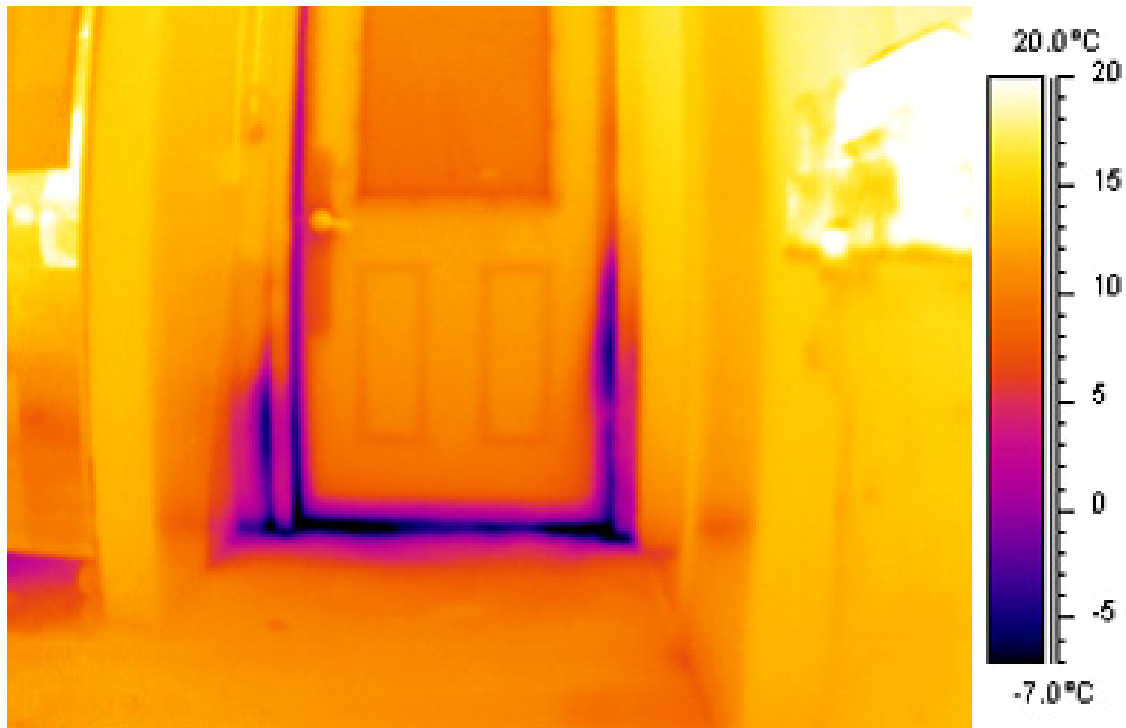
Figure 43. IR and visual images of the main entrance door in the west vestibule.
