# **Nondestructive Characterization of Low Velocity Impact Damage in Transparent Laminate Systems**

**ARL-TR-5582**

**June 2011**

# **Army Research Laboratory**

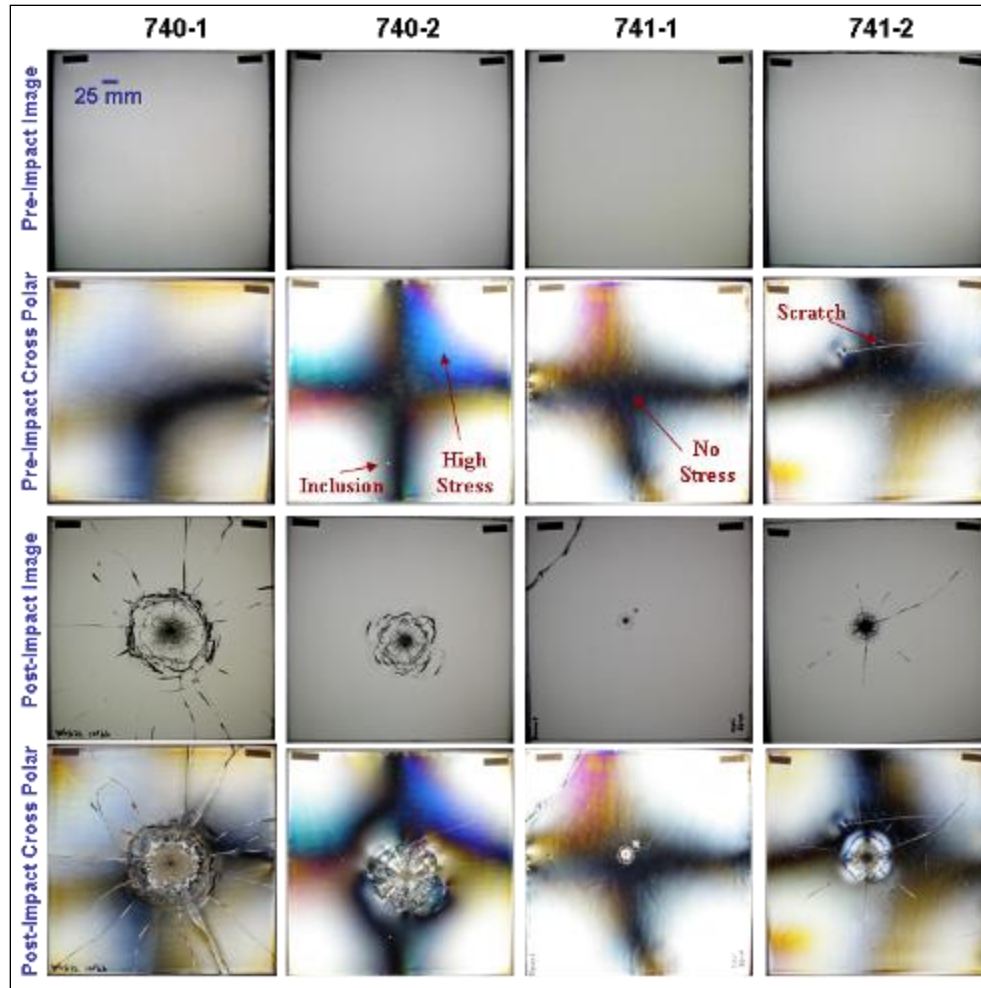
Figure 1. Visual characterization and cross-polarized digital images pre- and post-impact.

Through visual characterization, several millimeter-sized inclusions were found in the transparent laminate panels, numbering ~14 in 740-1, ~18 in 740-2, ~11 in 741-1, and ~36 in 741-2. In 741-2, two surface scratches and cracking damage at the upper edge of the panel were also visible (figure 1). Through cross-polarization imaging, variations in stress patterns were observed (figure 1). According to the Michel-Levy birefringence chart, the black regions represented areas with no stress, the white regions represented areas with minimal stress, the yellow-orange regions represented areas with a significant degree of stress, and the red-blue regions represented areas with a relatively high degree of stress (7). Despite the panels being fabricated in the same manner, the stress patterns appeared to be drastically different. While 740-1 showed minimal stress with some yellow-orange regions near the edges, 740-2 showed large regions of high stress throughout the center. Panels 741-1 and 741-2 showed some significant yellow-orange stress regions, with 741-2 exhibiting a high stress region near two of the largest inclusions.

After impacting the series 1 panels with the air gun and the series 2 panels using sphere impact testing, the laminates were observed and compared to their pre-impacted states. The first qualitative observation from the digital images was that the degree of damage appeared to be greater for the thicker 740-series laminates. This was especially evident when comparing the impact damage diameter of ~168 mm and extensive radial cracking in 740-1 to the minimal impact damage diameter of ~28 mm and absence of radial cracking in 741-1. The crack in the upper left corner of 741-1 was believed to be caused by the clamp used to hold the panel in place during air gun testing. For the sphere impact tested panels, the ~132-mm-diameter damage at the impact region of 740-2 was approximately twice the size of the ~63-mm-diameter damage of 741-2. However, for the higher velocity sphere impact testing, the crack formation trend was reversed, with radial cracking present in the thinner laminate panel but not in the thicker laminate. When observing the impacted panels through cross-polarizers, some local stress variations were found, but the overall patterns did not appear to be drastically altered. There was an observable change in 740-2 that appeared to indicate stress relief after impact, in which a blue high stress region changed to a black region where no stress was apparent. In contrast, the impact region of 741-2 appeared to show concentric high stress regions in the same orientation of what was perceived to be a cone crack at the point of impact. Overall, the 740-series panels exhibited a higher degree of damage after impact when compared to the 741-series panels. As the velocity was increased and mass decreased from air gun to sphere impact testing, the magnitude of damage was reduced from 20 times larger (740-1 vs. 741-1) to twice as large (740-2 vs. 741-2). In terms of visibility through the transparent panels, the 741-series panels performed better, as the degree of damage was less pervasive.

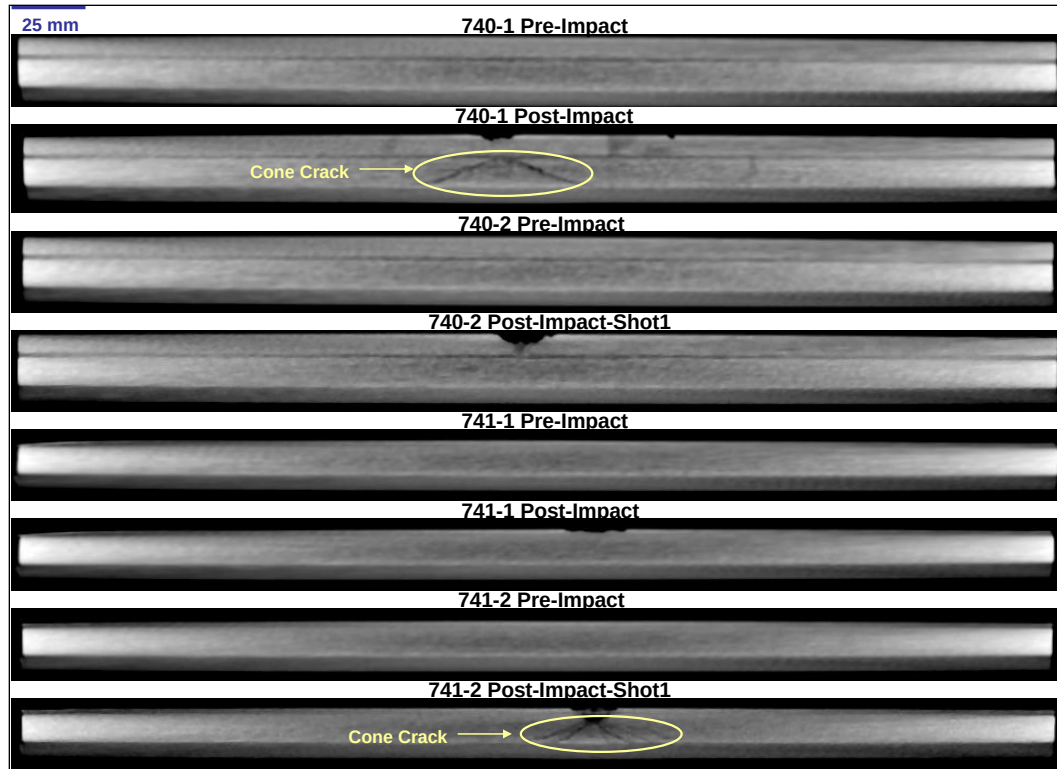
Figure 2. XCT cross-sectional images pre- and post-impact.

The DRs of the pre-impacted panels were unable to detect any distinguishable features. All of the images appeared to be homogeneous, as the inclusions and surface scratches could not be resolved. On the other hand, the XCT images detected and contrasted the laminate layers effectively (figure 2). For the 740-series panels, the Borofloat strike face layer, Starphire interlayer, and polycarbonate backing layer were readily apparent in the cross-sectional image slices. Although the Eagle glass strike face layers in the 741-series panels were 12 times thinner than the Borofloat strike face layers, they could still be resolved in the XCT images, though this was more difficult near the edges.

After impact, the DRs showed damage at the immediate impact point where the sphere struck the panel, but the extent of damage in the surrounding area was unable to be resolved. For 740-1, the radial cracks were apparent upon careful observation, and appeared as hairline cracks extending from the central impact location to the edge of the panel. However, the radial cracks observed in the visual and cross-polarized images for 741-2 could not be resolved in these DRs. The XCT cross-sectional slices captured from the center of each impact were much more revealing (figure 2). For 740-1, inspection of the strike face showed the amount of material ejected after impact and indicated how deep the damage extended below the surface. The most interesting feature was the cone crack that formed at the top of the Starphire layer and extended all the way through this second layer. While it was difficult to distinguish damage at different layers through visual observation, the XCT images provided a definitive distinction of damage as a function of depth. In contrast to 740-1, the XCT image of 740-2 indicated that the damage at the impact site did not extend all the way through the strike face layer and that the second layer remained undamaged. For 741-1, the damage appeared to occur only in the Eagle glass strike face layer, while the damage in 741-2 extended into the Starphire layer and formed another cone crack similar to the one observed in 740-1. These results were consistent with the optical images, as panels that restricted the damage to the strike face layer did not result in radial cracking, while panels that allowed penetration into the second layer resulted in radial cracking and more extensive damage. While the DRs provided little information beyond impact location, XCT images provided a wealth of information for effective characterization through the depth of each panel.

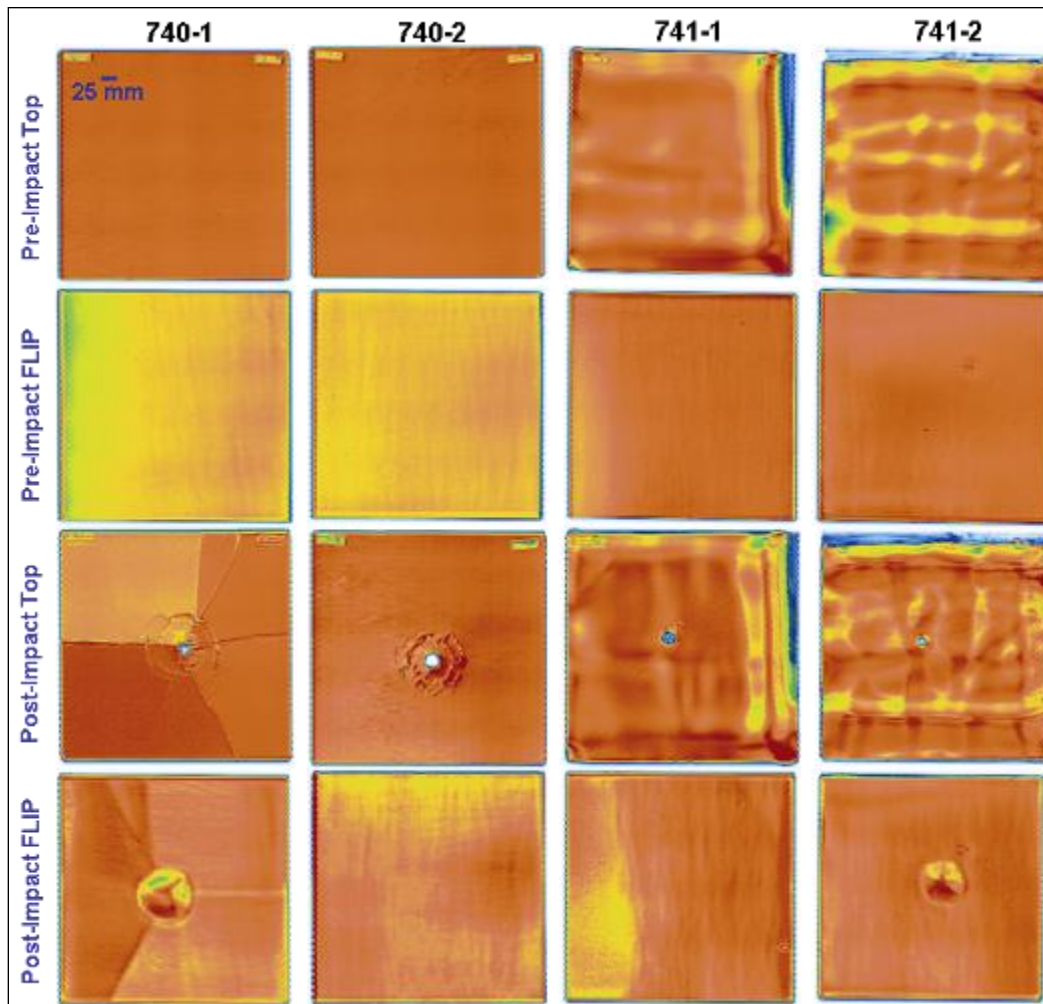
through the strike face as well as the back face to observe acoustic variations from either side (figure 3). While the 740-series samples appeared to be relatively homogeneous, surface/near-surface inclusions were detected that were consistent with visual observations.

Figure 3. Surface/near-surface UT C-scan images pre- and post-impact.

An interesting phenomenon occurred upon observation of the 741-series. Due to the reduced thickness of the Eagle glass strike face layer, significant amplitude variations caused by surface variations and uneven deposition of adhesive layers in the near-surface were detected. Since the C-scan images collected through the strike face side of these panels were sensitive to adhesive variations, a much greater contrast was apparent. When these same panels were ultrasonically imaged through the back face, these features were not detected, and the results were comparable to those of the 740-series panels scanned in the same orientation. The damage to the upper edge of 741-2 was also distinguished in the C-scan images, as a lower amplitude signal was evident where pre-impact cracking was present.

After impact, the ultrasound C-scan images were adept at showing the damage in great detail. For 740-1, the surface/near-surface scans showed the point of impact as a complete loss of amplitude (figure 3). The cone cracks as well as the radial cracks were also observed in these

images, in contrast to the DRs, which were only able to resolve the radial cracks. The C-scan images through the back face of 740-1 showed a circular region representative of the bulge that occurred in the polycarbonate backing layer post-impact. The dimensional change was an observation unique to the C-scan images and was found in both 740-1 and 741-2, the two samples in which damage to the Starphire layer was identified in the XCT images. For the other two samples, C-scan images through the back face revealed no isolated regions of damage. For the 741-series samples, the adhesive pattern variations appeared to change upon impact to the panels. This could have been an indication of physical change to the adhesive layers, which were designed to mitigate stress and prevent crack propagation into successive layers (1).

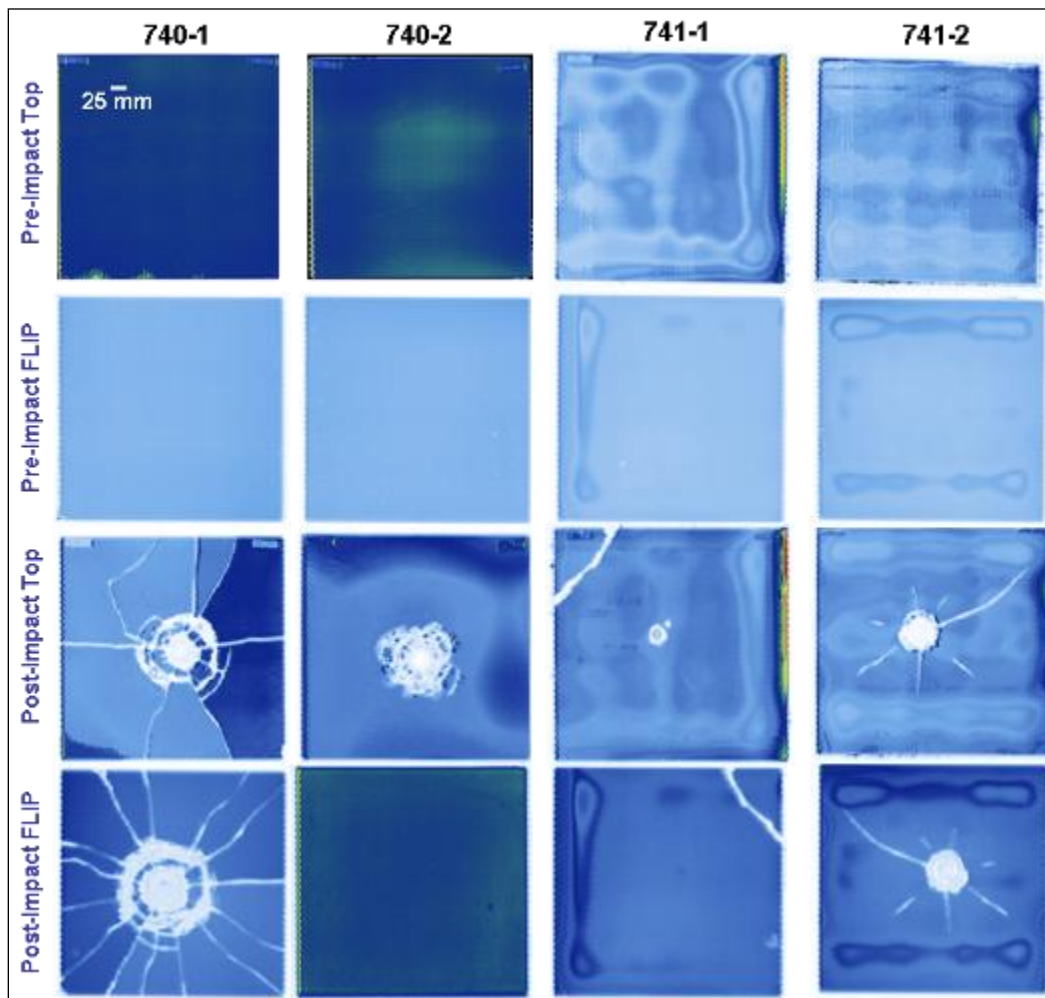
For the second set of images, the bottom surface reflected signal was gated and the amplitude changes through the entire bulk of each panel were evaluated (figure 4). The 740-series panel scans were once again homogeneous. The only distinguishable features were inclusions with lower amplitude values than the rest of the panel. The 741-series panel scans showed more intricate adhesive patterns through the thinner strike face glass layers. In this case, the scans through the back face also showed adhesive patterns in which there were acoustic variations. A vertical band on the left side of 741-1 and parallel horizontal bands in the upper and lower regions of 741-2 were indicative of these patterns. As opposed to the previous scans that only showed surface/near-surface amplitude variations, the bottom surface scans represented a greater volume of the sample and enabled similar adhesive features to be observed through both sides of each panel.

Figure 4. Bottom surface reflected signal UT C-scan images pre- and post-impact.

The bottom surface reflected signal C-scan images though the bulk of each sample were very effective at contrasting damage, with cracked or damaged regions resulting in a complete loss of signal (figure 4). For 740-1, scanning through the strike face showed crack patterns within the Borofloat layer, while scanning through the back face showed crack patterns in the Starphire layer. While several cracks were able to penetrate both layers, the majority of the 18 radial cracks were unique to either the Borofloat or Starphire layer. By scanning through both sides of the panel, the depth locations of these cracks were resolved. For 740-2, the intricate damage pattern was well represented in the C-scan image and the scan through the back face indicated no penetration into the Starphire layer. For 741-1, the bulk adhesive patterns did not appear to change as much as in the surface/near-surface images. The damage at the point of impact and crack in the corner were clearly visible, and small indications of damage were detected in the back face scan. With the XCT images for 741-2 indicating damage to the Starphire layer, the impact region and resulting radial cracks were as apparent through the strike face images as they were through the back face images. Overall, the C-scan images were very effective at representing the damage to each panel after air gun and sphere impact testing.

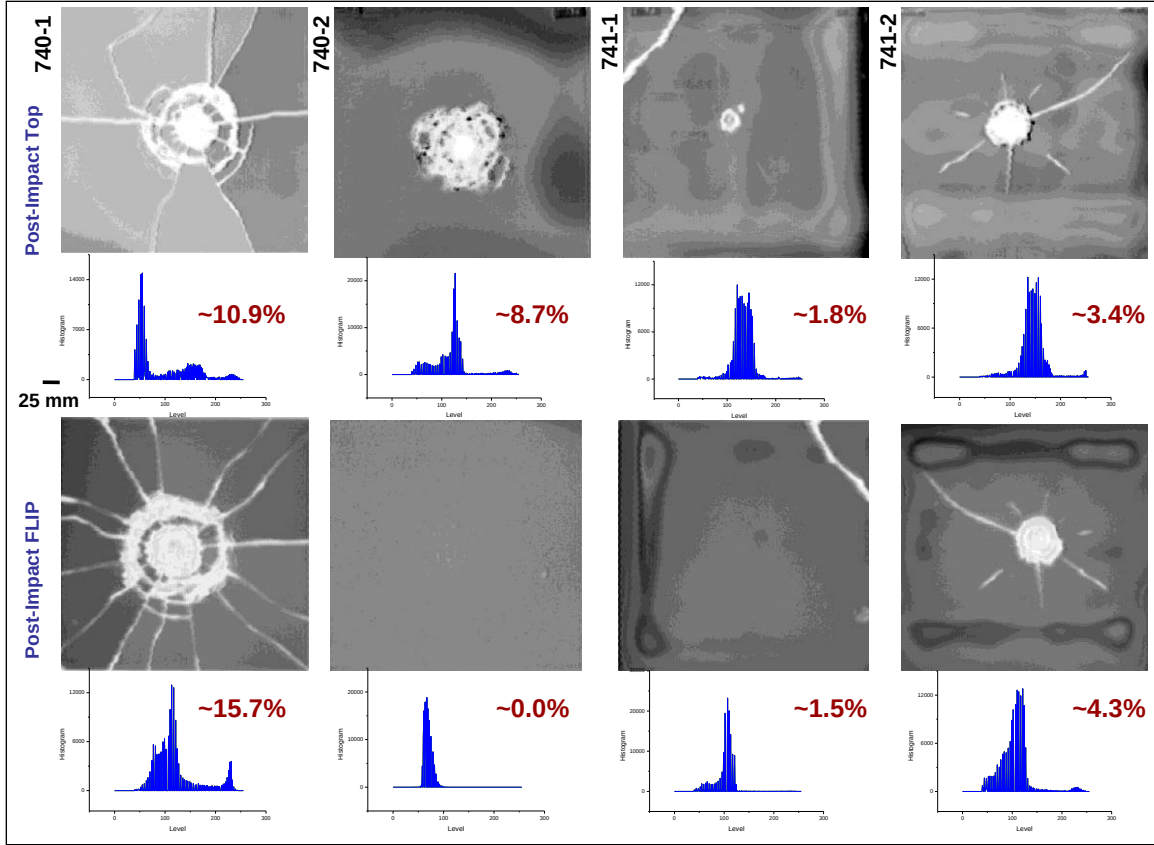
Estimated percent damage values were calculated for C-scan images representing the strike face and back face of each of the four transparent panels. The inverted grayscale images and corresponding histograms are shown in figure 5. For panels 740-1 and 741-2, which showed cone cracking in the Starphire layer and significant damage through the back face, the estimated percent damage increased. The damage increased from 10.9% to 15.7% for panel 740-1 due to the higher number of radial cracks present in the Starphire layer. For panel 740-2, in which there was no damage to the Starphire layer, the percent decreased from 8.7% to 0.0% since no damage could be detected in the C-scan image through the back face. For panel 741-1, the percent damage decreased from 1.8% to 1.5%. Despite the absence of a cone crack in the Starphire layer, the crack in the corner of the sample propagated through both the Eagle glass and Starphire layers, which accounted for the majority of damage through both the strike face and back face images. The quantitative damage threshold technique proved to be a useful means for estimating and comparing volumetric percent damage values for the transparent panels.

Figure 5. Quantitative histogram images and percent damage from the strike face and back face.

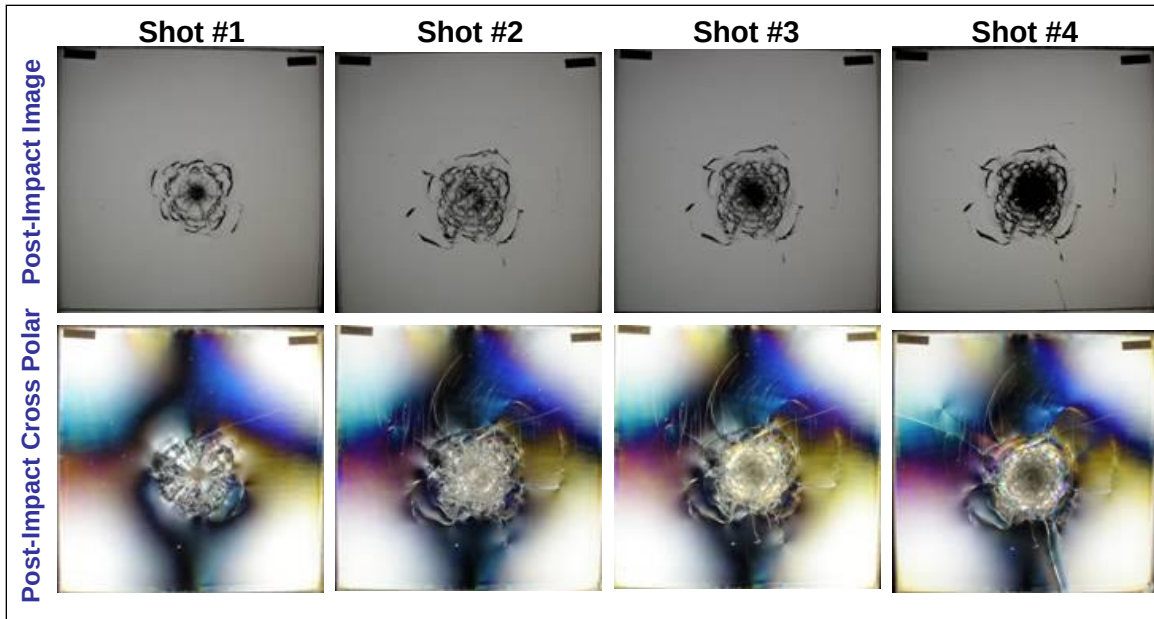
Figure 6. Visual and cross-polarized digital images of 740-2 after each of the four sphere impacts.

Figure 6 shows the progression of damage through digital and cross-polarization images. After the second impact, multiple cracks formed within the original damage zone from the first impact. Several larger cracks also started to propagate, expanding the diameter of the damage zone. The damage to panel 740-2, as observed in the visual and cross-polarized images, did not appear to change significantly after the third impact. After the fourth and final impact, three of the cracks that had started to propagate after the second impact had fully propagated to the edge of the panel.

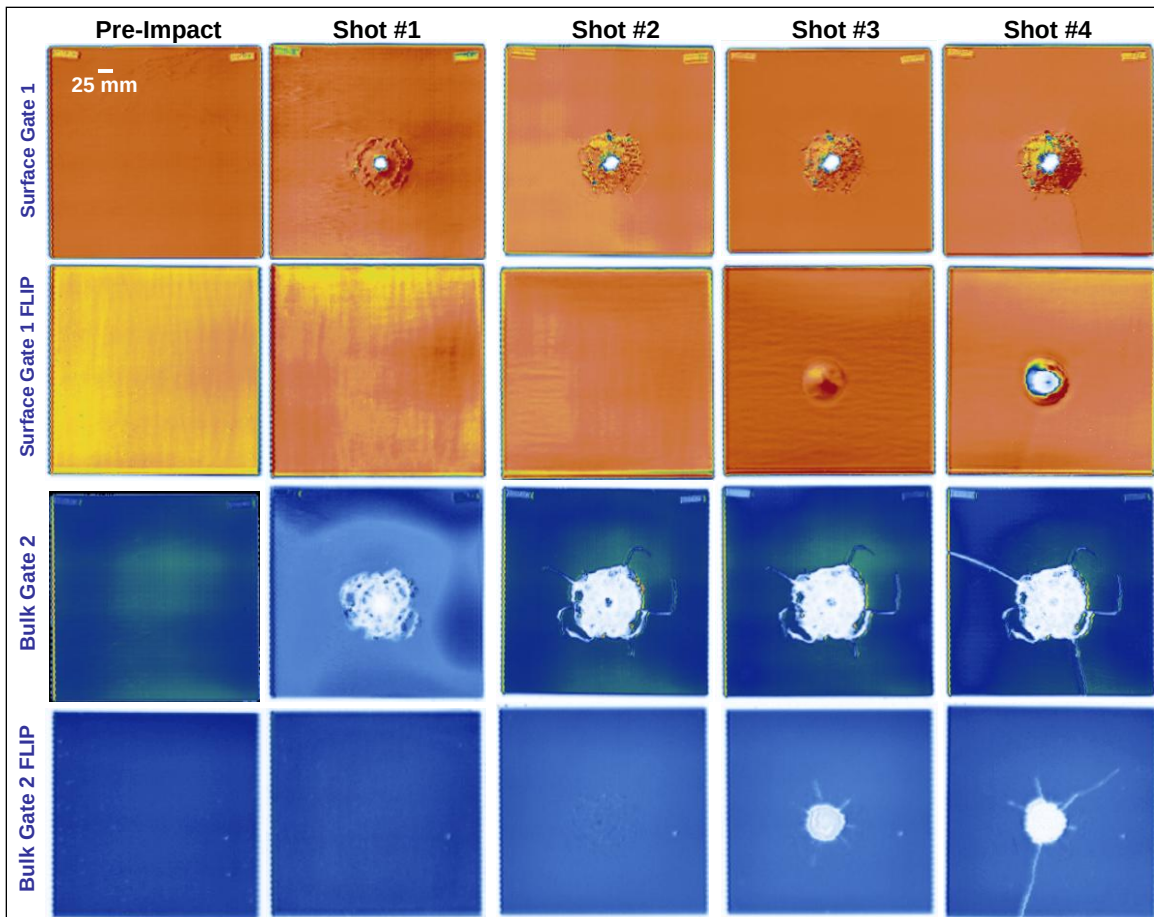
Figure 7. Surface and bulk C-scan images of 740-2 cumulative damage from the strike and back face.

In figure 7, C-scan images of the surface/near surface of panel 740-2 after each impact are shown in succession, with the first row representing the strike face images and the second row representing the back face images. The strike face images showed the degree of damage at the point of impact and its slight degree of expansion after each impact. Damage due to cracking was not present until after the final impact, where a radial crack propagated to the lower edge of the panel. The back face images showed no indication of damage to the Starphire layer until after the third impact, at which point there appeared to be a slight physical deformation to the back face opposite the point of impact. After the fourth impact, a severe degree of damage resulting in complete signal loss was evident in the surface/near surface C-scan image. The third and fourth rows represented bulk C-scan images through the entire volume of panel 740-2. For the third row containing the strike face images, the damage zone expanded after the second impact, was very similar after the second and third impacts, and resulted in propagation of two radial cracks to the edge of the panel after the fourth impact. For the fourth row containing the back face images, some micro-cracking was evident after the second impact. The third impact revealed the presence of damage and the early formation of radial cracks within the Starphire layer. After the fourth impact, several of these radial cracks began to propagate, with one extending out to the edge of the panel. This demonstrated that out of the three edge cracks that were detected, one of them was present in the Starphire layer. These results showed a large contrast between panel 740-1, which had a large number of radial edge cracks after a single impact, and panel 740-2, in which four impacts to the same location were required to produce a radial edge crack.

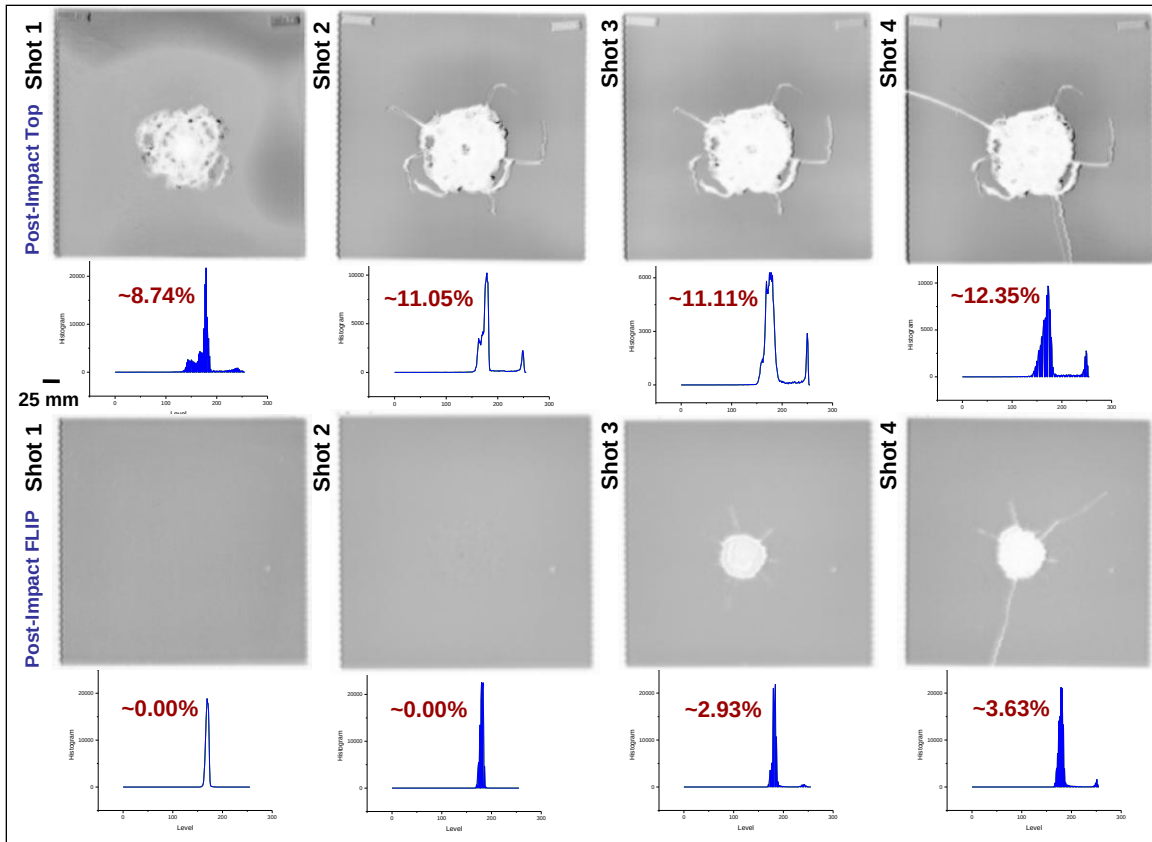
Figure 8. Histogram images and percent damage from the strike and back face of 740-2 after each impact.

For the strike face images, the quantitative results were consistent with the qualitative observations from visual inspection. The percent damage increased from 8.74% to 11.05% after the second impact with additional cracking to the damage zone and initial crack propagation, from 11.05% to 11.11% after the third impact with a minimal increase in damage, and from 11.11% to 12.35% after the fourth impact with radial crack propagation to the edges. For the back face images, there was no detectable damage after the first or second impacts, as the initial micro-cracking was not distinguished. After the third impact, the damage increased to 2.93% and again to 3.63% as one of the radial cracks propagated to the edge of the panel. All of the quantitative results consistently showed an increase in cumulative damage after each impact test.

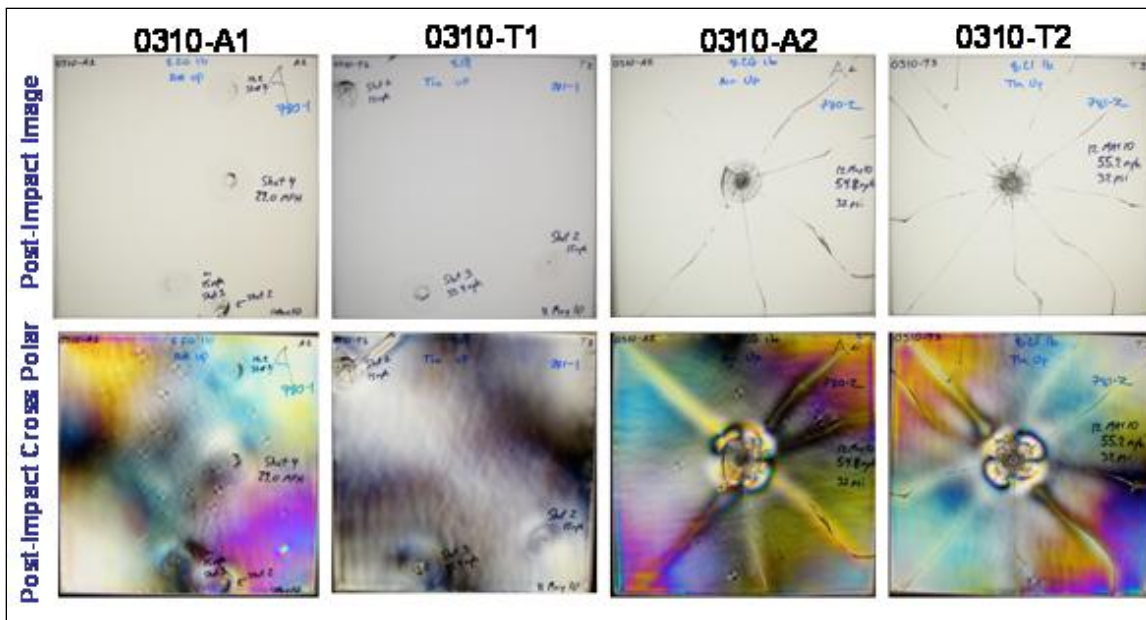
The same characterization methods used to evaluate the 740- and 741-series panels were applied to these panels. Visual characterization was conducted on the four panels in a pre-impact and post-impact state. Cross-polarization techniques were used to observe residual stress states before and after low velocity impact. The post-impact images are shown in figure 9. The four impacts to 0310-A1 and three impacts to 0310-T1 occurred at a high enough velocity to produce damage to the surface as well as delaminations in the two laminates. Despite multiple impacts to each panel, there did not appear to be any overlap between damage regions.

Figure 9. Visual characterization and cross-polarized images of the 0310-series post-impact.

In the cross-polarization images, panel 0310-T1 showed minor residual stress patterns while the other three panels displayed regions of higher residual stress, especially in the corner locations. The impacts to 0310-A2 and 0310-T2 both showed radial cracks originating from the point of impact and extending to the edge of each panel. In terms of the number of radial cracks, 0310-A2 exhibited 6 cracks as compared to 10 for 0310-T2, resulting in an improvement from the standpoint of visibility.

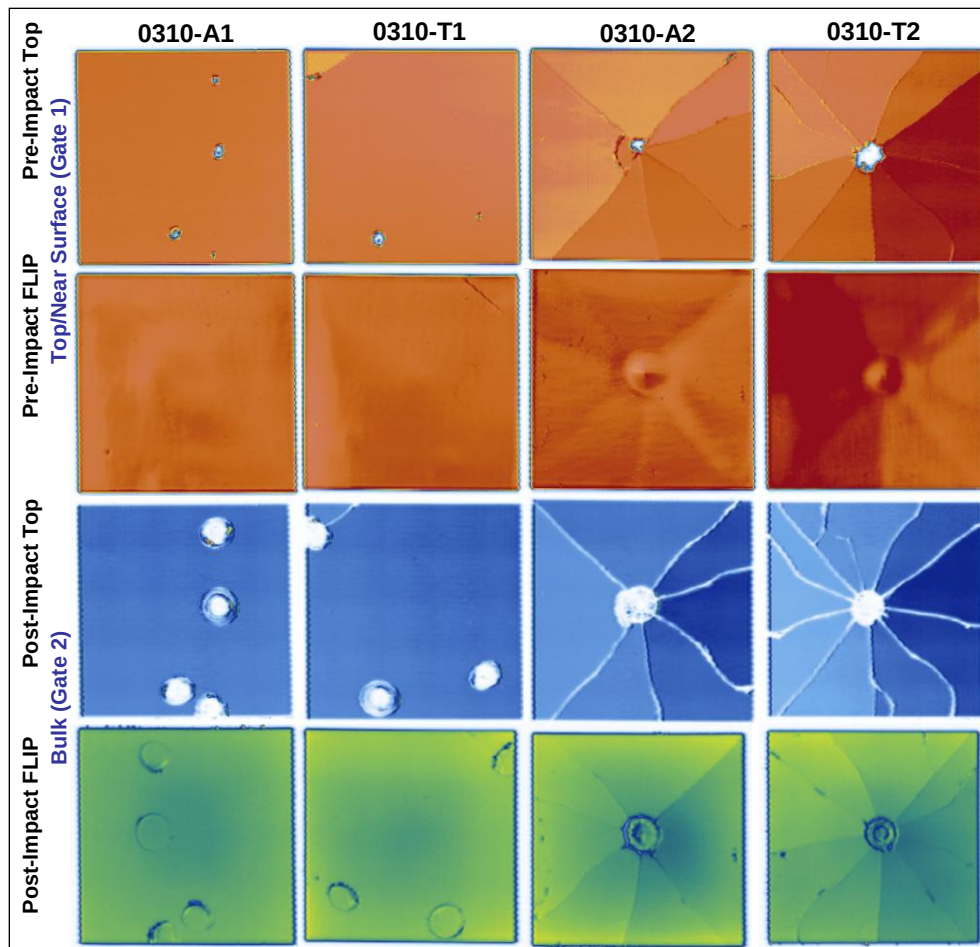
Ultrasound C-scan images were collected for all of the panels in both the pre- and post-impact states. Surface/near-surface images were mapped to show changes in signal amplitude at and near the point of impact of the Borofloat strike face. Bottom surface images were mapped to show changes in signal amplitude through the bulk of each panel. The post-impact surface/near surface images through the strike face and back face (rows 1 and 2, respectively) and post-impact bulk images through the strike face and back face (rows 3 and 4, respectively) are shown in figure 10. The surface/near-surface images for 0310-A1 and 0310-T1 were similar, with point of impact damage represented by complete loss of signal at each impact. The two highest velocity impact strikes resulted in the largest indications of residual surface damage. The surface/near-surface image for 0310-A2 exhibited a smaller degree of damage at the point of impact when compared to 0310-T2, but also showed a near-surface indication of a cone crack that connected two of the radial cracks. The images through the back face showed no detectable damage for 0310-A1 and 0310-T1, but both 0310-A2 and 0310-T2 showed surface indications of deformations resulting from a cone crack, as were previously detected in 740-1 and 741-2. The circular region representative of the bulge in the polycarbonate backing layer appeared to be larger in diameter for 0310-A2 as compared to 0310-T2.

Figure 10. Surface/near-surface and bulk UT C-scan images of the 0310-series post-impact.

The bulk images for 0310-A1 and 0310-A2 revealed damage that was much larger in diameter than the surface/near-surface images. This indicated that the damage through the bulk of these panels was the result of delaminations at the Borofloat/Starphire interface. While the surface indications were much smaller, the diameter of damage due to delamination of the glass layers appeared to be similar regardless of the impact velocity. The C-scan images through the back face mirrored these results, highlighting the damage perimeter for each impact. The bulk images for 0310-A2 and 0310-T2 identified all of the cracks that were detected visually, clearly showing a partial crack and a crack that split off of one of the main radial cracks, each which was difficult to see in the digital and cross-polarization images. The bulk images through the back face also revealed small features near the edges of the panels that could not be resolved through visual means. The combination of surface/near-surface C-scan images through the strike and back faces provided a wealth of damage information that could not be otherwise detected.

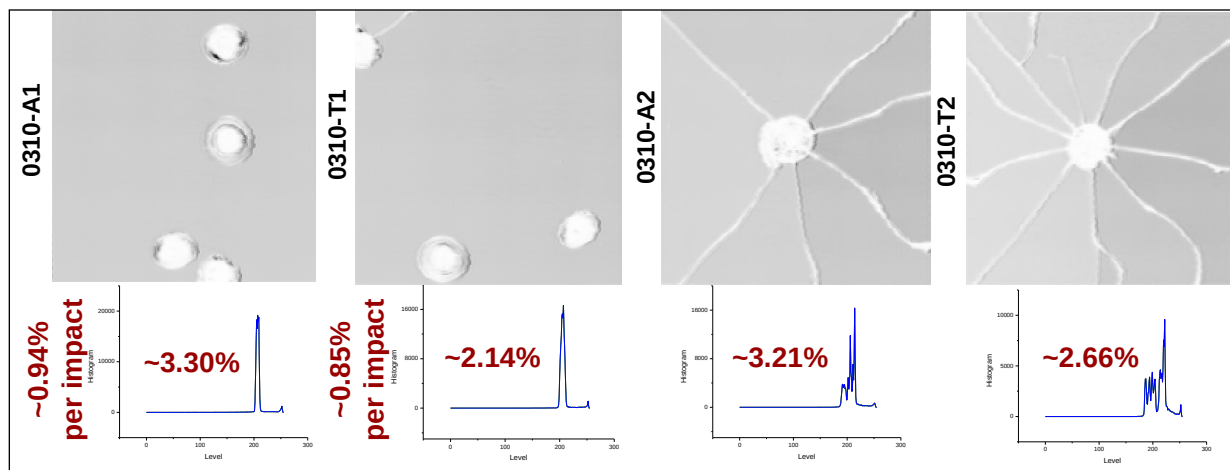
The quantitative damage threshold technique was applied to determine the degree of damage through both the strike face and back face of all the 0310-series panels (figure 11). A direct comparison of panel 0310-A1, which had a total damage percent of 3.30%, and 0310-T1, which had a total damage percent of 2.14%, did not tell the whole story. Since 0310-A1 was subject to an additional impact and both panels were subject to impacts that demonstrated only half the damage since they occurred at the edges, the average damage per impact was a more useful value. While 0310-A1 had an average of 0.94% per impact, 0310-T1 was slightly lower at 0.85% per impact. For panel 0310-A2, which had a total damage percent of 3.21%, and 0310-T2, which had a total damage percent of 2.66%, the results appeared to be counterintuitive at first due to the difference in the number of cracks. However, while panel 0310-T2 exhibited 10 radial cracks, the percent damage appeared to be influenced more by the larger cone crack in 0310-A2, as evidenced in both the surface/near-surface and bulk images captured through the back face. The tin-side-up panel, 0310-T2, showed a higher number of radial cracks and the air-side-up panel, 0310-A2, indicated a larger cone crack, but the small variations in percent damage were not enough to definitively claim that one was superior to the other.

Figure 11. Histograms and percent damage from the strike faces of the 0310-series after impact.
