Ballistic Testing and Product Quality Surveillance for  
the Interceptor Body Armor - Vest Components  
Need Improvement

January 3, 2011

SUBJECT: Ballistic Testing and Product Quality Surveillance for the Interceptor Body  
Armor – Vest Components Need Improvement (Report No. D-2011-030)

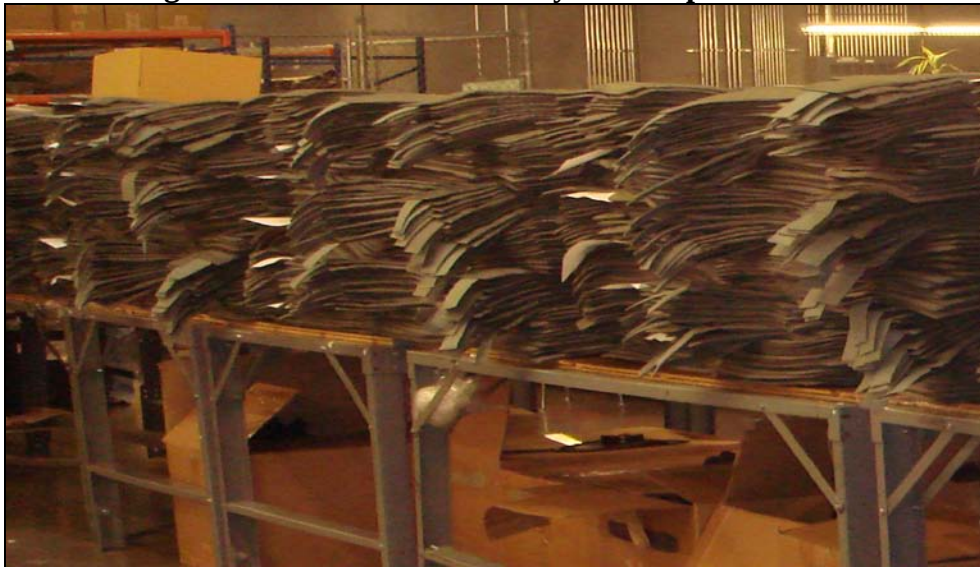
**Figure 2. Ballistic Panels Ready for Sample Selection**

The LAT sample selection process began with Point Blank personnel notifying DCMA QARs when a lot of ballistic panels was ready for a LAT. An assigned QAR reported to the Point Blank plant and selected samples. Depending on the lot size, the QAR would select three, five, or eight samples; see Finding A, "Lot Acceptance Tests Not Always Required" section for details. Because a vest had more than one ballistic panel, the QAR ensured all applicable panels were pulled for the same serial numbers or samples by placing the panels on a table and comparing the serial numbers. Figure 2 is an example of a ballistic panel lot ready for sample selection.
