# Inspector General

## Ballistic Testing for Interceptor Body Armor Inserts Needs Improvement

| Report Documentation Page | | | | Form Approved<br>OMB No. 0704-0188 | |
|---|---|---|---|---|---|
| 1. REPORT DATE<br><b>01 AUG 2011</b> | | 2. REPORT TYPE | | 3. DATES COVERED<br><b>00-00-2011 to 00-00-2011</b> | |

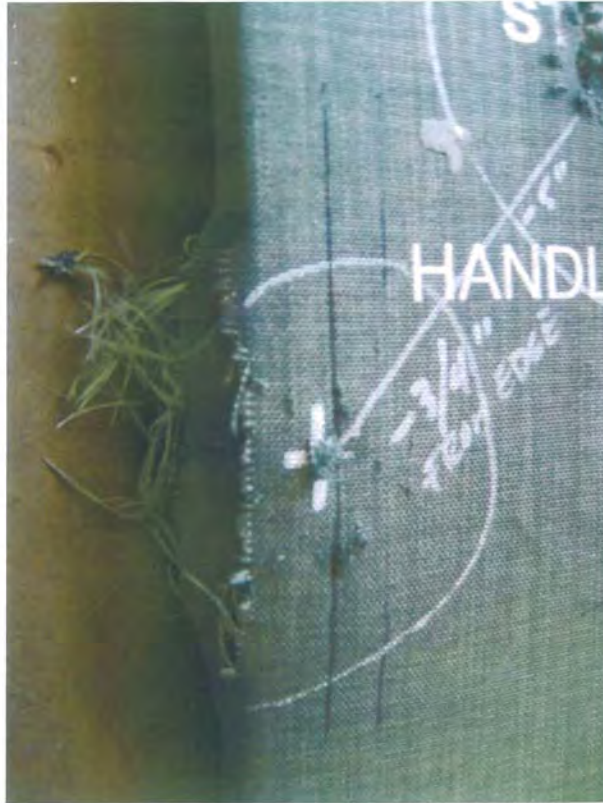
**Figure 2. Photograph of the Contested Ballistic Insert**

PM SEQ did not properly document and support its decision to overturn a potential catastrophic failure as defined by the COPD. PM SEQ accepted ballistic inserts on contract W91CRB-04-D-0040 although a LAT had a BFD of 48 mm. PM SEQ officials did not adequately document their decision to accept the lot even though the COPD considers a BFD of 48 mm to be a catastrophic failure. The chief scientist claimed that the lot did not fail because the shot was too close to the edge. The COPD requires that the first shot be between .75 and 1.25 inches from an edge. PM SEQ did not document the incident.

On March 29, 2007, an additional ballistic insert was tested and achieved a passing score. Based on this test, PM SEQ accepted and distributed the lot. Figure 2 contains a photograph of the ballistic insert, taken by the contractor and provided to us by PM SEQ. However, there were no identifiable serial numbers or tile numbers to indicate that the ballistic insert in question was the same as the one in the photograph. We asked to see the ballistic insert, but PM SEQ staff could not locate it.

In instances that involve a disputed test, PM SEQ should maintain adequate documentation in the event that future questions are raised. Documentation should include photographs, x-rays, serial numbers, or the actual item, as appropriate.

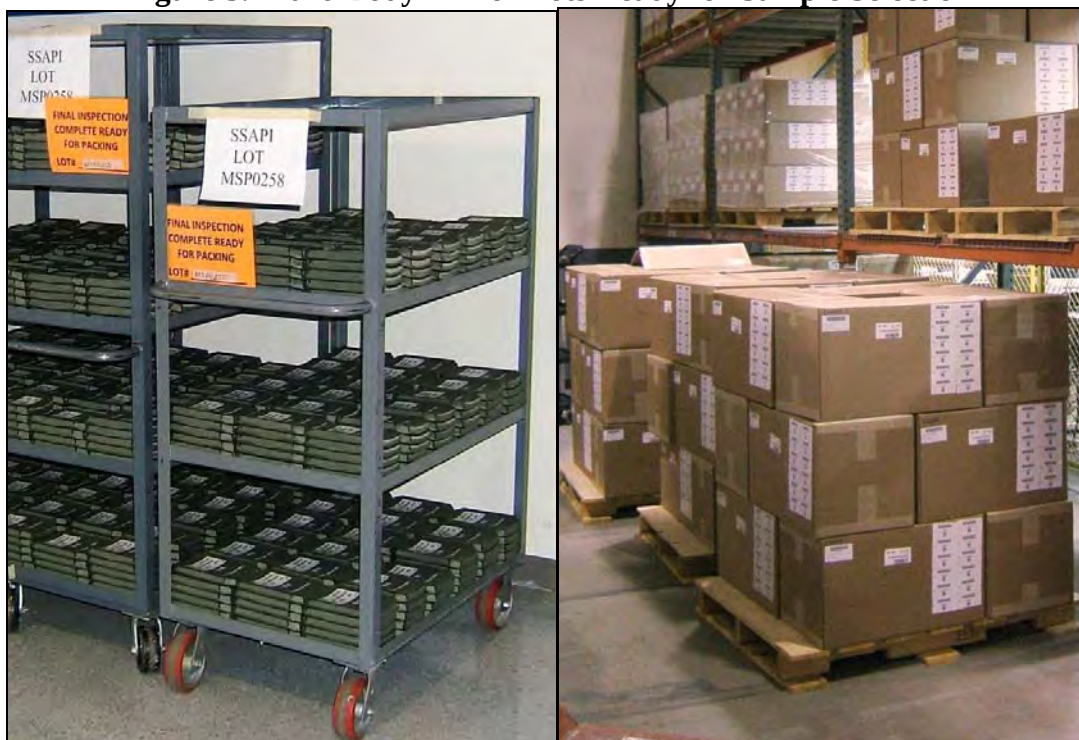
**Figure 3. Hard Body Armor Lots Ready for Sample Selection**

The QAR selects the samples and observes as a contractor employee verifies that weight and dimensions comply with contract requirements. The contractor employee records the serial numbers on the DD 1222, "Request for and Result of Tests," and the QAR signs it. The QAR then sends the samples and the DD 1222 to the applicable test lab for LATs.
