# **Extensive Characterization of Cracking in As-fabricated Composite Ceramic Panels Via Ultrasonic and X-ray Computed Tomography Testing**

**ARL-TR-5638**

**August 2011**

**William H. Green and Raymond E. Brennan  
Weapons and Materials Research Directorate, ARL**

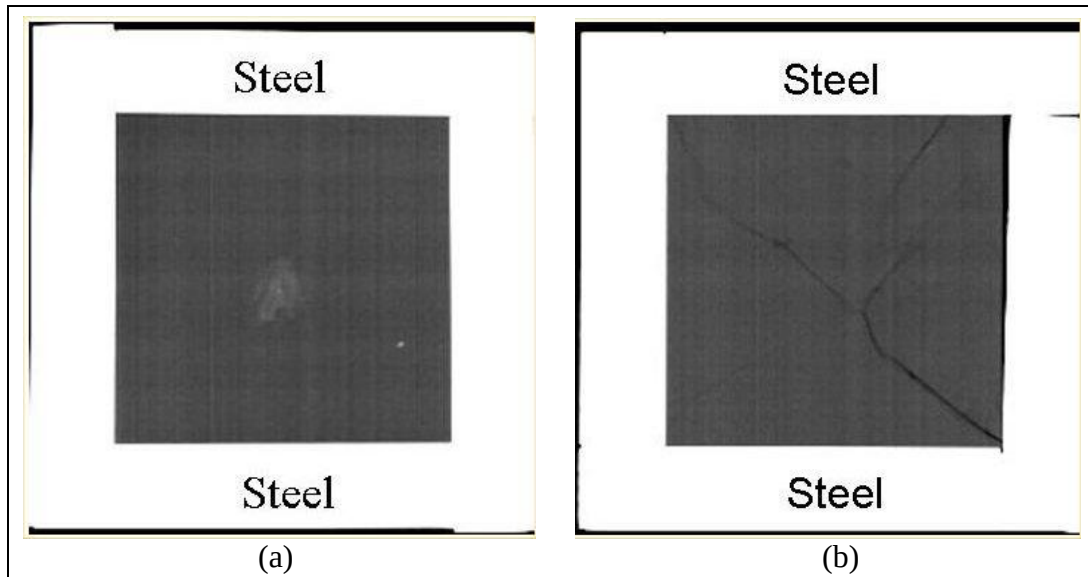
Each of the two specimens consists of a 4 in x 4 in x 0.50 in boron carbide ( $B_4C$ ) tile surrounded by four 5 in x 1 in x 0.50 in pieces of steel all bonded onto a 6 in x 6 in x 0.87 in aluminum backing plate. The four pieces of steel were placed such that each one extended 1 in past the side of the tile in a wraparound surround. Digital radiographs (DRs) of each specimen were taken through their thickness using the 420 keV x-ray tube and linear detector array (LDA) setup in centered rotate-only (RO) mode. The x-ray technique parameters of the DRs were 400 keV and 2.0 mA and the geometry of the source-to-object-distance (SOD) was 750.00 mm and the source-to-image-distance (SID) was 940.00 mm. Figure 1 shows DRs of each specimen, in which the gray-shaded tiles are in the center and the steel surround pieces around the tile are white. This is because the steel attenuates the x-rays significantly more than the tile and aluminum. The DR of the first specimen (figure 1a) shows no cracks in the tile and no gaps between the sides of the tile and the steel surround. The lighter blotchy area in the center of the tile is due to material that was on the rear of the aluminum backing. The slight vertical banding is an image artifact (i.e., not physically in the specimen) due to offset and gain (window) adjustment to optimize image detail. The DR of the second specimen (figure 1b) shows cracks in the tile and a significant gap, which gets larger towards the top of the image, between the side of the tile and the vertical right surround piece. The cracks extend to the vicinity of the upper two and lower right corners of the

tile, with a fainter indication extending to the lower left corner. The DR clearly shows the tilt of the vertical right surround piece.

Figure 1. Through-thickness DRs: (a) specimen number 1 and (b) specimen number 2.

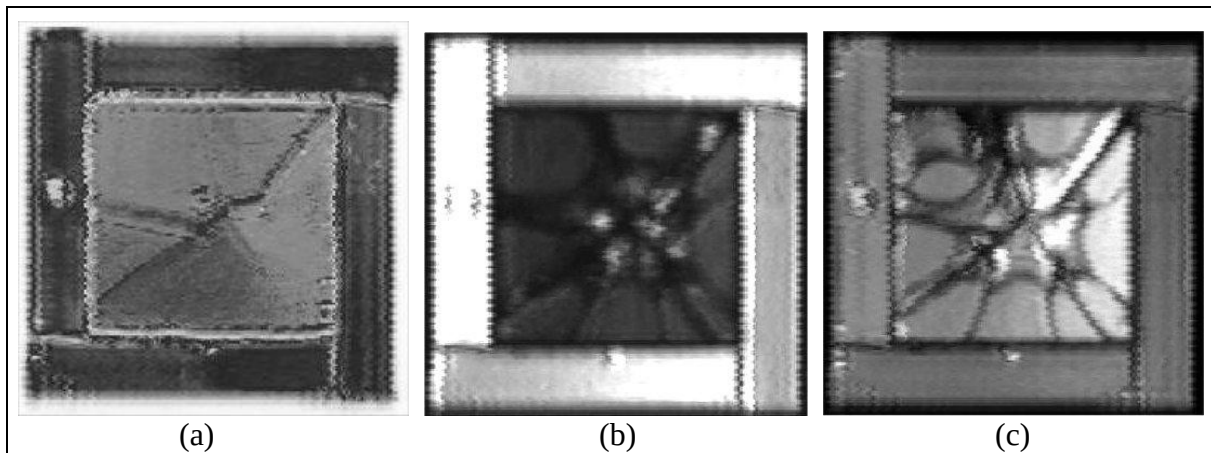
Figure 2 shows three ultrasonic variable amplitude C-scans in which the up direction from the bottom of the images corresponds to increasing  $z$  in the DR scan of the specimen. The scan in figure 2a was gated to show the front surface and near surface characteristics of the specimen and indicates two major cracks in the tile. The scan in figure 2b was gated to show only the signal amplitude at the rear surface of the tile. The scan in figure 2c was gated to show the overall bulk characteristics of the tile. Both of the images in 2b and 2c show widespread attenuation, indicated by the darker areas, most likely due to cracks within the tile. Figure 3 shows a through-thickness B-scan presentation of the specimen going from left to right approximately halfway between the bottom and top of the tile. The B-scan view shows the ultrasonic amplitude against time (i.e., depth), which is on the  $y$ -axis, over the length of the line (horizontal) defining the cross-sectional location. The physical side locations of the steel surround pieces are marked and the vertically larger white areas (e.g., left side) indicate more immediate loss of signal. The B-scan clearly shows where cracking damage is resulting in relatively fast signal attenuation, including much of the left side, the center area, and part of the right side.

Figure 2. Ultrasonic C-scans of specimen 1: (a) surface/near-surface of specimen, (b) rear surface of tile signal amplitude only, and (c) bulk characteristics of tile.

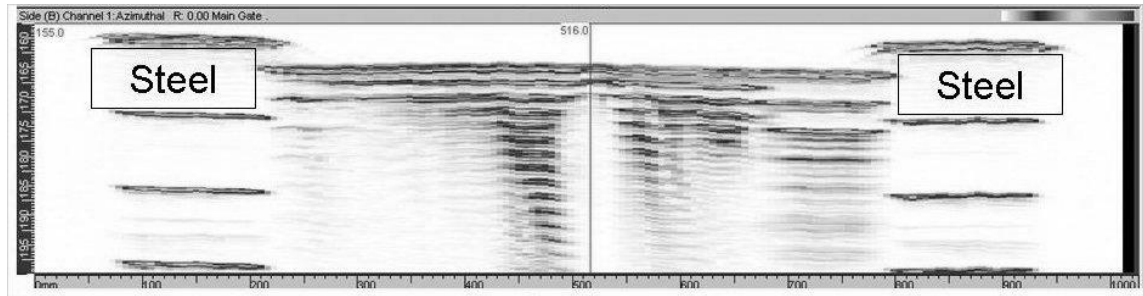
Figure 3. Through-thickness, or depth, B-scan presentation of specimen 1 going from left to right approximately halfway between the bottom and top of the tile. The physical side locations of the steel surround pieces are marked.

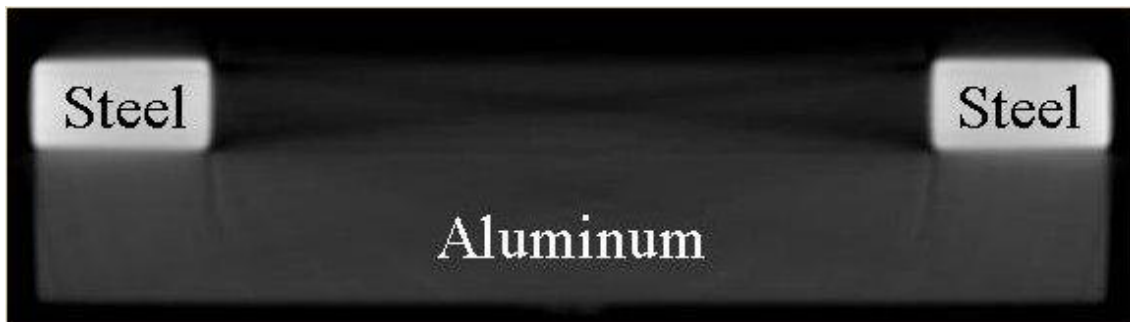
Figure 4 shows a representative XCT scan (image) of the specimen in which the aluminum backing plate and steel surround pieces are labeled. The front surface of the tile is located at the top of the image. The darkened cross pattern in the tile is due to a combination of the location of the steel in relation to the tile and significantly greater x-ray attenuation by the steel as compared to the tile. The image does not show indications of cracks. This is most likely due to some combination of the difficulty in image interpretation caused by the cross pattern artifact and very tight cracks with small or no gaps (i.e., “kissing” cracks).

Figure 4. Representative XCT scan (image) of specimen 1 with locations of steel surround pieces and aluminum backing plate labeled. Note the darkened cross pattern artifact between the pieces of steel.

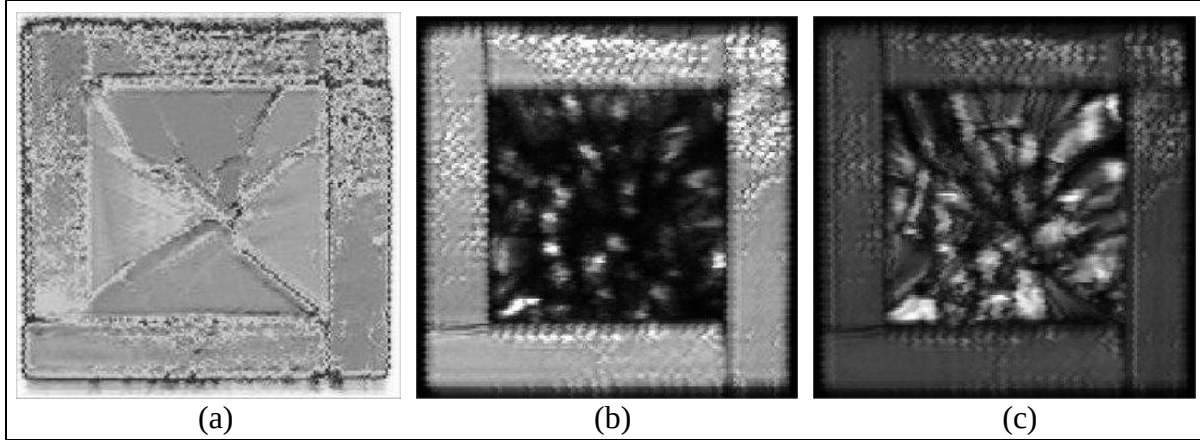
Figure 5 shows three ultrasonic variable amplitude C-scans in which the up direction from the bottom of the images corresponds to increasing  $z$  in the DR scan of the specimen. The scan in figure 5a was gated to show the front surface and near surface characteristics of the specimen and indicates at least five major cracks in the tile. The scan in figure 5b was gated to show only the signal amplitude at the rear surface of the tile. The scan in figure 5c was gated to show the overall bulk characteristics of the tile. Both of the images in 5b and 5c show widespread

attenuation, indicated by the darker areas, most likely due to cracks within the tile. Figure 6 shows a through-thickness B-scan presentation of the specimen going from left to right approximately halfway between the bottom and top of the tile. The B-scan view shows the ultrasonic amplitude against time (i.e., depth), which is on the y-axis, over the length of the line (horizontal) defining the cross-sectional location. The physical side locations of the steel surround pieces are marked and the vertically larger white areas indicate more immediate loss of signal. The B-scan clearly shows where cracking damage is resulting in relatively fast signal attenuation, which occurs over the majority of the cross section.

Figure 5. Ultrasonic C-scans of specimen 2: (a) surface/near-surface of specimen, (b) rear surface of tile signal amplitude only, and (c) bulk characteristics of tile.

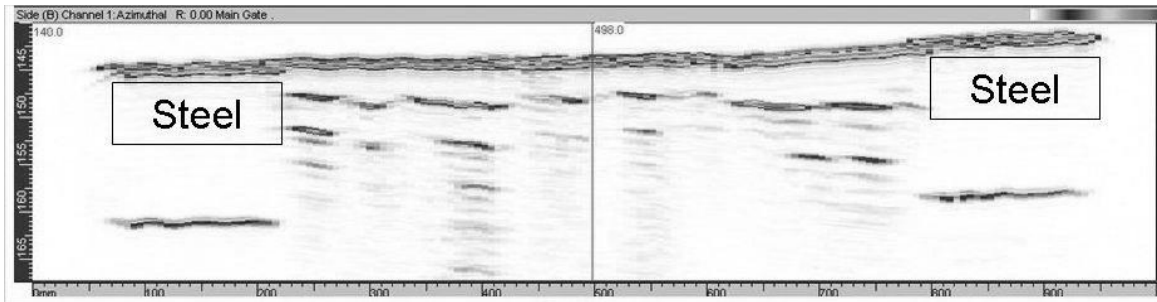
Figure 6. Through-thickness, or depth, B-scan presentation of Specimen 2 going from left to right approximately halfway between the bottom and top of the tile. The physical side locations of the steel surround pieces are marked.

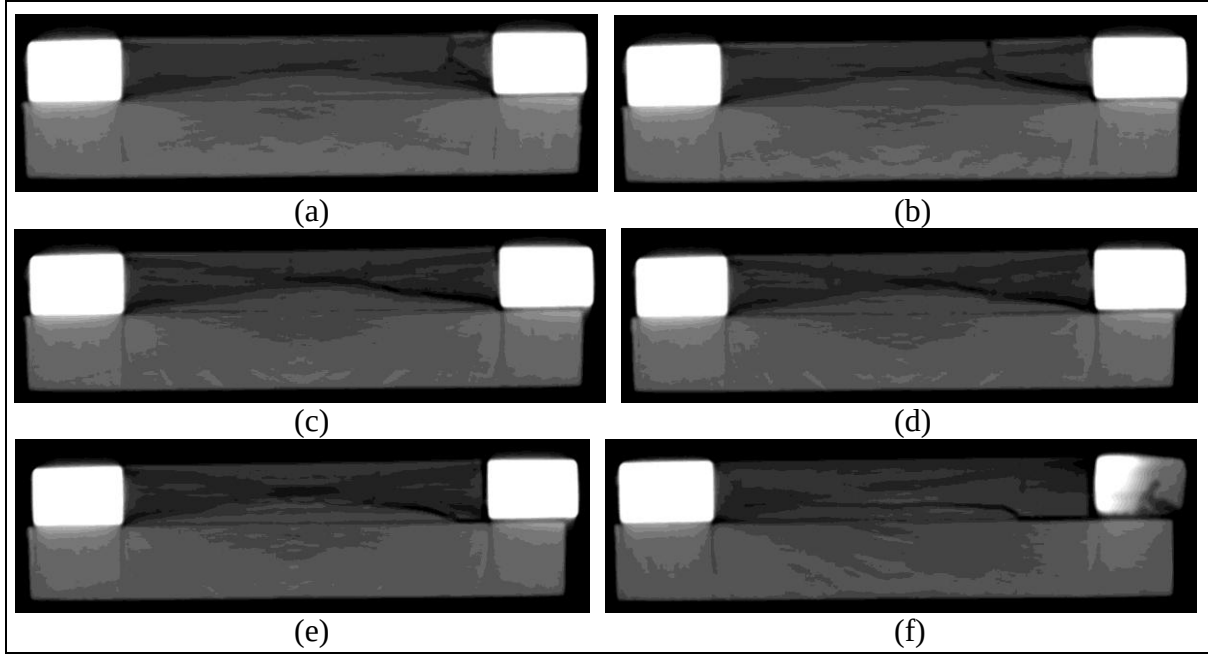
The vertical positions (z-direction) of the bottom and top of the tile were 330.5 and 432.0 mm, respectively, in the XCT scans. Figure 7 shows a series of XCT scans (images) of the specimen at vertical positions of 339.70, 353.20, 382.90, 395.50, 413.50, and 431.50 mm (a–f). The front surface of the tile is at the top of the images. The presence of cracking in the tile is evident near its bottom on the right side as shown in figure 7a. The cracking continues to extend into the interior and towards the front of the tile as the positions of the scans increase, finally reaching

from one rear side corner to the other. Other cracks approximately perpendicular to the faces of the tile also extend from this main feature to the front of the tile. The image at a height of 431.50 mm (f) also shows that part of the rear face of the tile on the right has come away from the backing plate and is no longer in intimate contact with the plate. This is the same side of the tile adjacent to which the tilted steel surround piece is located. It is evident that the crack enters the interior of the tile at the juncture between contact and stand off of the rear face of the tile with the backing plate.

Figure 7. A series of cross-sectional XCT scans (images) of specimen 2: scans (a–f) were taken at vertical positions of 339.70, 353.20, 382.90, 395.50, 413.50, and 431.50 mm, respectively.

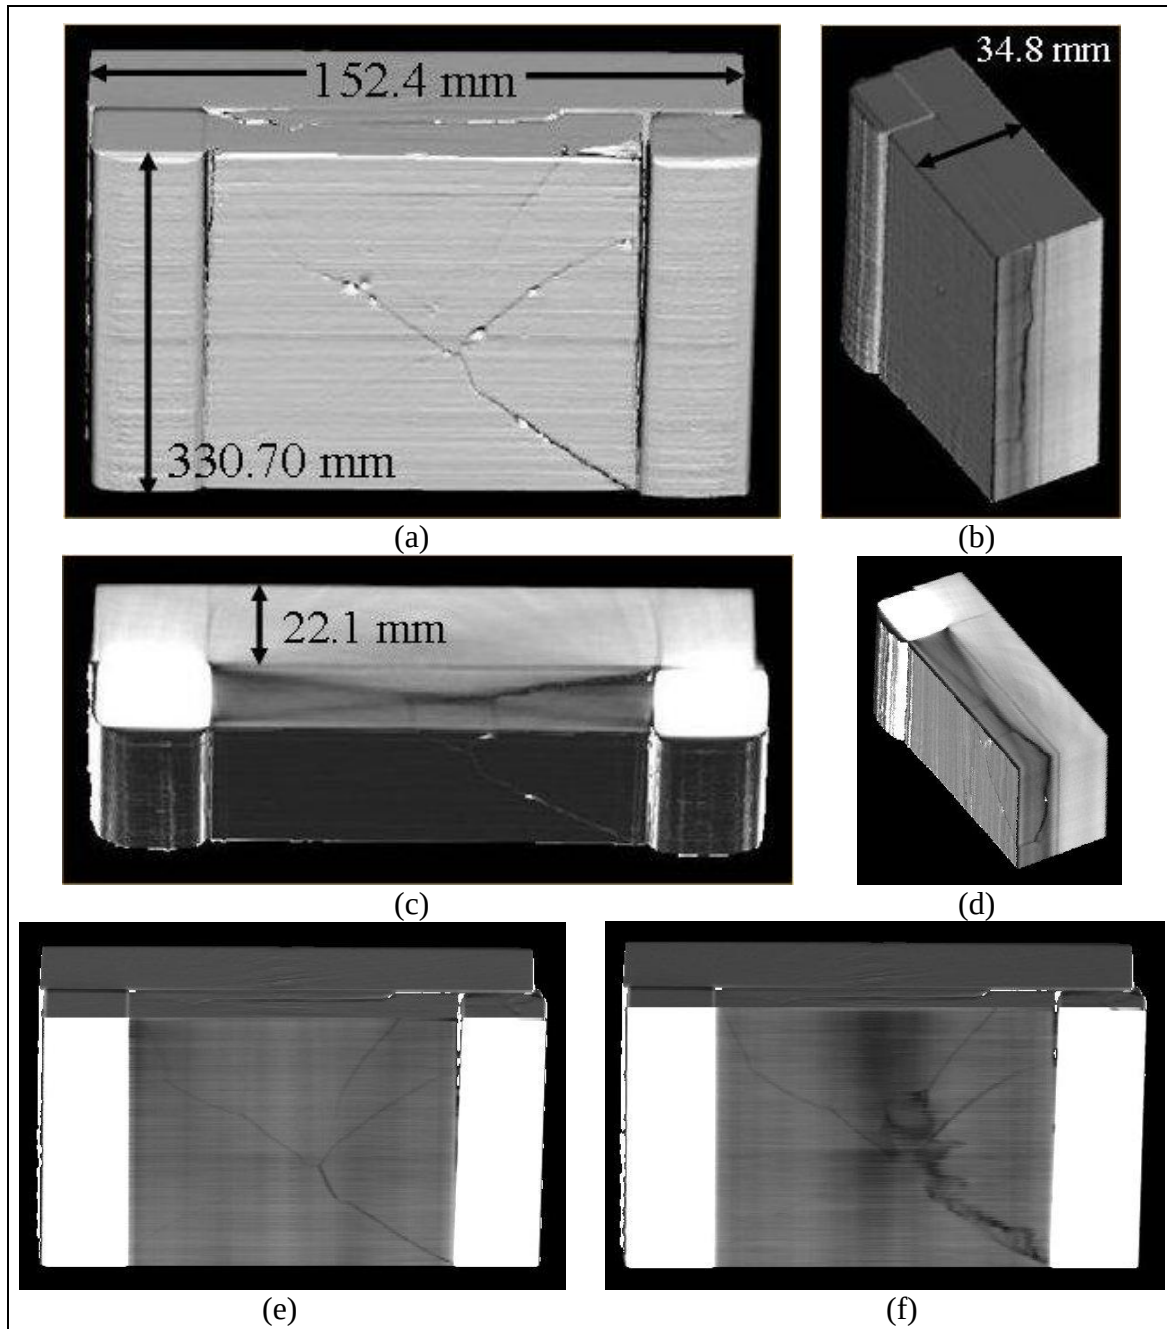
The excellent dimensional accuracy and the digital nature of XCT images allow the accurate volume reconstruction of multiple adjacent or overlapping slices. A virtual three-dimensional (3-D) solid image is created by electronically stacking the XCT images, which have thickness over their cross sections (i.e., voxels), one on top of the previous from the bottom to the top of the specimen or scanned height to generate its virtual volume. Figure 8 shows a series of 3-D solid images of the scanned volume with sections virtually removed in figure 8b–f. The method of virtual sectioning, which is essentially only showing a portion of each scan, allows viewing of generated surfaces anywhere in the scanned volume in 3-D space. The view in figures 8a, 8b, 8e, and 8f is looking at the front of the specimen with it tilted forward. In figures 8c and 8d, the specimen has been tilted forward as well as rotated in order to better view the side sections. Figure 8a shows the entire scanned volume with surfaces and no sections virtually removed. In figure 8b, approximately the right-hand side of the specimen has been virtually removed. The main lateral crack near the rear of the tile is visible, as are some perpendicular cracks that go to

the front surface of the tile. In figure 8c, approximately the top half of the specimen has been virtually removed. It shows cracking at about the middle of and to the right in the sectioned surface, as well as the connections between the crack indications on the front surface and the interior cracks perpendicular to the surfaces. In figure 8d, approximately the top half as well as a smaller section on the right-hand side of the specimen has been removed. The connection of the cracks from one sectioned surface into the adjacent sectioned surface at the intersection (edge) of the two surfaces is evident. In figure 8e, a few millimeters of material in the thickness direction parallel to the faces of the tile has been removed from the front of the specimen. The crack pattern looks similar to the crack pattern on the surface of the tile (figure 8a). In figure 8f, about half of the thickness of the tile has been removed. More severe damage in the center region where the cracks come together, as well as in the lower right area, is evident. The vertical darker broad band in the center of the tile is the manifestation of the relative attenuation effect of the steel as compared to the tile (and aluminum).

Figure 8. A series of 3-D solid visualization images of specimen 2: (a) entire specimen with the front tilted forward, (b) section removed perpendicular to thickness, (c) section removed perpendicular to height, (d) sections removed perpendicular to both thickness and height, (e) section removed parallel to the faces showing the majority of thickness of the tile, and (f) section removed parallel to the faces showing about half the thickness of the tile.

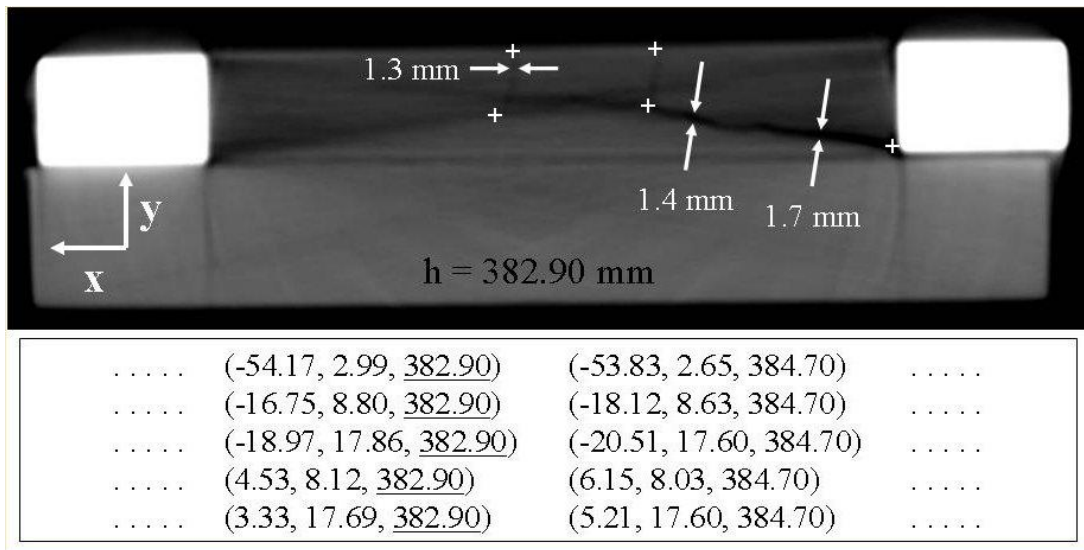
Figure 9. XCT scan (image) at vertical height of 382.90 mm and defining spatial locations of crack planes.

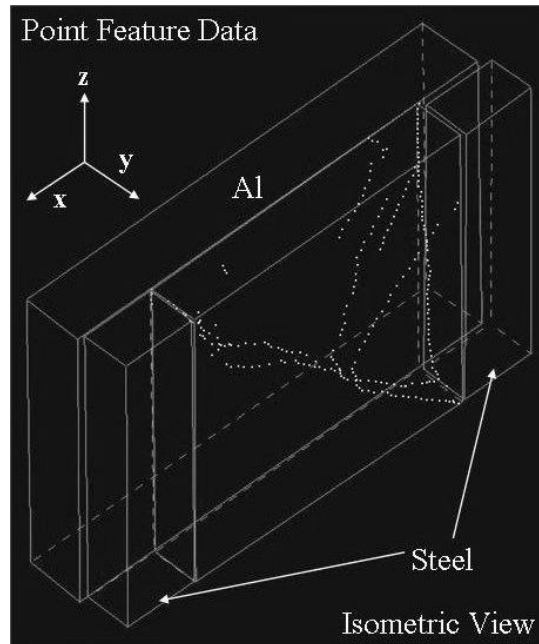
Figure 10 is an isometric view of the scanned volume of the specimen, in which the edges of each component are shown in wire frame mode and dashed lines indicate rear or blocked view edges. The points defining the crack locations and orientations are shown within the body of the tile. The tilted steel surround piece is on the right side of the image. Figure 11 is an isometric view of the scanned volume showing the points and the boundary curves that were fit to the points. Figure 12 is an isometric view of the scanned volume showing only the boundary curves within the body of the tile. Figure 13 is an isometric view of the scanned volume showing gridded surfaces fit to the boundary curves defining major crack regions and their interconnection. Figure 14 is an isometric view of the scanned volume showing shaded surfaces

Figure 10. 3-D point cloud of the defining locations of the crack planes.

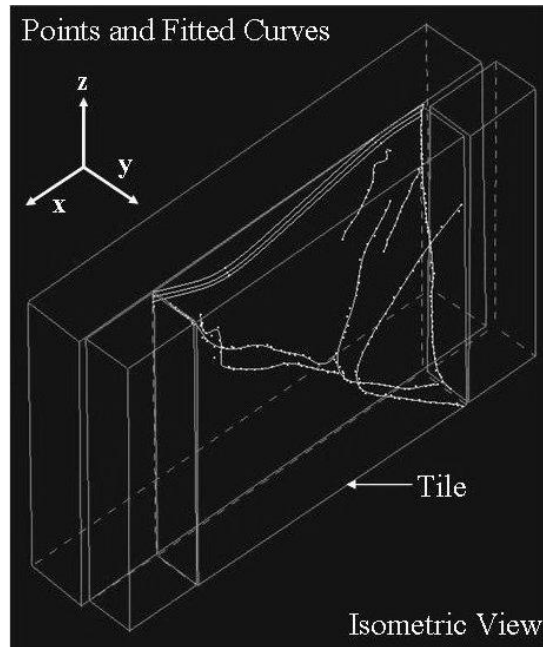
Figure 11. 3-D point cloud and boundary curves of the crack planes.

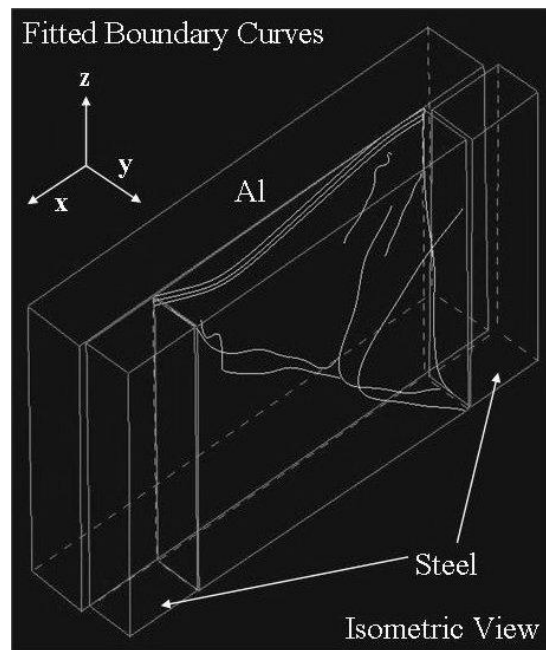
Figure 12. Boundary curves of the crack planes.

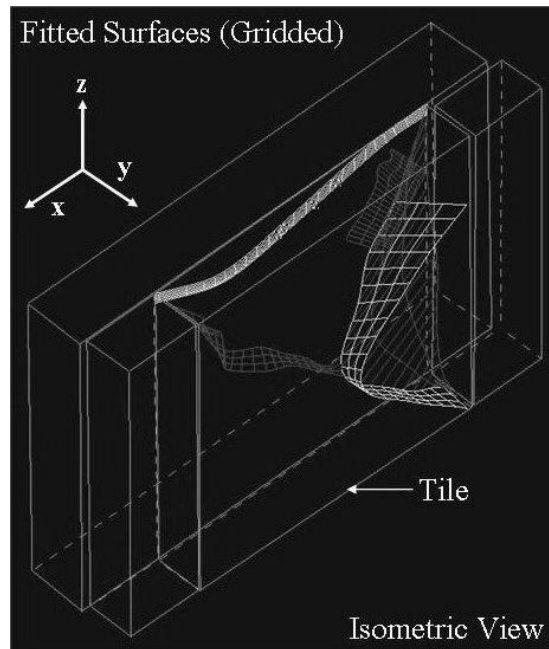
Figure 13. Fitted crack plane surfaces (gridded).

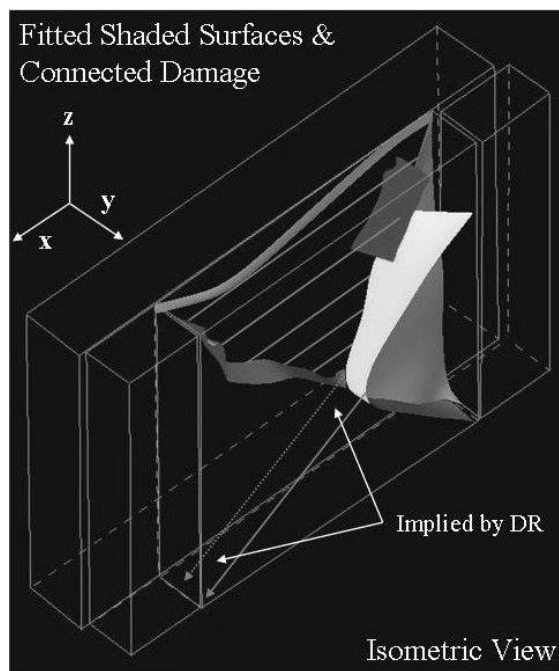
fit to the boundary curves defining major crack regions and their interconnection, as well as other crack plane features. The parallel gray lines drawn in the top of the tile indicate that there is also a crack plane in the region spanned by them. Secondly, the relatively faint crack indication in the lower left area of the DR of the specimen is marked by the two parallel arrows in the lower left part of the body of the tile. Figure 15 is an isometric view of the tile only showing the various crack regions, indicating that a significant volume of the tile is severely cracked. This volumetric representation of the damage also clearly shows that the crack regions go from both side-to-side and bottom-to-top in the body of the tile.

Figure 14. Crack plane surfaces showing the entire specimen.  
The tilted steel piece is on the right.

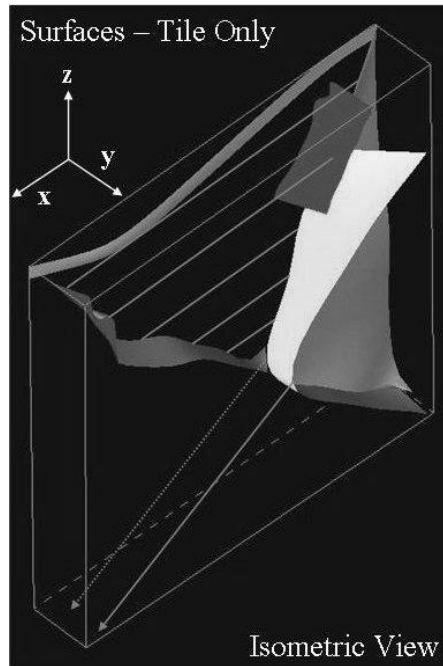
Figure 15. Crack plane surfaces showing the tile only.
