*Monitoring Completed Navigation Projects Program*

## **Lock Wall Expedient Repair Demonstration Monitoring, John T. Myers Locks and Dam, Ohio River**

October 2011

Final report

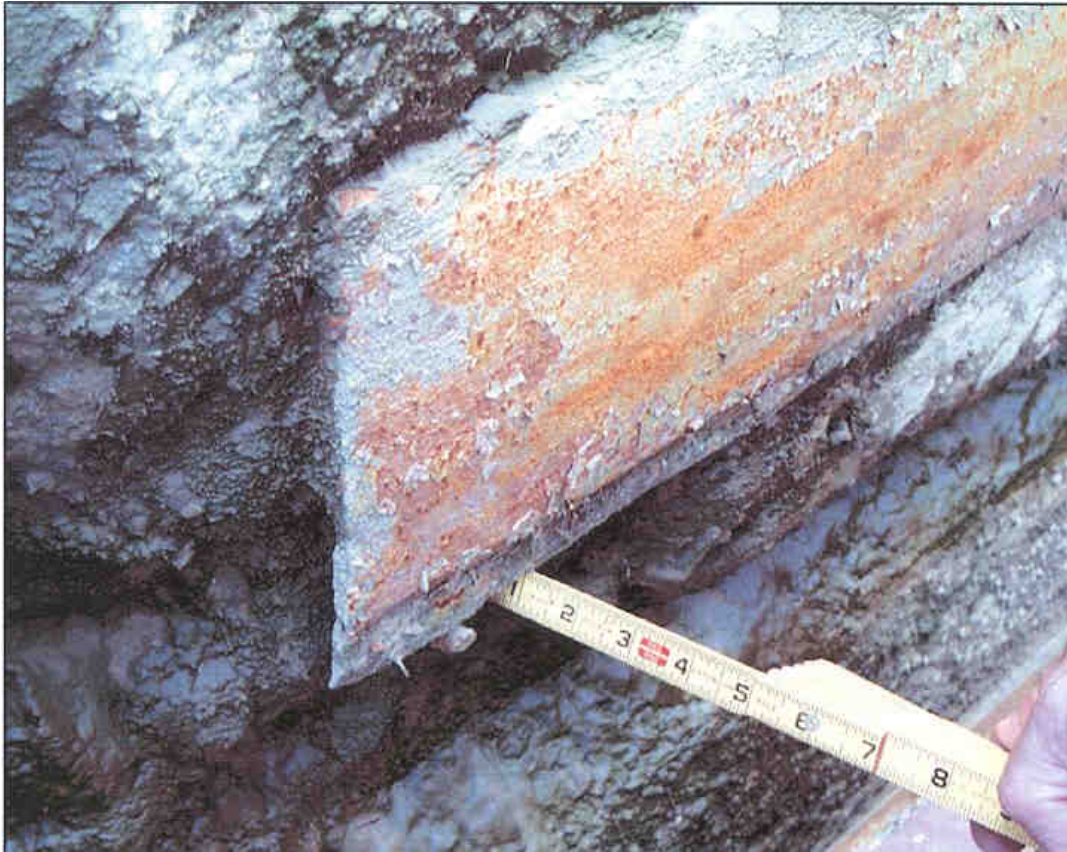
terminated near a monolith joint. Examples of this type of damage are shown in Figures 8 - 10. The relatively small concrete section between the end of the armor and the monolith joint is inadequate to resist the impact loads transmitted through the armor. Apparent bending of the armor beyond the last anchor also appears to contribute to localized crushing and subsequent loss of concrete section (Figure 9). Significant loss of concrete (Figure 10) makes these areas more susceptible to damage during chamber filling and emptying, particularly where barges have protruding steel plates such as shown in Figure 11.

Figure 10. Type I loss of concrete section, John T. Myers.

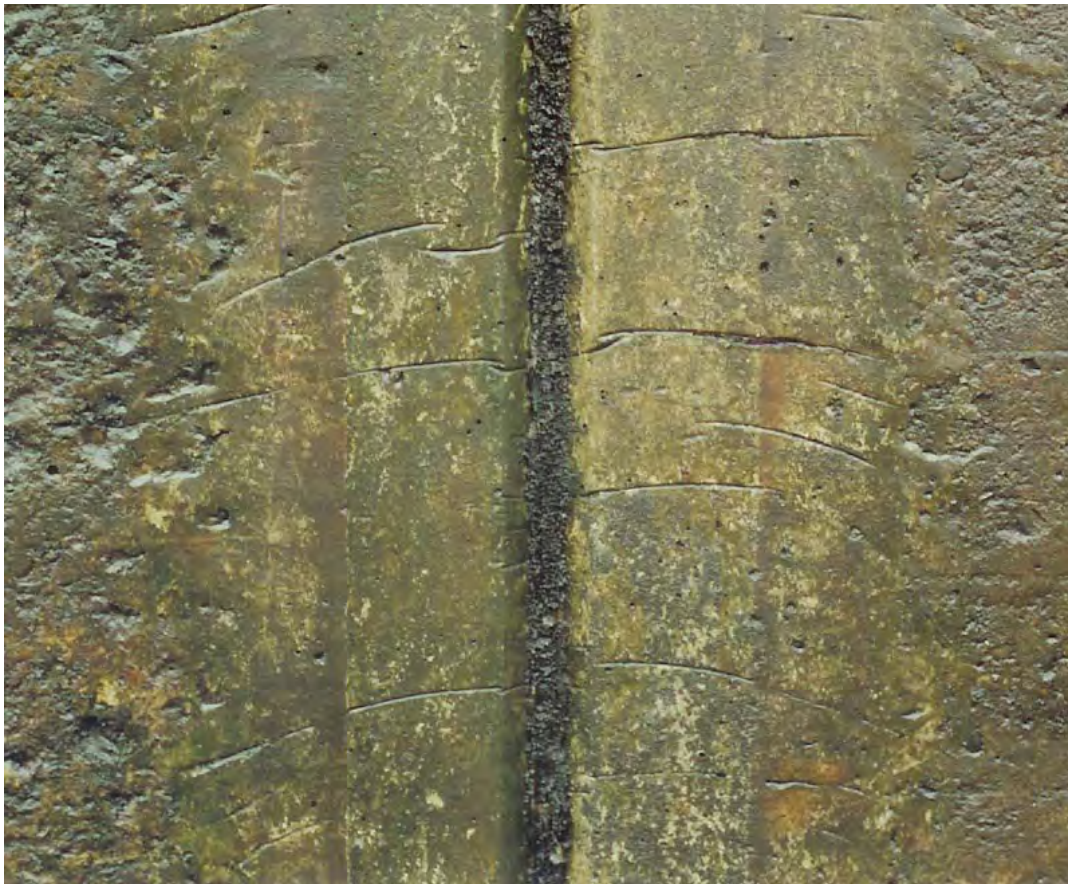
Figure 17. Condition of repair after 3 years of service, Lock 2, Upper Mississippi River.

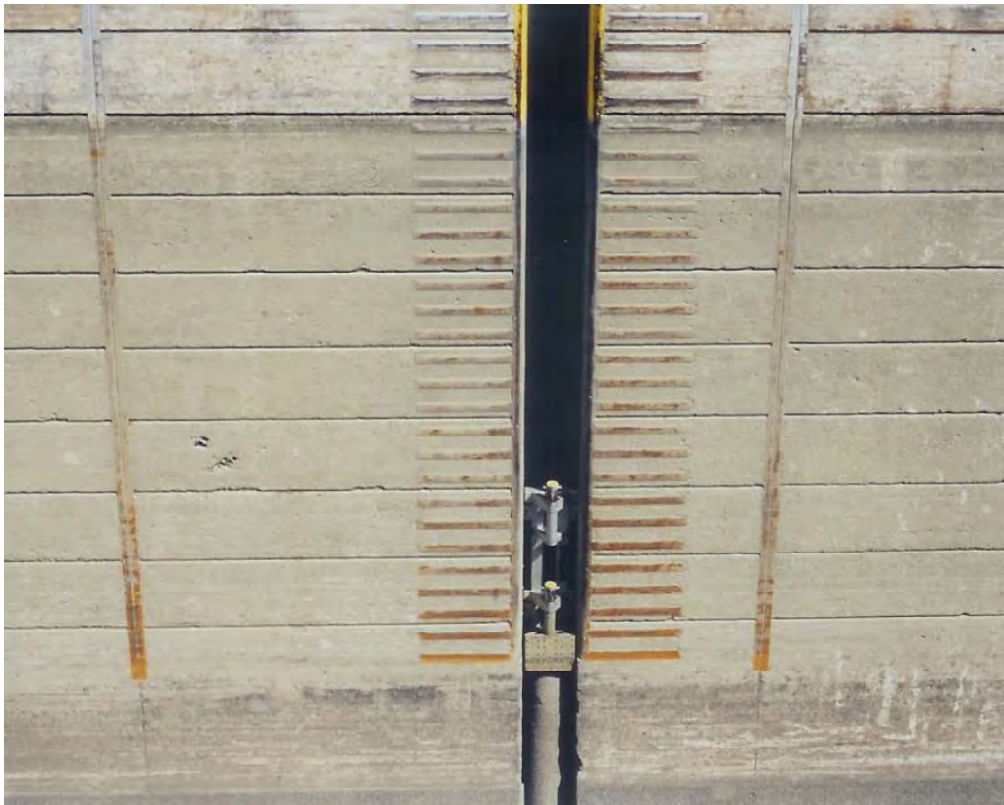
Figure 19. Armor condition, McAlpine Lock, 1999.

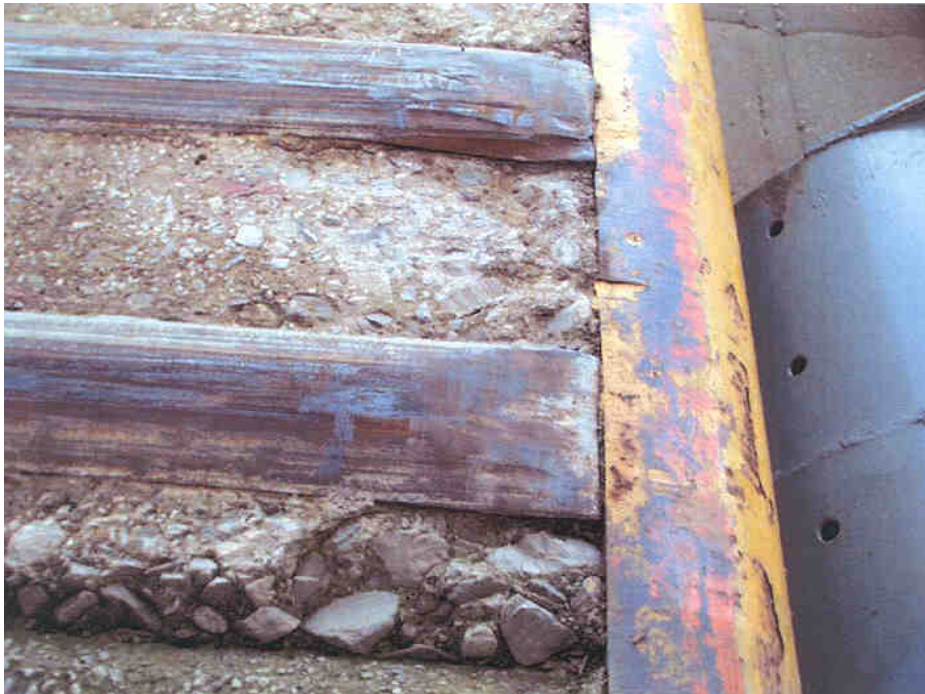
impact and abrasion (Figure 23). However, this protection was compromised in some cases because the wall armor was flattened by barge abrasion (Figures 24 and 25). Continued loss of wall armor section combined with loss of concrete section (Figure 26) will exacerbate this type of damage with potentially serious consequences for lock operations.

Figure 23. Typical Type II damage, John T. Myers, localized crushing of concrete.

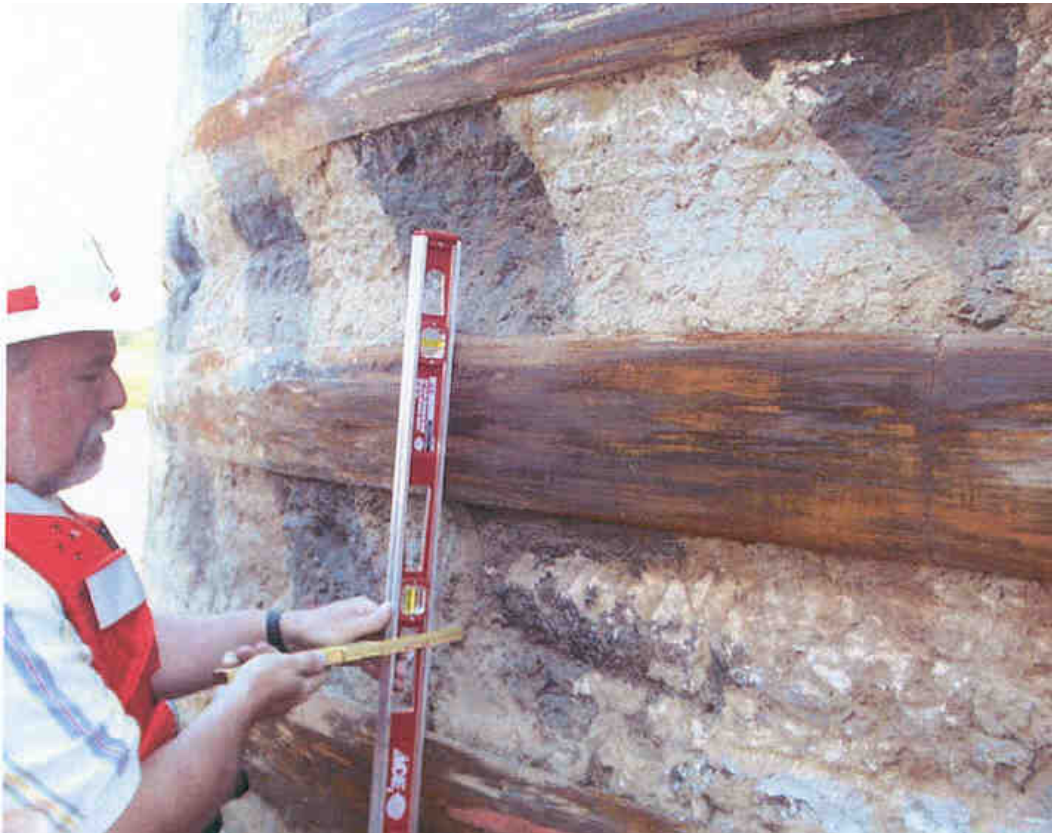
During the 1999 survey, CELRL personnel stated that the consequences of a catastrophic event such as barge sinking were not as dire in the area of a bullnose as they would be inside the lock chamber; therefore, problems within the lock chamber should be addressed first. Therefore, the need for repair of bullnose damage at this time is questioned. These areas should be monitored periodically to determine the rate of concrete abrasion because continuing loss of section could ultimately affect the armor anchor system. Also, continued abrasion could undermine the edges of the wall armor,

Figure 32. Typical Type V damage, John T. Myers, bullnose.

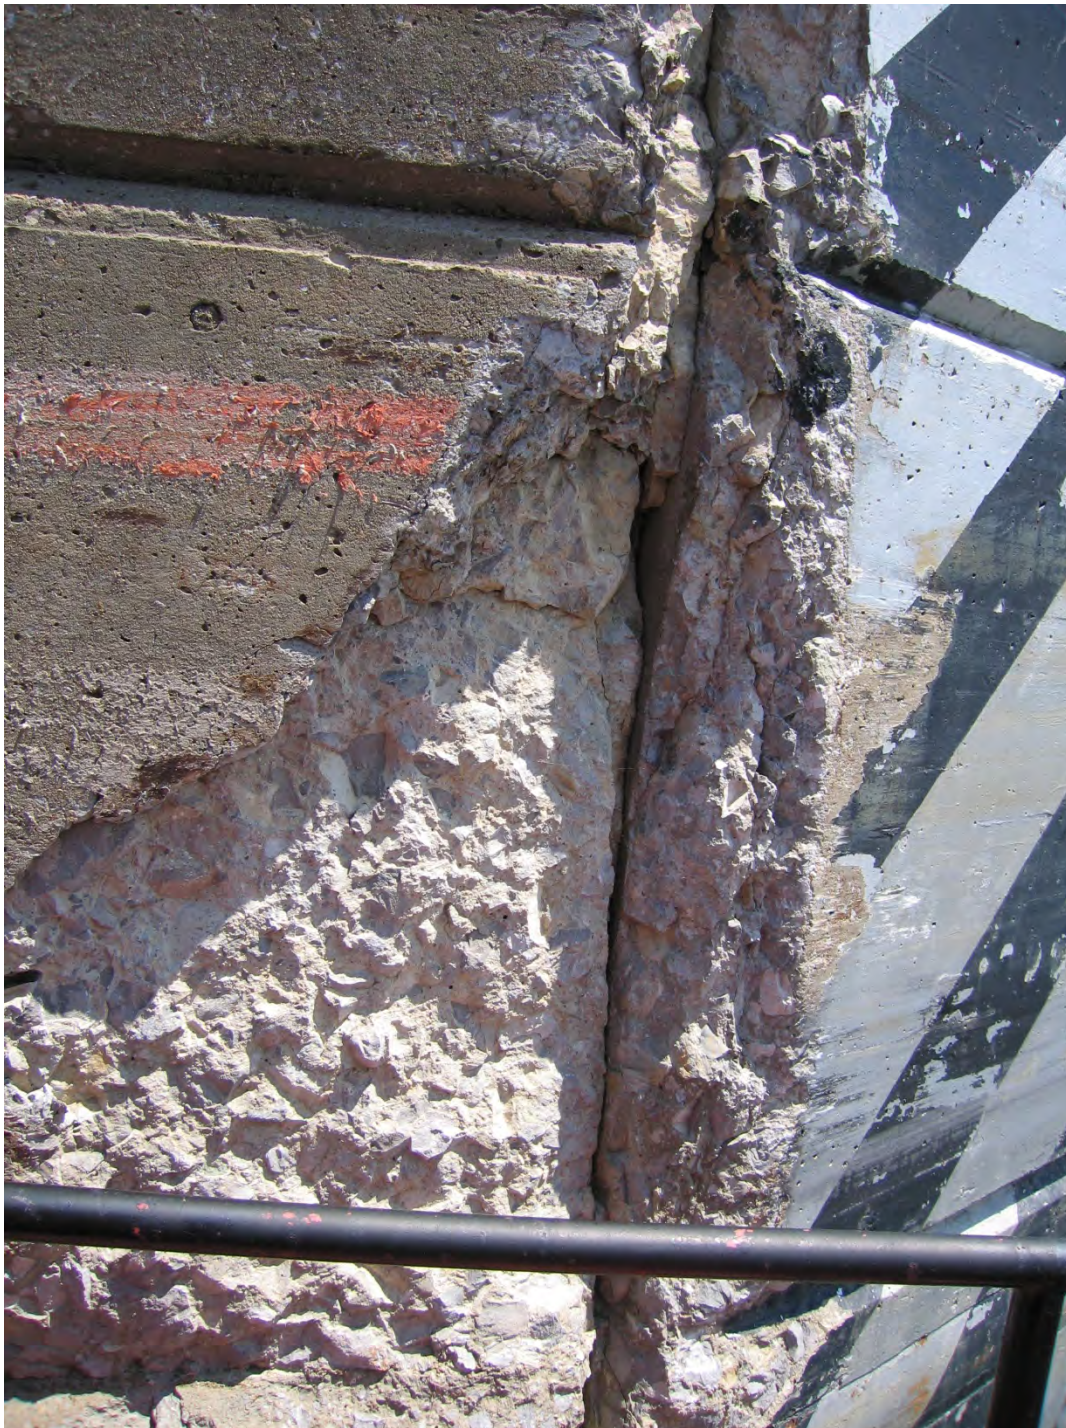
Figure 39. Closeup photo of major concrete damage at the vertical joint to be repaired.

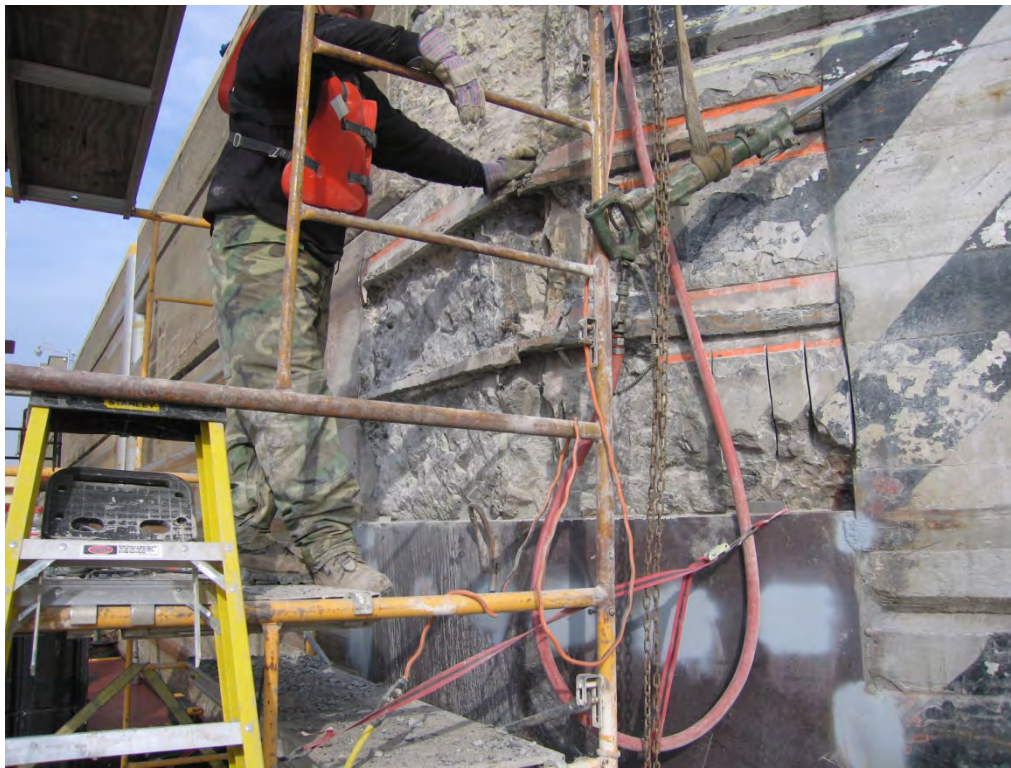
Figure 43. Sawed concrete being removed by impact hammer.

Saw cuts by a diamond blade saw were made along the template lines 36 in. outside the joint on the upstream monolith L-36 and 48 in. outside the joint on the downstream monolith L-35 for a minimum of 2 in. deep or to sound concrete. A hand-held impact concrete breaker was used to dislodge concrete within the sawed area being repaired (Figure 43).

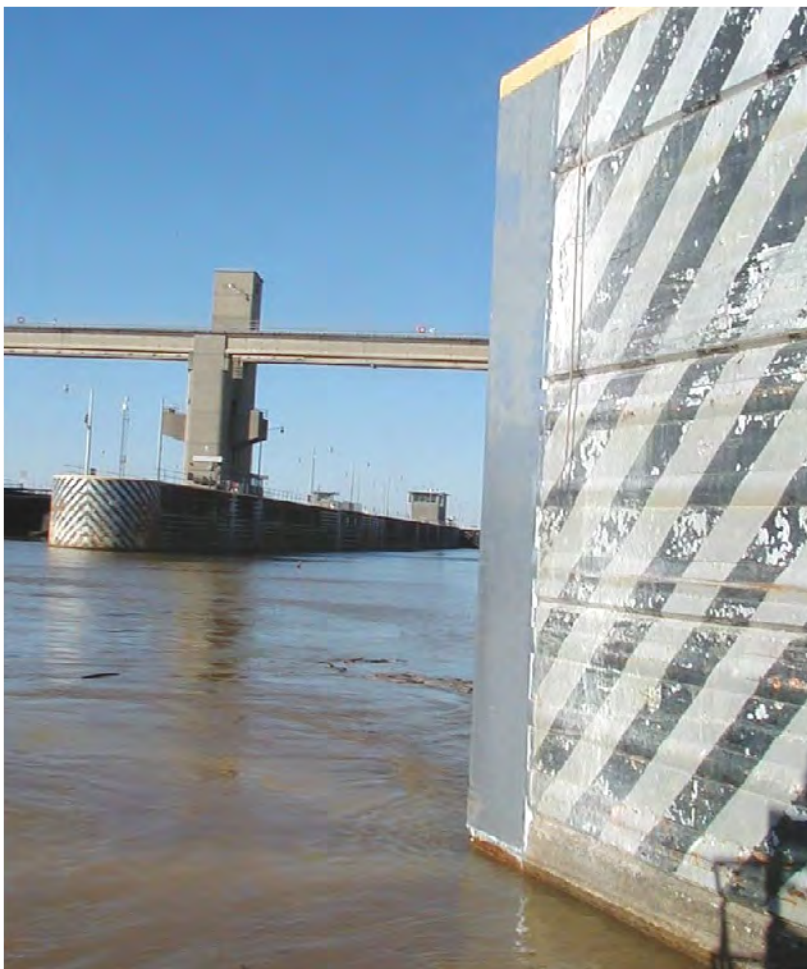
Figure 45. Completed repair of 600-ft chamber upper land-wall approach vertical joint at low water pool elevation, John T. Myers Locks and Dam.

This repair technique effectively connected two concrete monoliths with one continuous steel plate that was firmly anchored into the sound concrete of both individual monoliths. The completed repair is shown in Figure 45 at low water pool elevation and in Figure 46 at high water elevation on the Ohio River.

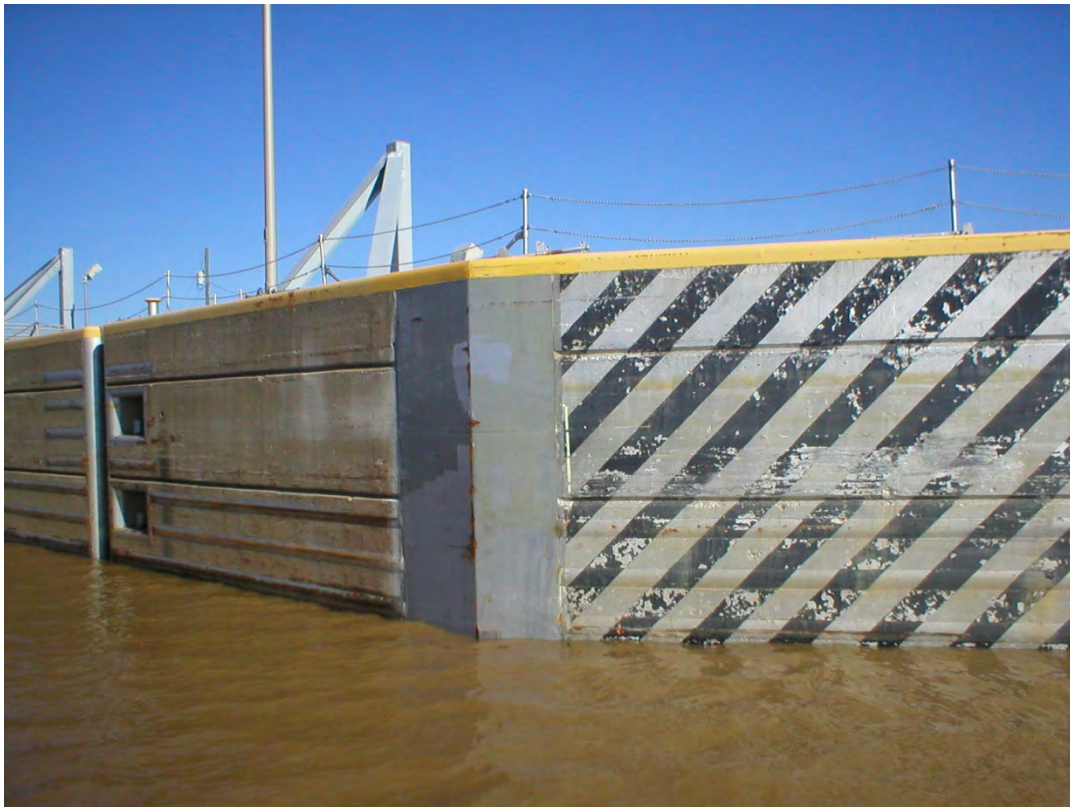
Figure 46. Completed repair of 600-ft chamber upper land-wall approach vertical joint at high water elevation on the Ohio River.

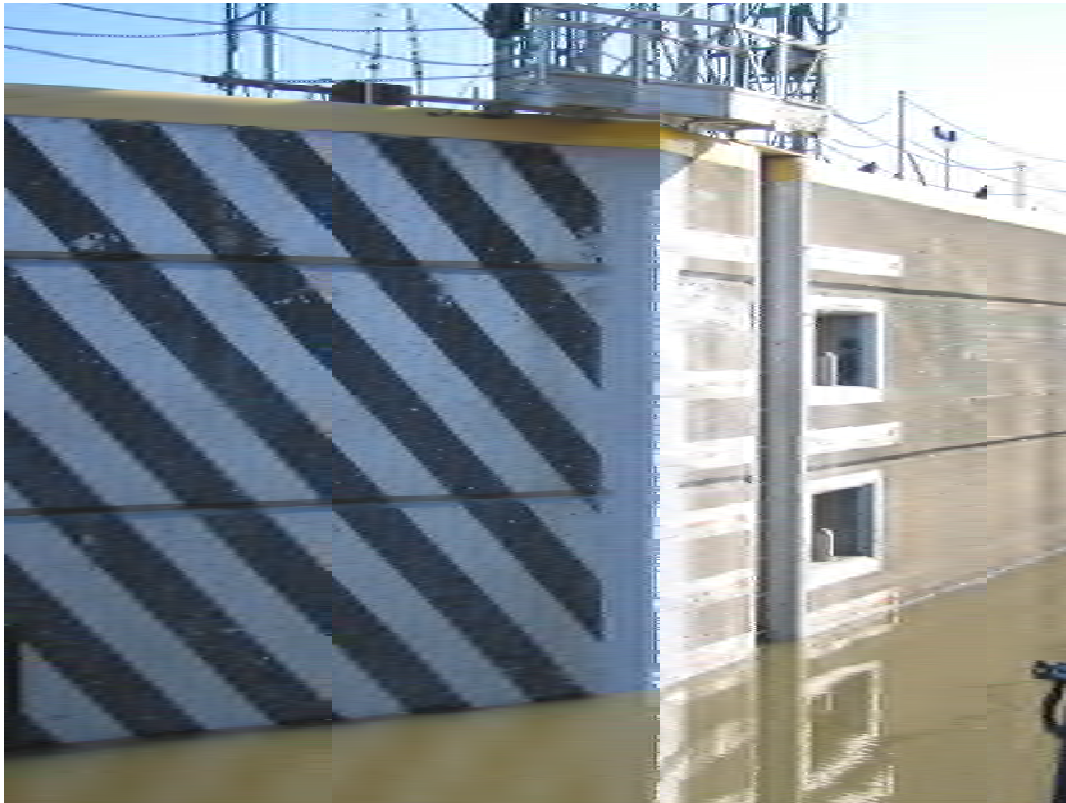
Figure 57. Completed repair of 600-ft chamber lower land-wall approach vertical joint at high water elevation on the Ohio River.

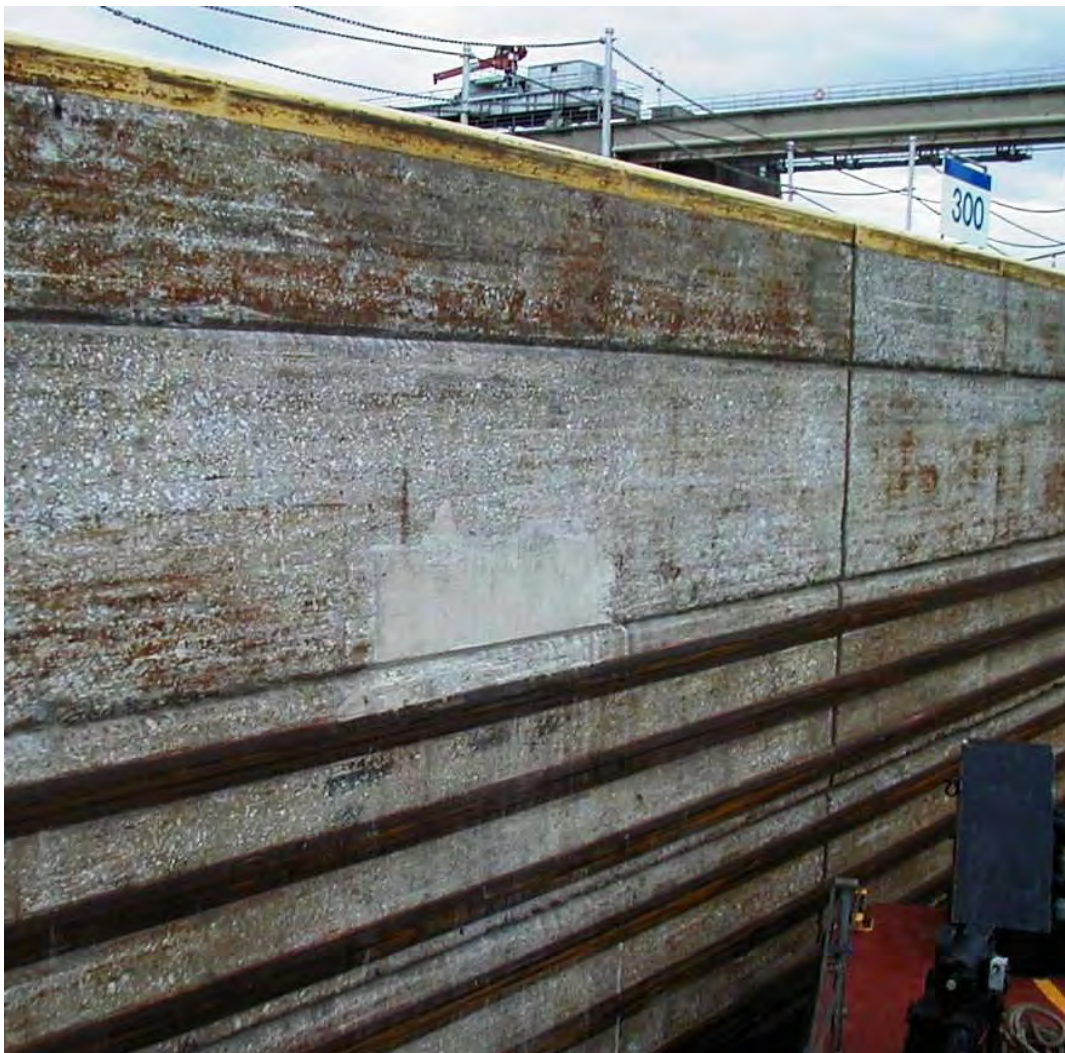
Figure 75. Completed repair of lock approach wall 5 days after placement.

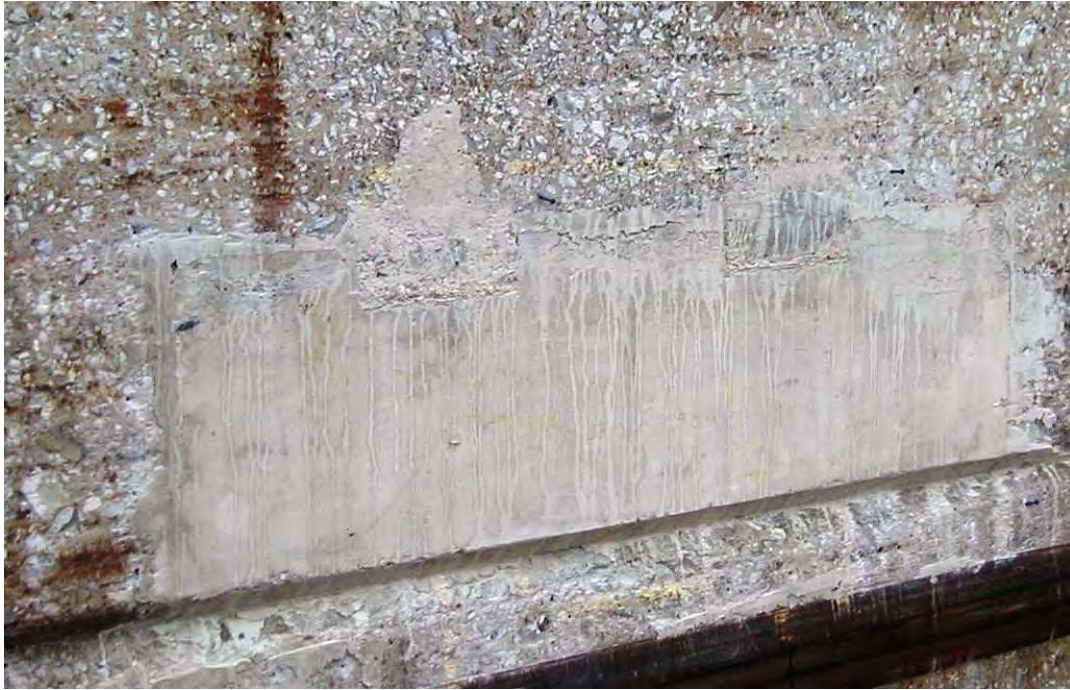
Figure 76. Closeup of completed repair 5 days after placement.
