COST AND PERFORMANCE REPORT

Ultrasonic Guided Wave Technology for Non-invasive Assessment of Corrosion-induced Damage in Piping for Pollution Prevention in DOD Fuel Storage Facilities

ESTCP Project WP-200819

Version 2

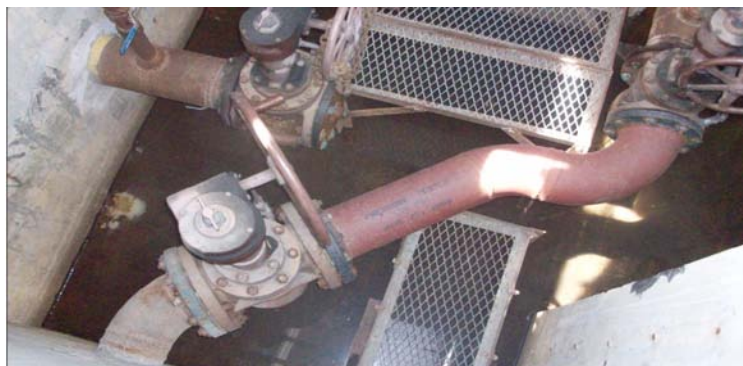
Figure 3. Pipeline accessories inside a valve pit. A section of the pipeline between Block 20 and Valve Pit 21 was replaced 4-years ago because of structural weakness as revealed by pressure testing. It has a mixture of 10 inch and 6 inch pipes connected through reducers and valves.

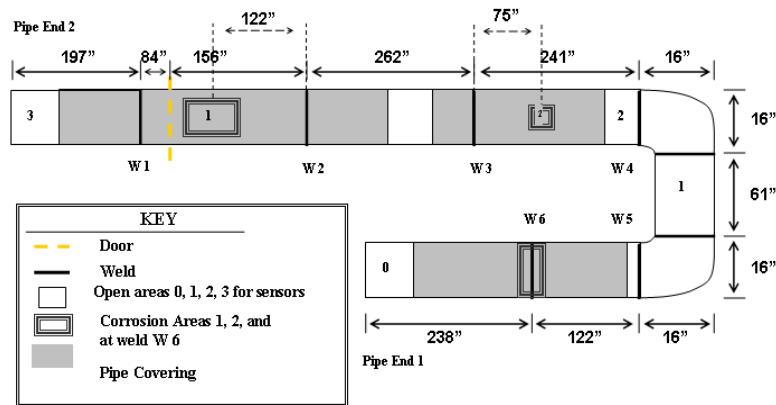
Figure 4. Location of ultrasonic measurement points and corrosion defects in the 8.6 inch diameter pipeline at NSWCCD.

Figure 4 illustrates the locations of the corrosion-induced defects. Two defects (unknown to the inspectors) were placed in the long straight sections of the pipeline. One of the defects not only increased systematically in its depth, but also along the pipe axis and along its circumference as the exposure progressed (Defect 1). The other defect was intended to be a "small" defect (Defect 2) having a fixed lateral dimension of approximately 3 inch x 3 inch, but with increasing material loss in the thickness direction. The goal was to achieve a wall thickness loss exceeding 50% in this defect by the end of Phase I.

In Figure 4 regions 0, 1, 2, and 3 shows where transducers were mounted. We see that waves excited by Sensor 3 propagating in the negative direction should reach Defects 1 and 2 before reaching an elbow. Waves excited by Sensor 2 propagating in the positive direction should reach Defects 2 and 1 before it reaches the pipe end. Waves excited by Sensor 1 should see Defects 2 and 1 after crossing an elbow in the positive direction, and see the Defect W6 in the negative direction after crossing an elbow. Waves excited by Sensor 0 and propagating in the positive direction sees Defect W6 before reaching either elbow and beyond.

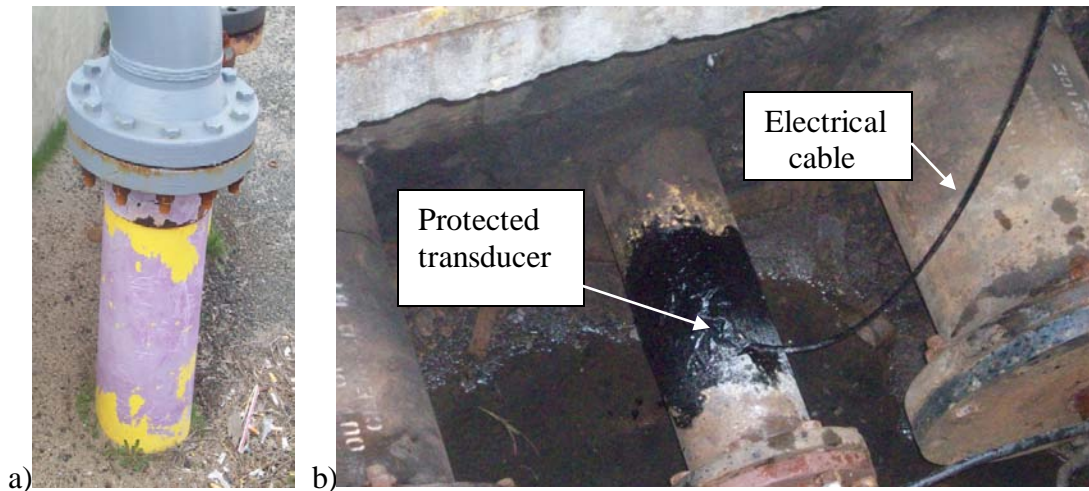
Figure 6. Surface conditions of tested pipe.

- 6a) Protective paint on a section of pipe to be removed prior to transducer mounting.
- 6b) Protective tar coating and lead wires for a transducer in the underground pipeline.

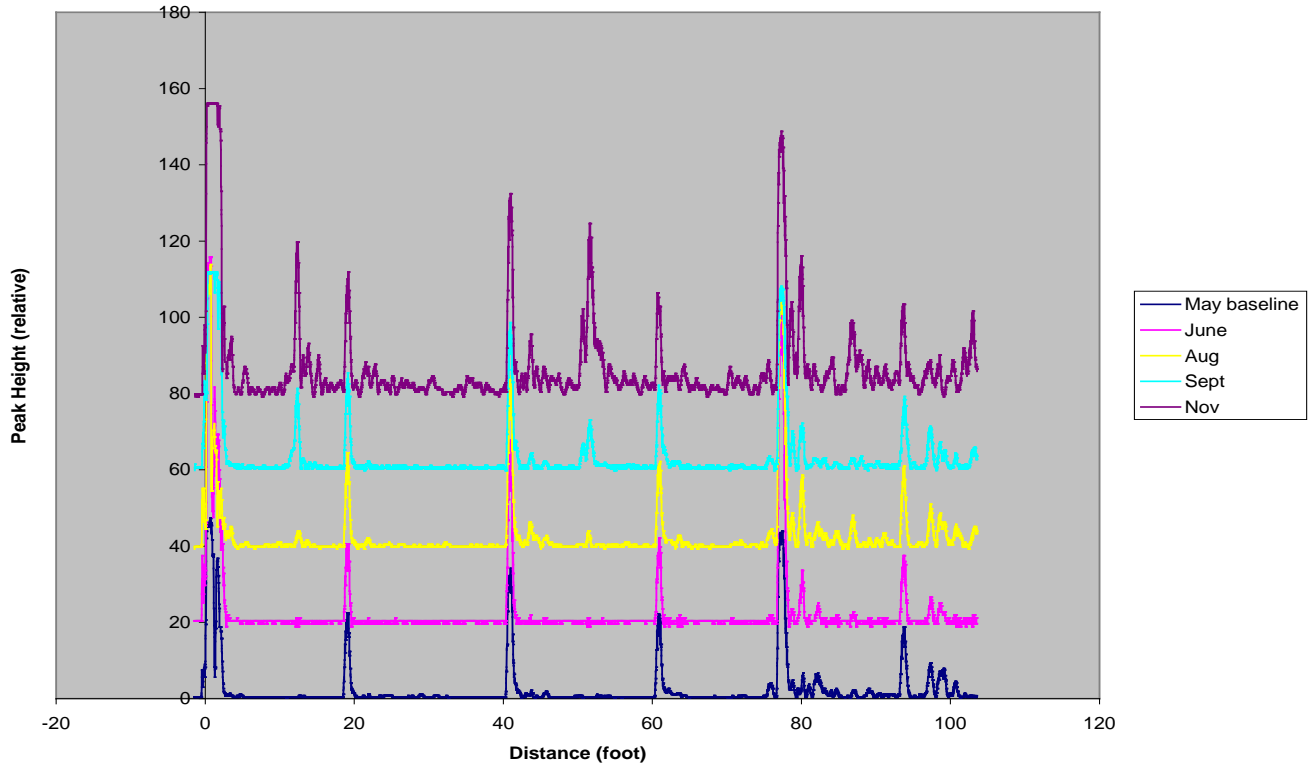
Shown in Figure 9 is the summary of the above-ground ultrasonic wave data over time as compared to the baseline with a systematic increase in defect peak height with successive stages of corrosion from a transducer placed at location 2. Waves from one transducer detect the presence of welds, elbows, and one or more defects in the guided wave propagation path. As expected, the signal height depends on the size of the defect, the distance between the transducer and the defect, and the number of welds in the wave propagation path. We note that the noise level increased in the later months as corrosion progressed, but was less than 0.1 of the weld signal height at about 80 feet.

Figure 9. Systematic increases in defect detection over time as compared to the baseline. Systematic increases in peak heights for growing Defects 1 and 2 sensed by transducer at location 2. Defect 1 was located at approximately 50 feet and Defect 2 was located at approximately 12 feet. The other large peaks, approximately 20 feet apart, are from the welds in the pipeline. The baseline signal (May 2008) is blue, the June signal is pink, the August signal is yellow, the September signal is light blue, and the November signal is purple. An offset of twenty units along the vertical axis has been added to each successive trace before plotting.

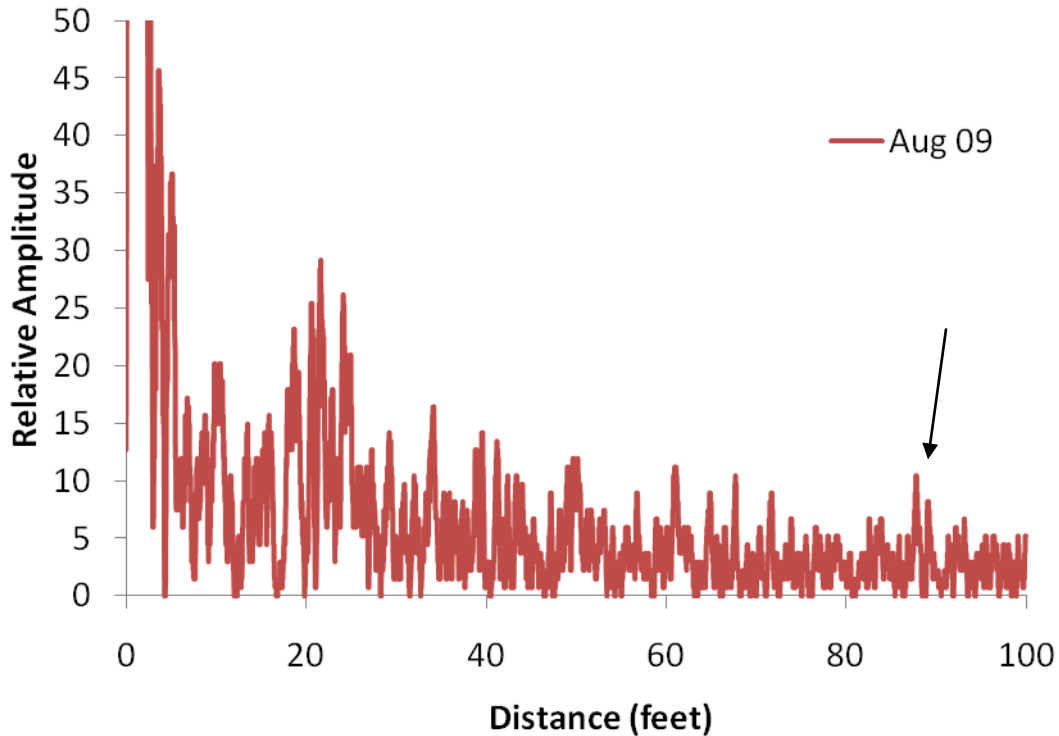
Figure 11. Signal trace at baseline obtained by sensor #22532 inside VP 21 propagating guided waves towards BL 20.

Shown in Figure 11 is the baseline trace for wave propagation from VP 21 towards BL 20. The peaks located up to 20 feet represent signals, first from the leakage of the transducer excitation, followed successively by the signals at the wall interface, and from welds and reducers along the pipeline. Of note is the pair of peaks above noise level at about 90 feet, which could be identified to originate from the region on the ground where pipe repair and replacement were made a few years back. The height of these two peaks was approximately twice as large as the noise level, which was 4 times as large as that typically observed in the laboratory tests in Phase I.

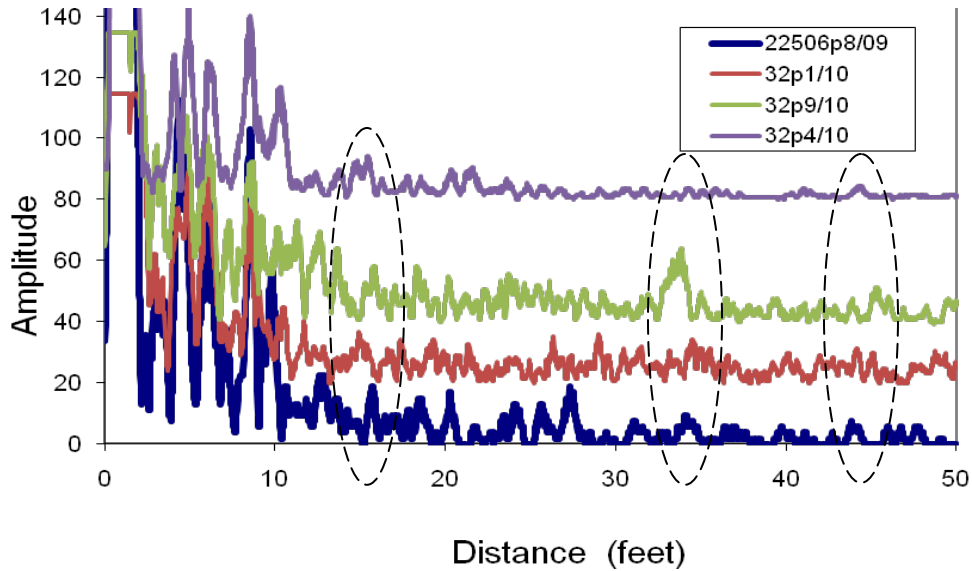
Data traces in Figure 13 are for waves propagating from VP 5 towards VP 20 from sensor #22506. Focusing on the groups of peaks around 16 feet, 35 feet, and 44 feet, we observe that the normalized peak heights at some locations (e.g. 35 feet) have not been increasing consistently or they remained relatively unchanged over the course of the monitoring effort. The locations where peak heights remained constant most likely originated from static structural features such as welds. Inconsistent changes in peak heights could be due to signal noise and/or multiple reflections unrelated to defects.

Figure 13. Monitoring signal changes in data sets obtained by above-ground sensor #22506. An offset of twenty units along the vertical axis has been added to each successive trace before plotting.

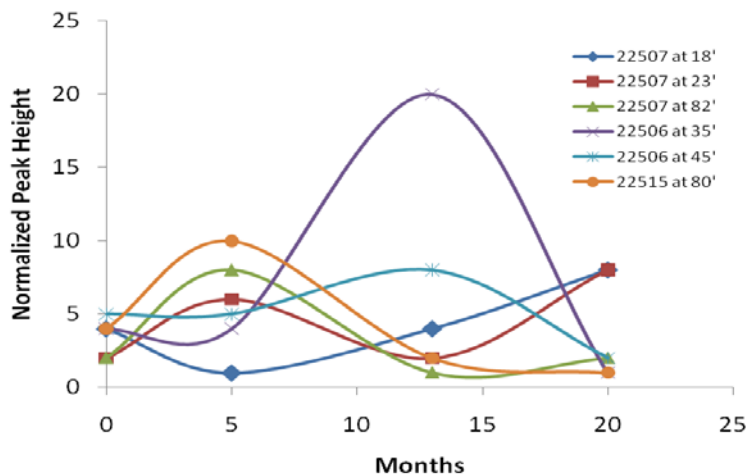
The results of the experiment in Phase I are shown in Figure 14. We observed that none of these peaks increased systematically in amplitude during the 20 months of monitoring. Thus, further monitoring is required to determine whether these locations have corrosion-induced defect growth.

Figure 14. Changes in normalized peak height at suspected defect locations detected by three above-ground transducers. Typical signal noise was 2 vertical units.
