## **Investigation of Failed Components from a 7-in High Altitude Research Program (HARP) Cannon**

**ARL-TR-5814**

**November 2011**

**Weapons and Materials Research Directorate, ARL**

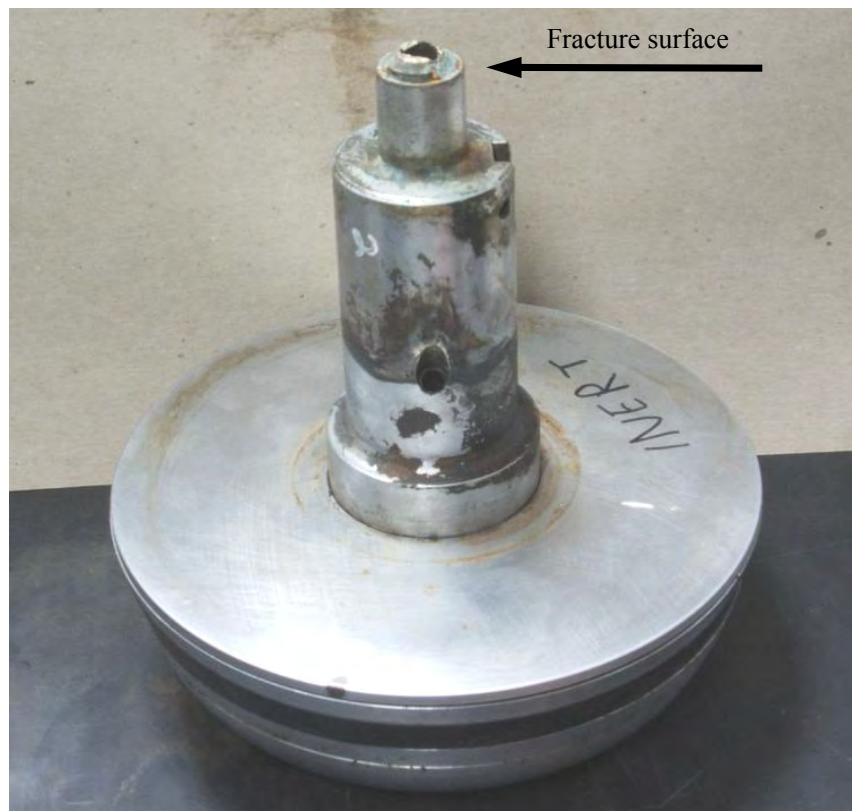
The investigation was conducted in a twofold manner: first, we examined the recoil unit tube and then the breech spindle. These components are shown in their as-received condition in figures 1 and 2.

Figure 1. As-received M113A1 breech assembly spindle.

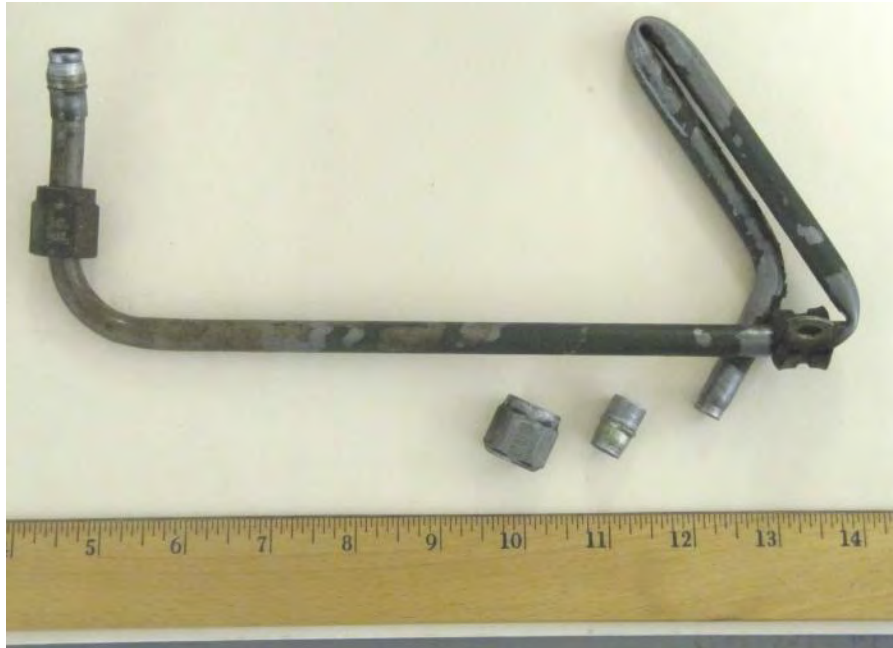
Figure 2. As-received M174 recoil unit replenisher/recuperator tube.

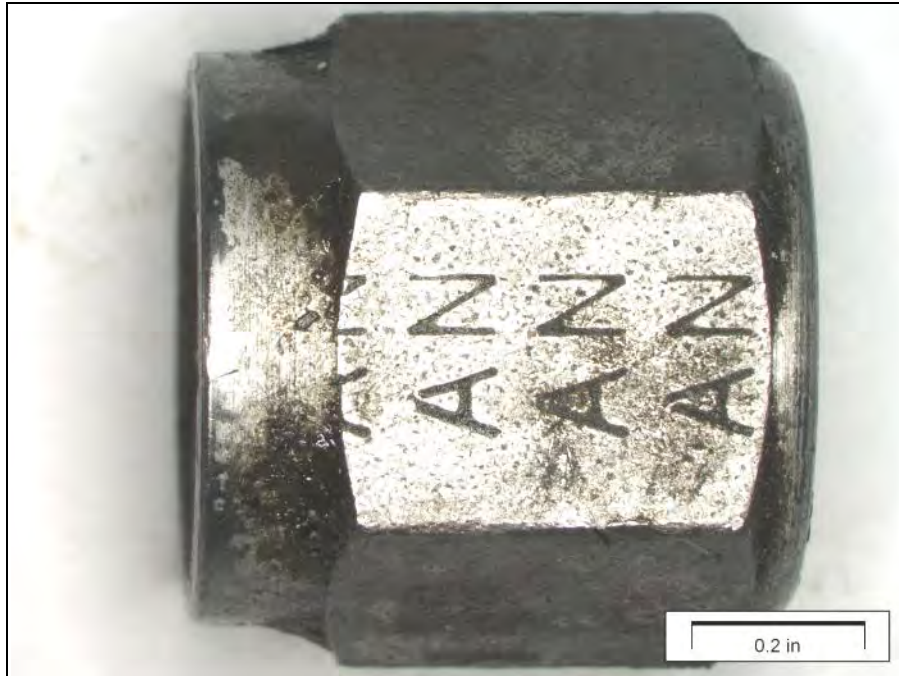
The external surfaces of the M174 recoil unit tube were photographed and examined for defects and/or witness marks from impact, installation, or corrosion. This component was removed from the M174 recoil unit by removing the locking nut on the fixed end of the tube. The other end was visibly bent (figure 2) and the joint failed at the nut-stud/coupling interface as observed during the initial inspection after the event. The locking nut remained on its respective coupling with the ferrule after the failure. Since there were no visible metal fracture surfaces, the failed joint design and surfaces were examined. There were no observable impact marks on the tube, which would have caused the tube to become dislodged from its mount. The nut and ferrule removed from the failed end of the tube are shown in figures 3 and 4.

Figure 3. Nut from the failed end of the tube.

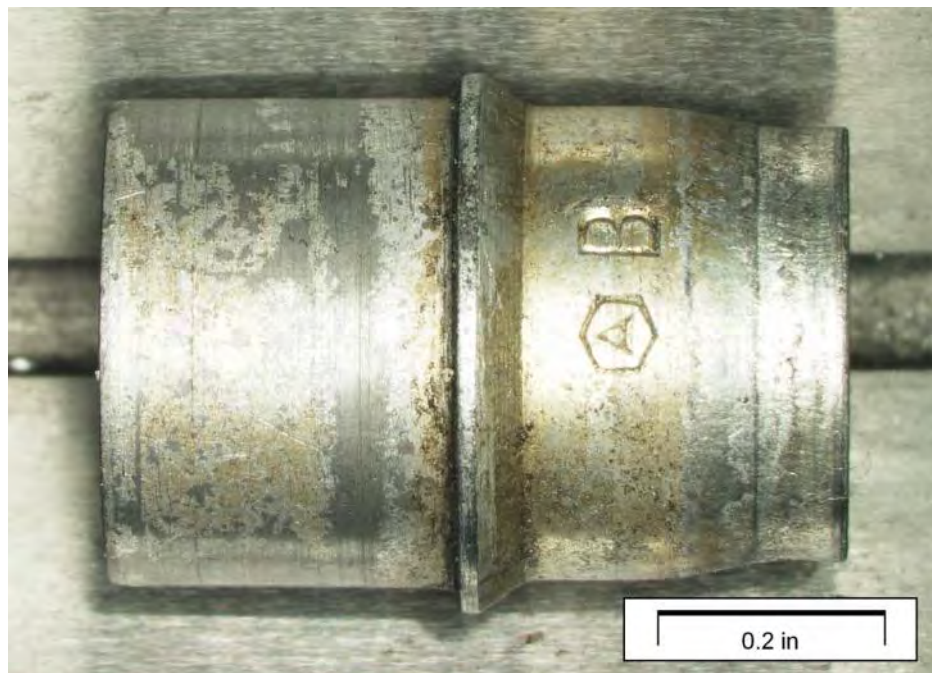
Figure 4. Ferrule from the failed end of the tube.

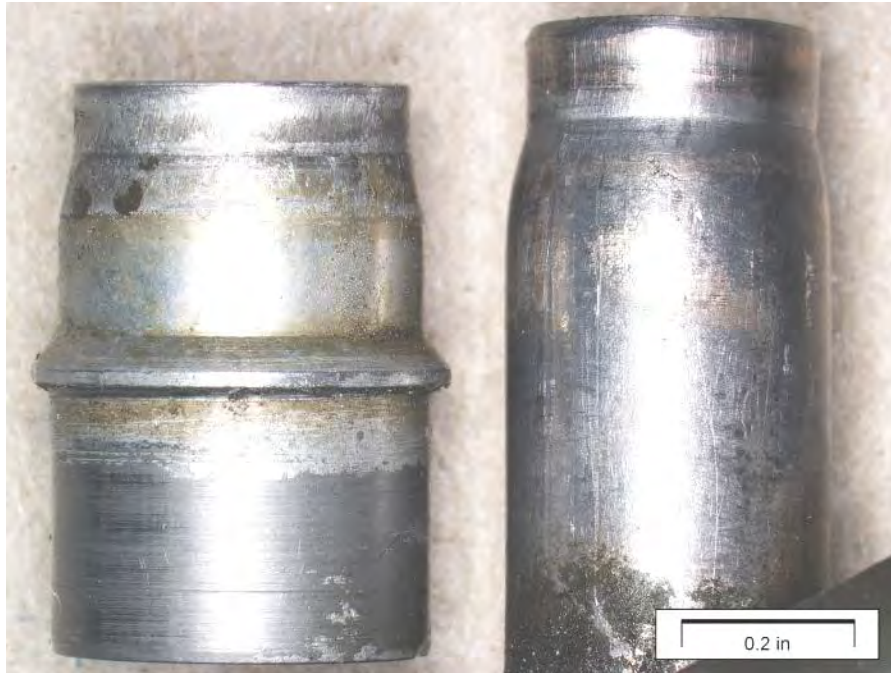
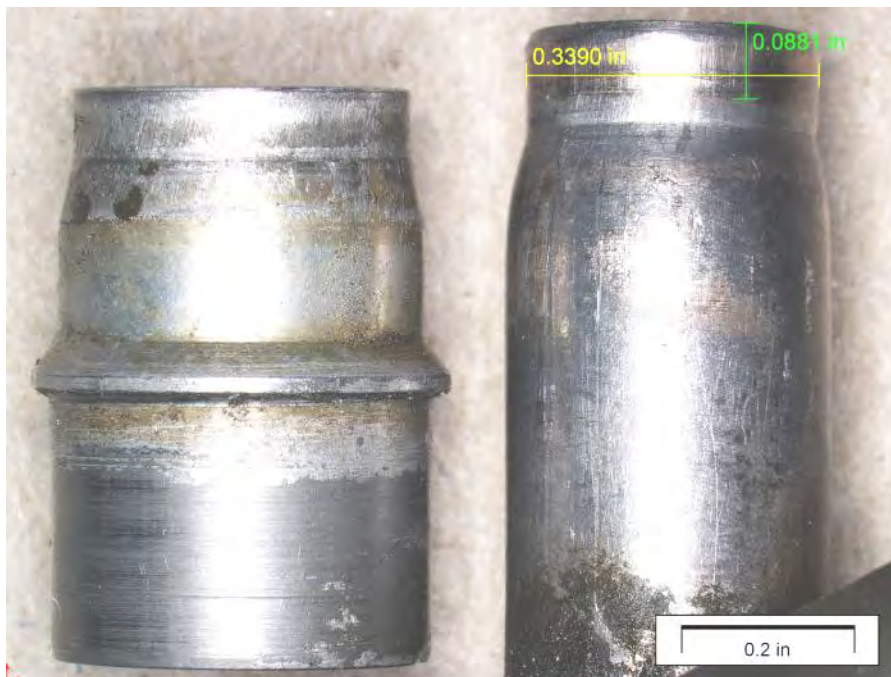
Considerable care was taken to match up the ferrule with its original location on the tube. Witness marks were identified and mated with corresponding marks on the interior of the ferrule. This was done in an attempt to ensure that the joint was properly installed as designed. Figures 5 and 6 present “side A” of the ferrule and the failed end of the tube in their approximate original position as determined from the witness marks observed. Measurements of these locations can be observed in figure 6. Figures 7 and 8 present “side B” of the ferrule and the failed end of the tube in their approximate original position as determined from the witness marks observed. The corresponding measurements are available in figure 8.

Figure 5. Ferrule position matched with the failed end of the tube, side A.

Figure 6. Measurements of ferrule position matched with the failed end of the tube, side A.

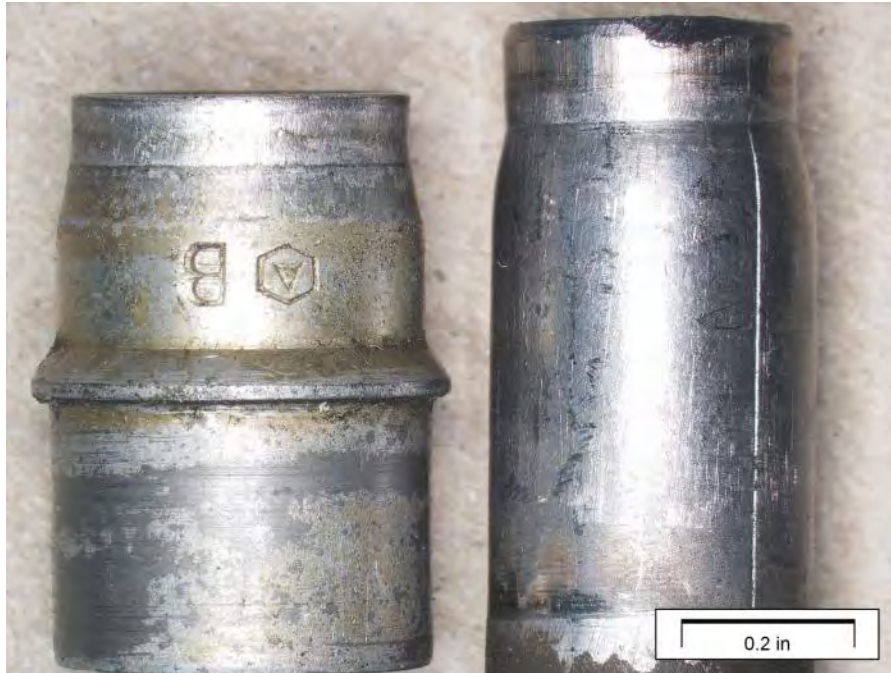
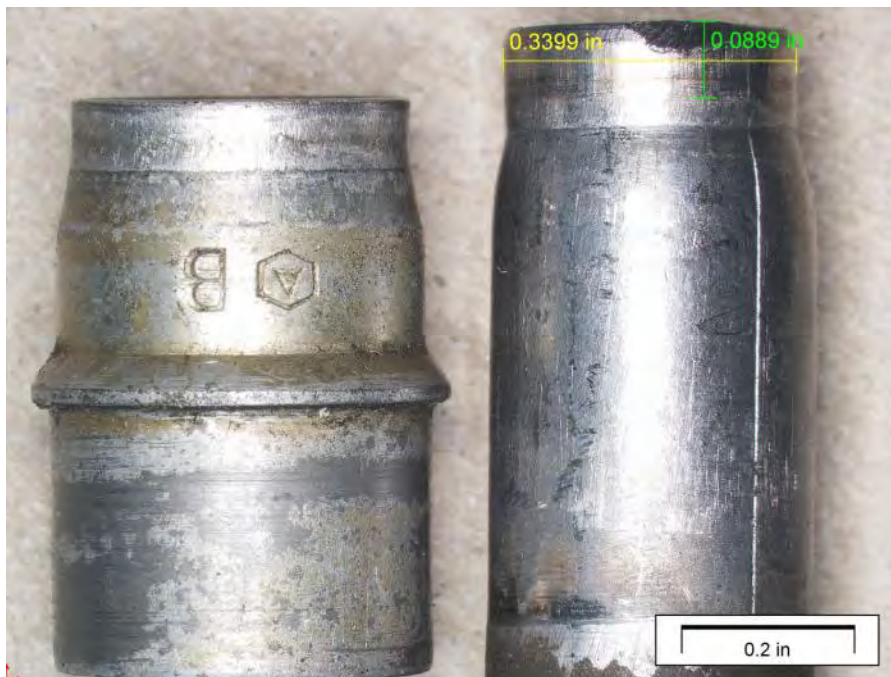
Figure 7. Ferrule position matched with the failed end of the tube, side B.

Figure 8. Measurements of ferrule position matched with the failed end of the tube, side B.

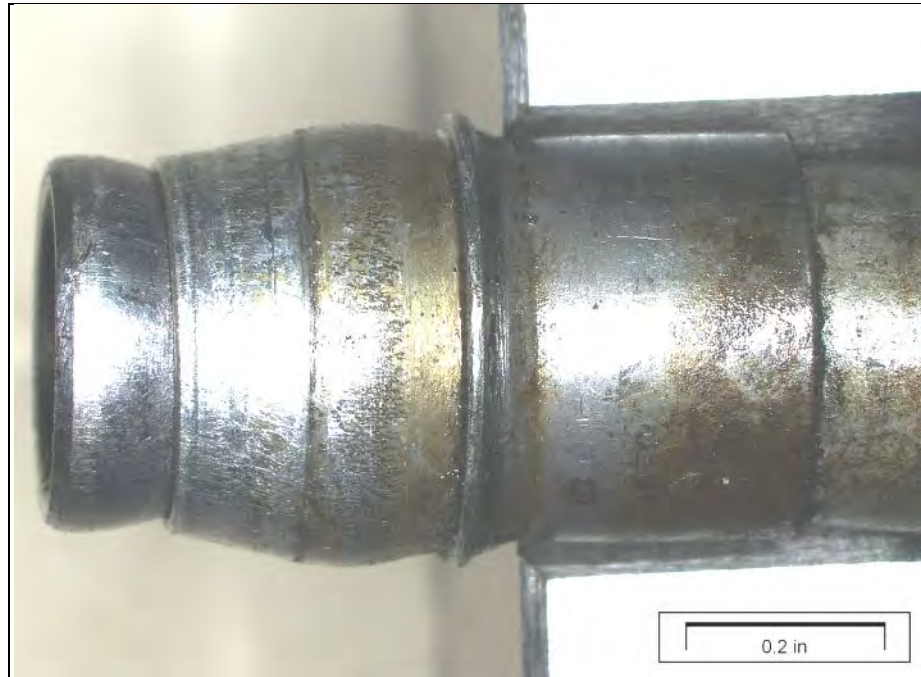
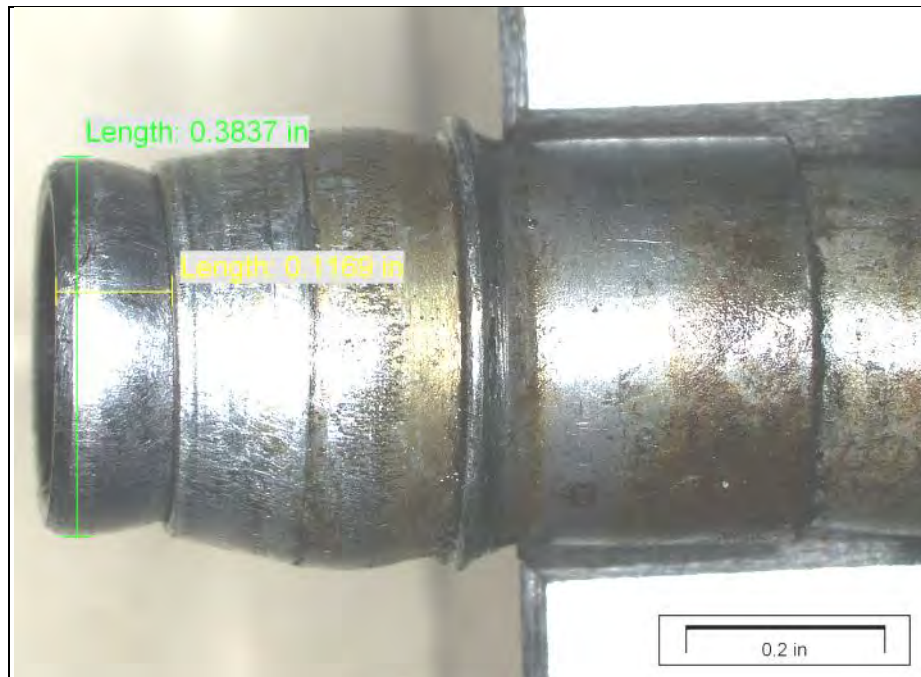
The joint on the failed end was then compared with the disassembled intact end of the tube. This comparison would provide insight on the original joint design and the intended dimensions. Figures 9–12 show both sides of the intact end of the tube as well as a dimensional analysis of these areas.

Figure 9. Intact end of the tube, side A.

Figure 10. Intact end of the tube with measurements, side A.

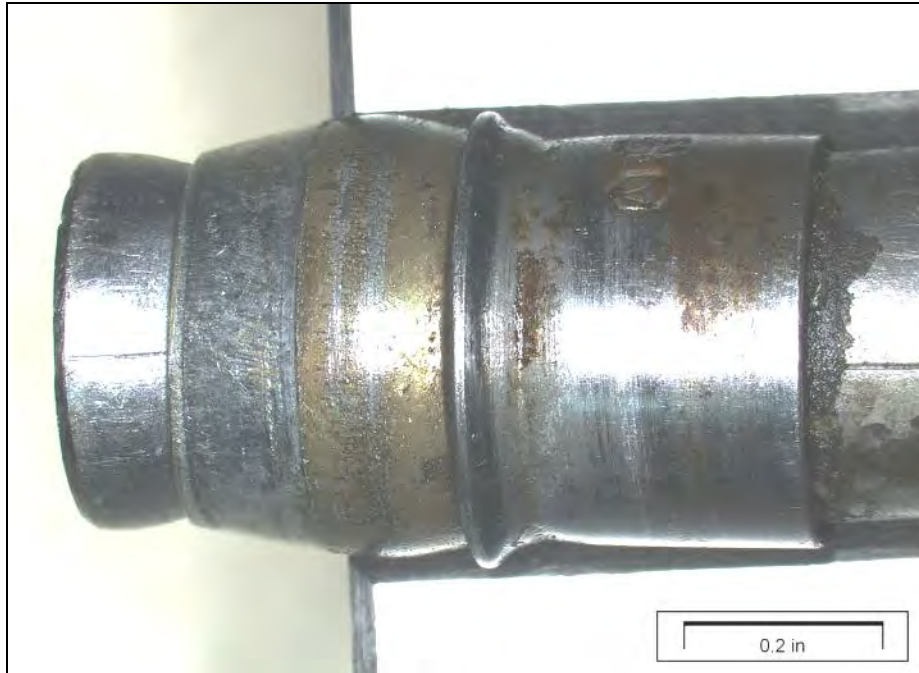
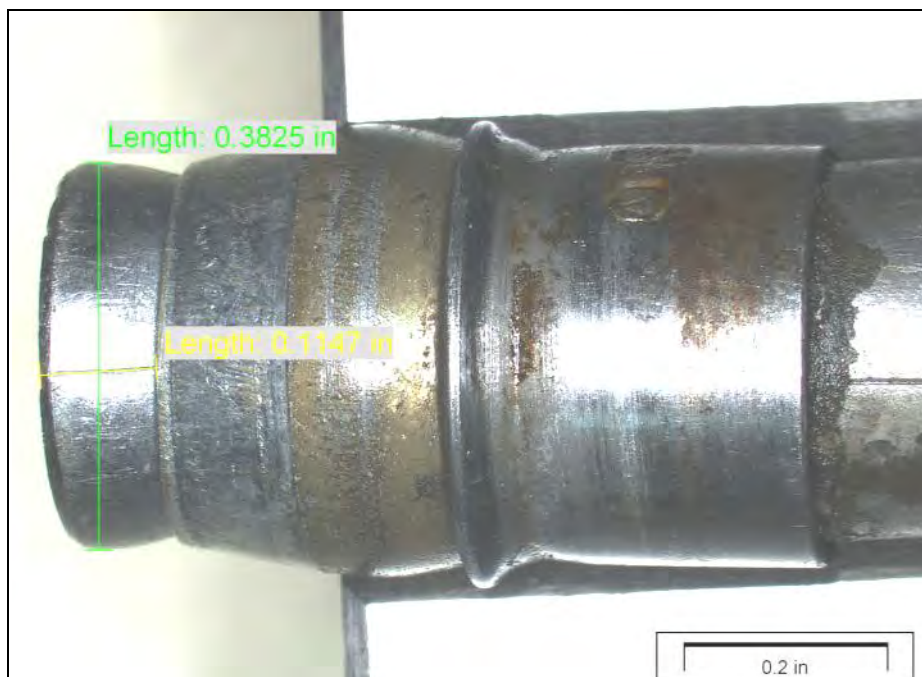
Figure 11. Intact end of the tube, side B.

Figure 12. Intact end of the tube with measurements, side B.

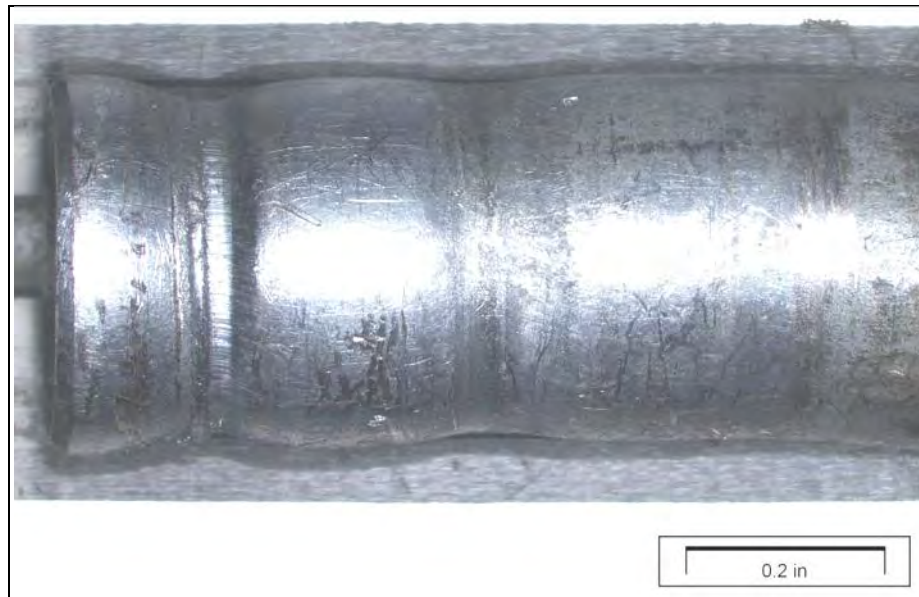
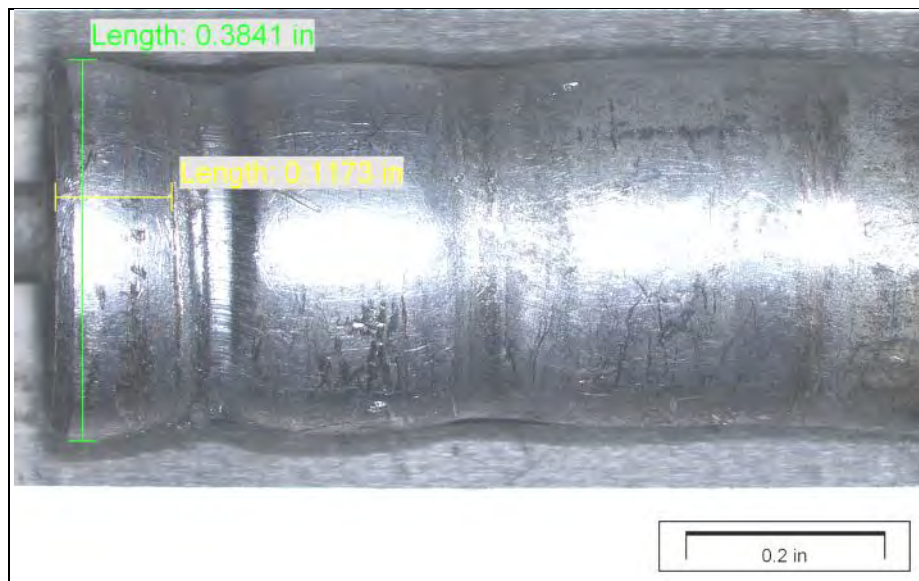
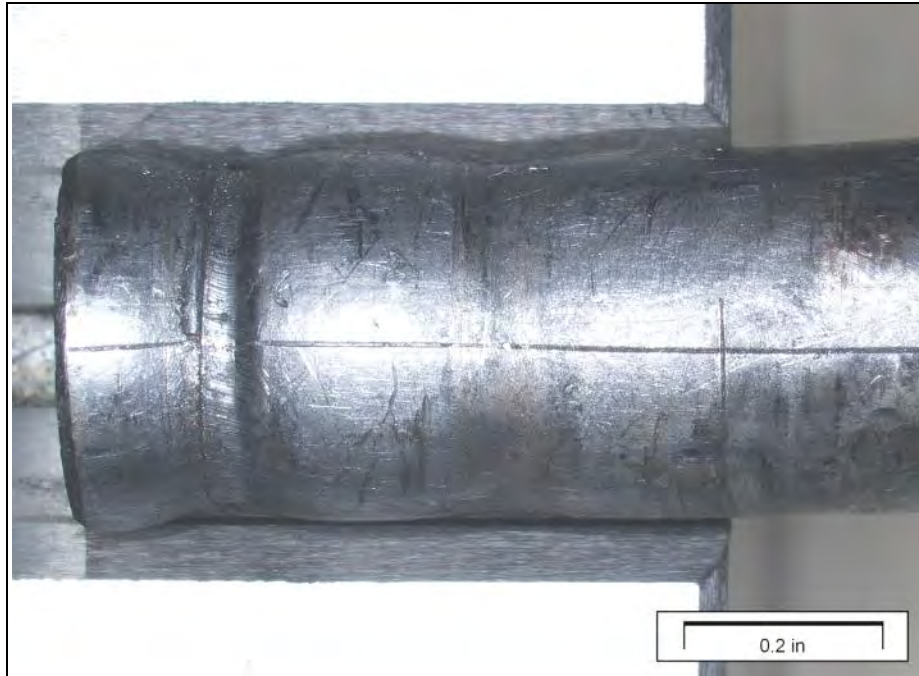
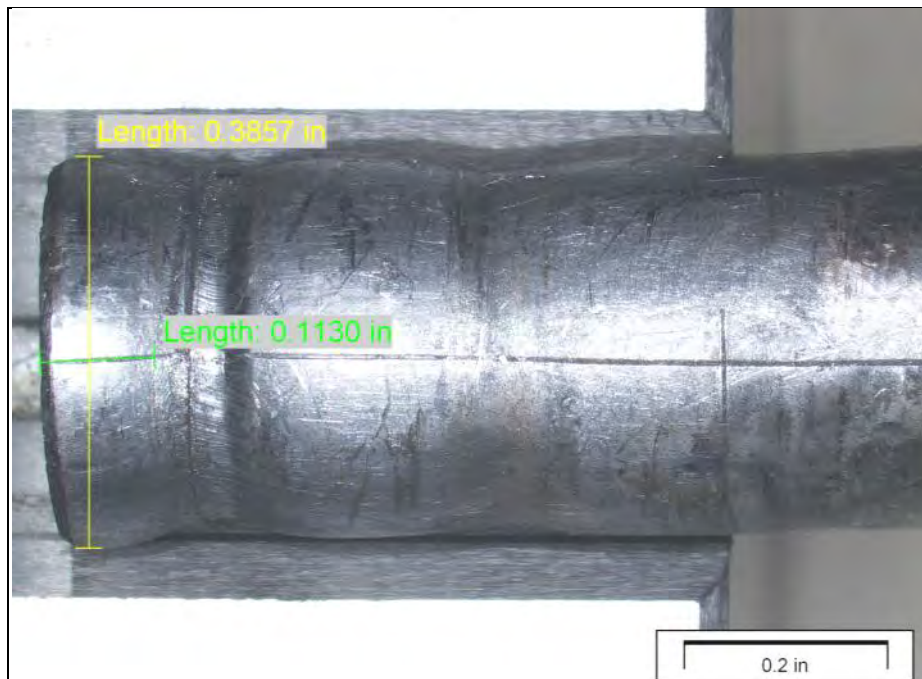
This analysis demonstrated several things. The resting place of the ferrule on the failed end of the tube was considerably closer to the end of the tube when compared with the intact end. The tubing was also visibly flared on each end. The flare on the failed end was less than on the intact end; however, this would have likely been affected by the forcing of the tube out of the ferrule. The ferrule from the intact end was carefully sectioned from the tube without damaging the underlying surfaces. Both sides of the intact end of the tube can be observed after the removal of the ferrule in figures 13–16, with and without dimensional measurements.

Figure 13. Intact end of the tube with ferrule removed, side A.

Figure 14. Measurements from intact end of the tube with ferrule removed, side A.

Figure 15. Intact end of the tube with ferrule removed, side B.

Figure 16. Measurements from intact end of the tube with ferrule removed, side B.

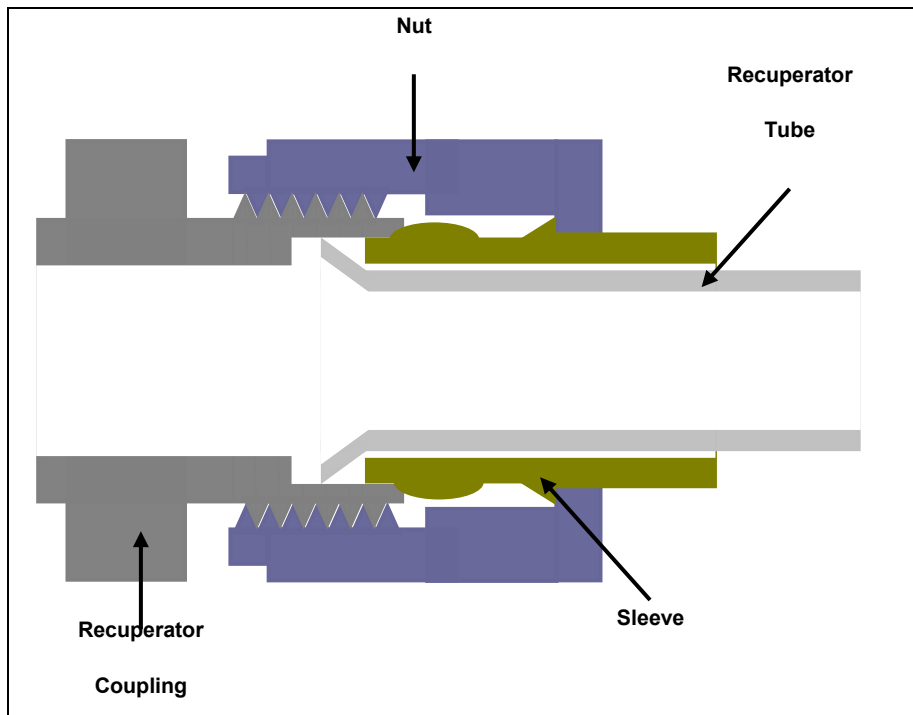
The M174 hydraulic line joints examined have an interesting design. Hydraulic joints are usually either a compression or flare type. In compression joints, the ferrule is compressed between the nut and the end fitting causing it to clamp down on the tubing by a reduction in the inner diameter (ID) of the ferrule. The ends of the tubing are not usually flared. In flare joints, the tubing ends are flared and the tubing is sandwiched between the end fitting and the ferrule, or between the end fitting and the nut itself, if the design doesn't include a ferrule. In either case, the tubing is physically sandwiched and held in place by the torque of the nut. Both joint designs are shown by example in figures 17 and 18. The flare design is a much more secure fitting and will hold a much greater line pressure than a simple compression fitting. The actual design in this case appeared to have traits of both types. The tubing was flared before installation; however, the tubing was not sandwiched between clamped metal surfaces. It was most similar to a normal compression design type. A schematic of the actual design used on the M174 recoil unit can be observed in figure 19 and compared with both figures 17 and 18.

Figure 19. Schematic of the hydraulic line joints on the M174 recoil unit.

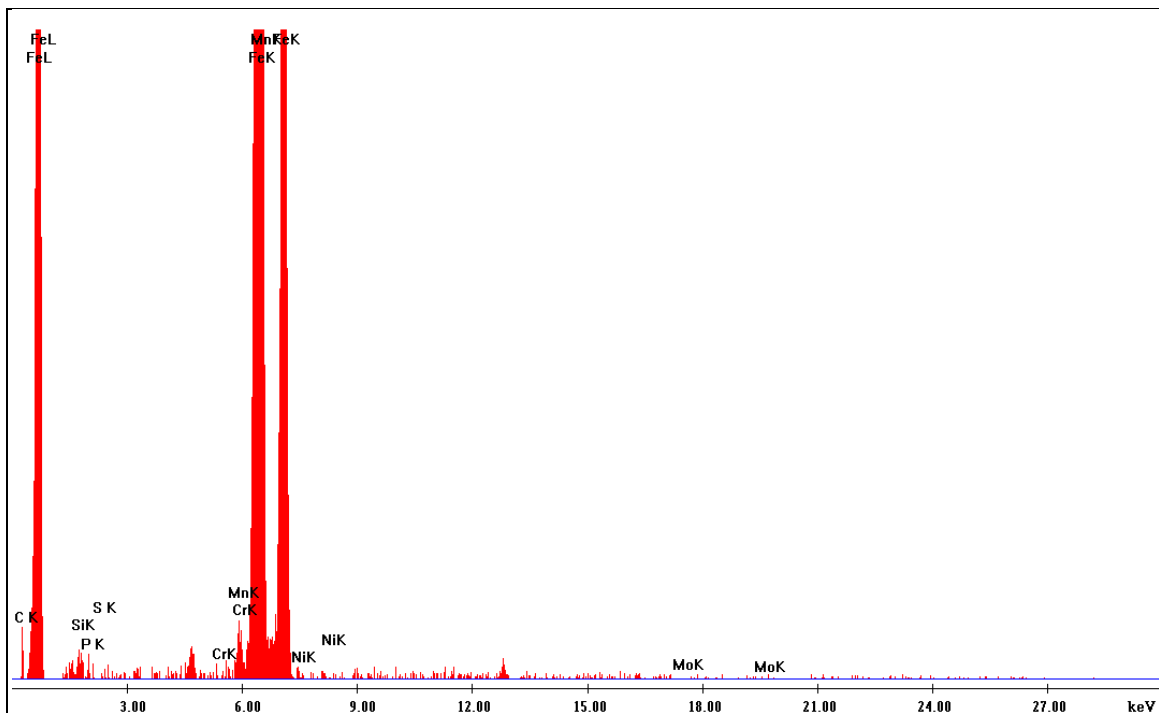
The chemistry of the failed tube was determined with EDS and compared with that of known materials frequently used in the tubing industry. The elemental composition conformed to that of ASTM-A-254 (1) spiral-wound copper-brazed steel. Figure 20 presents the EDS spectrum obtained from the M174 recoil unit failed tube. Table 1 shows the elemental composition in comparison to known accepted values for ASTM-A 254 (1) steel. It should be noted that performing EDS analysis to determine carbon and sulfur levels is extremely inaccurate. EDS is a very useful tool for analyzing metallic and semi-metallic elements of higher atomic number. Experience using this tool and analyzing the resultant data confirms that the material in this case was ASTM-A-254 (1) steel. A cross section of the material can be observed in section 2.4.

Figure 20. EDS spectrum from the failed M174 recoil unit tube.

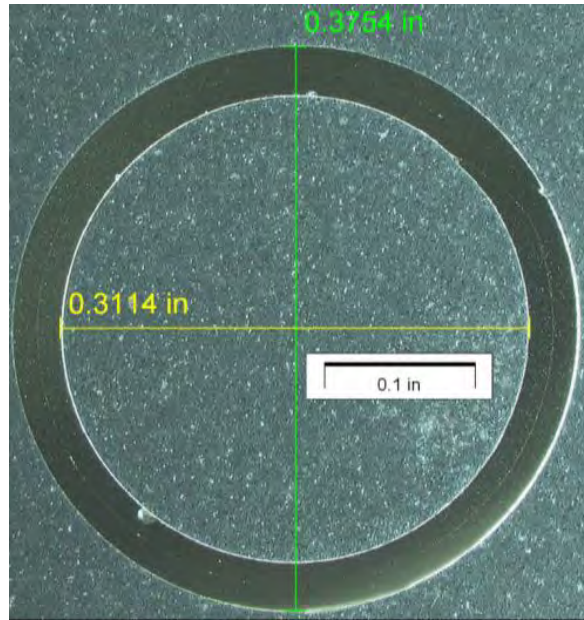
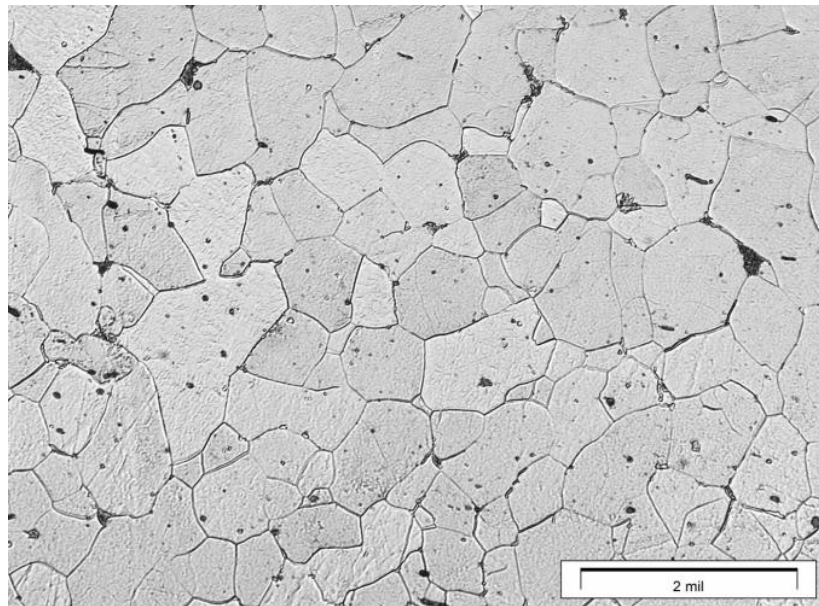
The microstructure of the M174 recoil unit tube was analyzed by polishing and nital etching a cross-sectional mount obtained from a radial cut of the tube. Figure 21 shows the cross section. The single-strip type of spiral-wound and copper-brazed steel tube can be observed on this figure as well as the overall cross-sectional dimensions. The polished and etched microstructure can be observed in figure 22. The structure consists of primarily ferrite and is consistent with that expected for this alloy.

Figure 21. Cross section of the failed M174 recoil unit tube material.

Figure 22. Ferritic microstructure of the failed M174 recoil unit tube material.

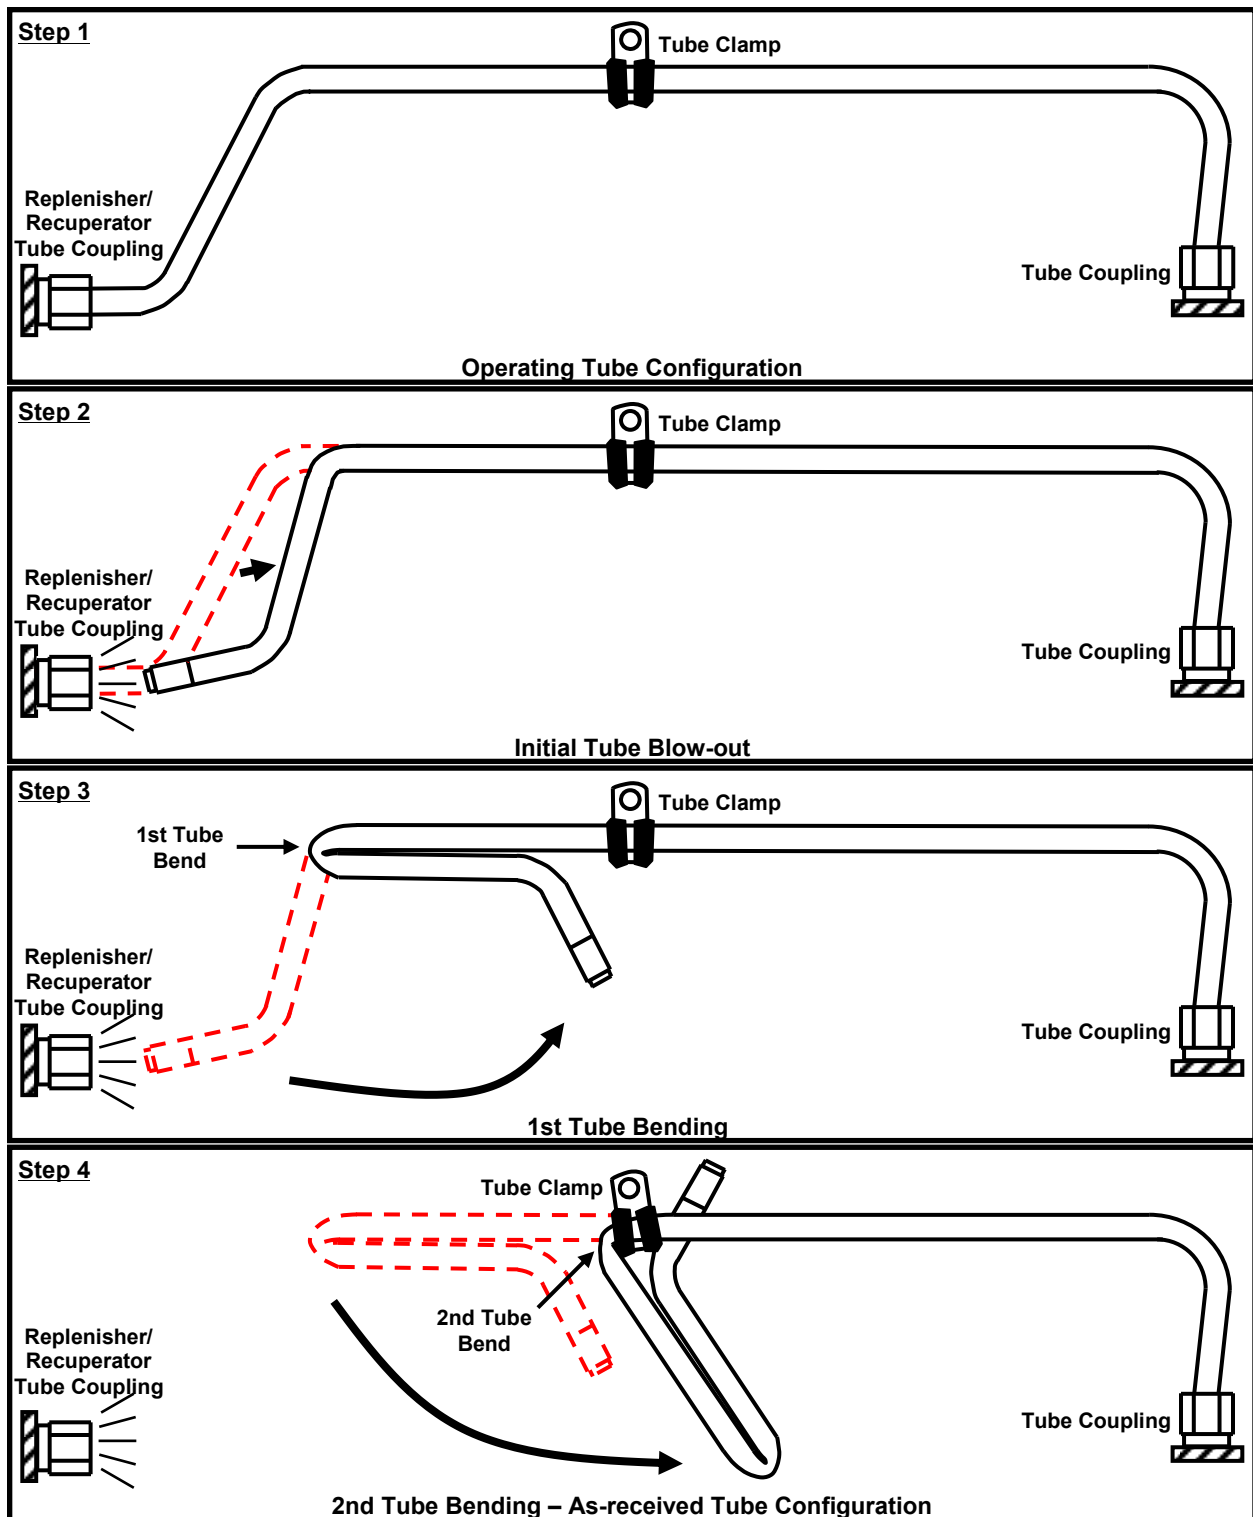
The failure of hydraulic lines is usually either from a pullout of the tubing or a tubing burst, if the burst pressure is exceeded. In accordance with ASTM-A-254 (1), tubing of the size used on the M174 recoil unit should have a proof pressure of ~5.5 ksi. Commercial calculations for the burst pressure of this tubing yield ~10 ksi. A diagram of the likely failure steps for the replenisher/recuperator line can be observed in figure 23.

Figure 23. Likely failure steps for the replenisher/recuperator line.

The failure of the replenisher/recuperator line on the M174 recoil unit was due to a line pressure event greater than its design pressure. There was no indication that the joint was installed improperly or that there was anything wrong with the materials involved. The ferrule on the failed end was likely flared before installation and was in place only slightly closer to its respective tubing end when compared to the joint on the non-failed end of the tube (via measurements in figures 7–16). Although nonstandard, the joint design was similar to a simple compression joint. This type of joint allows the tubing to slip out of the ferrule and away from its fitting when a given pressure is exceeded. If the joint had been of the flare type, it is likely that the joint would have held, but it might have induced a burst of the line itself, if the maximum burst pressure was exceeded. The cause of the high pressure event remains unknown.

- The failure of the replenisher/recuperator tube on the M174 recoil unit was due to the hydraulic line pressure exceeding the coupling design pressure. Since the main chamber pressure was unlikely to be abnormal, it is thought that some other, yet to be discovered, failure occurred within the interior of the recoil unit.

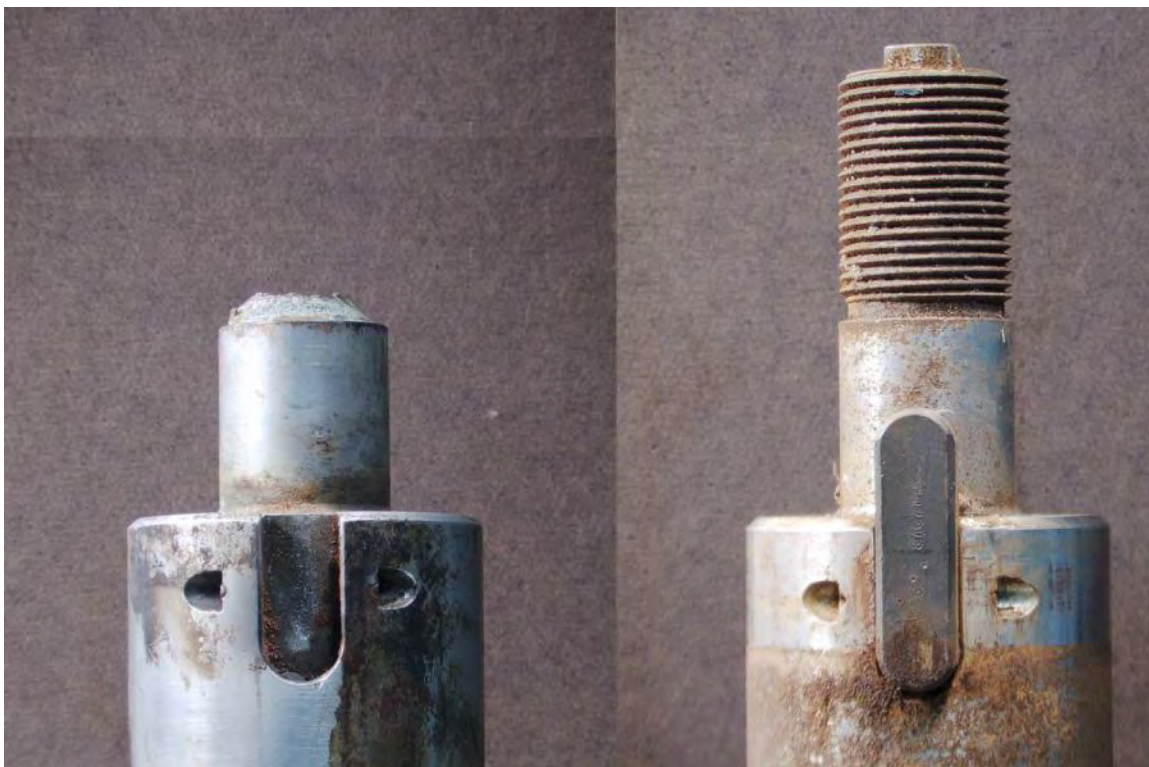
Coincidentally, this area is near the exit of the Mk-15 primer cartridge when fitted and locked into the interior bore of the spindle. This relationship can be observed via the simplified schematic in figure 25. From a design perspective, it is likely less than optimum that the exit from the primer charge is located upstream and adjacent to the machined step for the threads. A side-by-side comparison between the failed spindle and an intact example can be viewed in figure 26.

Figure 26. Side-by-side comparison between the failed and an intact spindle.

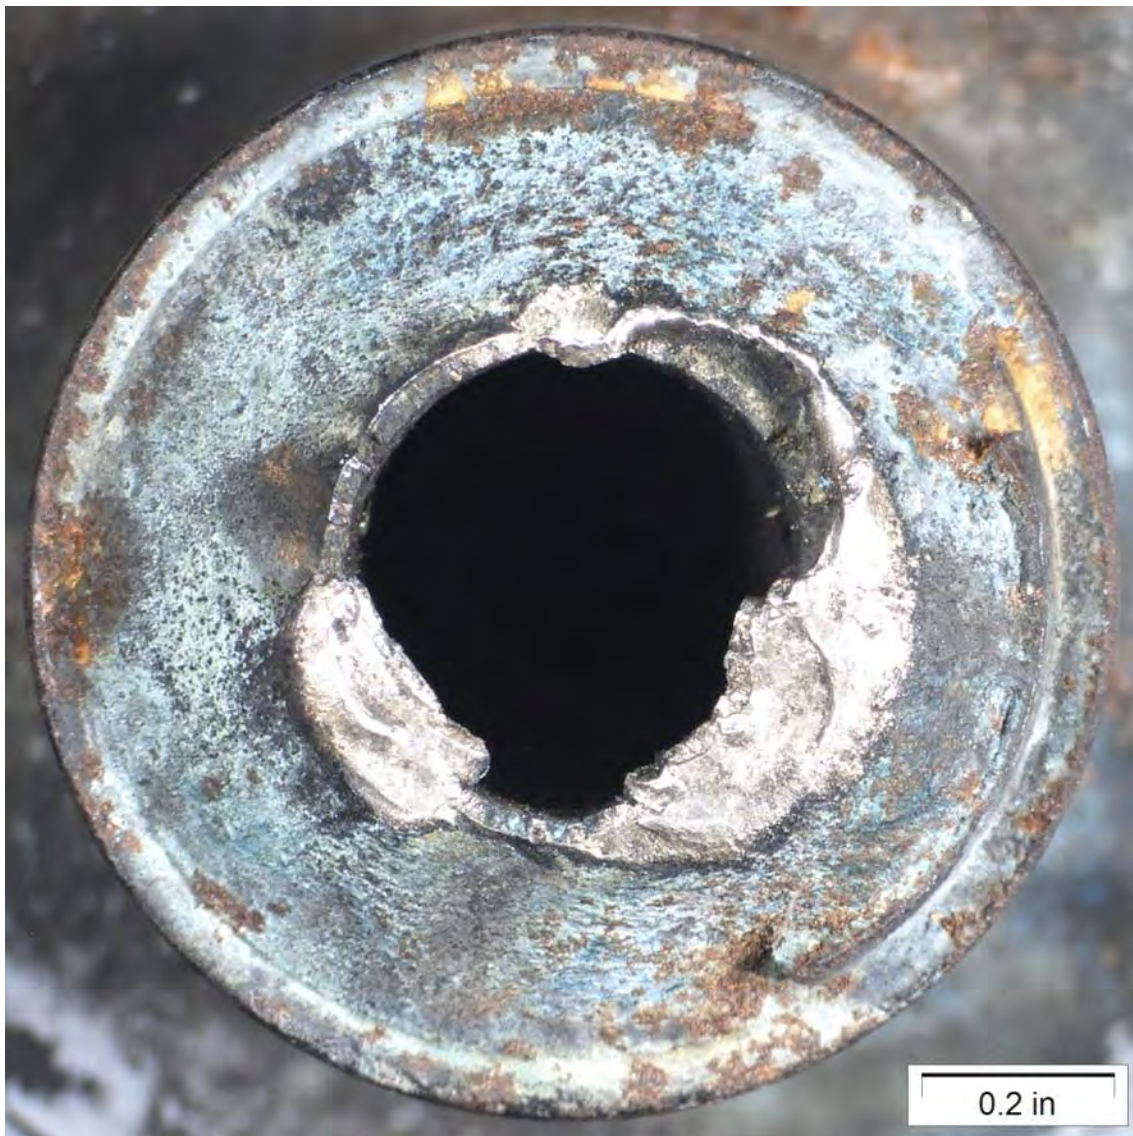
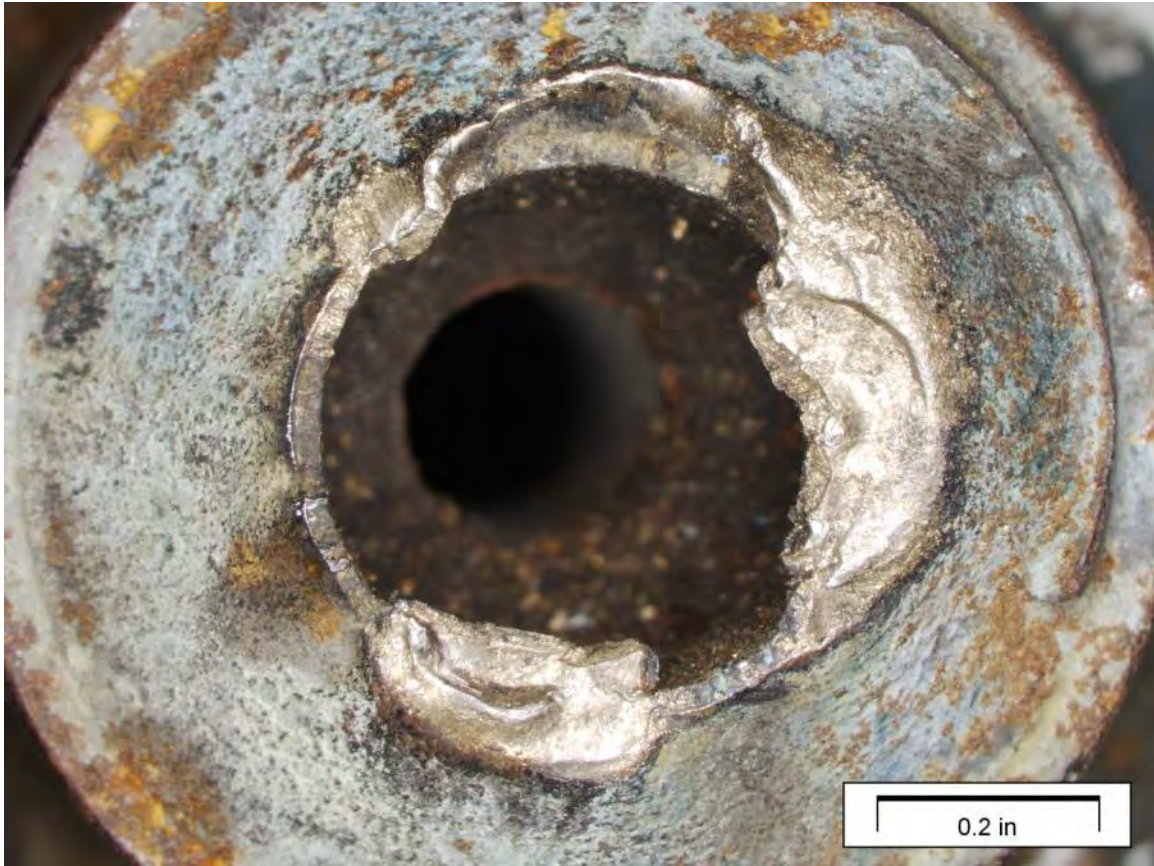
The as-received fracture surface can be observed in figure 27. This figure shows some flash rust (orange/brown), residue from primer and/or main propellant wash (blue/green), and three marred metal areas (shiny metallic color) where the fracture was smashed against another hard metal surface. This likely occurred on the second shot during the event against the missing mating fracture half, as this marred surface was well protected inside the recesses of the breech carrier after the catastrophic failure. Greater detail of these marred surfaces and the surface of a circumferential radial crack are presented in figure 28. The figures show considerable hot gas wash over the surface from the primer and main propellant charge. These residues were confirmed through laser induced breakdown spectrometry (LIBS).

Figure 27. As-received spindle fracture surface.

Figure 28. Greater detail of the marred areas and radial crack from the interior.

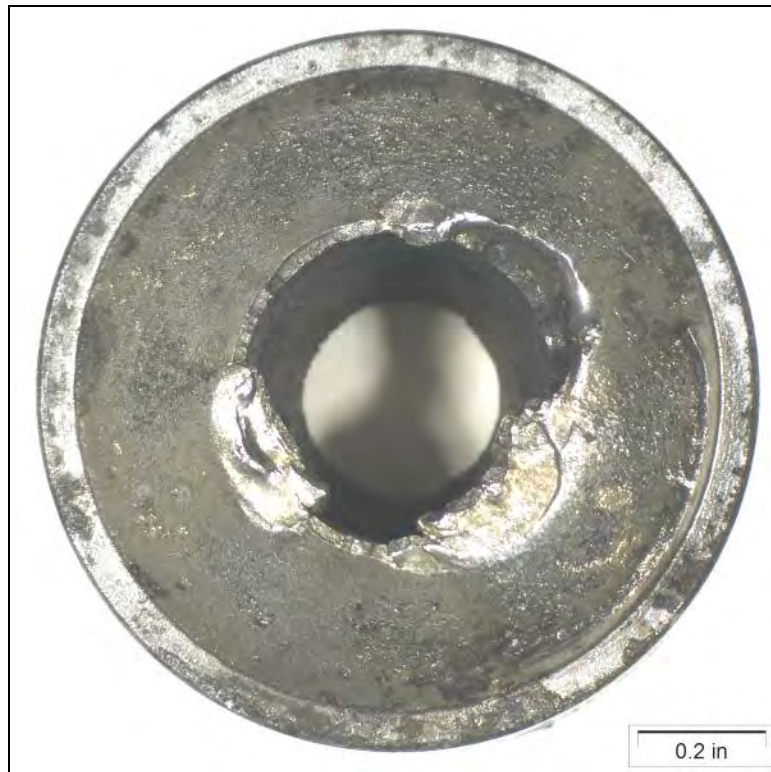
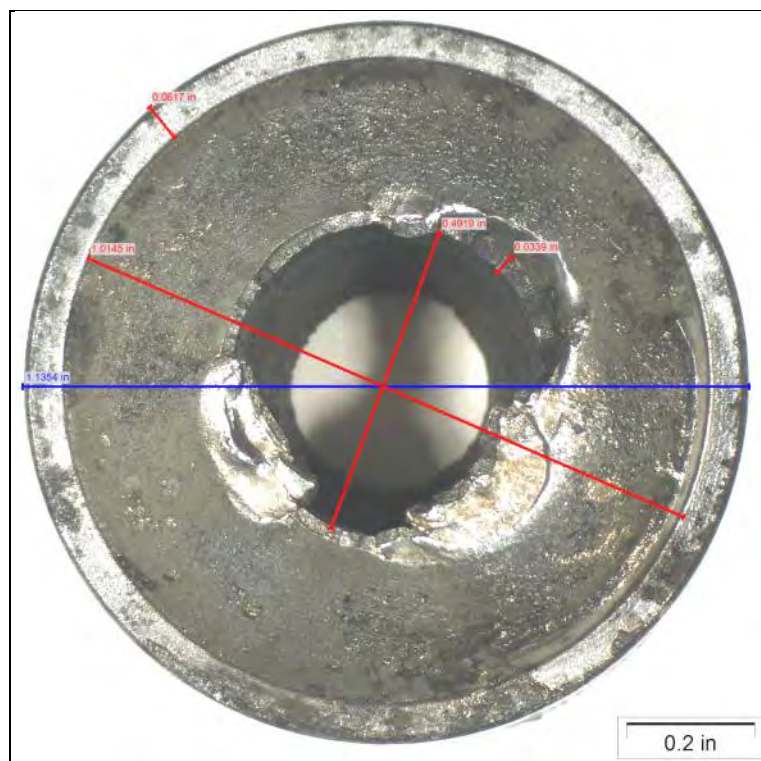
After the LIBS analysis, the surfaces were delicately cleaned to provide a clearer picture of the fracture morphology. The cleaned surface is represented in figure 29 and with dimensions applied in figure 30. After this cleaning, it became obvious that the circumferential radial crack originated on the interior bore of the spindle. Oblique lighting techniques were applied to facilitate showing the radial cracks with more detail. Four views of the interior surface taken at 90° rotations are presented in figures 31–34. Enhanced contrast images of these areas are presented in figures 35–38 to demonstrate the extent of the cracking. This area is normally covered with chromium plating to prevent this kind of erosion and cracking, as shown in the schematic of figure 25. However, the enhanced corrosion protection of chromium over steel does not last forever, and once it is depleted, erosion and cracking of the steel ensues by a hydrogen-assisted stress corrosion cracking mechanism. The “hydrogen assisted” part of the mechanism is related to the hot gas propellant wash products forming gaseous hydrogen that is then absorbed by the steel, embrittling it. There was a great deal of corrosive action evident from the hot gas propellant wash products on the fracture surface.

Figure 29. Cleaned spindle fracture surface.

Figure 30. Cleaned fracture surface with dimensions.
