## **Investigation of Failed Components from a 7-in High Altitude Research Program (HARP) Cannon**

**ARL-TR-5814**

**November 2011**

**Weapons and Materials Research Directorate, ARL**

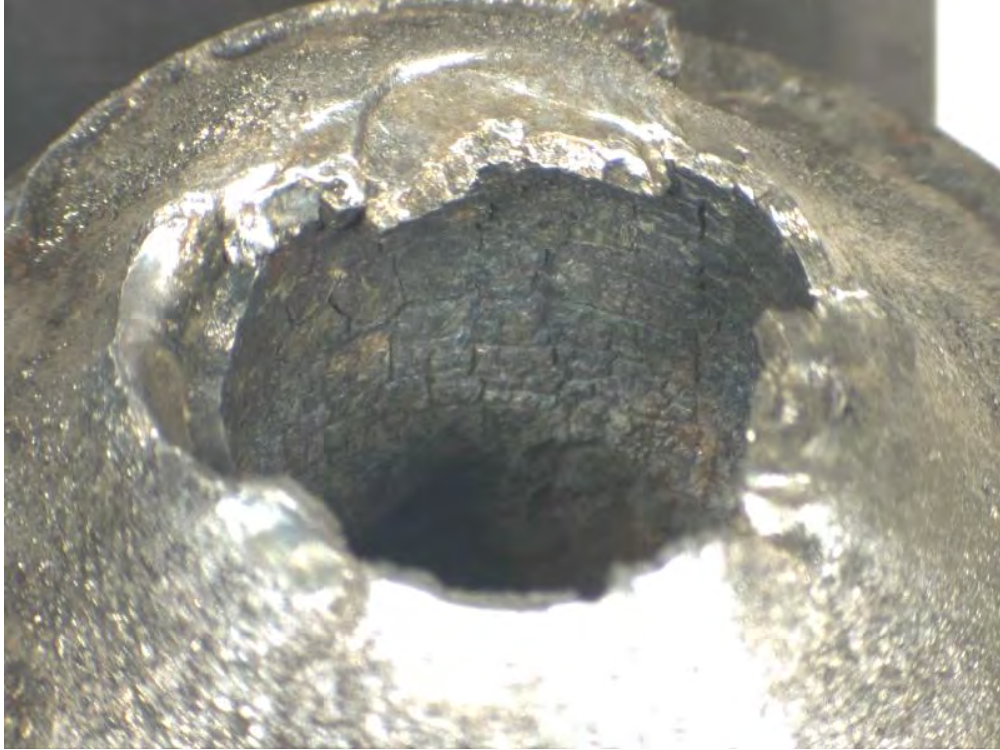
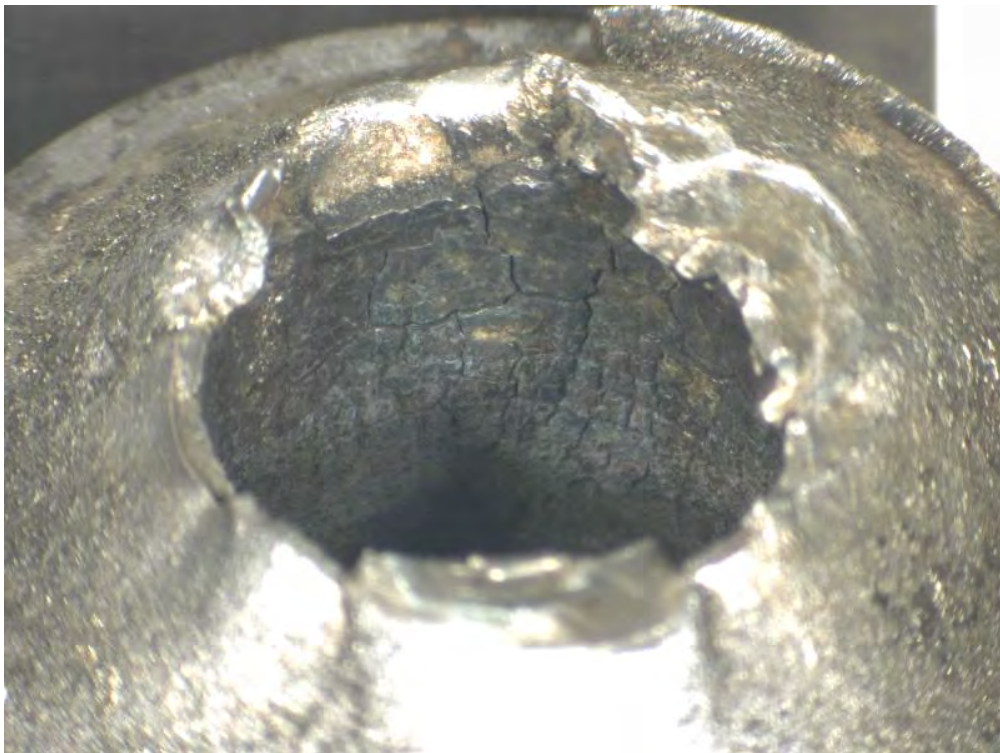
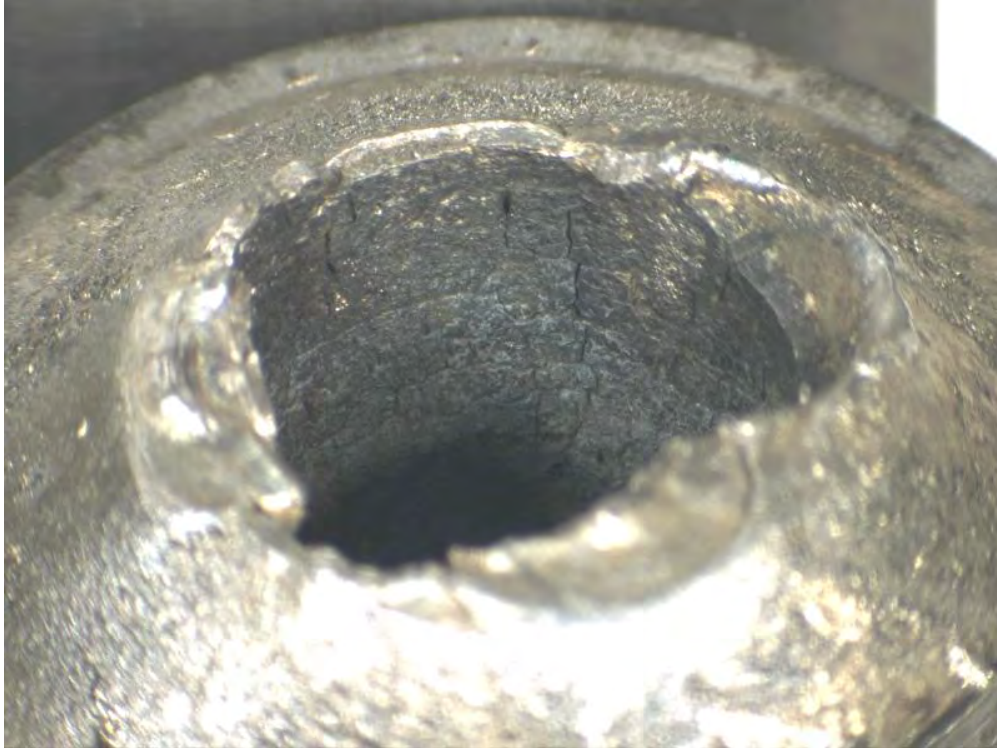
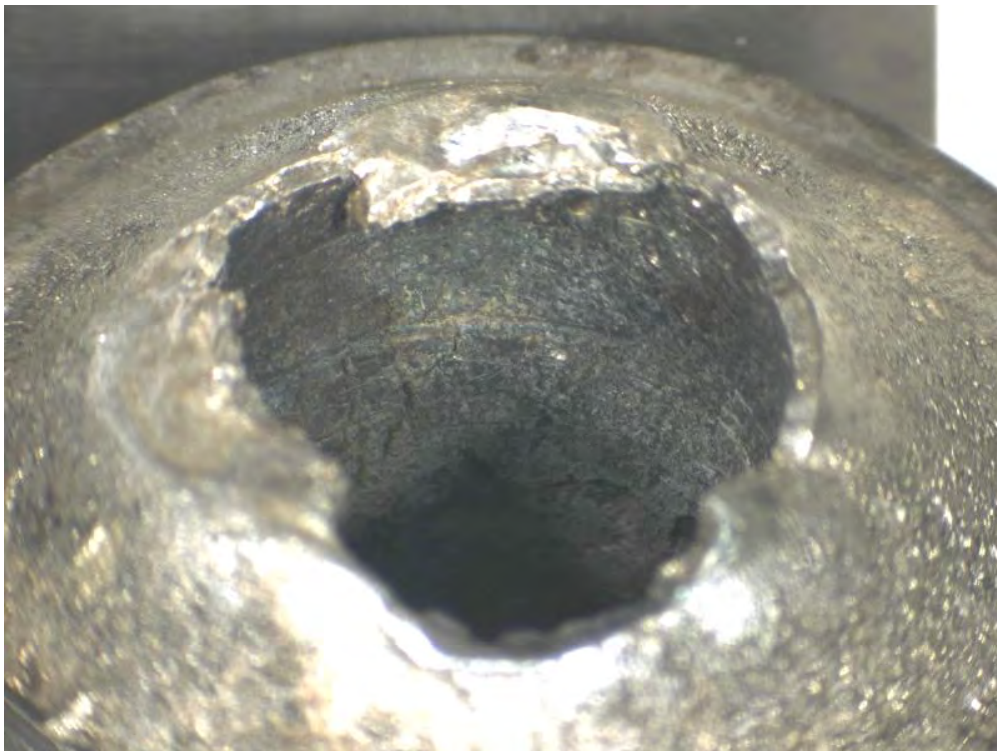
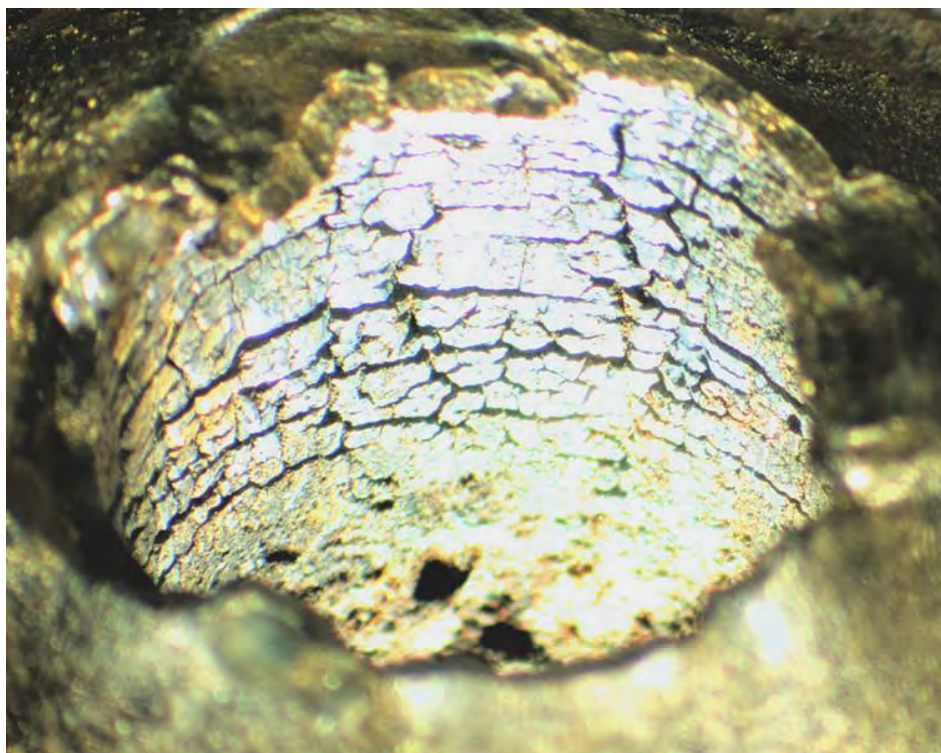
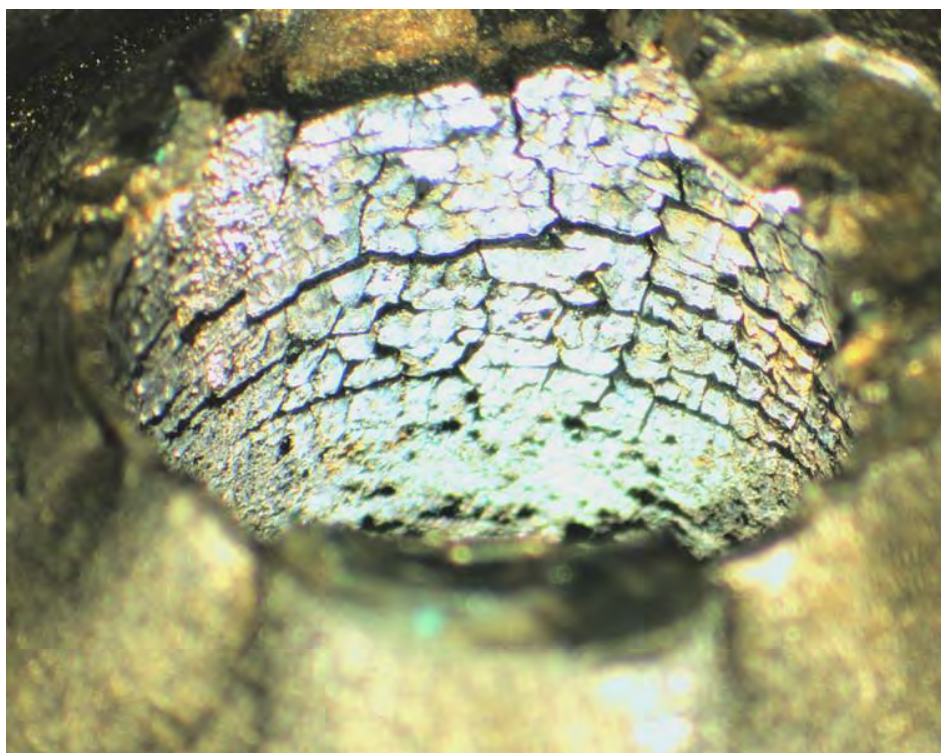
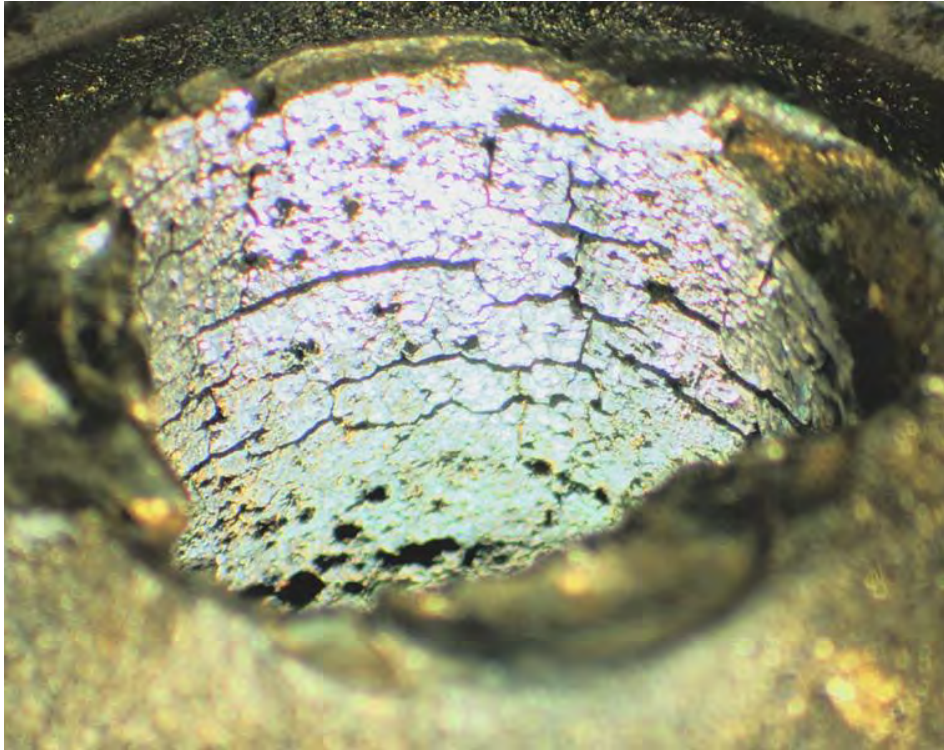
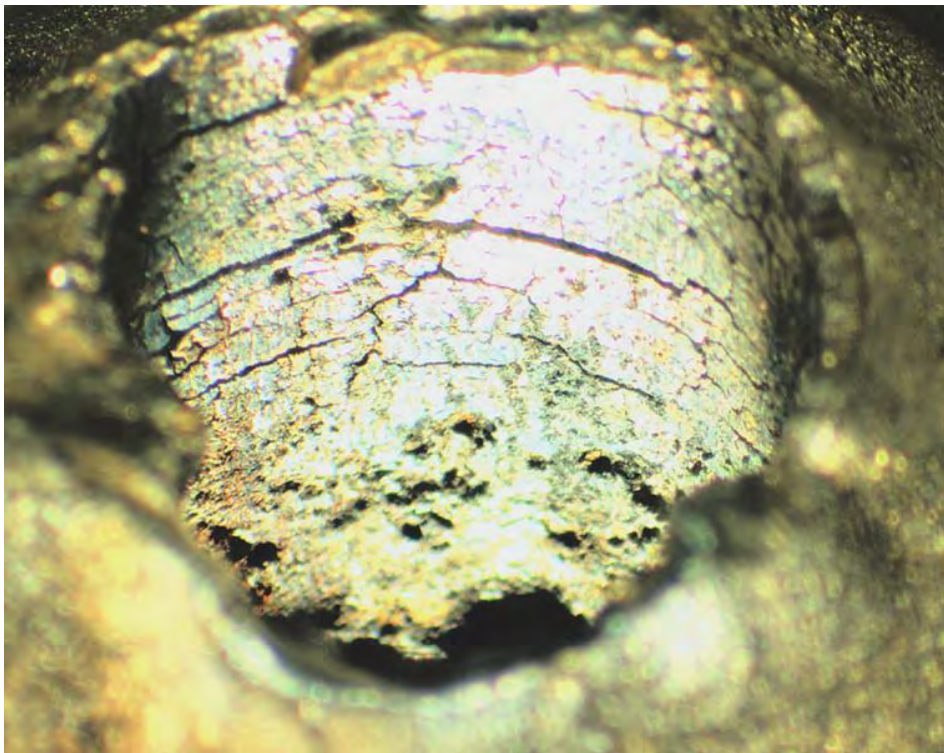
Figure 31. Interior bore of the spindle showing cracks.

Figure 32. Interior cracked bore in figure 31 plus a 90° rotation.

Figure 33. Interior cracked bore in figure 32 plus a 90° rotation.

Figure 34. Interior cracked bore in figure 33 plus a 90° rotation.

Figure 35. Enhanced contrast image of the area in figure 31.

Figure 36. Enhanced contrast image of the area in figure 32.

Figure 37. Enhanced contrast image of the area in figure 33.

Figure 38. Enhanced contrast image of the area in figure 34.

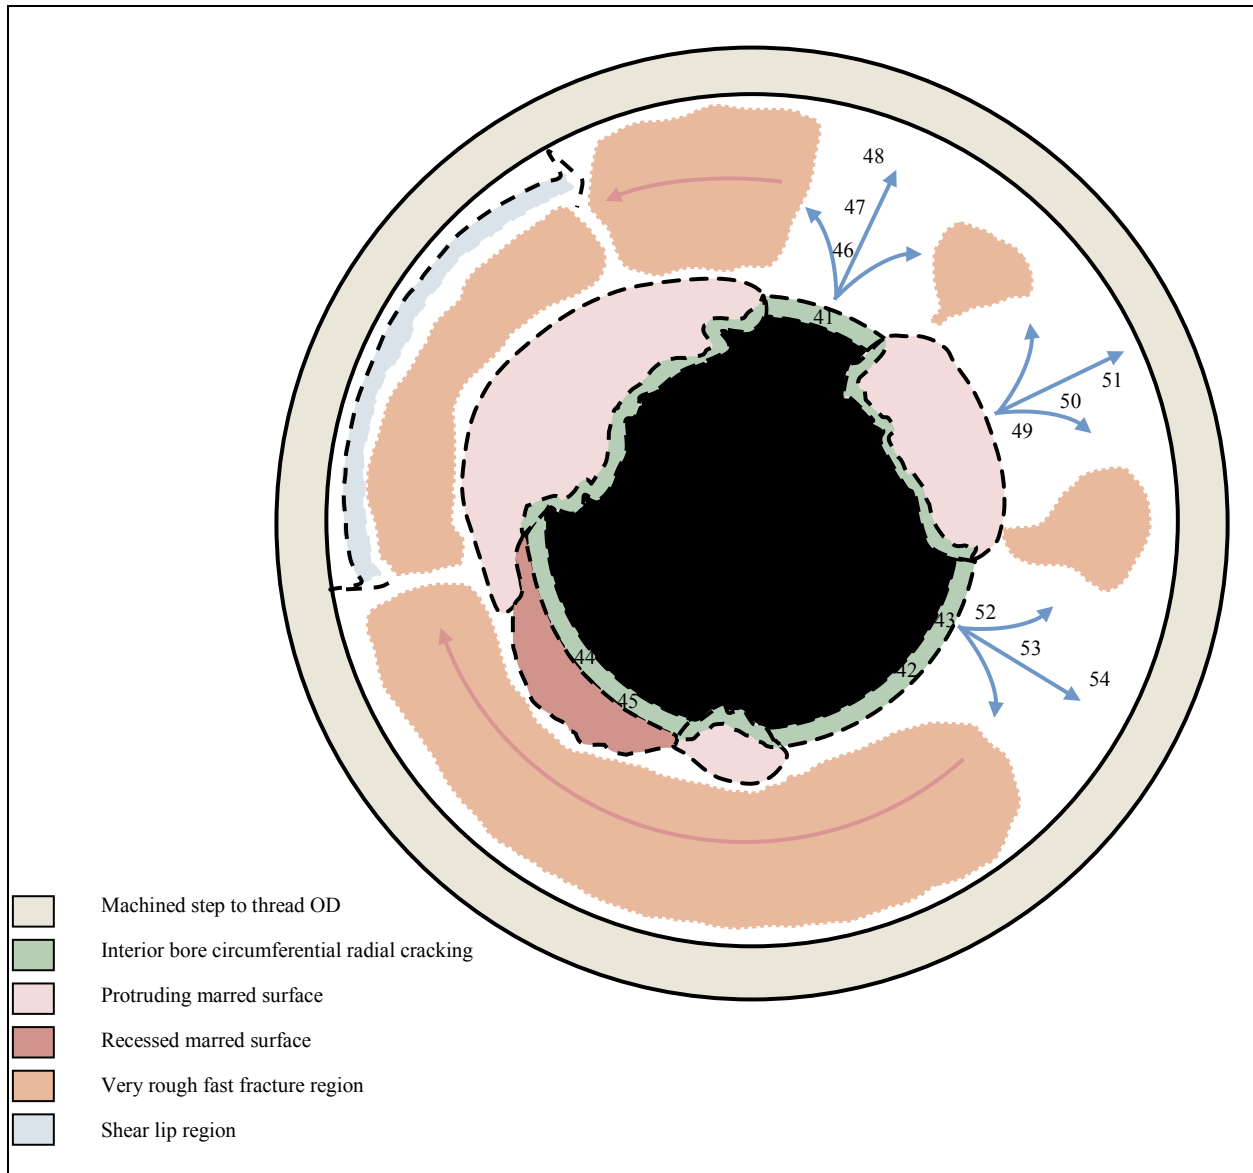
A fracture schematic labeling the details discussed previously is presented in figure 40 for clarity and can be compared with figures 27–39. Figure 40 also shows the areas where the scanning electron microscopy (SEM) images were obtained in the next section.

Figure 40. Failed spindle fracture schematic.

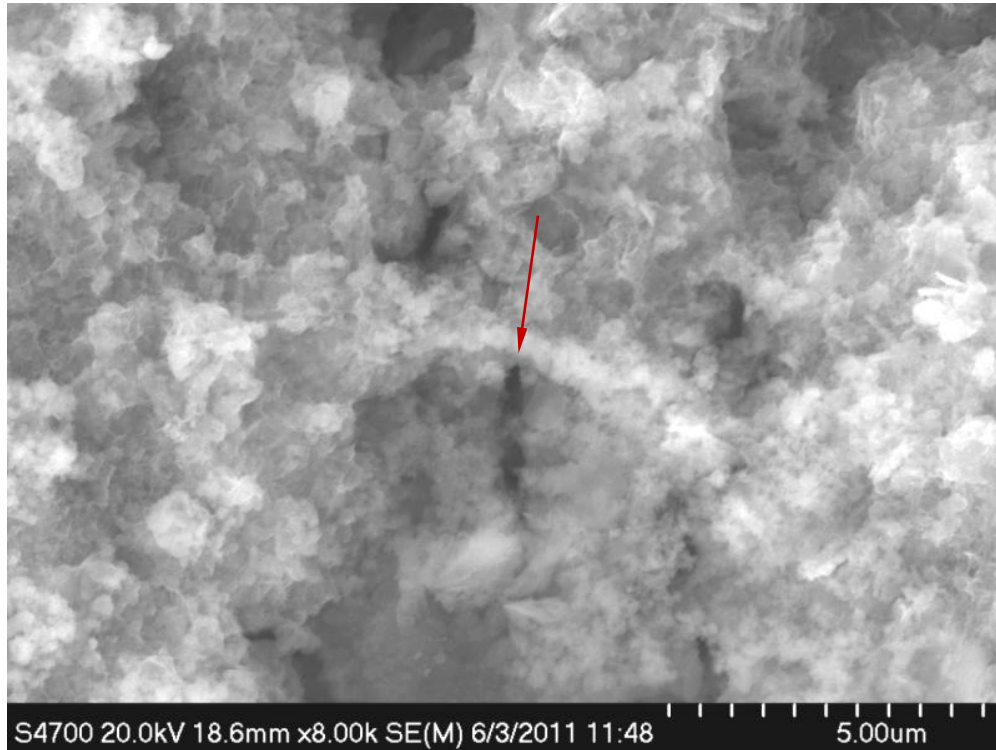
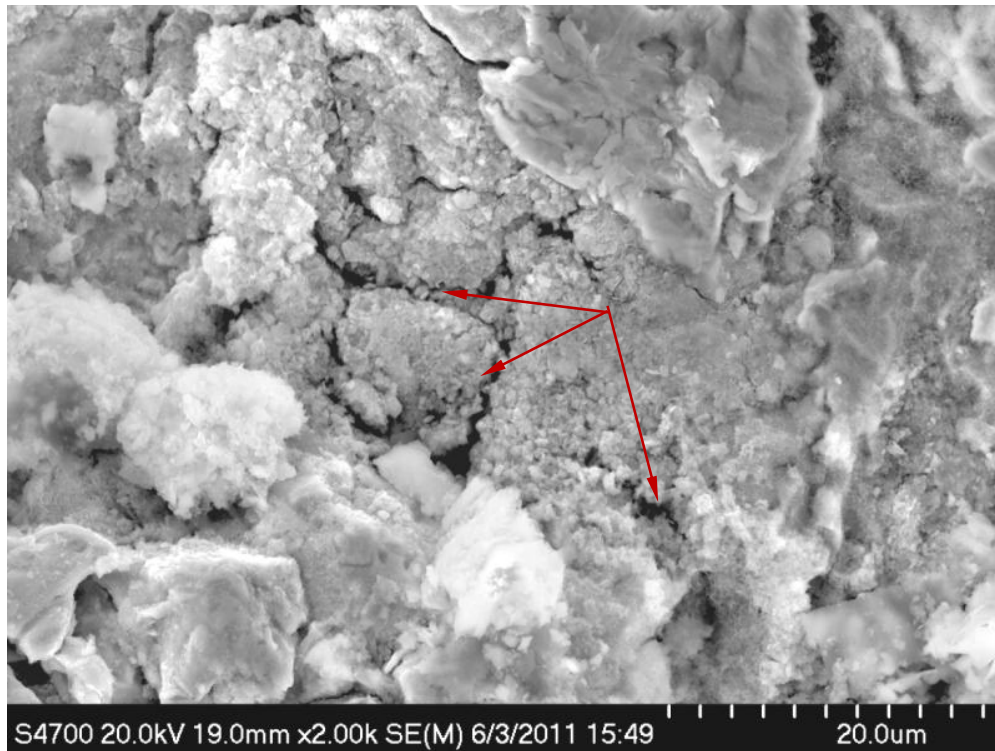
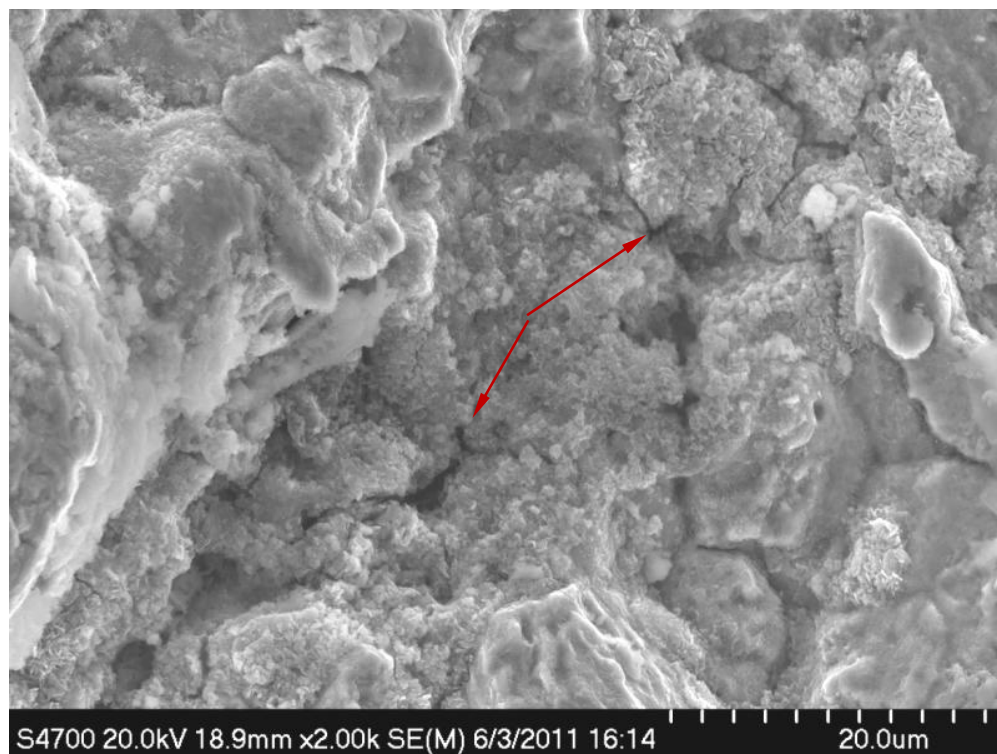
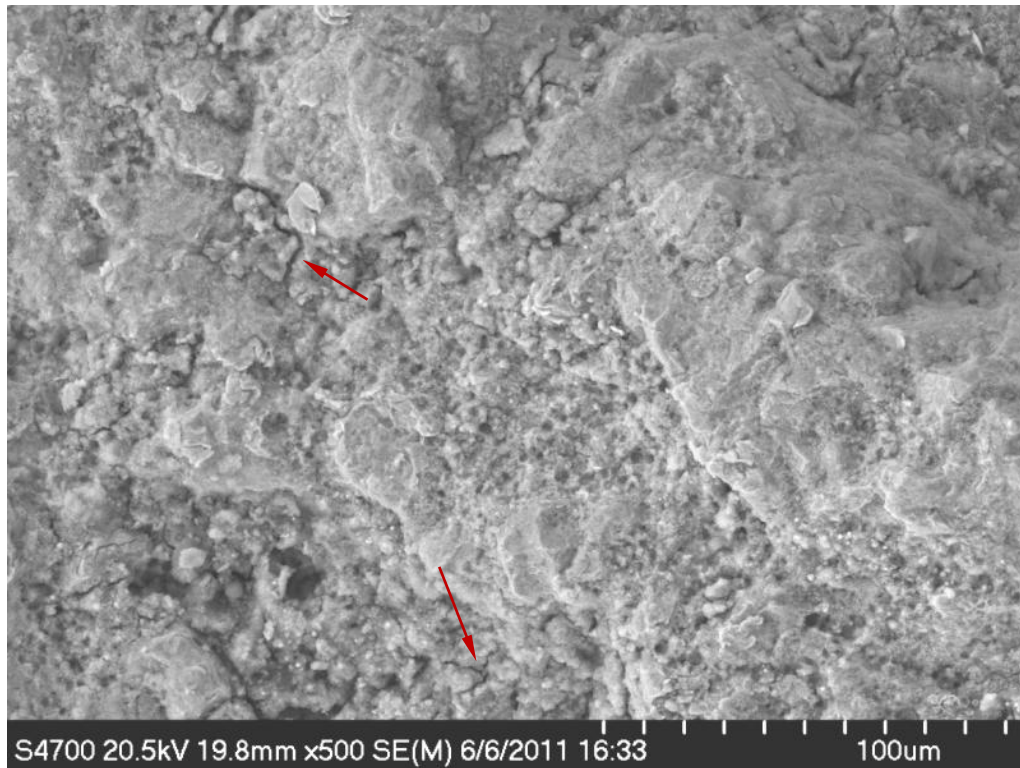
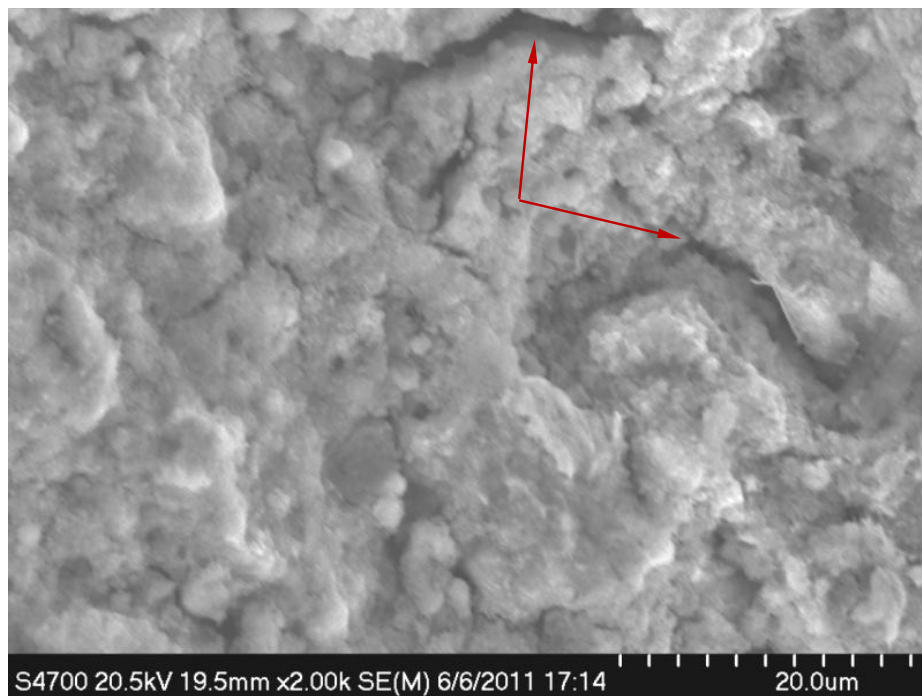
SEM was then conducted on the fracture surface to verify the fracture morphology and confirm the failure mechanism. The surface of the interior bore circumferential radial crack was examined. Figures 41–45 show this surface at various magnifications and demonstrate both the corrosive nature of the mechanism and the intergranular characteristics of the hydrogen effects. The intergranular cracks are denoted with red arrows in the photos.

Figure 41. Crack from bore showing stress corrosion cracking (SCC) and intergranular cracks, area 41.

Figure 42. Crack from bore showing SCC and intergranular cracks, area 42.

Figure 43. Crack from bore showing SCC and intergranular cracks, area 43.

Figure 44. Crack from bore showing SCC and intergranular cracks, area 44.

Figure 45. Crack from bore showing SCC and intergranular cracks, area 45.

- The failure of the breech spindle was due to normal loading coupled with a hydrogen compromised material. The influx of hydrogen was made possible by the erosion of the normally protective chromium layer on the interior bore of the spindle. There is no history of anything other than the black powder loaded Mk-15 primer being used in this system. However, the Mk-15 black powder traditionally does not have the adiabatic flame temperature necessary to cause significant erosion of the chromium layer and there is negligible physical erosion in the area. These two facts would suggest that, at some point in the history of this spindle, experimental primers were used, although no evidence of that assertion was uncovered. In any case, the protective chromium layer on the interior bore was worn away and the unprotected steel substrate absorbed hydrogen from the propellant/primer charge byproducts during the normal erosion process while forming cracks on the interior spindle bore. This hydrogen absorption coupled with the cracks lowered the fracture toughness below the critical level for the applied stress on the component. Again, this stress was not abnormally high. Without being hydrogen compromised and without the presence of the interior cracks, this component should have been able to withstand stresses  $2.5\times$  higher than that applied during the failure event.

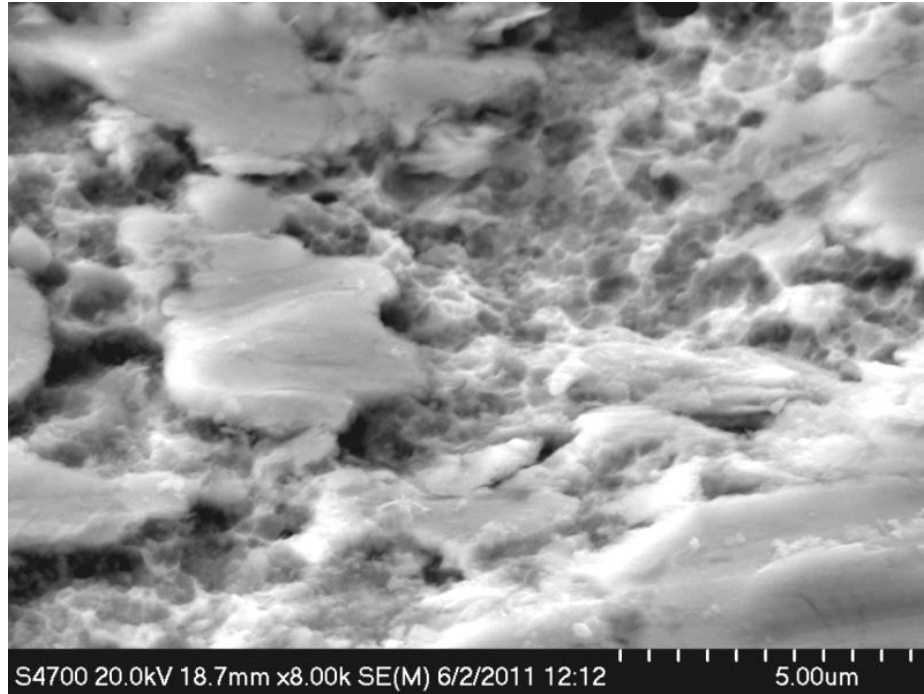
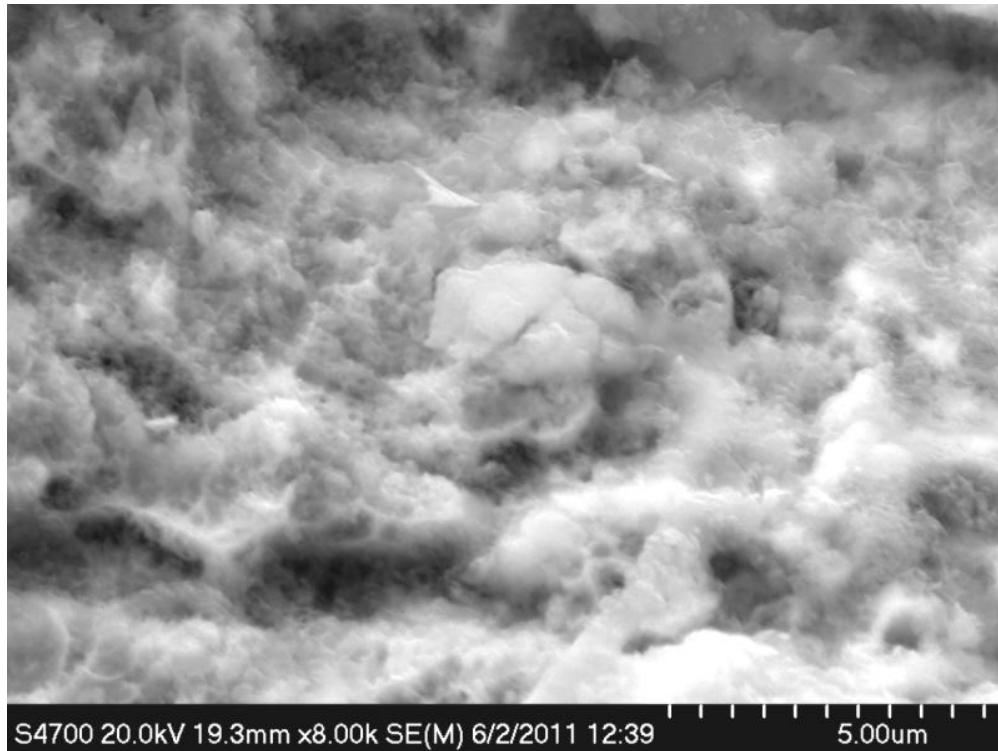
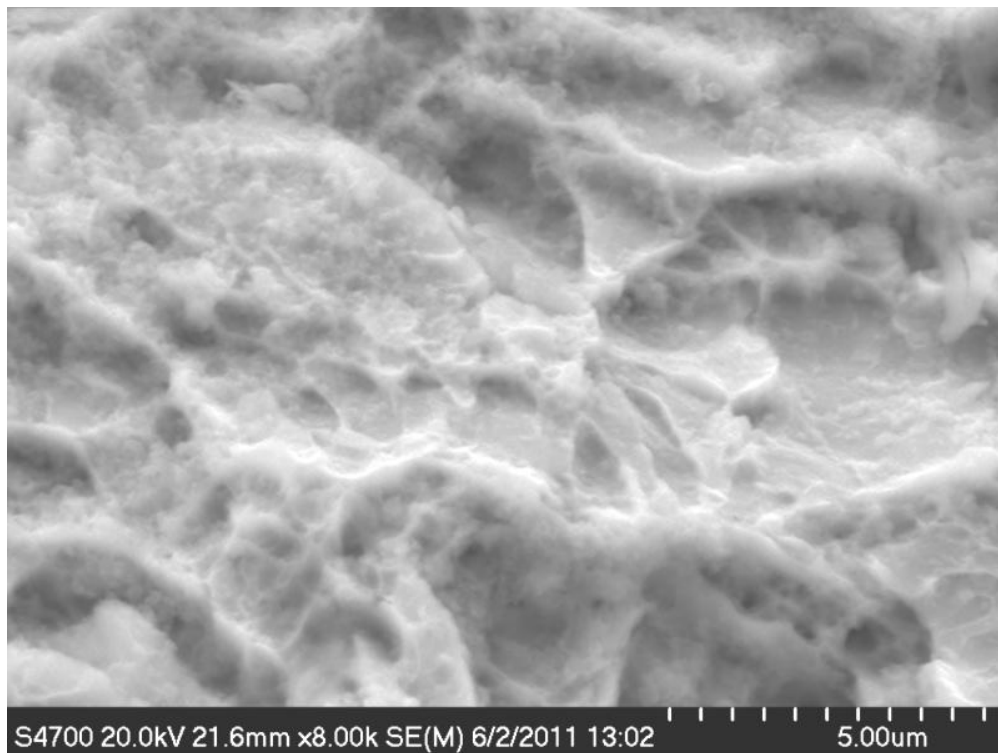
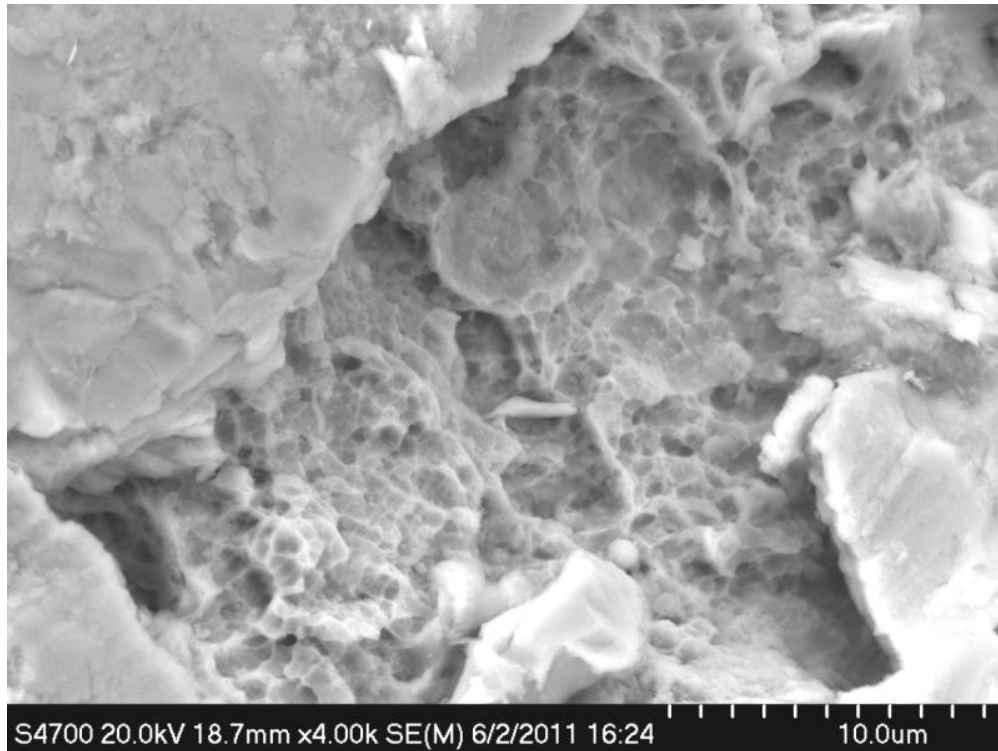
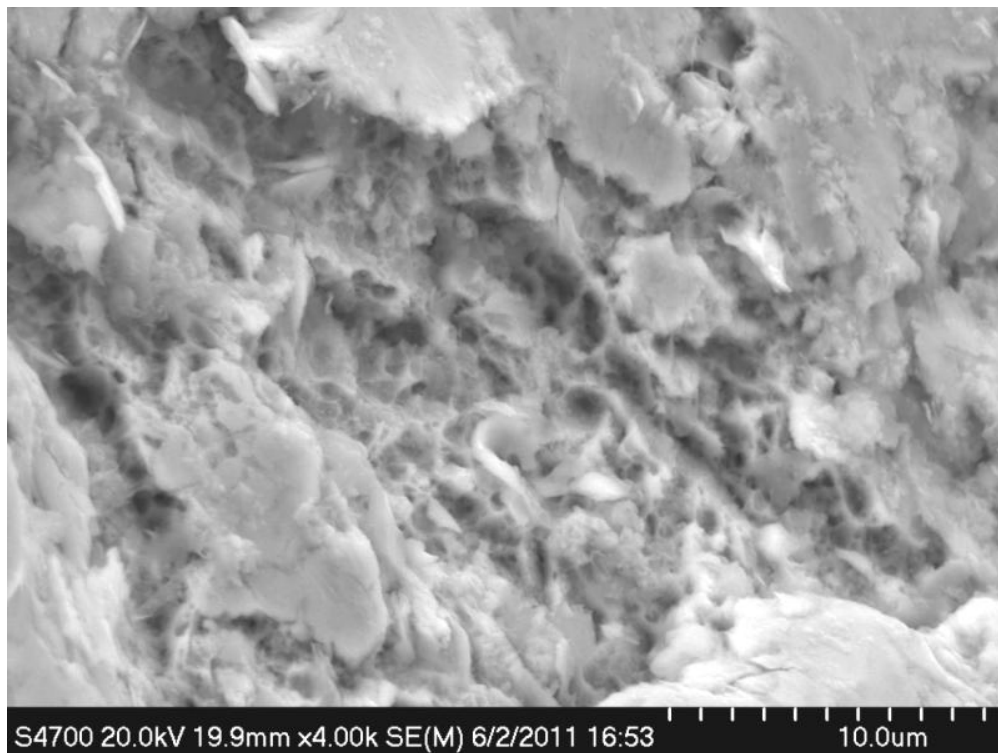
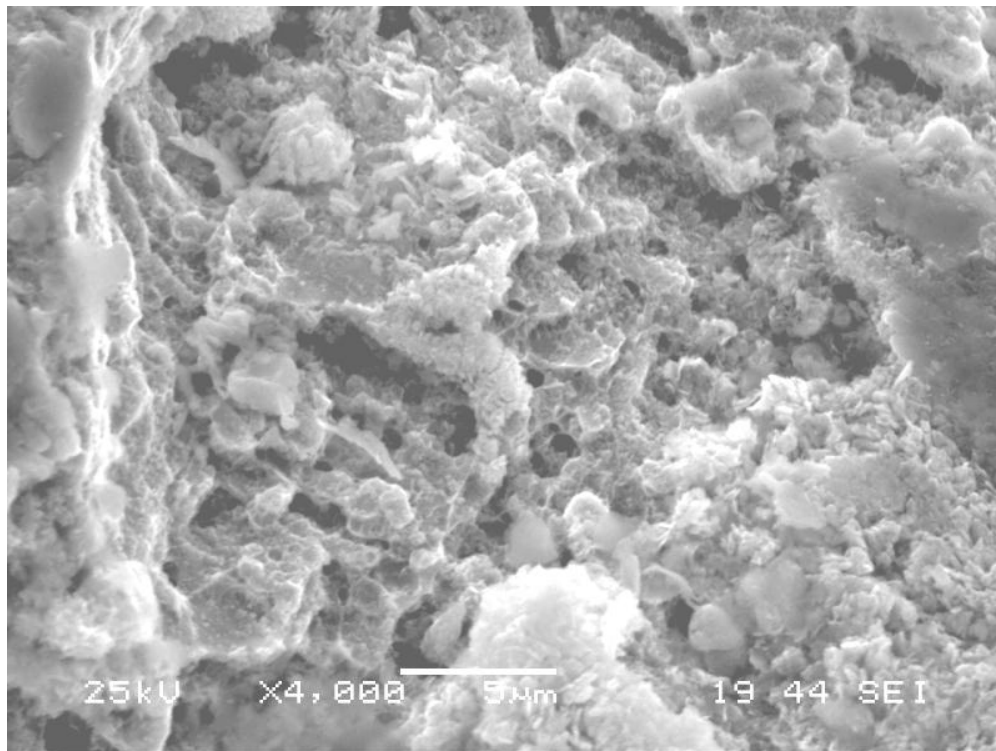
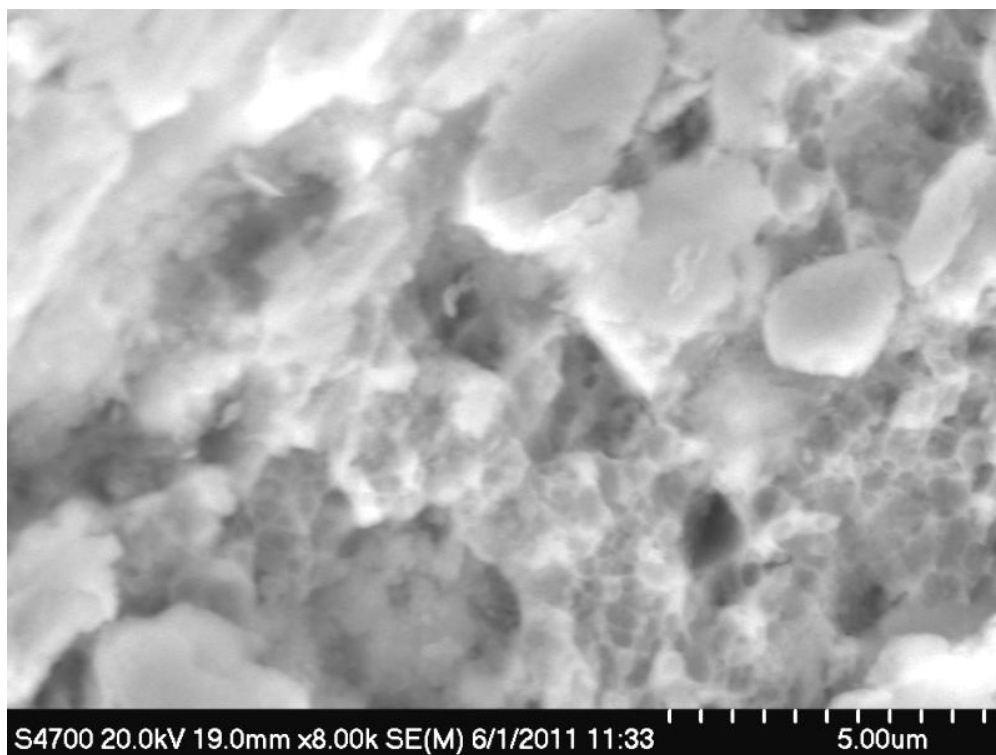
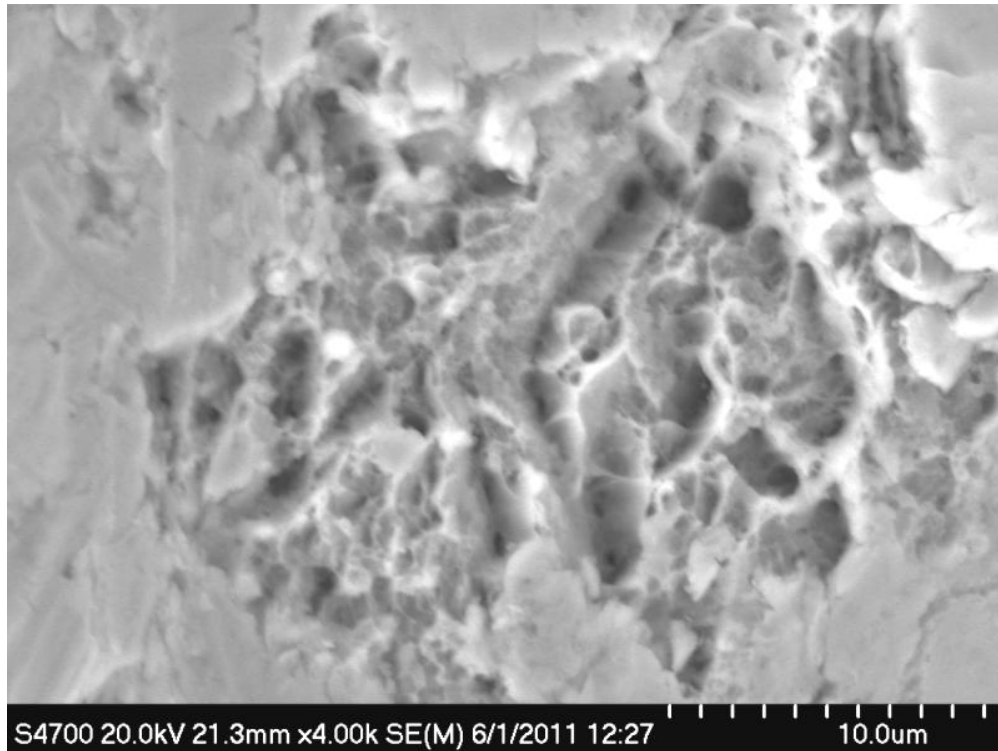
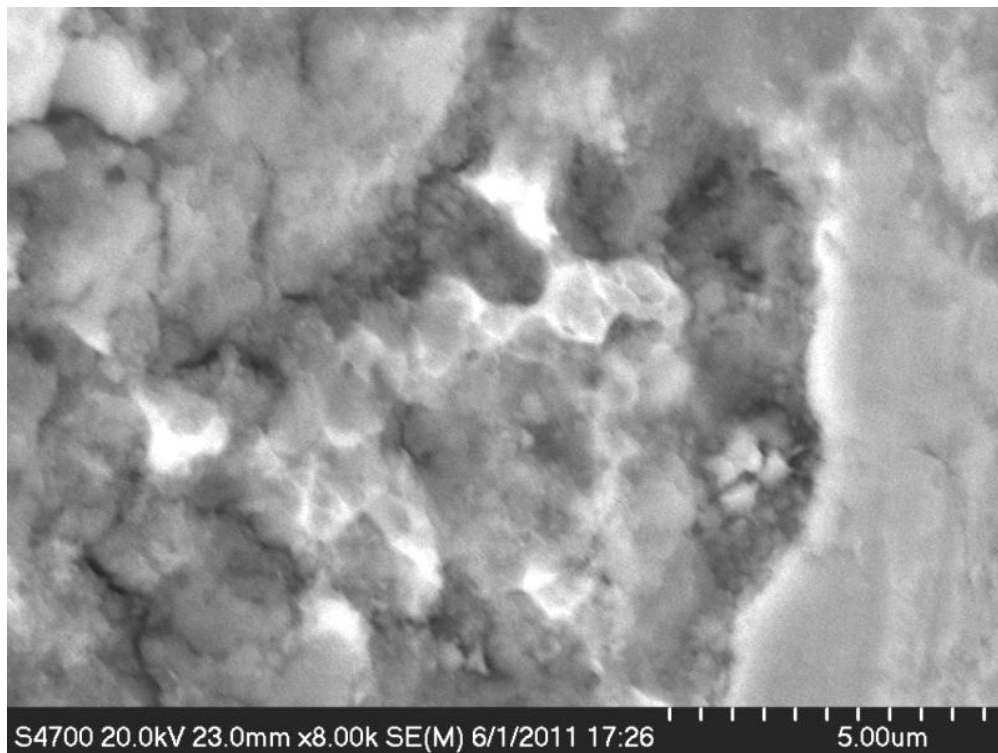
A linear series of images was then obtained from each of the three fracture origin regions. The minuscule changes in fracture morphology can be observed as the crack progresses in each of the three areas. Figures 46–54 show these three areas, respectively.

Figure 46. Fracture morphology in area 46, as depicted in figure 40.

Figure 47. Fracture morphology in area 47, as depicted in figure 40.

Figure 48. Fracture morphology in area 48, as depicted in figure 40.

Figure 49. Fracture morphology in area 49, as depicted in figure 40.

Figure 50. Fracture morphology in area 50, as depicted in figure 40.

Figure 51. Fracture morphology in area 51, as depicted in figure 40.

Figure 52. Fracture morphology in area 52, as depicted in figure 40.

Figure 53. Fracture morphology in area 53, as depicted in figure 40.

Figure 54. Fracture morphology in area 54, as depicted in figure 40.

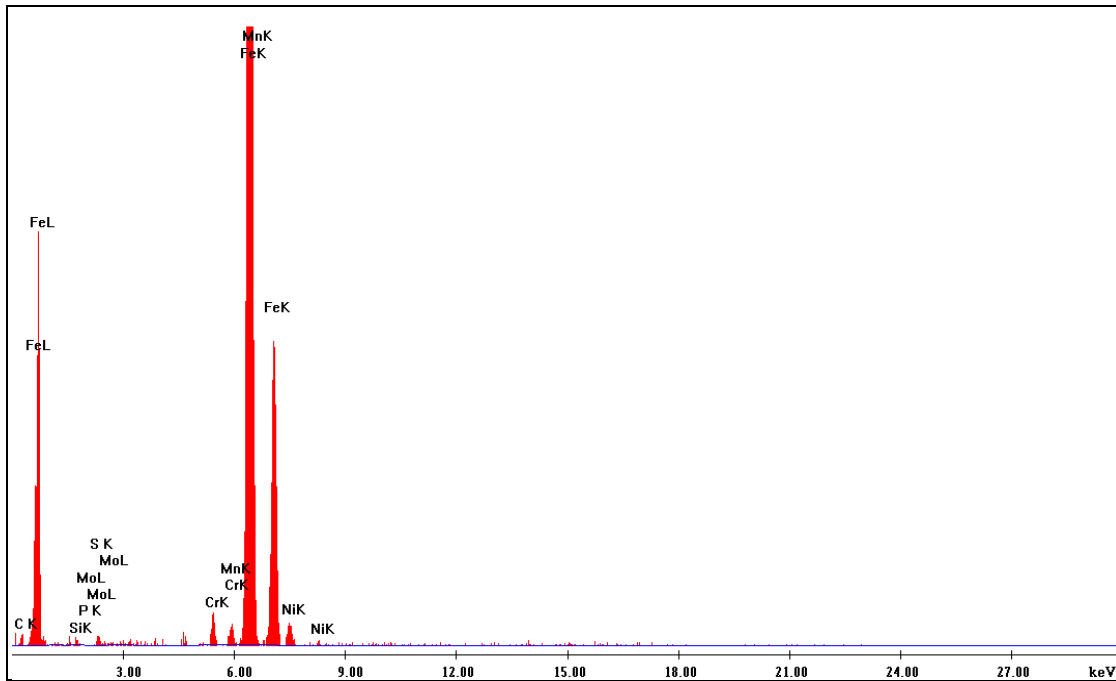
EDS was performed to verify the chemical constituency of the 4340 steel alloy. This material was originally procured under MIL-S-5000 (3), which has since been cancelled and superseded by SAE-AMS-S-5000 (4). The chemical composition conformed to the requirements within the specification. The results of the EDS analysis are presented in figure 55 and in tabular form in table 3. EDS also confirmed that the chromium layer on the interior bore had been eroded away. There were no traces left on the interior surface. The chromium plating was confirmed to exist on the exterior surface in the failed area.

Figure 55. EDS spectrum obtained from the failed spindle material.

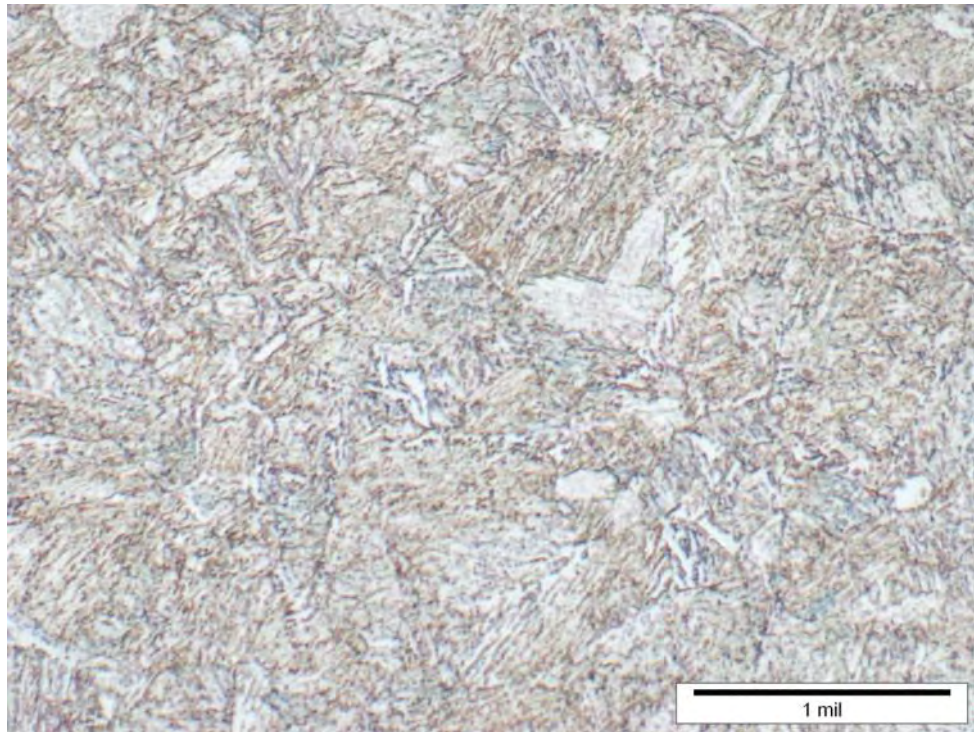
The microstructure of the spindle was analyzed by polishing and nital etching a cross-sectional mount obtained from a radial cut near the fractured end. Figure 56 shows the cross section revealing the etched microstructure. The structure consists of primarily tempered martensitic lathes and is consistent with that expected for this alloy.

Figure 56. Microstructure of the failed spindle etched with nital.

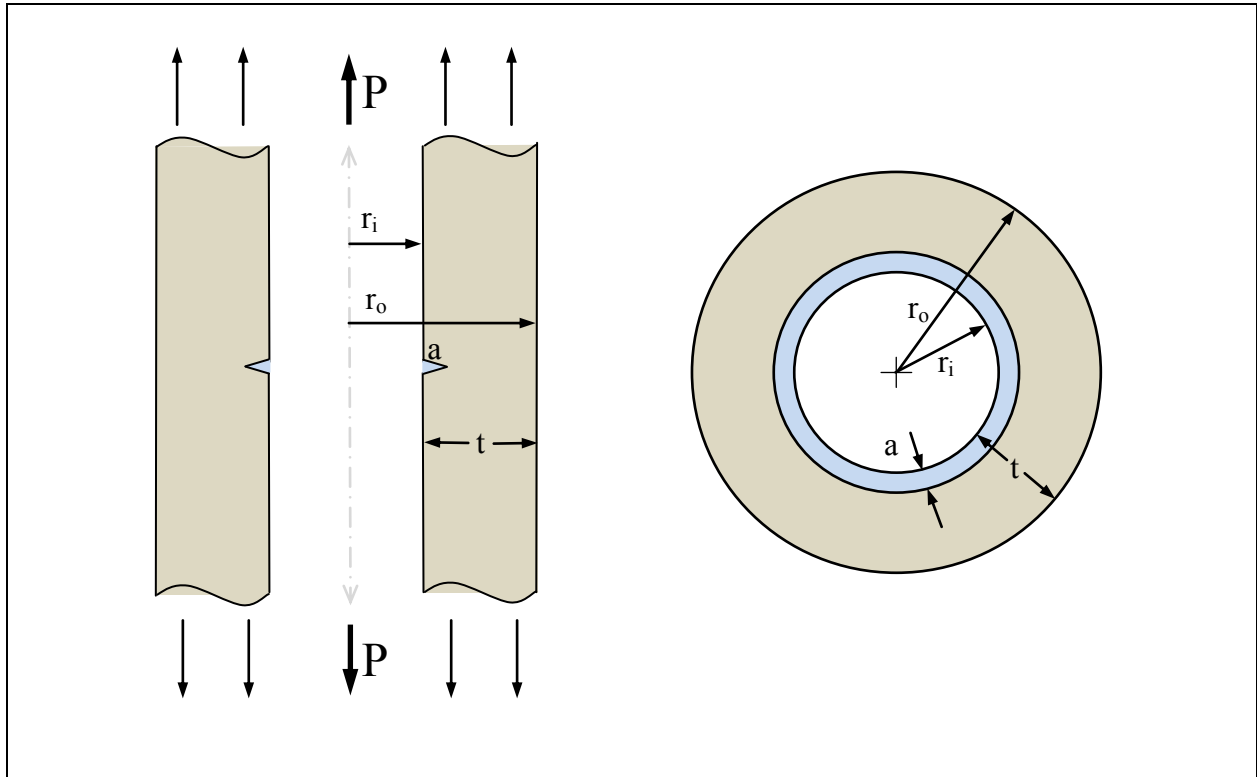
The evidence in the failure of the HARP breech spindle suggests the component failed most likely under a single load cycle. There was a crack-like defect along the circumference of the interior bore in the radial direction. When a component fractures in this manner, the failure is determined by the material property called fracture toughness, or  $K_{Ic}$ . The geometry in the failed region is similar to a tube with the radial circumferential crack on the interior wall, as represented by the schematic in figure 57.

Figure 57. Schematic of the loading on the failed breech spindle.

This leaves  $a/t$  equal to 0.14 and  $r_i/r_o$  equal to 0.50. From the numerical solutions provided, the function value becomes 0.99. If we assume that the breech spindle failed on the first shot during the catastrophic event, as the evidence suggests, the stress on the spindle could be approximated at 36 ksi. The solution for  $K_{Ic}$  becomes  $11.7 \text{ ksi}\sqrt{\text{in}}$ . The fracture toughness for 35 HRC 4340 steel is nearly  $100 \text{ ksi}\sqrt{\text{in}}$ , an apparent conflict. However, in this case, the material was severely hydrogen compromised, as previously discussed. The term  $K_{Ic}$  then becomes  $K_{Isc}$ , the SCC fracture toughness. Grendahl (6) has previously shown that the value for  $K_{Isc}$  in (similar, but not identical) HRC 38 vacuum arc re-melted 4340 steel was measured at  $13 \text{ ksi}\sqrt{\text{in}}$ , certainly within measureable error for agreement.
