ESTCP Cost and Performance Report

Ultrasonic Guided Wave Technology for Non-invasive Assessment of Corrosion-induced Damage in Piping for Pollution Prevention in DOD Fuel Storage Facilities

September 2011

Project: WP-200819

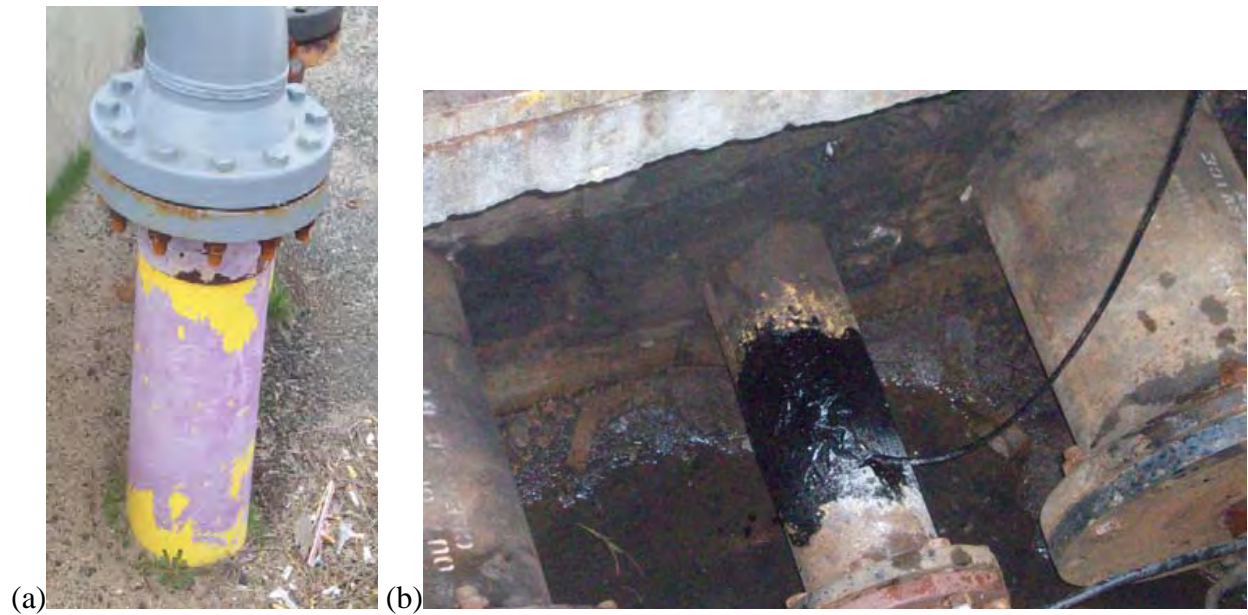
Figure 6. Surface conditions of tested pipe.

- (6a) Protective paint on a section of pipe to be removed prior to transducer mounting
- (6b) Protective tar coating and lead wires for a transducer in the underground pipeline

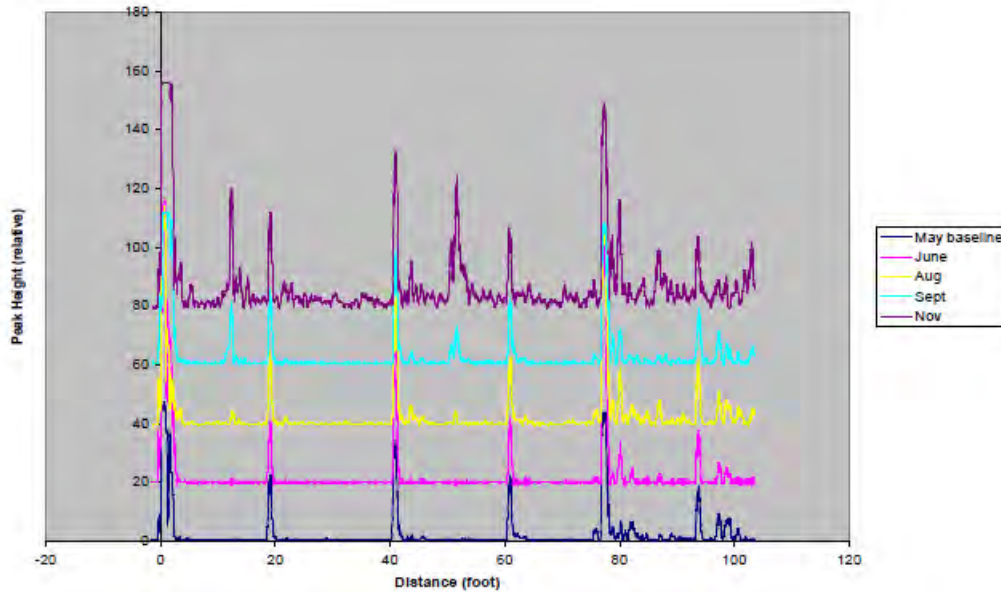
Figure 9. Systematic increases in defect detection over time as compared to the baseline.

Shown in Figure 9 is the summary of the aboveground ultrasonic wave data over time as compared to the baseline with a systematic increase in defect peak height with successive stages of corrosion from a transducer placed at location 2. Waves from one transducer detect the presence of welds, elbows, and one or more defects in the guided wave propagation path. As expected, the signal height depends on the size of the defect, the distance between the transducer and the defect, and the number of welds in the wave propagation path. We note that the noise level increased in the later months as corrosion progressed but was less than 0.1 of the weld signal height at about 80 ft.

Systematic increases in peak heights for growing Defects 1 and 2 sensed by transducer at location 2. Defect 1 was located at approximately 50 ft, and Defect 2 was located at approximately 12 ft. The other large peaks, approximately 20 ft apart, are from the welds in the pipeline. The baseline signal (May 2008) is blue, the June signal is pink, the August signal is yellow, the September signal is light blue, and the November signal is purple. An offset of 20 units along the vertical axis has been added to each successive trace before plotting.

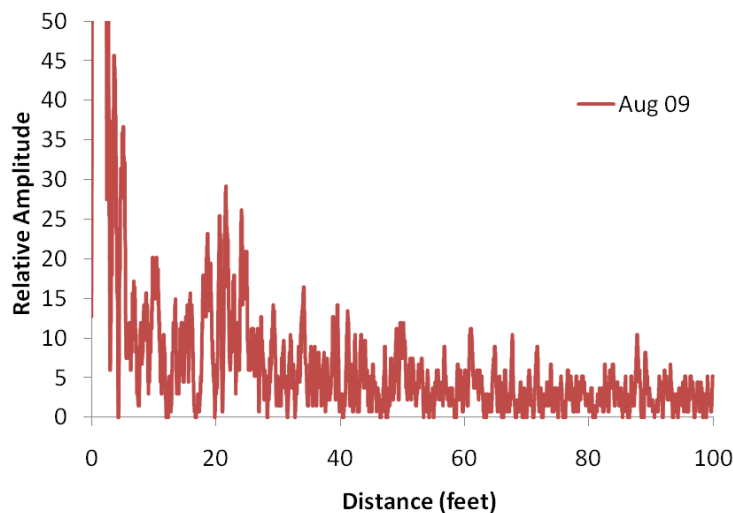
Figure 11. Signal trace at baseline obtained by sensor #22532 inside VP 21 propagating guided waves towards BL 20.

Shown in Figure 11 is the baseline trace for wave propagation from VP 21 towards BL 20. The peaks located up to 20 ft represent signals, first from the leakage of the transducer excitation, followed successively by the signals at the wall interface, and from welds and reducers along the pipeline. Of note is the pair of peaks above noise level at about 90 ft, which could be identified to originate from the region on the ground where pipe repair and replacement were made a few years back. The height of these two peaks was approximately twice as large as the noise level, which was four times as large as that typically observed in the laboratory tests in Phase I.

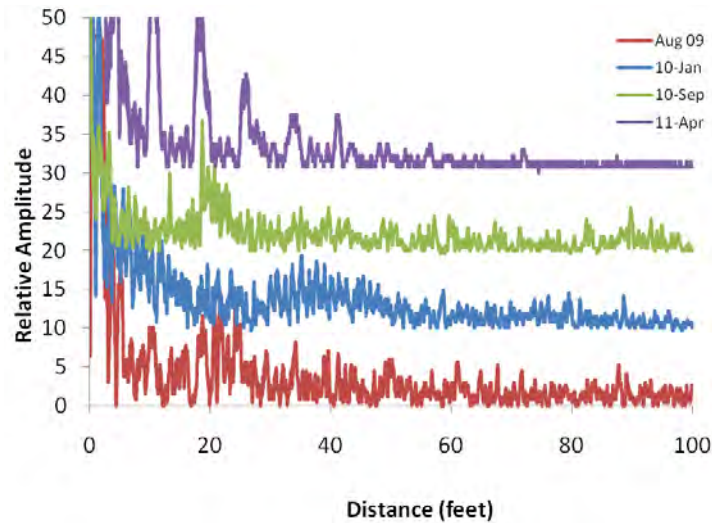
Figure 12. Monitoring changes in data sets obtained at the baseline and successive months by underground sensor #22532.

An offset of 10 units along the vertical axis has been added to each successive trace before plotting.

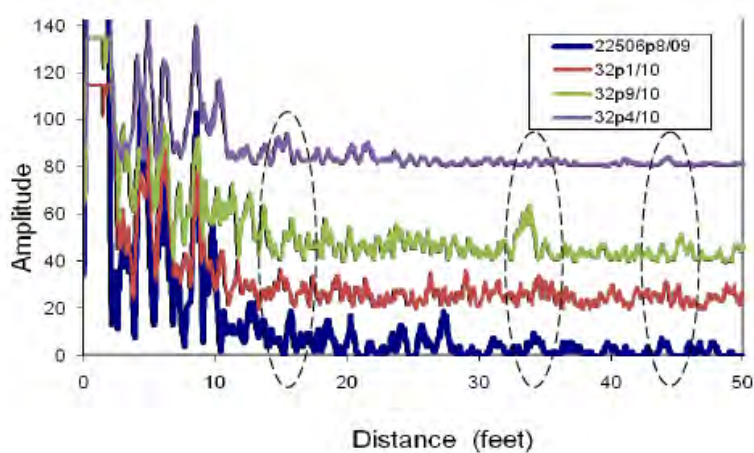
Figure 13. Monitoring signal changes in data sets obtained by aboveground sensor #22506.
An offset of 20 units along the vertical axis has been added to each successive trace before plotting.

Data traces in Figure 13 are for waves propagating from VP 5 towards VP 20 from sensor #22506. Focusing on the groups of peaks around 16 ft, 35 ft, and 44 ft, we observe that the

normalized peak heights at some locations (e.g., 35 ft) have not been increasing consistently or they remained relatively unchanged over the course of the monitoring effort. The locations where peak heights remained constant most likely originated from static structural features such as welds. Inconsistent changes in peak heights could be due to signal noise and/or multiple reflections unrelated to defects.

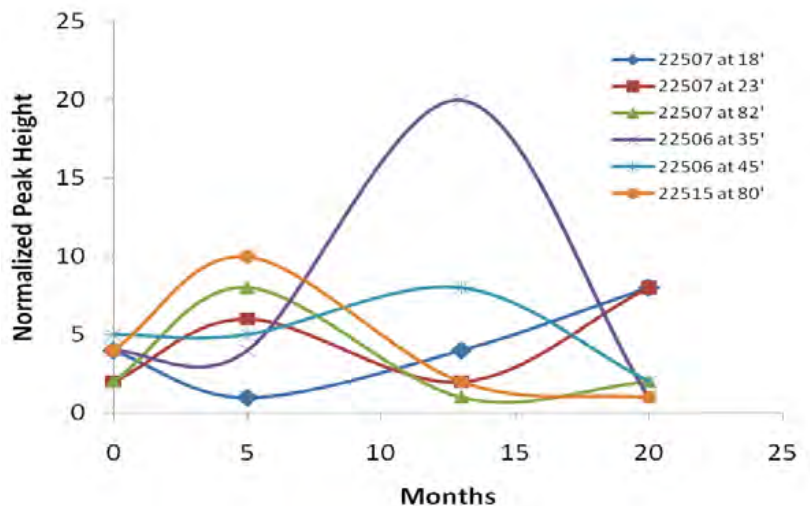
Figure 14. Changes in normalized peak height at suspected defect locations detected by three aboveground transducers.

The results of the experiment in Phase I are shown in Figure 14. We observed that none of these peaks increased systematically in amplitude during the 20 months of monitoring. Thus, further monitoring is required to determine whether these locations have corrosion-induced defect growth.

Typical signal noise was two vertical units.
