ABU GHRAIB DAIRY  
ABU GHRAIB, IRAQ

**SIGIR PA-09-172**  
**JANUARY 14, 2010**

## Abu Ghraib Dairy

### Summary of Report: PA-09-172

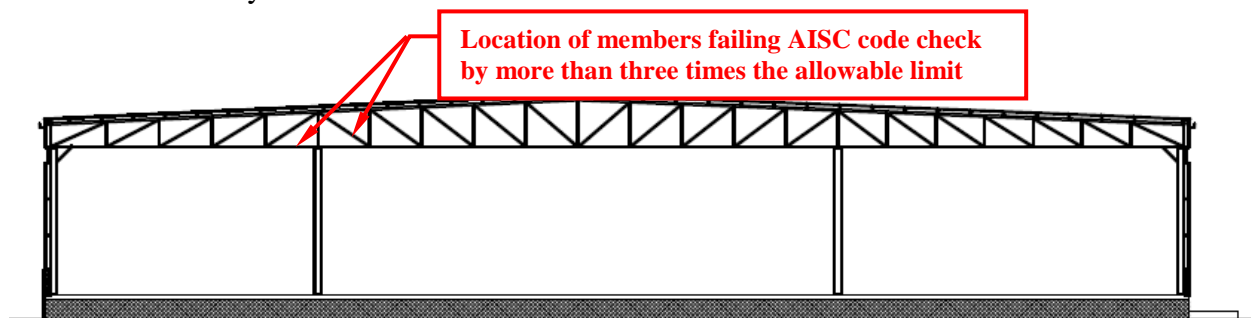
**Figure 2. Primary truss configuration**

- Based on the contractor's calculations, five members of the truss were designated as failing the AISC code check. Two of the members failed the code check by more than three times the allowable limit (Figure 2). Failing by a factor of this magnitude indicates that the members could yield and possibly fracture under the design load.

The contractor's proposed structural design consists of steel columns and continuous truss construction with sandwich panel cladding<sup>18</sup> for the roof and sidewalls. Roof loads are carried by the multi-span steel trusses, which have two configurations. The primary configuration has steel columns supporting the truss at the ends and at approximately one-third span (Figure 2). The columns are centered on a truss panel point (the location of intersecting truss members), which is appropriate. Based upon the contractor's drawings, it appears that the member sizes have been modified to accommodate the stress reversal<sup>19</sup> over only one of the interior columns.

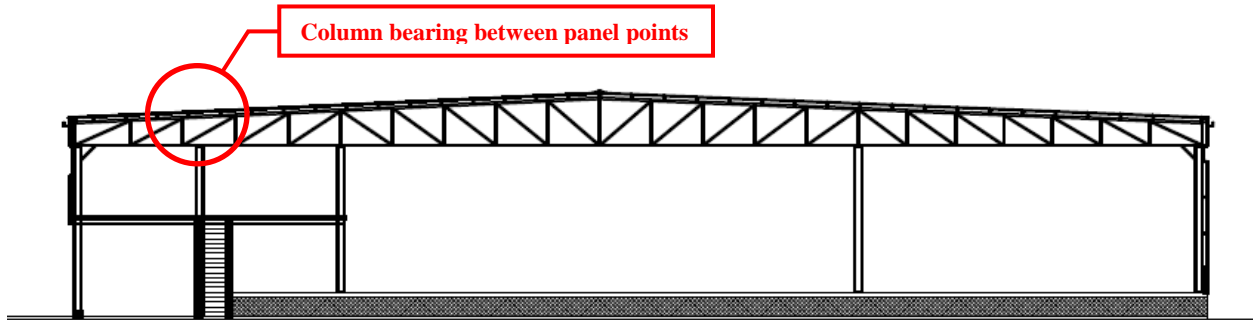
**Figure 3. Truss configuration at mezzanine level**

In the area of the mezzanine, the plans show additional columns (Figure 3), which extend through the mezzanine to the underside of the truss. The additional bearing locations provided by these columns are not at a truss panel point. The resulting reactions from these columns will introduce bending into the lower chord of the truss. SIGIR is

concerned that the members used in the lower chord of the truss are relatively light and do not appear to have the capacity to resist a significant amount of bending stress in addition to the compressive load that will result from the intermediate support.

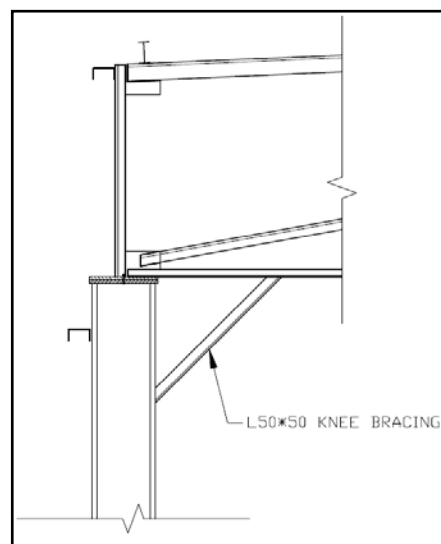
**Figure 4. Knee brace detail**

The contractor's design drawings do not address the method used to resist lateral loads parallel to the building's gable. It appears that the design incorporates diagonal cross bracing between several bays in the direction parallel to the ridge; however, there is no indication of bracing parallel to the gable (slope). In addition, the building's use of column and truss construction requires additional consideration of lateral loads. The only members that appear to be placed to provide lateral stability in the axis of the gable are the diagonal knee braces (Figure 4). These knees appear to be severely undersized, considering their location and configuration.

If the braces are used to resist lateral loads, the connection between the columns and truss would become, at least, partially fixed. This would introduce significant load into the lower chord of the truss, which appears to be already undersized. Fixing the truss/column connection would also introduce a lateral component into the column reaction; special consideration would then be required in the design of the foundation to resist this load.

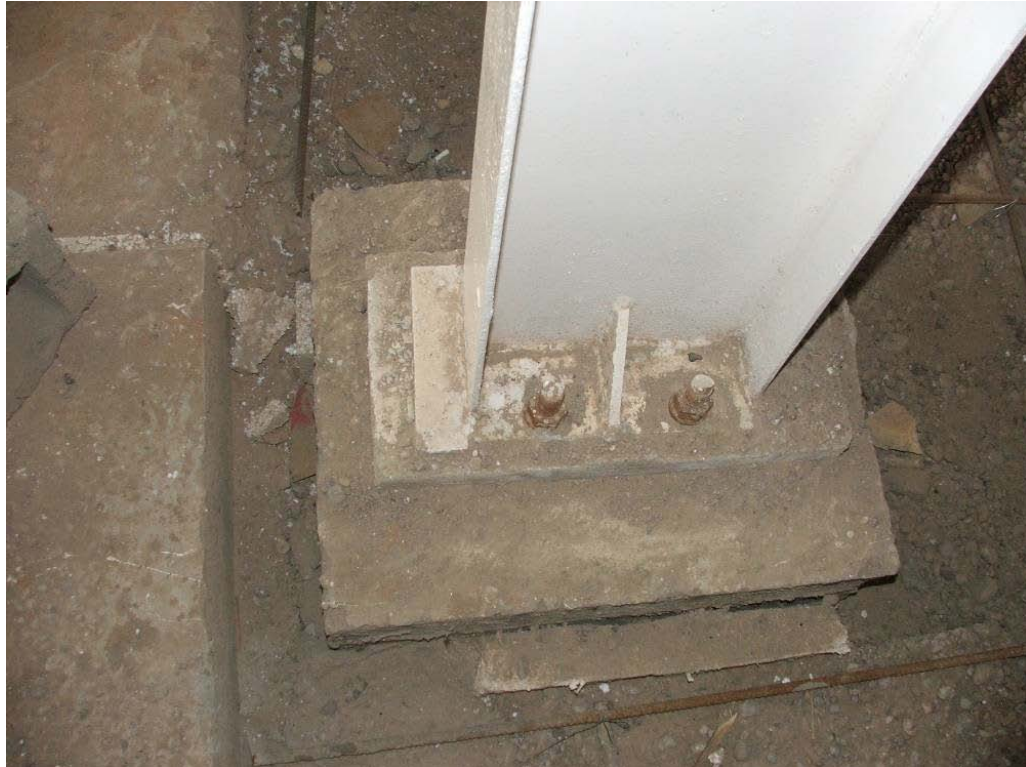
At the time of the site visit, the foundations for the facility were installed. The foundation system appeared to be concrete pedestals with steel anchor bolts attached to the base plates of the steel columns (Site Photo 1). The foundation system also included spread footings to support the concrete pedestals and columns. Since the foundation was in the later stages of construction, only the upper portion of the foundation was exposed for inspection; consequently, SIGIR could not verify the construction of the foundation.

**Site Photo 1. Typical foundation pedestal and anchor bolts**

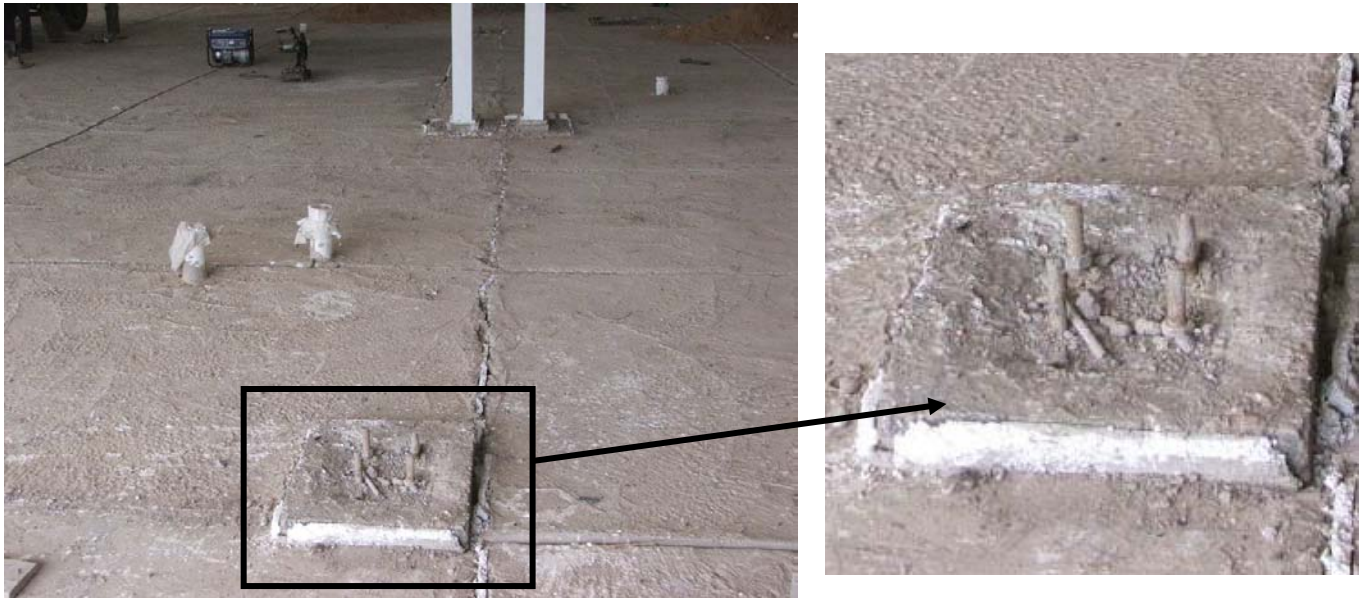
SIGIR noticed several sets of anchor bolts not attached to structural columns (Site Photo 2). The contractor's project manager stated that these anchor bolts are intended to attach the mezzanine columns to the foundation. It appears that the contractor did not adequately protect the anchor bolts during construction of the concrete slab, since SIGIR observed bolts coated with concrete and, in some cases, bolts that had been bent. These bolts may be damaged to the point that the mezzanine columns cannot be placed over the bolts without modification to the base plate or re-bending the bolts. The concrete-coated bolts require cleaning, and if the underlying threads are damaged, they may require re-threading to accept a nut to secure the base plate.

**Site Photo 2. Unprotected, exposed anchor bolt group**

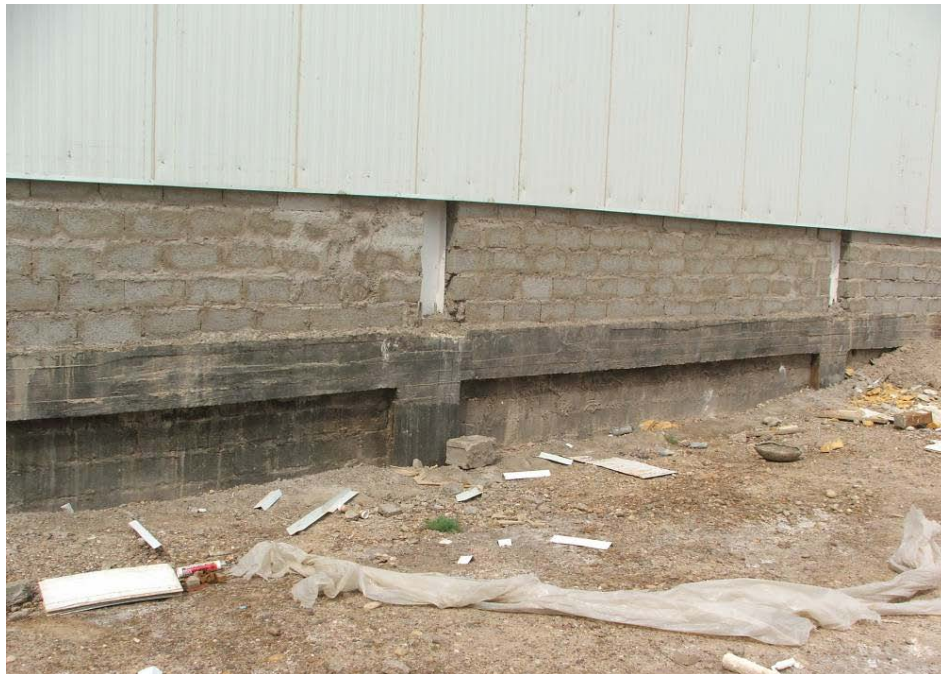
The foundation system included a perimeter concrete masonry unit (CMU) wall (Site Photo 3), which acts as a grade separation barrier and contains the backfill beneath the floor slab in the building. Due to a construction error, the CMU wall was not constructed on the exterior of the steel framing; rather it has been constructed between the steel columns. This created several issues with the structure that need to be addressed.

**Site Photo 3. Perimeter CMU wall**

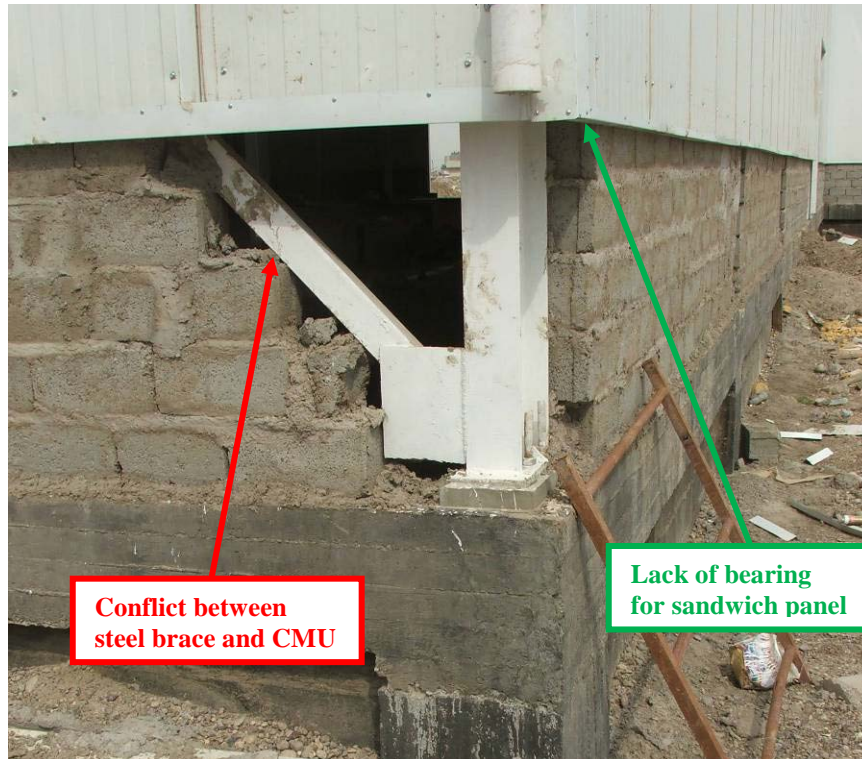
The CMU wall interferes with the steel cross bracing between several of the columns (Site Photo 4). It appears as if the contractor's solution to this issue was to lay the CMU wall around the bracing and coat the entire area with plaster. However, this approach may cause future problems as the steel bracing moves independently of the CMU wall causing recurrent cracking at the location.

**Site Photo 4. Cross brace conflict with CMU perimeter wall**

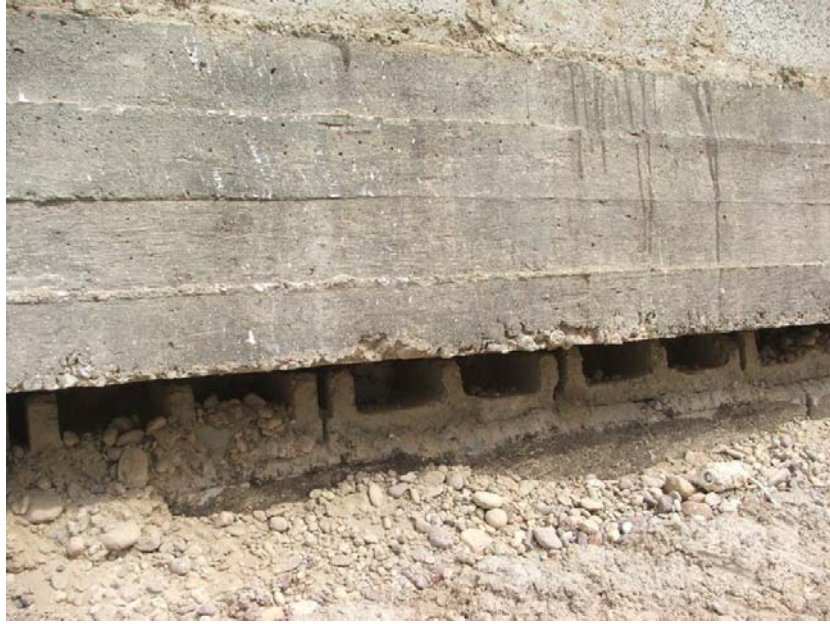
**Site Photo 5. Course of CMUs placed with cores horizontal**

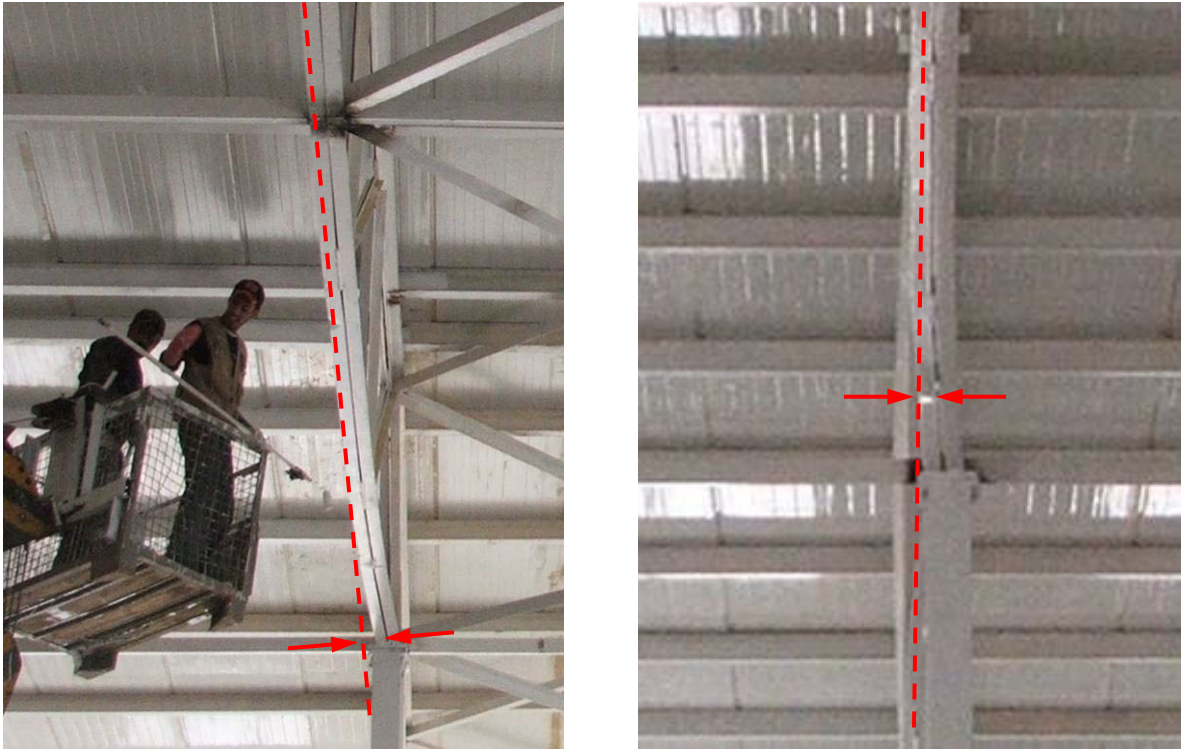
SIGIR noticed deformation (buckling/bending) of several of the roof trusses near one of the interior column lines (Site Photos 7 and 8). Due to the limited time available on site and the lack of aerial access to the steel framing, SIGIR could not determine the magnitude of the displacement; however, the fact it could be detected visually from the ground level indicates that the displacement is significant.

**Site Photos 7 and 8. Lateral bow in lower truss chords**

Based on the contractor's calculations, the lower chord members adjacent to the interior column are overstressed and are unable to support the design load. The truss is a continuous truss, which results in compression loads in the members. A compression failure of the lower chord could result in buckling of the chord and lateral displacement. This corresponds with the behavior of the lower chord SIGIR observed. While the contractor's calculations indicate that the displacement may be indicative of the initial stages of truss failure, other factors may also have contributed to the misalignment, such as poor construction techniques used during the erection of the trusses or "adjustment" of the trusses during installation of the bracing. Either scenario could have further amplified any deformation of the trusses.

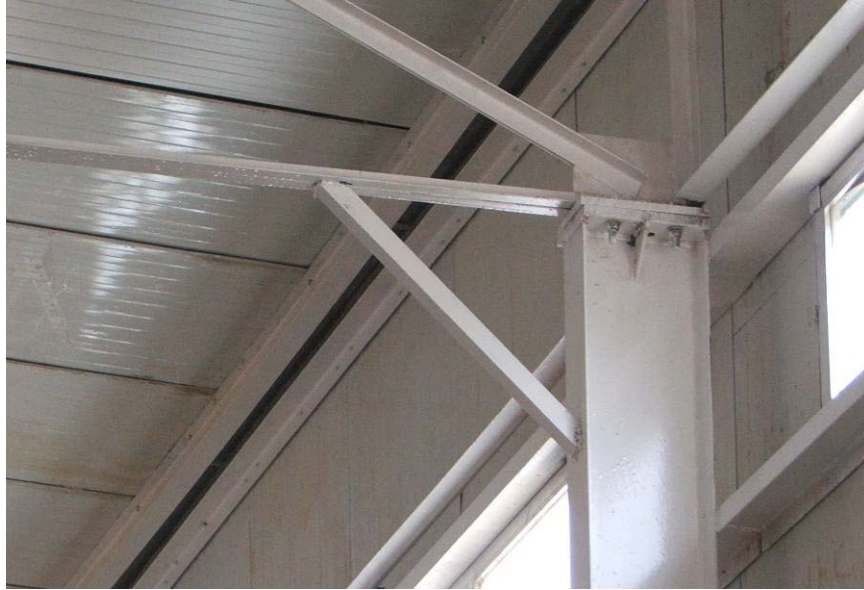
To provide lateral bracing parallel to the trusses, diagonal braces were welded to the steel columns and the lower chord of the truss (Site Photo 11). SIGIR observed what appeared to be significantly undersized braces in place, which could lead to excessive bending in the lower chord of the truss.

**Site Photo 11. Diagonal brace from column to truss lower chord**

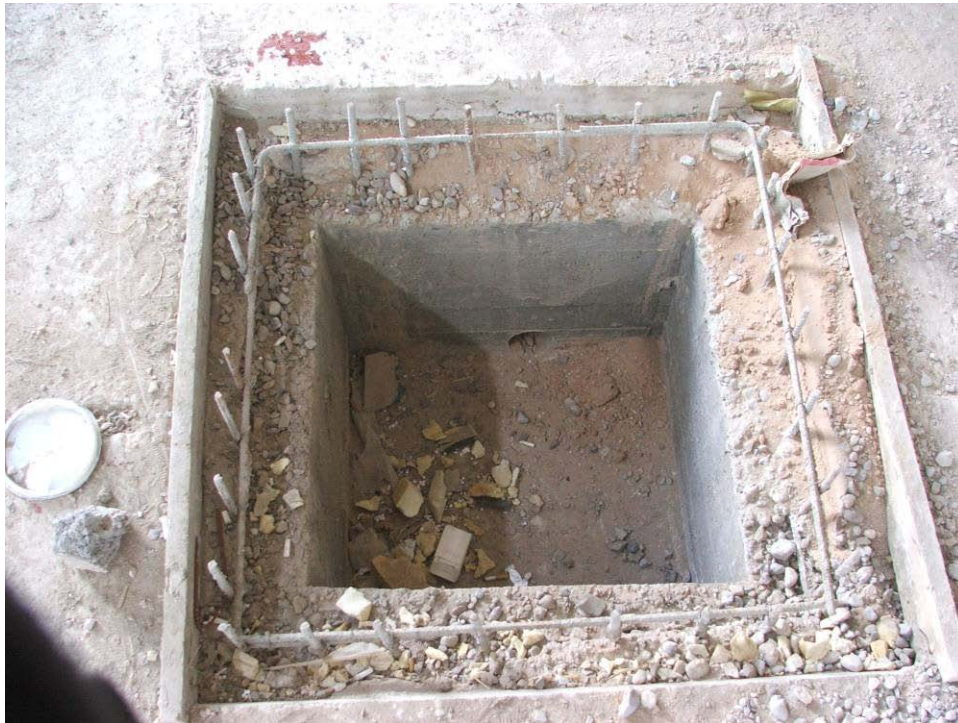
SIGIR observed sanitary sewer manholes in several locations in the floor (Site Photo 12). The sanitary manholes were constructed as cast-in-place reinforced concrete with polyvinyl chloride sewer piping cast directly into the manhole walls. The contractor failed to install a manhole on the interior of the building; instead the contractor installed a polyvinyl chloride elbow. This will result in future problems because the sewer line is not accessible for cleaning.

**Site Photo 12. Cast-in-place sanitary sewer manhole**

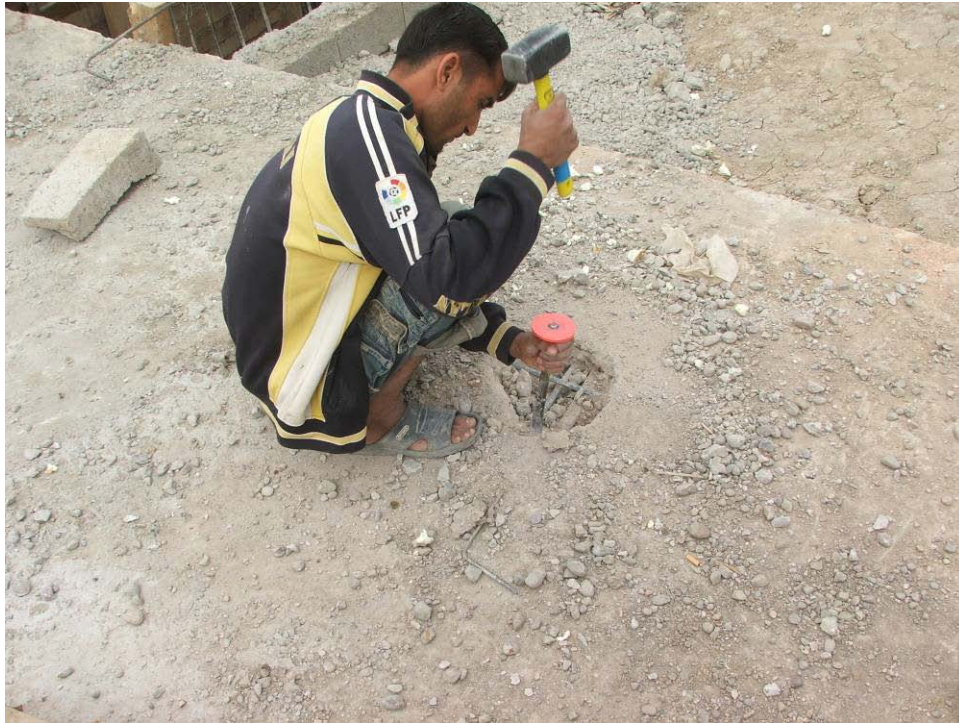
At the time of the site visit, the contractor had substantially completed the construction of the reinforced concrete fuel and potable water storage tanks. The tank floors, walls, and lids had been poured, and the access hatches and ladders installed. In addition, the pipe penetrations to the tanks below grade appeared to be installed. SIGIR observed the contractor completing backfill around the tanks, installation of the above grade vent pipe penetrations, and coating of the tank interiors (Site Photo 13).

**Site Photo 13. Chiseling tank lid for pipe penetration**

The contractor did not cast the vent pipe penetrations into the tank lid at the time of construction; rather the contractor is attempting to install the vent pipes after completion of the lid. This construction technique requires chiseling of the concrete, cutting the

reinforcing steel, and grouting the pipe in place. This “modification” weakens the lid and creates increased potential for leakage.

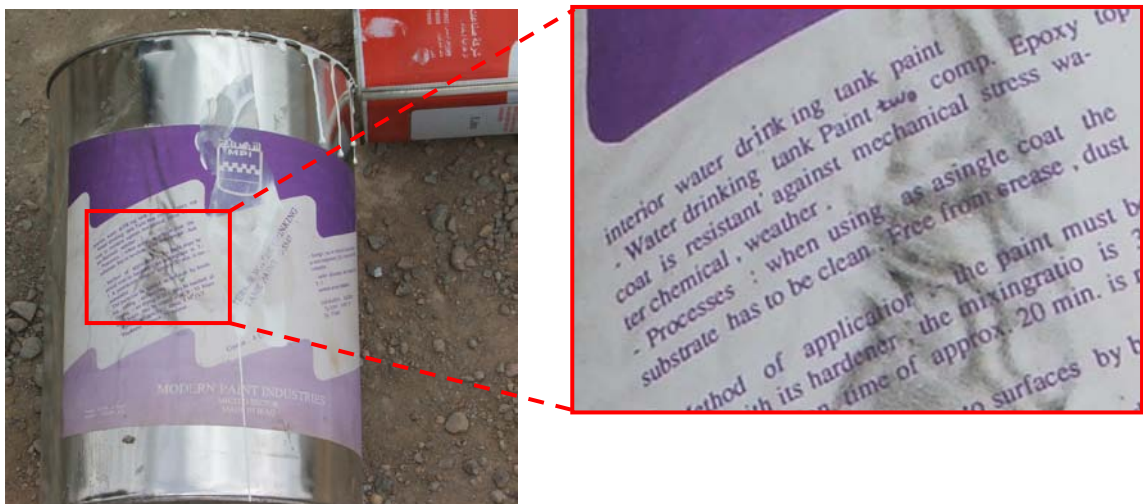
SIGIR observed the contractor applying coatings to a liquid tank’s interior. The labels on the coating containers (Site Photo 15) stated that the coatings were two-part epoxy and the material was compatible for use with potable water.

**Site Photo 15. Coating for potable water tank**

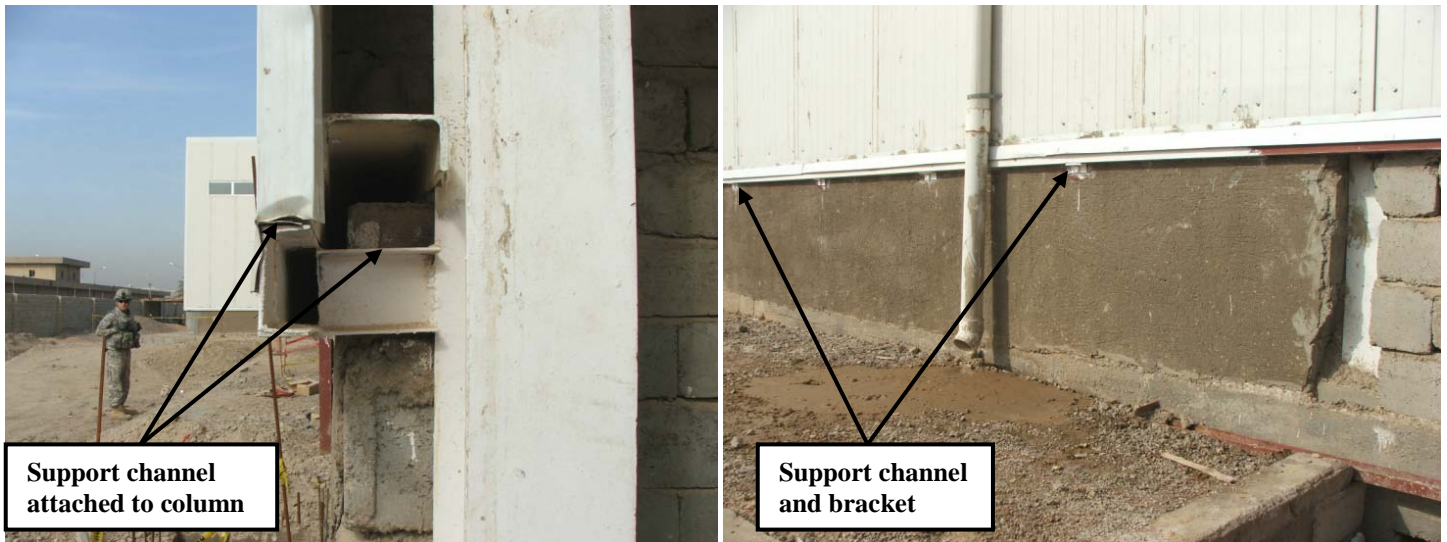
Site Photos 21 and 22. Support channel for sandwich panel

Another previously noted deficiency was the lack of support for the sandwich panels used as cladding for the building exterior. This lack of support was due to the contractor's deviation from the original design, which located the perimeter CMU wall to the interior of the steel framing. To remedy this situation, the contractor installed steel channels

around the perimeter of the building attached to the columns and supporting the panels (Site Photos 21 and 22).
