United States
Department of Defense

Better Contract Oversight Could Have Prevented
Deficiencies in the Detention Facility in
Parwan, Afghanistan

SUBJECT: Better Contract Oversight Could Have Prevented Deficiencies in the Detention Facility in Parwan, Afghanistan (Report No. DODIG-2012-089)

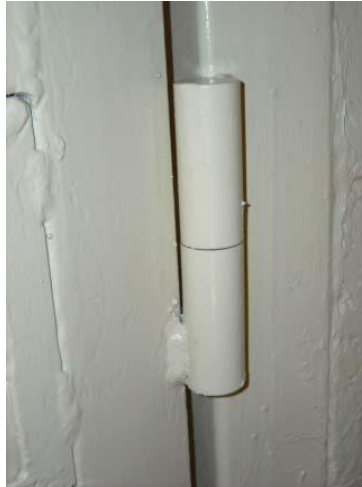
Figure 4. DFIP Hinge

The DFIP cell door hinges were not adequate to hold the weight of the cell doors and required re-welding and replacement. The technical specifications required that each door have full-mortise, heavy-duty hinges that complied with ANSI/BHMA A156.1. To fulfill that standard, the door should have had 1 ½ pairs butt hinges with rectangular leaves welded to both the door and the transom bar. According to the American National

Standard Institute,³ a butt hinge is defined as a hinge with rectangular leaves, usually of the same size, and multiple bearing contacts. Figure 4 shows original hinges installed by the DFIP contractor.

The hinges used did not meet the American National Standard Institute definition of a butt hinge because they did not have rectangular leaves or multiple bearing contacts. The original hinges also do not meet the definition of a 1 ½ pair's butt hinge as required by the statement of work, as the hinges do not have multiple bearings. As a result, some of the doors had broken hinges and other door hinges showed signs of stress from carrying the full load of the door. DFIP authorities were aware of the situation from the time the facility was accepted. USACE TAN engineers stated that the contractor acknowledged the problem and indicated that it was a systemic issue and would replace the doors before the end of the warranty period. However, the doors continued to remain an issue 9 months after acceptance when DoD OIG engineers conducted their inspection in July 2010.

Some of the doors had broken hinges and other door hinges showed signs of stress from carrying the full load of the door.

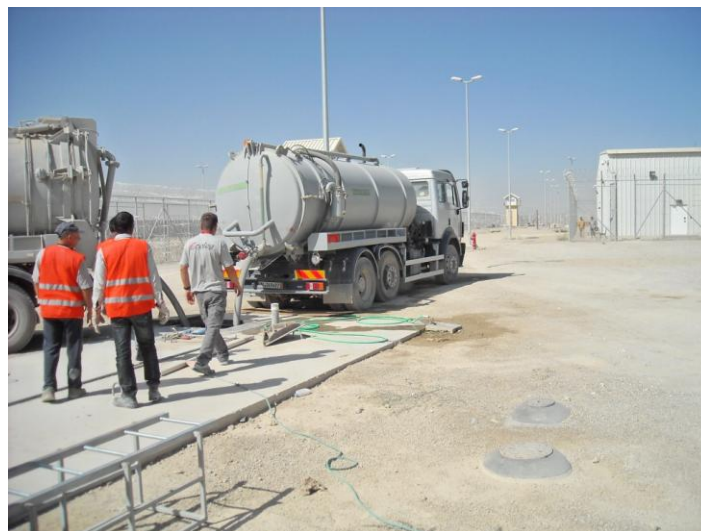
Figure 6. Trucks Collect Sewage

The contractor built the sewage system with two lift stations designed to allow sewage to pass from the detention facility to the two lift stations located in the DFIP secure courtyard. The two lift stations located in the courtyard would then pump the sewage uphill through transfer lines to a collection point located outside the detention facility. Once at the collection point, sewage trucks collect the sewage for disposal, as shown Figure 6.

According to DoD OIG engineers, who inspected the sewage system in July 2010, the two lift station pumps located in the DFIP courtyard were not built with grinders and were not operational. The lack of grinders caused the sewage to solidify because of the non-organic materials, such as uniforms, being flushed down the toilets by the detainees. Once the sewage hardened inside the lift station, the waste level began to rise above the sewage lines

In April 2010, Joint Task Force 435 personnel justified purchasing the sewage material grinders by stating that the two lift station pumps were replaced at a considerable cost, and the system was being pumped out from the lift station holding tanks. The justification also stated that the continued operation without the grinders could result in the having to remove, rebuild, or replace the pumps at an even greater cost.

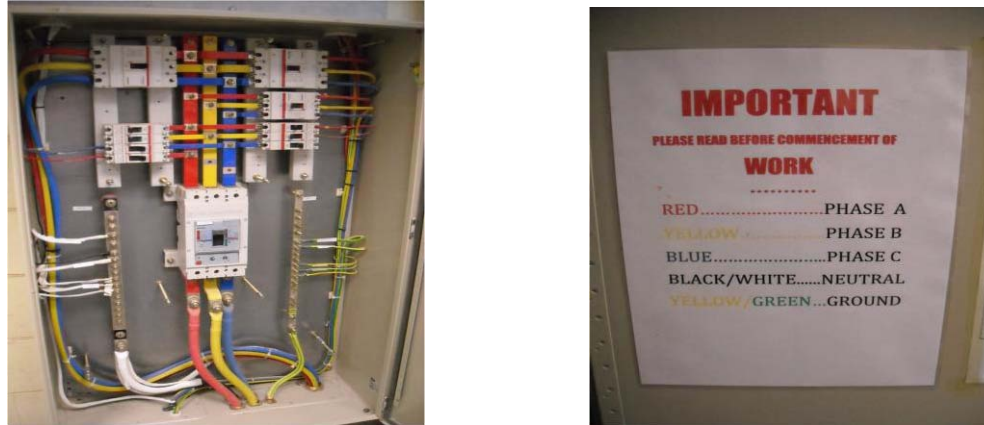
Figure 7. The Electrical System Panel (left) and Explanation of the System (right)

Personnel who had experience with the British Standard installed the British Standard electrical system during construction, and posted the explanation of the British Standard inside the electrical panels (see figure 7 [right]).

Contractors, once U.S. personnel started operating the facility, made changes to the British Standard wiring convention so that it conforms as close as possible to the American Standard. According to DoD OIG and USACE TAN engineers, an experienced electrician should know the difference between the two standards before performing maintenance. However, our engineers concluded that personnel who work with or around the electrical equipment at the DFIP were not safeguarded from electrical safety hazards.

Continued failure to correct the electrical code violations increases the risk of loss of service and the potential of the loss of life for anyone attempting repairs.

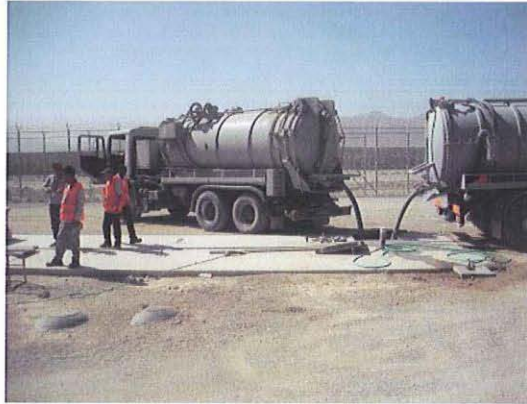
Figure 4. Contractor trucks removing sewage from DFIP lift stations.

To prevent the two sewage lift stations from overflowing, Fluor must bring four sewage removal trucks (see Figure 4) a day into the compound. Because the DFIP is a secure location, every time the trucks have to enter the facility the risk of a security incident increases.

To maintain the health and security of the individuals working and housed at the DFIP, USACE AED-N should require the contractor to immediately repair the lift stations in accordance with the warranty provisions in the contract and ensure the lift stations meet the requirements set forth in the contract.
