*Monitoring Completed Navigation Projects Program*

## **Kaumalapau Harbor, Hawaii, Breakwater Repair**

May 2012

Final report

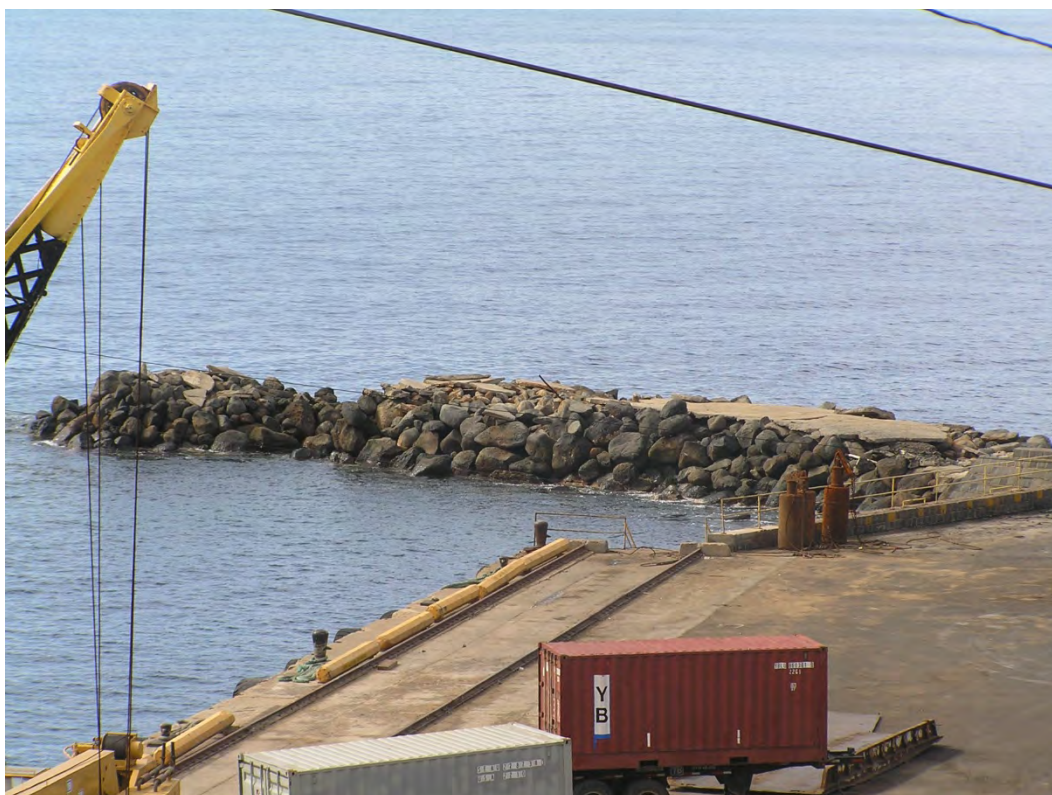
events, and repairs, resulted in a large, broad rubble mound, with a side slope of about 1 vertical on 1.5 horizontal. By the 1990s, the deteriorated condition of the breakwater permitted significant wave energy to reach the pier, resulting in berthed vessel motion that rendered cargo handling and fuel offloading difficult, and at times hazardous or impossible (Figure 1.3).

Figure 1.3. Deterioration of Kaumalapau Harbor breakwater prior to 2007 repair.

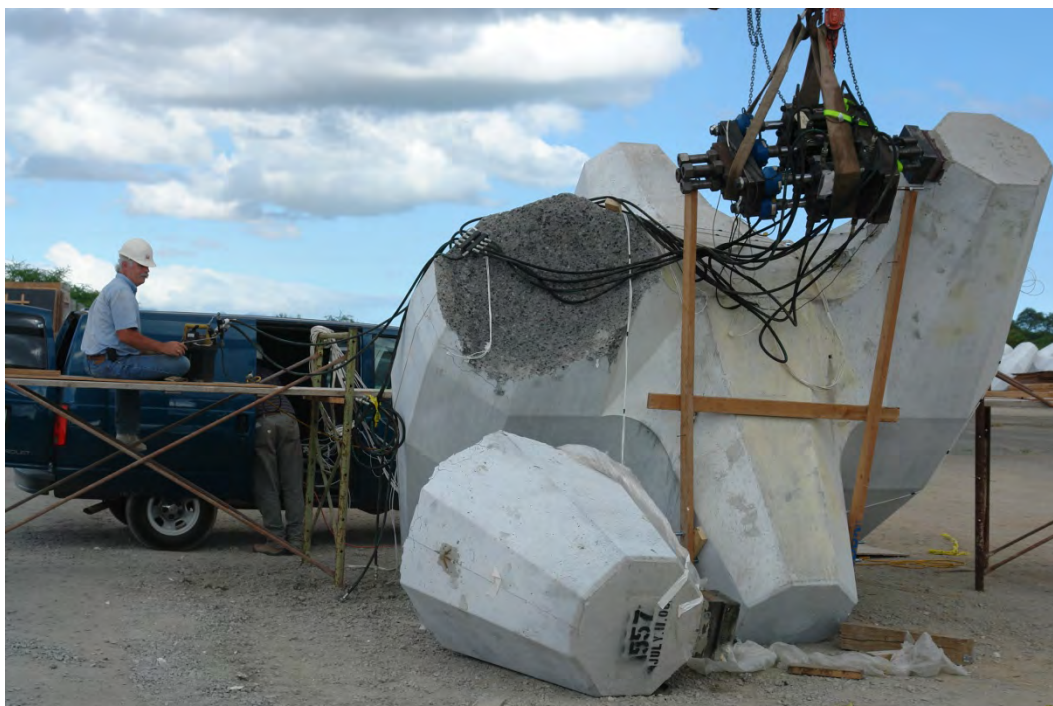
The Core-Loc failed just above the saddle in the upper half of the leg (Figure 5.8). The extreme outer fiber tensile strain on the failure plane occurred at the location of strain rosette 3. The failure plane started at the mid-height of the rosette and traveled in a plane that was at an angle of approximately 35 deg downward from the horizontal until it emerged from the Core-Loc leg on the compression face approximately 14 in. below strain rosette 1.

Figure 5.8. Core-Loc armor unit after testing to failure (O'Neil and Haskins 2008).

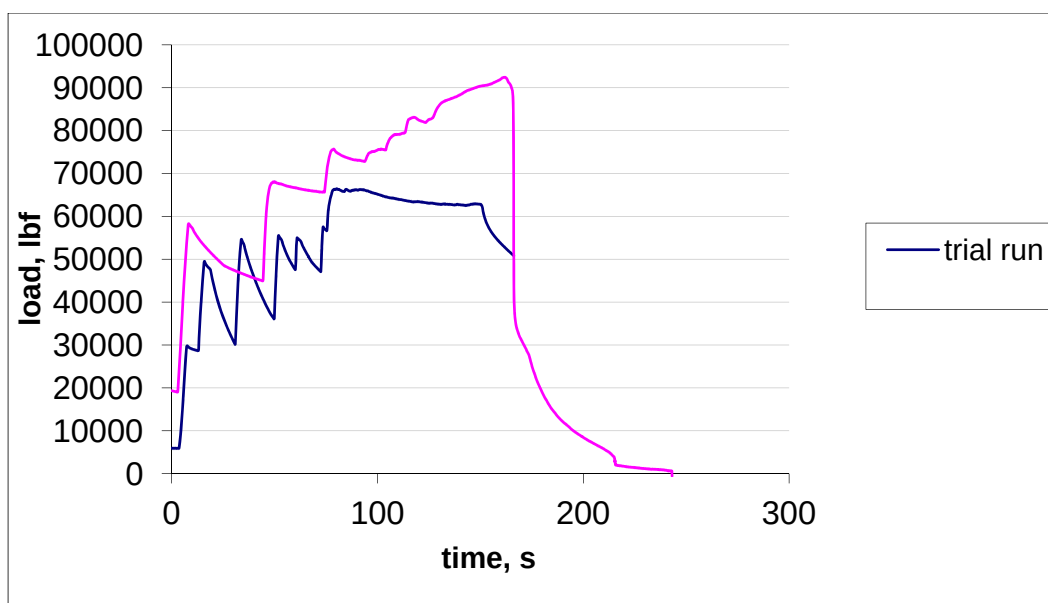
The 94,000 lbf actual failure load was approximately 42 percent of the 223,600 lbf theoretical failure load. In the theoretical calculations, the tensile stress capacity of the concrete was chosen as the highest test result achieved from an entire month of material flexural tests (925 lbf per square inch (psi)), while the contract required tensile stress was only 700 psi at 28

Figure 5.10. Load vs. time plots for the trial and failure runs of the test Core-Loc (O'Neil and Haskins 2008).

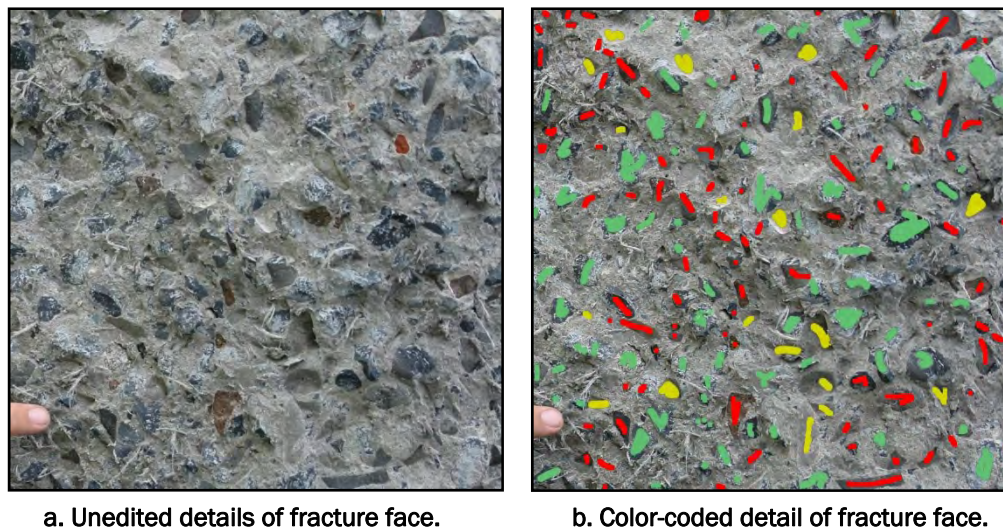
This analysis is subjective to a degree, but indicates that in the 1-sq ft area, there are 89 fractured aggregates, 83 aggregates pulled out on this face of the fracture plane, and 19 cement paste pockets indicating aggregates that pulled out on the opposite face. Of the total 191 visible areas of aggregate to paste bond, approximately 53 percent pulled out of the cement paste. This is undesirable because, if the cement paste does not bond well to the aggregate, the aggregate does not contribute to the strength of the concrete. This can have a tremendous effect on the overall strength of the composite because the strong tensile properties of the aggregate are not part of the composite strength. Poor quality concrete paste or dirty aggregate could be responsible for this condition, and are discussed in further detail below.

a. Unedited details of fracture face.

b. Color-coded detail of fracture face.

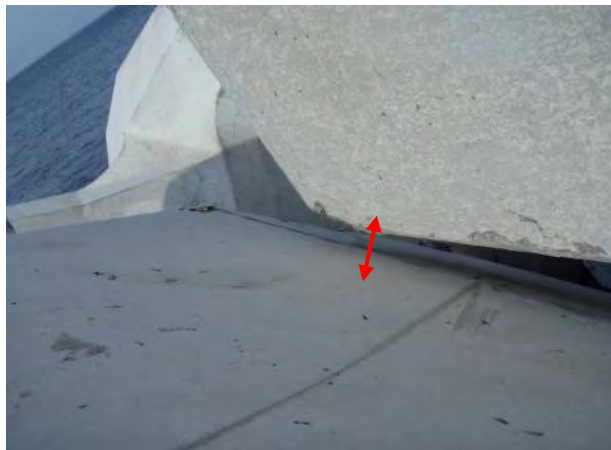
Figure 10.4. Approximately 2-in. gap between armor unit #605 and adjacent unit at Station 0+50 on ocean side trunk (2007 photo). Unit #605 has moved 1.6 in. (4 cm) from 2007-2010 (T-LiDAR).

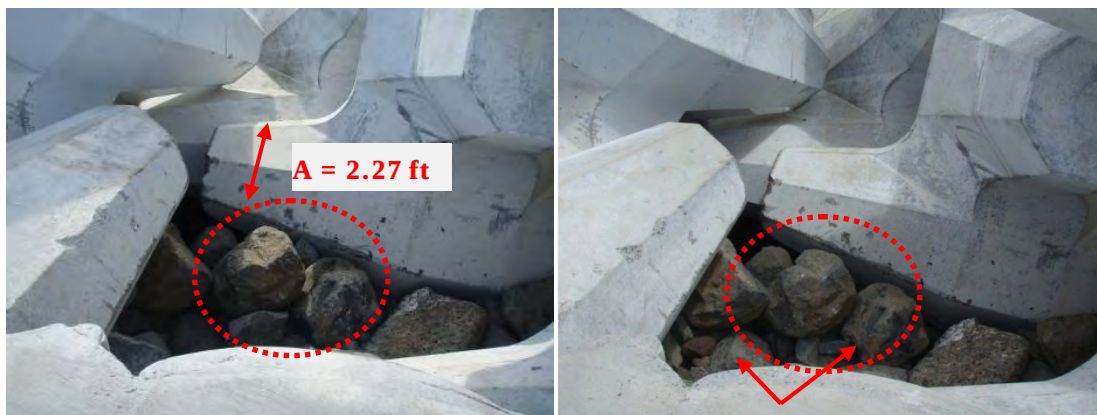
Figure 10.8. 2007 photo of undersized stone between ~0.8- and 2.5-ft diam, near crest on harbor side of breakwater head (left). 2009 photo of same location with noticeable changes including broken stones and additional small stones indicated by arrows (right).

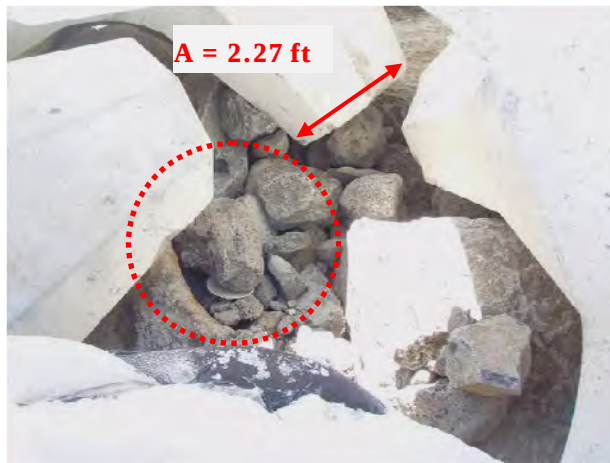
Figure 10.9. Undersize stone between ~0.5- to 2-ft diam, in void between armor layers and concrete cap on harbor side of breakwater head (2010 photo).

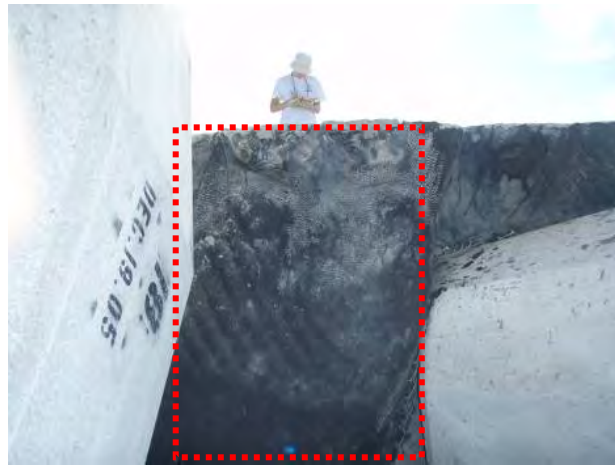
Figure 10.11. Exposed underside of concrete cap at Station -0+28 along ocean side trunk.

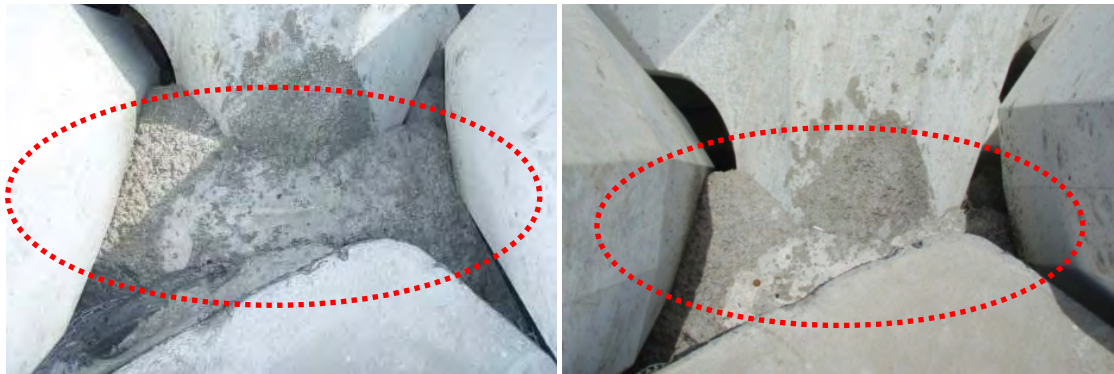
Figure 10.13. Grouted area along harbor side trunk at Station 1+80 (2007, left). Same area appears to have had some weathering and loss of grout (2009, right).

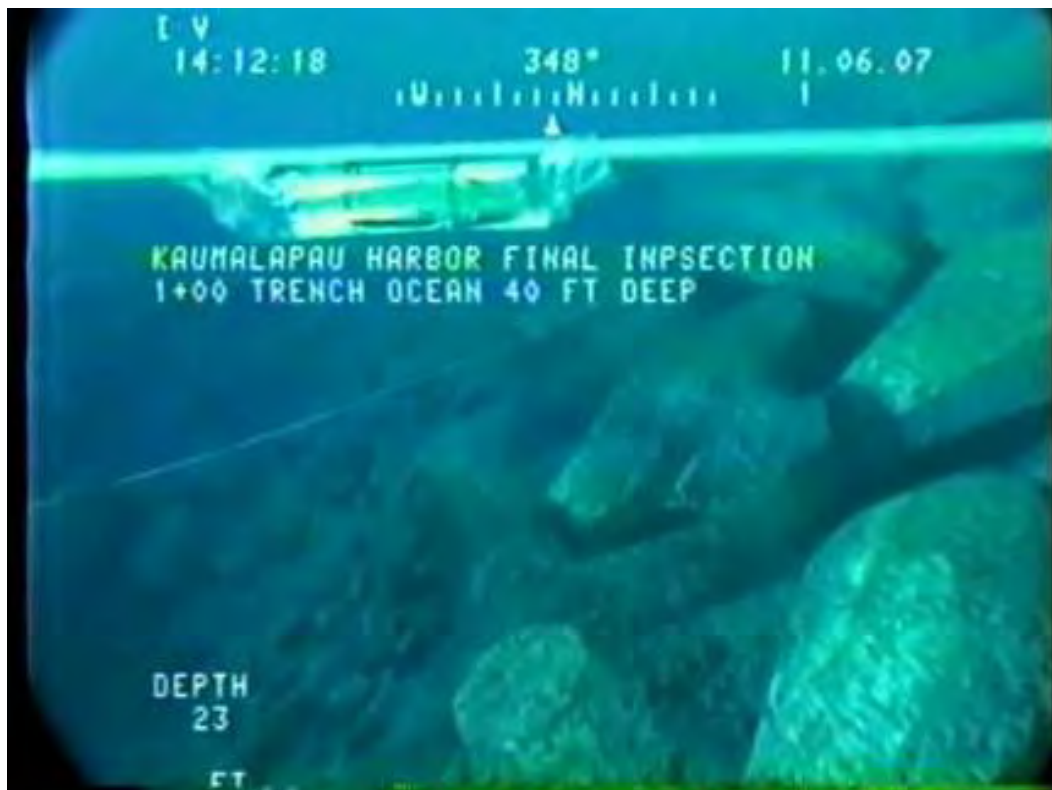
Figure 10.32. Ocean side trunk at approximately Station 1+00. Interlocking of armor units appears somewhat loose and toe trench appears to have widely varying stone sizes.

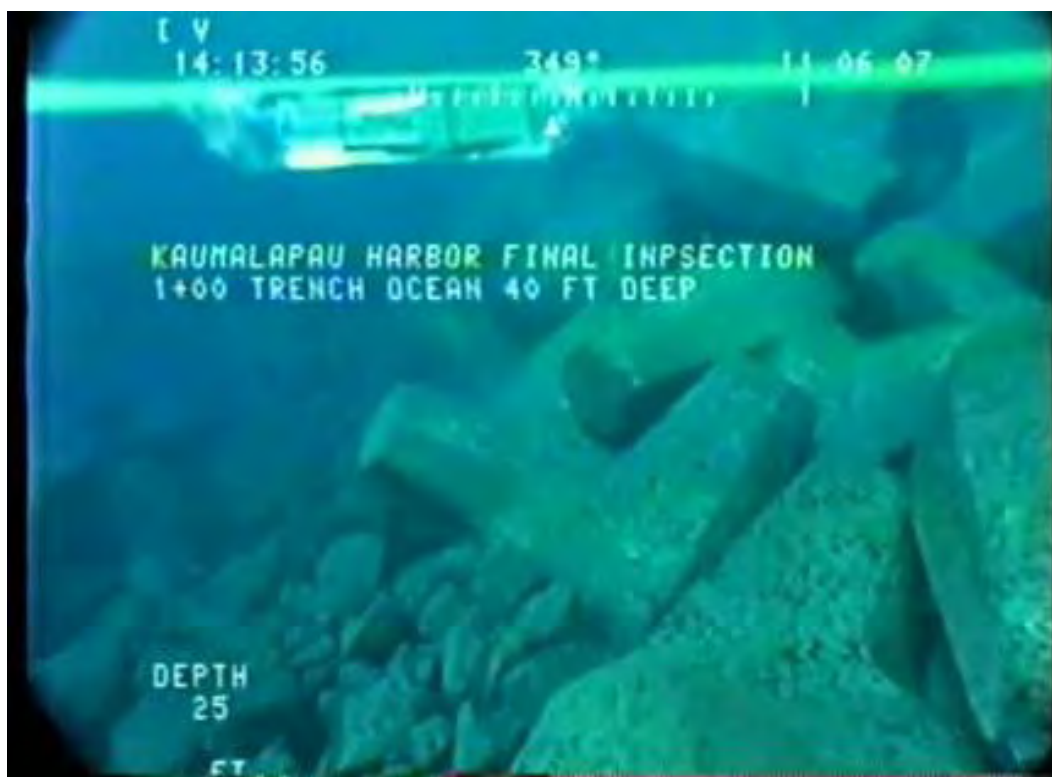
Figure 10.33. Ocean side trunk at approximately Station 0+50. Embedded toe unit in “cannon” orientation is visible with “straddled” unit directly above well interlocked.

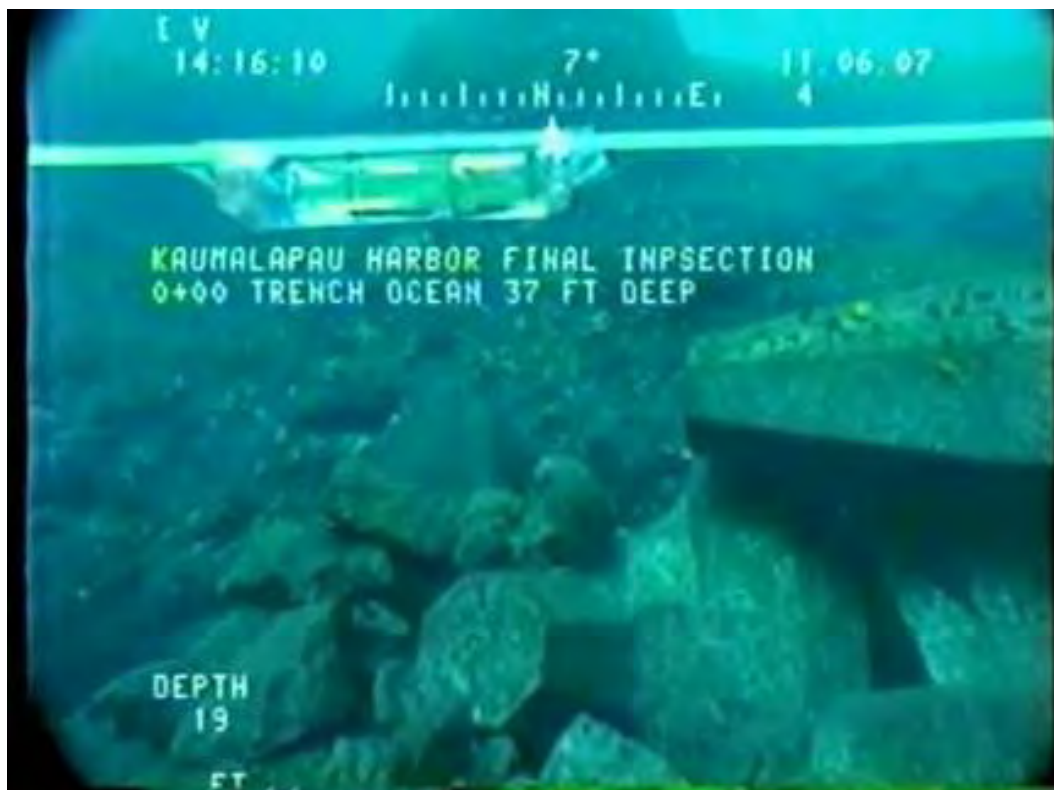
Figure 10.35. Ocean side root. Tieback of armor layer into reef platform appears flush. Scattered armor stones from toe trench or stone buttress visible near tieback.

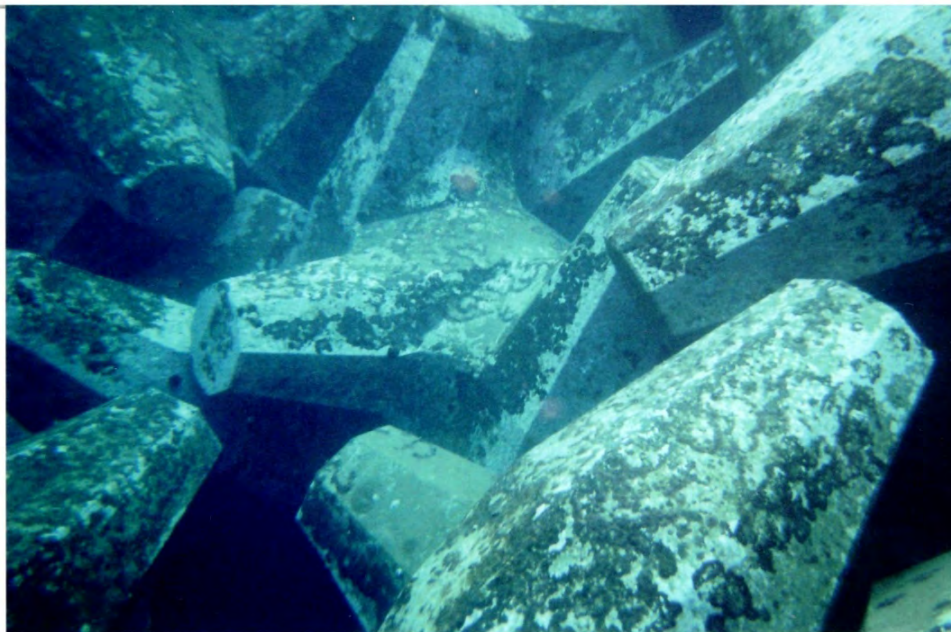
Figure 10.37. Photo of side slope armor units. No damage visible and well interlocked. (Photo by Orville T. Magoon, August 2009).

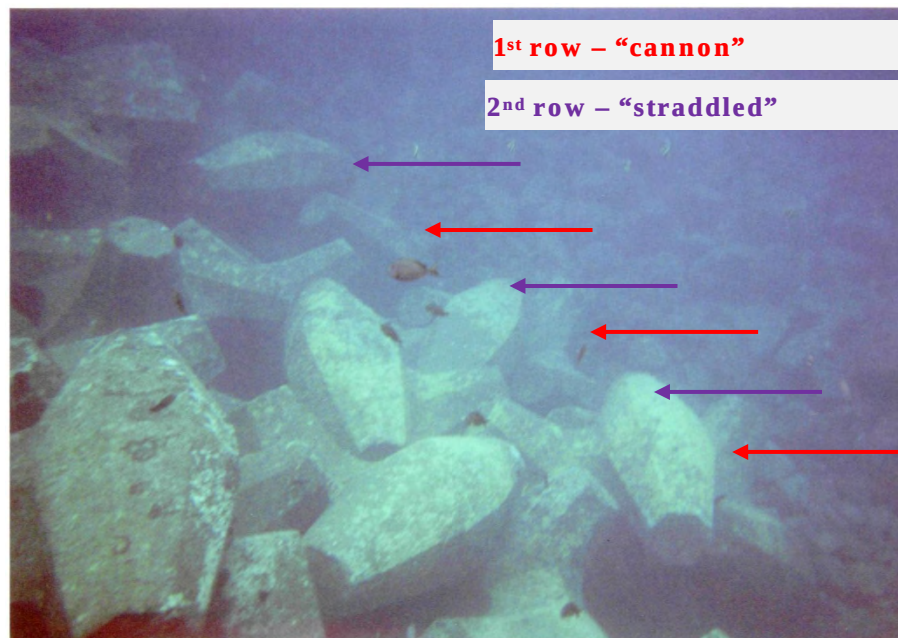
Figure 10.38. Photo of breakwater toe and toe trench. First row of "cannon" oriented units appears uniform and second row of "straddled" units well seated on first row. (Photo by Orville T. Magoon, August 2009).

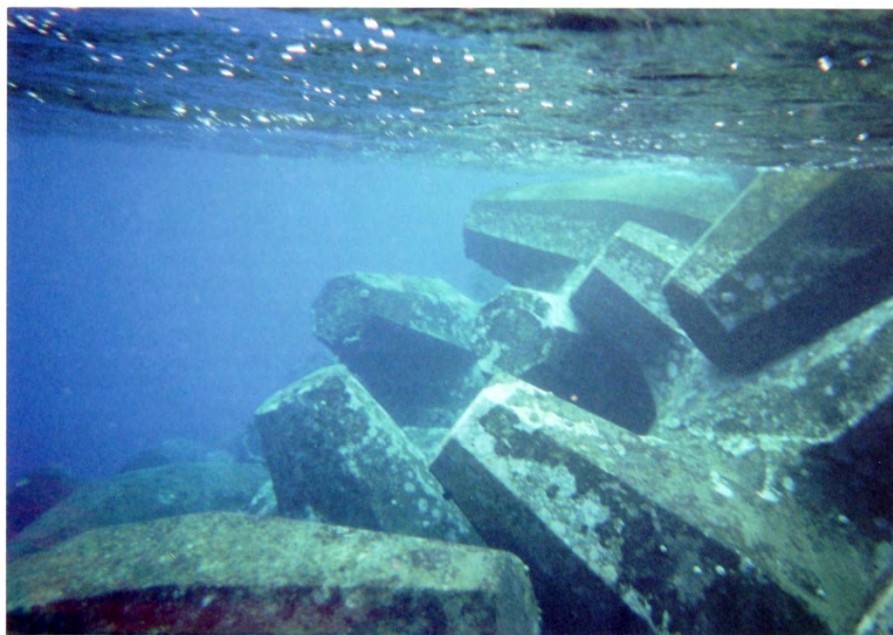
Figure 10.39. Photo of armor units near water surface showing no visible damage and consistent interlocking. (Photo by Orville T. Magoon, August 2009).
