# Fatigue Crack Initiation from Pitting Introduced during the Anodising Process

*Cathy Smith*

**Air Vehicles Division**  
Defence Science and Technology Organisation

DSTO-TR-2729

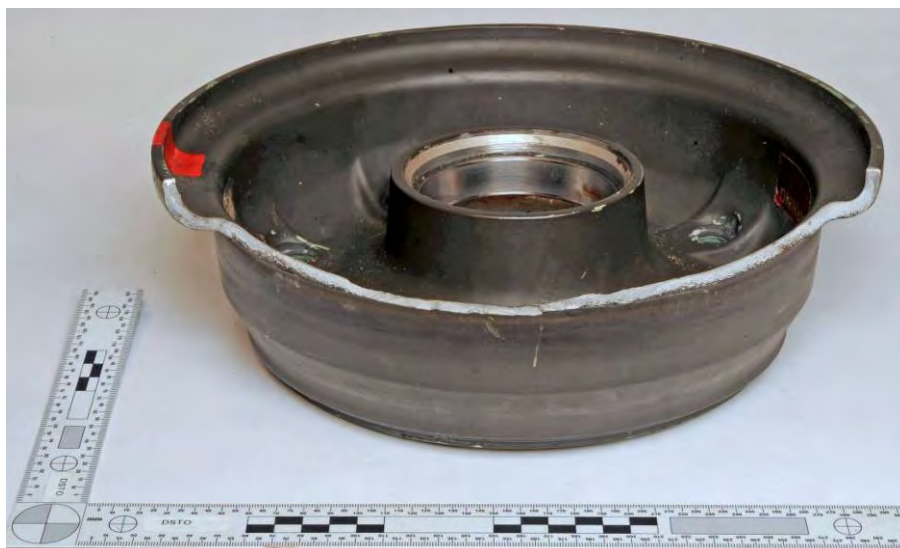
The left hand forward inboard wheel from an ADF rotary wing aircraft was found to be fractured during scheduled Daily Flight Servicing [8]. Figure 1 shows the wheel following removal of the tyre. A section comprising approximately one third of the circumference of the rim had broken away from the wheel at the bead seat and was located on the taxiway. The wheel had been in service for 1798 airframe hours (AFHRS) and was manufactured from aluminium alloy 2014-T6 with a sulphuric acid anodising surface treatment.

Figure 1. Photograph of the wheel following removal of the tyre. A section comprising approximately one third of the circumference had separated from the wheel at the bead seat.

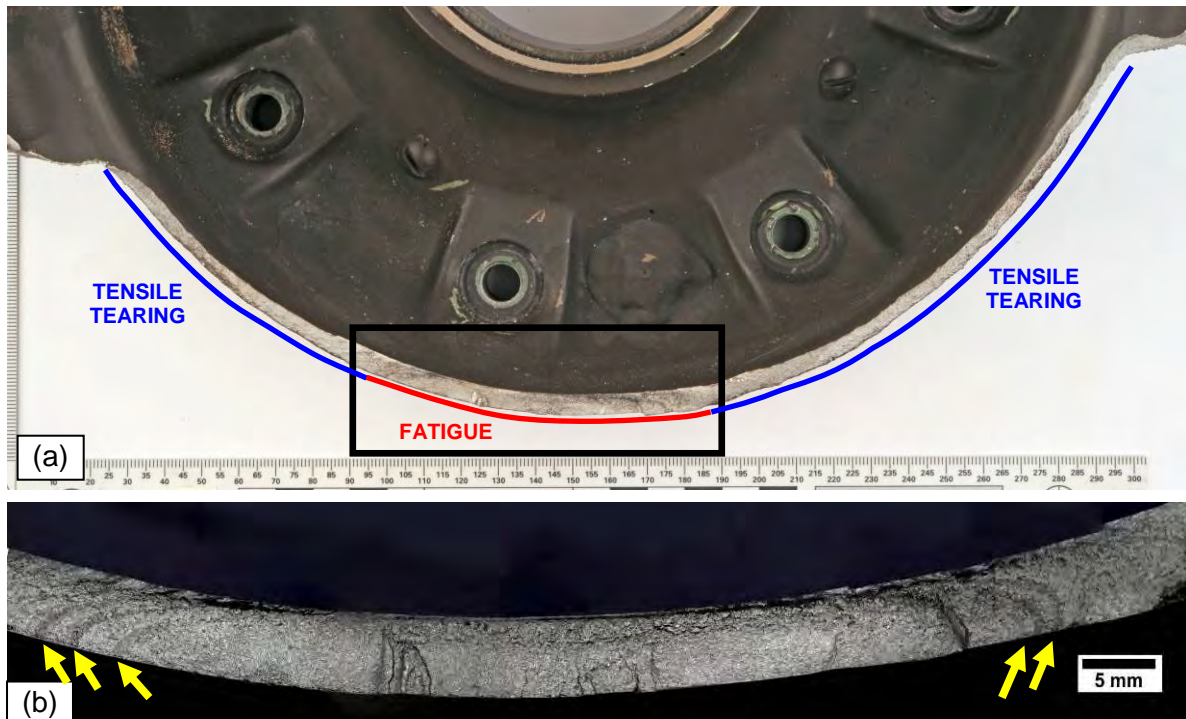
Examination of the fracture surface revealed the presence of progression marks and tear bands, indicative of fatigue cracking, see Figure 2. The area of fatigue cracking extended approximately 85 mm around the circumference of the wheel before final tensile failure occurred. It was observed that numerous fatigue cracks had initiated on the outer surface of the wheel and propagated inwards. Higher magnification examination revealed surface etch pits up to 40  $\mu\text{m}$  diameter and 40  $\mu\text{m}$  depth, and corrosion pits up to 300  $\mu\text{m}$  in diameter and 100  $\mu\text{m}$  in depth, at the origins of the fatigue cracks. Paint was observed within these pits, see Figure 3.

Figure 2. Photographs of (a) the fracture surface of the wheel with the areas of tensile tearing indicated with blue lines and the area of fatigue indicated with a red line, and (b) a higher magnification image of the fatigue region (area boxed black in (a)). Tear bands at the outer edges of the fatigue region are indicated with yellow arrows.

Failure of the wheel occurred at the bead seat radius, which is typically a region of high bending stress and is therefore prone to initiation and growth of fatigue cracks, with small surface defects providing the crack initiation sites. Operational stresses arising during aircraft landing and taxiing provided the driving force for crack propagation.

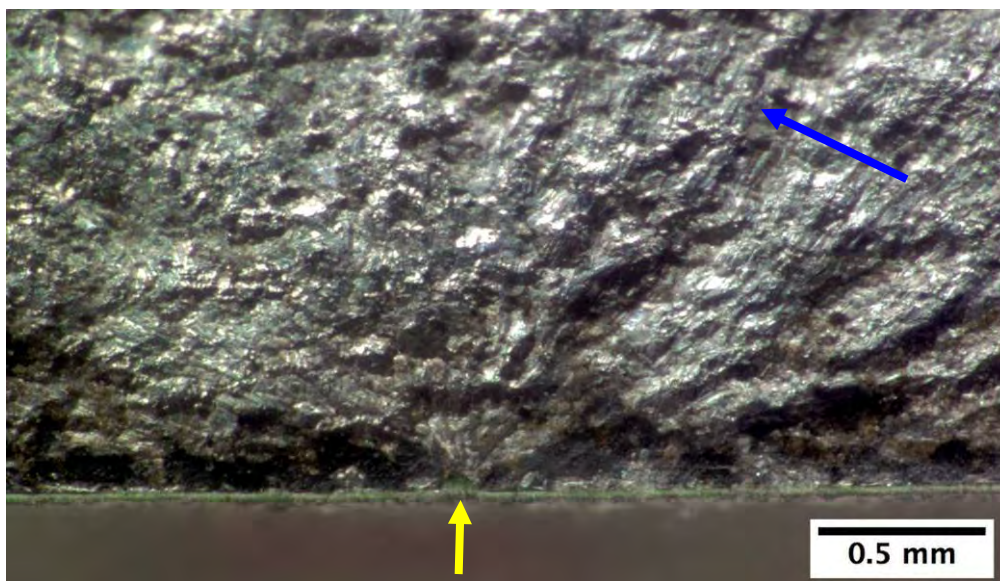
Figure 3. Photograph of a fatigue crack observed on the fracture surface. A fatigue progression mark is indicated with a blue arrow. The pit at the origin of the crack (approximately 40  $\mu\text{m}$  in depth), which was observed to have been painted, is indicated with a yellow arrow.

Fatigue cracking had initiated from etch and corrosion pits present on the wheel's external surface. The etch and corrosion pits were anodised and painted, indicating that they had formed prior to anodising. The existence of etch pits over all surfaces suggests that they likely formed when the wheel was immersed in a bath during a pre-anodising process. The corrosion pits likely grew from etch pits due to environmental exposure prior to surface finishing.

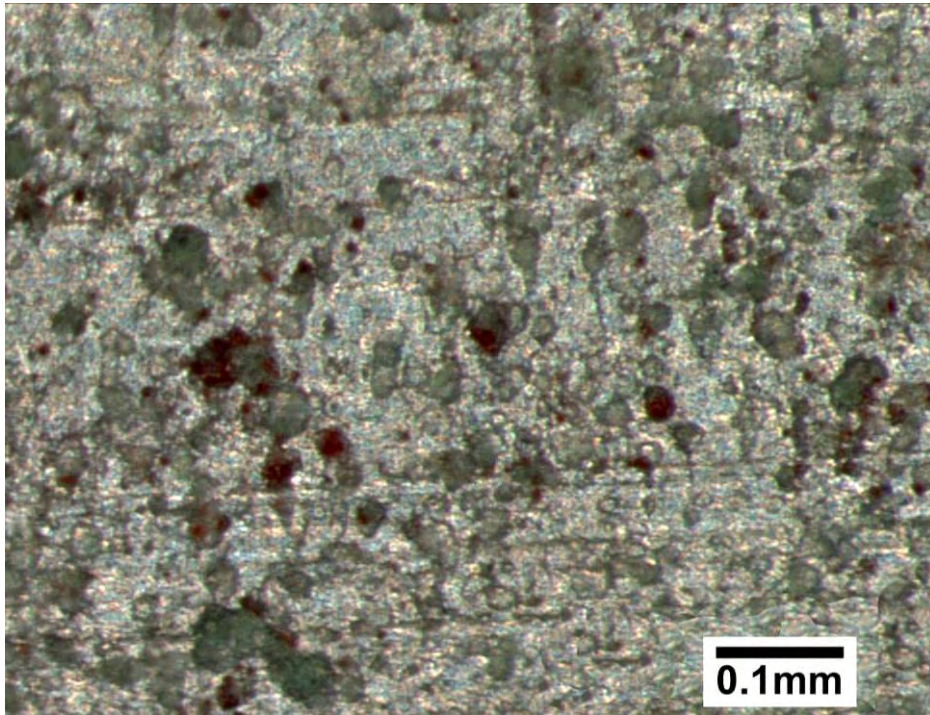
Following removal of the paint from a section of the wheel, it was observed that the surface of the wheel was extensively pitted, with smaller rounded etch pits and larger corrosion pits present, see Figure 4 and Figure 5. The size of these pits was consistent with the pits observed at the fatigue crack origins.

Figure 4. Photograph of the outer surface of the wheel following paint removal. The surface exhibited extensive rounded etch pits up to 40  $\mu\text{m}$  diameter.

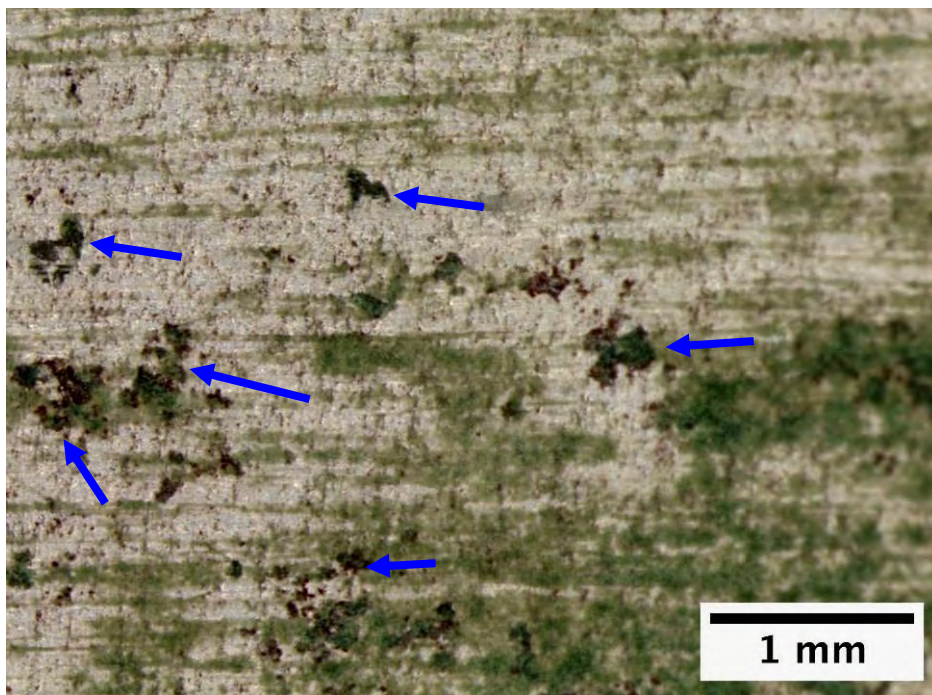
Figure 5. Photograph of the outer surface of the wheel following paint removal showing dispersed corrosion pits, indicated with blue arrows.

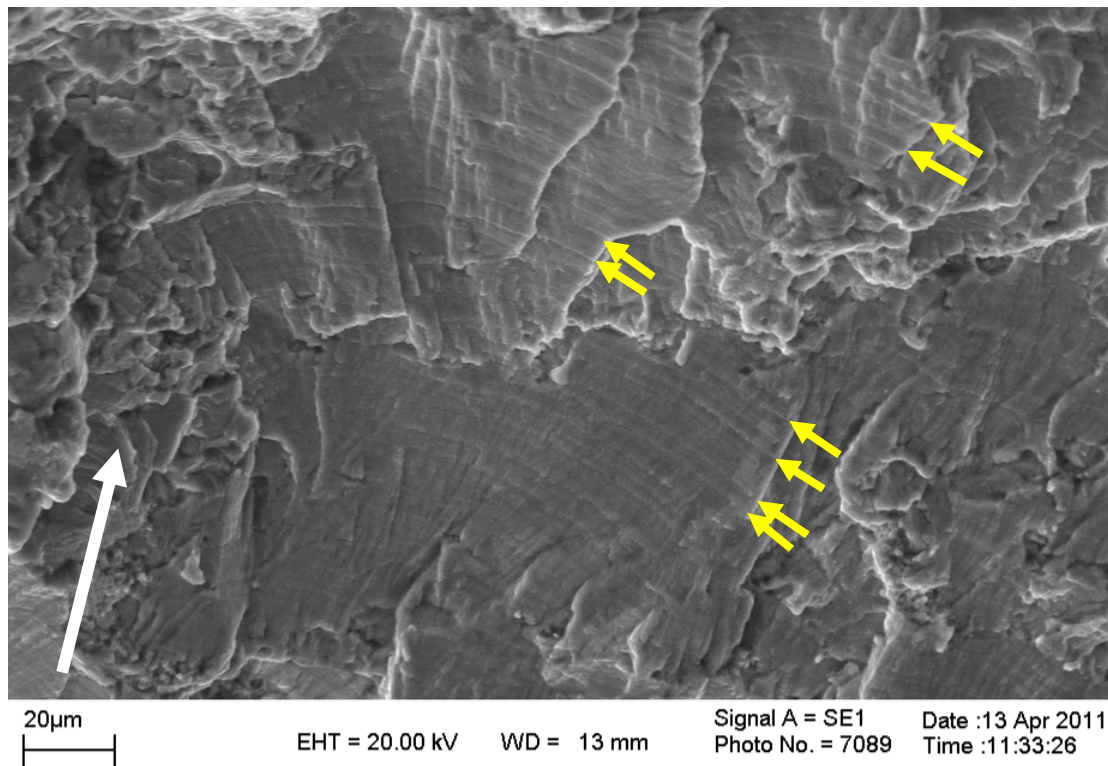
Scanning Electron Microscope (SEM) examination of the fracture surface confirmed that the failure mode was consistent with fatigue, with progression marks present over the fracture surface, see Figure 6. Examination of the corrosion and etch pits present at the crack initiation sites revealed that they had been anodised and painted, see Figure 7 and Figure 8, which indicated they were present at production.

Figure 6. SEM photograph of the fracture surface on which numerous progression marks were observed, examples indicated with yellow arrows. Crack growth direction is indicated with a white arrow.

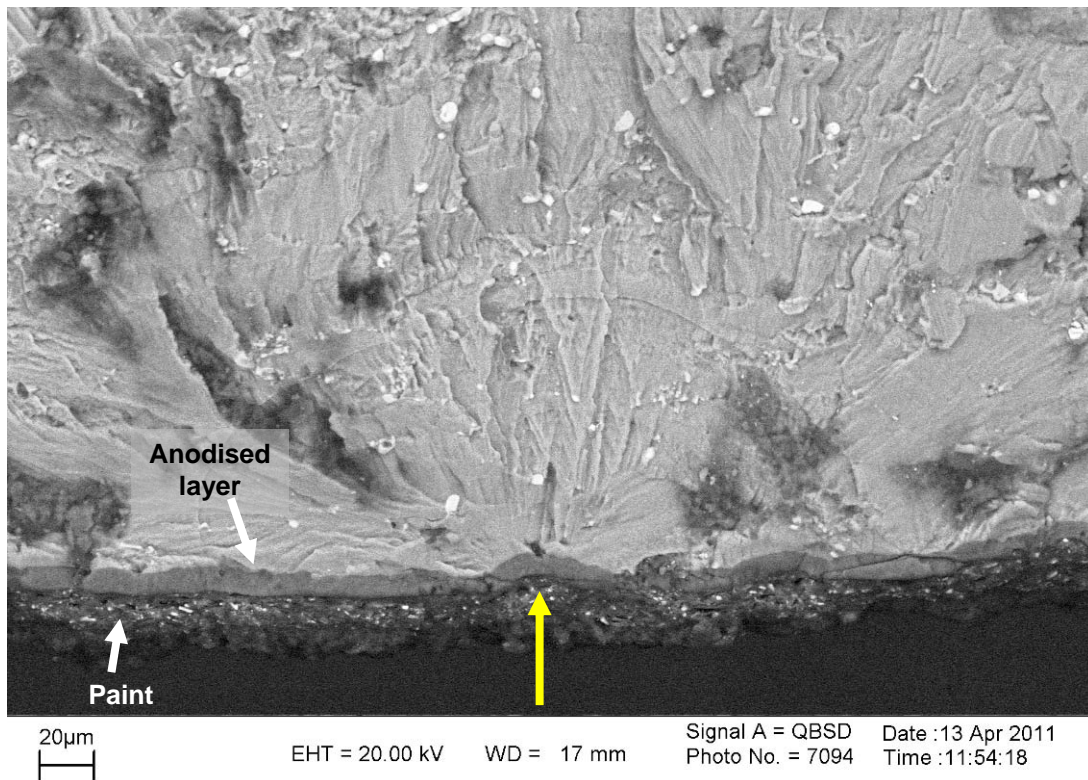
Figure 7. SEM photograph showing a fatigue crack that initiated from a surface pit (8  $\mu\text{m}$  depth), indicated with a yellow arrow. The pit was observed to be both anodised and painted.

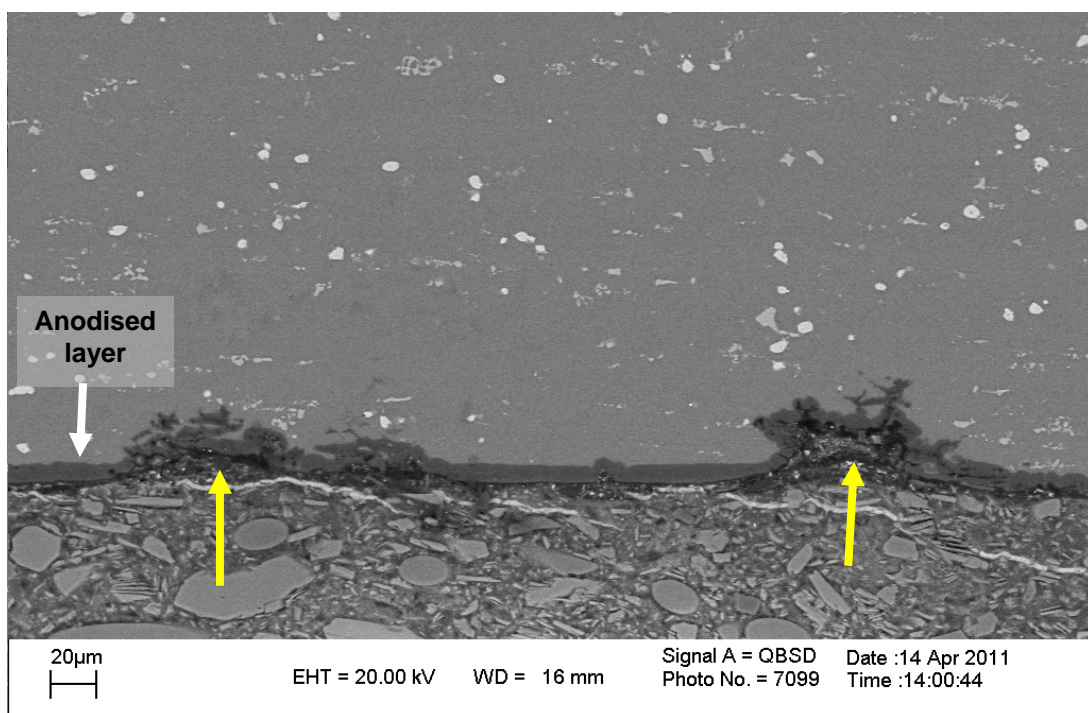
Figure 8. SEM photograph showing two corrosion pits in cross-section, indicated with yellow arrows. The surfaces of the pits were found to have been anodised.

As the wheel was supplied by the manufacturer in the anodised condition, and the etch pits present on the surface formed during the pre-anodising treatments, it is likely that other wheels anodised in the same batch would also exhibit surface pitting.

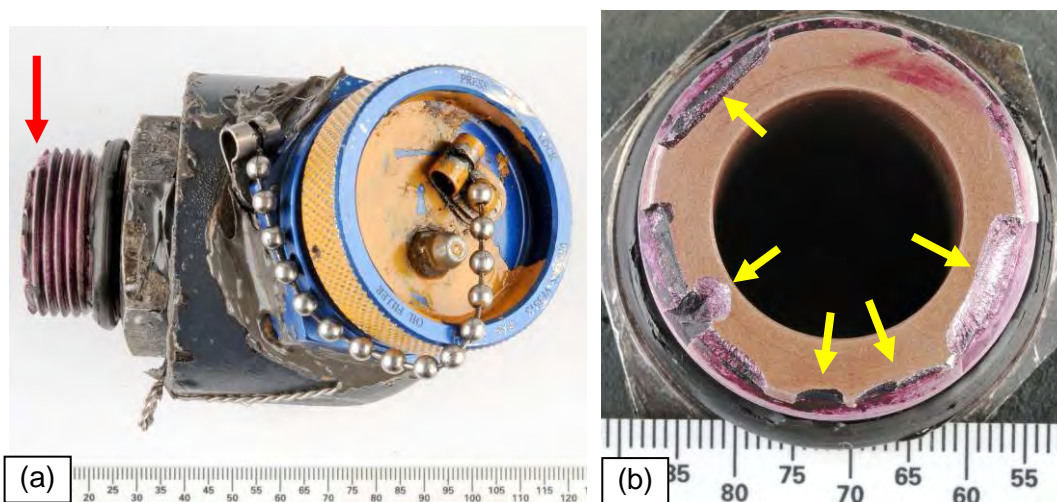
During removal of the gearbox oil filler assembly from an ADF rotary wing aircraft, the first thread of the oil filler adapter was found to have fractured [9]. Two failures of this type had previously occurred. The adapter, shown in Figure 9, was manufactured from aluminium alloy L168-T6 (equivalent to AA 2014) with a chromic acid anodising surface treatment.

Figure 9. Photographs of the oil filler adapter as received. The first thread was fractured, as indicated with a red arrow in (a). Fracture occurred in several locations, examples indicated with yellow arrows in (b).

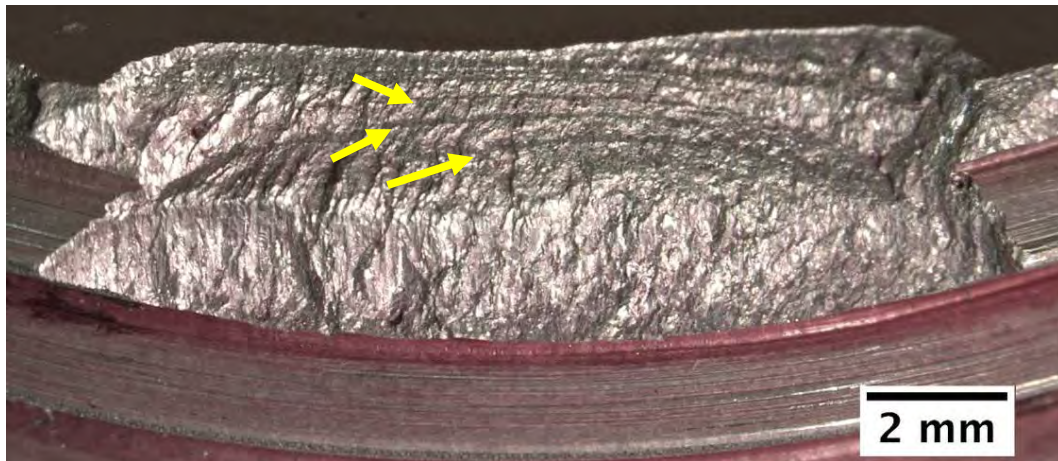
Following cleaning, the fracture surfaces on the first thread were examined and found to be consistent with fatigue cracking, see Figure 10. The cracks had initiated at corrosion pits up to 80  $\mu\text{m}$  diameter and 30  $\mu\text{m}$  depth at the thread roots, see Figure 11. SEM examination of the fracture surfaces confirmed cracking was via fatigue, with numerous progression marks present, see Figure 12 for example, and corrosion pits present at the crack initiation sites, see Figure 13.

Figure 10. Photograph of the cracking present on the first thread. The cracking originated at the thread root and was consistent with fatigue. Examples of progression marks are indicated with yellow arrows.

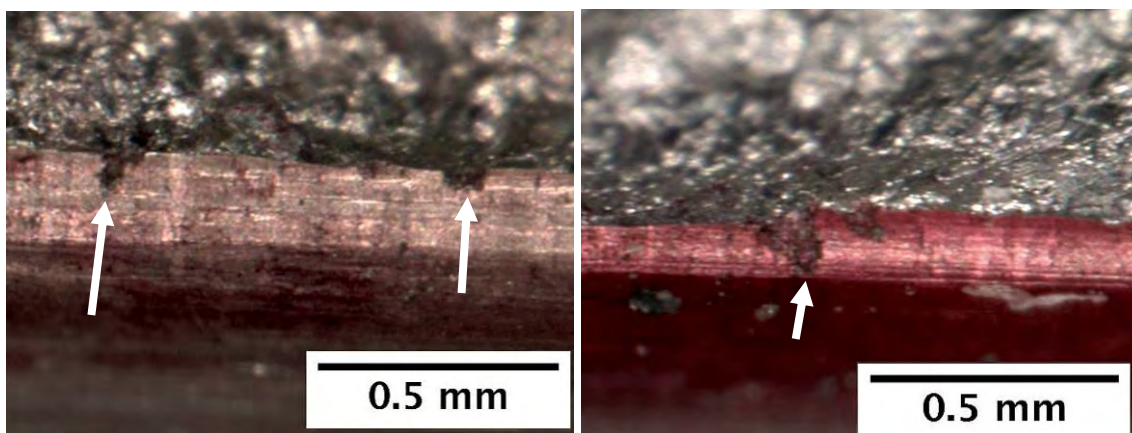
Figure 11. Photographs of pitting (arrowed white) observed at the initiation sites of the fatigue cracks. Corrosion pits up to  $80\ \mu\text{m}$  diameter and  $30\ \mu\text{m}$  depth were observed.

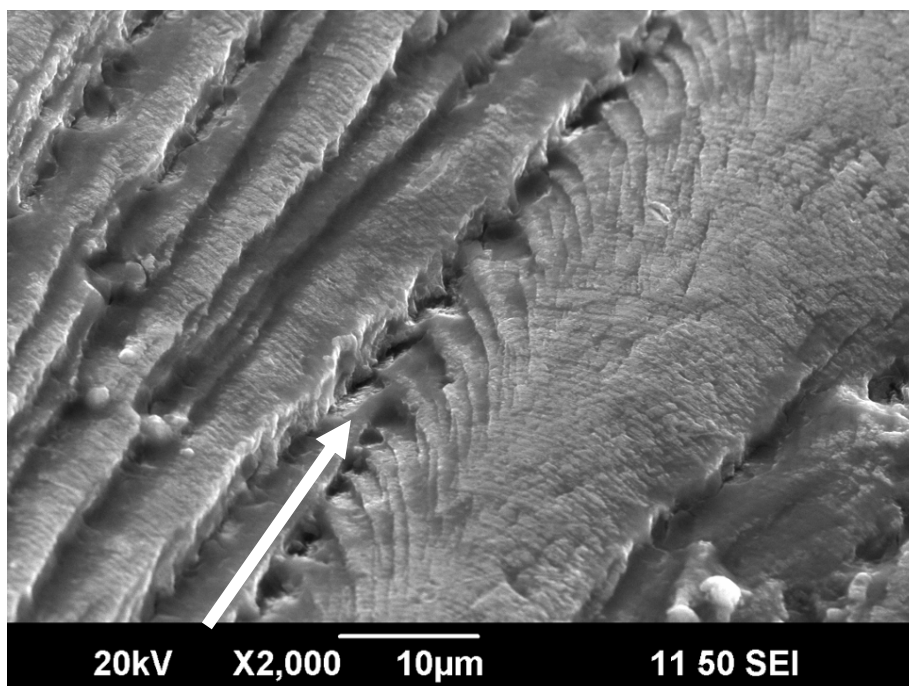
Figure 12. SEM photograph of the fracture surface showing the numerous progression marks, appearing as a series of curved bands on the surface. Crack growth direction is indicated with a white arrow.

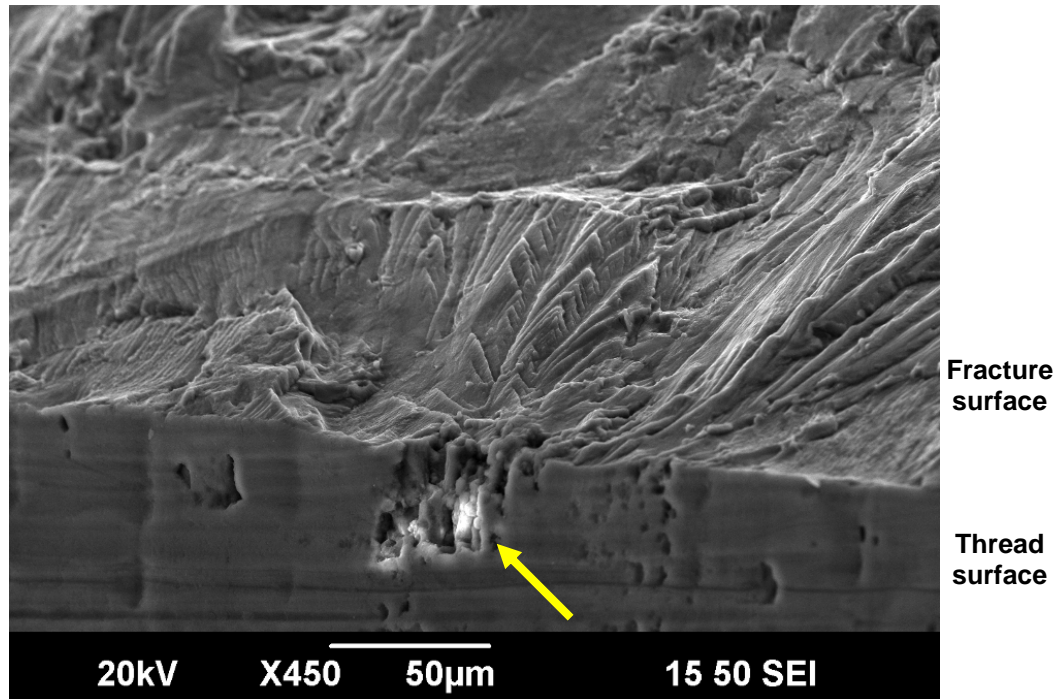
Figure 13. SEM photograph showing fatigue crack initiation from a surface pit (arrowed yellow).

The pits acted as stress concentrators for crack initiation, with stresses arising from normal operations providing the driving force for crack growth. As the component was supplied by the manufacturer in the anodised condition, other oil filler adapters from the same batch were likely to suffer from significant etch and corrosion pitting.

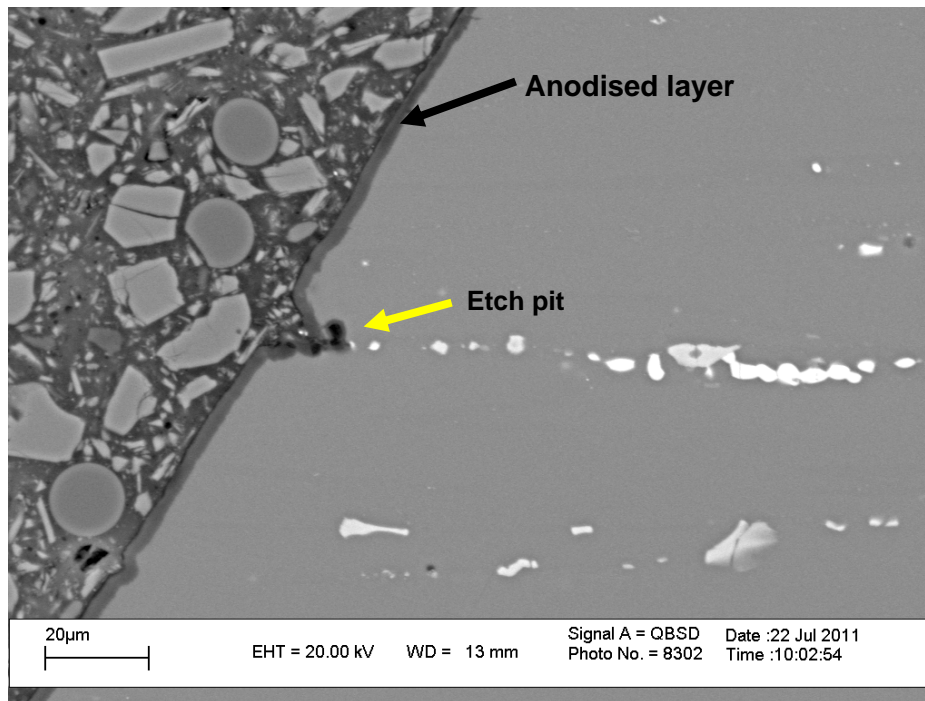
Cross-sections cut through the threaded section of the oil filler adapter revealed the presence of fine etch and larger corrosion pits on the threads, see Figure 14 and Figure 15. The surfaces of the etch pits were anodised while the corrosion pits were only partially anodised, which indicated that further corrosion and growth of the pits had occurred following anodising.

The etch pits would provide ideal sites for the initiation of corrosion pits due to environmental contamination prior to anodising. In addition, the presence of the etch pits may have caused discontinuities in the anodised surface layer, making the component susceptible to localised corrosion and corrosion pitting following anodising.

Figure 14. SEM photograph of etch pitting observed in a polished metallographic cross-section through the oil filler adapter. The surfaces of the pits were anodised. Pits were observed to be up to 12  $\mu\text{m}$  in diameter and 10  $\mu\text{m}$  in depth.

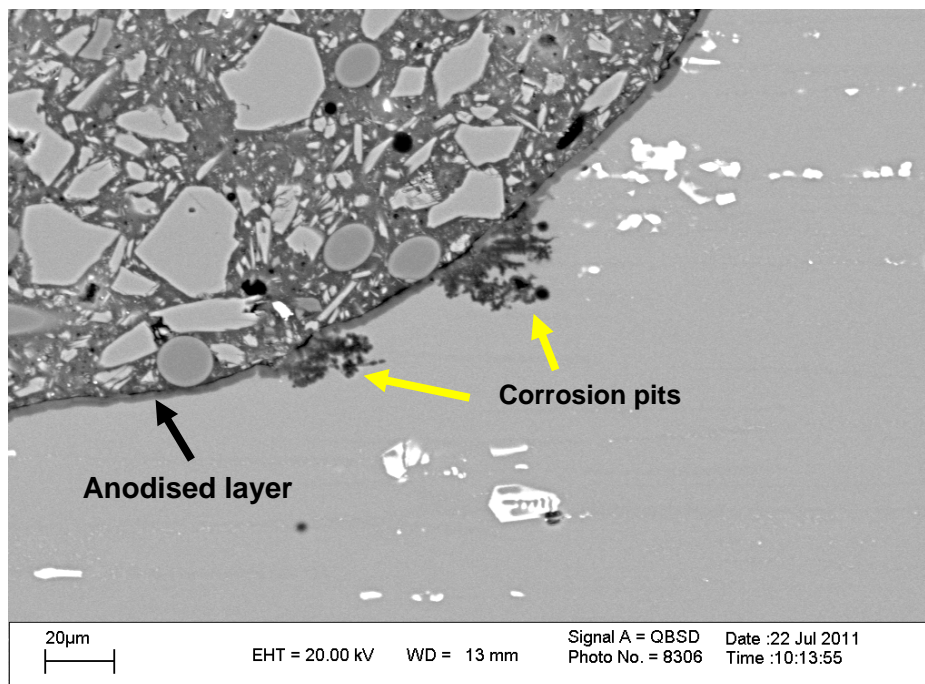
Figure 15. SEM photograph of corrosion pitting observed in a polished metallographic cross-section through the oil filler adapter. An anodised layer was present at the surface and within the pits.

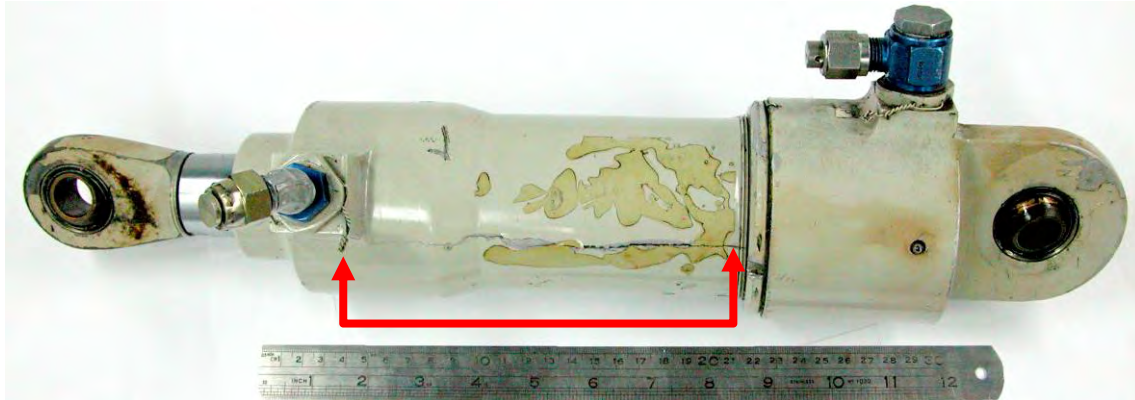
Cracking was observed on the hydraulic cylinder of the left hand retractor actuator from the main landing gear of an ADF fixed wing aircraft [10]. The crack ran along the length of the cylinder and was found to be 163 mm long, see Figure 16. The hydraulic cylinder was manufactured from aluminium alloy 2014 in the T6 condition.

Figure 16. Photograph of the main landing gear hydraulic cylinder. A 163 mm crack was present along the length of the cylinder, as indicated with a red arrow.

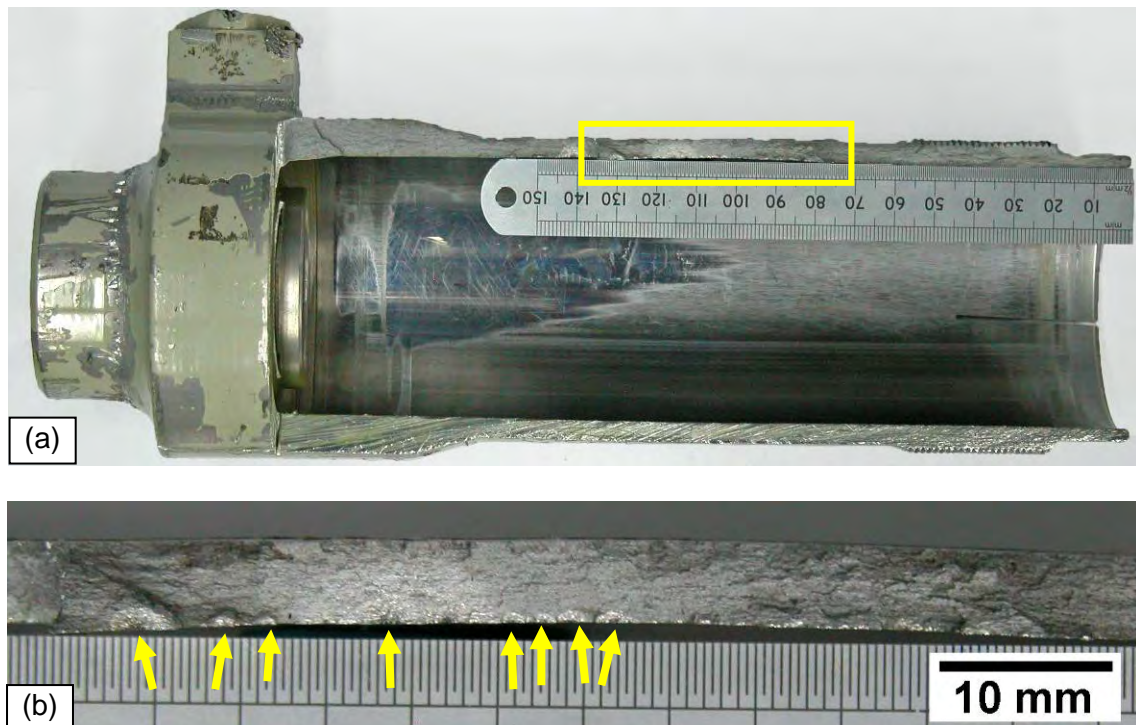
Examination of the fracture surfaces revealed the presence of multiple cracks in the wall of the cylinder, see Figure 17. Progression marks were present on the fracture surfaces indicating that the cracking had propagated via fatigue. Based on the orientation of the progression marks, the crack originated from the bore of the cylinder and propagated towards the outer surface.

Figure 17. Photographs showing the fracture surface of the hydraulic cylinder. The area marked with a yellow box in (a) is shown at higher magnification in (b). Multiple crack initiation sites were observed, with examples indicated with yellow arrows.

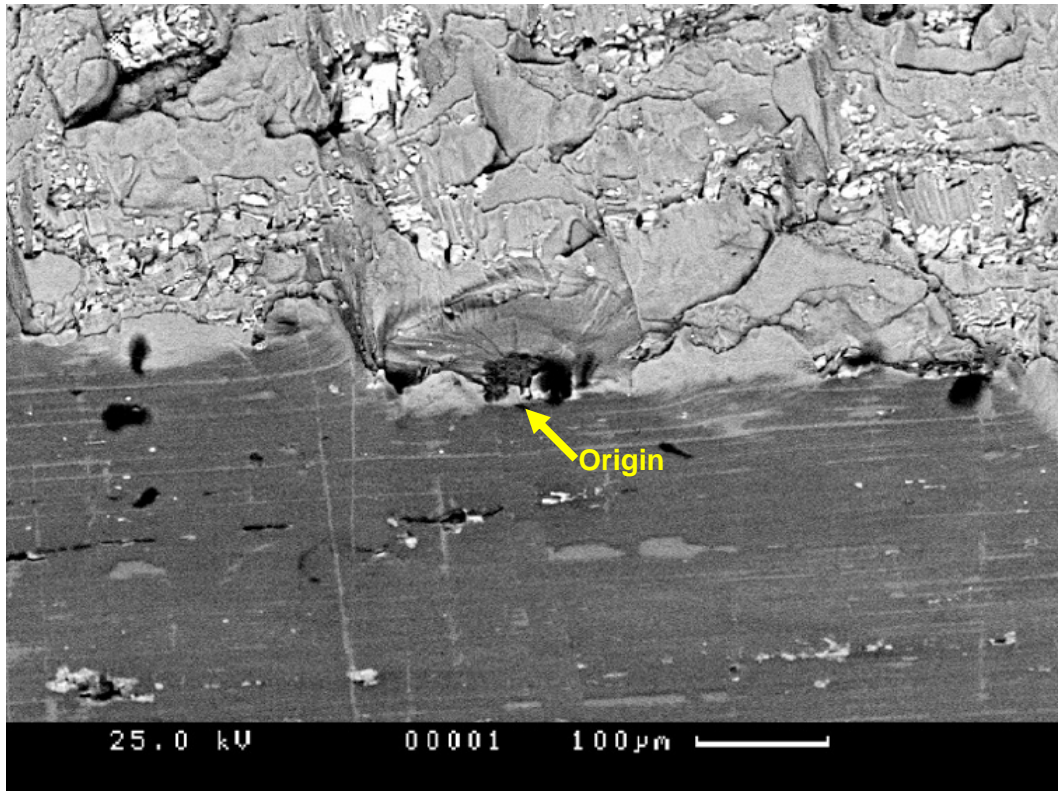
SEM examination of the fracture surface revealed that multiple cracks had propagated from pits in the surface of the bore of the cylinder, see Figure 18. The pits were measured to be between 20 and 80  $\mu\text{m}$  in depth. Pitting was observed over the entire surface of the cylinder bore.

Figure 18. SEM photograph showing one of the crack origins. Cracking had initiated at a pit, which appears as a dark area at the origin.

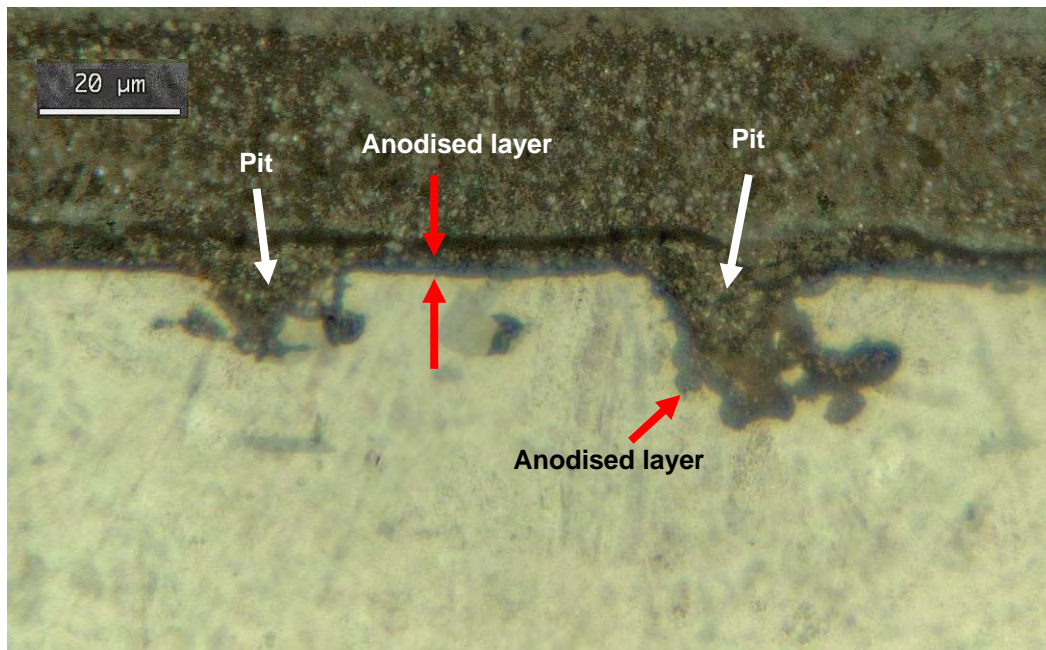
Metallographic examination of cross-sections from selected areas of the cylinder confirmed the presence of pitting damage to the bore of the cylinder. The surface of the pits exhibited evidence of anodising, see Figure 19. This indicated that the pits were present in the cylinder when the cylinder was last anodised, being either at manufacture or overhaul. The pits provided crack initiation sites and the cracks grew undetected from the inside of the bore.

Figure 19. Photograph of pitting (depths of 11  $\mu\text{m}$  and 20  $\mu\text{m}$ ) in the surface of the cylinder bore. Note that the anodised layer is present within the pits.

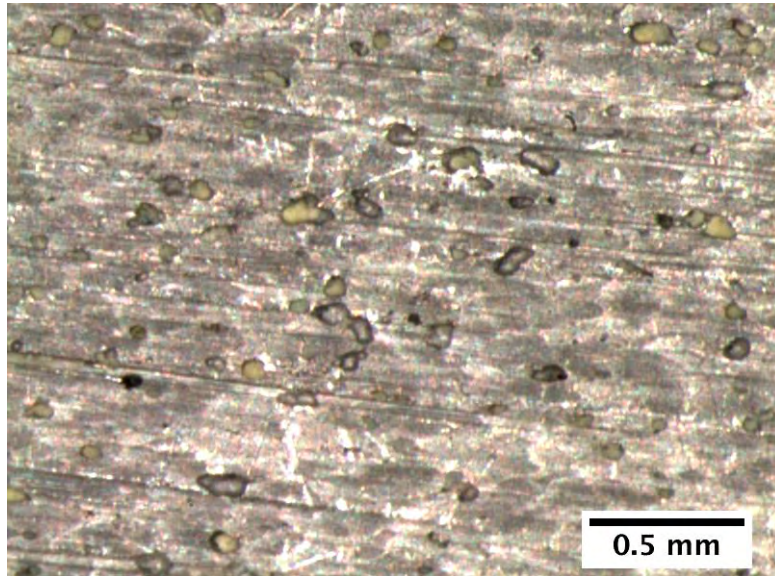
Examination of the two rescue hoist arms revealed the presence of fine etch pits on all surfaces. The pits were typically 50 – 100  $\mu\text{m}$  in diameter, see Figure 21. In addition to the fine etch pitting, a distribution of larger corrosion pits was observed on the outer surfaces of the rescue hoist arms, see Figure 22. The locations of the corrosion pits were generally consistent between the two rescue hoist arms, see Figure 23. The corrosion pits were up to 5 mm in length, with some containing dark coloured deposits and others being filled with paint or containing paint particles that were consistent in size and shape with the paint observed within the etch pits, see Figure 24.

Figure 21. Photograph of fine etch pits observed on the body of the rescue hoist arms. Etch pits on the body were typically 50 – 100  $\mu\text{m}$  in diameter.

The two rescue hoist arms were from the same manufacturing batch and both had fine etch pits present over their entire surfaces. These etch pits were found to be both anodised and painted, indicating that they formed prior to anodising. The existence of etch pits over all surfaces suggested that they formed when the parts were immersed in a bath during the pre-anodising process.

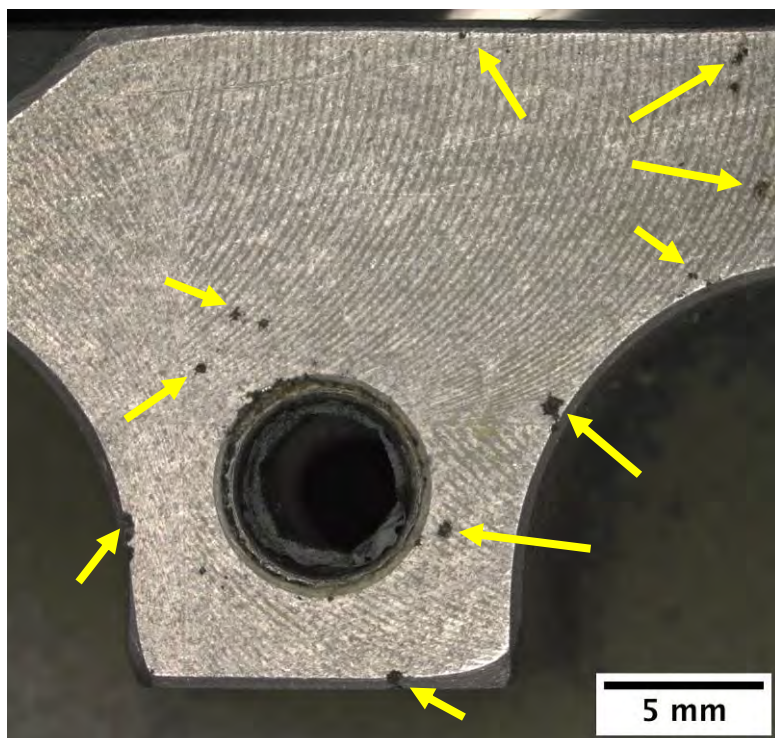
Figure 22. Photograph showing examples of the corrosion pits observed on the body of the rescue hoist arm, indicated with yellow arrows. Corrosion pits up to 5 mm in length were observed.

Corrosion pits were also present on both rescue hoist arms. The large size and localised nature of the corrosion pits suggested that they formed due to exposure to a surface contaminant. As the locations of the corrosion pits were consistent between the two rescue hoist arms and limited to the exterior surface of the body, it is likely that contamination occurred during a process which all parts were subjected to during manufacture or storage, for example parts handled with contaminated gloves or equipment, or stored on contaminated racks.

Due to the presence of significant surface etch pits and localised corrosion pits, the rescue hoist arms were considered no longer fit for purpose. The presence of the etch pits and, in particular, the larger corrosion pits introduced unquantifiable stress concentrations that could initiate cracks during subsequent in-service loading, both cyclic and sustained. As such, all rescue hoist arms from the same manufacturing batch were rejected.

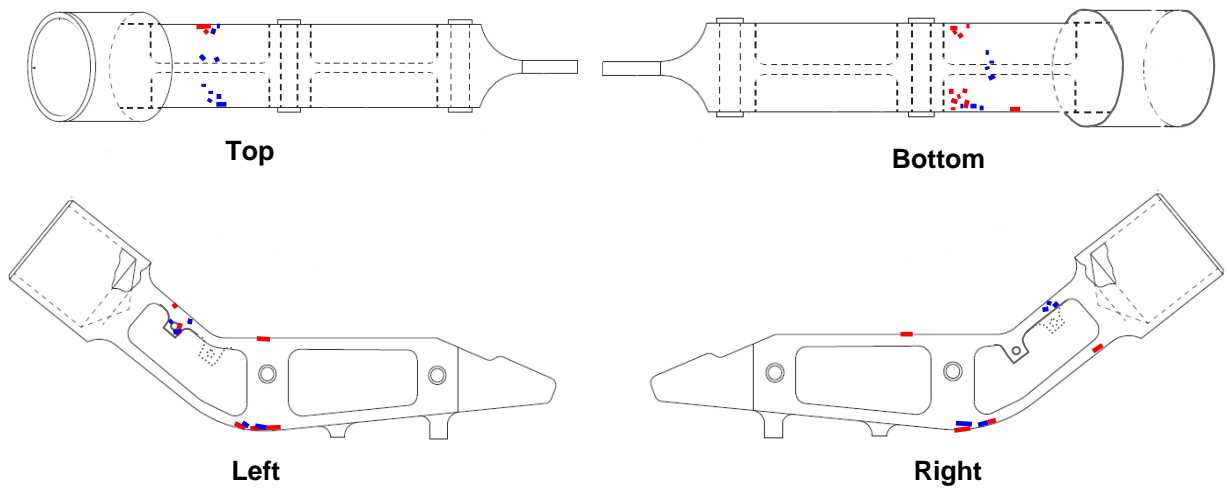
Figure 23. Diagrams showing locations of corrosion pits on each face of the rescue hoist arms. Red points indicate corrosion pits on rescue hoist arm 1 and blue points indicate corrosion pits on rescue hoist arm 2. Locations were generally consistent between the two rescue hoist arms.

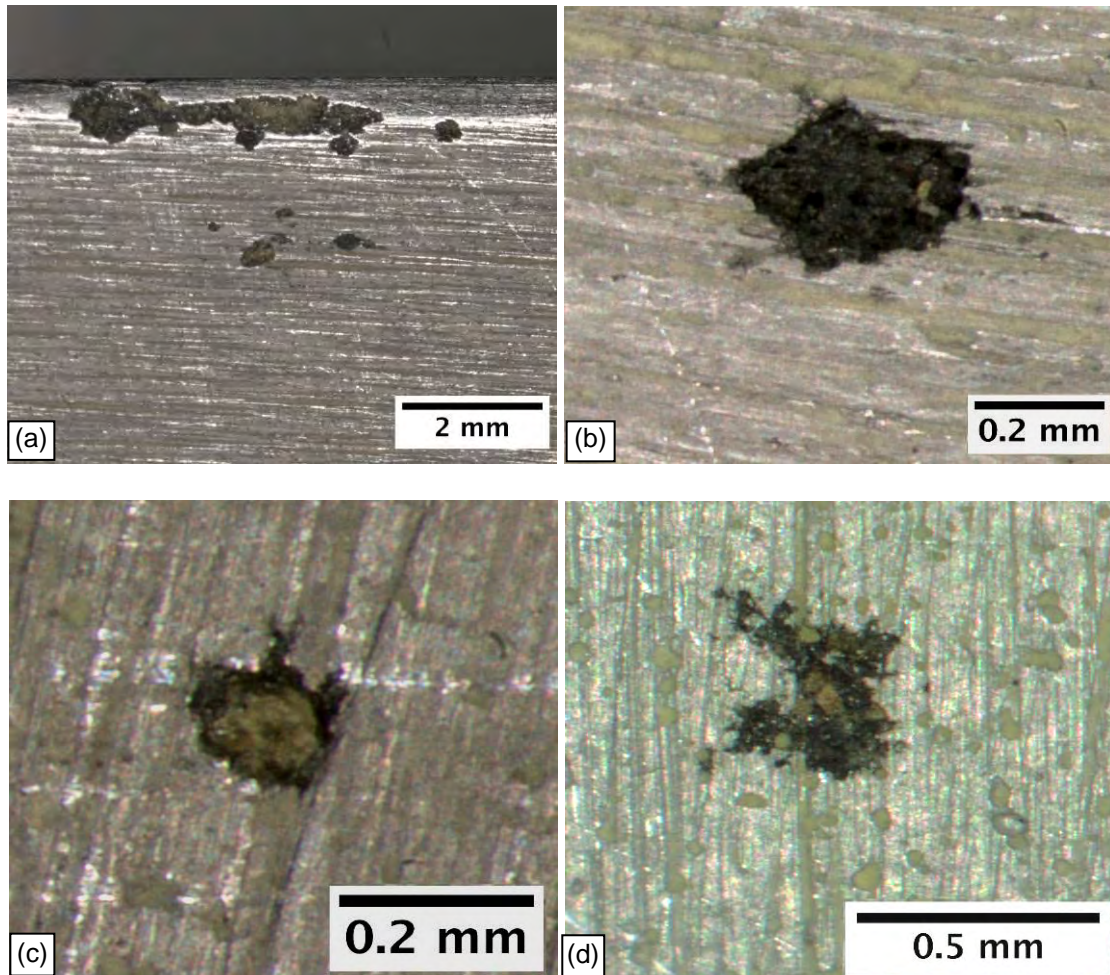
Figure 24. Photographs showing (a) corrosion pits up to 5 mm in length. The pits were observed to contain (b) dark coloured deposits, or (c) residual paint. In some cases (d) the paint within the corrosion pits consisted of particles that were similar in size and shape with the paint observed in the finer etch pits.

The corrosion pits formed some time after anodising. The surface etch pits may have caused discontinuities in the anodised surface layer, making the alloy susceptible to localised corrosion. It is also possible that the rescue hoist arms were stored for some time following anodising and prior to painting, during which time the corrosion pits began to form due to surface contamination. Following painting, the corrosion pits continued to grow undetected beneath the paint layer.

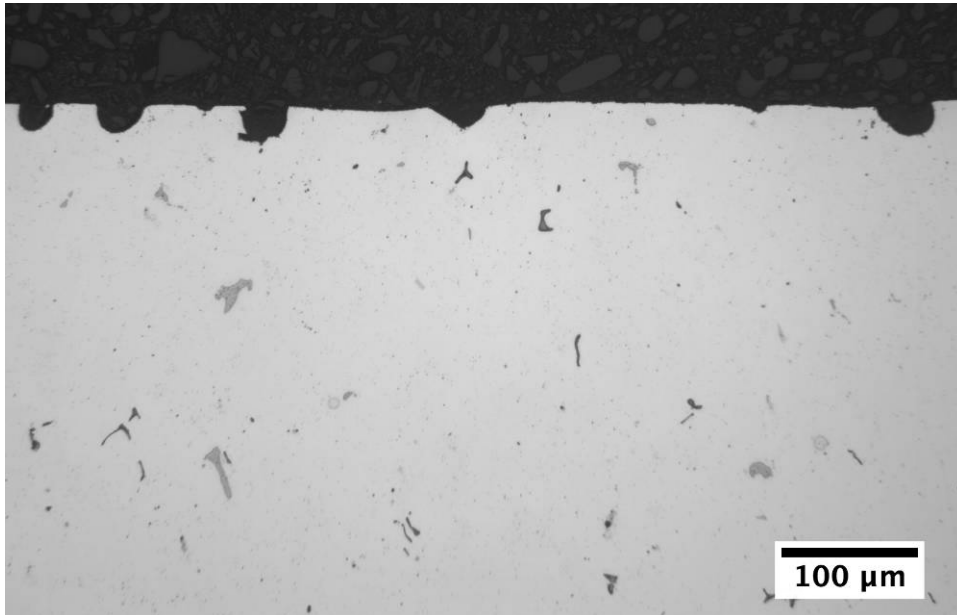
Cross-section examination of the etch pits revealed they had a rounded shape and a typical depth of approximately  $25\mu\text{m}$ , see Figure 25. An anodised layer was observed on the surface of the etch pits, see Figure 26. Examination of the corrosion pits in cross-section revealed that the pits were in the order of  $300\mu\text{m}$  in depth and had a branched, irregular structure, see Figure 27 for example.

Figure 25. Micrograph of a cross-section from a rescue hoist arm showing the etch pits were up to  $25\mu\text{m}$  in depth.

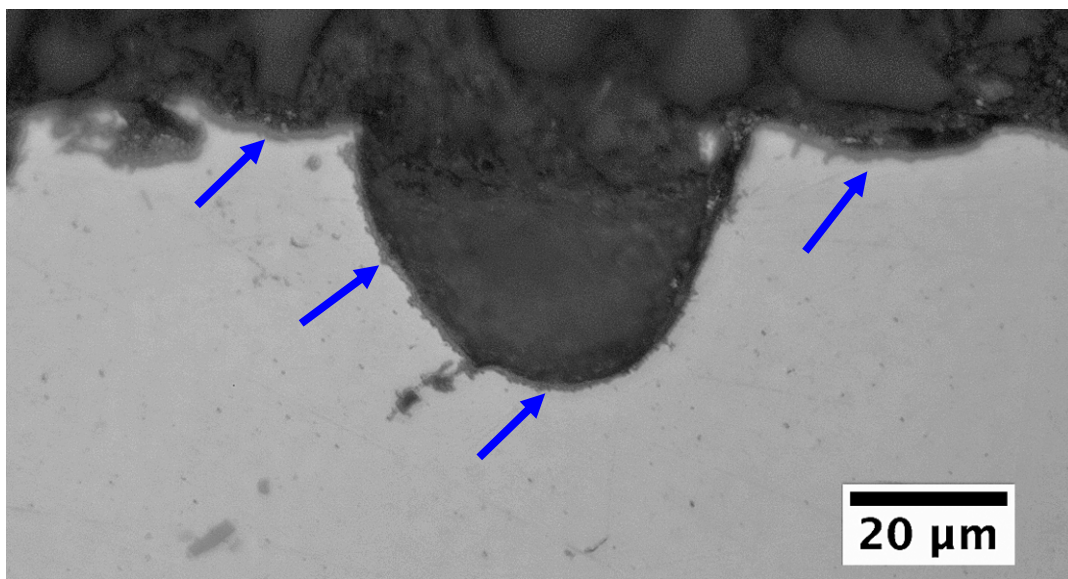
Figure 26. Micrograph of a rescue hoist arm in cross-section showing the presence of an anodised layer on the surface of the component and within the etch pits, as indicated with blue arrows.

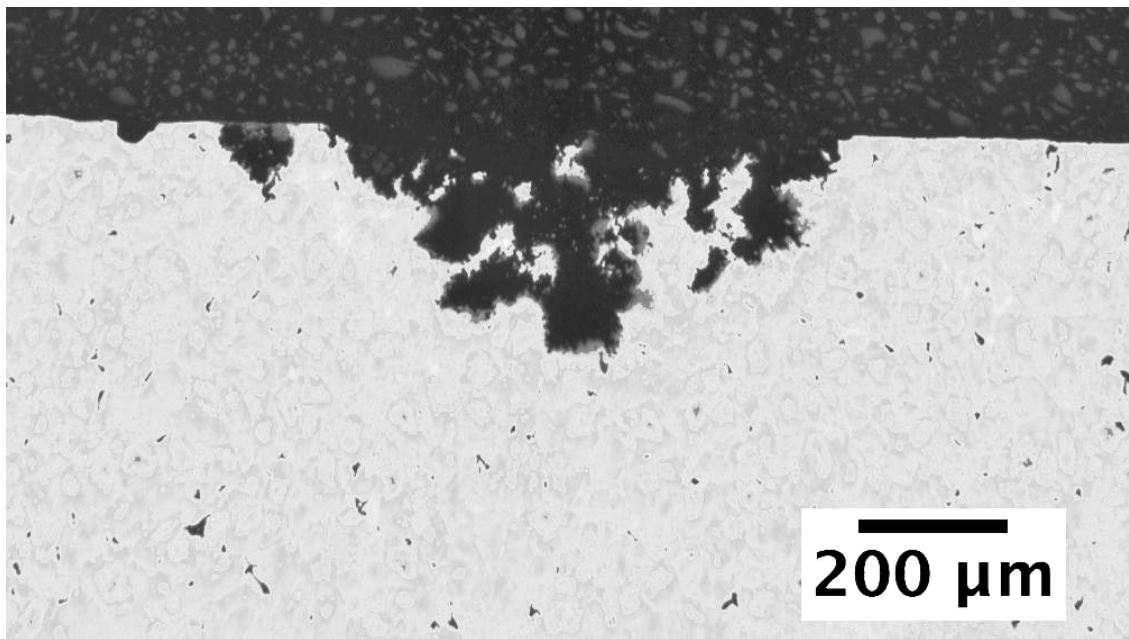
Figure 27. Micrograph of a rescue hoist arm in cross-section showing the corrosion pits had a branched and irregular structure.
