Report No. DODIG-2012-132 September 14, 2012

# Inspector General

## Project Planning Resulted in Outstanding Building Deficiencies and Decreased Functionality of the Main Fire Station at Naval Station Great Lakes

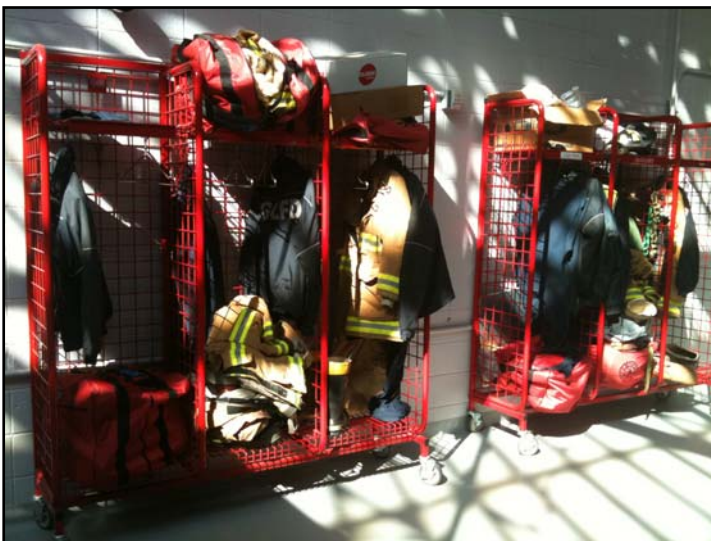
**Figure 2. PPE in Stored in Open Bay and Exposed to Direct Sunlight After the Renovation**

The storage area for PPE in the fire station did not comply with the manufacturer's requirements for storage and maintenance of equipment or the UFC for Fire Stations, which increased the firefighters' risk of injury. PPE, which includes protective garments worn by firefighters, was designed to protect individuals against health and safety hazards. According to the Fire and Emergency Manufacturers and Services Association, Inc., exposure to direct sunlight will cause the materials in the protective ensemble to deteriorate, and proper storage of the PPE can extend its life, maintain its performance, and reduce potential health hazards. The manufacturer for the PPE worn by Great Lakes firefighters stated that improper storage may result in damaged PPE and could increase the risk of death, burns, injuries, diseases, and illnesses. The UFC for Fire Stations

the storage area for firefighters' PPE was relocated to open areas in the apparatus bay, where the PPE was directly exposed to sunlight, as shown in Figure 2. Therefore, to meet the UFC for Fire Stations and the manufacturer's guidelines for proper care, and prevent increased risks to the health and safety of the firefighters, the PPE should be in a negatively pressurized room with a dedicated exhaust system vented outside.

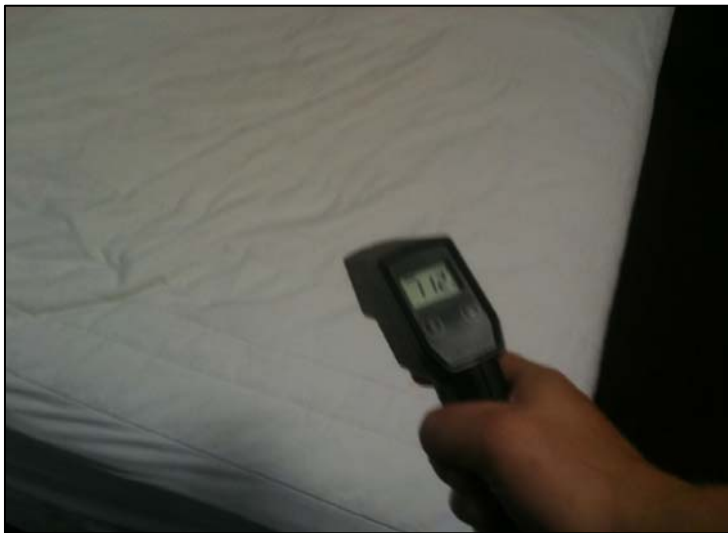
**Figure 4. Temperature Inside a Dorm Room Exceeded 100 Degrees Fahrenheit**

*Firefighters stated that during the winter, temperatures inside the dorm rooms reached 55 degrees Fahrenheit and, during the summer, temperatures reached 112 degrees Fahrenheit...*

112 degrees Fahrenheit, as shown in Figure 4. Before the renovation, a radiator regulated the temperature in the fire station. After the renovation, the dorm rooms had a centralized thermostat control, but problems with the heating and air conditioning made the rooms extremely uncomfortable and almost uninhabitable. When firefighters respond to emergency calls, their ability to perform their work is directly tied to how rested they are. Living conditions in the fire station did not provide a comfortable and relaxing environment, which may affect the performance of the firefighters when responding to emergencies. According to the Naval Station Great Lakes Fire Chief, NAVFAC Midwest and the contractor repaired the condenser, condenser fan, and computer board for the HVAC system. Additionally, NAVFAC Midwest officials and the contractor verified temperature readings in September 2011. However, according to the Naval Station Great Lakes Deputy Fire Chief, as of April 2, 2012, neither the contractor nor NAVFAC Midwest corrected the HVAC issues. The Deputy Fire Chief stated that firefighters continue to experience problems with the temperatures throughout the fire station. On April 11, 2012, NAVFAC Midwest officials stated that they would work with the Great Lakes Fire Department to address the temperature issues in the dorm rooms.

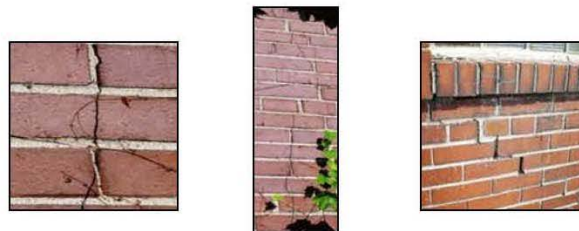
## Preliminary Results: West Exterior Wall Cracks

*As of August 26, 2011, the audit team observed vertical cracks on the west exterior brick wall.*

- The Phase II Technical Proposal, Factor 2, Exterior Architectural Elements, states that for Exterior Masonry Walls, "the exterior brick and masonry façade, parapet wall and coping requires some maintenance consisting of tuck pointing and the repair of vertical cracks and water infiltration."
