SIGAR Inspection – 13-1

## KUNDUZ ANA GARRISON: ARMY CORPS OF ENGINEERS RELEASED DYNCORP OF ALL CONTRACTUAL OBLIGATIONS DESPITE POOR PERFORMANCE AND STRUCTURAL FAILURES

OCTOBER  
2012

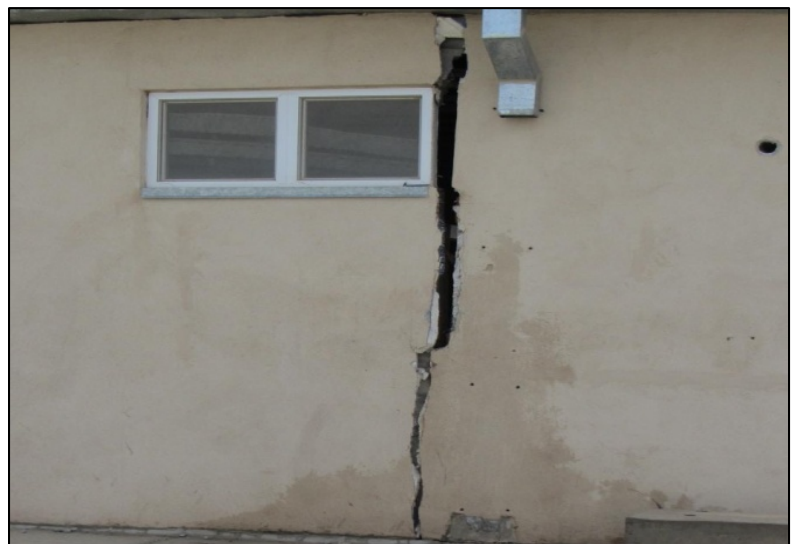
Exterior Structural Failure, Building 603 (latrine), Kunduz Army Garrison, March 2012

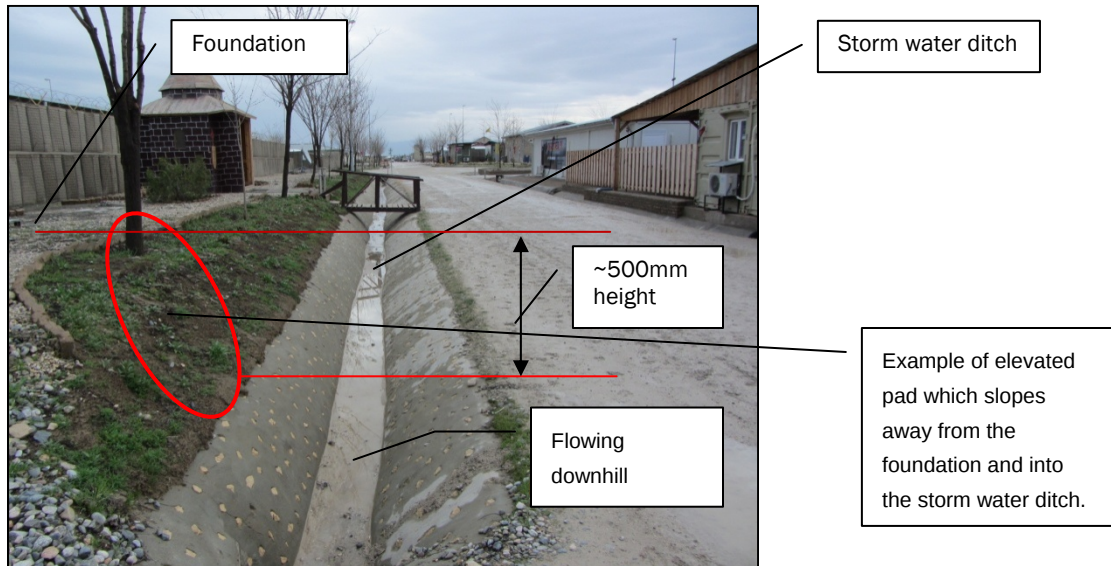
**Figure 1 - Kunduz PRT March 2012 with Elevated Building Pad and Positive Drainage System**

Figure 1 illustrates a typical drainage channel and elevated building pad at the Kunduz PRT.

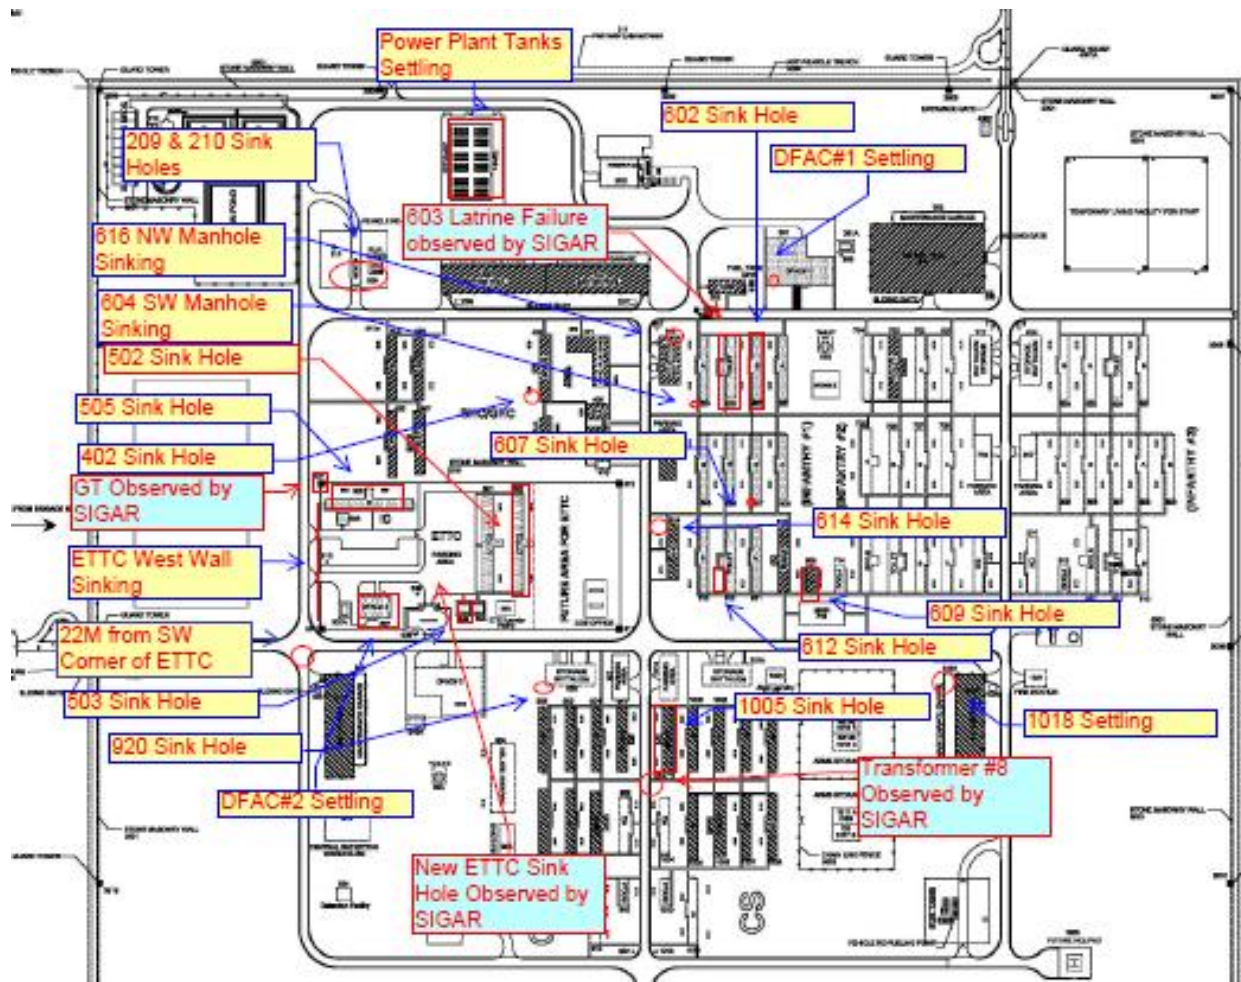
**Figure 2 - SIGAR Analysis of Historical Sink Holes and Structural Failures**

Soil instability continues to cause sink holes and structural failures at Camp Pamir, as can be seen in figure 2. Based on our review of data provided by USACE-TAN, we have noted sink holes and structural failures over a 2-year period, highlighted in yellow. We also noted our observations from the site visit on March 25, 2012, highlighted in blue. These included new sink holes occurring at various locations, including the ETTC. During the site visit, we also observed structural failures at transformer 8 and building 603 (latrine), and noted that building 604 (barracks) was visibly beginning to settle.

Source: USACE-TAN, Kunduz ANA-Master Plan phase II, submitted by DynCorp on September 28, 2008. Note: We highlighted sink holes and structural failures discussed in Q-01 QA Daily Reports (0033) and SIGAR Record of Site Visit to Kunduz, Camp Pamir. Yellow background callouts are sourced from historical QARs over a 2-year period. Blue background callouts indicate areas observed during the March 25, 2012 site inspection.

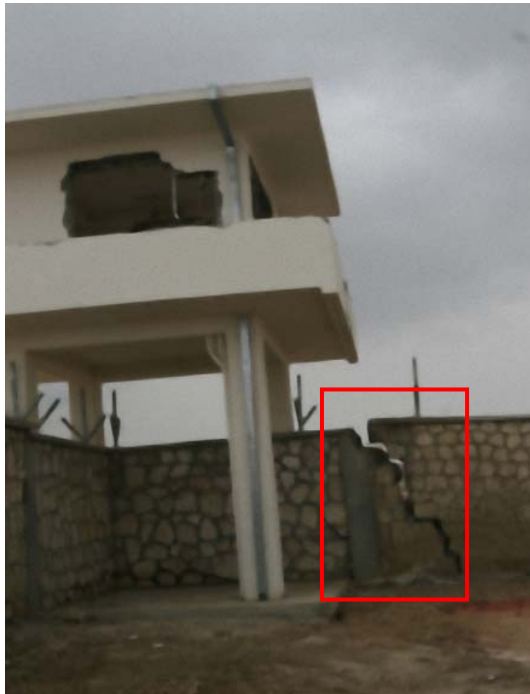
Figure 3 - Guard Tower and Wall, January 2010

In April 2010,<sup>8</sup> we reported that several structures (see figure 3) had failed<sup>9</sup> following a December 2009 rainfall. We also observed severe settling and improper soil grading and noted that the probable cause for the settling was lack of adequate site preparation. We reported that the soil at the site appeared to have the characteristics of collapsible soil—loose, dry, low-density materials that collapse and compact if exposed to water. According to USACE-TAN documentation and SIGAR analysis, the sinkholes appeared after DynCorp mobilized onsite and began removing a half meter of topsoil, thereby changing localized drainage patterns.

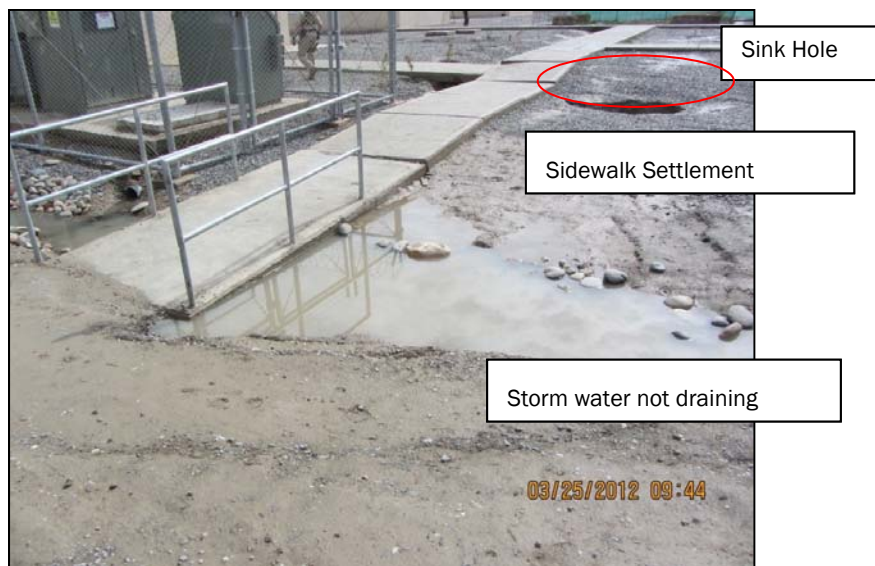
Figure 5 - Soil Failure around Transformer 8

During the March 25, 2012 inspection, we observed a sink hole developing and general structural settling around transformer 8 due to collapsible soil conditions.<sup>19</sup> As a result, the transformer concrete pad is at risk of structural failure. Failure of this transformer would result in a loss of electrical power over a large portion of Camp Pamir, causing significant financial loss and increasing the risk of injury through fire and electrical shock. The location of transformer 8 is noted in figure 2. Figure 5 shows the area surrounding transformer 8 and some of the problems that we observed, including a sink hole, sidewalk settlement, and standing storm water.

<sup>19</sup> In its response to this report, USACE-TAN stated that it has submitted a basic contract change to ANA Kunduz Garrison Utility Upgrade (W5J9JE-12-C-0021) to Omran Holding Group to repair the referenced sinkhole.

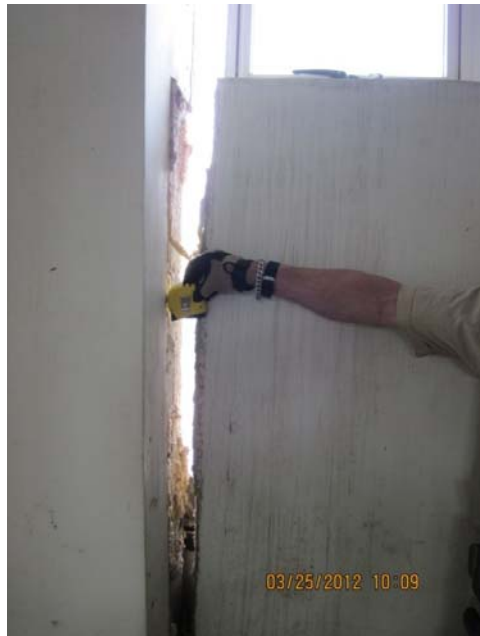
**Figure 6 - Interior of Building 603**

During our inspection on March 25, 2012, we observed that building 603 (latrine)<sup>20</sup> was unusable due to structural failure because of soil subsidence.<sup>21</sup> We also noted that building 604 (barracks)<sup>22</sup> adjacent to the latrine was beginning to settle and was at risk of failure. USACE-TAN officials attributed the structural failure to water infiltrating into the soil underneath the building. The location of these facilities is noted in figure 2. Figures 6 and 7 are examples of wall separation, both inside and outside building 603.

<sup>20</sup> In its response to this report, USACE-TAN stated that a replacement latrine is included in a modification to contract W5J9JE-11-C-0076, Biltek, Garrison Expansion (phase III) project.

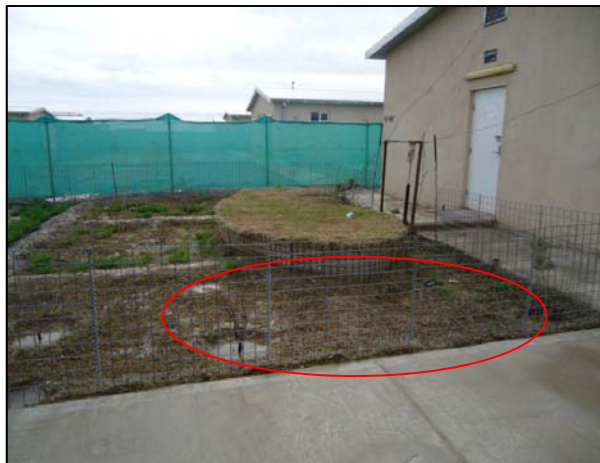
**Figure 8 - Improper Grading and Landscaping**

During our site inspection on March 25, 2012, we observed improper landscaping and site grading, which further exacerbated the impact of collapsible soil conditions at Camp Pamir. In accordance with the contract technical requirements, DynCorp was to design and provide landscaping for the compound and provide grading around facilities to slope away from all sides of the buildings at a minimum of 3 percent for 3 meters. We did

not observe any contractor-installed landscaping or graded sloping away from buildings.<sup>23</sup> The lack of adequate landscaping, along with improper grading, enables water to infiltrate under buildings and camp facilities, placing extra loading on the collapsible soil and further contributing to soil subsidence and structural failures.

<sup>23</sup> In its response to this report, USACE-TAN stated that it is addressing the drainage issues through the ANA Building Repair contract (W5J9JE-12-C-0031). It further noted its contractor will extend concrete aprons around the perimeters of 61 buildings to a minimum slope of 0.5 percent and a distance of 1.5 meters away from the building foundation.

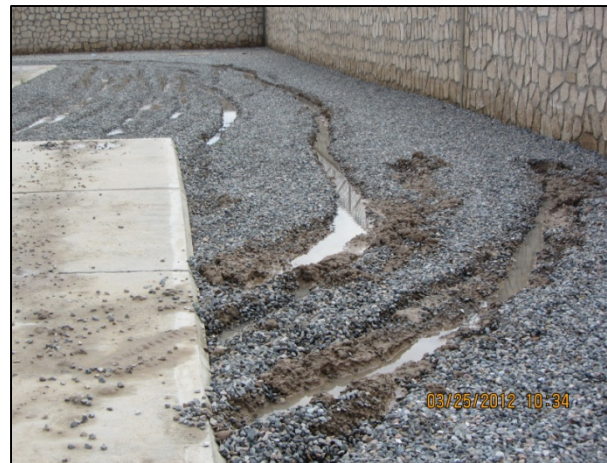
**Figure 9 - Ruts from Off-Road Driving**

Sidewalks were also not built in accordance with contractual specifications, which required them to be wide enough to be used as fire lanes and service roads for vehicle access close to camp facilities. We noted off-road vehicle traffic and vehicle parking adjacent to camp facilities instead of in authorized parking areas, which left deep ruts in the soil. Shipping containers were placed in improper locations as well. These practices, along with the relatively flat terrain and improper grading, further contribute to soil subsidence and structural failures by putting extra loading on the soil and allowing water to infiltrate under building foundations.

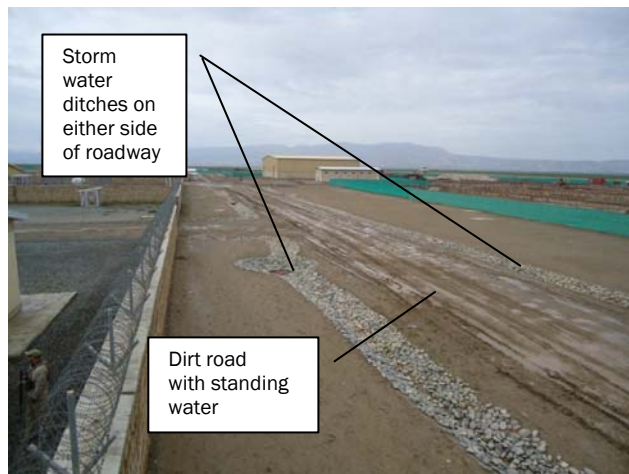
**Figure 10 - Standing Water on Road Indicating that Water is Not Draining into Storm Water Ditches as Designed**

appropriate road grading, water accumulated on the road surfaces and drainage channel, indicating improper drainage. Figure 10 illustrates standing water on one of the road surfaces.
